Fault Tree Analysis Method for Deterioration of Timber Bridges using an Australian case study

This paper identifies common causes for timber bridge deterioration and demonstrates an integrated approach based on fault tree analysis (FTA) to obtain qualitative or quantitative estimation of the risk of failure of timber bridge sub-systems. Level 2 inspection report for a timber bridge in Queensland, Australia has been utilized as a case study in this research to identify the failure modes of the bridge.

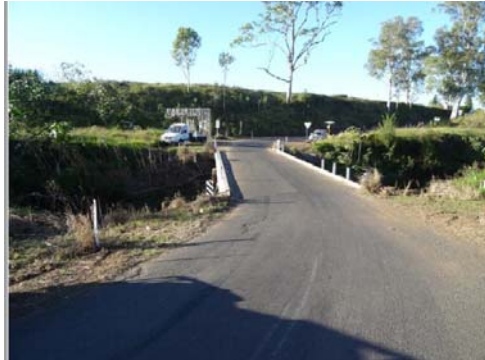
Strategies for the selection of a case study has been researched in the past (Flyvbjerg 2006). It is important to select a critical case study which gives the information needed to complete at least one sub tree of the fault tree diagram for timber bridges. From the several timber bridge inspection records, the selected case study is the Middleton's Bridge crossing Lockyer Creek on the Lockrose Road North in Lockyer Valley Regional Council area in Queensland, Australia (Figure 1). It is a two span, single lane timber Girder Bridge with an overall length of 19.35 m, a width of 5.48 m and a load limit of 35 tons. The superstructure was made up of hardwood timber curb and hardwood timber deck planks installed transversely, supported by five timber girders, corbels at the piers and two timber headstocks at the abutments and pier. The substructure is made up of four timber piles and eight timber wales/bracings. The bridge is about 20 degrees skew to the road alignment. Both approaches are bitumen sealed.

Figure 1: Middleton's Bridge

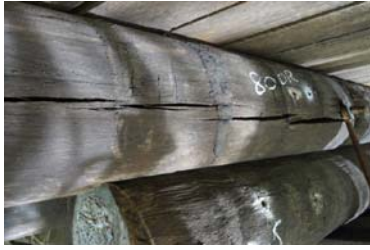
(a) Splitting (girder with a fastener)

The condition of each element of the bridge is rated using four condition states where condition state 1 is the best and condition state 4 is the worst (MainRoads-Queensland 2004). Figure 2 shows some selected photos to demonstrate the failure modes of structural members of this bridge.

Out of all different types of deterioration for the case study timber bridge, splitting and snipping of girders is the most common mode (Figure 2 and Table 1). It can be due to various events such as shrinkage of green timber element, changed cross section and snipping initiated due to notches and fasteners and spread due to overloading. Figure 5 illustrates the fault tree for the splitting of timber bridge stringers.

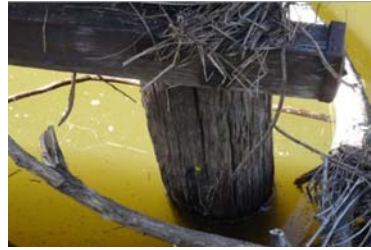
(b) Vertical splitting (pile)

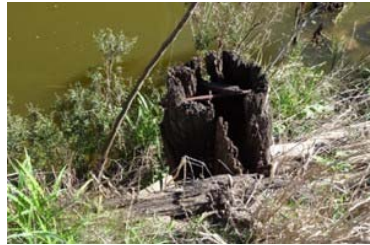
(c) Severe rot and pipe (wingwall pile)

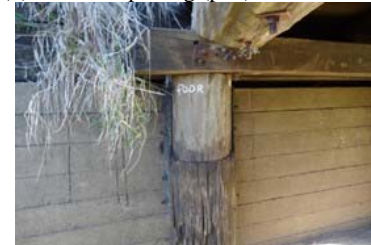
(d) Incorrect splice (abutment)

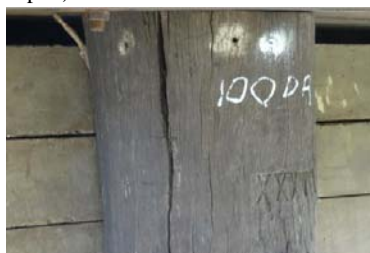
(e) Vertical splitting (overloading-top of pile)

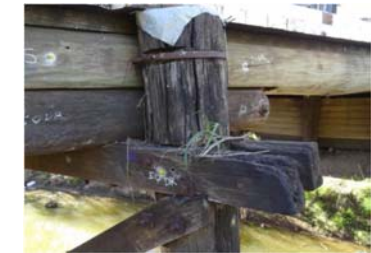
(f) Vertical splitting (changed section-top of pile)

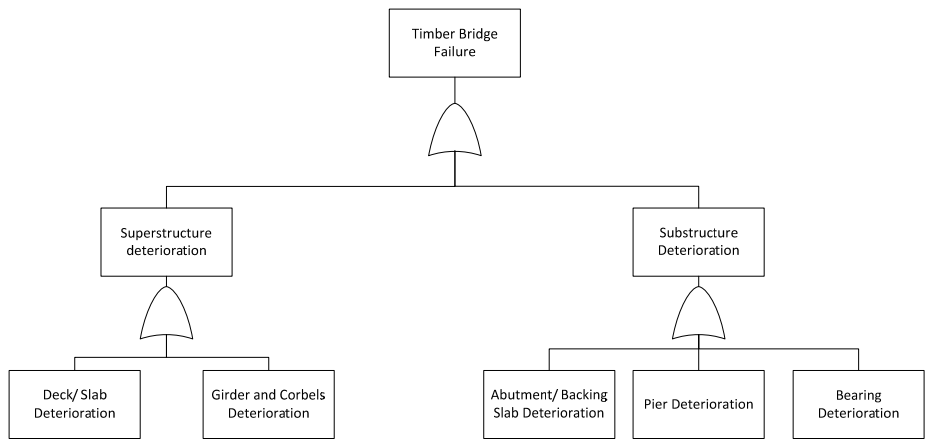
Based on the observations from the case study bridge (Table 1, 2 and Figure 2) and the available literature (Austroads 2009; Bootle 1983; Mainroads 2014), the top level of a fault tree diagram for a timber bridge was developed as shown in Figure 3. The main event, timber bridge failure can be triggered because of either the superstructure or substructure deterioration. Each of the basic events is connected to the main event using OR gate because the output event occurs if any one of the input events occurs.

Figure 3: Top level fault tree frame

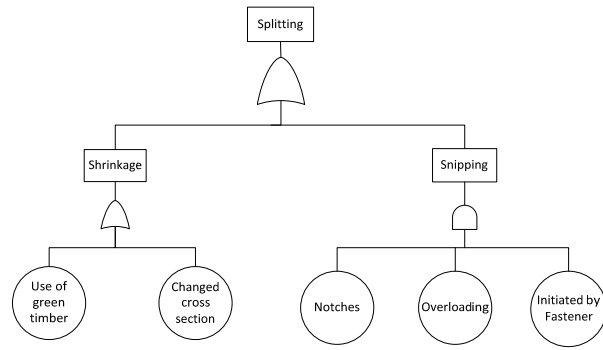
Figure 5: Fault tree for Splitting Failure

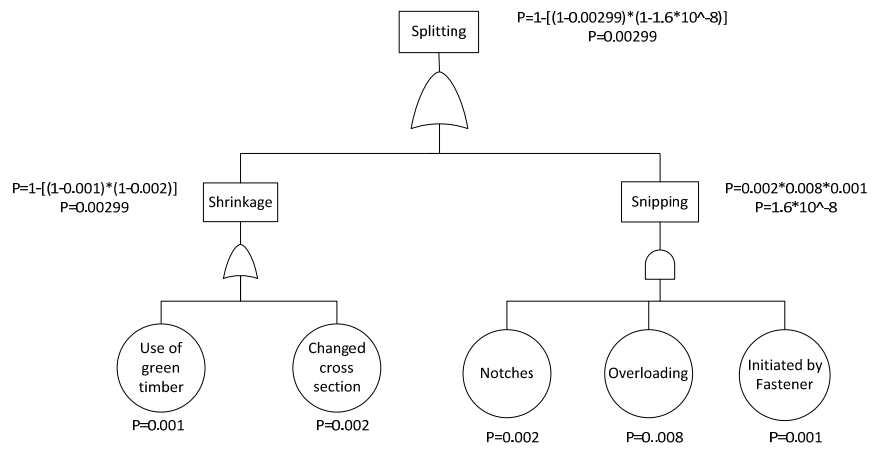
Splitting branch of the FTA for timber bridge deterioration is demonstrated using assumed probabilities for basic events (Figure 6). For example, it was assumed that the probability of having a changed cross section for a member is 0.002 and that for using a green timber is 0.001. Either the use of green timber or changed cross section will lead to shrinkage. Hence an OR gate (Equation 2) is used to link these 2 basic event to the shrinkage. The same approach was used to find the snipping probability (Equation 1) and ultimate probability of splitting (Equation 2) to be 0.00299 (Figure 6). This is the probability that can be used for splitting in Figure 4.

Figure 6: Application of the method for splitting branch of FTA

Similar approach can be used to establish the probability of failure due to other causes such as fungal attack, termite attack etc in Figure 4. If the probability of these causes is assumed to be equal to that of splitting (0.00299) then if timber deterioration occurs when 2 out of 6 causes occur, then the probability of timber deterioration can be calculated as, $P = 1 - (1 - 0.00299^2)^6 = 0.0000536$. This is the probability for timber deterioration in Figure 4. The bottom events of Figure 3 are all related to timber deterioration though these values may differ from one another. If it is assumed to be the same as 0.0000536, then the probability of substructure and superstructure damage will be 0.00016079 and 0.00010728 respectively. Hence the probability of failure of the bridge will be 0.000268.
