**APPLICATIONS OF NEW THERMOPLASTIC CFRP REBARS AND
MECHANICALLY ANCHORED
CARBON FIBRE SHEETS IN REINFORCING AND
STRENGTHENING CONCRETE BEAMS**

A Thesis

Building, Civil, and Environmental Engineering

Concordia University

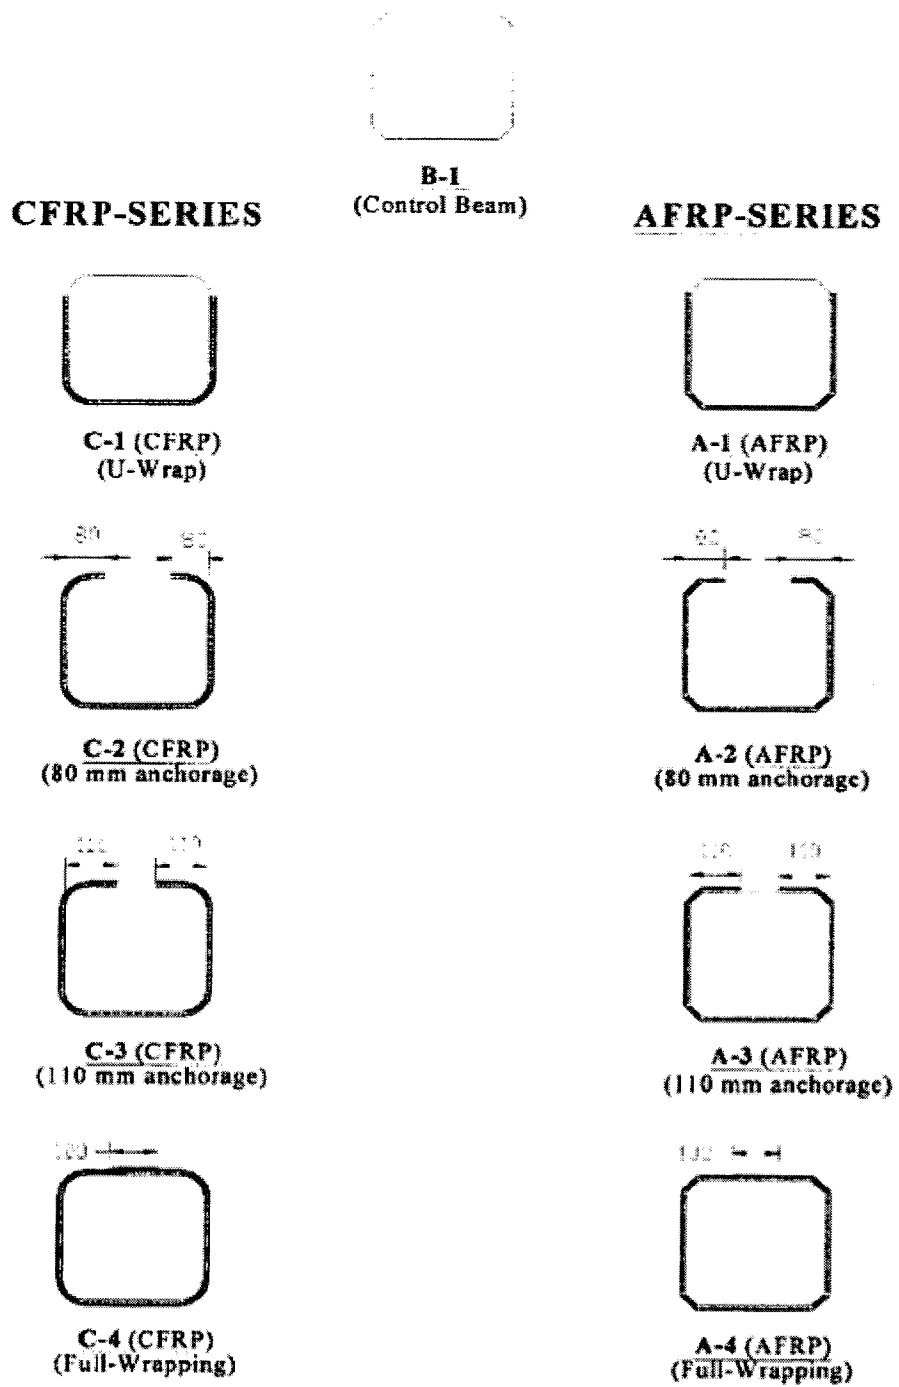
Figure 2.8 Strengthening schemes tested by (Adhikary et al., 2004)

configurations are shown in Figure 2.8. It was found that the proposed bonded anchorage method was more effective than the U-jackets method. Moreover, the interface bond strength was reduced and the strain in the FRP sheets was increase allowing the beam to fail at higher shear strengths.

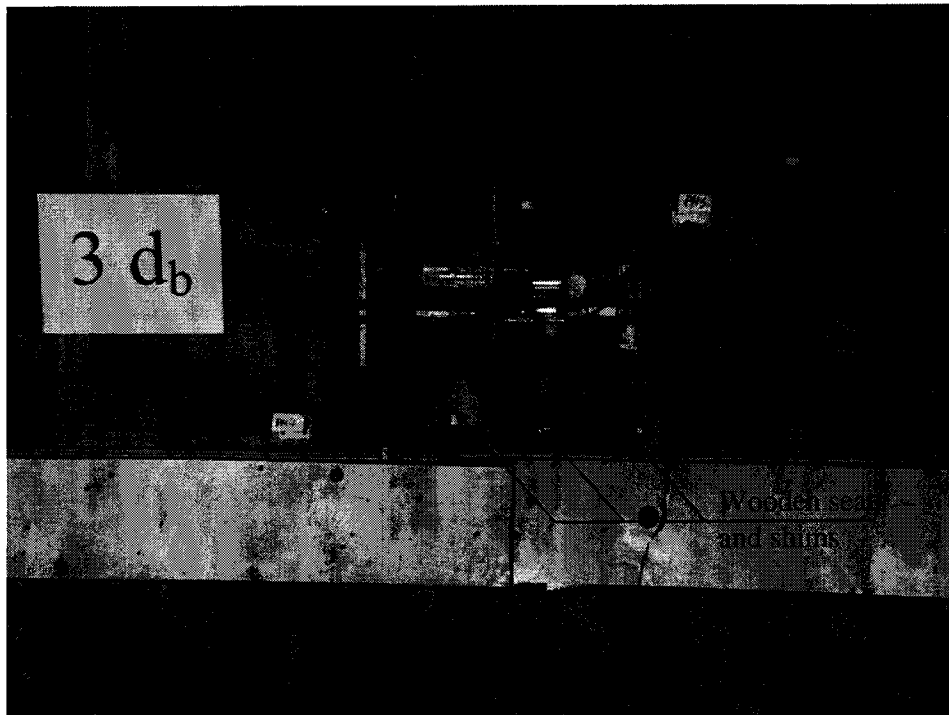
Figure 3.15 Bent bars and stirrups test setup

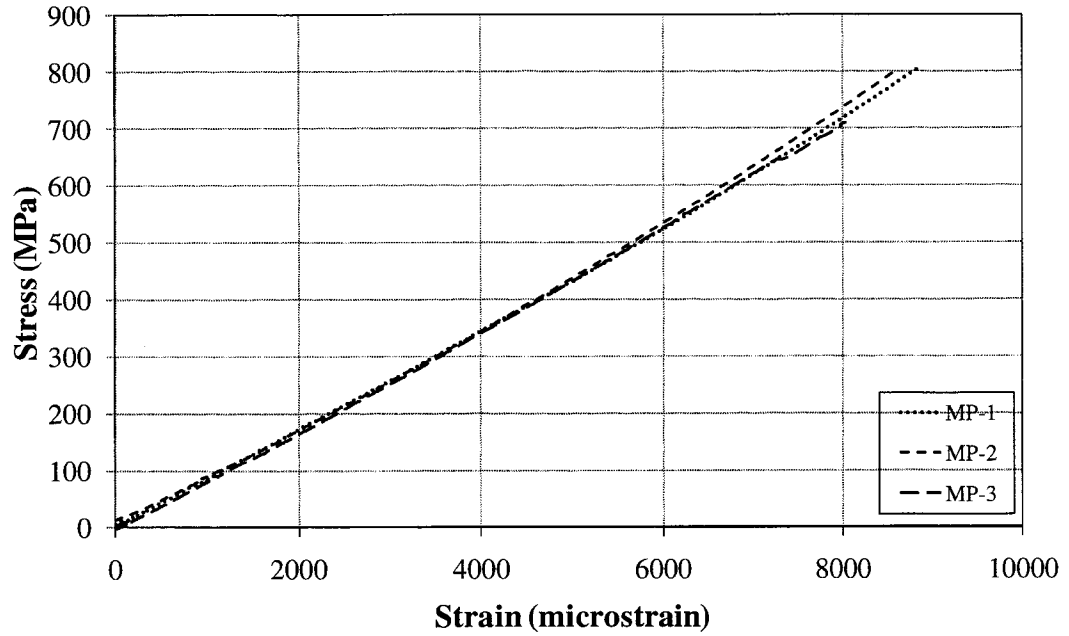
Figure 4.1 Stress-strain relationship of CFRP rebars tested in the mechanical properties test

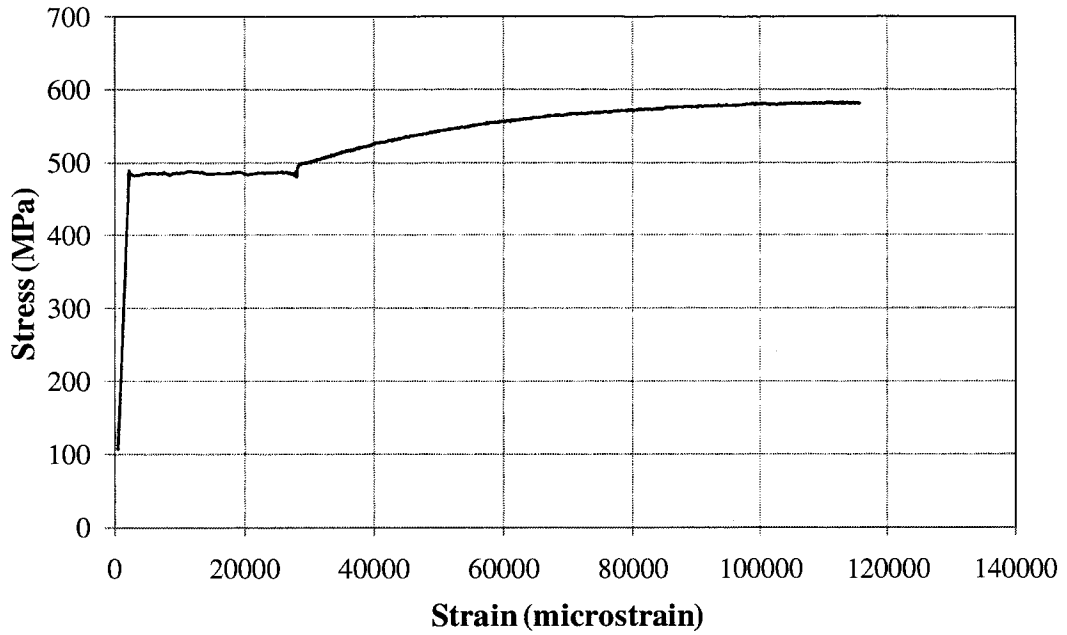
Figure 4.5 Stress-strain relationship of specimen PLS-30-1

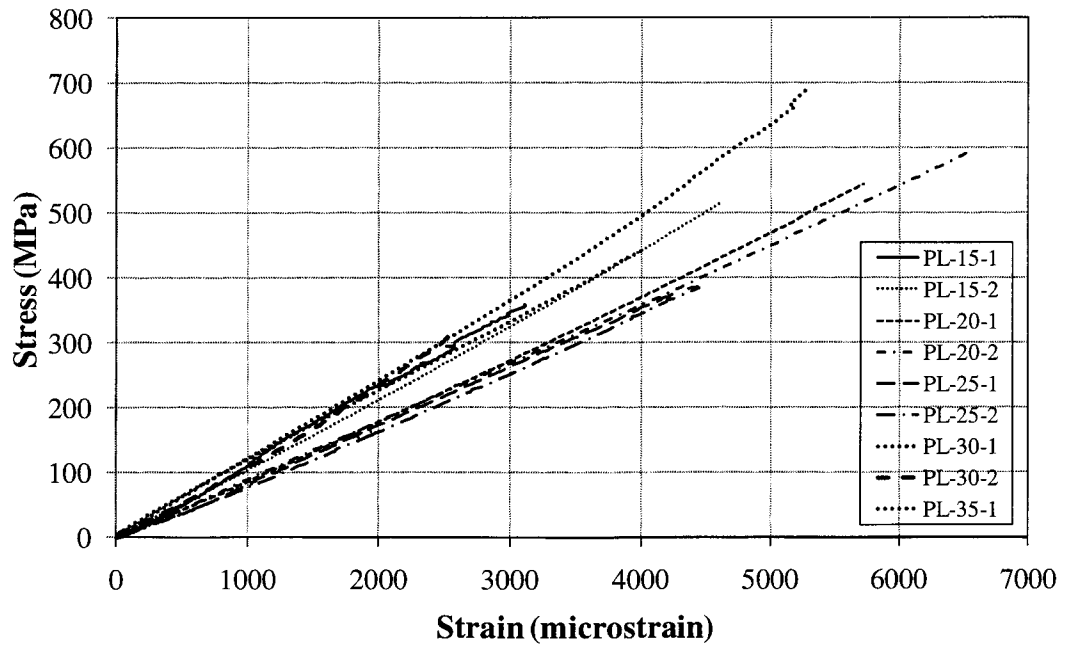
Figure 4.6 Stress-strain relationship of the CFRP rebars tested in the pullout and bond strength test

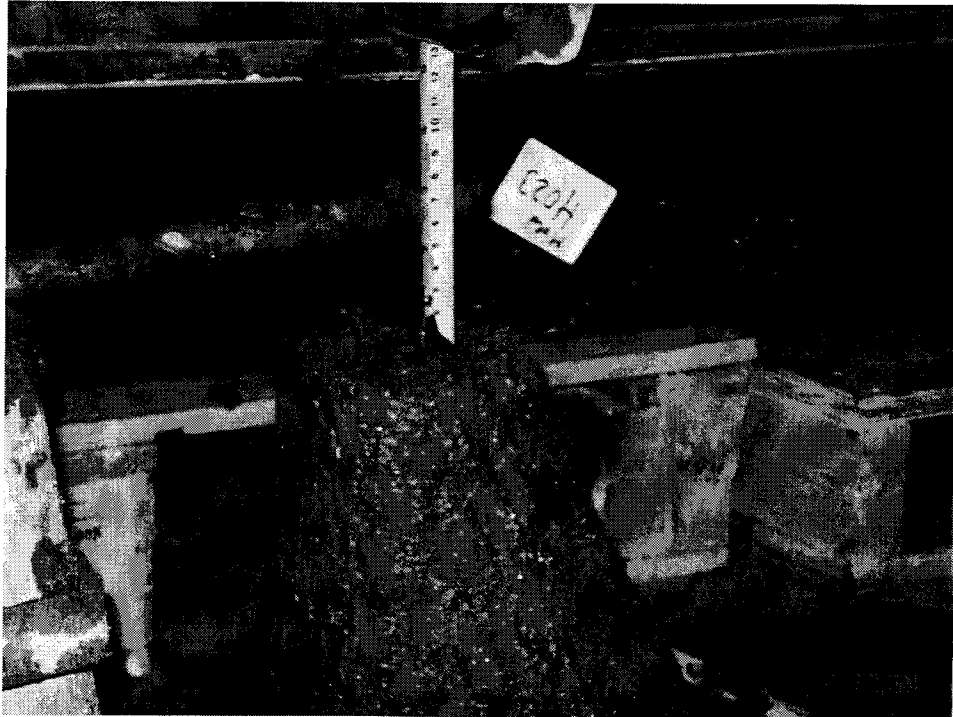
Figure 5.8 Slump test

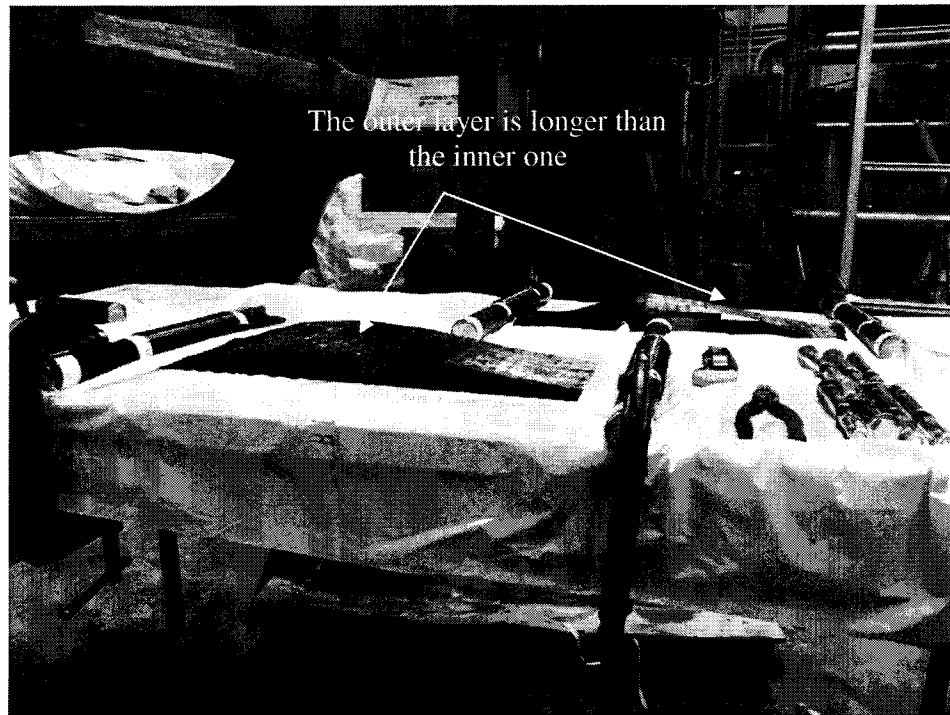
Figure 5.14 Anchor of beam B-2 while being manufactured

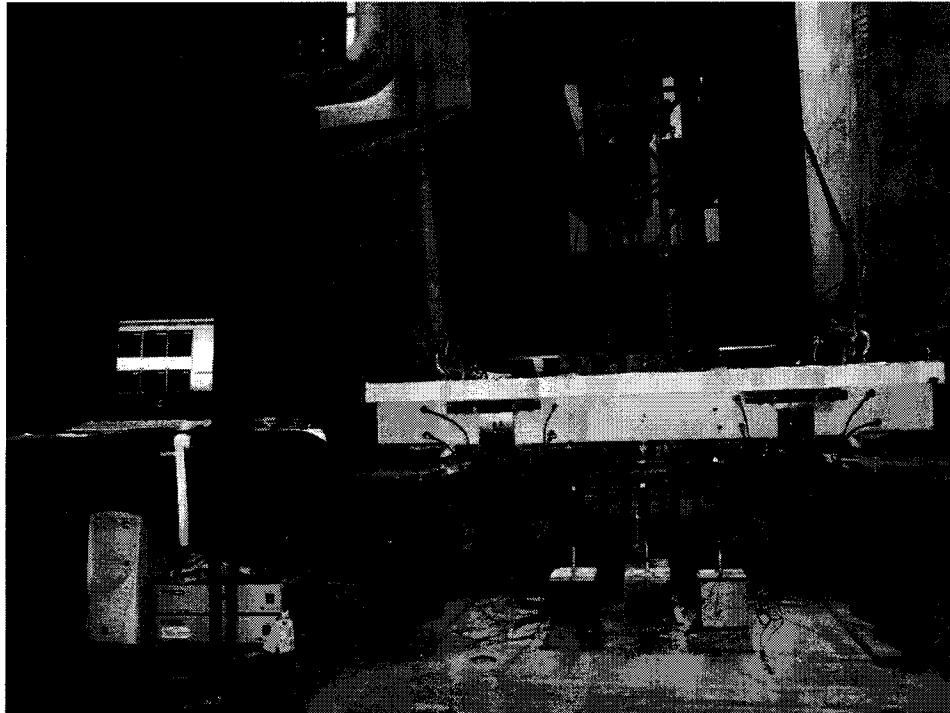
Figure 5.16 Test setup and strong reaction frame

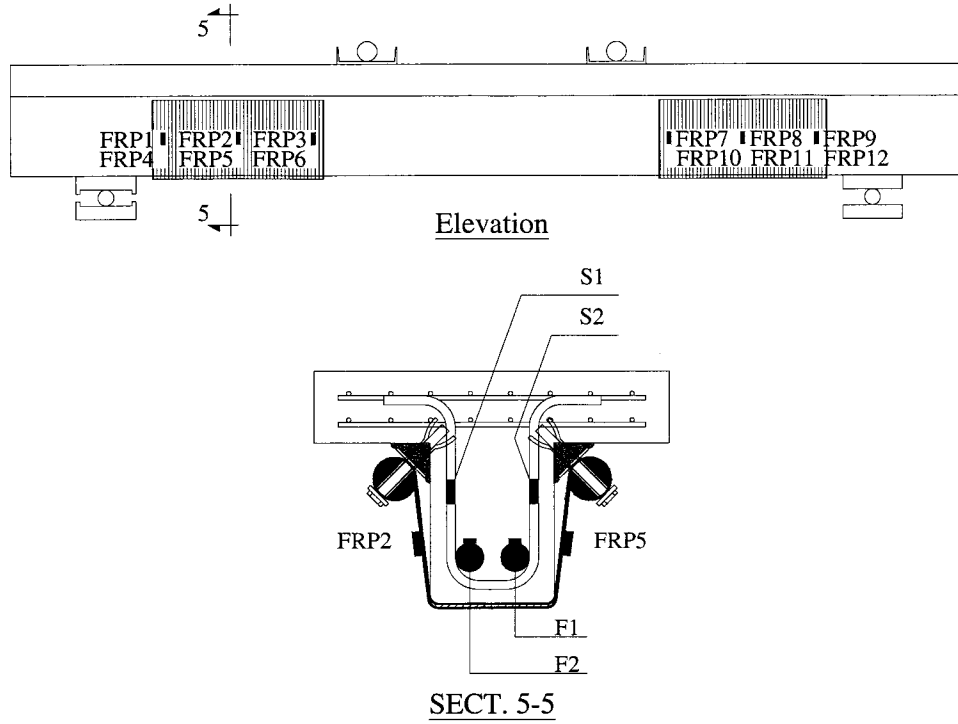
Figure 5.18 Instruments of beam B-1

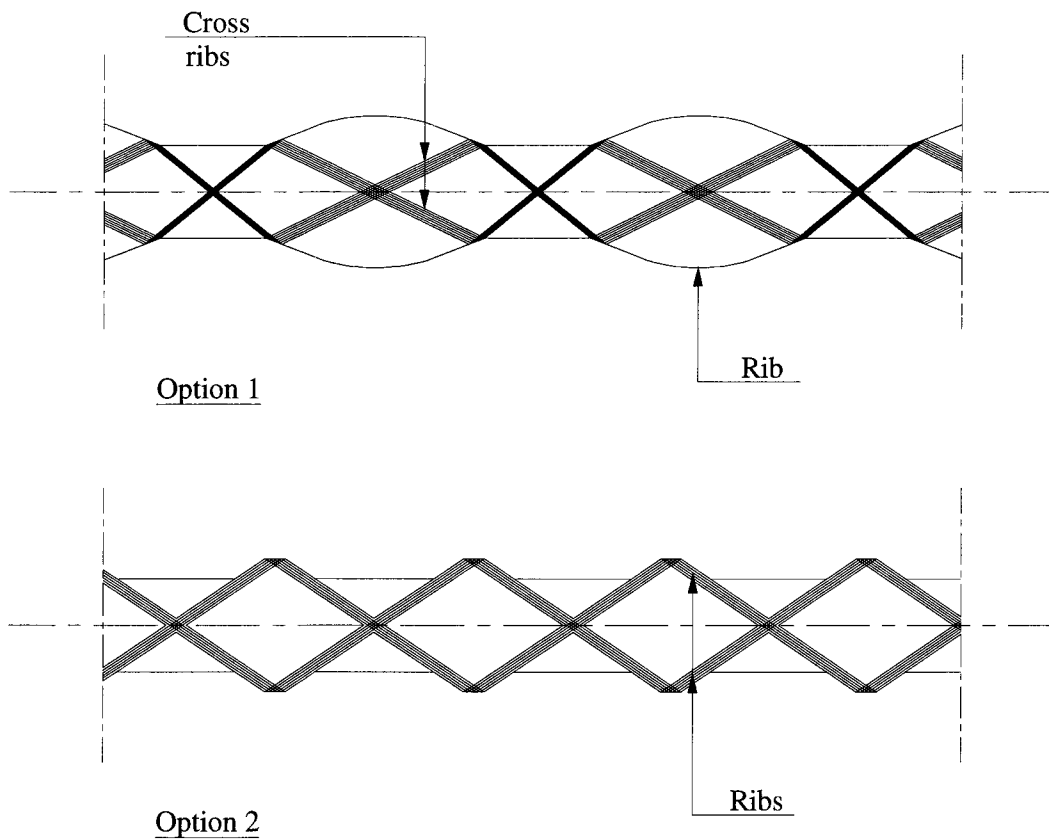
Figure 7.1 Recommended new design for CONCOM thermoplastic CFRP rebar

shown in Figure 8.1 (option1), additional fibres are needed to be wound around the rebar to reduce the splitting forces that exist due to the inclined fibres in the ellipsoidal ribs. This geometric design can be manufactured using the compression molding technique.

Another design could be used in manufacturing the rebars using the pultrusion technique. In this design the rebar will be pultruded in a circular cross section, then additional fibres are wound around the rebar to increase the bond stress of the rebar and to improve the strength of the bent rebars as shown in Figure 8.1 (option 2).

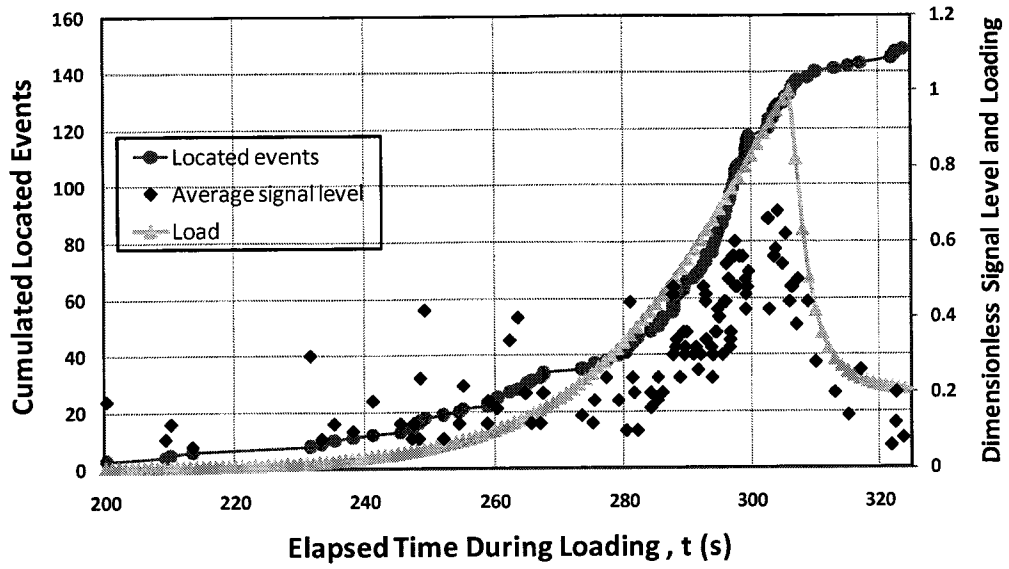
Figure A.3 AE activity of cylinder #3 (WINS, May 2009)

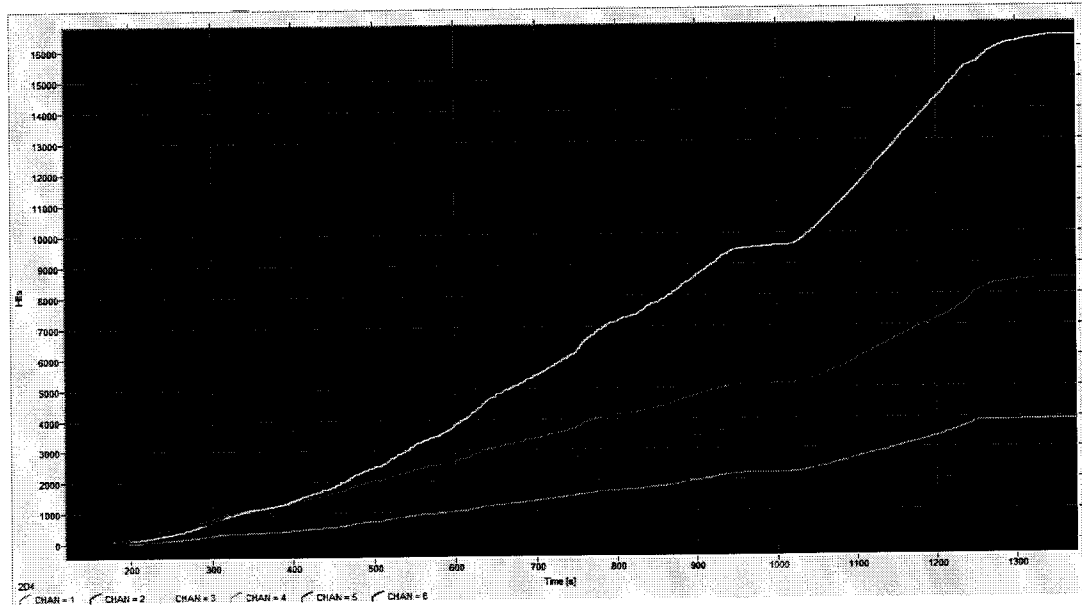
Figure A.8 Instantaneous hits on all channels versus time of beam B-0 (WINS, March 2009)
