Advanced Cyclic Accelerated Aging Testing of Solar Reflector Materials

SolarPACES 2018, Casablanca

The Raiselife Project

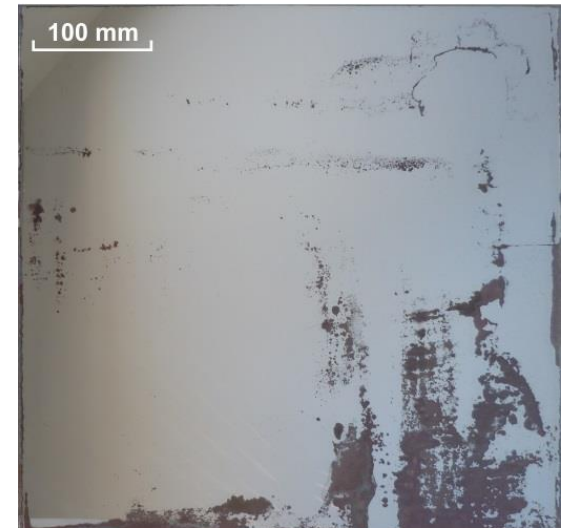
- Weak material analyzed in previous work
- Strong degradation outdoor
- After only 7 years of exposure
- **UNE tests** done, long testing times up 2000-3000 h
- **Degradation is not provoked**

- But backside degradation in UVH

- **Combined UVH & CASS** provokes corrosion silver layer

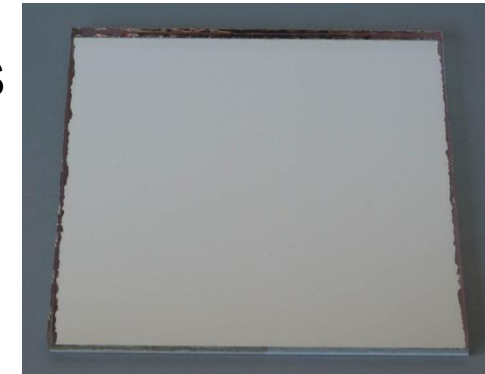
- 1000 h UVH followed by 480 h CASS produces corrosion in silver layer
- This result was reproduced for two further materials from old test campaigns
 - CASS only shows no/little corrosion
 - UVH + CASS provokes considerable corrosion

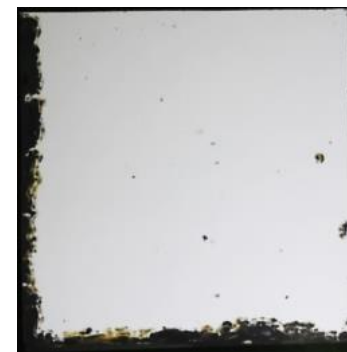
T2

- **UVH influence** on degradation seems to be **weak**
- **But** comparing
 - T2: CASS only
 - T4: UVH-CASS weekly cycles
 - T6: sequence UVH followed by CASS
- When only duration in CASS is considered T4 is the most aggressive one
- This influence was only detected in certain cases

ca. 500h CASS

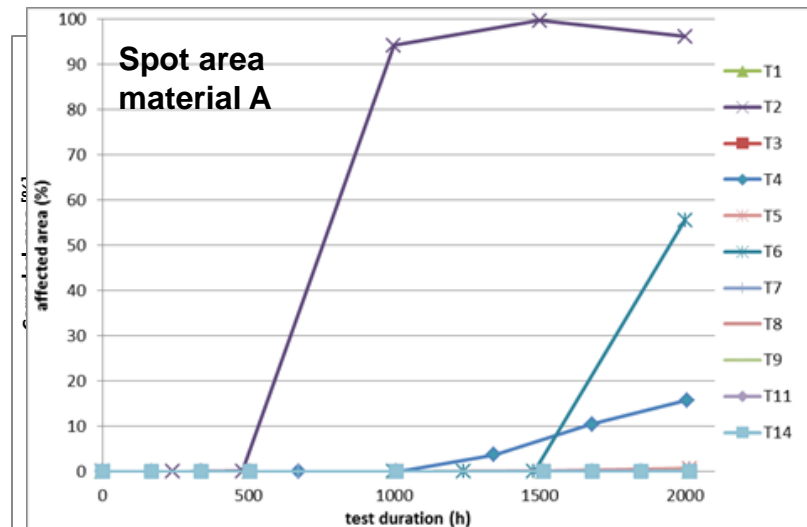
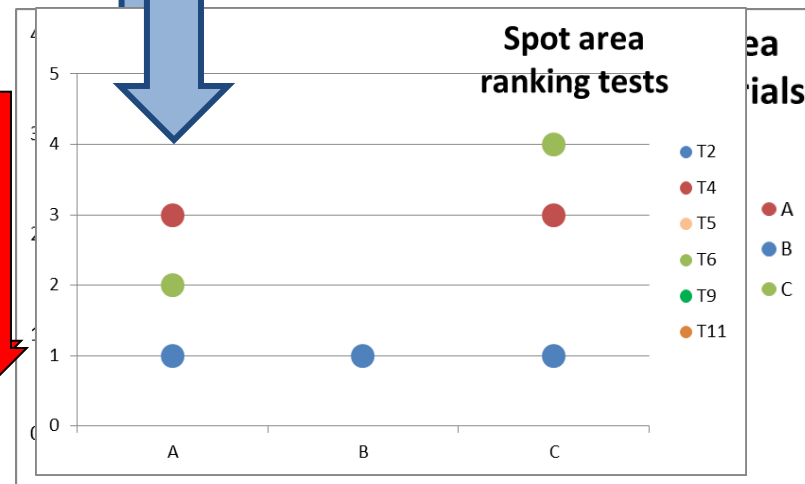
- Comparing parameter evolution of tests and materials

- Ranking of **test aggressiveness** and **material durability**
- Depends on analyzed parameter, only possible when sufficient degradation takes place
- Can be different for tests and materials

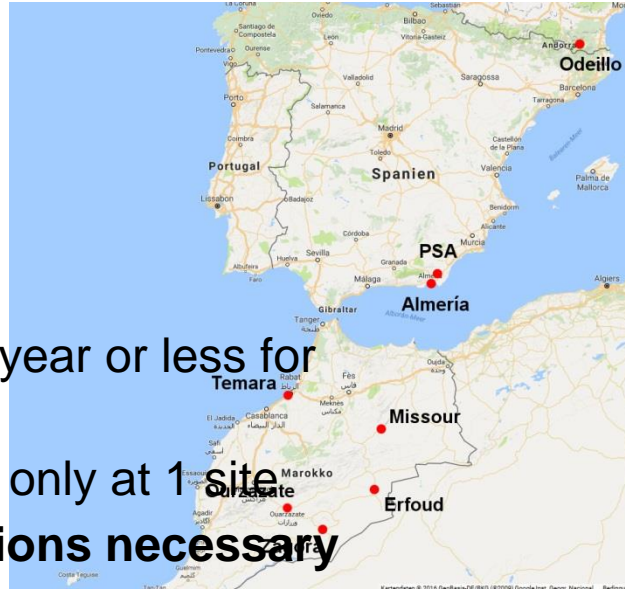
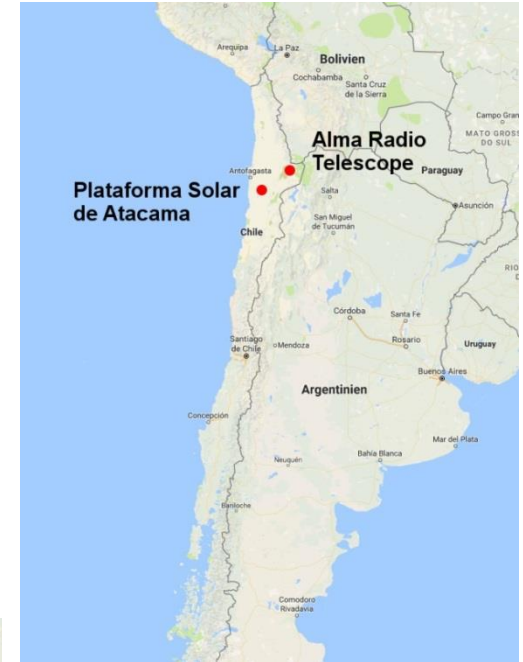
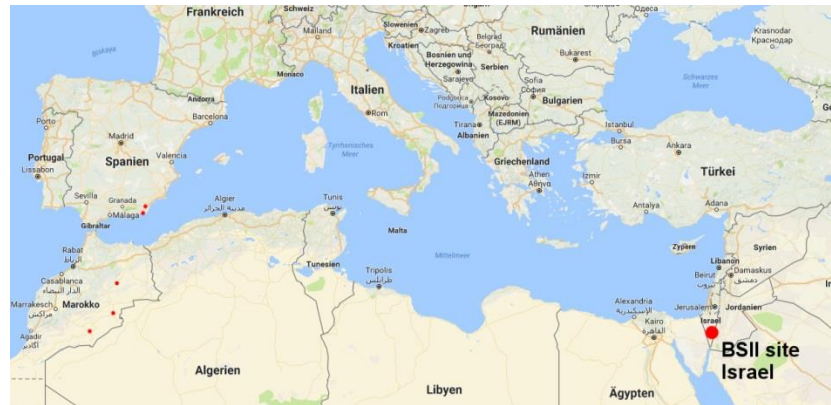
- Further analysis with outdoor data
- 11 sites available

- Exposure duration of 1 year or less for the analyzed materials
- Considerable corrosion only at 1 site
- **Longer outdoor durations necessary**
