## Review Article

# Head-Neck Taper Corrosion in Hip Arthroplasty

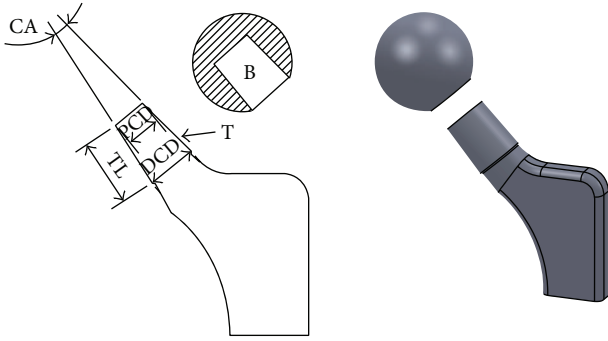
FIGURE 1: Diagrammatic representation of a femoral head-neck taper junction consisting of a female bore (B) and male trunnion (T). The trunnion length (TL), proximal cone diameter (PCD), distal cone diameter (DCD), and cone angle (CA) are displayed.

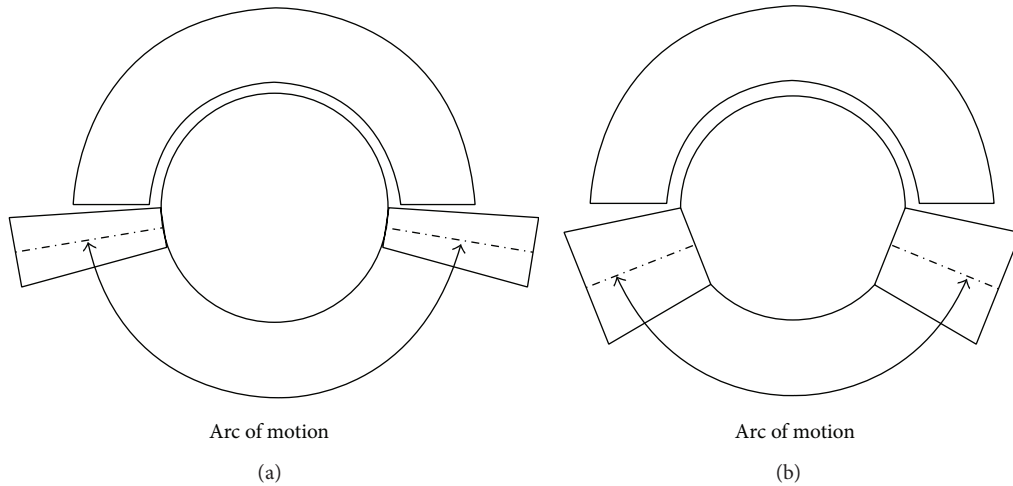
FIGURE 2: The effect of a long, thin taper junction (a) and a short, thick taper junction (b) on impingement and range of motion.

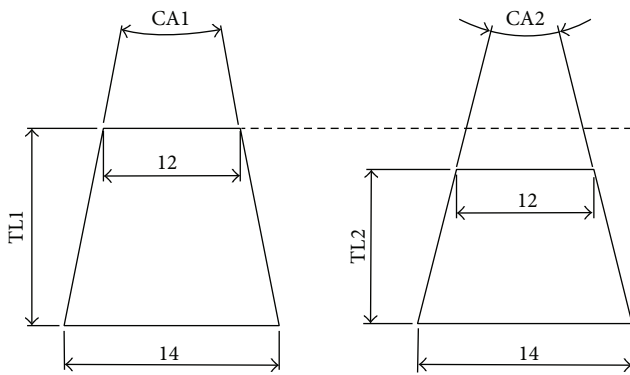
FIGURE 3: Illustration to demonstrate the effect that trunnion length has on cone angle with a constant proximal and distal diameter, for example, in a “12/14” taper. With increasing trunnion length ( $TL1 > TL2$ ), the cone angle decreases ( $CA1 < CA2$ ) assuming the proximal cone diameter and distal cone diameter remain constant.

Trunnions are now manufactured shorter in order to reduce the dislocation risk; with time, 14 mm/16 mm trunnions have been replaced by narrower 12 mm/14 mm trunnions [18]. An important concept to understand is that not all “12/14” tapers have the same cone angle, as the angle is also dependent on the trunnion length (Figure 3).

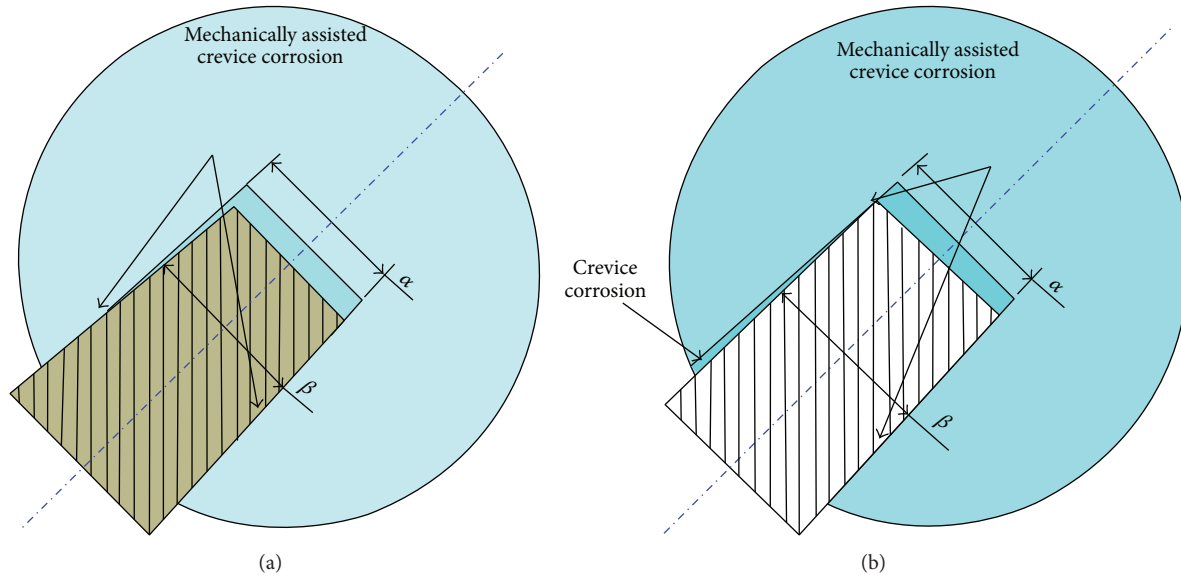
FIGURE 4: Mechanically assisted crevice corrosion in different scenarios of angular mismatch: (a) head angle,  $\alpha$ , greater than neck angle,  $\beta$ ; and (b) head angle,  $\alpha$ , less than neck angle,  $\beta$ ; crevice corrosion can potentially occur in this design due to the corrosive fluid present at the interface.

needs further investigation as there are theoretically increased risks of corrosion with angular mismatch (Figures 4(a) and 4(b)).

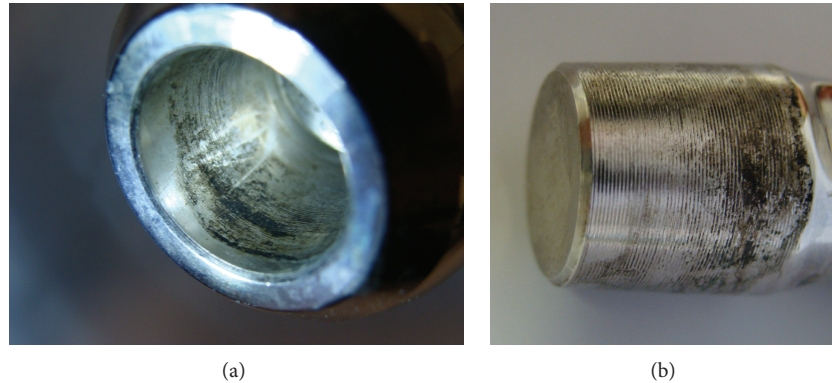
FIGURE 5: Fretting and corrosion damage on the (a) bore of a CoCr femoral head and (b) Ti-alloy trunnion from a retrieved failed metal-on-polyethylene THR.
