Dismantling and decontamination of large-sized radiation-contaminated equipment during Research Building B decommissioning at the Bochvar Institute site*

The article presents the results of work on dismantling the large installation equipment of Research Building B at the Bochvar High-technology Research Institute of Inorganic Materials (Bochvar Institute). The works were carried out as part of Building B preparation for decommissioning. The purpose of dismantling the large-sized capacitive equipment was to reconstruct the large installation site for managing radioactive waste generated during Building B decommissioning. The works on decommissioning a radioactively contaminated building within a densely populated district of megalopolis were carried out for the first time.

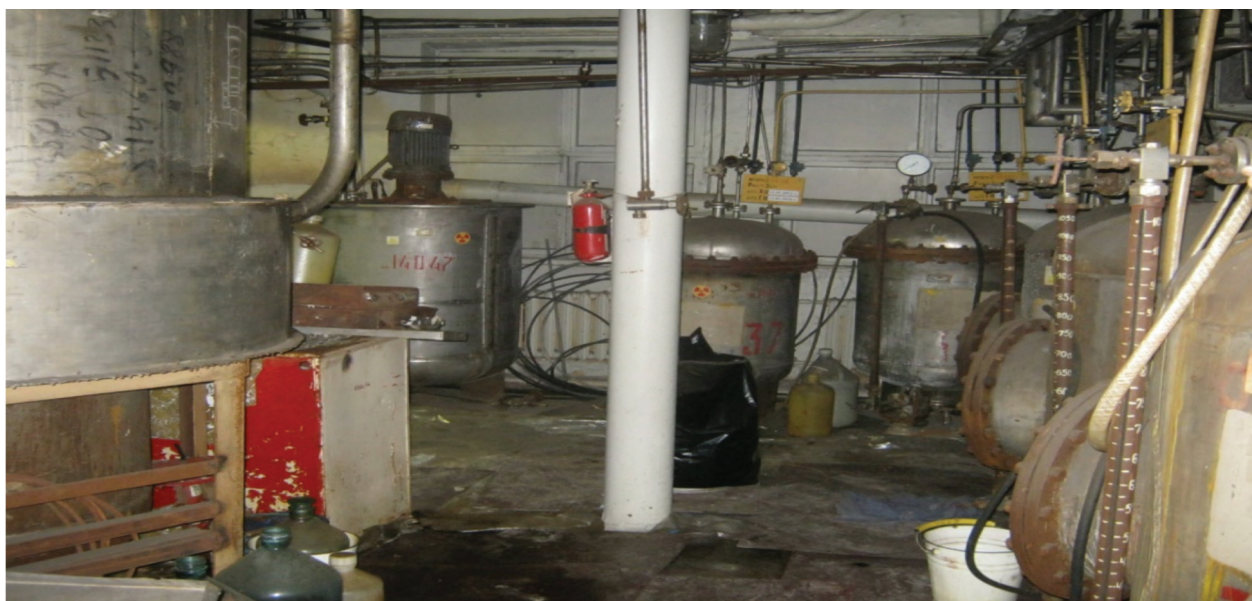
The radiochemical facility had four decks. The floor of the lowermost deck was concrete and the floors of upper deck were made of corrugated metal sheeting. The facility area on the lowermost deck floor is 138.6 m². The entrance to the facility was from the second deck. The main equipment of the facility included tanks, pumps, pipelines, receivers, pulsators, electrical appliances, and instrumentation and automated control systems (Fig. 1). A list and brief characteristics of the capacitive equipment are given in Tab. 1.

Figure 1. Radiochemical facility equipment.

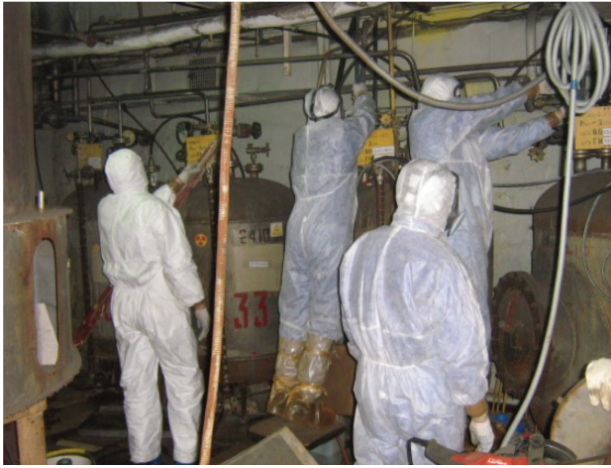
Before starting the main work on dismantling the large-sized equipment, the large installation piping manifolds and process pipelines were dismantled and removed. The manifold connections were partly flanged and partly welded. The total length of the dismantled radiation-con-

taminated pipelines was about 1500 m (with pipe diameters from 12 to 120 mm). The pipes were made of stainless steel, rubber, plastic, and ferrous metal. The piping manifolds were removed both using a hydraulic tool and manually (the connector for mating flanges) (Fig. 2). The instrumentation of the monitoring, measuring and control systems was completely dismantled; the instrumentation and automated control cables were disconnected from the sensors and instruments of control, protection and alarm systems, and dismantled.

Figure 2. Dismantling the process pipelines.

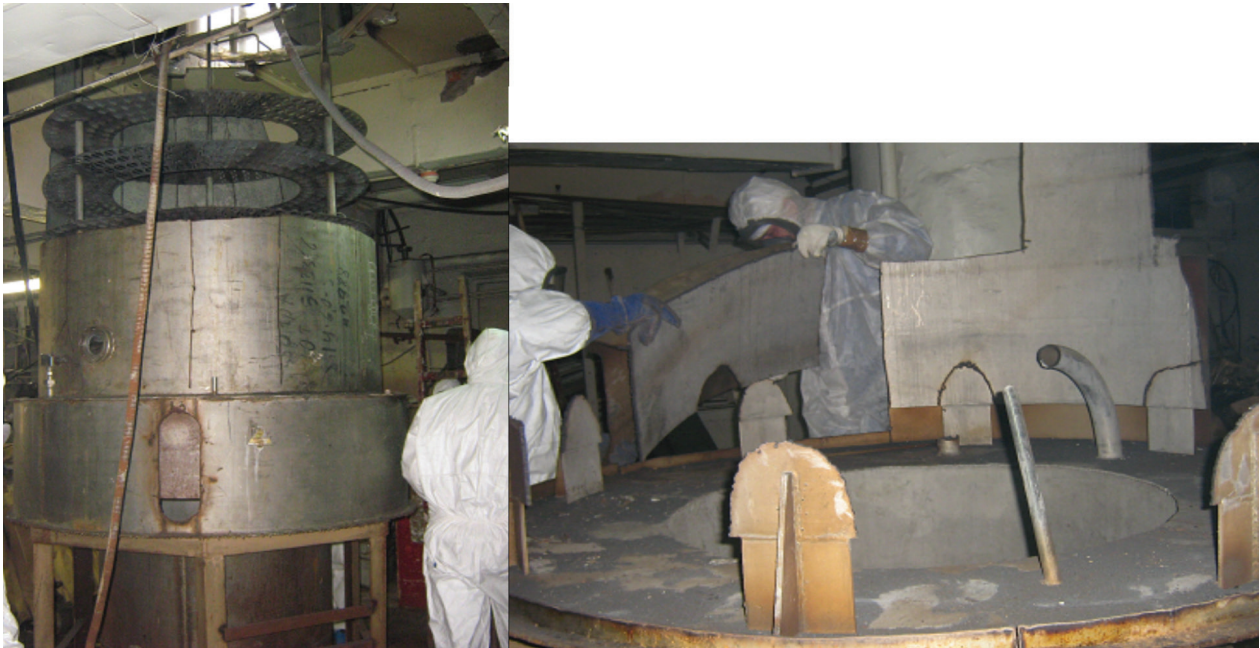
To dismantle them in accordance with the design solutions, a monorail hoist was mounted and a winch was installed on the beam channels of the facility the uppermost deck. Hatches were cut into the upper deck floors and the columns were dismantled through these hatches (Fig. 3).

Dismantling was carried out using plasma cutters and a local suction to prevent radionuclides from entering the air of the working area.

Figure 3. Removal of the column-type equipment.

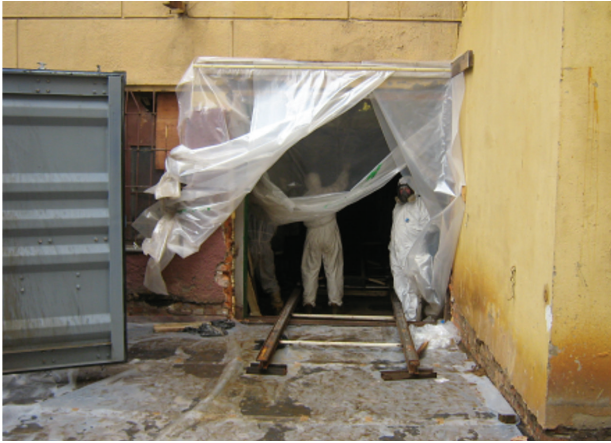
In order to remove large-sized capacitive radioactive wastes from the large installation the lowermost deck, the window opening was expanded. The expanded opening was reinforced with welded metal structures. From the outside, the opening was sealed with two layers of

For the mechanized removal of the large-sized capacitive equipment, crane runways and guides were created and carts were used. The crane runways and guides were made in a mobile version to extend them beyond the building for at least one meter, to mechanize the movement of large-sized radioactive waste into the transport container (Fig. 4).

Figure 4. Opening in the wall of the radiochemical facility; crane runways.

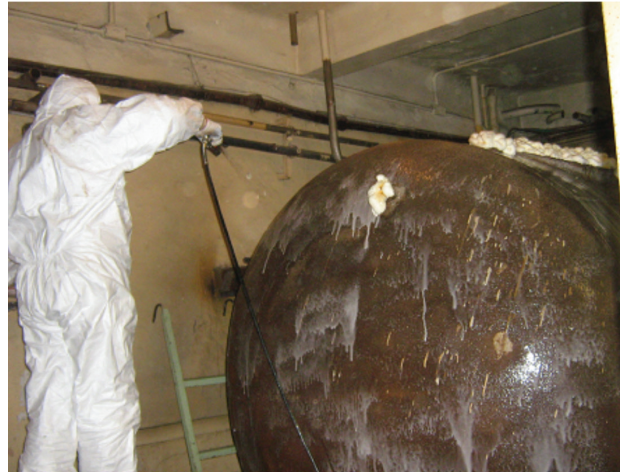
During the dismantling process, all the holes in the equipment were filled with mounting foam. Polymer coating based on polyvinyl alcohol was applied on the equipment to be removed, to localize surface radioactive contamination. To create a more stable coating, it was applied twice: the second layer was applied after the first layer was completely dried (Fig. 5).

Figure 5. Applying polymer localizing coating.

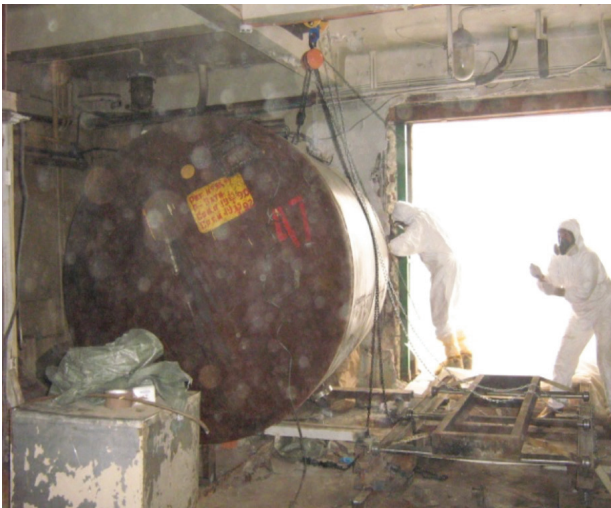
The dismantled large-sized equipment was disconnected from the beds and stands; then, with the help of the hoist and the winch, it was moved onto a cart on the crane runways; afterwards it was fixed on the cart and moved into a transport container (Fig. 6).

Figure 6. Dismantling and removal of the large-sized capacitive equipment.

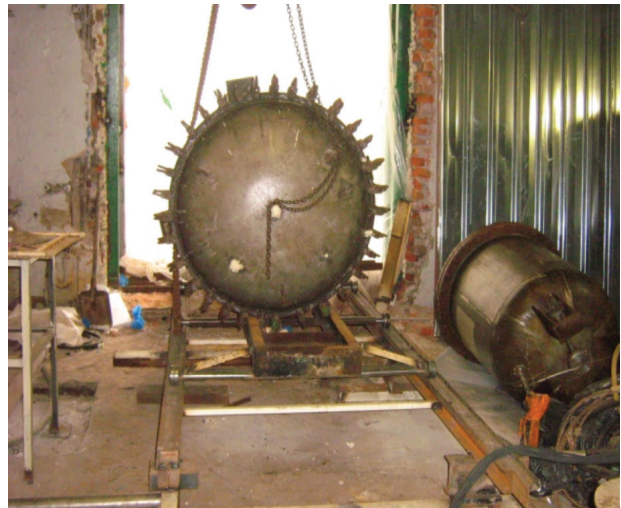
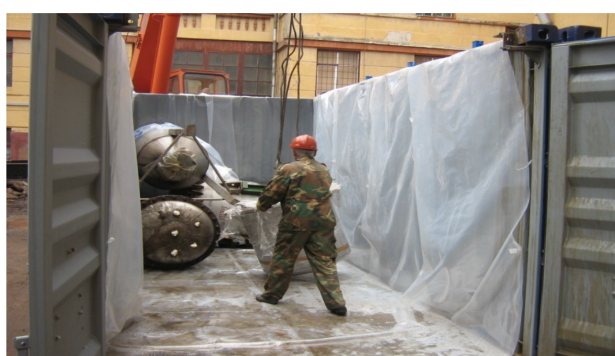
The large-sized process equipment was loaded into the PU-2ETS-ST containers (Fig. 7) and sent to FSUE RosRAO for compaction, conditioning and temporary storage before being transferred to the National Operator for RW and Technological Waste Management (Vereshchagin et al. 2017).

Figure 7. Loading of the large-sized radiation-contaminated equipment into the PU-2ETS-ST transport containers.

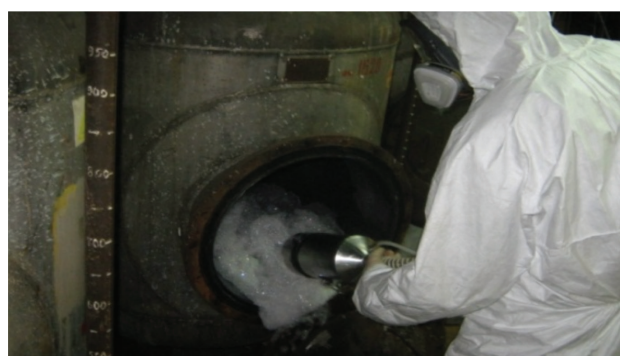
Figure 8. Foam decontamination of the internal equipment surfaces.

As mentioned above, it was not possible to completely decontaminate the internal equipment surfaces. Decontamination was carried out by treating the internal equipment surfaces with acidic foam compounds (Fig. 8). The decontamination factor ranged from 25 to 70. As a result

of the decontamination works, the radioactive waste activity was reduced (for radiation-determining transuranic radionuclides, the RW class was changed from 3 to 4) (Resolution of the Government of the Russian Federation No. 1069).
