THE WALL MOSAICS AT THE CATHEDRAL OF EUFRASIUS IN POREČ:  
A PRELIMINARY REPORT

*This article provides the findings of a study of the 6<sup>th</sup> century wall mosaics at the Eufrasiana. It was based on a visual analysis of the lower mosaics (to the inscription) done from scaffolding during June of 1997. After a review of the conservation history and pre-restoration records, the authors characterize three phases of mosaics: the original work, a limited restoration from 1886 (Solerti), and an extensive restoration from 1890-1900 (Bornia). Analyses are offered of both the original and restored tesserae, setting beds and setting techniques. Bornia took great pains to preserve as much as possible of the original mosaics.*

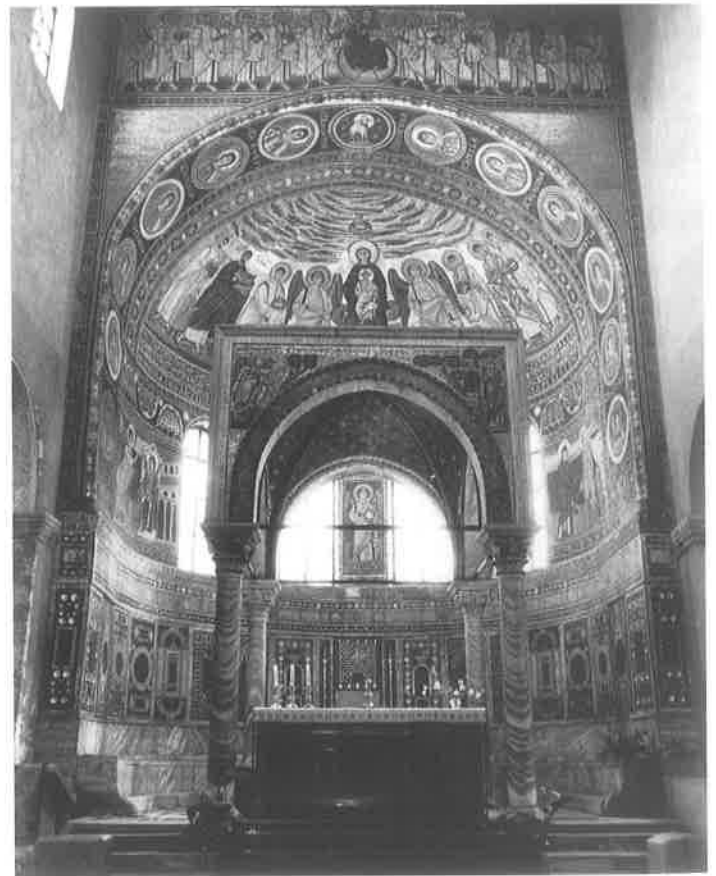
Fig. 1. Apse Mosaics of the Cathedral at Poreč

The Eufrasiana, while of inestimable value to scholars as the best surviving example of a cathedral complex, is probably most well known for the splendor of its wall mosaics, the jewel of a remarkably well preserved decorative program (Fig. 1).<sup>6</sup> The basilica and its mosaics date to the

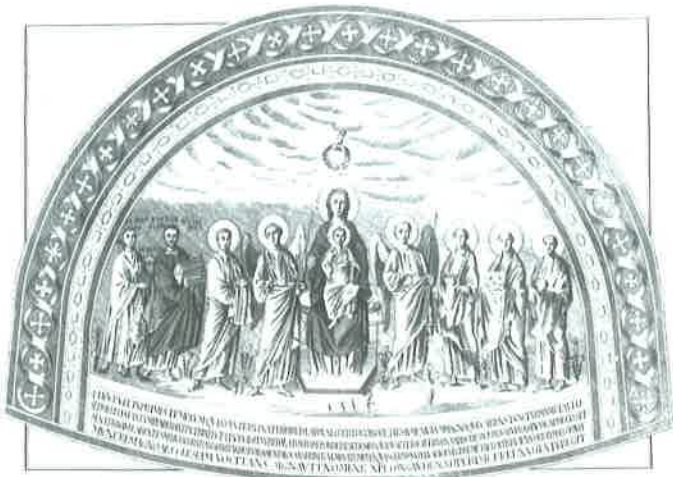
Fig. 2. Engraving of Mosaics, 1763

The earliest preserved visual record of the mosaic in the apse is an engraving made in 1763 (Fig. 2).<sup>23</sup> Apart from general stylistic differences, the most striking discrepancy between the eighteenth century rendering and the mosaic in

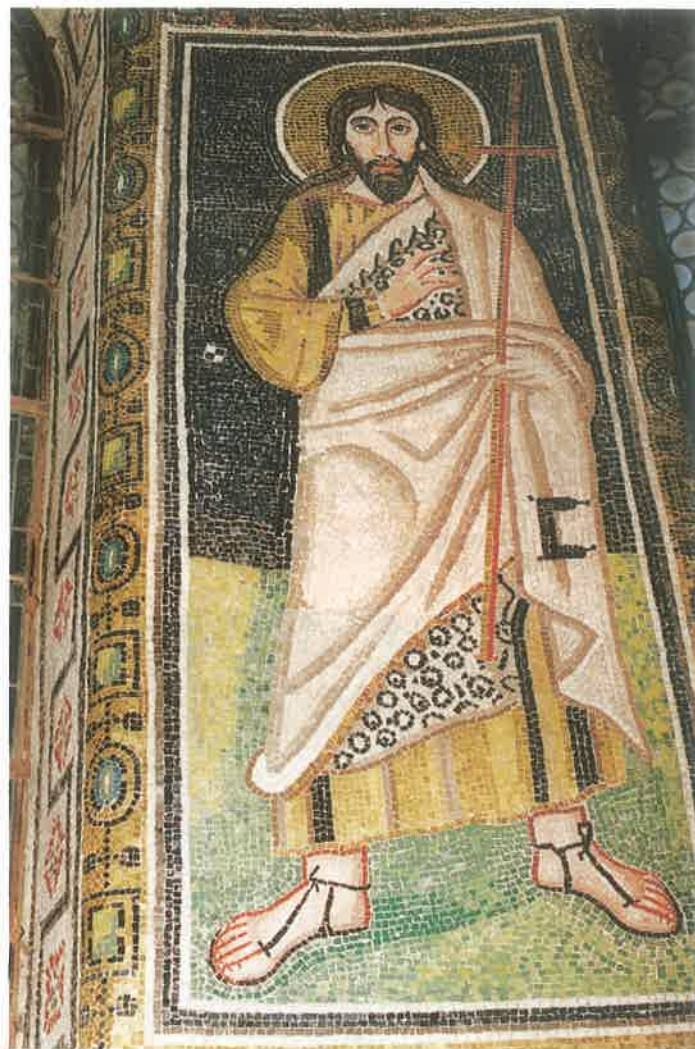
Fig. 6. John the Baptist (south pier)

The discrepancies between the various pre-restoration records, both written and visual, raise the problem of their trustworthiness as sources. Many of the drawings were finished in studios, after visits to the site, and even the more meticulous of the recorders made mistakes. The problem was evidently compounded by the condition of the mosaics themselves, which must have been blackened by dirt and candle smoke.<sup>33</sup> In addition, the mosaics were apparently patched with painted plaster, as revealed by T. G. Jackson, in his book of 1887: "The mosaics are a good deal patched with painted and gilt plaster in different places, but on the whole they are extremely well preserved, and have at all events hitherto escaped the misfortune of restoration."<sup>34</sup> Jackson also noted that the chrismon at the apex of the apse was entirely in plaster: "At the crown of the arch within a circle is the monogram [of Christ], though now only in painted plaster, the mosaic having perished."<sup>35</sup> Jackson's description of the figure on the right hand pier between the windows, presently portrayed in the guise of John the Baptist (Fig. 6), is especially significant: "...very

little remains of the original mosaic, the figure being made up with painted plaster; it seems to have had a white dress and to have held a cross staff." Like von Eitelberger and Lohde, Jackson identified the saint as John the Baptist, but tentatively. In addition, he evidently had some difficulty making out the left hand figure, now characterized as Zacharias (Fig. 32); he described this personage as a "saint in a short tunic richly ornamented and fringed, with a gold purse(?) hanging in front, and wearing a purple cloak fastened at the throat with a large clasp: he holds a casket with a coped top." Thus both from Lohde's and Jackson's publications we can conclude that nineteenth-century observers had trouble reading this mosaic. Like Lohde, Jackson suggested that the figure may have represented Maurus.<sup>36</sup>

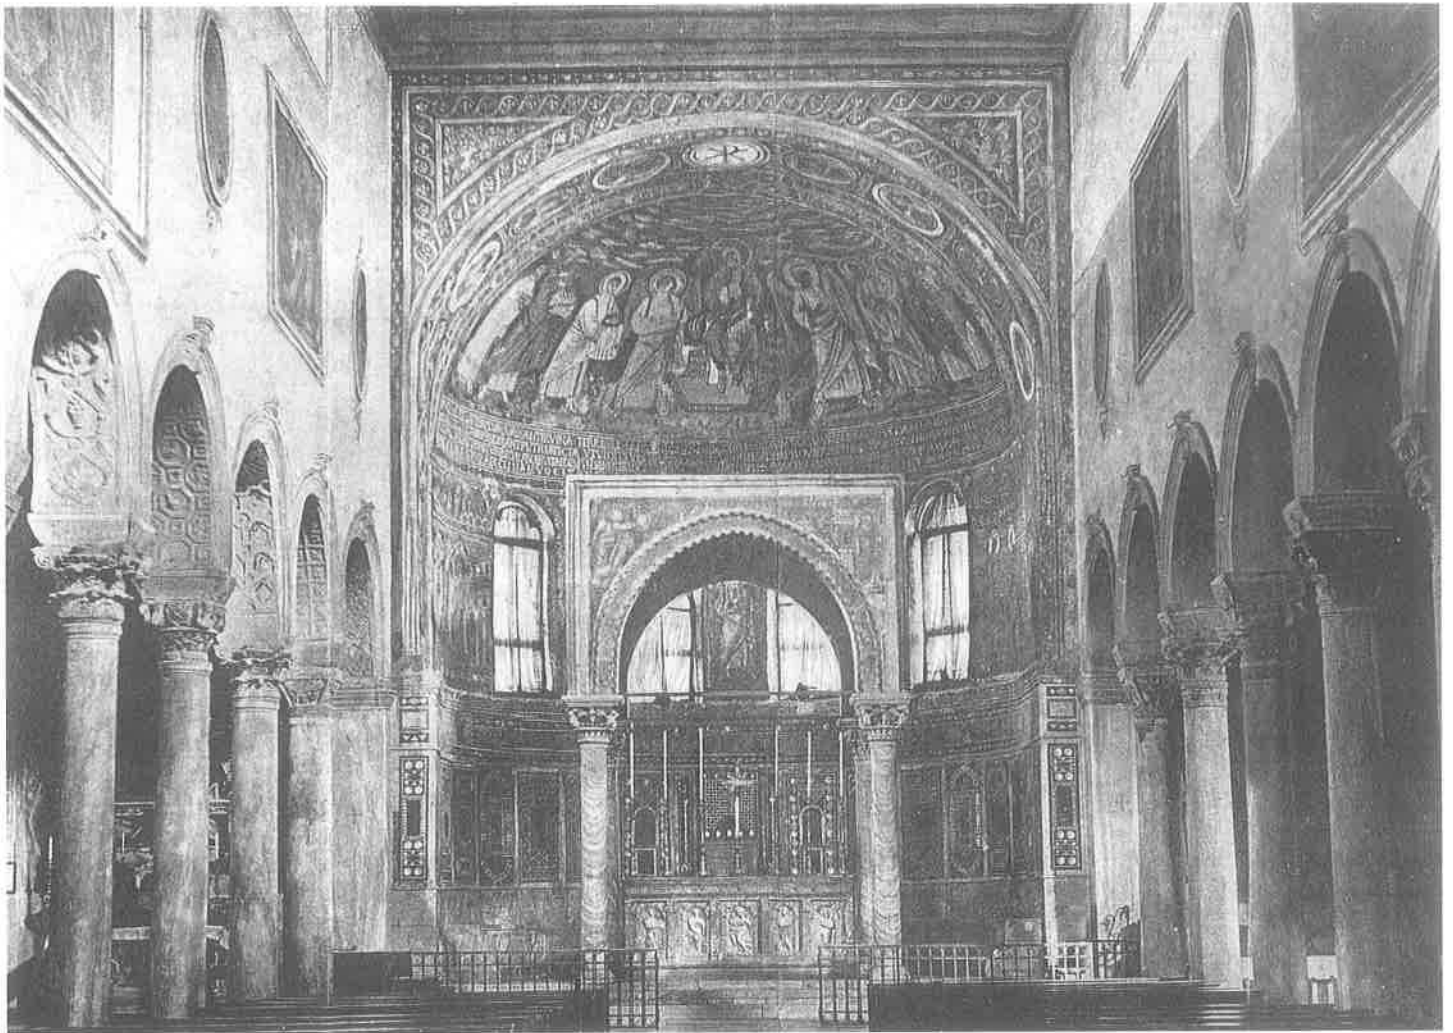
Fig. 10. Pre-restoration Photograph from Marucchi

Only one pre-restoration photograph of the apse was published, in 1896 (Fig. 10).<sup>37</sup> A photograph might be thought to give the most useful and incontrovertible evidence of the pre-restoration state of the mosaics, but here too there are problems of interpretation. Because of the blackening of the mosaics, the curvature of the apse, and the presence of the ciborium which impedes the view of the mosaics on the lower wall, the photograph gives only limited information. But it does clearly show that the Virgin's footstool appeared in a symmetrical frontal perspective, as in all the earlier engraved views. It also records a chrismon at the crown of the vault instead of the modern lamb, and, so far as the grainy quality of the reproduction allows a judgement, it suggests that the tunic of the angel on the central

pier had one clavus stripe rather than two. A surprising feature of the photograph is that it is extremely hard, if not impossible, to see the hand holding the wreath above the Virgin's head, while the pattern of clouds in the upper part of the mosaic appears to be different from that seen today. The hand with the wreath is a feature that appears clearly in all of the earlier published prints, except perhaps for the engraving in *Die Österreichisch-ungarische Monarchie* (Fig. 7), where it is also hard to make out the motif. The hand and wreath were also described in the texts by von Eitelberger, Lohde, and Jackson.<sup>38</sup> Perhaps an explanation is to be sought in the poor quality of the photograph, or else in the overpainted and blackened condition of the mosaic itself.

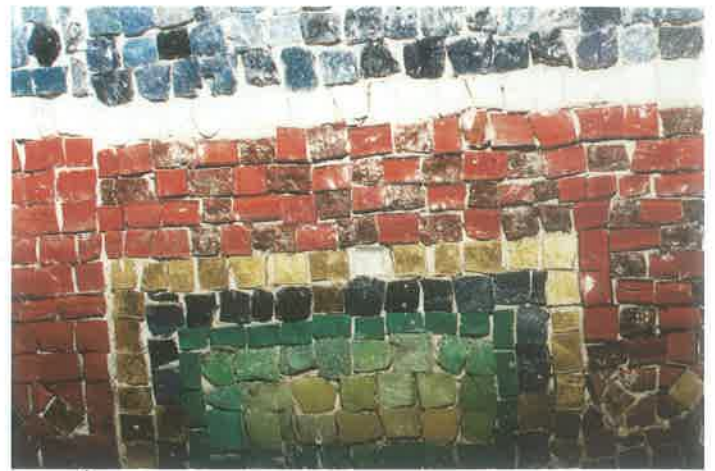
Fig. 12. Border under Annunciation, detail

Fig. 12, a detail from the band beneath the Annunciation, offers an opportunity to see old and new tesserae used in a different relationship. The 4 rows of red tesserae above the rectilinear jewel represent, apparently purposefully, a mixture of old and new tesserae. Both types of tesserae are red streaked with light and dark. In the case of the new tesserae, which, with their relatively flat surfaces, appear

graph is from a pole of the scaffolding). Often the new gold tesserae are used almost exclusively in limited areas, especially in halos (Figs. 32, 36) and in the gold jeweled bands (Figs. 17-20). In other instances, they replace a line of missing gold cubes (Figs. 11-12), or replace individual tesserae (Fig. 30).

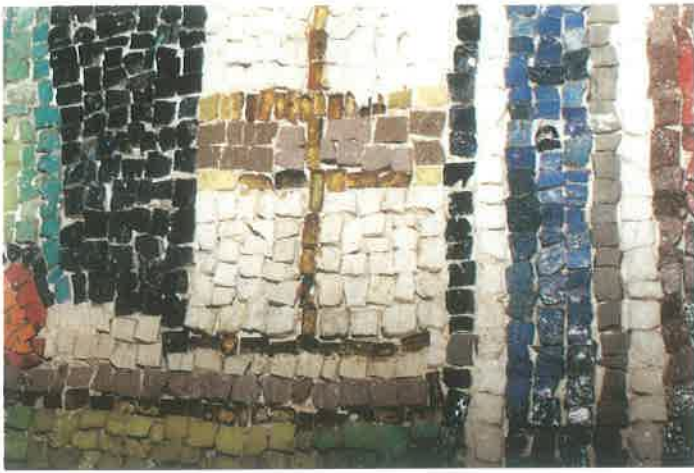
Fig. 13. *The Visitation, detail of house*

This technique was apparently used, as we have found traces of this process in bits of gold clinging to the edges of adjoining white stone cubes. In Fig. 13, a detail of the Visitation, edges streaked with gold can be seen along the two rows of white tesserae that flank the vertical row of amber tesserae. In the photograph, this appears as a brownish edging. But we are uncertain to what extent the varnish technique was applied.<sup>56</sup>

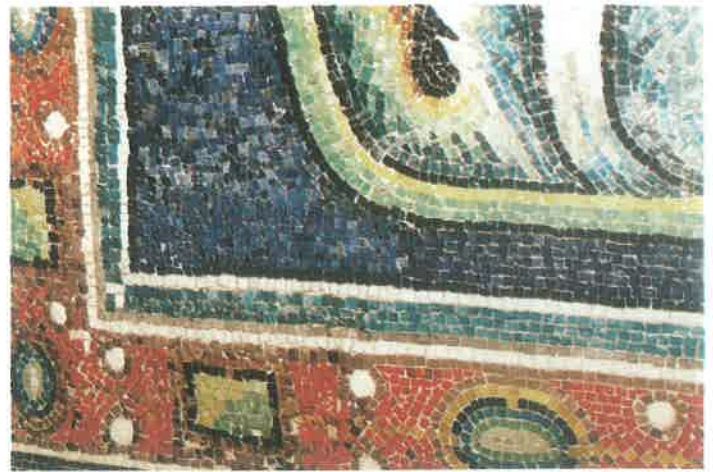
Fig. 14. *South Intrados of Apse, detail of Acanthus Cup and Border*

3. The acanthus cup under the medallions with saints (south); left corner. 45 h x 37 w. (Fig. 14)
4. The Visitation; the lower right corner of the house. 41 h x 29 w. (Fig. 13)

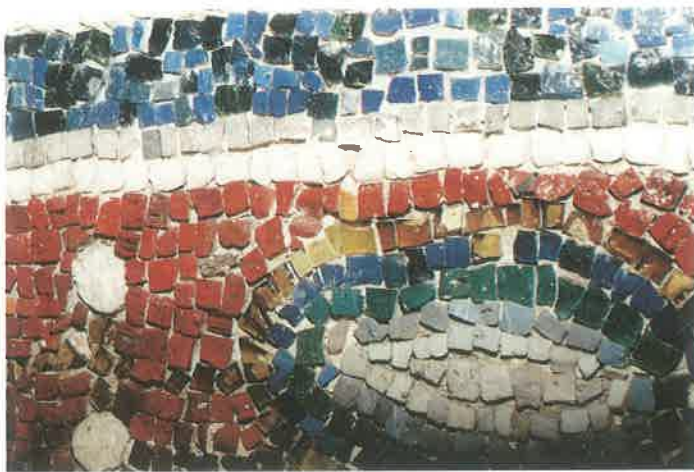
Fig. 15. *Border under Visitation, detail*

The color and texture of the original setting bed, as well as the irregularity in setting, can be seen in Fig. 15, part of

the red jeweled border under the Visitation. The center of the jewel (the two light blues) retains the original setting bed. It is grayish-white in color (although the color varies from spot to spot), it appears worn, and the tesserae project from the surface. The sides of the tesserae do not line up with one another evenly, and the oval form they create is, itself, distorted.<sup>45</sup>

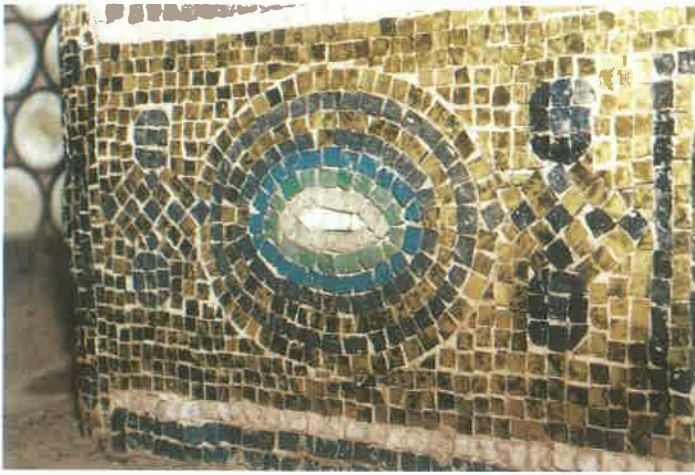
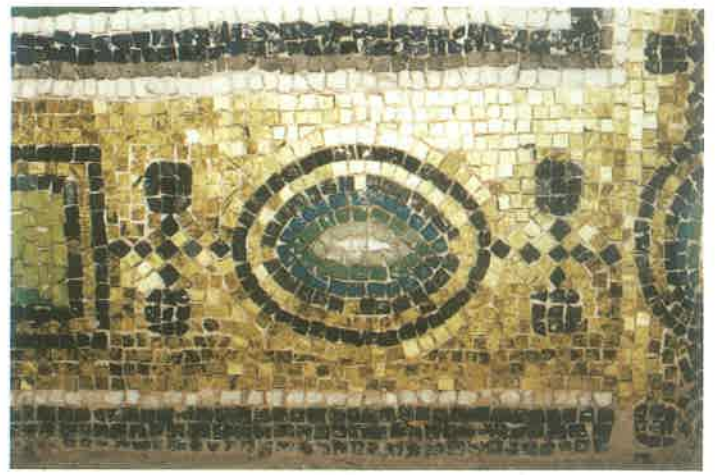
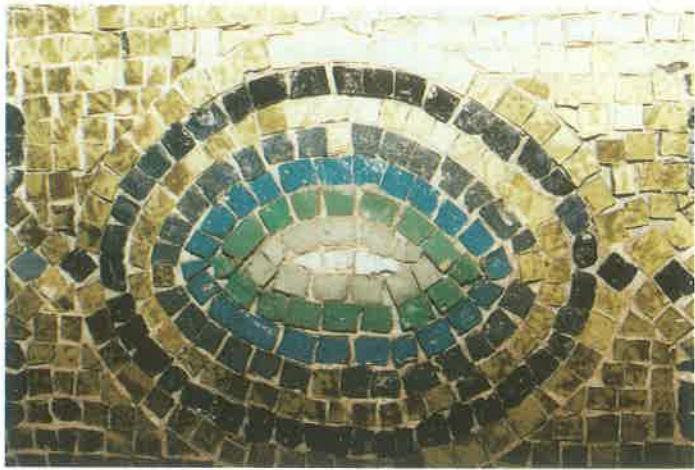
We offer several examples of Bornia's typical setting, which we will then contrast with the original setting. Figs. 16-18 illustrate details of the gold jeweled band running beneath the standing angel on the central window pier. The entire border under the angel is substantially a product of restoration. Fig. 16 shows the far north side of the border; Figs. 17-18 serve as details of the south end of the border. The trademark pink of Bornia's setting is most apparent in Figs. 16 and 18. All three photographs demonstrate the constancy of setting technique, with the neatly cut cubes placed at uniform intervals. The evenness of the setting bed, which

lies nearly flush with the surfaces of the tesserae, can be seen best in Fig. 18. The bright, flat finish typical of new gold tesserae is most visible in Fig. 17.

Figs. 16-18, details from the gold jeweled band beneath the standing angel, represent an exceptionally well executed

combination of new and old tesserae. The gold tesserae are almost all new, as one can see from their even sizing and their brilliant and flat mirror finish. But the other tesserae are a careful mixture of new and old. A number of what appear to be black tesserae are actually very dark blue, original tesserae, as seen best in Fig. 18. The inner center of the jewel (Fig. 18), three milky-blue tesserae surrounded by a ring of pale green tesserae, uses all original tesserae, probably in a partly original setting.

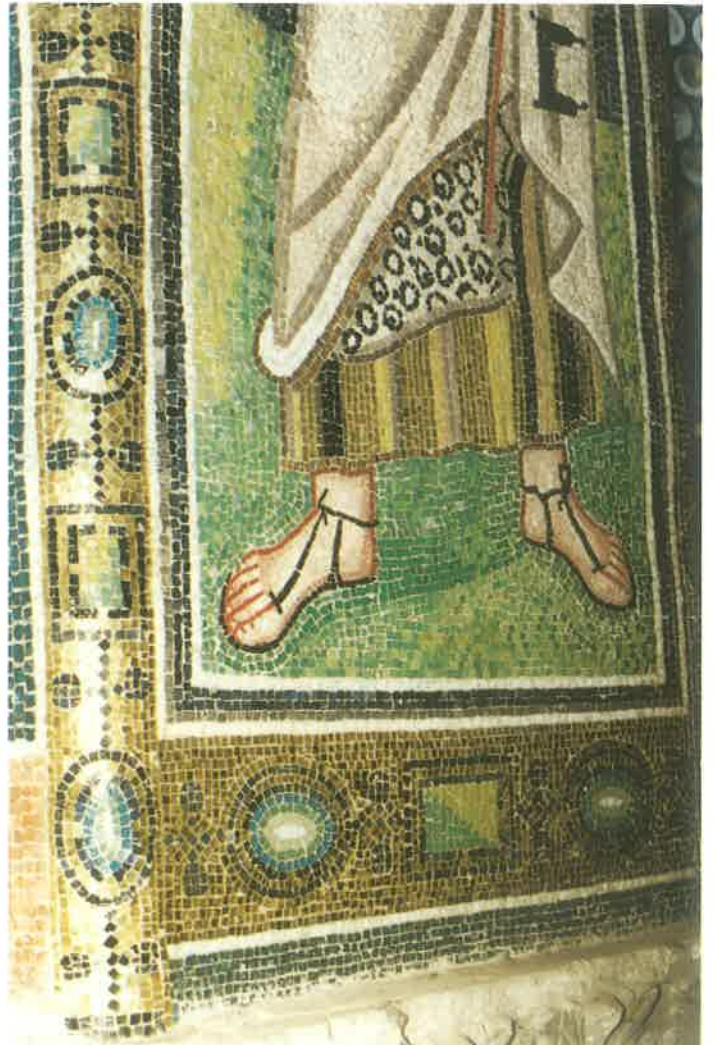
Fig. 19. St. John the Baptist (south pier), lower half of figure

The application of Bornia's settings to a larger area may be seen in Fig. 19, a detail of John the Baptist, on the south window pier. Large areas of this figure, as well as the gold band underneath and along both sides of it, were heavily restored by Bornia, perhaps because the original mosaic had already been replaced by painted plaster, as Jackson's description suggests. The general "look" of Bornia's work

may be seen easily in the lower gold band, as well as the feet and tunic of the saint, and in several rows of tesserae around the feet. In these sections, the tesserae are set regularly and even with the surface, whose lighter color helps to create a dotted line effect. The vertical bands of colors in the tunic accentuate the rhythmic regularity of the setting.

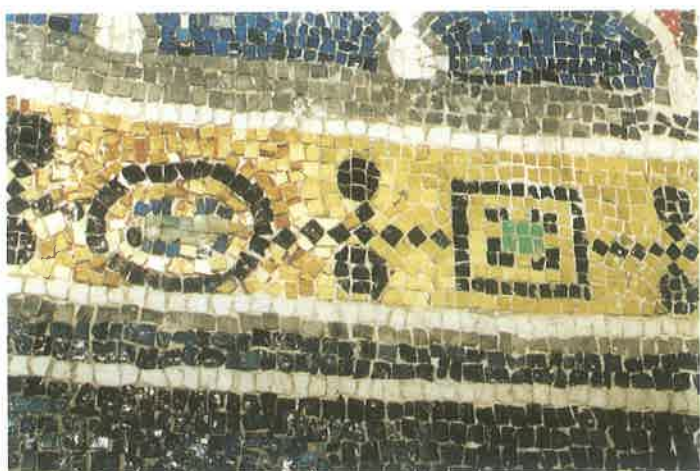
Fig. 20. Border above Annunciation, detail

We may look at two further comparisons of Bornia's restoration with similar substantially unrestored areas. Here again, the distinction is clear. In Fig. 20, a segment of

gold band above the Annunciation, the left half is mainly original while the right half is primarily new. The uneven surface and setting on the left abruptly becomes smooth and consistent to the right. With the possible exception of the 6 green tesserae in the center of the square jewel, all the tesserae on the right are new, precisely sized and cut. The tesserae, particularly those from the two black discs in the center to the end of the square jewel, are set in even rows, including those gold tesserae set obliquely to either side of the black tesserae. This unyielding consistency breaks down a bit near the "black" discs (on the absence of real black tesserae in the original mosaics, see below, p. 214) at the right side of the photograph, some of which are original tesserae in original beds. To see how these different methods affect less geometric designs, compare the foot of John the Baptist (Fig. 19) with a detail of the foot of the standing angel (Fig. 21). The foot of the angel is primarily original, although the green background is heavily patched, and a strip of several rows of tesserae beneath the long strap of the sandal was repaired by Bornia. While Bornia, aiming at authenticity, copied details such as a line of red tesserae to define the upper edge of the foot and toenails, the precision and "newness" of John's foot is unmistakable.

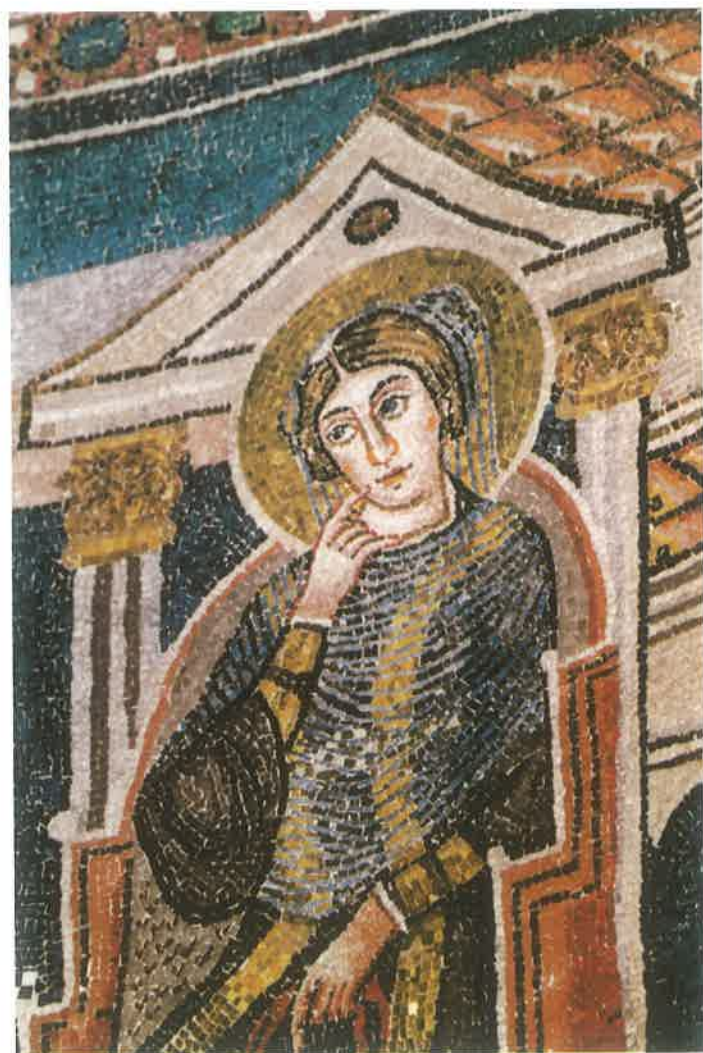
Fig. 22. The Annunciation, detail (Photo: Andreescu-Treadgold)

21. Zacharias, left side of hair and all of beard. (Fig. 36)
22. Annunciation, Virgin's veil and face, and right hand. (Fig. 22)
23. Gold jeweled band above standing angel (central pier), farthest two right hand jewels. 13 h x 50 w. (Fig. 20)

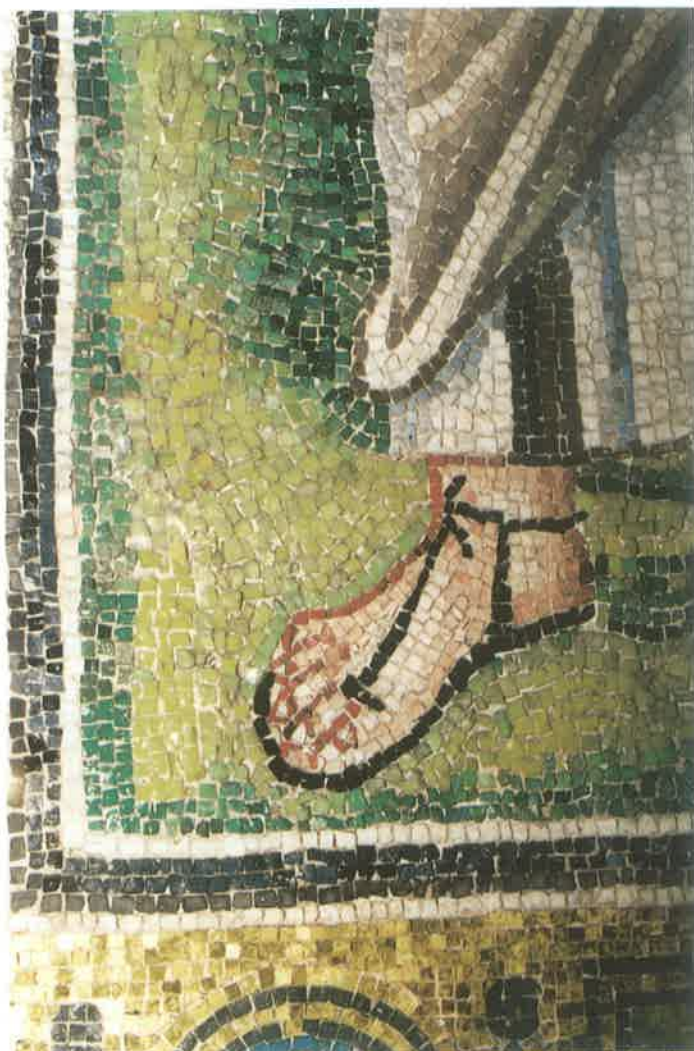
Fig. 21. Standing Angel (central pier), lower left corner

14. The standing angel (central pier); area of left foot, lower hem and background. 42 h x 42 w. (Fig. 21)
15. Zacharias (north pier); area with lower left foot, embroidered hem and background. 46 h x 28 w.

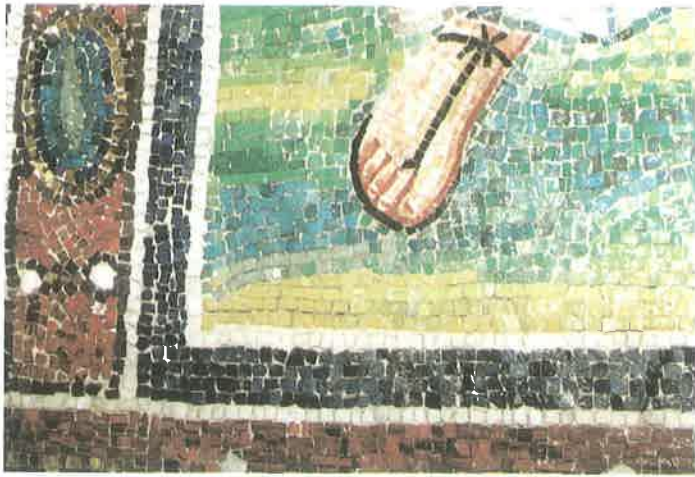
Fig. 23. *The Annunciation, Foot of Gabriel, detail*

16. John the Baptist (south pier), area with lower left foot, hem and background. (Fig. 31)
17. Annunciation, Gabriel, area of lower left foot, hem, background and adjacent blue border. 43 h x 43 w. (Figs. 23-25)

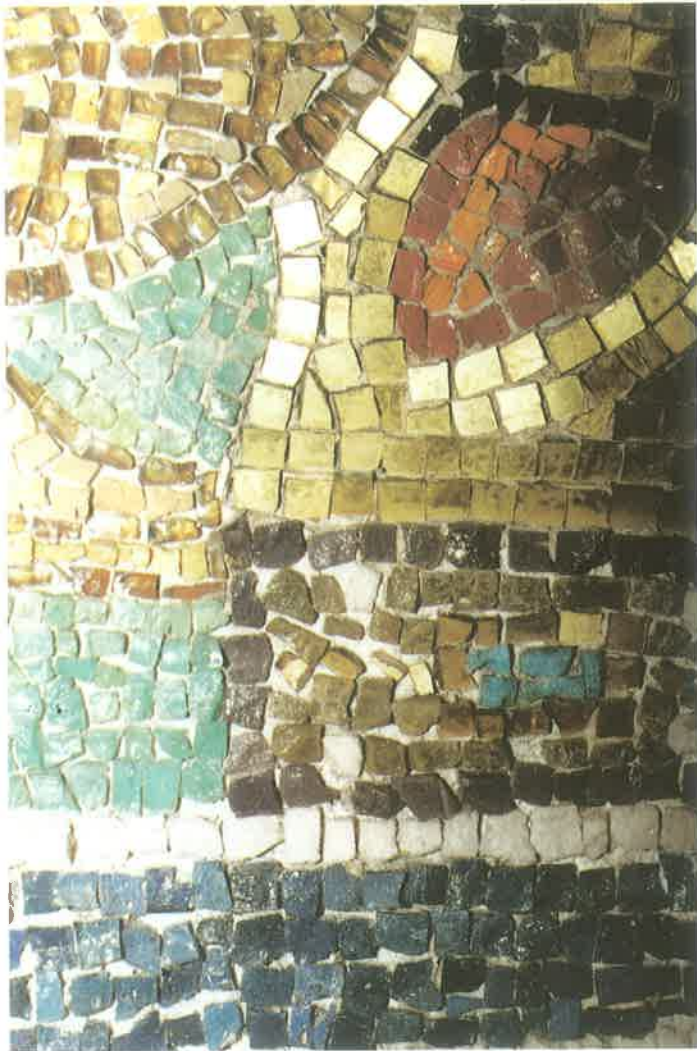
Fig. 26. *The Annunciation, Basket of Yarn and Footstool of Throne, detail*

18. Annunciation, Virgin, area of left foot and basket. 35 h x 35 w. (Fig. 26)
19. Zacharias' box. 22 h x 28 w. (Fig. 35)
20. Zacharias, censer with chain and hand. 46 h x 13 w. (Figs. 33-34, 42)

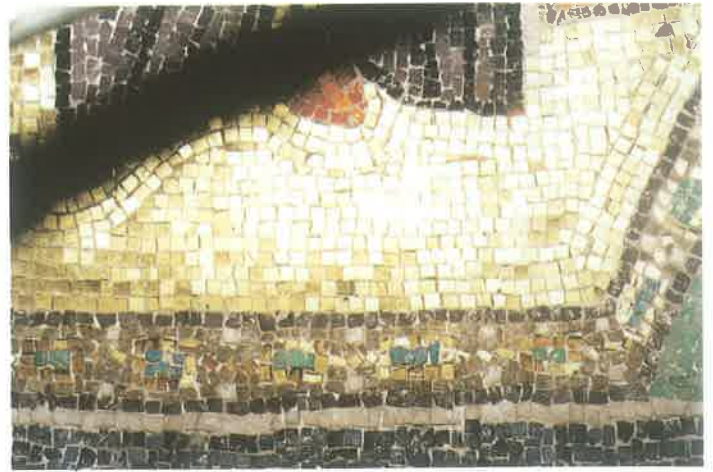
Fig. 27. *The Annunciation, Footstool of Throne, detail*

The entire footstool of the Virgin’s throne, with the exception of its jeweled base, has been replaced with these new gold cubes (Fig. 27; The dark shadow in the photo-

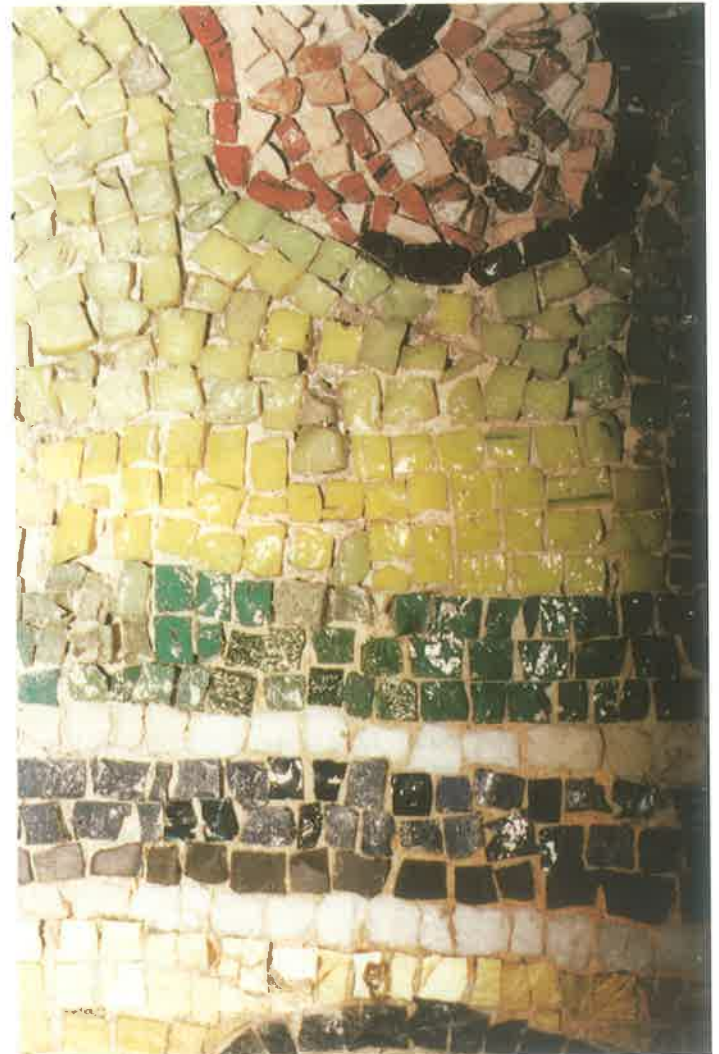
Fig. 28. *Standing Angel's Foot (central pier), detail*

Areas of repair, even if they utilize many new tesserae, lack the systematic and uniform appearance of the more heavily restored areas we have seen. Fig. 28, a detail from the standing angel, illustrates just such a case. The far left edge of the photograph shows part of a gold jeweled band, with dark colored tesserae from an oval jewel.<sup>49</sup> The straight lines of tesserae (from the left: white, slate grey, dark blue, white) comprise the border around the figure, while the emerald green (3 rows) and lime green (3-4 rows) tesserae form part of the background of the figure. The left two thirds of the photograph are heavily restored, with Bornia's pinkish setting. In particular, the black and gold tesserae are all new. It consequently appears highly regular. The edge of the foot, at the right side of the photograph, is substantially original, and its tesserae have a notably jumbled appearance. The vertical rows of tesserae in the center, par-

ticularly the green, offer a transition, in which Bornia used some new and some old tesserae. The pink setting bed used here, its surface flush with the tops of the tesserae, tells us instantly that this is restoration, but note that, on account of the greater irregularity in the sizes and shapes of the tesserae, the setting technique is less regular than the areas which were nearly entirely reset.

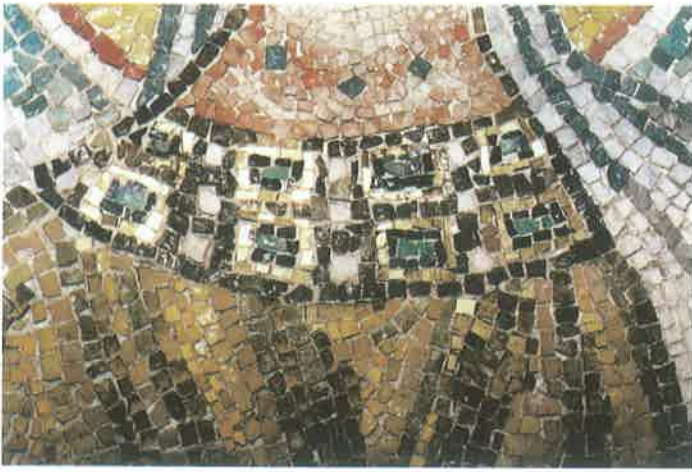
Fig. 29. *St. Filicita*s, Collar, detail

Equal care marks the collar of *St. Filicita*s, one of the female saints in the intrados. The lavish collar at the neck of her tunic consists of 8 rectangular jewels (Figs. 29-30). A close look reveals that the first and third jewel (top row, counting from the left) are significantly original. In each case, one or two green or turquoise tesserae are surrounded by rows of dark blue and then gold tesserae. In these two jewels, we can see the irregular shapes of the old tesserae, as well as the sparsely preserved setting bed (Fig. 30). In addition, much of the background of the collar, consisting of purple and off white tesserae, is original. But the remaining jewels, the second and fourth in the top row, and all in the bottom row, have new centers, as demonstrated by their new gold tesserae, thick, full setting bed, and relatively even settings.

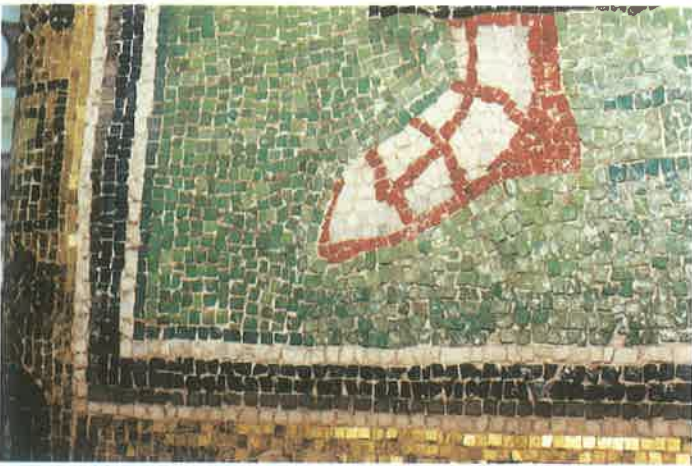
Fig. 31. *Zacharias* (north pier), lower left corner

Fig. 31, the area around the foot of *Zacharias*, which preserves several different approaches, is probably most typical of the mosaics overall. The foot and the borders to the side and below it are substantially restored, although,

except for the gold, using many original tesserae. The green background to the left of the foot combines large patches of repair using predominantly new tesserae with smaller areas of original mosaic. Thus the fabric of the mosaic in this area appears disjointed. The green background directly underneath the foot is substantially original mosaic.

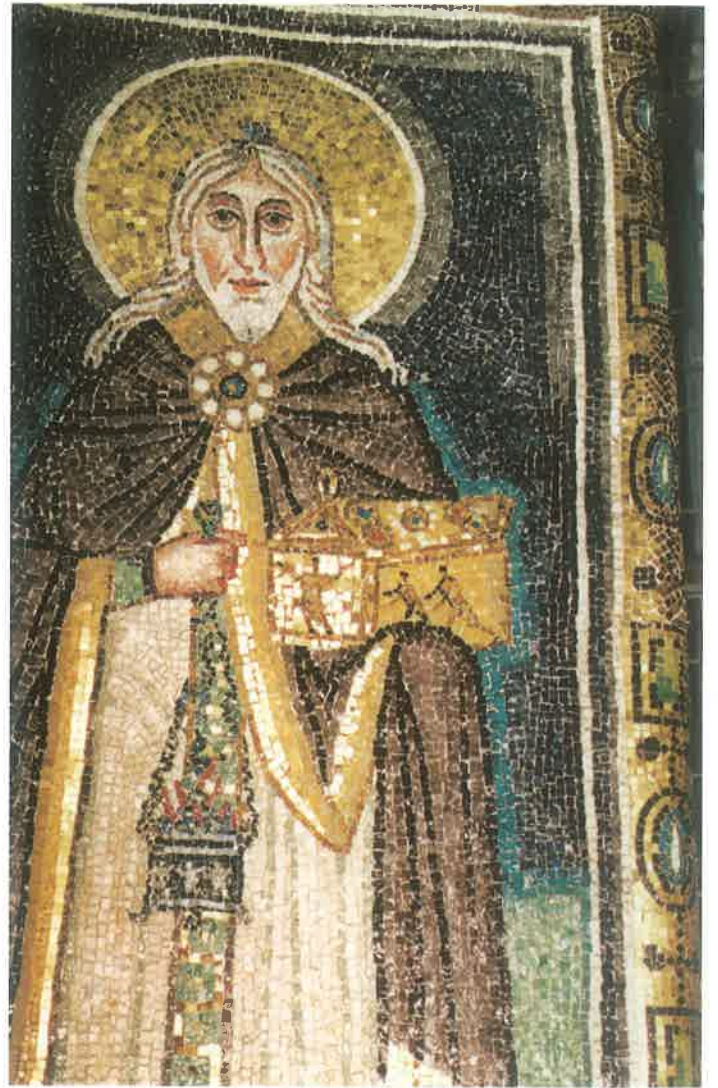
Fig. 32. *Zacharias* (north pier)

graphical significance. Again, Zacharias on the north window pier offers several examples (Fig. 32). As we have seen, this figure seems to have been sufficiently damaged that nineteenth century viewers had trouble recording it. Consequently, overall, it required quite a bit of intervention. Nevertheless, our initial analysis of Zacharias indicates that though some areas are newly set with new tesserae (the halo) and others newly set with old tesserae (parts of the

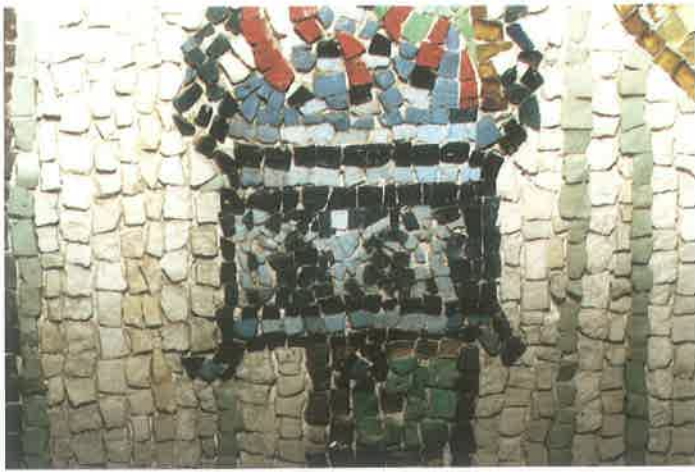
Fig. 33. Censer of Zacharias

cape), several key details, such as the censer in his right hand, and the box in his left hand, and the tip of his beard remain in their original state. Figs. 33-34, details of the censer, make this clear. The evenly placed rows of off white and light green tesserae in Fig. 33 form part of Zacharias' tunic. Though predominantly old tesserae, they are reset by the restorers. The censer itself, by contrast, is largely original. It is outlined in dark and light blue tesserae, some of which appear reset. The three figures in the center are executed in tiny original tesserae which are preserved intact. Fig. 34, a detail of the chain and flames of the censor, has the disheveled look of an area that is partly original, with a few small patches. In particular, the right of the three red flames, whose tesserae lie evenly in reset mortar, has been reset.

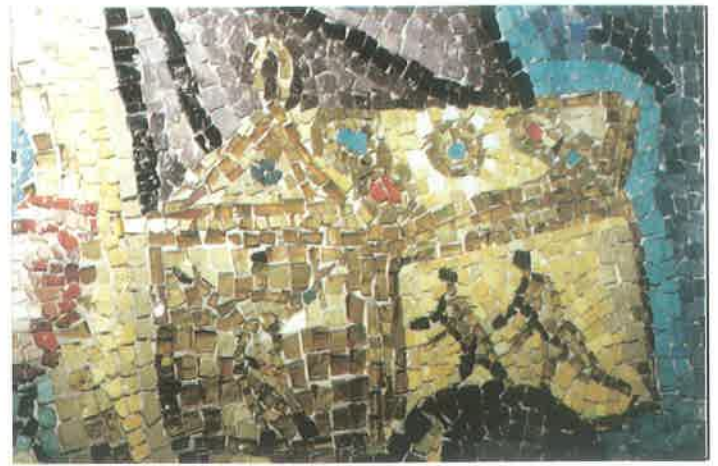
Fig. 35. Box of Zacharias

A similar approach marks the box carried by Zacharias (Figs. 32, 35, 42). The golden box is rectilinear, its gabled roof encrusted with gems. An orant figure decorates the front of the box, towards whom, it would appear, the two figures on the long side of the box hasten. Because of the angle of the photograph, the three figures stand out well in Fig. 32. Fig. 35, a close detail, reveals that the figures themselves are almost all original, using very small, irregularly formed tesserae mainly of an amber colored translucent glass (hereafter amber glass; see below, p. 216). One can see the difference between the reset and original areas especially well on the front of the box. The central orant figure uses very small irregularly shaped tesserae of the amber glass; a number of larger, more quadrangular tesserae of amber and yellow-brown glass define the edges of the box itself. Directly flanking the figure to either side, Bornia inserted patches consisting both of old and new gold tesserae. The patches reveal the level setting of fresh plaster (in this case more white than pink). The new gold tesserae are distinguished by their flat and golden surfaces. Most of the old gold tesserae have lost the upper layer of glass, along with part of the gold leaf.

in isolated instances. For example, at least some old gold tesserae were used together with new gold tesserae in Fig. 35, as the “background” to the orant figure on the box of Zacharias.

the reflection in Fig. 35 renders the gold tesserae themselves as an amber color, illustrates the technique well. On the side of the box, the two figures are done mostly in amber tesserae, while the background, which appears gold in the photograph, is actually set with yellow and tan tesserae.

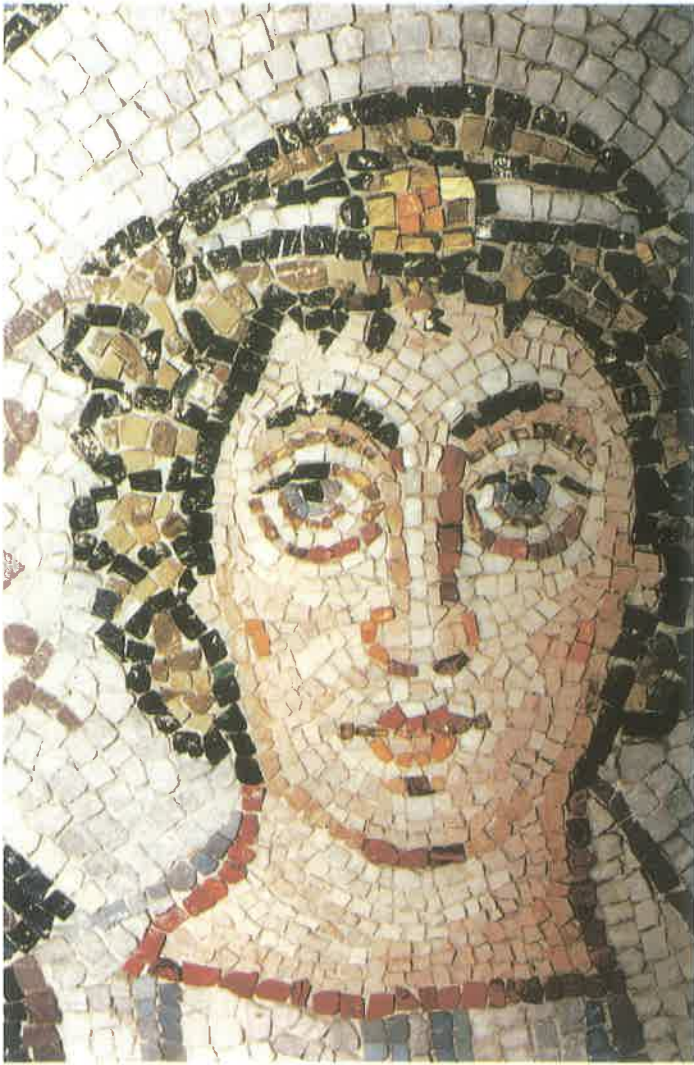
Fig. 37. *Standing Angel (central pier), Face and Halo*

24. Shell above standing angel (central pier), right half. 67 h x 40 w.
25. Standing angel (central pier), face and halo. 42 diam. (Fig. 37)
26. St. Filicitas (lowest medallion, north side of apse), left half of face, halo and collar. 53.5 h x 23 w. (Fig. 40)

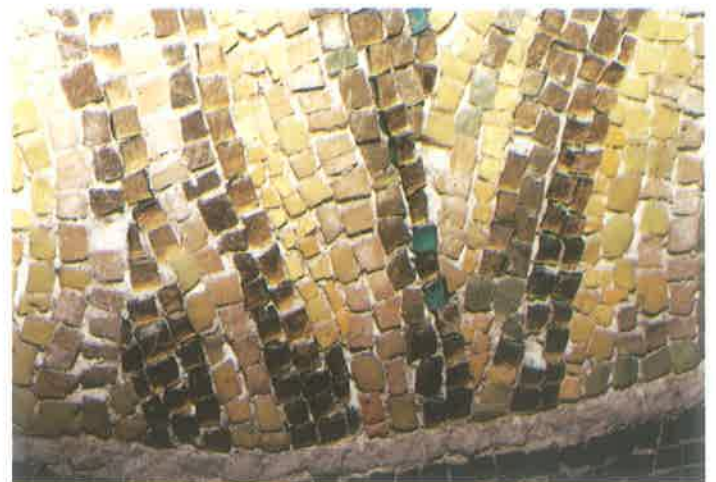
Fig. 39. *St. Filicitas, detail of Dress*

pling, iridescent shimmer. On the insides of some scallop shells, vertical rows of amber, beige, tan, yellow and gold tesserae fall in cascades of luminescent color (Fig. 41). One can see the same technique in Fig. 39, the gown of St. Filicita. A final example indicates the conscious use of gold-like colors specifically to model the gold, as opposed to the use of coloristic effects for their own value. In Figs. 32 and 42, the lining of the robe of Zacharias, two rows of gold tesserae are softened by a row or more of yellow glass, and then of yellow brick.<sup>60</sup>
