Multidisciplinary
SCIENTIFIC JOURNAL OF
MARITIME RESEARCH

Common failures of ship propulsion shafts

Goran Vizentin, Goran Vukelić, Mateo Srok

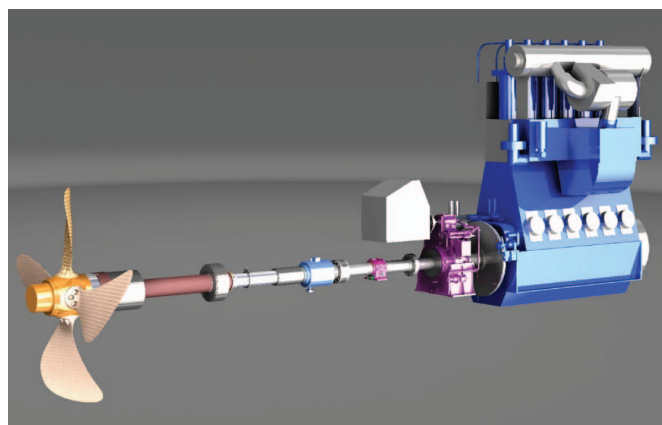
Figure 1 Typical Ship Propulsion System Elements Rendering

The propulsion system has a pivotal role on board ships. A typical marine propulsion system is comprised of the following main parts: main engine, driving device, marine shaft and propeller as shown in Figure 1. As far as fatigue is concerned, the main engine is a complex unit for itself. It represents a vibrations source (impulse operation) for the entire ship and the propulsion system as well. Here, the propulsion shaft will be discussed more in detail.

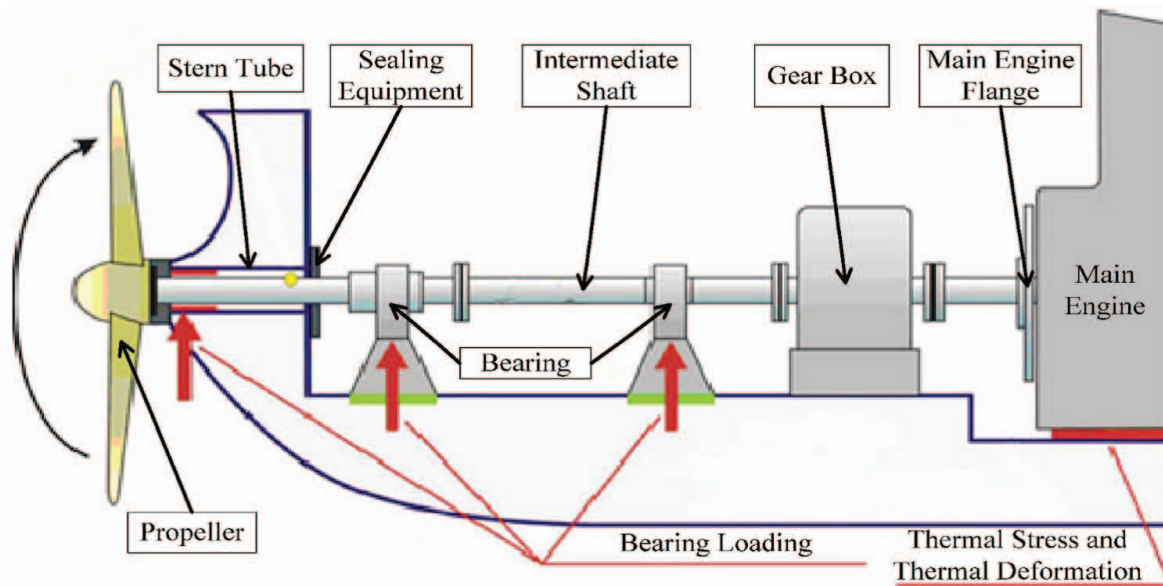
Figure 2 Propulsion System Elements and Loads Schematics [1]

The propulsion shaft is subjected to various types of loading during operation, namely torque moment, bending moment, axial thrust force and transversal loads (gravitational and centrifugal forces). The operating environment of the propulsion system is characterized by significant changes in temperatures and humidity, aggressive atmosphere (salt and/or oil mist), long lasting interrupted operating time (several months) and variations in load amplitudes. The risk of failures of the propulsion system additionally increases with the severity of sea and weather conditions as they have a direct effect on the dynamics of the load variation. All of the above has a direct influence on fatigue behaviour and life time of the propulsion shaft.

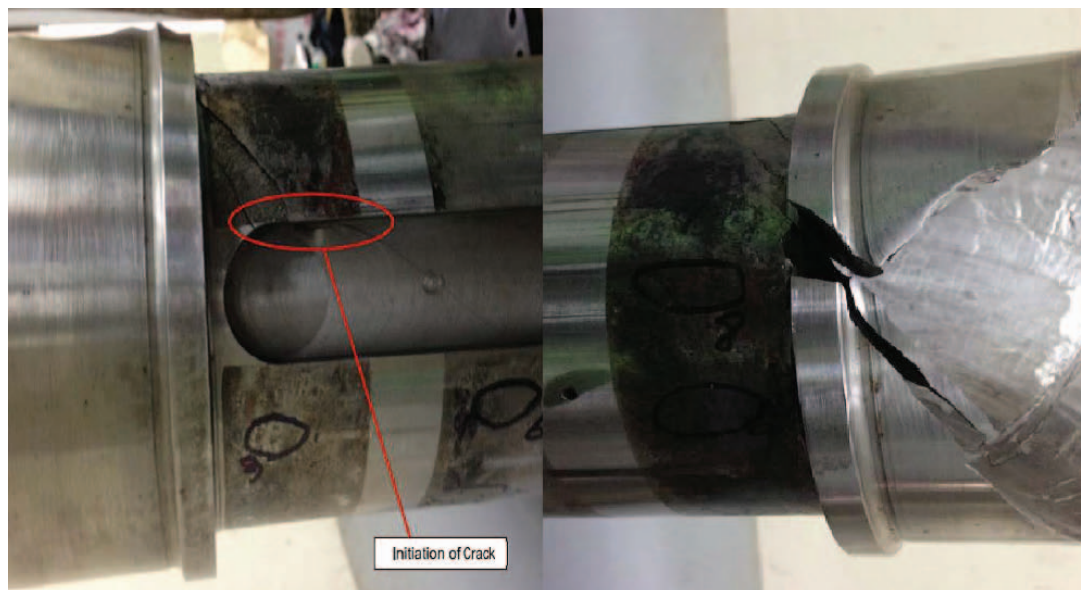
Figure 3 The Characteristic Torsional Failure Crack Shape [8]

The geometry of the ends of keyways represents a stress concentration factor in the cases of torque transmission through shaft keys for dynamic vibrational loads. Faulty machining of shaft key elements (key groove, keyway and key) geometry, inadequate run out radii or material imperfection can be root causes of torsional fatigue failure in shaft keys. The characteristic torsional failure indicator is the crack pattern that initiates at the end of the keyway and propagates in a 45° rotational direction in a helical shape, shown in Figure 3.

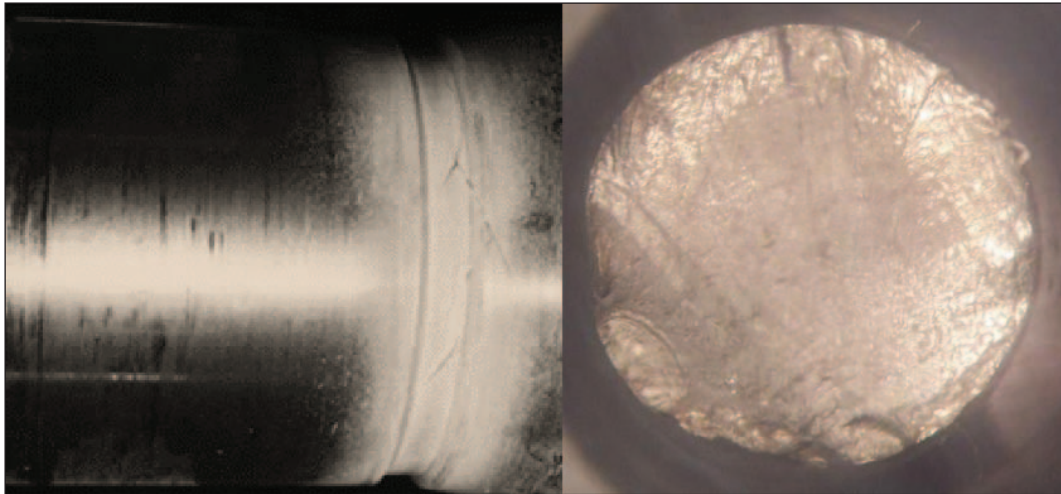
Figure 4 Shaft Fillet Failure Crack Shape [10]

studies of fractures initiated at this elements [10], [11] show fatigue due to cyclic torsional-bending load, with a crack that originates in multiple points on fillet shoulders on the shaft, gradually reducing the load bearing area of the shaft as it grows, and finally resulting in a sudden failure during overload as shown in Figure 4. The analysis for this case study has been comprised of chemical composition analysis, micro-structural characterization, fractography, hardness measurements, and finite element simulation.

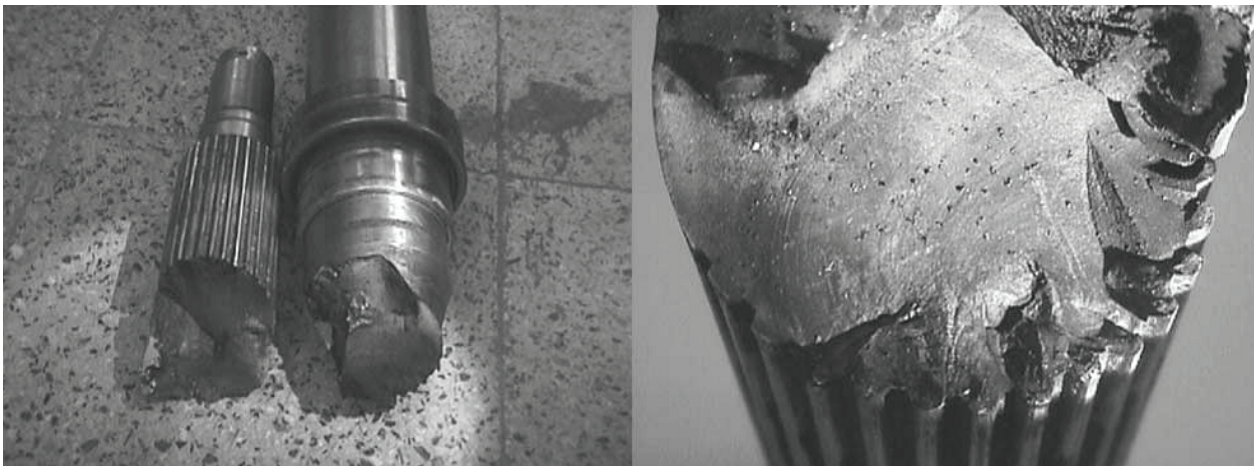
Figure 5 The Characteristic Torsion Failure Crack Propagation Shape (45° angle) [10]

The alternatives to shaft key joints are spline joints which are press fitted to other shaft elements. The analysis of spline joint failure [12] has shown that the press fitting of the joining elements can cause surface deformation which in turn causes surface cracks formation. Cracks usually start on the spline teeth at the shaft junction zone, Figure 5. Torsion fatigue caused by fluctu-

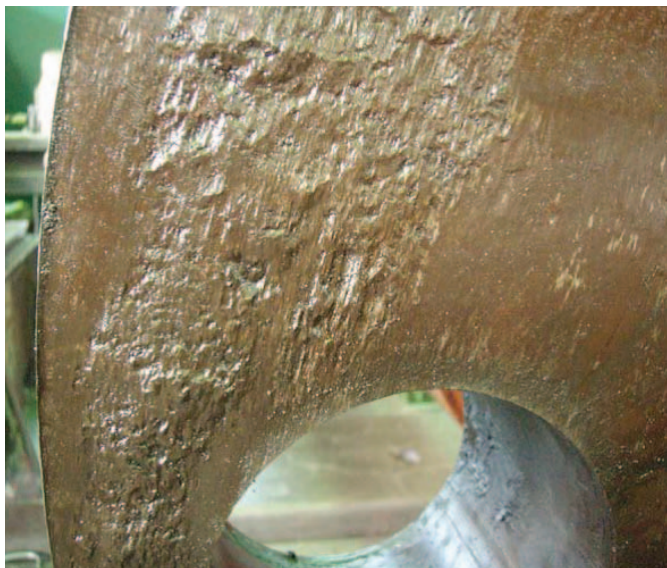
Figure 6 Fatigue Indicative Fretting on Surfaces [13]

of failure growth in planes angled from 35° to 60° which is not characteristic of pure torsion fatigue failures. The analysis has shown that the coupling bolts are subjected to an increasing bending moment which contributes to fatigue crack growth. The experimental research and numerical calculation done in this case study proved the hypothesis of variable bending stress in the coupling as the failure cause.

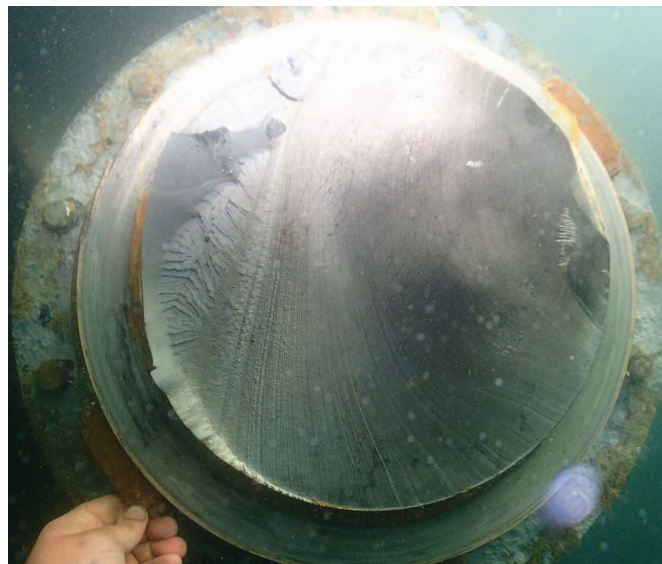
Figure 7 Uniaxial Fatigue Failure Crack Shape [15]

Abnormal performance of the propeller by way of one non-performing malformed blade can generate a uniaxial force which fluctuates once per rotation in a consistent transverse direction across the shaft. The fluctuating force generates a couple which can cause fatigue failure of the propeller hub [15]. Uniaxial type of failure is characterized by a fatigue fracture with a single origination point that progresses across the shaft from the side where the force is being applied and results in the final overload failure occurring on the opposite side from the fluctuating force.
