First Experience in Monitoring of Line Surge Arresters Installed on 110 kV Transmission Line Ston – Komolac in Croatia

In paper are presented some first results and experience in real time monitoring of line surge arresters installed on 110 kV transmission line Ston – Komolac in southern part of Croatia. Mentioned line is the first line in Croatian transmission network equipped with line surge arresters (LSA).

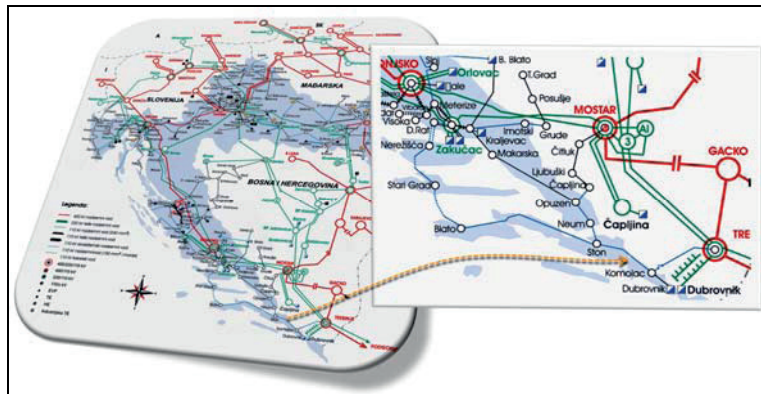
Figure 1-View to 110 kV transmission network in southern part of Croatia (blue lines)

There were several reasons for application of line surge arresters (LSA) on transmission line 110 kV Ston – Komolac. This line is the shortest connection of HPP Dubrovnik (2x120 MVA) to the other part of transmission network in south of Croatia (Fig. 1). The line was constructed in 1961 and a big reconstruction has been done in 1994 with increasing transmission power capability installing TACSR/ACS conductors [4]. Further, it is crossing the region with high soil resistance and it is often exposed to strong lightning-storms. Outages due to lightning usually stopped down the generators of HPP and finally cause black out in region of town of Dubrovnik.

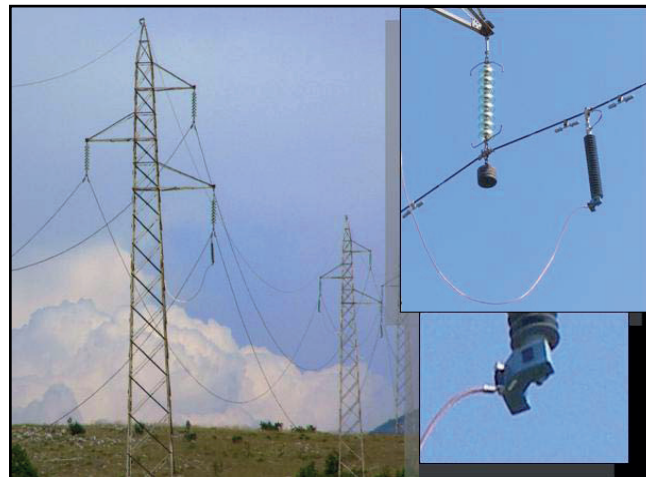
Figure 2-LSA on transmission line equipped with Excount II monitoring sensor

Due to that reasons it was decided to improve lightning performance of line with application of 110 pieces of gapless, IEC Class II line surge arresters [5], [6], [10]. Also, due to improving the analysis of expected results it was planned to equip the 61 line arresters with Excount-II type of monitoring sensors (Fig. 2).

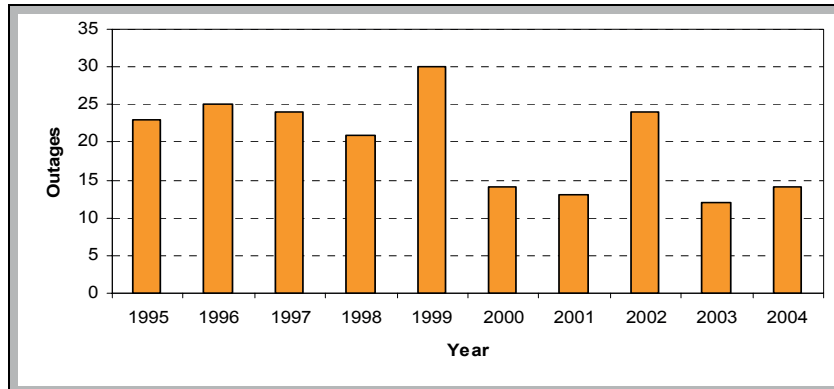
Figure 3-Number of annual outages during period of 10 years on 110 kV line Ston-Komolac (2004-up to June, 2nd only)

The installation and LSA arrangement on 110 kV line Ston-Komolac was based on performed study and computation on line simulation model [10], [11]. It was studied the lightning performance of line for different arresters arrangement along the line, also as a function of different tower earthing resistance. The goal was to find the optimal LSA arrangement to decrease a great number of backflashovers on insulator strings and a number of annual outages of line [12], (Fig. 3).

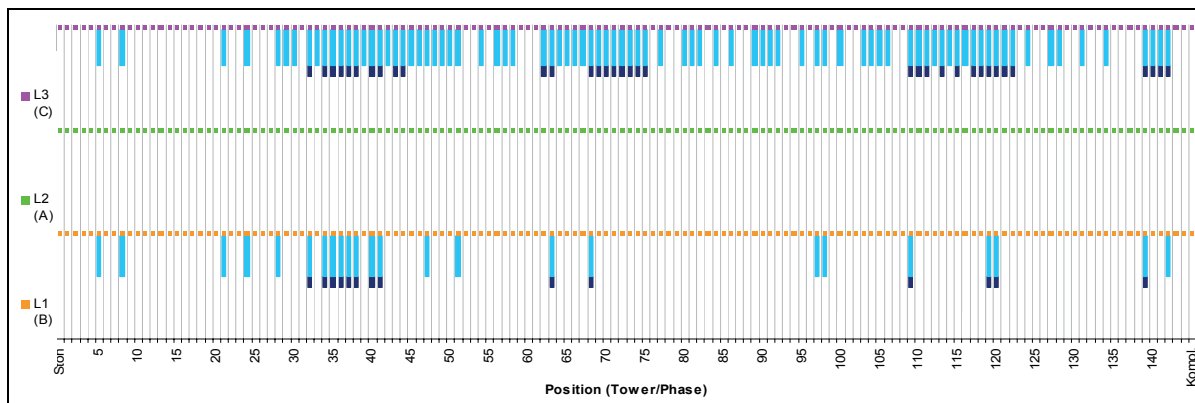
Figure 4-LSA arrangement along the line and installed Excourt II monitoring sensors (dark blue or black)

As a result of computation it was chosen the LSA arrangement with one or two arresters per tower what is showed on schematic diagram on Fig. 4. In Table 1 are given the necessary numerical data. Also it is showed schematic phase arrangement on tower top.

Further, expected reduction of number of annual outages of line - based on performed analyses on line simulation model - must be around 50 percent for chosen arrangement of LSA. For monitoring the LSA activity and for further analyses it was taken 49 Excourt II sensors arranged and positioned on lightning exposed line structures what is also showed on Fig. 4 and in Table 1.

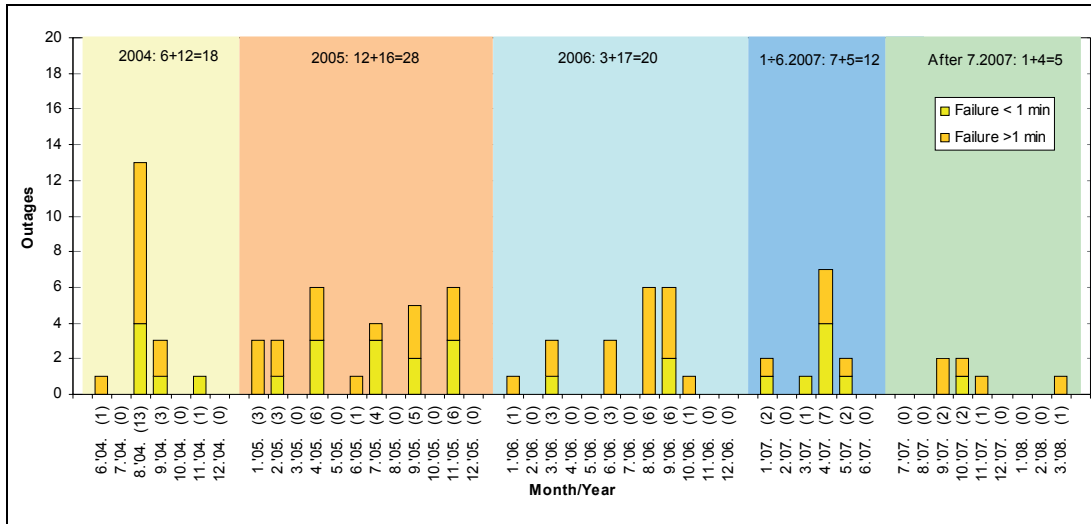
Figure 5-Review of outages on line 110 kV Ston-Komolac (before and after LSA application) (2007: 1-6 without LSA (blue), 2007: 1-12/2008:1-3 with LSA (green))

First results after 9 months of application show that a number of line outages has been reduced (more than 50 percent during 6 months in 2007), particularly in summer time period (Fig. 5). Also, it is in expected range according to calculated values [10].

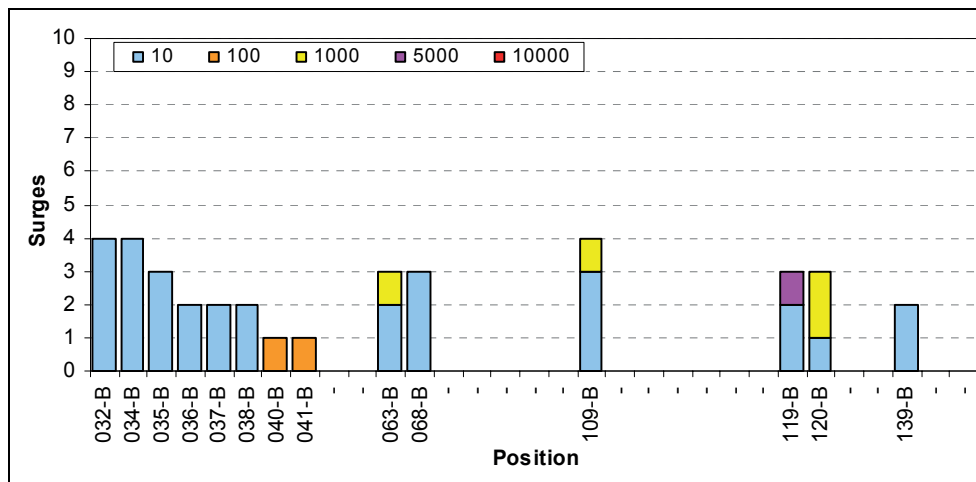
Figure 6-Review of LSA surges registered by Excourt II monitoring sensors in Phase L1 (B)

On Figures 6 and 7 it is shown the registered LSA surge current activity in accordance to sensor position (tower number) and corresponding phase. Additionally, it is shown the number of surges and level of surge current too.

In comparison the LSA activity in phase L1(B) with activity in phase L3(C) it can be concluded that the maximum number and level of surges are registered in phase L3(C). More intensive LSA activity was noticed in phase L3(C) on line tower No. 111 and on several neighbouring towers, too.

But, relating the installed number of monitoring sensors (monitored LSA) per phase and line length a little higher relative values can be calculated for LSA activity in phase L1(B), (see Table 1).

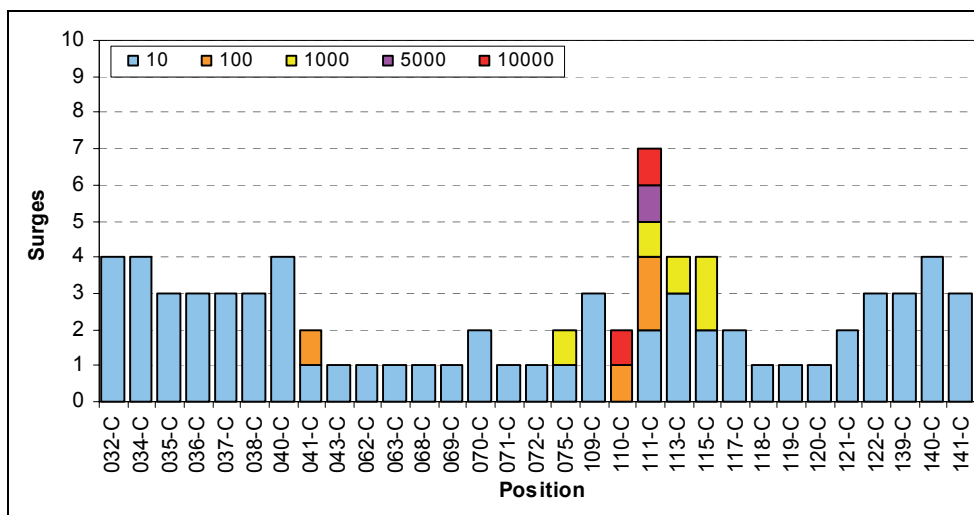
Figure 7- Review of LSA surges registered by Excourt II monitoring sensors in Phase L3 (C)

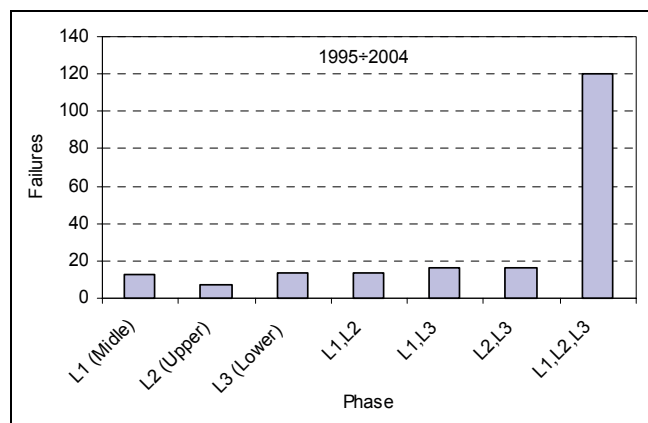
Figure 8- Review of events on line registered by distant relay protection

Of course, those are only the first results given in relatively short time of monitoring. In that sense on Fig. 8 is shown simple statistic review of failures due to events on line registered by distant relay protection during long time period. A portion of three-phase events is very significant.
