# Fire Protection of Historic Streetscapes

## Project Report

Sponsoring Agency: National Association of State Fire Marshals

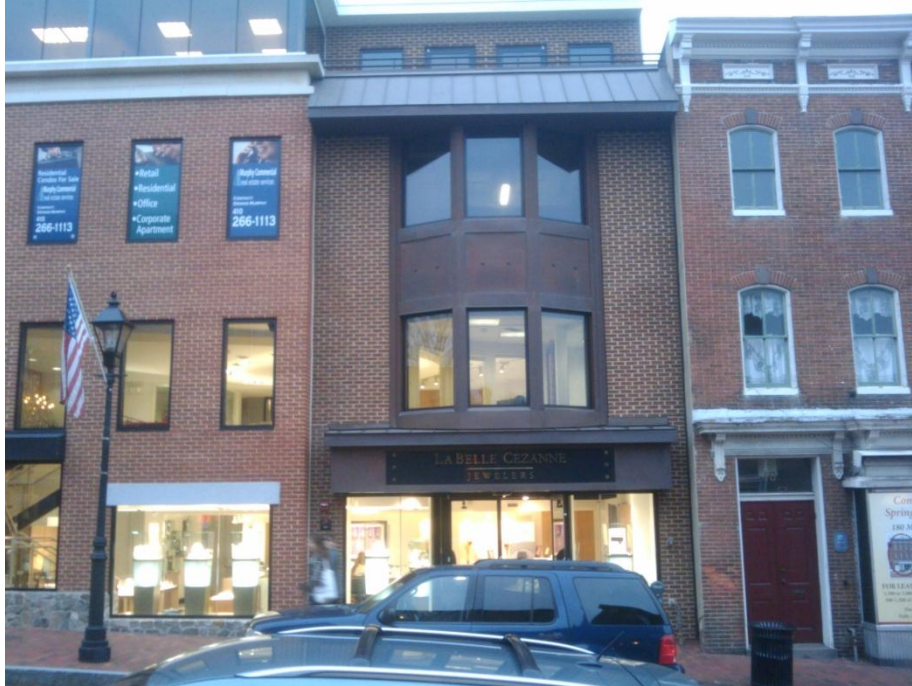
**Figure 2 Site of 1997 Annapolis Fire**

The location of the fire had remained an empty lot up through 2005. Finally, construction began on the buildings, seen in figure 5.

Unlike the original century-old buildings that once stood in its place, the newer buildings are far from historic-looking. In the building on the left, the brick is an entirely different color from the surrounding buildings. The top floor is completely composed of windows, which further detracts from the historic look of the streetscape. The first floor is also open to view because of large windows. The inside is also contemporary style, and is very visible to passersby. It does not appear that the designer even attempted to make the building fit the style of the rest of the historic streetscape. Annapolis is a nationally recognized historic district, but this building does not fit the “historic” mold that most historic districts follow.

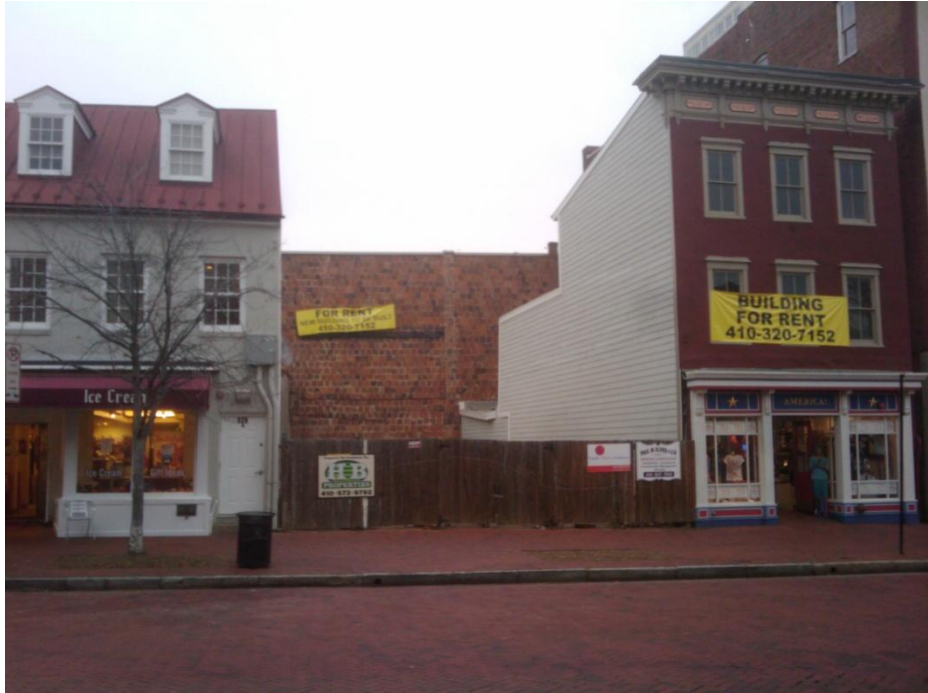
**Figure 3 Site of 2005 Annapolis Fire**

Since 2005, the lot where the buildings once stood remains vacant. The frame of the building on the right remains charred from the fire. The lot is in a very dense section of Main Street, so the hole that the fire left is even more prominent.

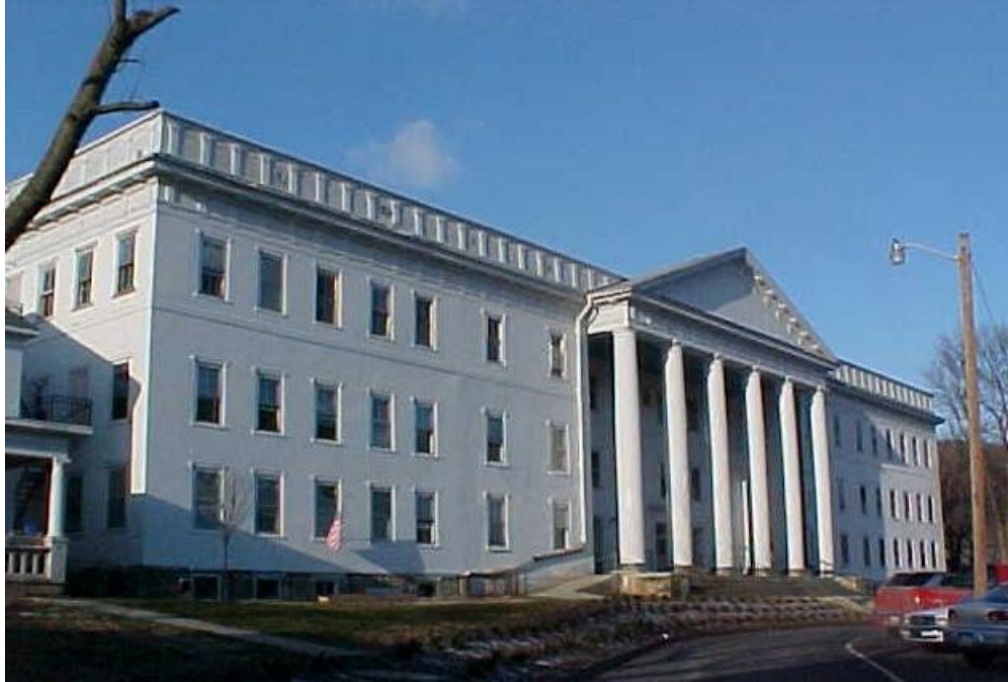
**Figure 4 The Bellefonte Academy, Bellefonte PA Source: E. Hammerstedt.**

The Bellefonte Academy Fire occurred on July 14, 2004. It destroyed 33 apartments and left 40 people homeless, leaving what was once the Bellefonte Academy a smoldering ruin (Bellefonte Fire Department). This complex was 198 years old and was an important historical aspect of Bellefonte (Bellefonte Fire Department). The fire created “fire storm” conditions, ignited two neighboring rooftops, sent burning material a distance of 10 blocks away, and required the 20 fire companies called to help fight the fire (Pennsylvania). These companies were soon forced to relocate to a defensive position due to rapidly deteriorating conditions inside the complex (Bellefonte Fire Department).

The loss of the Bellefonte Academy occurred due to improper maintenance, a severe lack of building inspections, and the lack of a fire detection and suppression system. The Bush House similarly lacked an adequate suppression system. Neither of these buildings has been rebuilt.

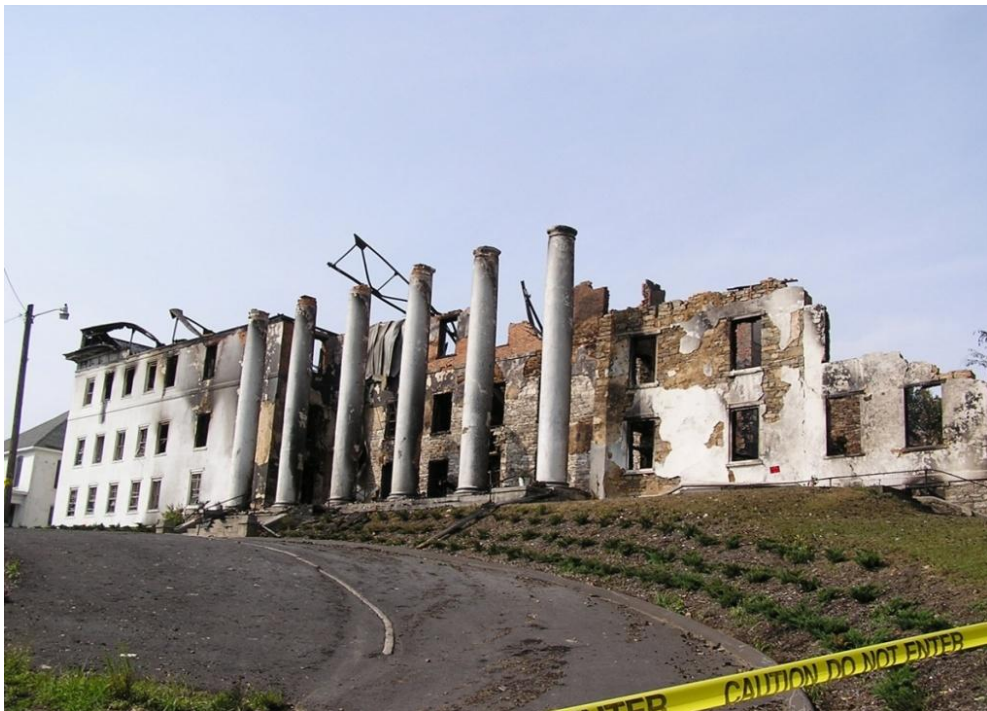
**Figure 5 The Bellefonte Academy Lot, Bellefonte PA (July 14, 2004). Source: E. Hammerstedt.**

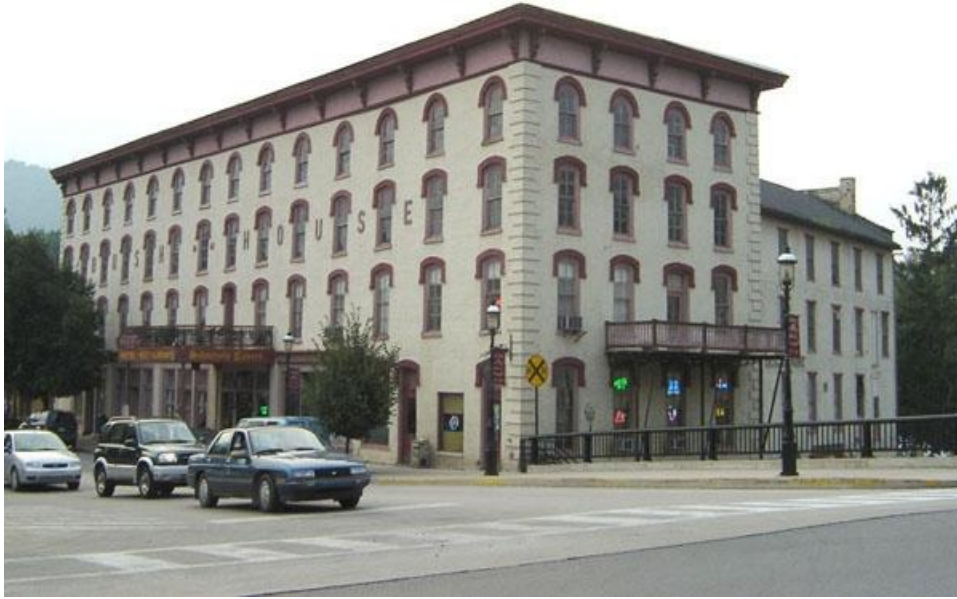
**Figure 7 The Bush House, Bellefonte, PA. Source: E. Hammerstedt.**

The Bush House was the sight of the second major fire in a historic building in Bellefonte. The Bush House originally was a 138-year-old hotel with a 4-story wood frame and brick walls. The building covered an entire city block but had no fire suppression system, such as sprinklers, in place (D. Gentzel, personal communication, November 11, 2009). When it burned down on February 8, 2006, it was home to seven different businesses, all of which were lost in the flame. To this day it has not rebuilt, leaving a piece of charred ground in Bellefonte's waterfront district (E. Hammerstedt, personal communication, December 2, 2009).

The Bush House was a vital piece of Bellefonte's economy because it was both a major landmark and a home to seven businesses. The Bush House had only a limited sprinkler system installed (E. Hammerstedt, personal communication, December 02, 2009).

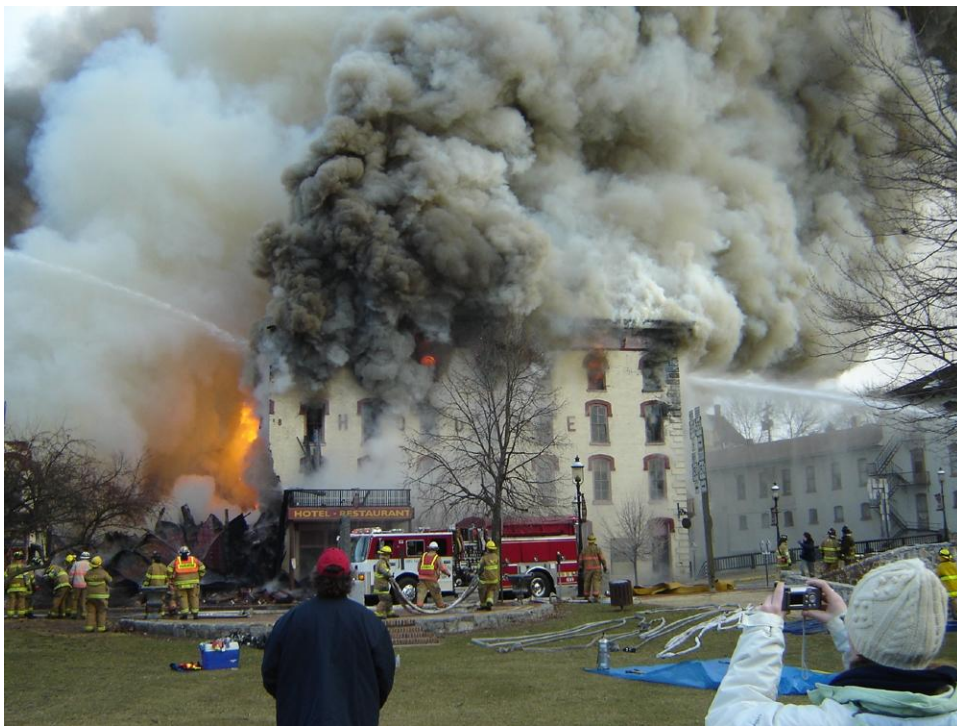
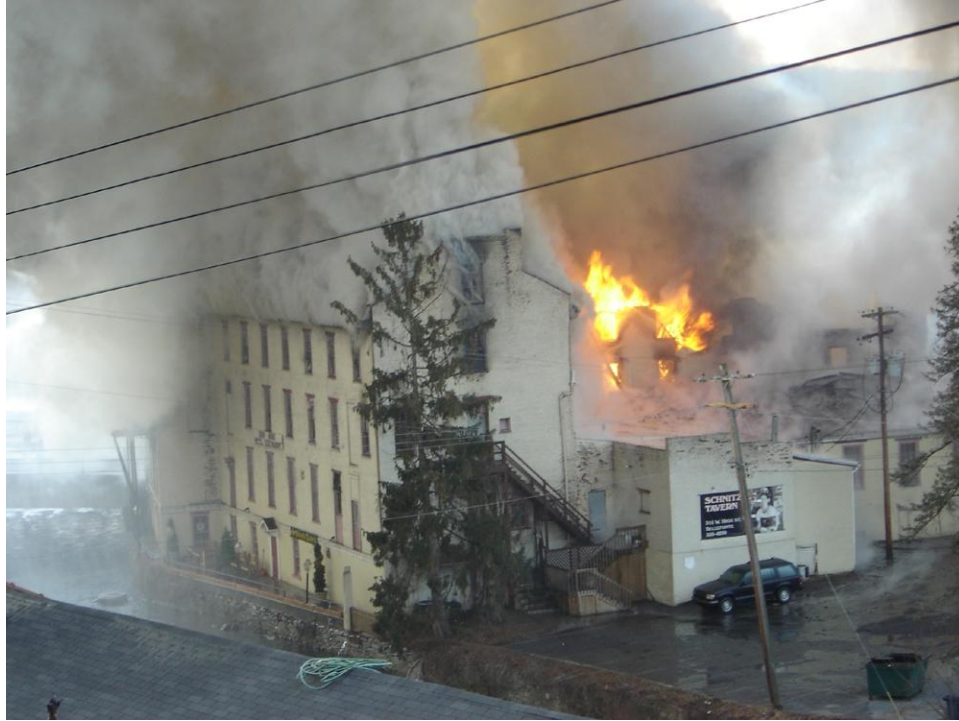
**Figure 8 The Bush House Fire, Bellefonte, PA (February 8, 2006). Source: E. Hammerstedt.**

**Figure 9 The Bush House Fire, Bellefonte, PA (February 8, 2006). Source: E. Hammerstedt.**
