# Auto-Accretion Powered by Microbial Fuel Cells in the Venetian Lagoon

Jessica L. Balesano  
*Worcester Polytechnic Institute*

Jodi Michelle Lowell  
*Worcester Polytechnic Institute*

## **AUTO-ACCRETION POWERED BY MICROBIAL FUEL CELLS IN THE VENETIAN LAGOON**

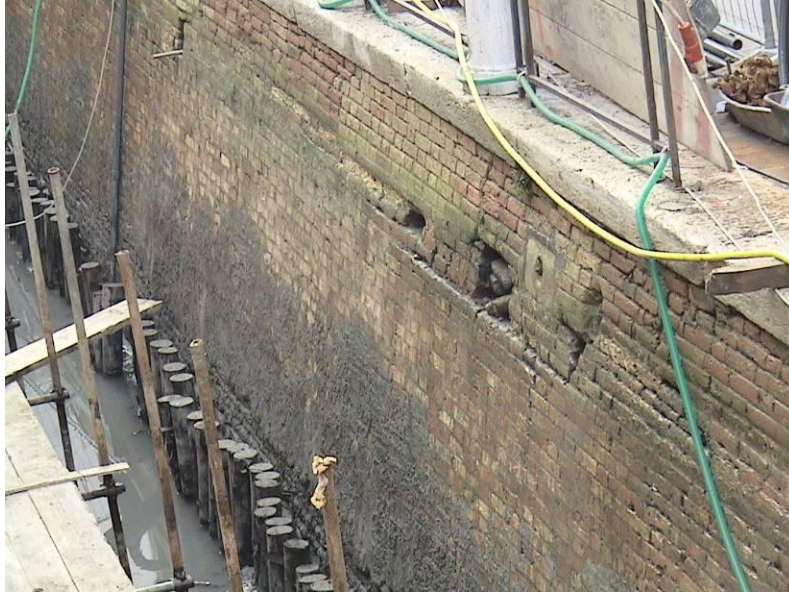
**Figure 1: Example of canal wall damage**

There are many sources of the canal wall damage beyond the mere age of the buildings and materials; one of these sources is *moto ondos*, or damage from boat wake. In open waters, the wake from boats can dissipate over a large area. In the canals and narrow waterways in the Venetian lagoon, however, there is less space and opportunity for the kinetic energy of the wave to be reduced before it strikes the canal walls. The impact causes disintegration of the existing wall material and brick mortar. Figure 1 is an example of the damage inflicted by *moto ondos*.

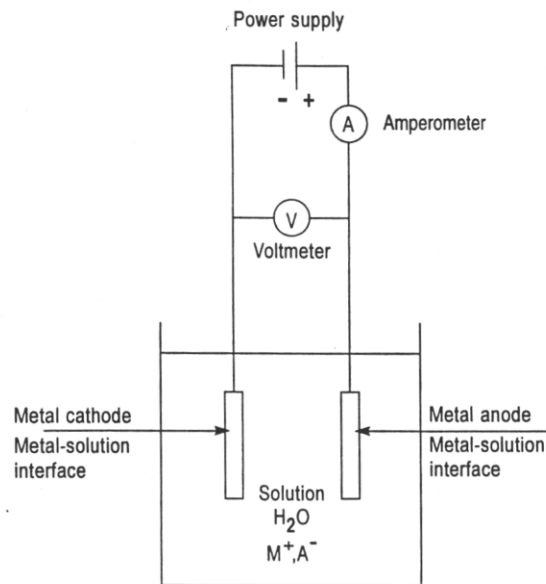
**Figure 2: Electrodeposition (From: <http://electrochem.cwru.edu/ed/encycl/art-e01-electroplat.htm>)**

The principles of electrodeposition can be used to accelerate accretion by inducing an electrical current. Electrodeposition is the process through which a material, usually a metal, is deposited onto the cathode of a circuit that consists of two electrodes – an anode and a cathode – connected by a power source. The circuit is completed by the electrolyte between the electrodes, as seen in Figure 2. In this case, the electrolyte is the seawater and the seawater minerals are the material that is deposited on the cathode. Additionally, the power supply that drives electrodeposition is a direct current supplier, such as a battery charger.

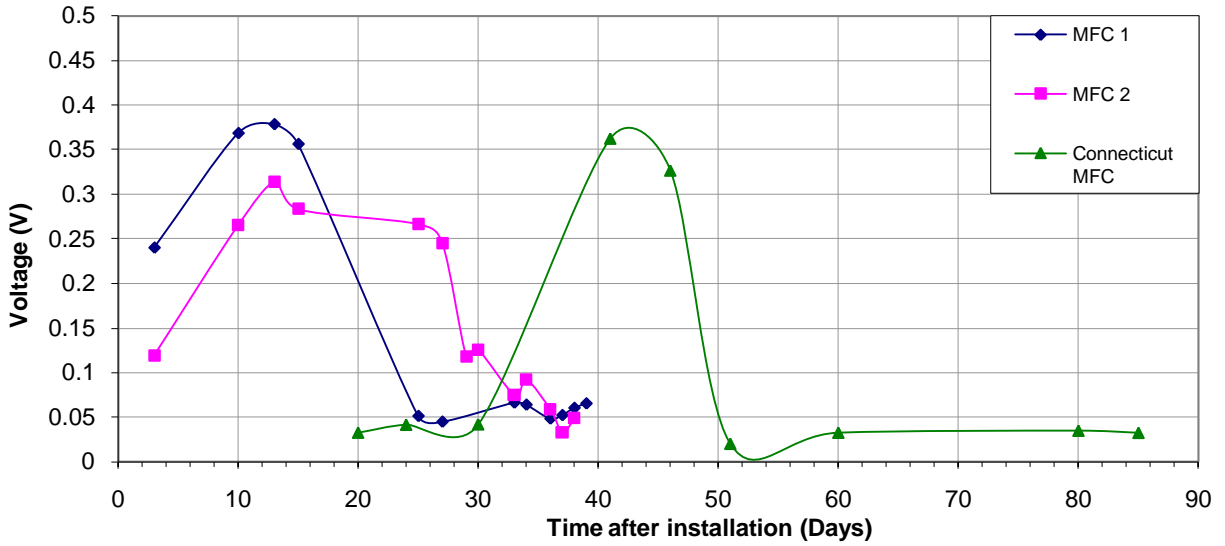
Figure 3: Voltage readings from MFC powered apparatuses

- The voltages for the MFC apparatuses shared a general trend, as shown in Figure 3. The difference was in the peak voltage time, in which case, the Connecticut apparatus took approximately 30 days longer to reach its peak value. The difference in water temperature, thus microbial activity, was identified as the likely cause of this.

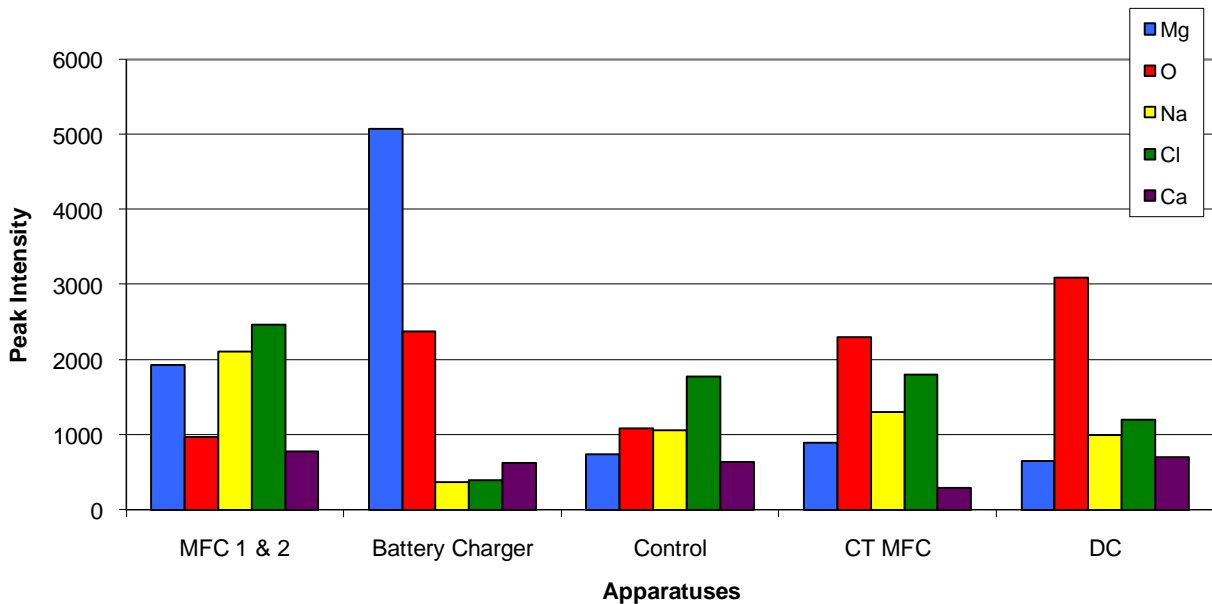
Figure 4: Relative accretion compositions

- Accretion thickness was greatest around the edges of the cathode.
- The MFC powered-apparatuses experienced accelerated accretion rates compared to the control and direct connect apparatuses, but were a mere fraction of that of the battery charger powered apparatus.
- The accretion composition differed between samples and apparatus cathodes. Figure 4 summarizes the general trends found.

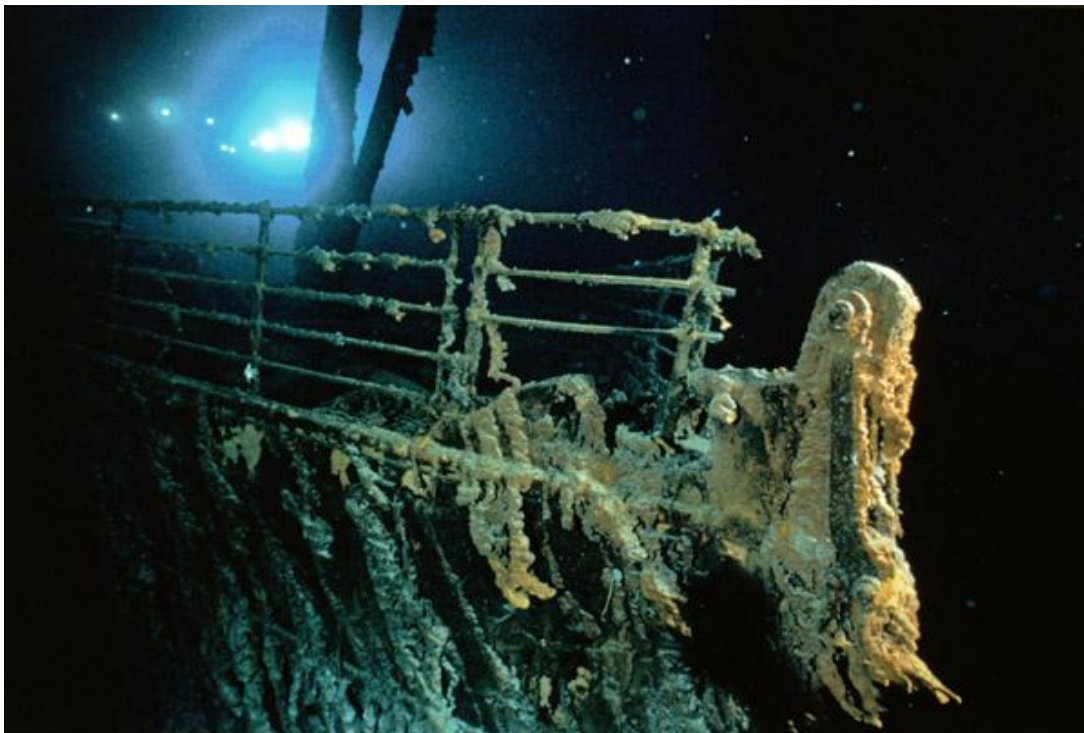
**Figure 5: Example of accretion on a ship wreck (From: <http://voyage.pierwisconsin.org/Titanic/Titanic%20bow%20railing.jpg>)**

Accretion is the accumulation of minerals on metallic objects submerged in seawater. This accumulation is a result of salts precipitating onto the surface of the metal caused by the galvanic behavior of the metal. Accretion is a naturally occurring process that is extremely slow; however it can be enhanced by an induced electric current. An example of naturally occurring accretion can be seen when viewing a shipwreck that has been underwater for many years. As seen in Figure 5, a layer of minerals has begun to build-up on the shipwreck.

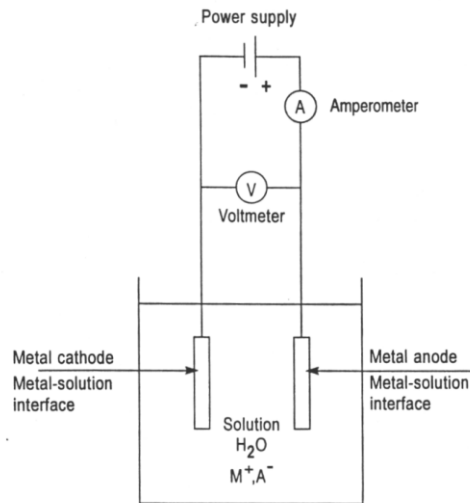
**Figure 6: Schematic of electrodeposition set-up (From: <http://www.intactlabs.com/index.php?t=applications&x=mfc>)**

Electrodeposition is the process by which a layer of material is deposited on a cathode through a current-induced electrical attraction. The process requires two electrodes - an anode and a cathode - a source of electricity, and an electrolyte all arranged in a circuit as shown in Figure 6. The electric current necessary to drive the electrodeposition is supplied by an external source connected to the two conductive electrodes. The electrolyte, the ionic fluid between the two electrodes, completes the electrical circuit, thus allowing the electrons to cycle around the open loop creating a current. The current produced by electrodeposition greatly increases the rate of accretion.

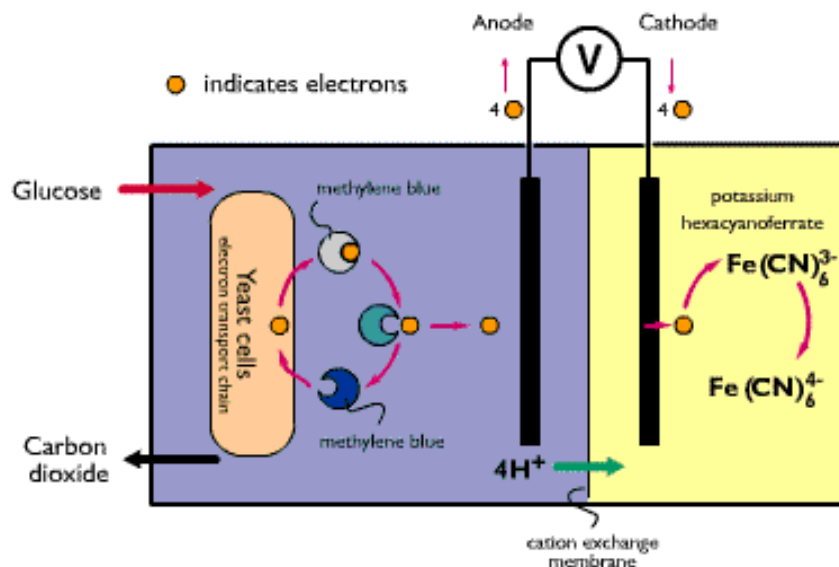
Figure 7: Typical microbial fuel cell (O'Malley, 2003)

A microbial fuel cell usually consists of two electrodes, an anode and a cathode, which are separated into compartments by a semi-permeable membrane. The anode compartment contains a medium comprised of microbes. This compartment also houses the substrate and, if present, the mediators. The compartment that holds the cathode contains a medium of electron acceptors. The electrons given off when the microbes metabolize the substrates are captured by the anode and are then transferred through the electrical circuit to the cathode (Gil et al., 2003). Figure 7 shows a diagram of a general microbial fuel cell. In this diagram, the methylene blue is the medium consisting of microbes, the yeast cells are the microbes, the glucose is the substrate, and the potassium hexacyanoferrate is the medium containing electron acceptors.

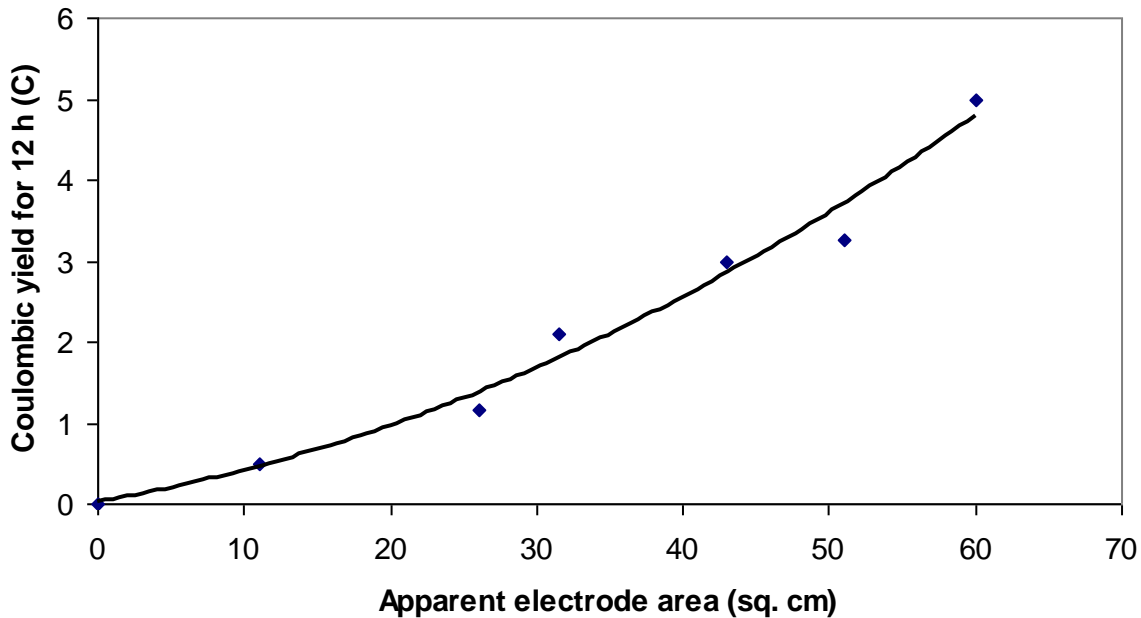
**Figure 8: Relationship between electrode surface area and Coulombic yield in a microbial fuel cell (Kim et al., 2002)**

surface area of the anode; the cathode area should be roughly equal to or less than that of the anode (Logan et al., 2006).

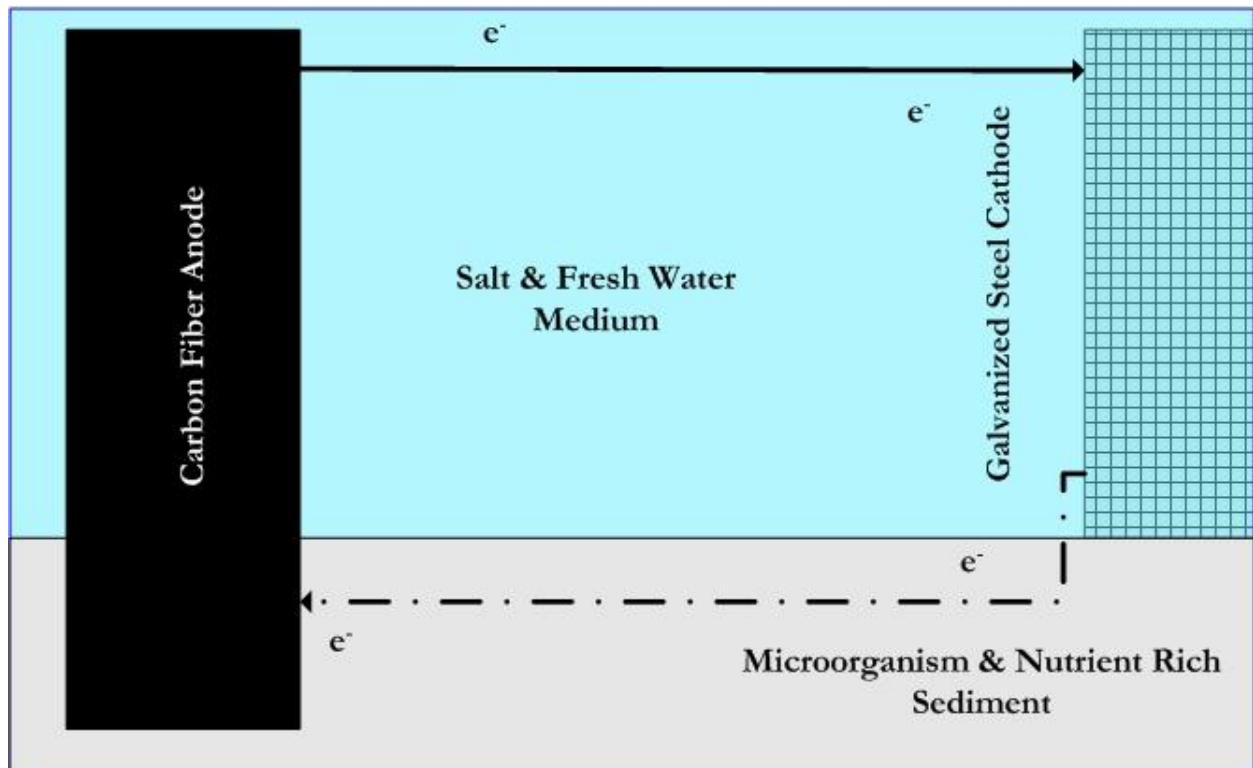
Figure 9: Modified microbial fuel cell (O'Malley, 2003)

A modified microbial fuel cell was used for the purposes of this project. A modified microbial fuel cell is a simpler version of the generic microbial fuel cell. The modified version does not contain any mediators and is used most frequently in seawater or wastewater. When this fuel cell is submerged in seawater, the anode is embedded in sediment containing microbes, and the cathode is placed in the seawater a short distance from the anode. Figure 9 shows a schematic of the microbial fuel cell that has been used in this project. This design allows the current produced by the MFC to drive the accretion of matter on the cathode, instead of solely generating power, which is the purpose of most fuel cells. The goal of this project was to maximize the amount of accretion forming on the cathode. To maximize accretion it was necessary to maximize the current produced by the MFC. This was done by manipulating certain design variables of the MFC, like the distance between electrodes.

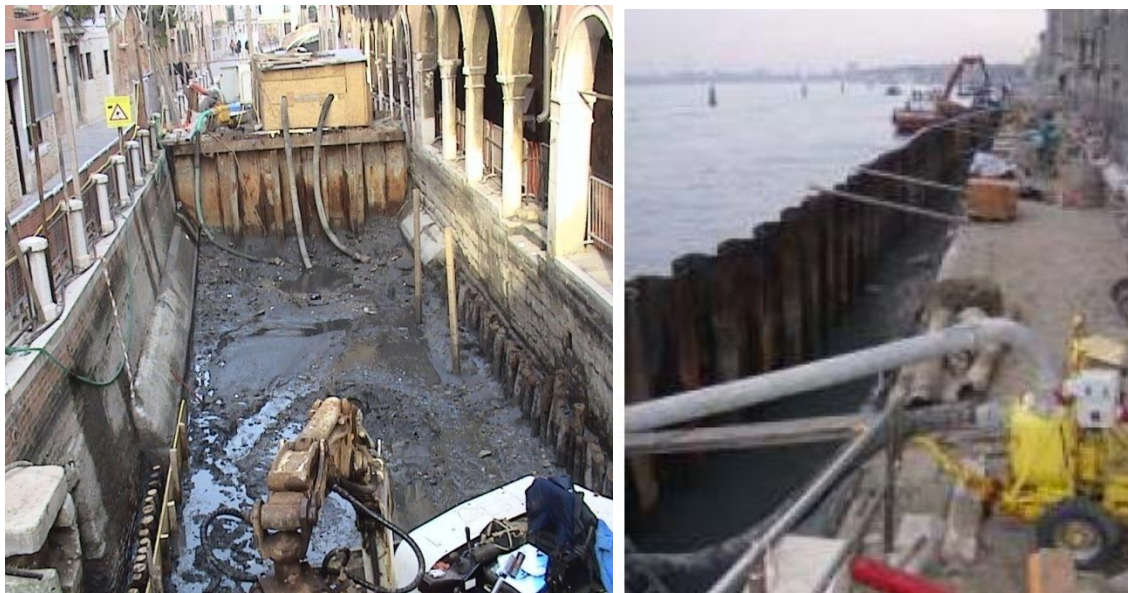
**Figure 10: Canal wall maintenance procedures: dry dredging (left), vertical maintenance procedure (right; Black et al., 2008)**

There are two methods of canal wall maintenance used in Venice, as seen in Figure 10. The first is called dry dredging, and it is used to repair smaller to average canals. During dry dredging the canals are completely drained of all water and the walls are manually repaired as the canal is dredged. This process typically takes six months to complete, during which time the canals are unusable. The average cost of dry dredging canals ranges from \$189 to \$4,766 per square meter of canal wall. The second method of canal wall maintenance is called the vertical maintenance procedure. This procedure is used to repair large and frequently traveled canals because they cannot be dredged all at once without causing extreme delays in transportation. In the vertical maintenance procedure a small portion of the canal is sectioned off relatively close to the wall so that boats are still able to pass. This section is then drained and the canal wall is repaired. The average cost of this procedure is about \$11,680 per square meter of canal wall (Black et al., 2008).

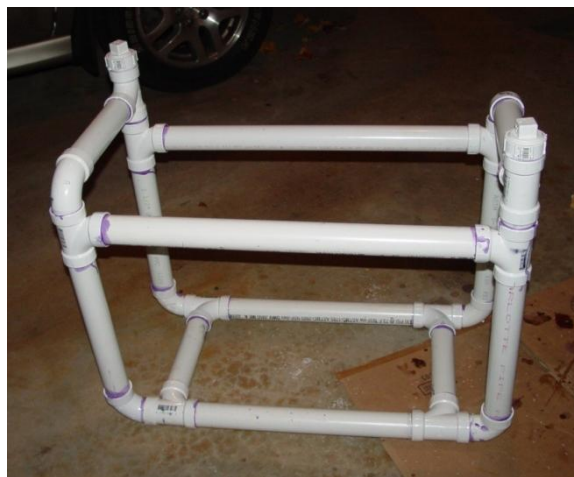
**Figure 11: Assembled frame for Connecticut apparatus**

The materials used for the apparatus construction were chosen for their physio-chemical properties and their availability in the local marketplace. The frame for the Connecticut apparatus as shown in Figure 11, for example, was made from poly-vinyl chloride (PVC) piping due to the wide-availability, low cost, and electrically insulating properties of the PVC piping and fittings. Also, it has high tensile strength properties, relatively no corrosivity in salt water, and was fairly lightweight. A primer and cement specified for PVC applications was chosen to bind the various pipes and fittings together. The dimensions of the frame were determined by the size of the electrodes that were secured inside of it.

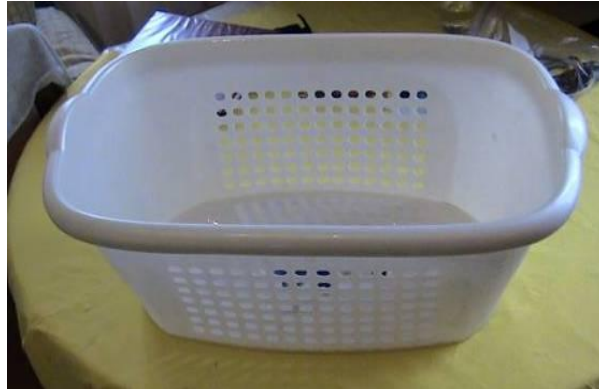
**Figure 12: Laundry basket frame for Venetian apparatuses**

The material used for the Venetian apparatuses' frames was a common plastic in the form of a laundry basket, see Figure 12. The high-strength plastic laundry basket was also widely available and reasonably inexpensive in Venice, relative to the cost, availability, and irregular angles of the PVC piping and fittings. It also shared the PVC's insulating, non-corrosive, and lightweight properties, yet did not require any assembly or binding agents.

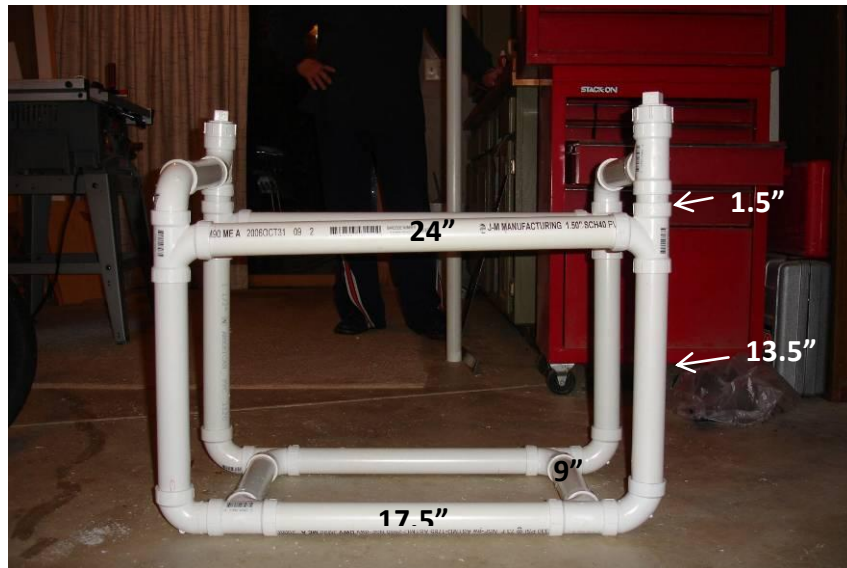
**Figure 14: Dimensions for Connecticut apparatus frame**

- 1) Obtained PVC pipes and cut to appropriate lengths:
  - a) 2 x 17.5" (44.45 cm) Bottom long pieces
  - b) 2 x 24" (60.96 cm) Top long pieces
  - c) 4 x 9" (22.86 cm) Bottom and top short pieces
  - d) 4 x 13.5" (34.29 cm) Vertical pieces
  - e) 2 x 1.5" (3.81 cm) Compensation for different fittings not aligning

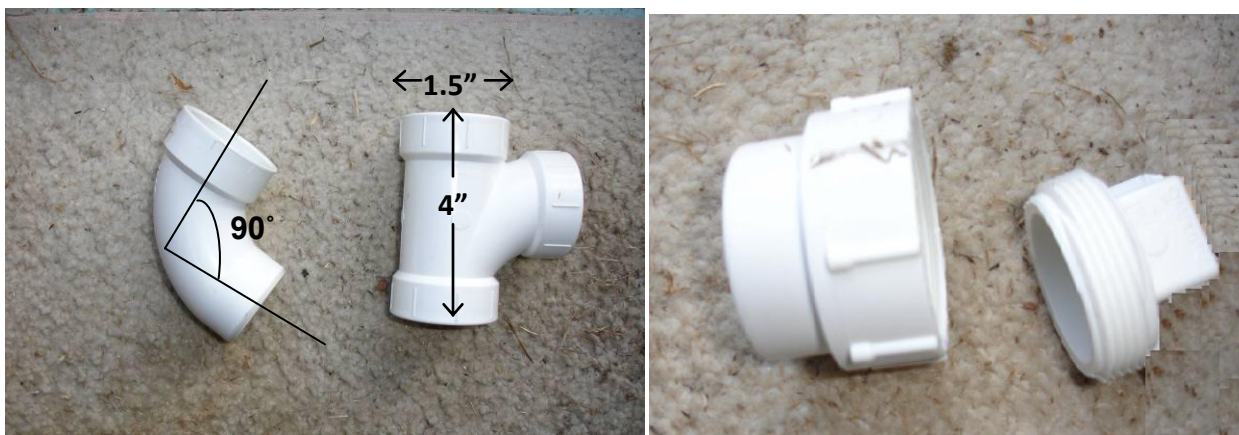
**Figure 15: Fittings for Connecticut apparatus frame (from left to right: 90-degree elbow, T, removable cap)**

- 2) Obtained the proper fittings:
  - a) 6 x 90-degree elbows
  - b) 10 x Ts
  - c) 2 x removable caps

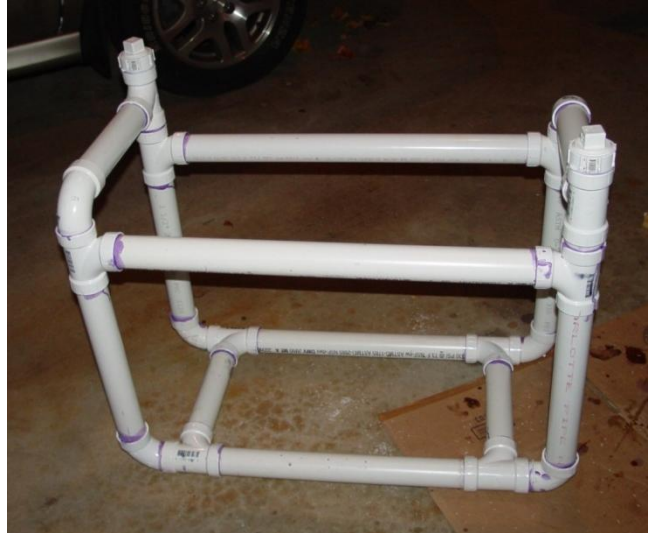
**Figure 16: Final PVC piping frame for Connecticut apparatus**

- 3) Assembled apparatus as shown in Figure 16, making sure to apply primer and cement to the PVC pipes and fittings that made contact with each other.

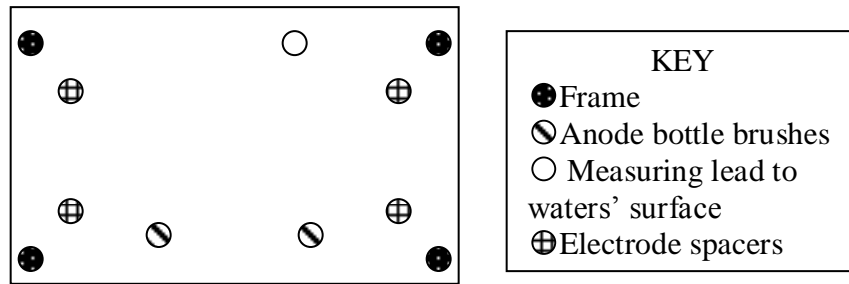
**Figure 17: Anode plate holes and connection points for Connecticut apparatus**

- 7) Drilled 12 holes into stainless steel (SS) plate – 4 for connection to frame, 2 for wire connection from anode brushes, 1 for measurement leads that run to the surface, and 5 for electrode spacers. See Figure 17 for location of holes.

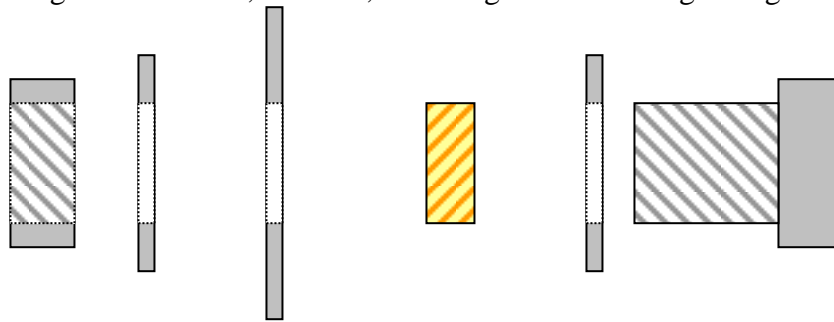
- 8) Connected copper wire from bottle brushes and measuring lead to the waters' surface to anode plate using metallic bolts, washers, and wing nuts according to Figure 18.

Nut – Washer – SS plate – Copper wire – Washer – Bolt

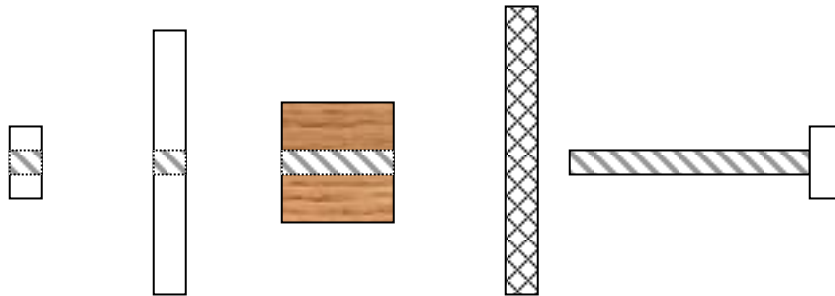
- 10) For construction of spacers, cut 1" (2.54 cm) thick spacers from wooden dowel. Drilled a pilot hole through the center. Connected electrodes according to Figure 19.

Plastic nut – SS plate – Wood spacer – Wire mesh – Plastic bolt

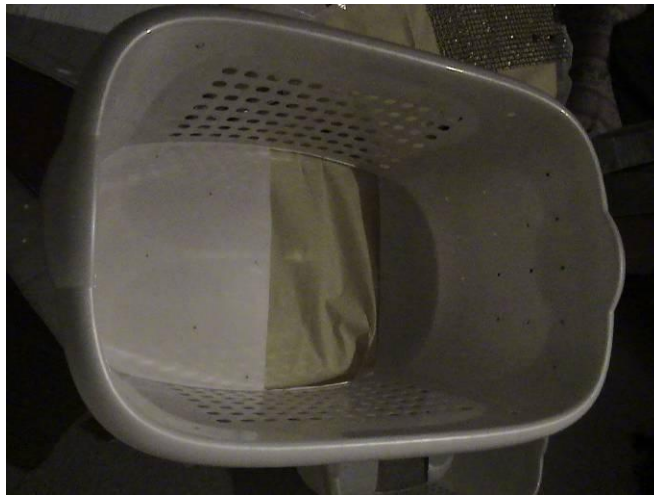
**Figure 21: Modified laundry basket**

1. Obtained 5 laundry baskets, as shown in Figure 12.
2. Determined and marked location for anode brushes, electrode plates, and rope attachments.
3. Drilled holes into ends of laundry baskets to allow for more flow throughout the basket.
4. Drilled holes for anode brushes and rope attachments.
5. Removed an equal amount of the bottom of the laundry basket from each of the apparatuses directly beneath the electrode plates and as far to the ends of the basket as possible to allow for the movement of water and sediment underneath the baskets. The parts of the bottom of the laundry basket that remained were the end with the anode brushes and a small part on the opposite end in order that rocks could rest on it to weigh the apparatus down. For consistency, all of the baskets were modified identically. See Figure 21.

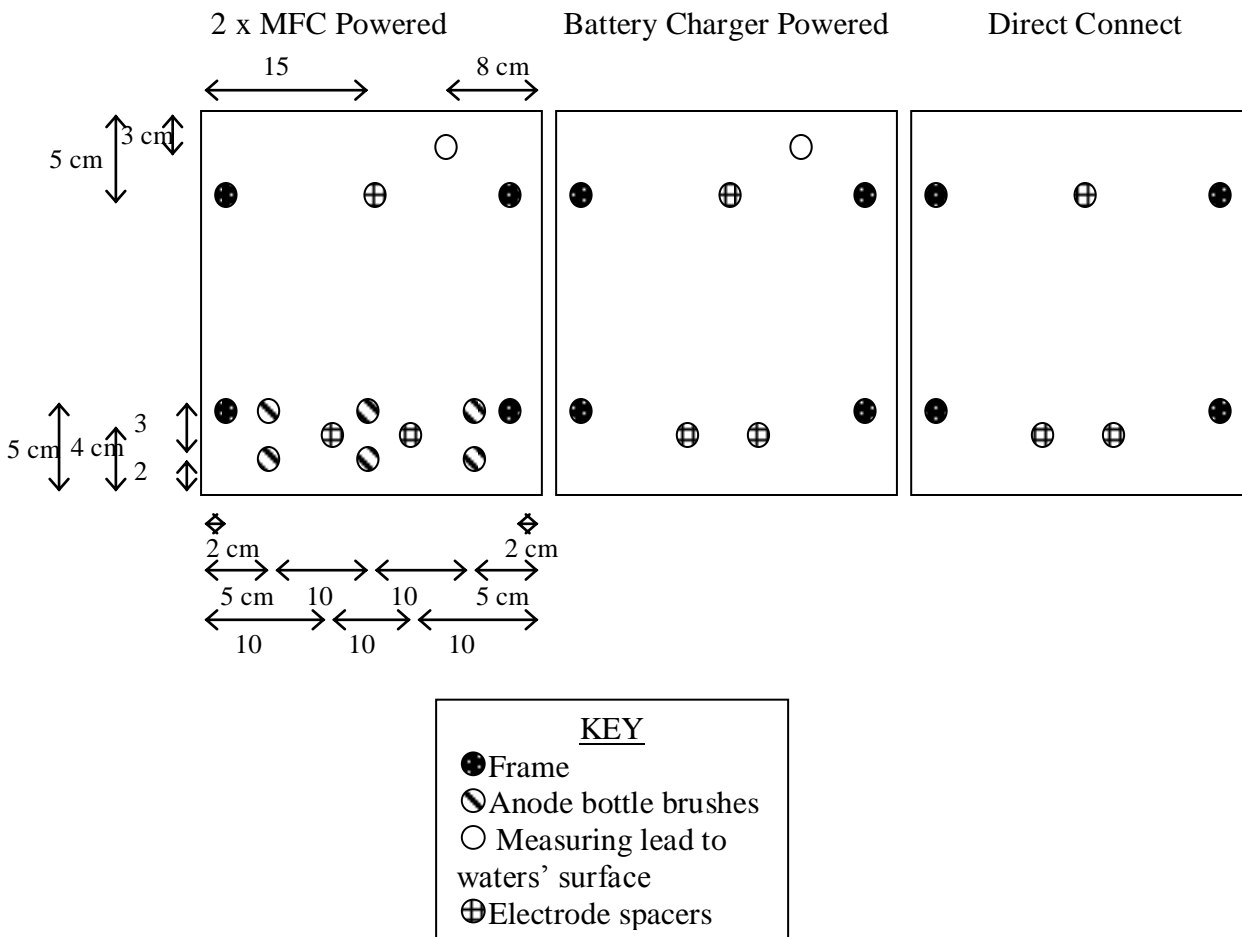
Figure 22: Anode plate holes and connection points for Venetian apparatuses

8. Holes were drilled into the four steel plates as shown in Figure 22. The measurements are to the center of the drilled holes.

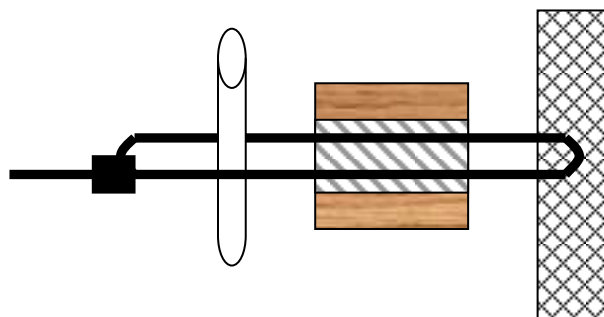
11. Cut twelve 3cm spacers - 3 spacers for each of the 4 anode plates. Drilled a pilot hole through the center and connected the anode and cathode plates using zip ties as shown in Figure 23.

Zip tie around: Plastic tubing – Wood spacer – Wire mesh  
**Figure 23: Configuration of electrode connection for Venetian apparatuses**

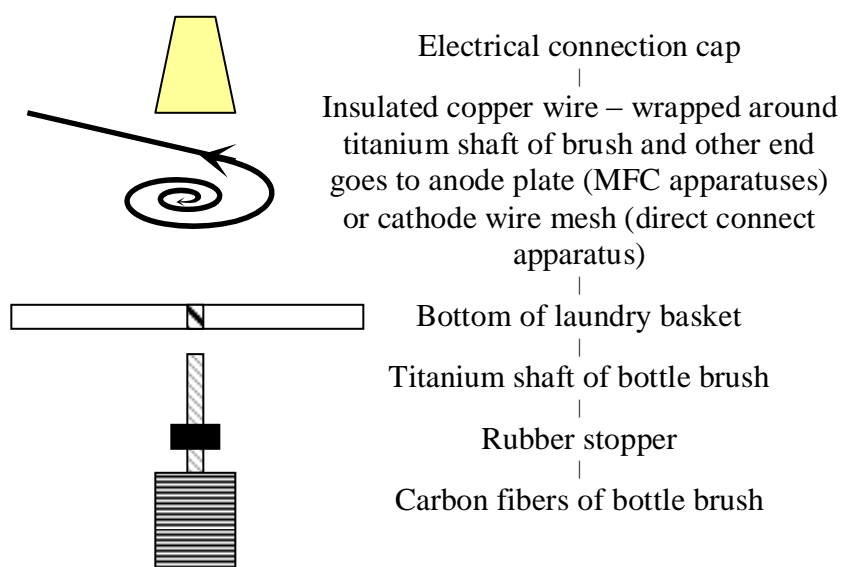
**Figure 24: Connection of anode brushes to basket**

- Divided the 18 anode bottle brushes evenly among the two MFC and one direct connect apparatuses, equating to 6 brushes for each of those three apparatuses. Attached the brushes to the apparatus baskets as shown in Figure 24.

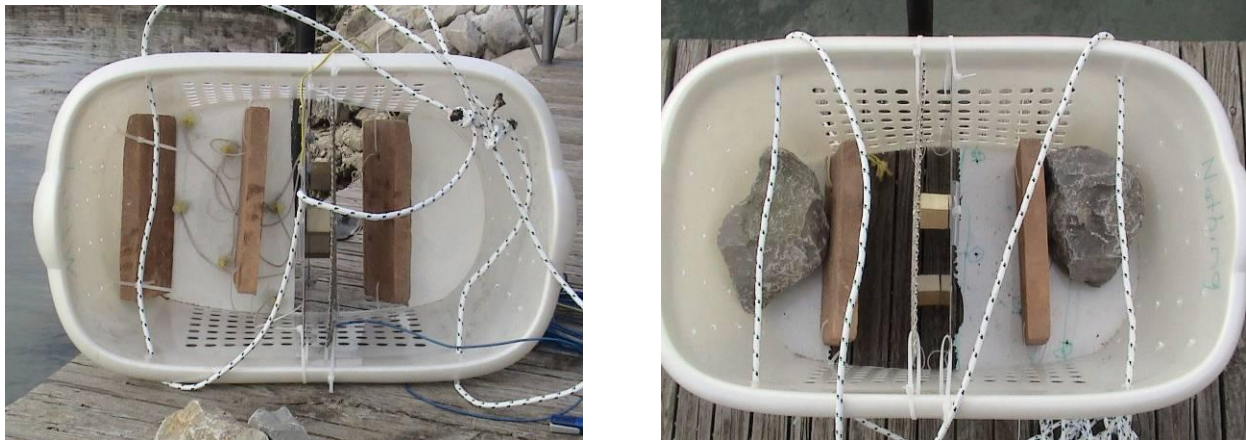
**Figure 25: Bricks secured inside MFC & direct connect apparatuses (left) and control & electric apparatuses (right)**

17. Threaded rope through the pre-drilled holes of the baskets and formed a loop on either side of the basket. Tied a single rope between the two loops with enough rope left on the end to ensure it would be long enough at the unknown depth. Burned the ends of the ropes to prevent fraying and unraveling of the strands.
18. Obtained bricks with one hole off to one end of the brick from around Lazzaretto Nuovo. Drilled another hole at the other end of the brick.
19. Secured brick to the insides of apparatuses using zip ties, as shown in Figure 25.

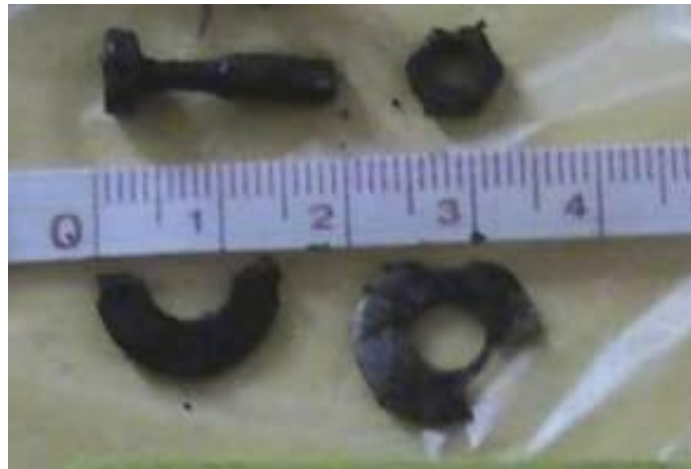
**Figure 26: Corroded bolt, nut, and washers**

While the numerical support for this proposed system was interesting, the unquantifiable conclusion of whether matter was accreted on the wire mesh cathode was the most important result. It was believed, however, that the apparatuses did not have ample chance to accrete the matter, largely due to corrosion. The apparatuses were regularly monitored and when the measured electrochemical properties were not as were expected about 30 days after installation, the apparatuses were hauled out of the water. The readings were not completely consistent up to that point, however, the fluctuations were attributed to a change in other uncontrollable variables, such as the tidal level. It was not until the readings continued to decrease dramatically that the apparatuses were lifted out of the water for closer inspection. That inspection led to the discovery of the worst case scenario: the copper wires and the nuts, bolts, and washers that were located at each of the wire connections suffered much damage from corrosion. Figure 26 shows the damage that one nut and washer withstood, as the silicon only provided a buffer to the corrosive seawater for less than 3 weeks.

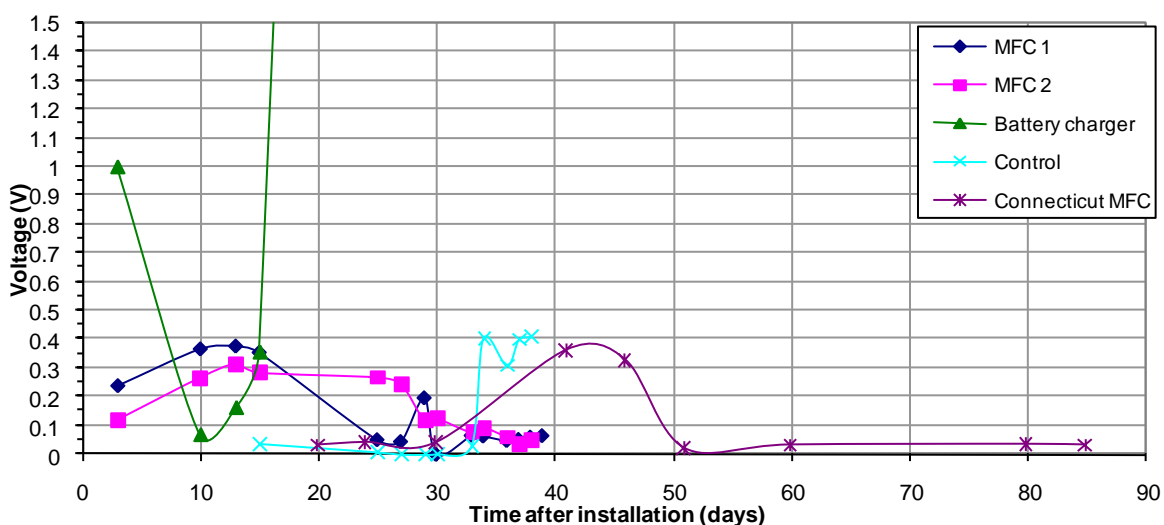
**Figure 27: Recorded voltages as a function of time**

The voltage was a reading of the electrical differences between the wire mesh and steel plate. The greater the amount of electrons flowing from the sediment to the steel anode plate, the greater the electrical potential difference. However, as the accretion accumulated on the cathode, an increase in the resistance and therefore decrease in voltage should have been measured. The voltage readings were recorded at various times of day at different tidal conditions. The results of the readings, see Appendix A: Apparatus Maintenance Schedules for readings schedule, were as shown in Figure 27.

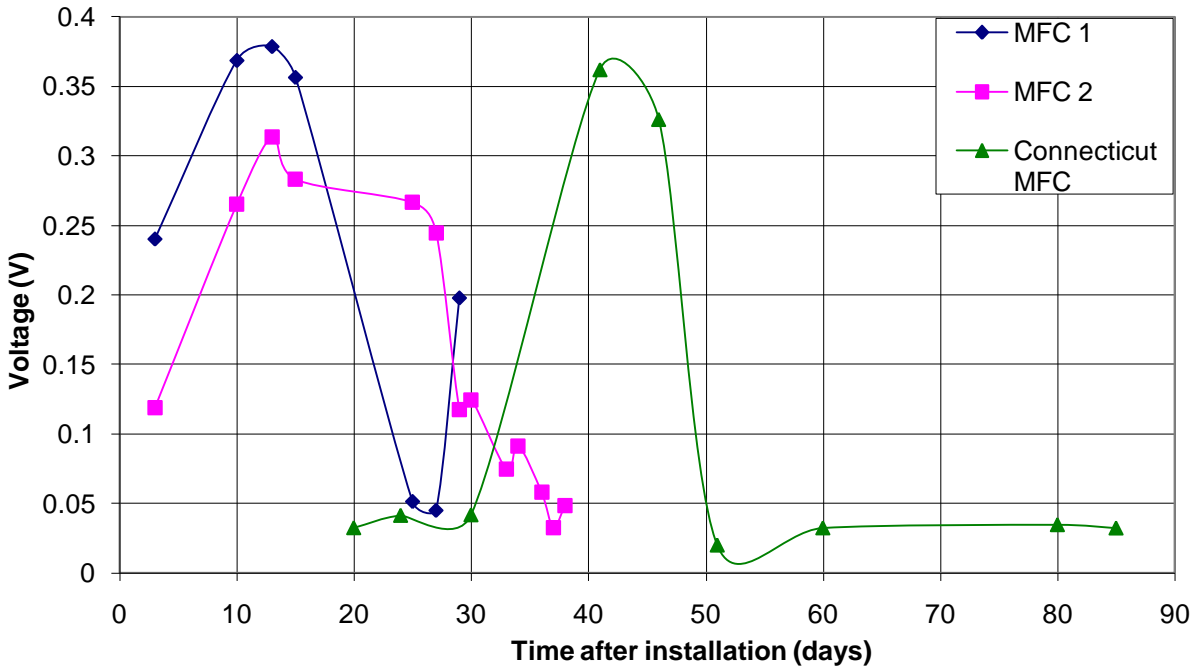
Figure 28: Voltages from MFC powered apparatuses

amplitude of peak voltage was nearly identical for the MFC 1 from Venice and the Connecticut apparatus, with the MFC 1 from Venice only achieving about a 4 percent higher peak voltage. The interesting difference in the trend was when the spike in voltage occurs. For the Venetian MFC powered apparatuses, the peak occurred at about 13 days after installation, versus after about 42 days for the Connecticut apparatus. This could be due to many factors, including the 5°C on average colder water temperatures in Connecticut, which, as previously discussed, would significantly decrease the amount of microbial activity, or the anode brush surface area (Aimo et al., 1999; Ltr\_1003, 2008; Ltr\_1103, 2008; Ltr\_1203, 2008; Ltr\_0104, 2008).

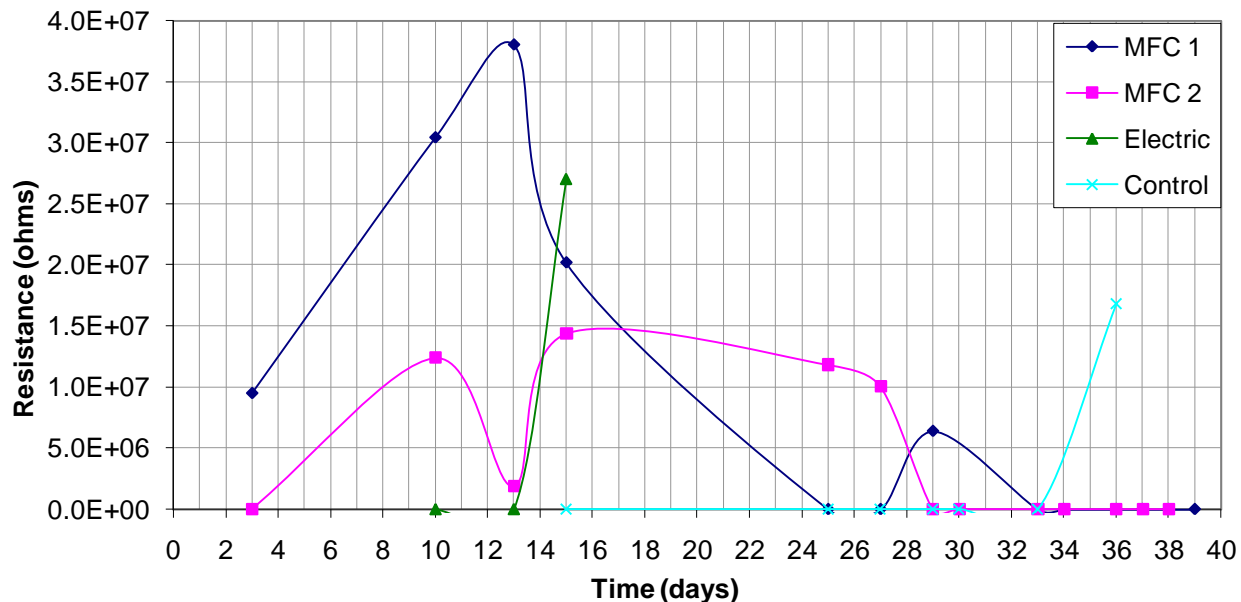
Figure 29: Recorded resistances as a function of time

Similar to the voltage readings, the recorded resistances seemed to be quite sporadic, as seen in Figure 29. The resistances for the Connecticut and direct-connect apparatuses were not recorded, but there was no clear trend that could be drawn from the data that was recorded, even with tidal conditions taken into consideration.

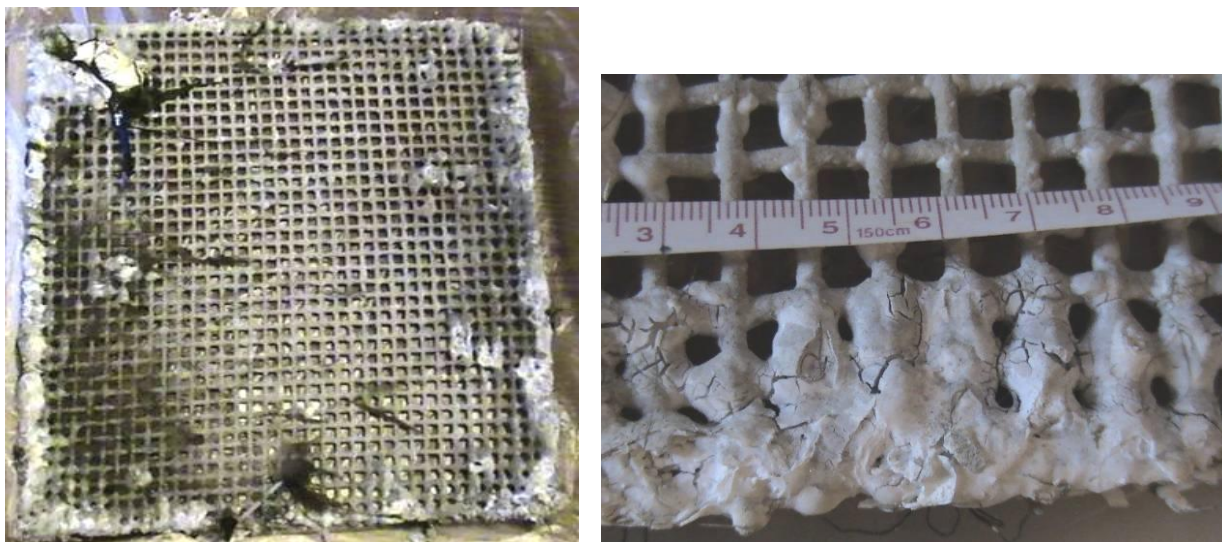
**Figure 30: Accretion on battery charger powered apparatus: accretion distribution on wire mesh (left) and magnitude of accretion difference of interior versus mesh edges (right)**

Unfortunately, only the battery charger powered apparatus accreted enough matter for the sample to be visually assessed without the assistance of a microscope. The distribution of the accretion was visible only on that apparatus. Figure 30 shows how the accretion thickness appeared to be relatively equal across the interior of the wire mesh, only slightly thicker than the interior near the electrical connections, and much thicker around the edges of the wire mesh. This was not the same result that Hilbertz (1979) achieved with his experiment of accretion powered by a DC current in the waters off of St. Croix. In his experiments, the accretion was thickest at the top of the wire mesh where the DC power was connected and then the thickness tapered off slightly as the distance to the power connection increased (Hilbertz, 1979). However, since his experiments had a full layer of accretion and the accretion achieved in Venice did not even close the gaps of the wire mesh, it was hypothesized that the Venetian apparatus may have achieved the same results with more time.

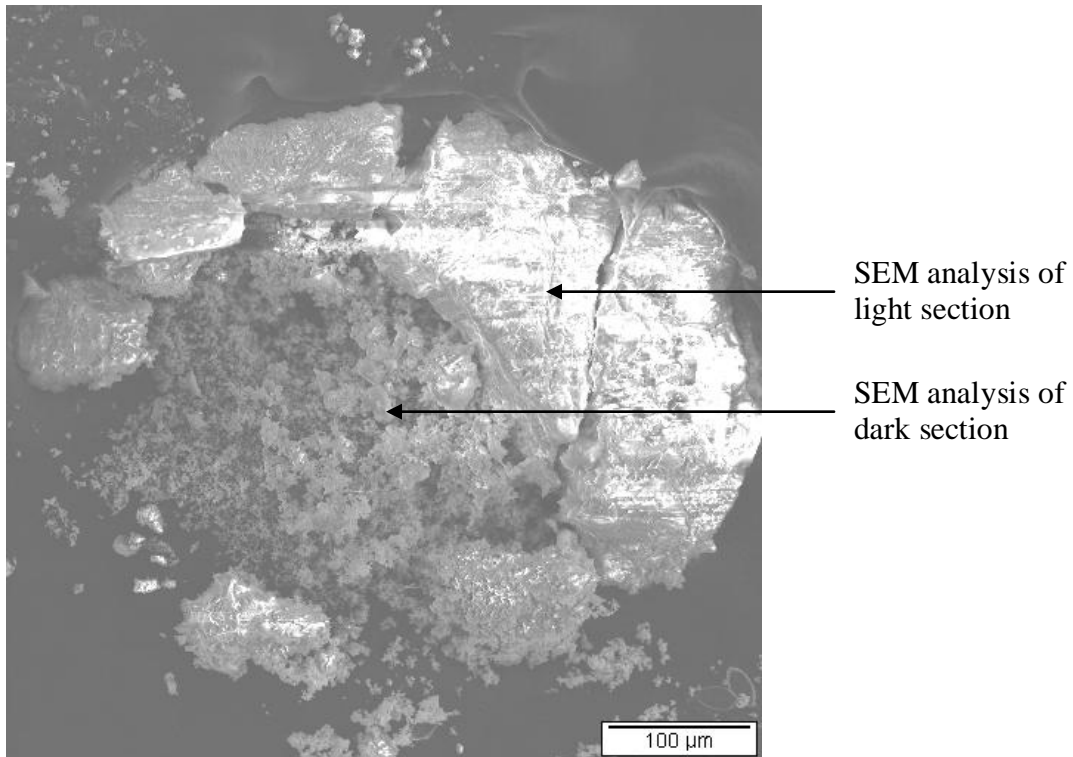
**Figure 31: Accretion particle 1 from MFC 1**

A few approximately 1-2mm flakes found on the surface of the MFC- powered apparatus 1 were analyzed using a SEM. There were flakes about this size scattered around the wire mesh, but the flakes picked up by the carbon tape and analyzed were found slightly off-center of wire mesh. Two flakes were analyzed by the SEM, one of which was analyzed in two locations on the same flake. This was done because of a visual difference seen using the SEM at 100X, also seen in Figure 31.

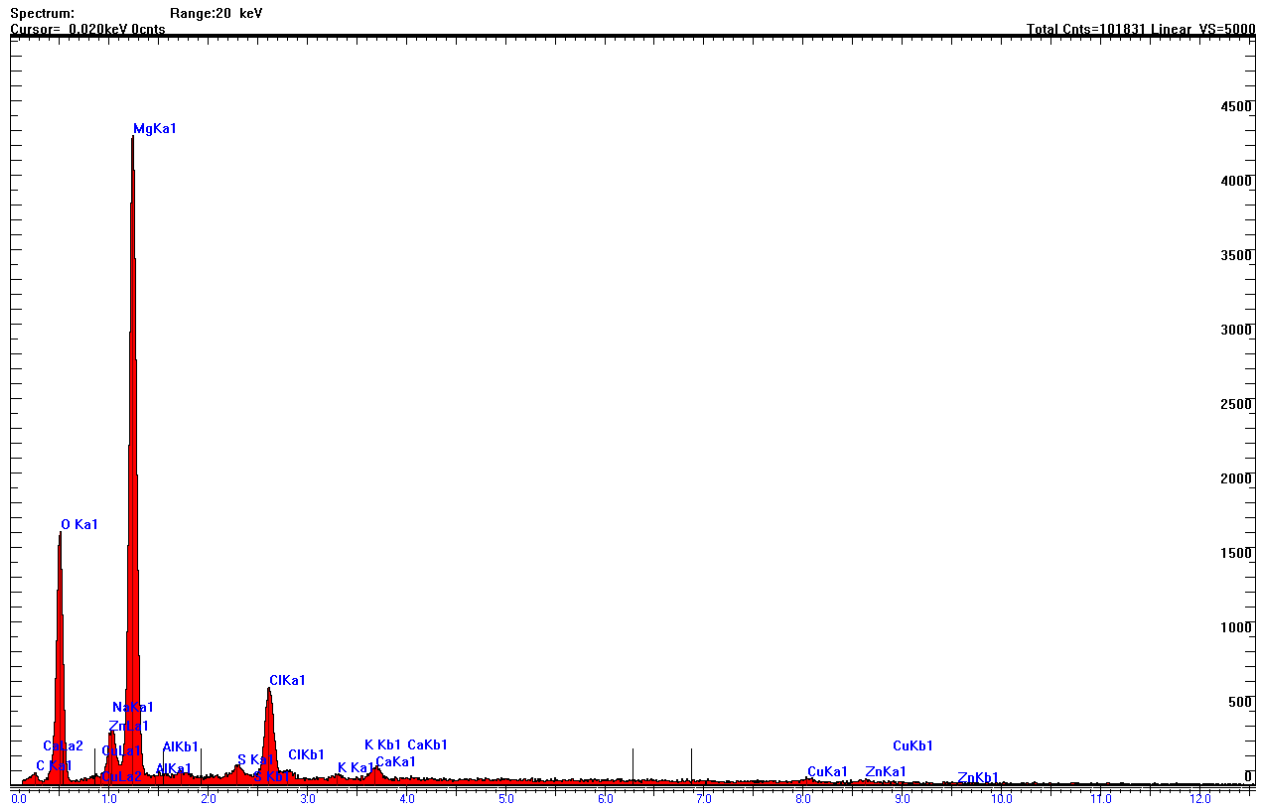
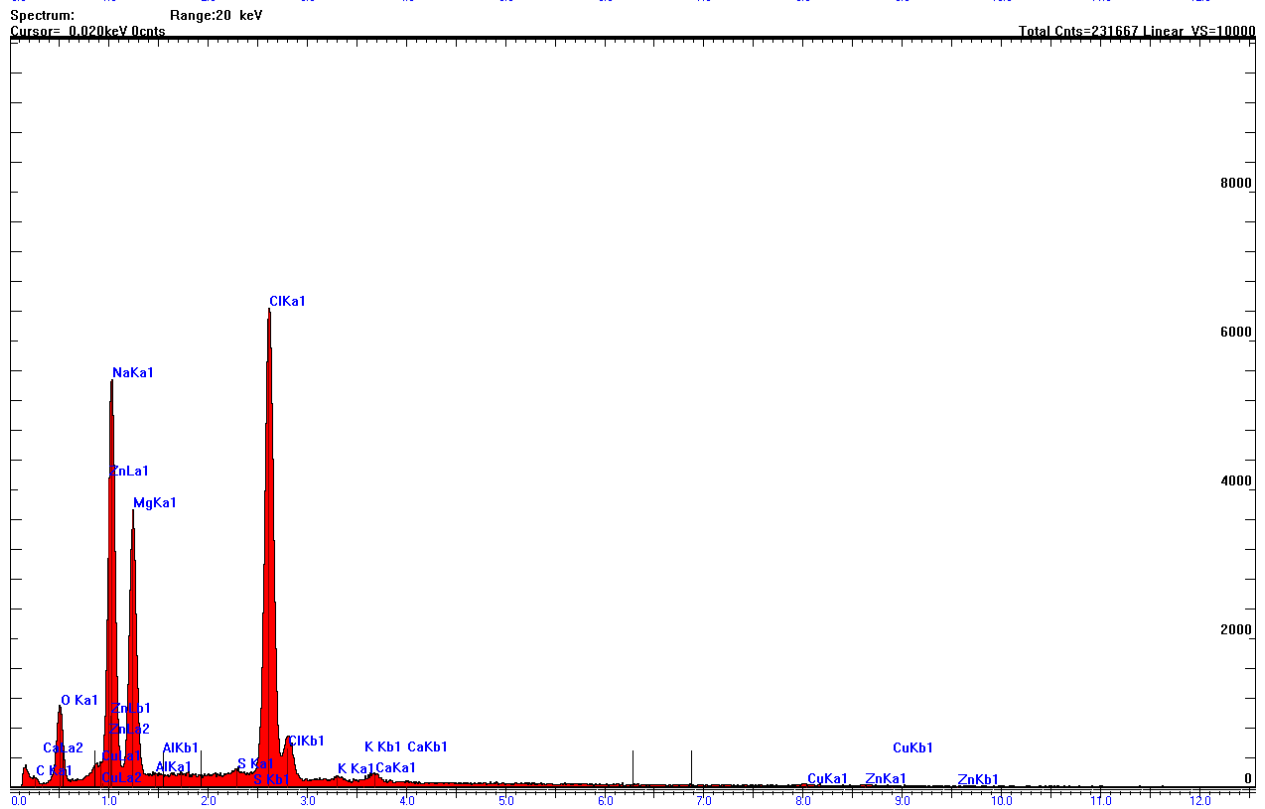
Figure 32: SEM analysis results of dark section (top); SEM analysis results of light section (bottom)

As seen in the SEM results in Figure 32, the major peaks, or elements, found in the dark section were mostly magnesium (Mg) and oxygen (O) as expected. The SEM analysis in the lighter-colored section of the same particle, however, revealed that the major elements in this portion of the particle were not Mg and O, but were sodium (Na) and chloride (Cl) with a large amount of Mg still present.
