# Auto-Accretion Powered by Microbial Fuel Cells in the Venetian Lagoon

Jessica L. Balesano  
*Worcester Polytechnic Institute*

Jodi Michelle Lowell  
*Worcester Polytechnic Institute*

## **AUTO-ACCRETION POWERED BY MICROBIAL FUEL CELLS IN THE VENETIAN LAGOON**

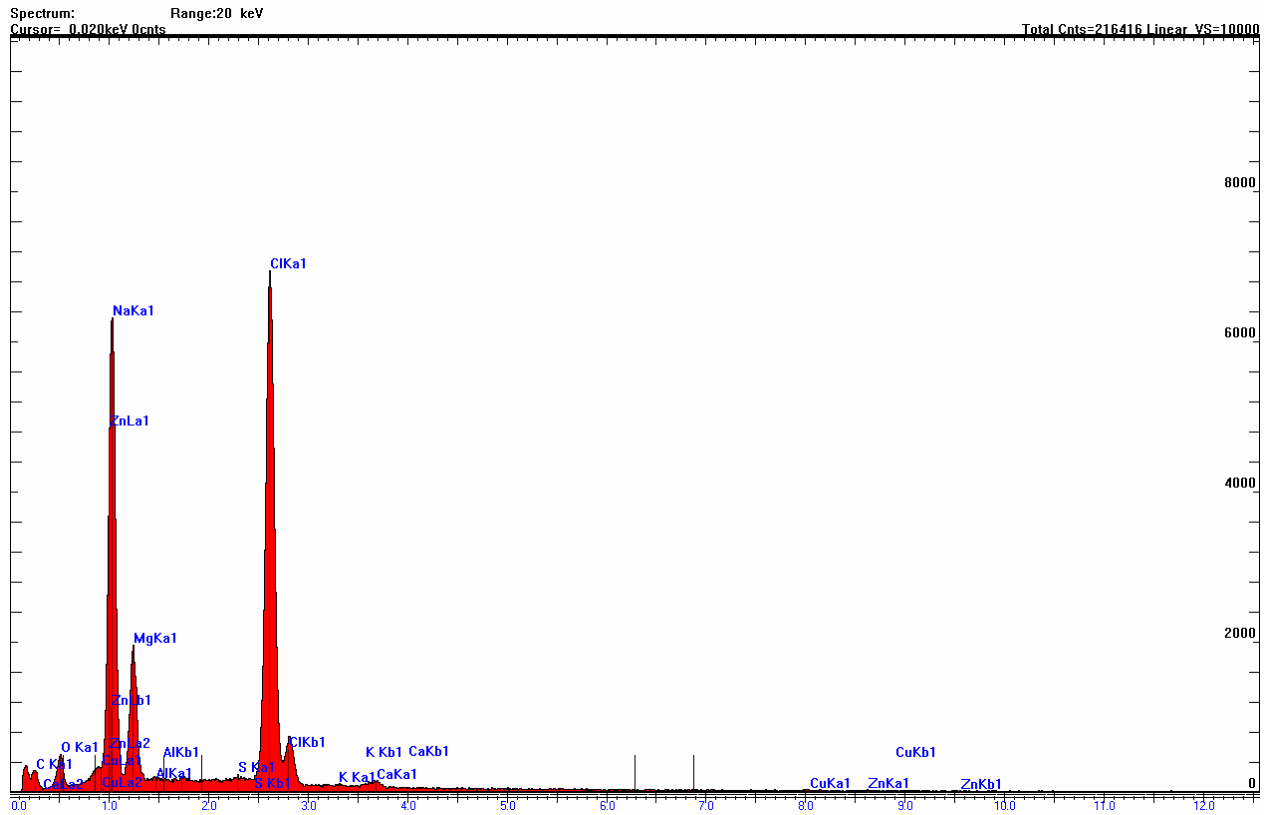
**Figure 33: SEM analysis results for accretion particle 2 from MFC 1**

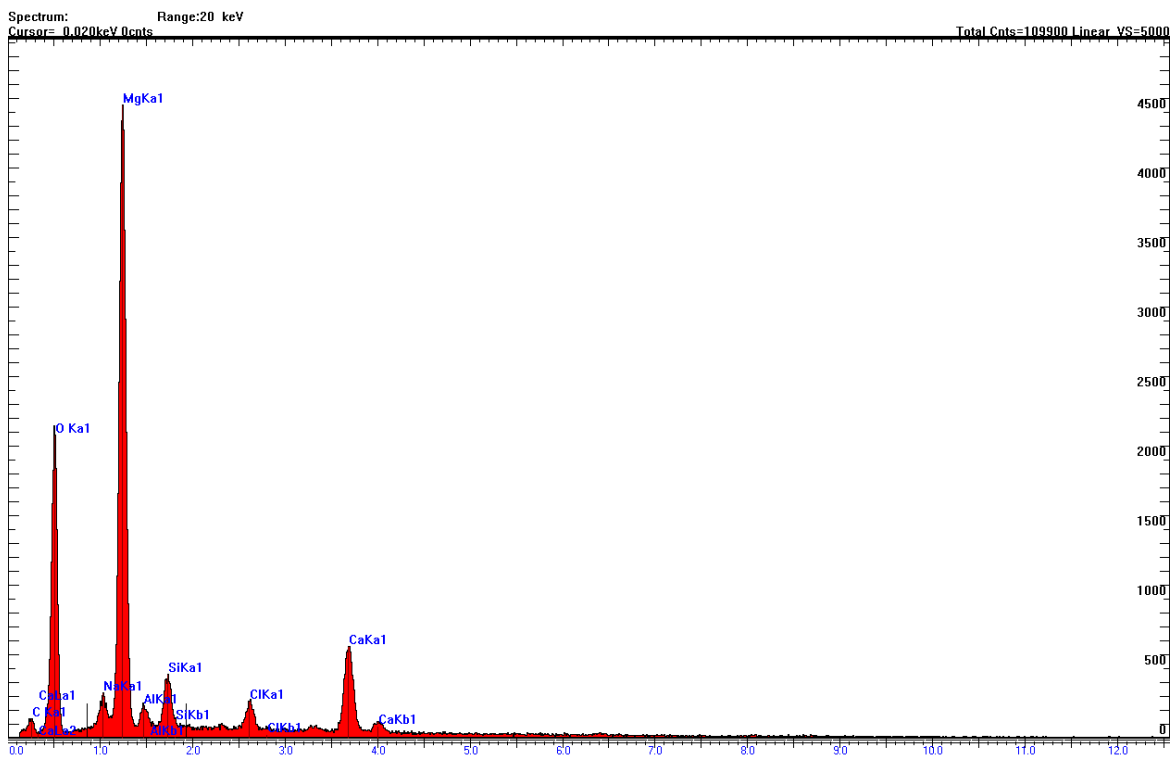
Figure 34: Accretion composition near the electrical connection to battery charger

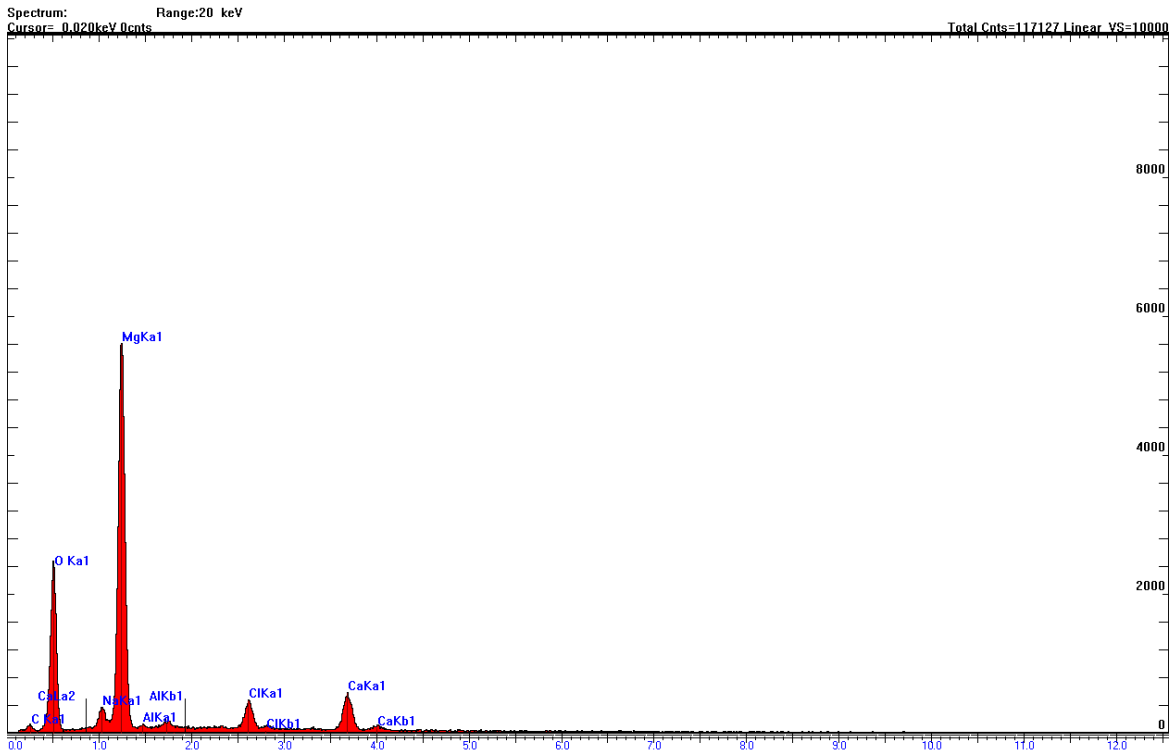
**Figure 35: Accretion composition far from electrical connection to battery charger**

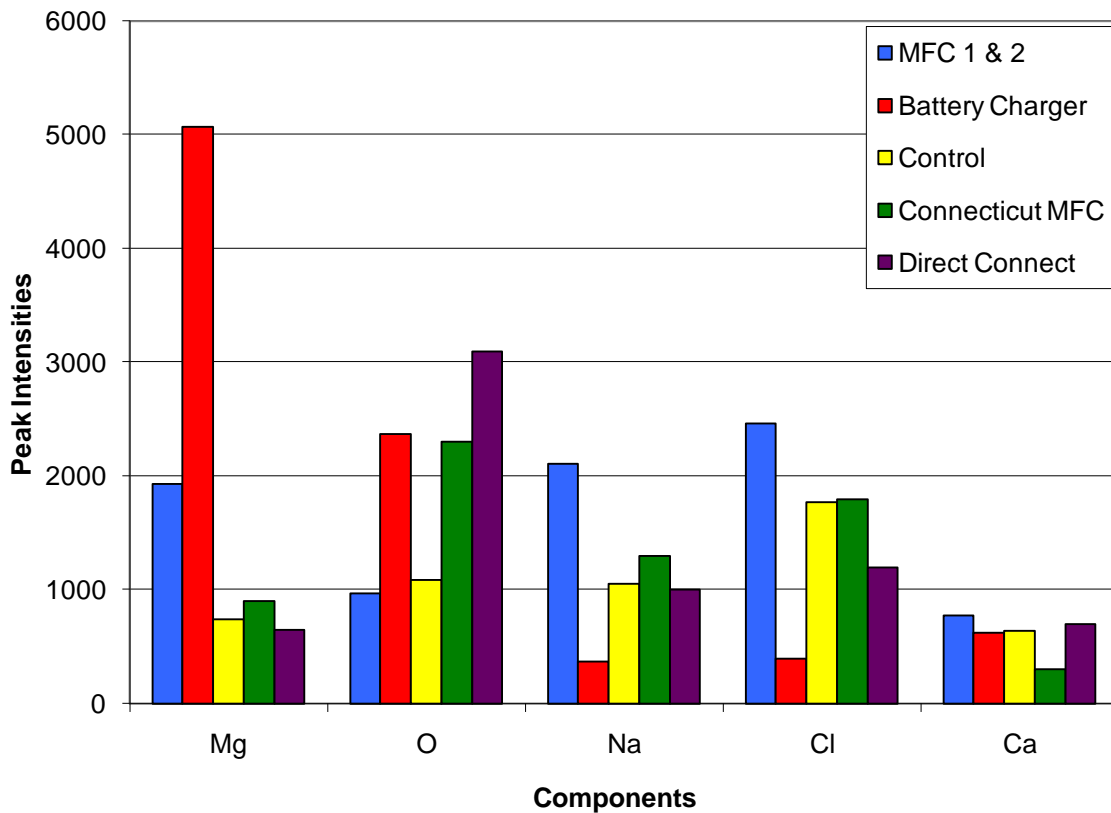
**Figure 36: Relative comparison of accretion components by apparatus**

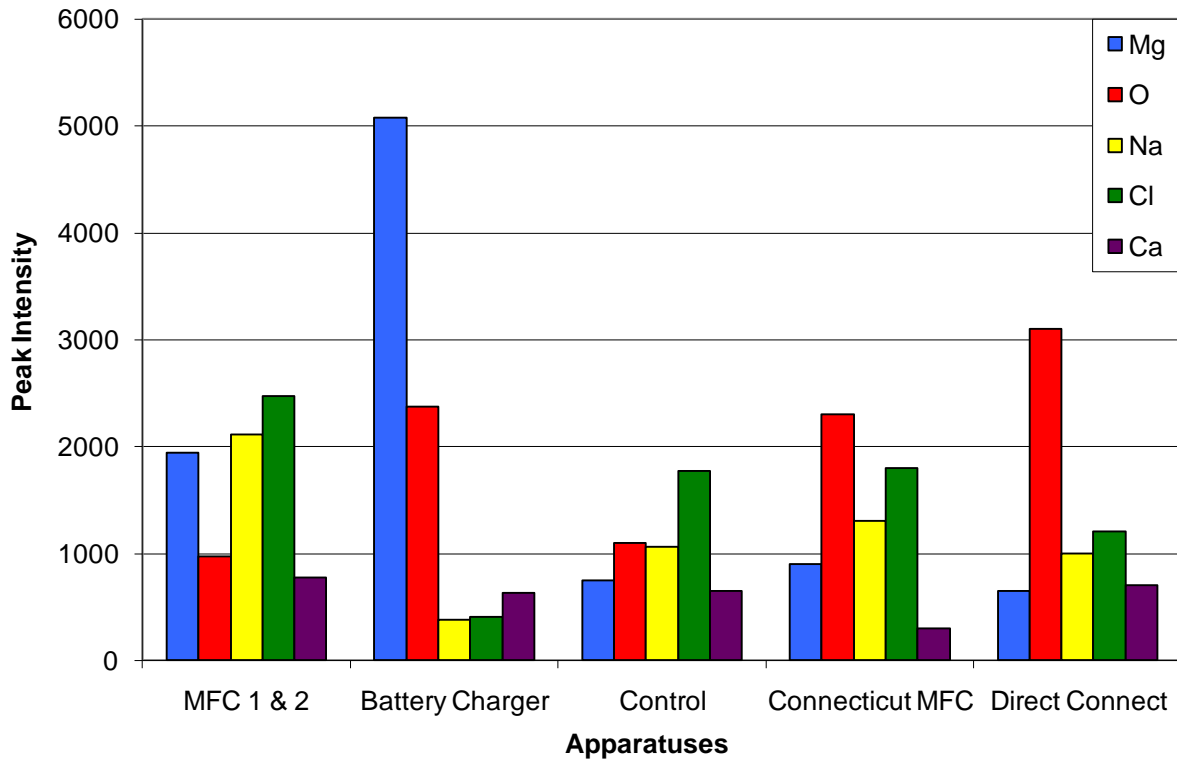
**Figure 37: Comparison of relative composition of each apparatus**

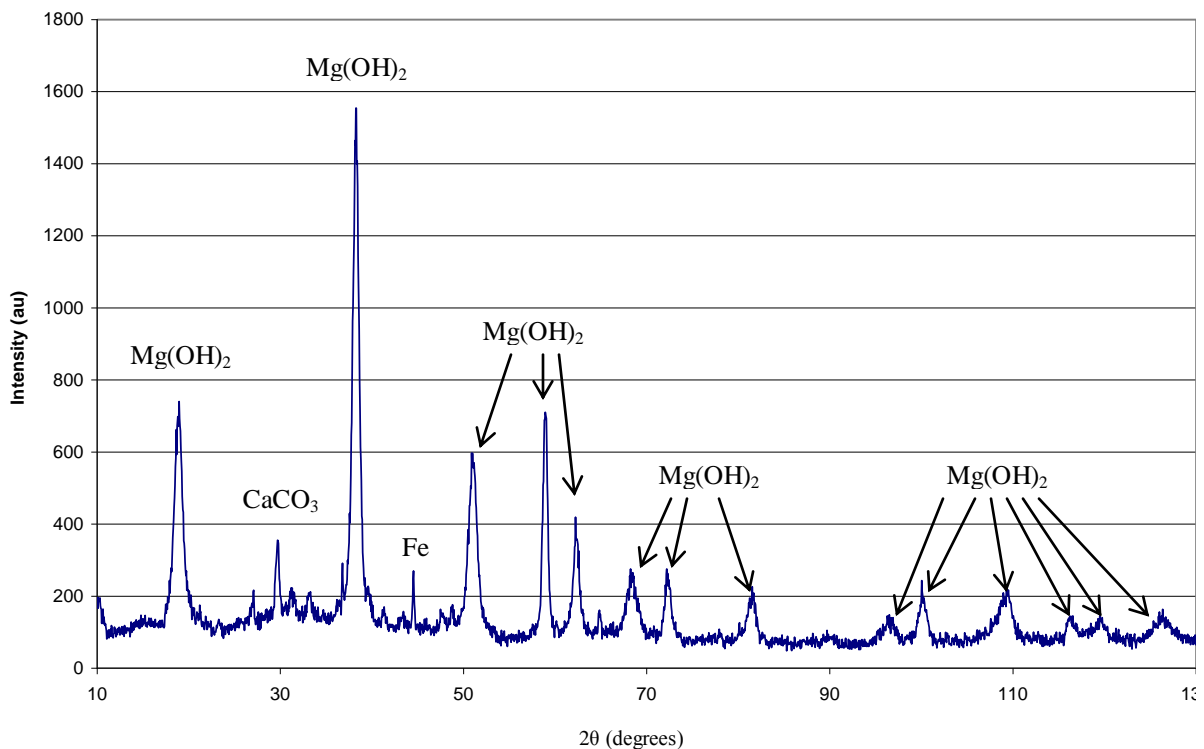
**Figure 38: XRD analysis of general accreted matter from battery charger powered apparatus's wire mesh**

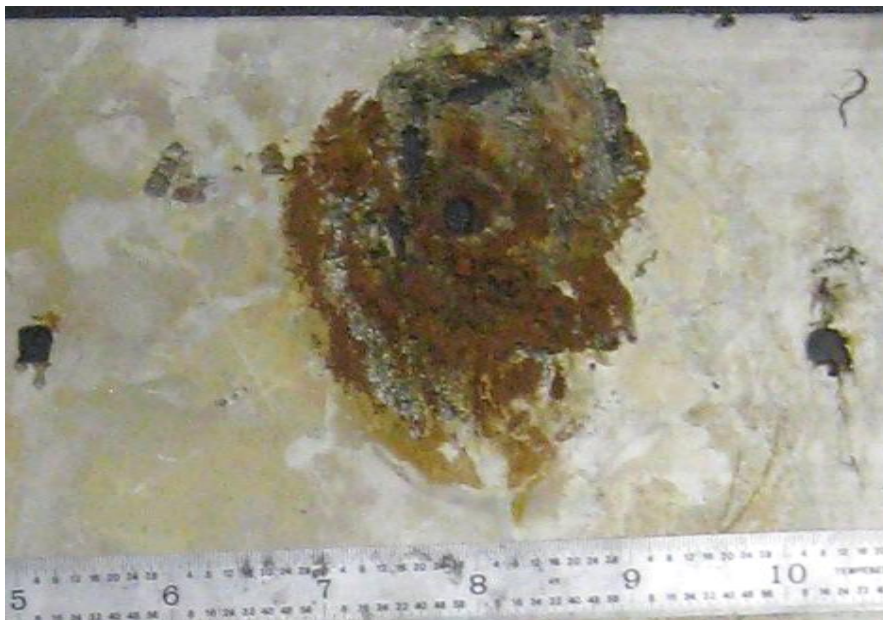
**Figure 39: Crevice corrosion at electrical connecting point on battery charger powered apparatus**

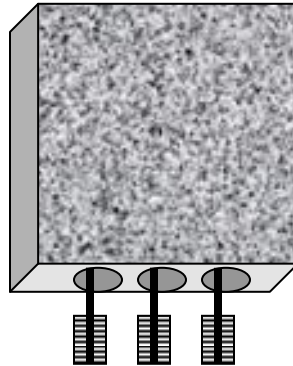
**Figure 40: Proposed alteration to anode brush-to-plate connection**
