# Close-Out Project at Worcester Trial Courthouse

# **Close-Out Project**

# **Worcester Trial Courthouse**

A Major Qualifying Project Submitted to the faculty of Worcester Polytechnic Institute In partial fulfillment of the requirements for the Degree of Bachelor of Science

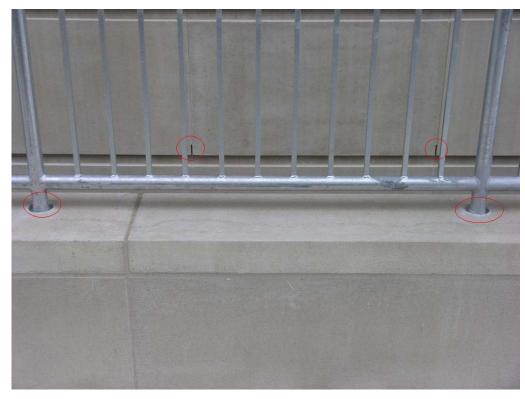
# Figure 9 – Example of RCL Items

Site visits with Dan Manescu, the QA/QC for Gilbane, were conducted to see how the Gilbane handles the open items. After a RCL list was generated from Prolog, we went through the courthouse, to see items which the subcontractors had forgotten. Figure 9 is an example of two uncompleted items which have been added to the rolling completion list. The first one is where grout between the stucco has been not fully filled at the bottom. The second is at the railing where the cement is not fully filled to the top.

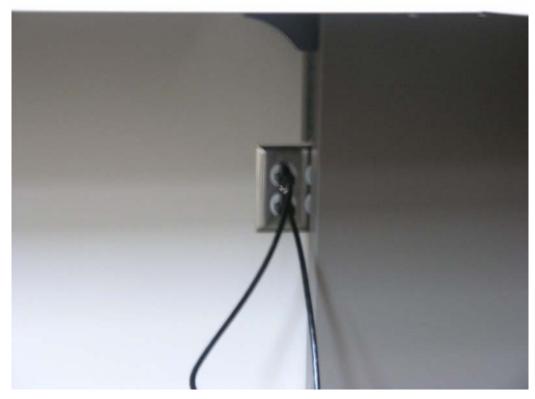
# Figure 10 - Example of Required Change Order

Another example can be seen in figure 10 where the original design did not take into account the furniture. The electrical switch will require an open-change, which means that it will result in open submittals for plans and specifications. The project is in the finals stages of construction but small changes still arise since it is a fast-tracked project.

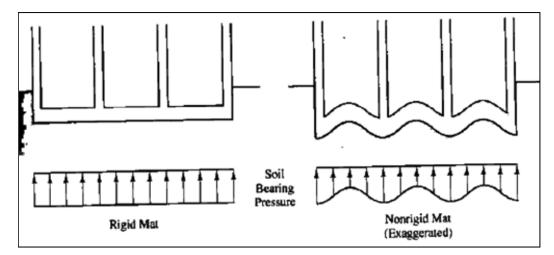
There are two basic types of mat designs: Rigid and Non-Rigid. The rigid method assumes there are no flexural deflections in the mat, so the distribution of soil-bearing-

pressure is considered to be uniformly distributed under the building. In contrast, the

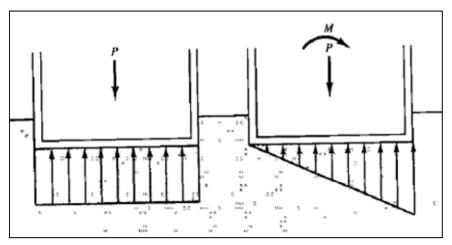
Figure 13 – Different types of loading interactions

This is the simplest approach to structural design of mats. Also known as the conventional method of static equilibrium, this method assumes that the mat is much more rigid than the underlying solids, which means any distortions in the mat are too small and will not significantly impact the distribution of the bearing pressure. The magnitude and distribution of the bearing pressure depends on the applied loads and weight of the mat. This is either uniform across the bottom of the mat or varies linearly across it.

This distribution makes it easy to compute the flexural stresses and deflections in the mat, and for analytical purpose the mat becomes an inverted and simply loaded two way slab. Hence, all the shears, moments, and deflections can be easily computed using the understanding of structural mechanics. But, since the width-to-height ratio is greater than those in slabs, the assumption of rigidity is no longer valid. Some portions of the mat may sag where there are greater loads and the redistribution of bearing pressure is not taken into account. Shear, moments and deformation estimates are not reliable.

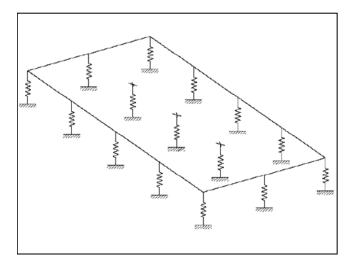
Figure 14 – Bed of springs

This method of describing bearing pressure is called a soil-structure interaction analysis because the bearing pressure depends on the mat deformations, and the mat deformations depend on the bearing pressure. Non-rigid methods must take into account that both the soil and the foundation have deformation characteristics which may be linear or non-linear. The deformation characteristics of the soil are quantified in the coefficient of sub-grade reaction, or  $k_s$ . Fig 14 shows how  $k_s$  form the basis of the "bed of springs" analogy.

This method uses a simple concept: The sum of these springs must equal the applied structural loads plus the weight of the mat, as illustrated by the following equation:

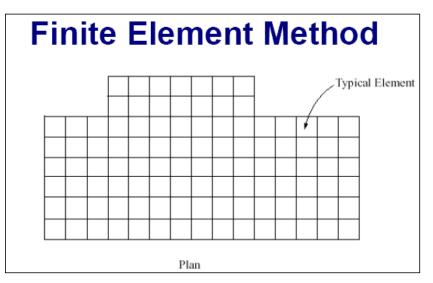
Figure 15 – Plan view of Finite Element Method

This method is an alternative method to the one-dimensional spring system (which makes the system simple to perform structural analysis). It models the mat, soil and superstructure in a three dimensional way. This method divides the soil into a network of small elements, each with defined engineering properties and each connected to the adjacent elements in a specified way. In theory, it should be the most accurate method as it divides the proposed area the foundation is spread over into a "pixel" like format. The structural and gravitational loads are then applied and the elements are stressed and deformed accordingly.

Fig 15 shows an example of a plan view where a site may be separated into tiny "pixels" for analyses of a unit area of land allowing independent reactions due to highly variable soils (meaning different soil bearing capacities).

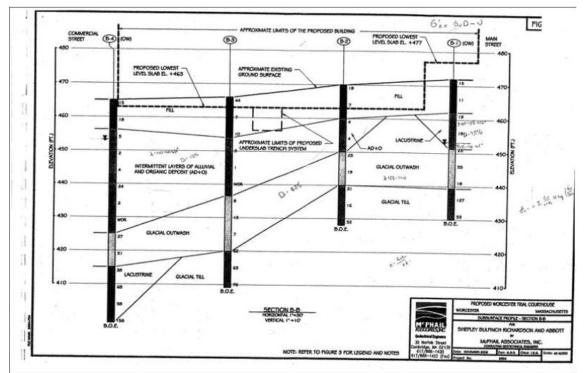
**Figure 16 – Cross-Sectional Profile of Bore Holes**

Fig 16 on the following page shows a cross-sectional profile of the earth as bore holes are made to investigate the depths of different soil strata at different depths. Fig 17 shows a plan view of the exploratory bore holes made on site. It can be clearly seen that the glacial till at the WTC site was not uniform, varying at depths of 25 to 30 feet at the commercial street end and to very shallow depths near the Main Street end.

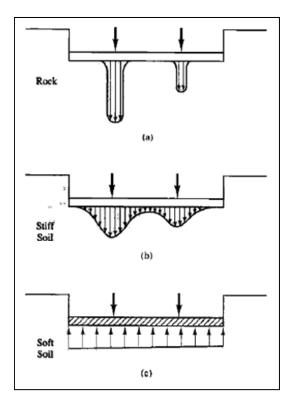
Figure 18 – Different types of Soil Reactions

It must be noted that the mat will react differently under different soil conditions. Fig 18 illustrates how it may react under conditions of (a) Rock, (b) Stiff Soil, and (c) Soft Soil:

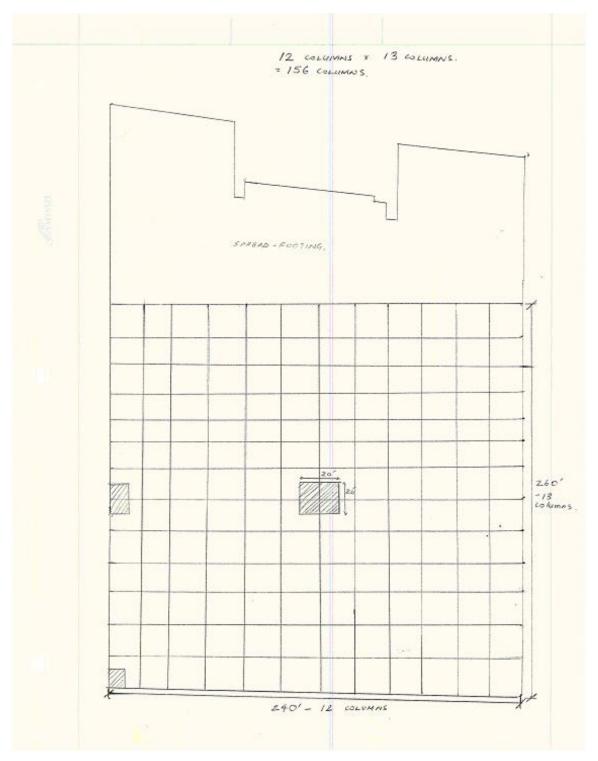
Figure 19 - Plan View

The factored loads were computed to be 3220 psf, applying a net load of 1288 kips on each column of dimensions 36" with a tributary area of 20' x 20'. Fig 19 on the following page clearly illustrates how this was done. This value includes all safety factors; the factored loads were deduced by backtracking PIF design capacities used by Gilbane with the PIF method in effect. The number of columns was determined by making a 12 x 13 column grid as observed from the structural drawings over the 240' x 260' square foot area. The factored net soil pressure was calculated as 3.22 ksf and the thickness of the mat foundation was determined to be approximately 3 feet. The spreadsheet with the calculations can be found in Appendix VIII as Mat Design.

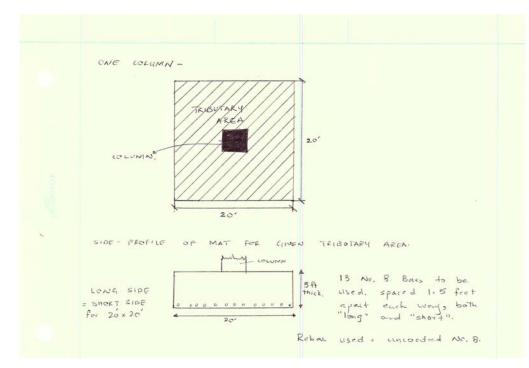
#### Figure 20 - Cross-section of Mat Foundation 20 x 20

From *Coduto's* excel files, we used the settlement analysis for shallow foundations interactive file to determine the net settlement using the "classical method". The net settlement we obtained was 8", resulting in 1541 cubic yards of additional fill required.

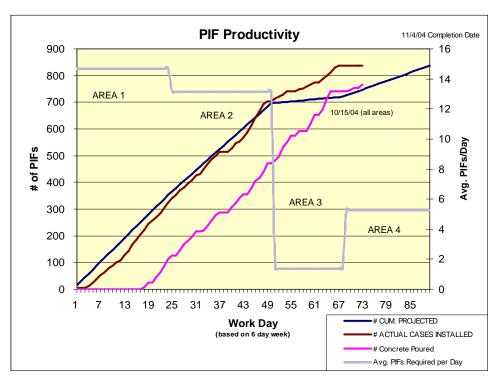
#### **Figure 21 – PIF Productivity**

Figure 21 shows the PIF Productivity by number of PIFs, by Work Days and Average PIFs per day. The total time it took to construction the pile foundation come to three months. Pile foundations are more labor intensive since different types of specialization is needed: carpenters, steel erectors, heavy equipment operators, constant and careful engineering testing.

The PIF schedule was obtained directly from the Prolog website, courtesy of Gilbane Building Company. A wide range of PIF relevant data was made available to us including matrices regarding Actual PIF Count, PIF by Area, Obstructions, As-Built Variances, PIF by location, etc. According to this data, the first PIF was poured on 7/23/2004, and continued all through 10/9/2004 as shown in the adjacent table 4.
