# The Snow Rake: Developing a Device to Remove Snow from Multiple Story Roofs

PROJECT REPORT

SUBMITTED IN PARTIAL COMPLETION OF THE REQUIREMENTS FOR A  
MECHANICAL ENGINEERING MAJOR QUALIFYING PROJECT

Project No: JMS-1604

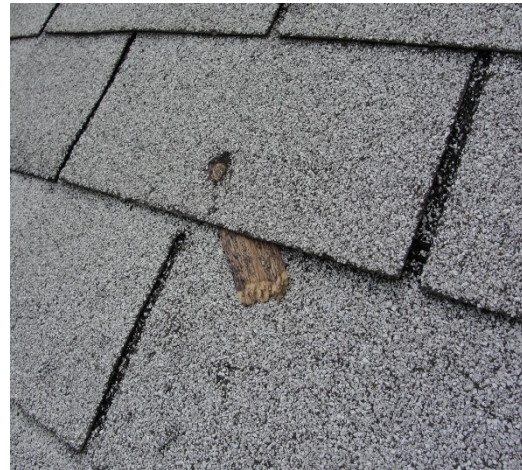
Asphalt shingles are the dominant roofing material in the United States, especially the Northeast. They are laid in an overlapping manner down the roof, seen in Figure 3. Also see Figure 3 for an example of damaged shingle.

*Figure 3: Roof Damage on an Asphalt Shingle*

There are several causes of irregularities that may cause the roof to be damaged before a snow-clearing mechanism could be deployed. The most common are poor installation/workmanship, expansion due to moisture, punctures and other weather damage, improper repairs, shrinking shingles, and blistering<sup>17</sup>.

All of the above could cause potential problems for a roof clearing system; the snow removal system was carefully designed to not damage the roof, and not to further any existing damage, which is a more pressing problem, as shingles may be partially separated from the roof's normal shingle pattern when damaged.

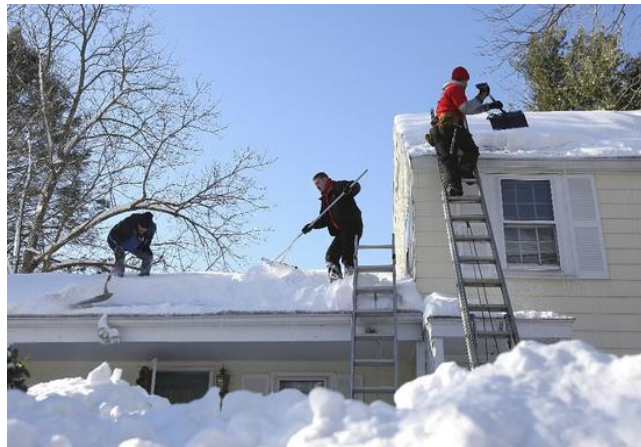
*Figure 6: Traditional Snow Clearing Method*

There are currently only a few different methods of clearing snow off a roof. The traditional method of shoveling is the most commonly used, but it can also cause a tremendous amount of damage to the roof. The use of metal or plastic shovels along with the damage done by walking on an asphalt shingle roof can severely decrease the life expectancy of a roof. The friction between the objects and the shingles causes the

shingles to deteriorate, peel up, or even break off. Shoveling the roof is extremely dangerous and can be avoided by using a snow rake. The snow, ice, and weather conditions create many risks for the workers on the roof, as seen in figure 6.

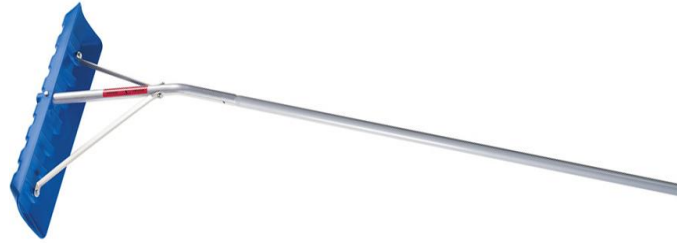
*Figure 7: True Temper Roof Rake*

Traditional snow rakes can also damage the roof if they do not have wheels or are used

incorrectly. The dragging of the plow on the shingles can damage them and decrease their life expectancy. Many rakes are now equipped with

small roller wheels on the bottom of the plow to gain clearance and roll over the shingles. An example of a traditional snow rake can be seen in Figure 7.

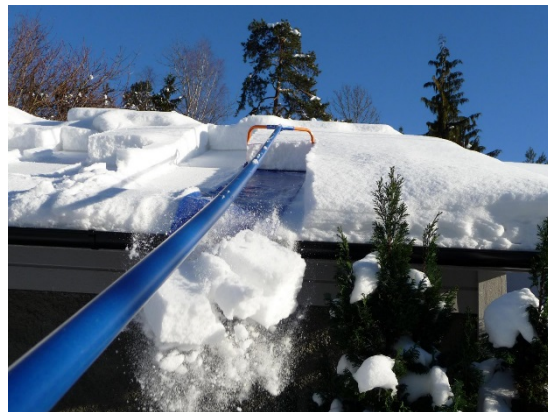
Advanced snow rakes have a different design and function than traditional snow rakes. Advanced snow rakes have a cutter head that disrupts the snow and the snow slides off of the roof onto a low-friction plastic sheet that trails the cutter head. These rakes remove the snow by using a pushing motion from the user rather than the pulling motion used with a traditional snow rake. The pushing motion allows the cutter head to break through the snow and the plastic sheet is dragged behind it.

*Figure 8: Advanced Roof Rake Clearing Snow*

The disadvantages of advanced snow rakes are similar to those of the traditional snow rakes; the length of the pole attached to the cutter head limits the user's reach. Advanced roof rakes have wheels on them to give clearance over the asphalt shingles. In general, advanced roof rakes perform better and cause less damage to roofs than traditional roof rakes. An example of an advanced snow rake can be seen in Figure 8.

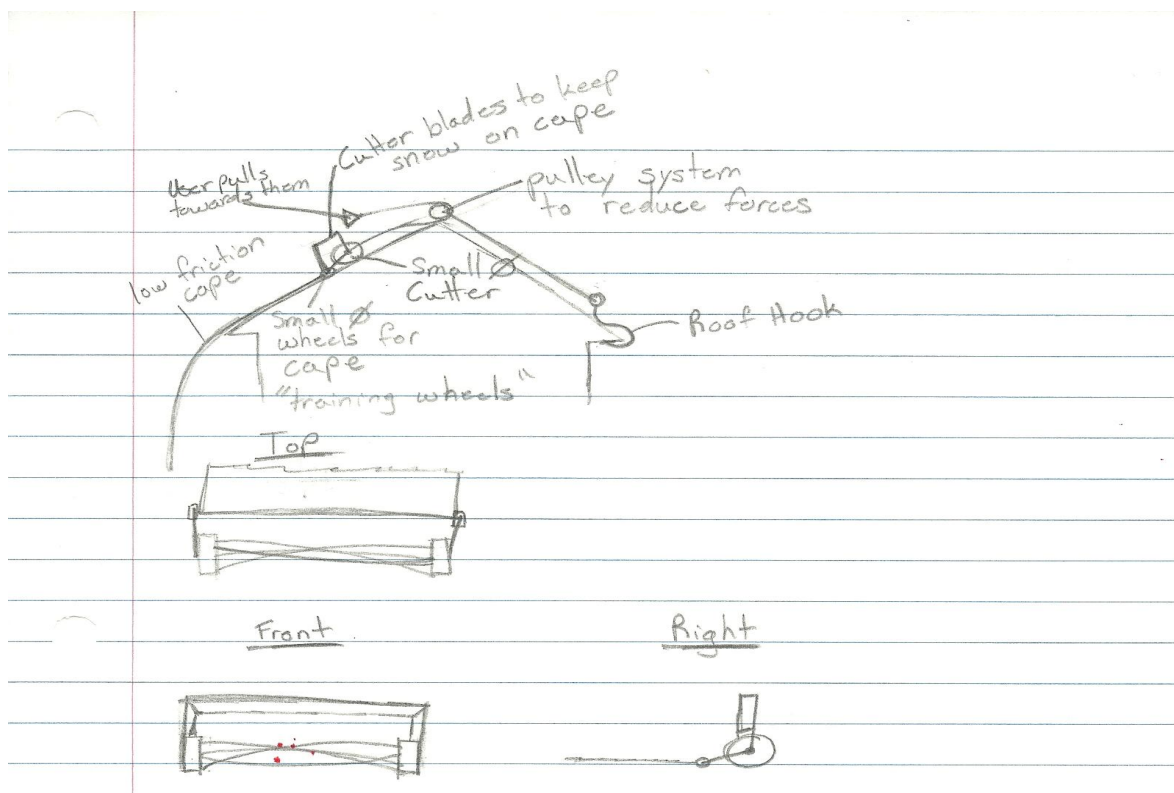
See Figure 9 for early concept drawings of the “Lawn Mower” design. This design mimics a push reel mower. The swirling wires are intended to cut through snow, and would also be used to break up any chunks of ice found in the snow.

Figure 9: Early Conception Sketches for the "Lawn Mower" Design

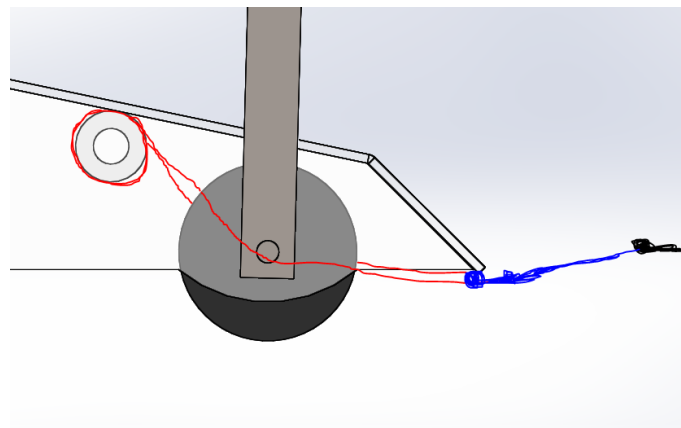
Figure 14: Ropes are Attached under the Wedge for Protection

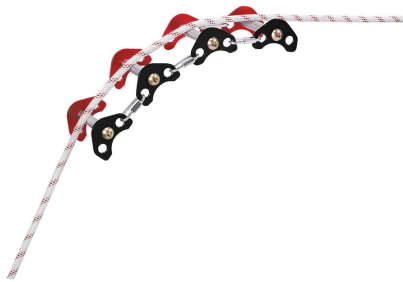
Figure 19: Petzl "Caterpillar"

act like a band saw and cut through the ridge of the roof, causing significant damage. Unfortunately, there were no commercial products that would protect the ridge of the roof from a load bearing rope; however, the Petzl "Caterpillar" rope guide, designed for rough

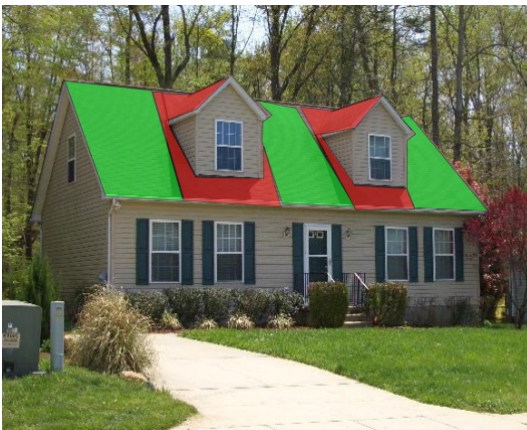
*Figure 22: Clearing a Roof with Dormers*

Unfortunately, as recorded in the local roof survey, many houses in New England have features such as dormers, angular junctions, or obtrusive chimneys that can get in the way of the roof rake. As a result, some roofs would have sections that are unable to be

cleared at all; however, in order to prevent ice dams and relieve the snow load from the roof, only about the first six to ten feet of the roof would have to be cleared. In order to clear a roof with dormers, the user would start clearing a section of the roof until a dormer interferes. To move to the next section of the

roof, the user will have to back the rake off the roof, detach the rope from the winch, and relaunch the rope on the other side of the dormer, see Figure 23 for details. A similar procedure was to be used whenever the rake is unable to clear a certain section of the roof. See Appendix for more illustration of clearing limitations.

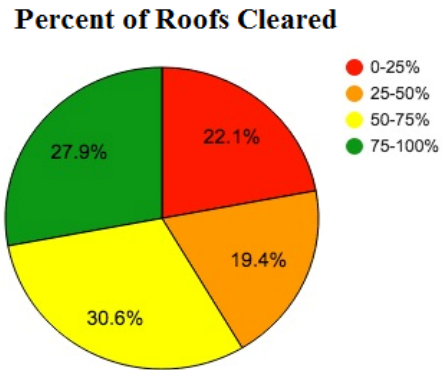
Based upon the two foot width of the rake, the placement limitations of the rake design, and the results from the local roof survey, it was estimated that the wedge rake design would be able to remove 75% or more snow from about 28% of roofs. See Figure 24 for the rest of the clearing estimates.

Figure 24: Roof Clearing Estimates Using Wedge Rake

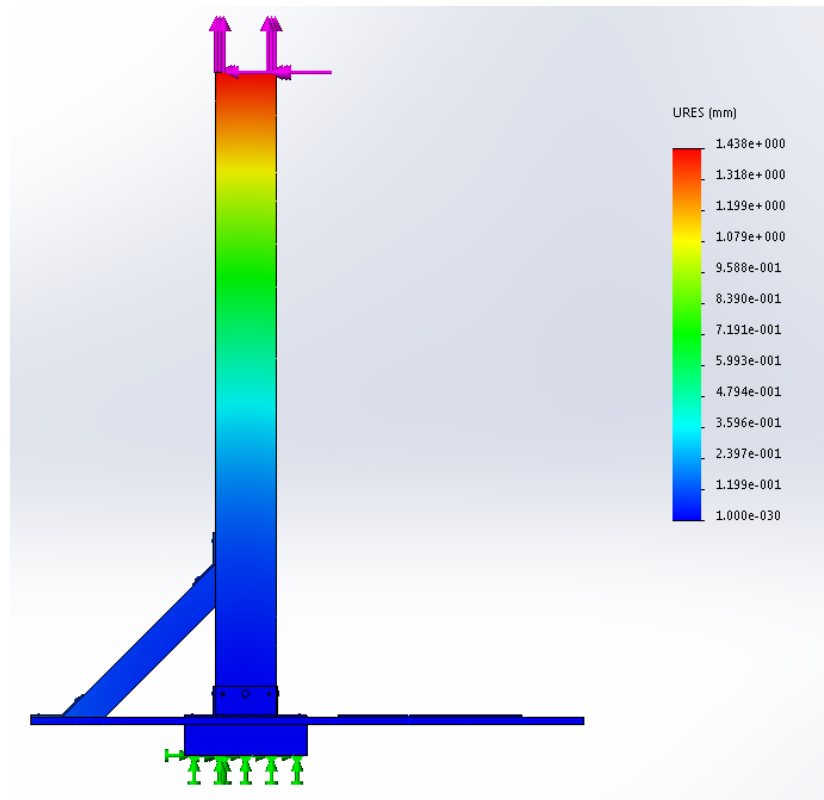
Figure 30 shows a simulation that shows the anticipated driving force of 200 lb acting 45 degrees from the post. Solidworks was unable to provide simulations of von Mises because wood can contain many defects, and has variable grain sizes and fiber density depending on the humidity, temperature, and the individual tree. Young's elastic modulus, although also variable, is closer to constant among each species of tree, and for red oak is generally accepted to be 12 GPa. The deflection shows a material with Young's modulus of 14GPa. The support angle bracket was assumed rigid to allow for faster simulations, while the bottom of the support board was fixed. The maximum deflection of the 4x4 post was 1.5mm. This was negligible, and meant it could be assumed the post would be straight throughout its loading cycle.

Figure 30 Expected Deformation of the 4x4 Post of the Driving Platform.

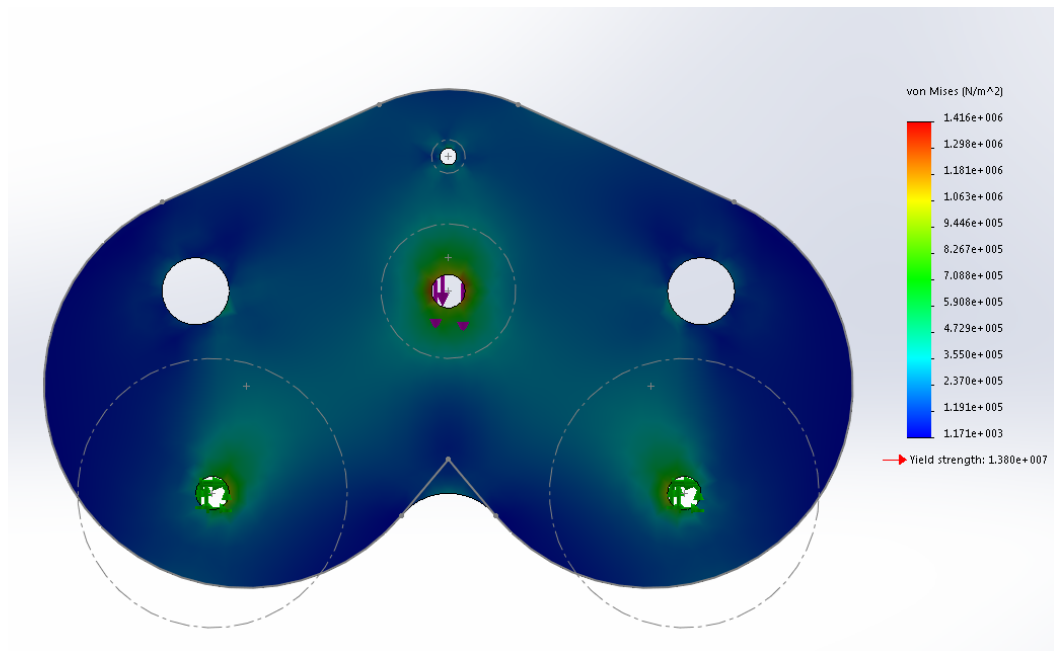
This simulation shows the anticipated tension force of 150 lb acting straight down on the center circle. A custom material was created to allow for an approximation of plywood with an ultimate yield of 14 Mpa. The surfaces inside the bottom holes were assumed to be fixed. Clearly the anticipated von Mises were well within the load limit of this plywood material.

Figure 31: A simulation and visual representation of the expected von Mises on the side of the millipede

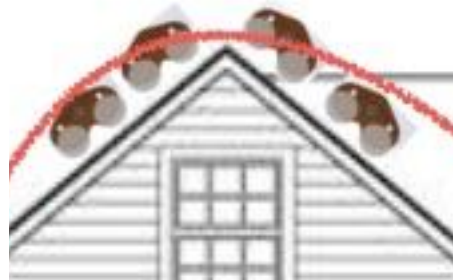
The first prototype of the millipede was planned to be identical to the design formulated in A-Term. It consisted of four, small, inverse-heart shaped devices connected by rope. These devices were intended to be used in a train to provide an area of support over the ridge of the roof. See Figure 32. The body and wheels of these devices

Figure 32: Original Millipede Design

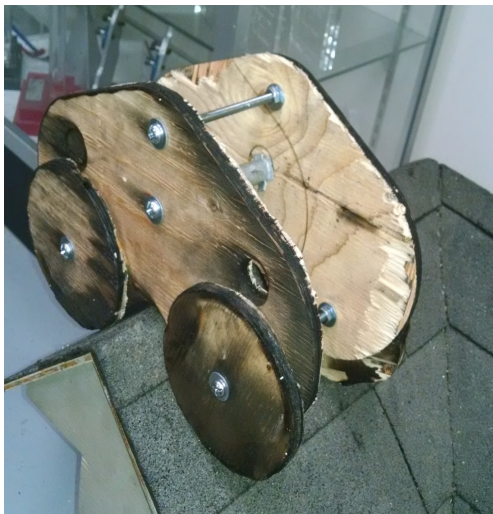
Figure 33: First Millipede Prototype

were to be constructed out of plywood and secured by long carriage bolts. After enough

parts were cut using the laser cutter to assemble one of the four rope guides, it was assembled with  $\frac{1}{4}$ "x6" carriage bolts. After assembly, it was tested on a mock roof. See Figure 34. After this testing, it was determined that the roof protector would be more effective if it were one large rope guide rather than four small ones.

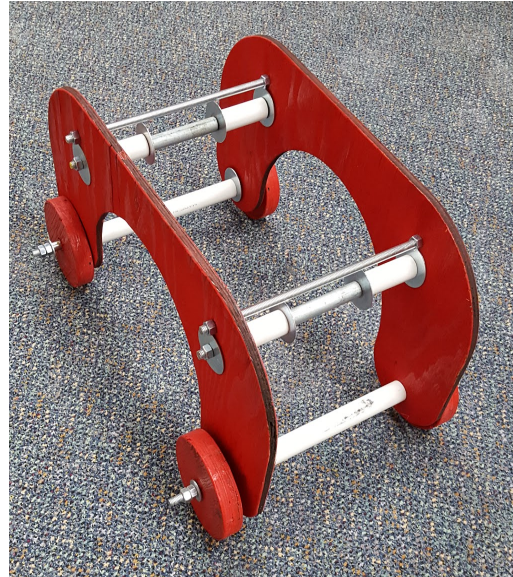
The second prototype of the millipede was redesigned to be considerably taller and longer, resembling an inverted “U,” as can be seen in Figure 35. The new design would only require that one device be placed on the roof, and would also ride over any roof vents, due to the greatly increased crest-over clearance. This design also utilized plywood, as it is quite rigid and cost effective.

contacting the roof. To ensure that the wood wheels roll smoothly on the roof, a steel sleeve was press fit into the wheels to act as a bearing on the threaded axle. Two of the rods on the top of the millipede act as the support for the power rope. In order to decrease friction, a piece of EMT conduit was cut to act as a bearing surface. The final two rods act as additional support and keep the rope on the EMT roller. To help keep the whole assembly aligned, and to increase

*Figure 35: Final Millipede Design*

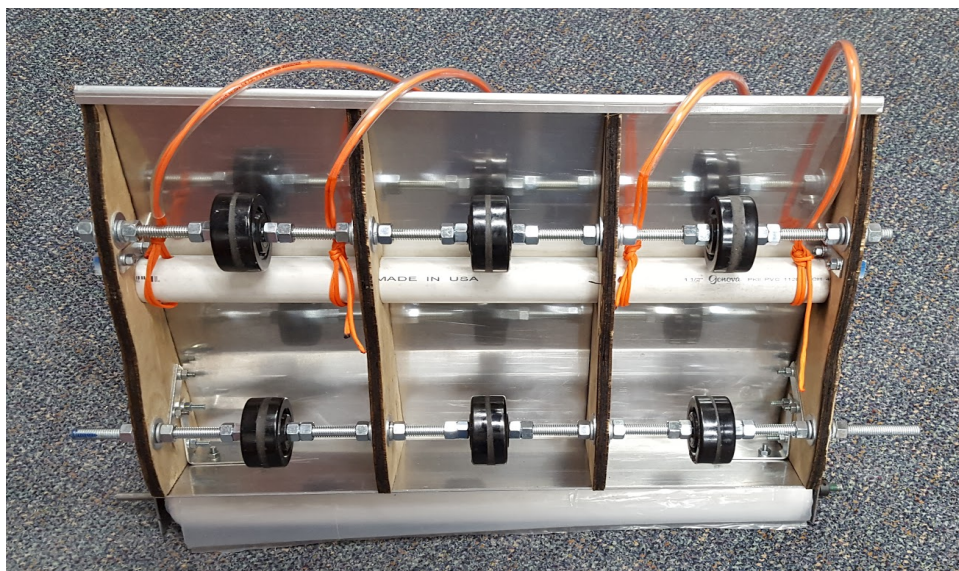
After the sheet aluminum was bent to shape, the next step was creating a frame that would hold the axles and provide a places for the ropes and breaker bars to attach. The frame was constructed out of four pieces of plywood laser-cut to shape. Taking lessons from the millipede construction, the  $\frac{3}{8}$ " steel rods that were to be used as axles were replaced with a  $\frac{1}{2}$ " threaded steel rods. The heavier threaded rod made assembly much easier and allowed for easy changes to the frame design. Once the wood supports and rods were cut to the appropriate size, six wheels were added, two between each support. Because the whole frame was held together with the threaded rod, it could simply be slid into the side of the wedge body. It was secured in place by two "L" brackets at the back of the wedge body. The breaker bars also served as a secondary method of securing the frame in the aluminum body. To attach ropes to the wedge, a piece of PVC was inserted in the frame. Ropes were passed through holes in the frame and covered in flexible PVC to increase wear resistance. The first frame of the wedge can be seen in Figure 37. The frame was slightly modified after further testing.

Figure 36: First Frame Design

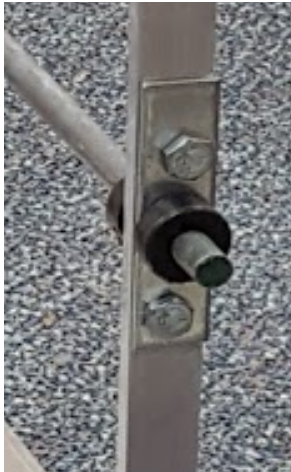
Figure 38: Breaker Bar Support

This bar was made out of the same aluminum stock. To reduce deflection at the top of the bars, a steel rod was attached through a hole drilled in the breaker bars and held in place with lock collars. To strengthen the area where this steel rod was placed, an additional steel bracket was bolted to the aluminum bar (Figure 39). See Figure 38 for a side view of the wedge with breaker bars.

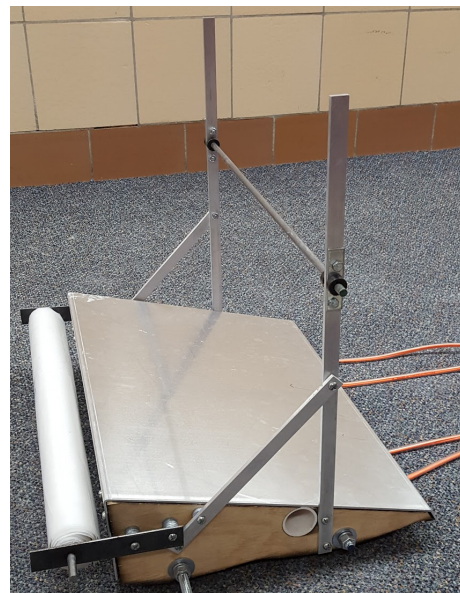
Figure 37: Side View of the Wedge

Once the frame was completed and attached inside of the wedge body, a set of breaker bars were attached to the side of the frame. These breaker bars were simply pieces of  $\frac{1}{4}$ "x  $\frac{3}{4}$ " aluminum stock about two feet long. Using a drill press, holes were drilled to correspond with a metal support bracket, which was bolted onto the inside of the frame. An additional support bar was installed on the side of the frame to increase rigidity.

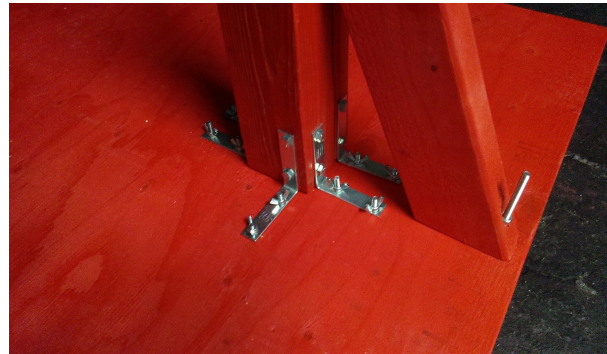
*Figure 39: Winching Platform Support*

The construction of the winching platform was relatively straightforward and only a few design changes were made. The platform consists of a  $\frac{1}{2}$ " sheet of plywood used as the standing platform for the

operator with a 4" x 4" (nominal) post with the winch attached to the top. The winch will be used to pull the main rope of the front of the wedge. The underside of the standing

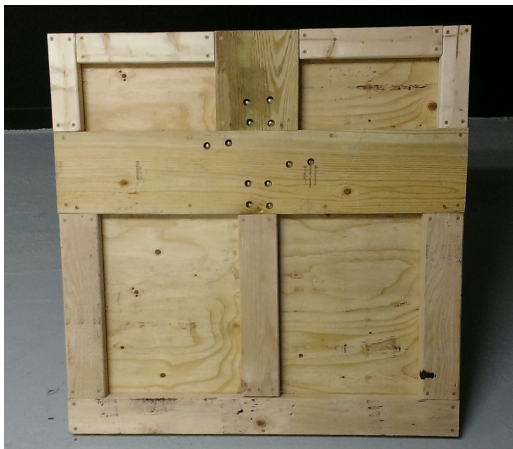
*Figure 40: Bottom of the Winching Platform*

using L-brackets on each side as well as a 2" x 4" (nominal) support on the front of the post. A close up of the attachment can be seen in Figure 40. The platform was sanded and painted red to match the millipede. The final Winching Platform design can be seen in Figure 42. The maximum moment expected to see acting on the platform is 450 ft-lbs of torque. This 450 ftLbs is caused by a 180 lb person standing 2.5 ft away. This equates to 150 lbs pulling 4 feet away at an angle of 45 degrees, as shown in Figure 43.

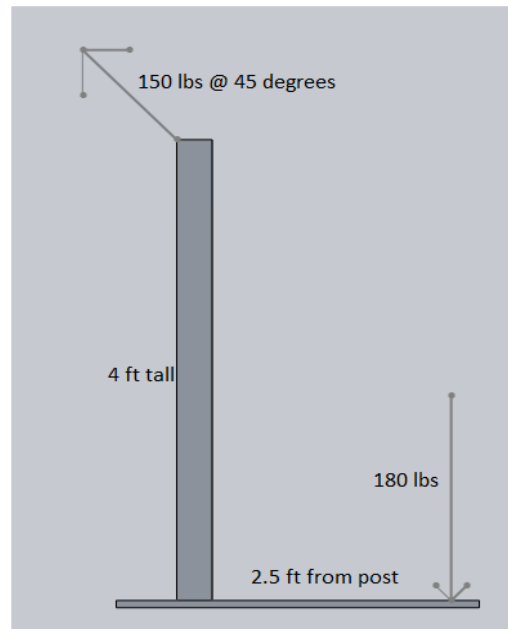
Figure 43 Static Diagram of Maximum Pulling Force Before Tilting

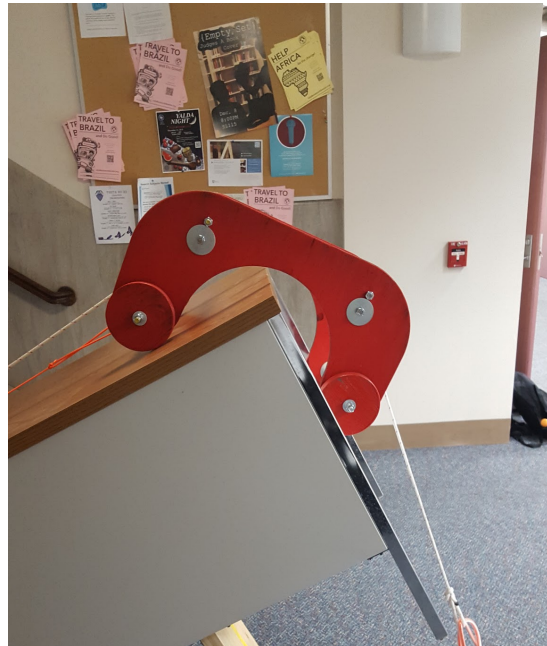
Before permission was obtained from WPI facilities to use the metal HVAC guard, a tilted desk was used as a test for the millipede (see Figure 44). This desk was left in the hallway and was destined for a dumpster anyway, limiting concerns of damaging. For the test, desk was raised to an approximate angle of a roof, and the corner of the desk was used as an approximate roof ridge. The millipede was then raised and lowered without issue or concern. The

*Figure 44: Initial Millipede Testing*

wedge was pulled off the ground to test the structural integrity of the millipede. A noted concern was the millipede could roll off the ridge with enough force. This was easily counteracted by temporarily tying down the millipede's guide ropes. In the field, one of these tie-down locations could be on the winch platform, while the wedge operator could hold another.

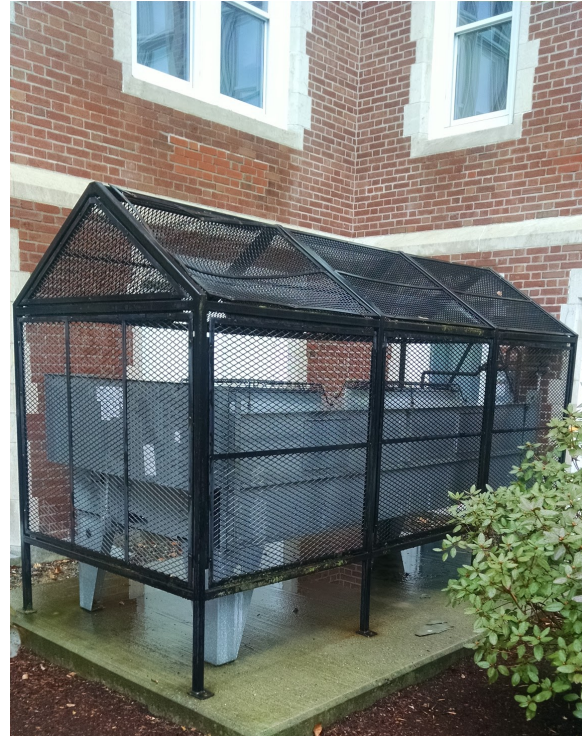
Figure 45: HVAC Grate Used for Testing

A HVAC guard, seen in Figure 45, was chosen to test the wedge for multiple reasons. The first reason was the ridge was low enough to be reached if there were concerns, and it had an open side where the wedge could swing freely as it would in true operation on a residential roof. Another reason was that it was made of metal, and so it would not be damaged by the ropes or the wedge if an unforeseen issue arose.

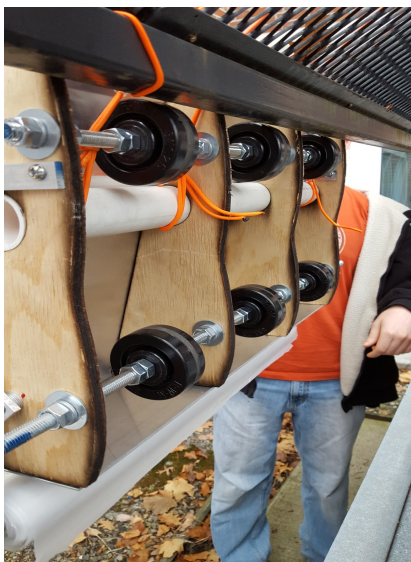
Figure 46: Wedge on HVAC Grate

climb over the lip of the roof. The wedge performed well once it was on the roof, but had difficulties climbing over the lip. This test can be seen in Figure 46. The difficulties with getting it up there were solved by two solutions in tandem. First, an additional axle with smaller wheels was placed in the main area of concern. This allowed the worst part of the scraping to be replaced by rolling instead. This final modification can be seen in Figure 47. Additionally, using the

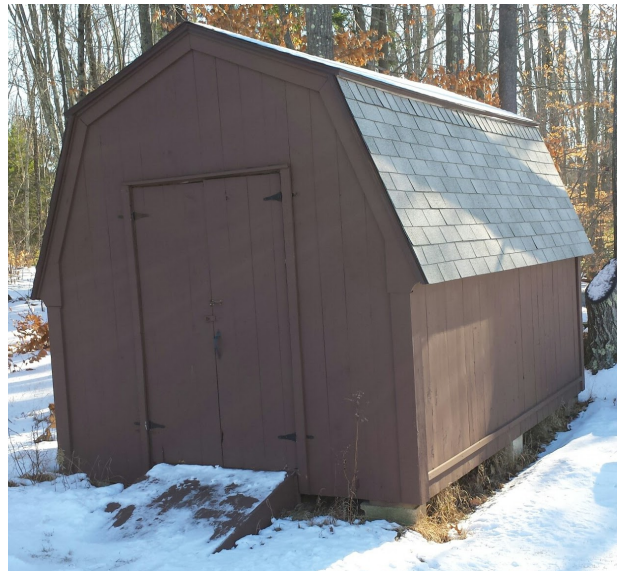
*Figure 48: Shed Used for Testing*

about damage due to unforeseen factors. In order to mitigate the possibility for damage, a storage shed was generously offered by a family member for this first “real” test. This shed, seen in Figure 48, was a good candidate for several reasons: it was shingled, it was low enough to easily observe equipment, and if it were damaged, it would be much less costly to repair than a roof. Unfortunately, the shed did

have a double angled roof. Although this was not ideal for snow clearing, it was sufficient to evaluate the principles of the snow removal system.

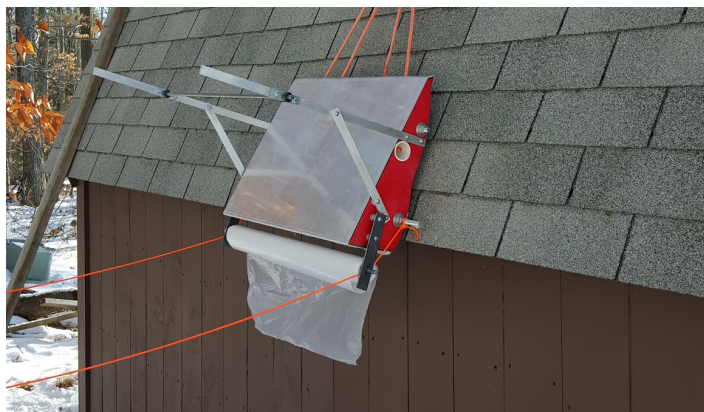
*Figure 49: Wedge on the Roof*

rear axle, the wedge itself would stay away from the side of the roof. Once on the roof, as seen in Figure 49, it was easy to maneuver with the two guide ropes attached to the rear axle. Although it was easy to steer the wedge on the roof, there was not enough movement here to set the wedge enough for a new pass. In order to clear a new section of roof, the wedge had to be backed off of the roof and pulled to the side. When this was attempted, the wedge began to pull on shingles as seen in Figure 50. This damage potential, combined with the difficulty of pulling the wedge through at least a foot of snow, makes completely removing the wedge from the roof for each pass unavoidable. While this is doable, it would make the clearing process significantly more time consuming.

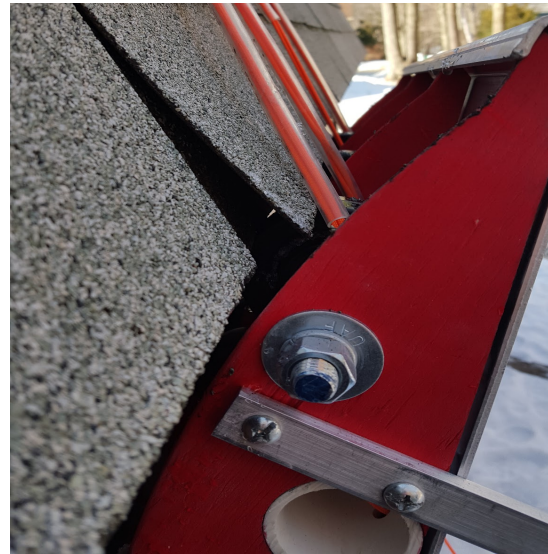
*Figure 50: Single Damage with Side-to-Side Movement*

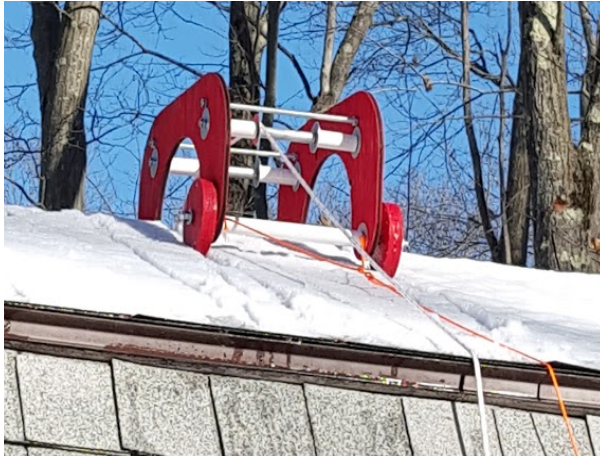
*Figure 51: Millipede on the Roof*

Upon testing, the millipede was able to hold the forces of the rope and wedge without issue. The EMT conduit bearings worked well to reduce friction and the rope never got stuck on the millipede. Several drop tests were also conducted from a height of approximately 10 feet. There was no damage recorded in these tests. Due to its center of gravity, it landed on its wheels each time.

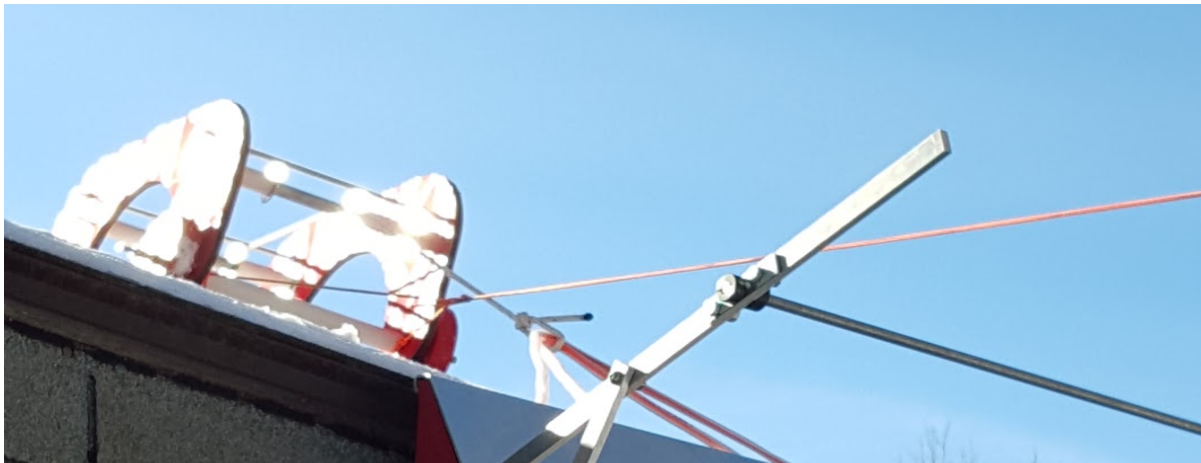
*Figure 52: Rope Interference*

Although securing the millipede on the side of the wedge stopped it from sliding, it also created its own problem; the single securing rope created interference with the wedge, as seen in Figure 52. Because the rope that prevented the millipede from sliding towards the platform had to be directly in line with the platform, it was directly in the path of the wedge, preventing it from completing a full path without dislodging the millipede.

This interference problem could be solved by replacing the single guide rope and loop on each side with two ropes, each attached at the extreme end of the axles. These ropes could be secured at an obtuse angle, allowing a clear path for the wedge. The additional rope on each side would also help to avoid tipping. There was one instance of the millipede tipping, as seen in Figure 53 during testing; however, using two ropes on each side would have solved

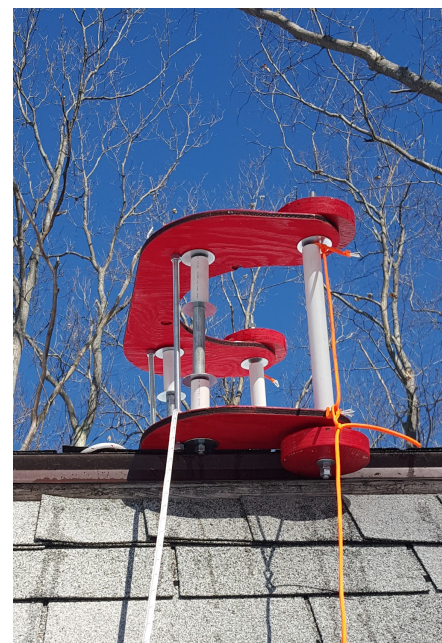
*Figure 53: Millipede Instability*

this. Unfortunately, adding two more ropes makes the system more complex and doubles the points that have to be anchored. When clearing a roof in a least a foot of snow, it is neither realistic, nor practical, to stake down and remove two additional ropes each time a new pass has to be made.

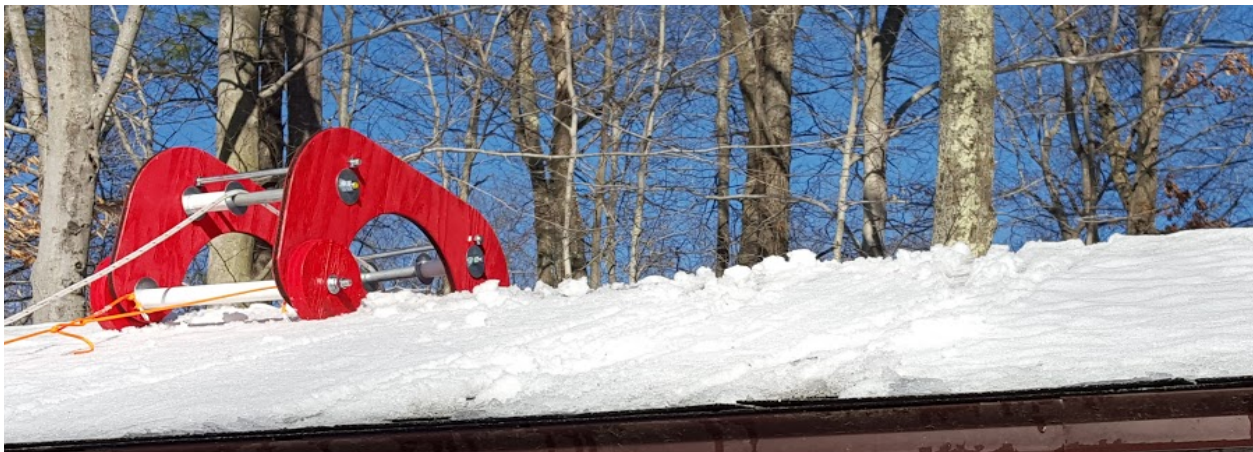
Finally, the ability to move through snow is a concern, since the wheels appeared to drag in less than an inch of snow. These drag marks can be seen in Figure 54. If the millipede's wheels do not roll well in an inch of snow, they will likely not work at all when working in conditions of at least a foot of snow. One potential solution for this issue is to place skis around the wheels of the millipede. This would allow for it to roll on bare shingles without damage and slide on more than a few inches of snow. Unfortunately, the addition of ski feet would not assist in changing its location on the roof for a new pass as it would have to move laterally into a column of at least one foot of snow. This would also mandate that the millipede be removed after each pass. Finally, the addition of weight, possibly in the form of weight plates, might prevent the sliding; however, this additional weight would make operation very cumbersome.

*Figure 54: Millipede Drag Marks*

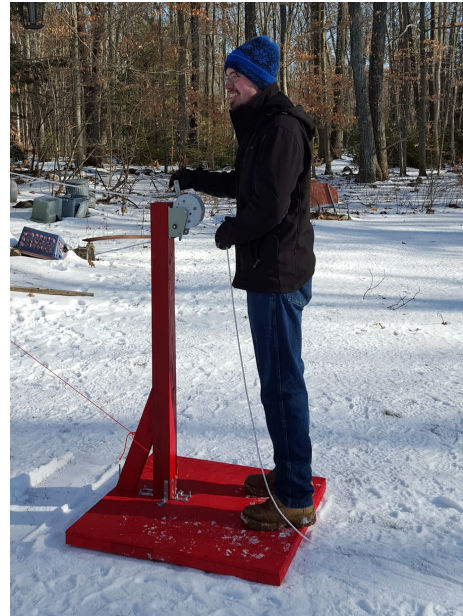
Figure 55: Winching Platform in Action

The winching platform, seen in Figure 55, was also, overall, very successful. There was no visible bending of the post during winching, and the platform itself was maneuverable enough to be moved without issue. The rope could be quickly attached to the winch, and the winch proved very smooth to use.

The platform's downfall proved to be something that none in the group had foreseen: should the wedge or a knot on the rope get caught on anything, the platform will either slide forward, or the front edge of

the platform will anchor in the ground, and the trailing edge of the platform will raise off the ground, as seen in Figure 56. This is quite unsettling for the operator, and furthermore, this is downright unsafe.

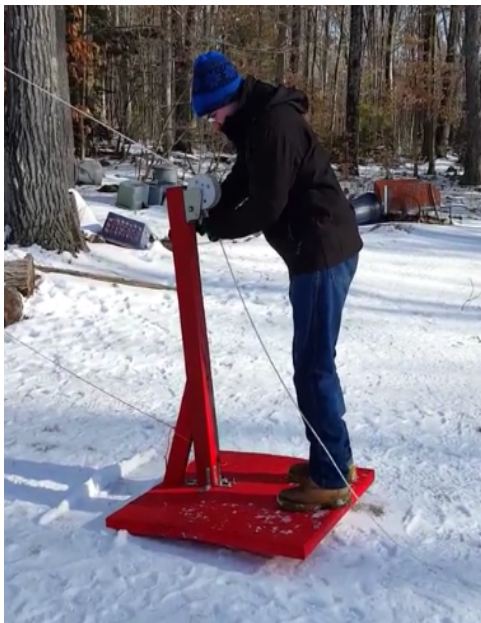
Figure 56: Platform Tipping

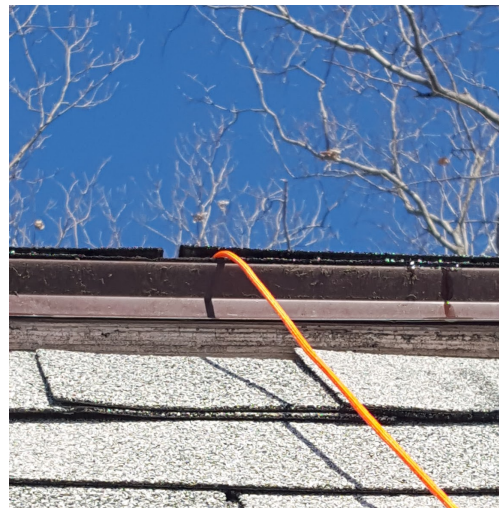
*Figure 57: Rope Caught Under Shingles*

The downside to the ropes, the driving force of the entire system, is they proved to be a high potential for shingle damage. During the design phase of the project, it was acknowledged that the ropes could cause shingle damage at the ridge of the roof. As a result, the millipede was designed to protect the roof ridge. It was also postulated that there was a slight possibility for damage from direct contact with the rope; however, if necessary, it was suggested a

plastic sheet could be used to prevent this. Unfortunately, when ropes were placed on the roof, even with no weight whatsoever, they would start to ride under the singles, especially at the ridge

of the roof, as can be seen in Figure 57. Furthermore, the rope would always find the underside of a shingle, regardless of its starting position. For example, should a rope be cast directly in the middle of a shingle, the rope would still wander, and find the underside of an adjacent shingle.

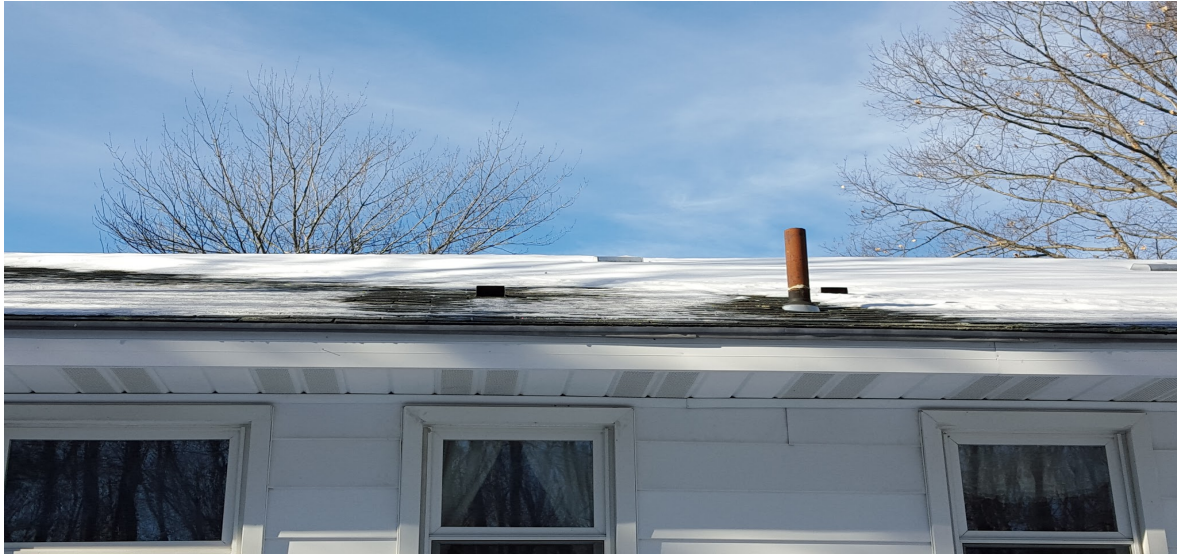
*Figure 58: Problematic Small Roof Vents*

Another concern about the system developed when examining the backs of several of the houses in the neighborhood where testing occurred. One house in particular, had at least four small vents on the rear of the roof, as seen in Figure 58. Previously, many of the houses examined did not have these vents; however, it would be impossible to tell if a particular house had any low profile vents on the roof when it is covered in snow. Furthermore, it is not likely that a homeowner would know the locations of any vents, or even know if they had any. As a result, it is very likely that while using the wedge to clear snow, it could become caught on a vent and very possibly tear it off.

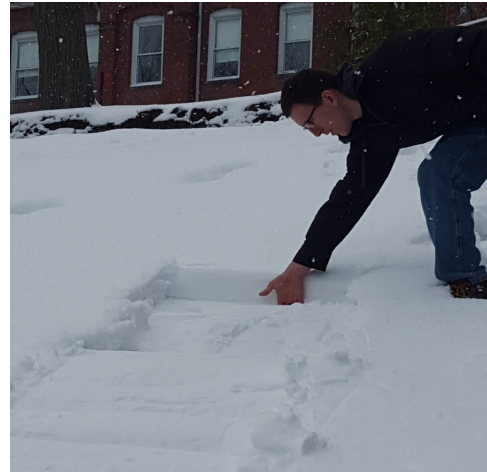
*Figure 59: Bar Drop Test*

The first test conducted, as seen in Figure 59, was a drop test of the bar and tarp to see how deep it would actually cut through snow. Surprisingly, the bar cut almost all the way to the ground, about six inches, when dripped from a modest high. On an actual roof, this would be more than ample, as the bar would dig itself deeper as it was pulled down the roof.

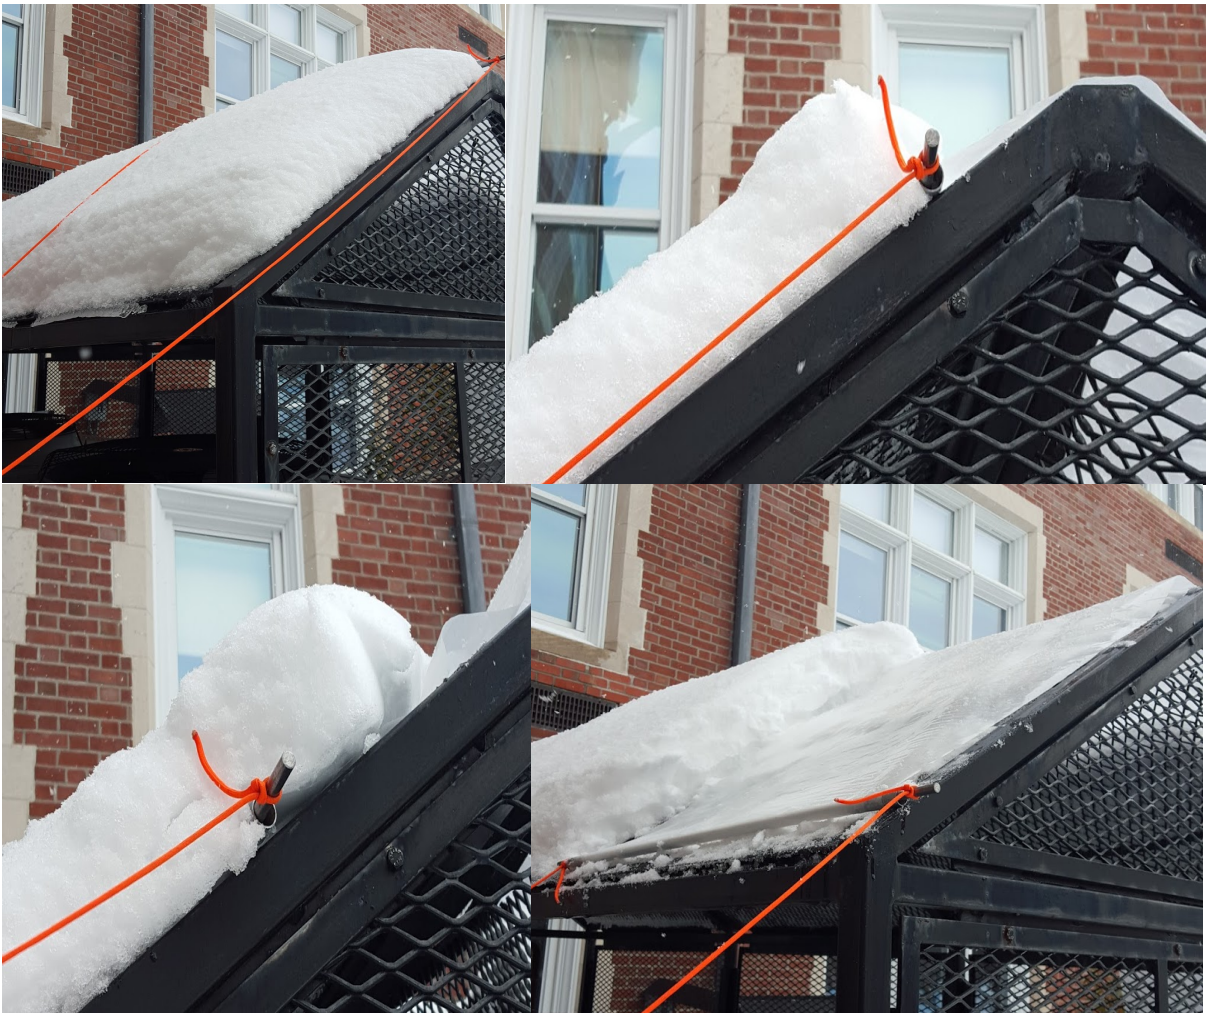
*Figure 60: Tarp Roller Roof Clearing*

After the drop test proved successful, the next step was to see if the tarp roller could clear a roof. This test, which was conducted on the HVAC guard outside of Higgins, also proved to be very successful. At the beginning of the test, the steel bar was placed at the top of the “roof” with the tarp trailing down one side and the pull ropes down the other side. As the ropes were pulled, the rod initially began to build up a head of snow; however, the rod soon found its way under the head. Once the tarp was under about 80% of the snow, the entire section of snow slid off the “roof”. This entire sequence of events can be seen in Figure 60.

Overall, this test proved that the tarp and rod combination could be extremely effective; the only issue was how to get it to the top of the roof. The only feasible solution was to use a remotely controlled quad-rotor type craft to deploy the rod at the top of the roof. The advantages of using a quad rotor is that it could quickly and accurately place the bar for each pass, while at the same time, it would keep ropes from having to cross the crest of the roof. Unfortunately, while feasible, using a quad-rotor for this task might not be practical. Due to the lift capability needed, which would be in the neighborhood of five pounds, any quad-rotor capable of deploying the rod and tarp would cost well over one thousand dollars. Ultimately, the prohibitive cost, new FAA registration requirements, and the skill needed to effectively operate a quad-rotor makes a prototype that could be dragged to the top of the roof much more practical.

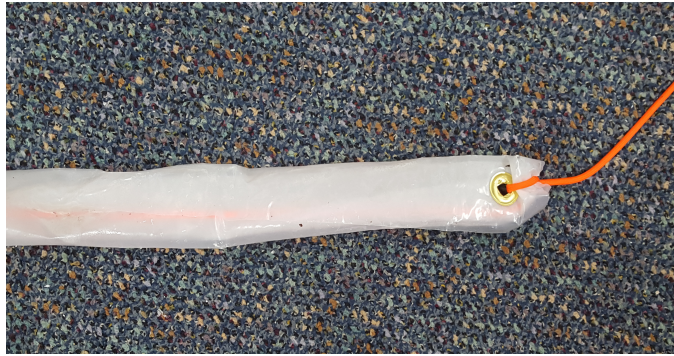
*Figure 61: Rope in the Plastic Ribbon*

Unfortunately, the only way to drag the tarp to the top of the roof is to use a rope over the ridge of the roof. While it was easy enough to launch a small line over the top of a roof with the “Big Shot Launcher,” placing this line there created the same potential for damage as out wedge design.

A simple solution for this problem was proposed: to wrap the rope used to drag the tarp to the top of the roof in a plastic ribbon. This ribbon, as seen in Figure 61, was attached to the back of the tarp like a tail. The rope inside the tail was attached to the main tarp with a series of grommets, as seen in Figure 62. Due to the size of this plastic “tail,” the rope was no longer small enough to slip between the small gaps of the shingles. Additionally, because the tarp assembly only weights about five pounds, and that the dragging did not include a snow load, the need for an additional roof ridge protector, such as the millipede, was not necessary.
