Tourist Impact in Acadia National Park: Investigating and analyzing tourist usage patterns on Park Loop Road to determine fee compliance solutions

Tourist Impact in Acadia National Park

Investigating and analyzing tourist usage patterns on Park Loop Road
to determine fee compliance solutions

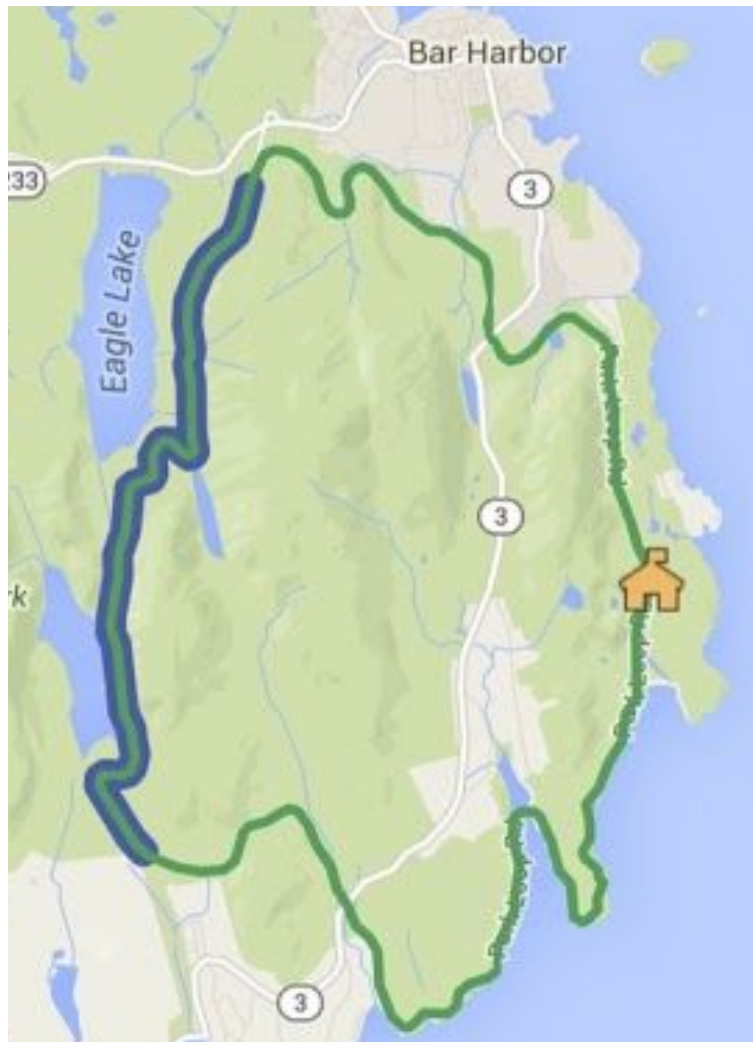
Figure 2: A map of Park Loop Road. The green portion is the one-way stretch, while the blue is the two-way portion. The yellow house represents the Sand Beach Entrance Station.

While Acadia National Park extends beyond Mt. Desert Island, most of the tourist traffic is concentrated along the eastern coast and into the center of the island along Park Loop Road. Park Loop Road is approximately 18.5 miles around, 5.11 miles of which is two-way. Including a three mile drive from the Hulls Cove Visitor Center along Paradise Hill Road and a six mile drivable ascent and descent of Cadillac Mountain, it is 27.5 miles around. The road is two lanes wide and one-way from the intersection at Paradise Hill until the intersection with Stanley Brook Road. Two way traffic travels for the remaining five miles of the loop. An entrance station to check and sell park passes is strategically placed roughly one half mile before Sand Beach and Ocean Path, two of the park's most visited attractions. A map of Park Loop Road can be found in Figure 2 below. The team identified 22 parking lots located along Park Loop Road, including at popular locations such as Sand Beach, Thunder Hole, Otter Cliff, the Jordan Pond House, and Cadillac Mountain. A map of parking lots is located in Figure 3 below. While these lots are designed to reduce congestion, they rapidly fill at peak hours resulting in overflow. In the case of Sand Beach, Thunder Hole, and Otter Cliff, these cars accumulate in the right lane of Park Loop Road. These attractions are the subjects of many of the traffic difficulties in the park, and park infrastructure is unable to handle the rising number of visitors. In fact, park officials

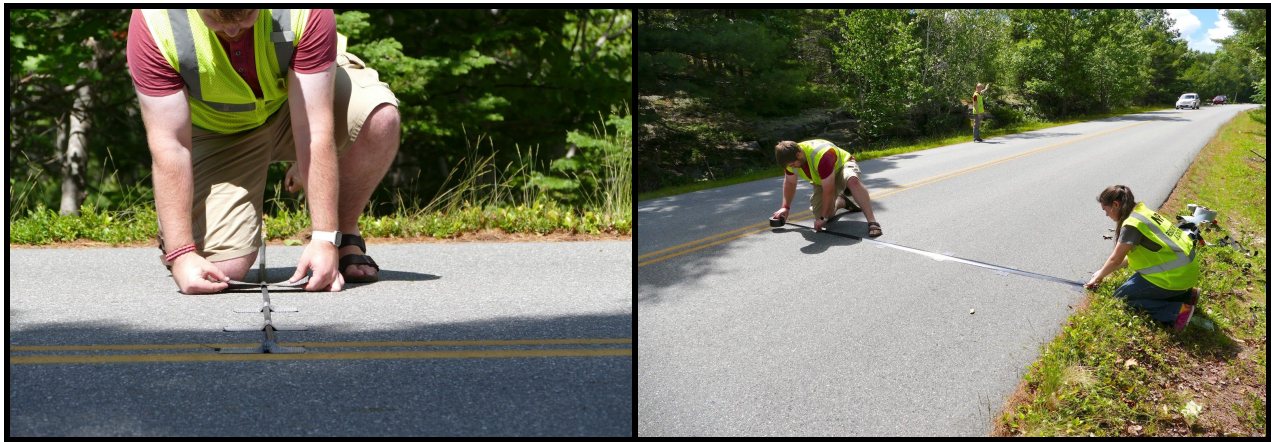
Figure 13: Installation of tube on Paradise Hill Road.

out on the road, each end was secured down using a nylon strip and nails. Roadway tape was then placed approximately every two feet with multiple layers over the metal end cap to prevent damage to vehicles should the end cap be driven over. The final layer of security was a layer of Gorilla Tape. This process was repeated at each of the locations. After all the tubes were in place and the hardware complete, the sensors themselves were placed and attached to the tube using $\frac{1}{4}$ " to $\frac{1}{8}$ " brass barbs seen below in Figure 14.

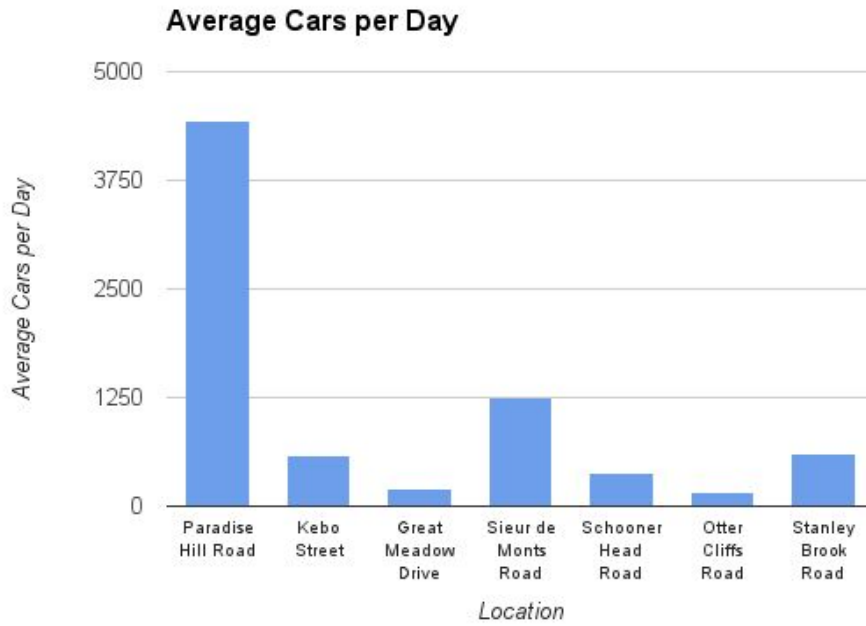
Figure 25: Average cars entering at each location per day.

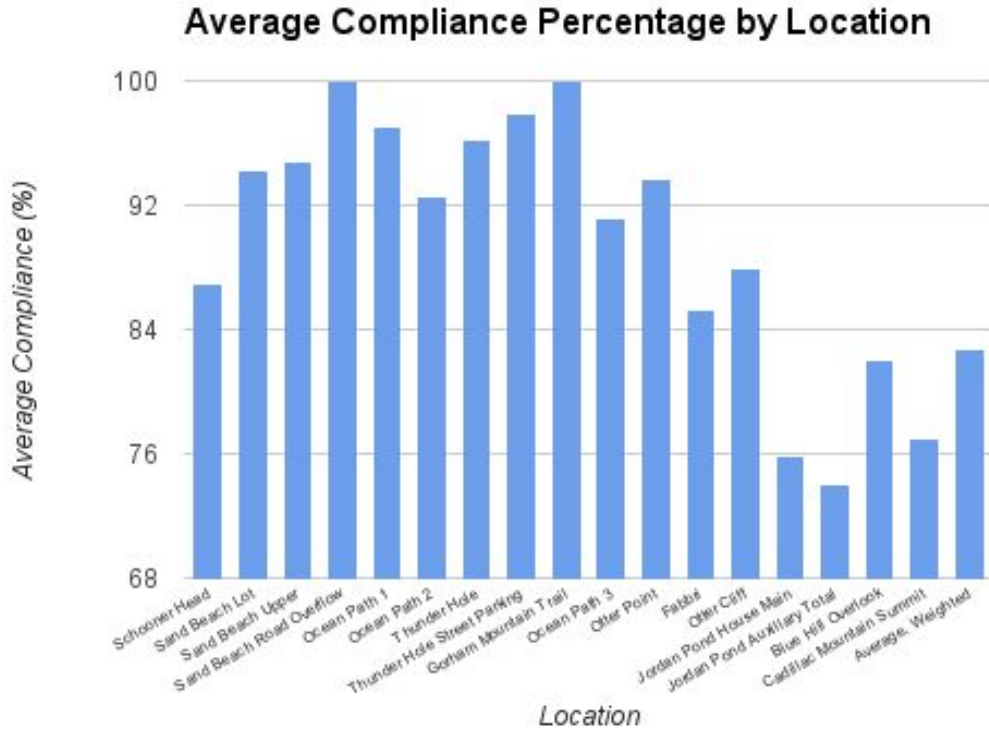
Figure 26: A graph of average park pass compliance by location of parking lot.

The average park pass compliance throughout Park Loop Road was found to be 84.9%. This average was determined by weighting data from individual parking lots to assure that the averages from larger parking lots had more influence than those from smaller lots. While this average compliance is much higher than previous estimates made by park officials of between 60% and 70%, it is important to distinguish the difference between compliance on Park Loop Road alone and compliance throughout the park.

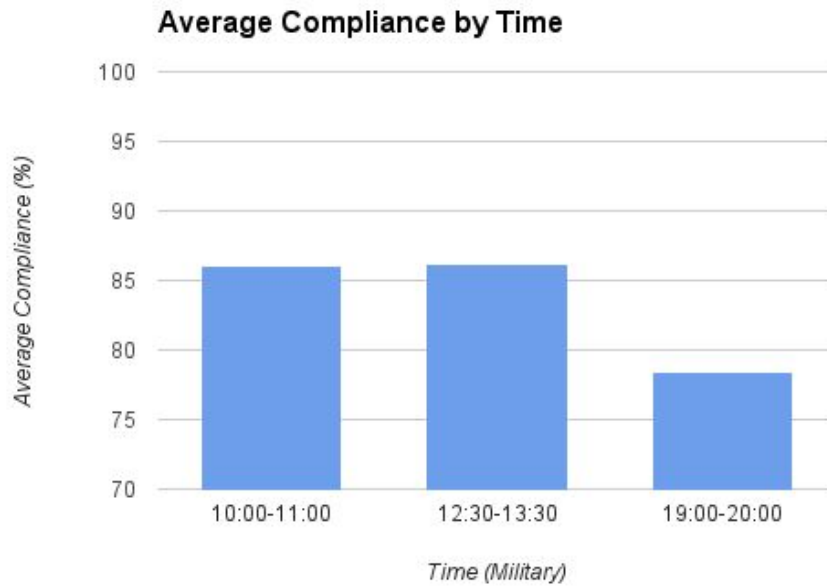
Figure 27: A graph of average park pass compliance by time.

Cars were found to be most compliant during the morning and afternoon counts, from 10:00AM to 11:00AM and 12:30PM to 1:30PM. The average compliance for the morning count was 86.1% and was 86.2% for the afternoon count. This is reasonable because those are within the operational hours of the Sand Beach Toll Station. Cars were least compliant in during the the evening counts, between 7:00PM and 8:00PM. The compliance for the evening count was 78.4%.

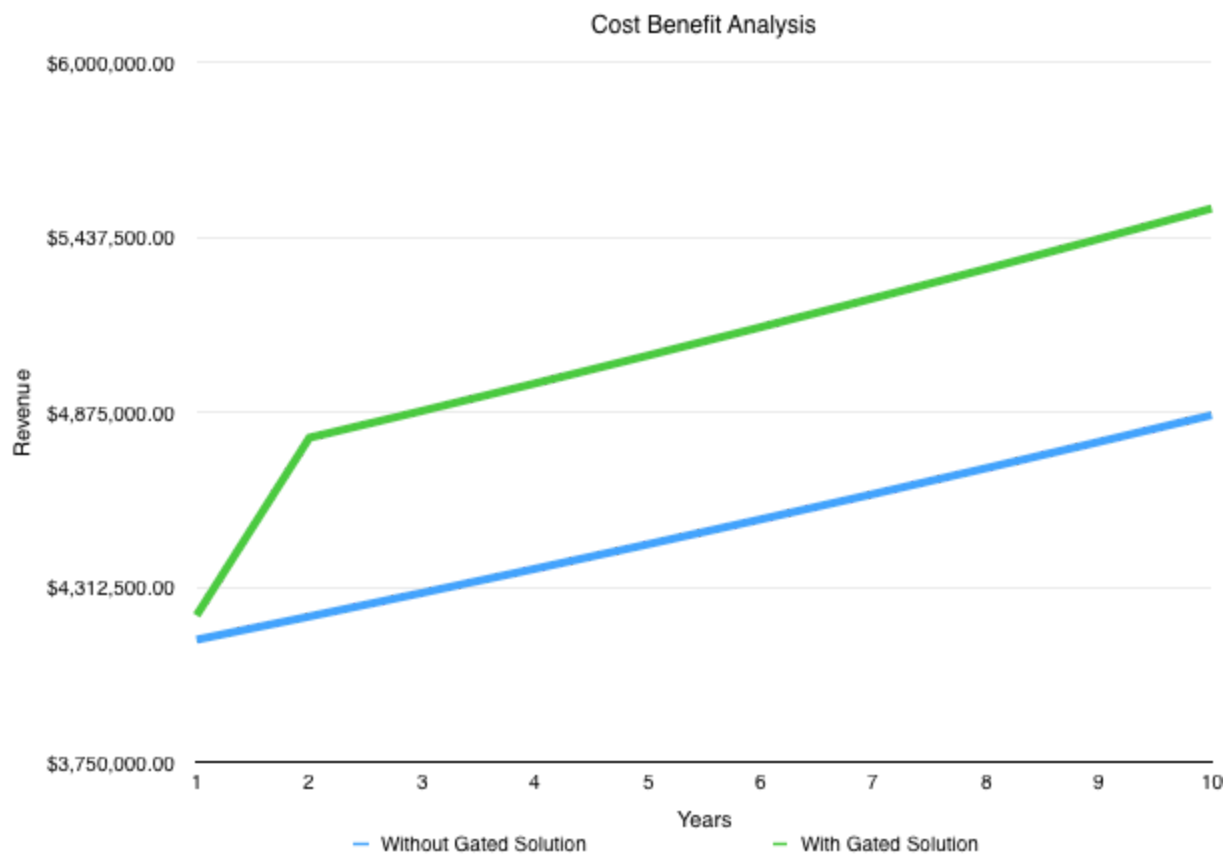
Figure 29: A graph of the cost-benefit analysis over the span of 10 years.
