Charlton Town Hall Space Optimization

Interactive Qualifying Project:
Charlton Town Hall Space Optimization

An Interactive Qualifying Project (IQP) Proposal submitted to the faculty of
Worcester Polytechnic Institute in partial fulfillment of the requirements for the
Degree of Bachelor of Science

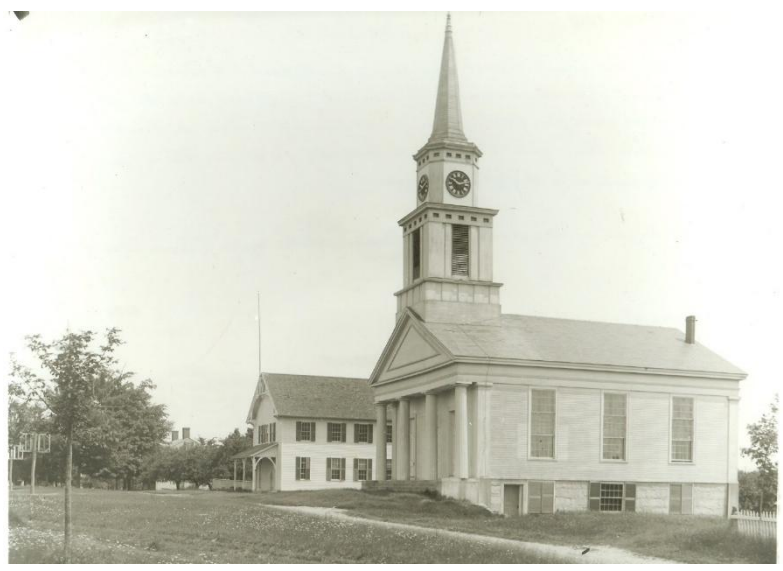
Figure 3: The Universalist Church and High School

When the large Universalist church was dismantled, a smaller Universalist church was built alongside a building that served as both the high school and Town Hall {Charlton Historical Society, Charlton Historical Society Archive}.

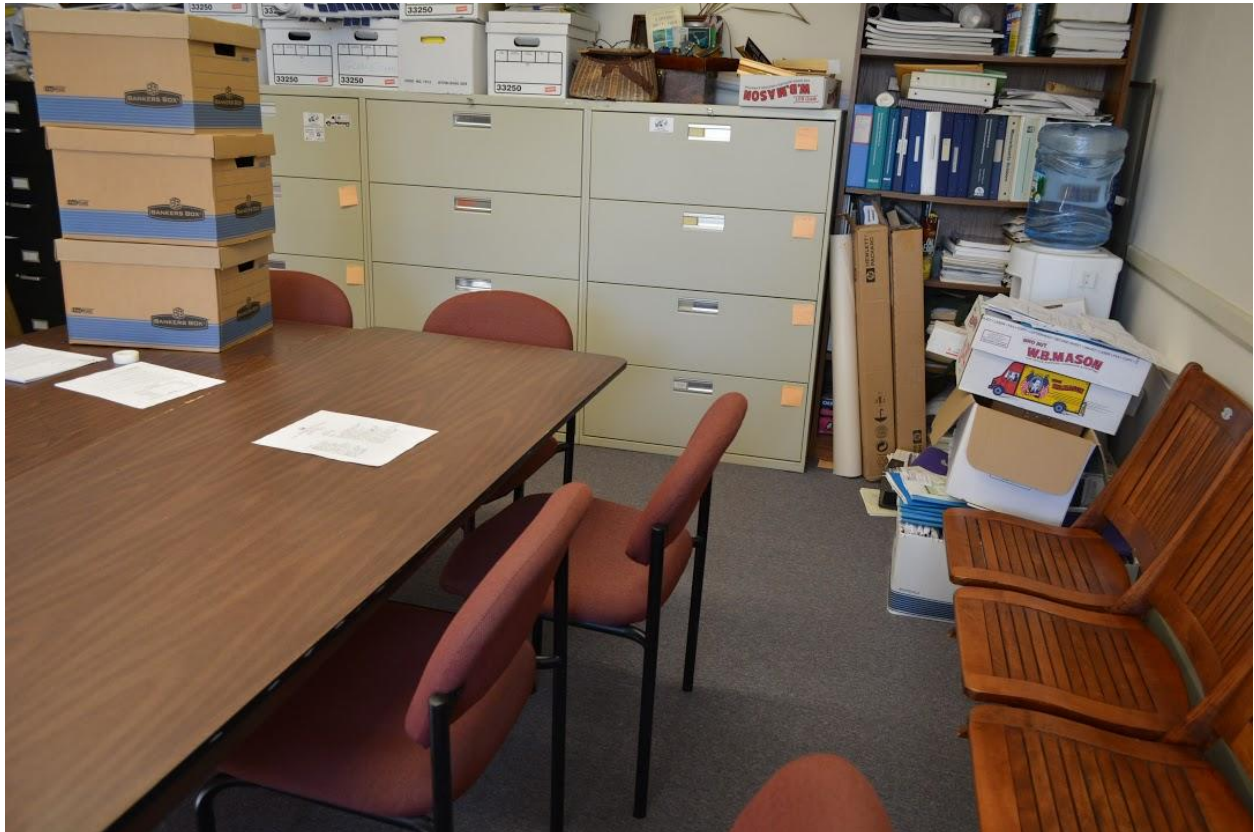
Figure 10: A Narrow Aisle in Conservation

Per ADA, there must be an accessible route to all public spaces that is at least 36" wide; this is not met inside offices, particularly Conservation and the Town Clerk, which are open to the public. {Adaptive Environments, 1995, ADA Title III Compliance Materials}

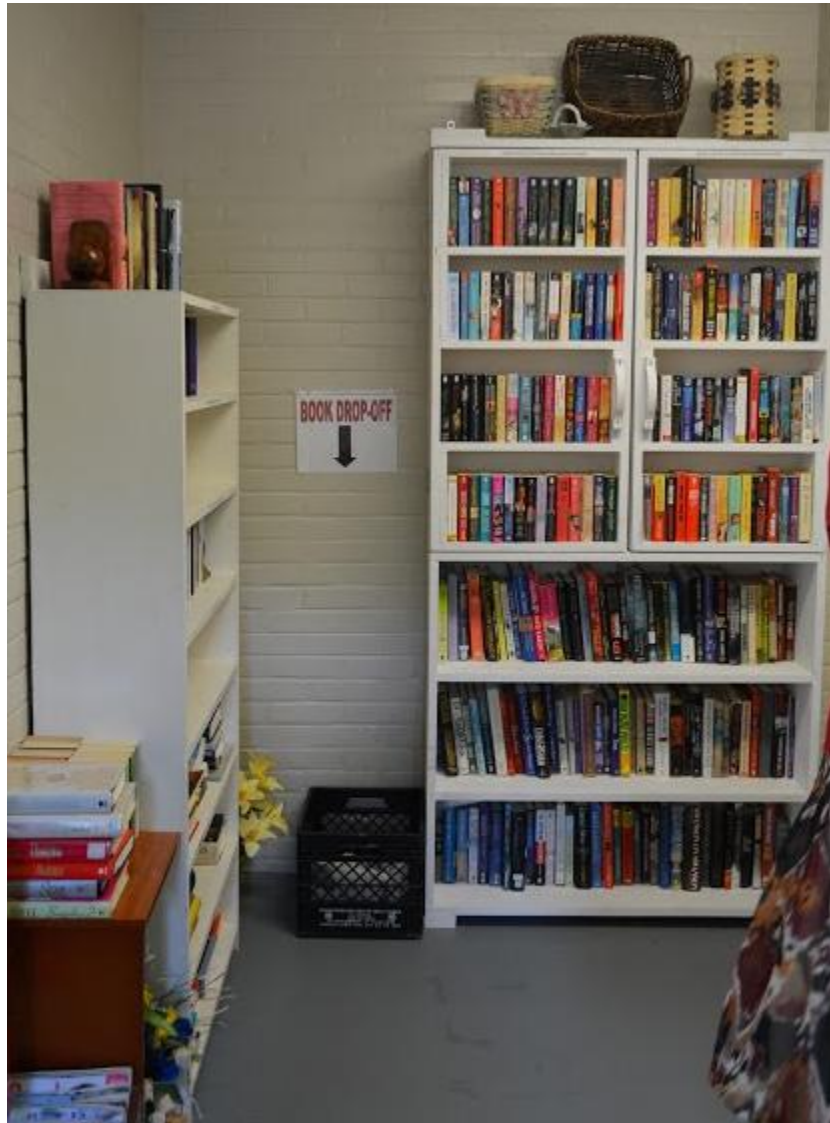
Figure 11: The Senior Center Library Area

Though the elevator is no longer disrupting the Outreach Coordinator's office, the nearby library area will need to be relocated. The Veteran's wall may also need to be moved. Stairs are going where the piano is located, so it too must move.

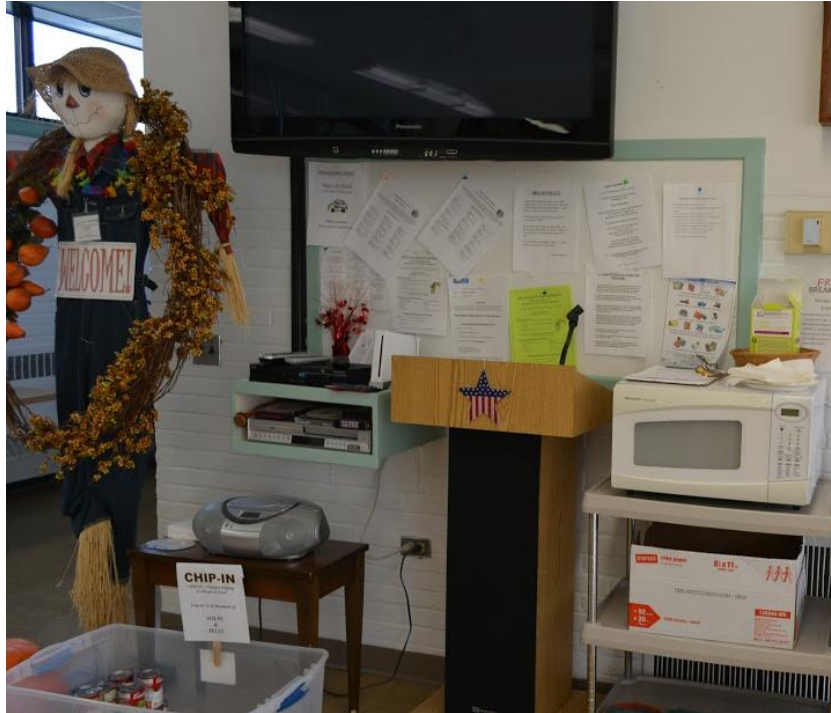
Figure 12: The Senior Center Bulletin Board is Poorly Placed

Bulletin Boards in the senior center are not utilized as much as would be hoped for. Located underneath a TV, people look at the TV instead, and one cannot get close enough to the boards, due to tables. Additional pamphlet holders for the walls were requested.

Option 9: Supply additional pamphlet holders for the walls, likely to be placed near the offices of the Director and Outreach Coordinator.

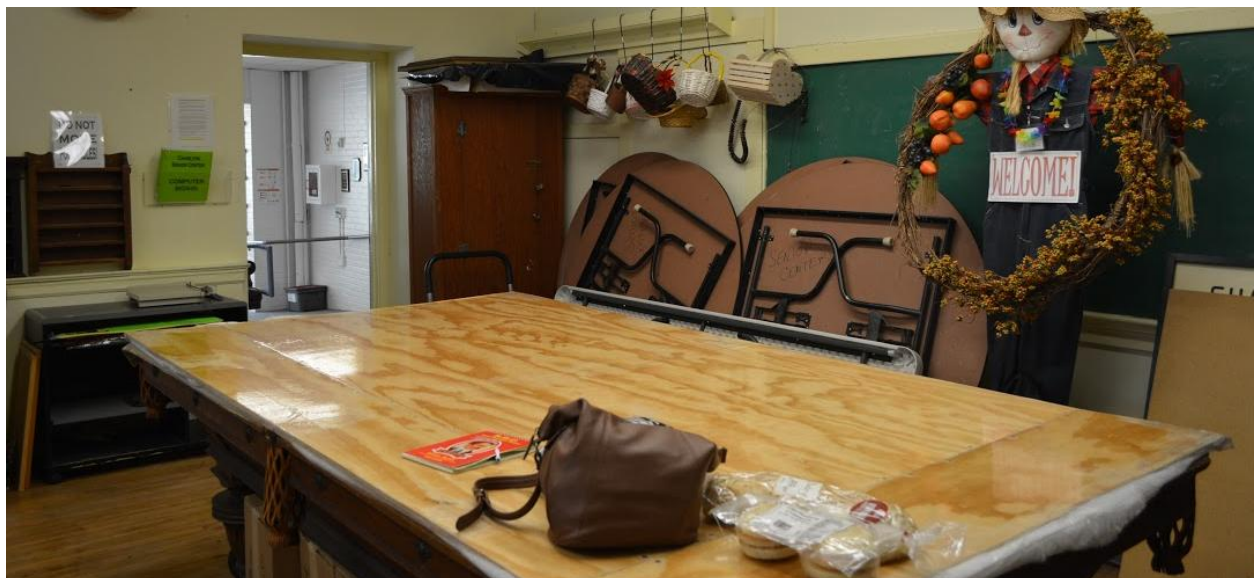
Figure 13: The Pool Table and Storage Beneath

Likewise per ADA, the pool table in the Multi-purpose/Pool room does not have proper knee clearance, and there is storage under it {Adaptive Environments, 1995, ADA Title III Compliance Materials}.

One other item that the IQP team noted was the folding tables in the multi-purpose/pool room, which can be seen in the above figure. These tables are often rolled into the main room for functions. Per the building plan, significant changes are being made to the main room; there will be stairs near the entrance to the multi-purpose room, and there will be a door at the bottom of the ramp. These changes may make it difficult to move the tables into the main room.

Option 5: Leave the tables where they are and address any problems with moving them as they arise.

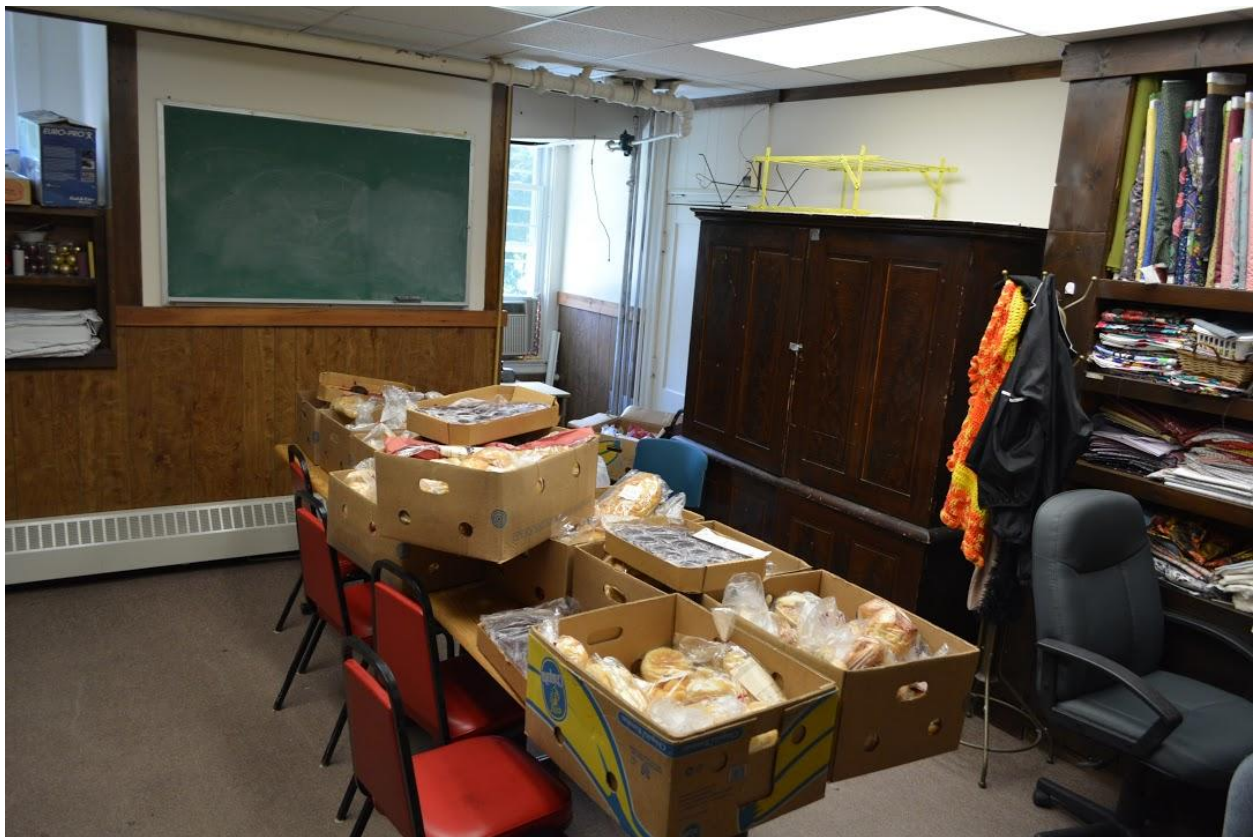
Figure 14: The Employee Break Room with Bread and Cloth Belonging to the Senior Center

Per ADA, the employee break room lacks compliant signage {Pioneer Valley Planning Commission, 2014, Leic-Char CHABR FY14}.

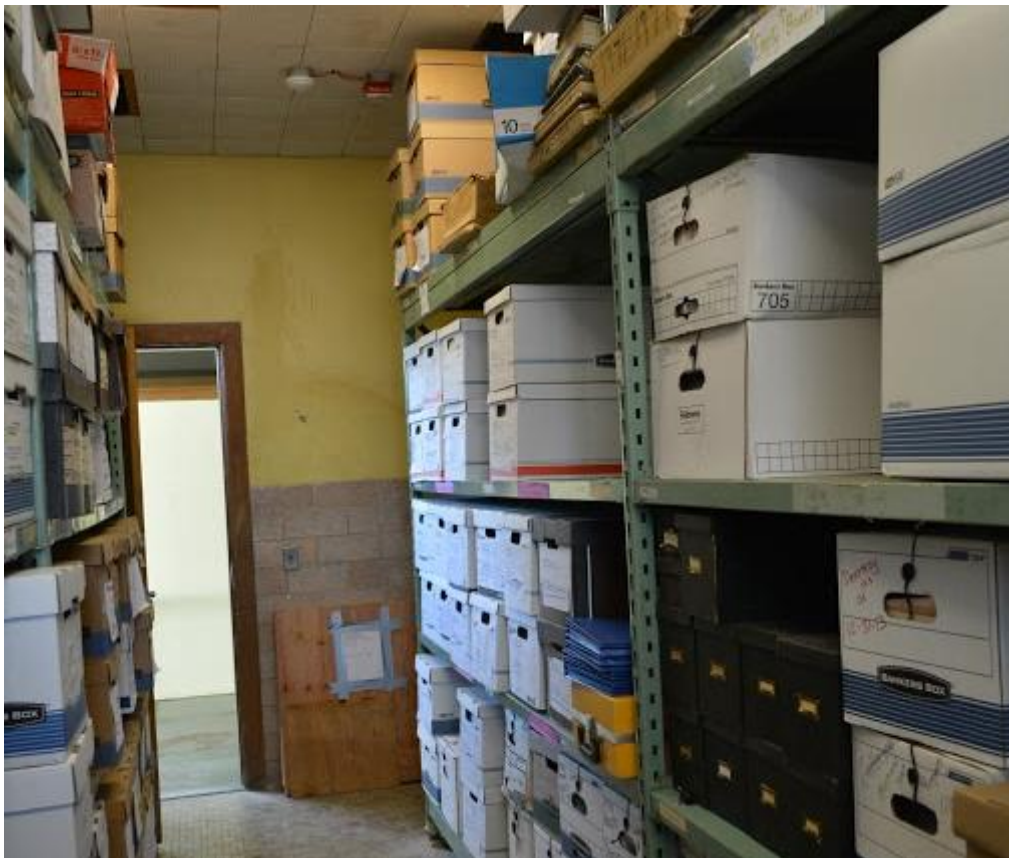
Figure 15: Storage in the Archive Room

A concern was raised that the Board of Selectmen is not fulfilling its responsibilities regarding the conditions of the archive room. In particular, a need for humidity control was cited. After following up with a selectmen and the town administrator, as well as referencing town bylaws (sections 50-10 and 50-26), it was determined that the Board of Selectmen are not responsible for the storage conditions. Each department is in charge of its own file storage {Town of Charlton, 2014, Town Bylaws}.

Option 1: Per Charlton's bylaws, there is no need for humidity control, and each department is in charge of its own storage. The Board of Selectmen are not responsible for the conditions in which each department stores its archive files, but it might still be worthwhile to

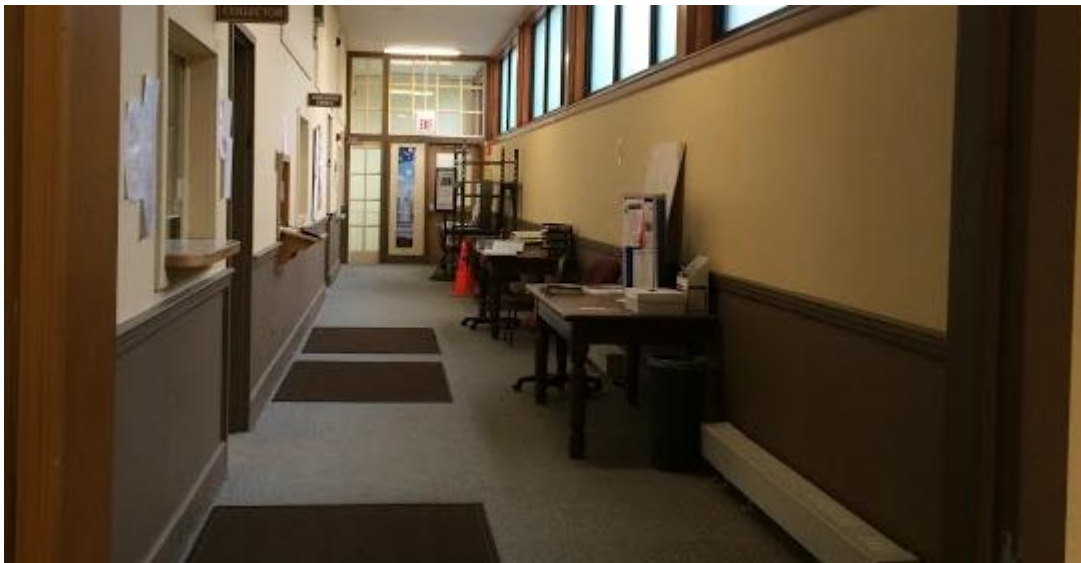
Figure 16: The Hall by the Collector and Assessor with Low Tables and Protruding Keyboard Shelf

The wall mounted keyboard shelf protrudes too far per ADA requirements {Pioneer Valley Planning Commission, 2014, Leic-Char CHABR FY14}.

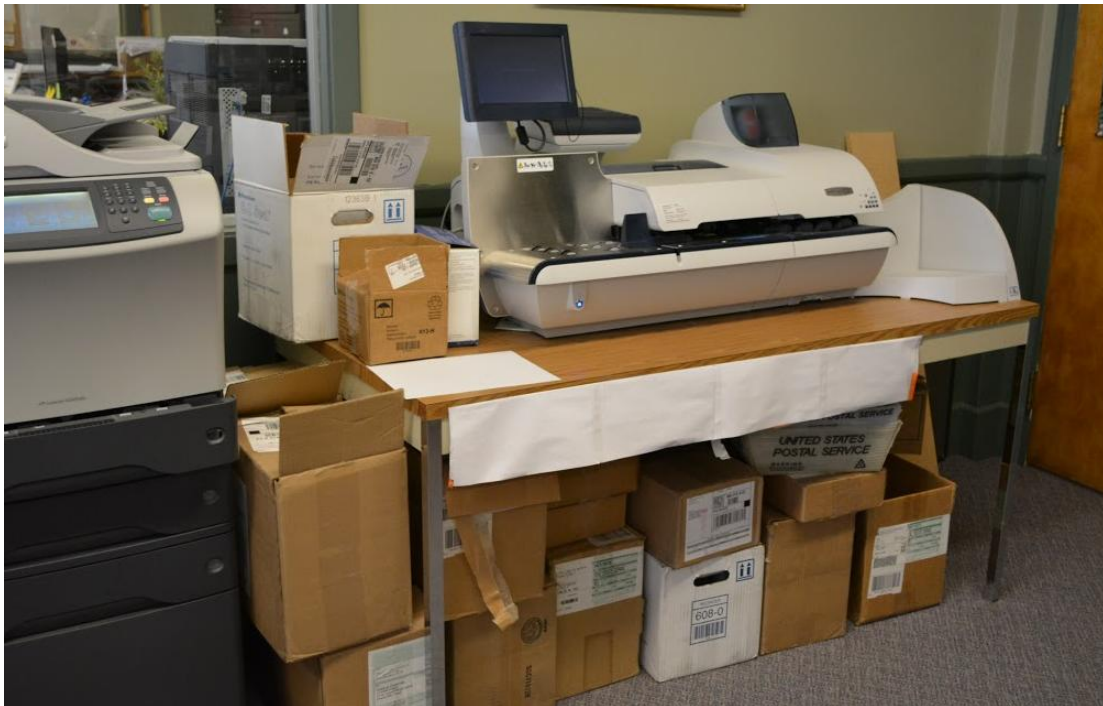
Figure 17: The Collector's Postage Machine

The Collector has storage that needs to be frequently accessed, but is an eyesore to the public; there are forms in boxes underneath the postage machine.

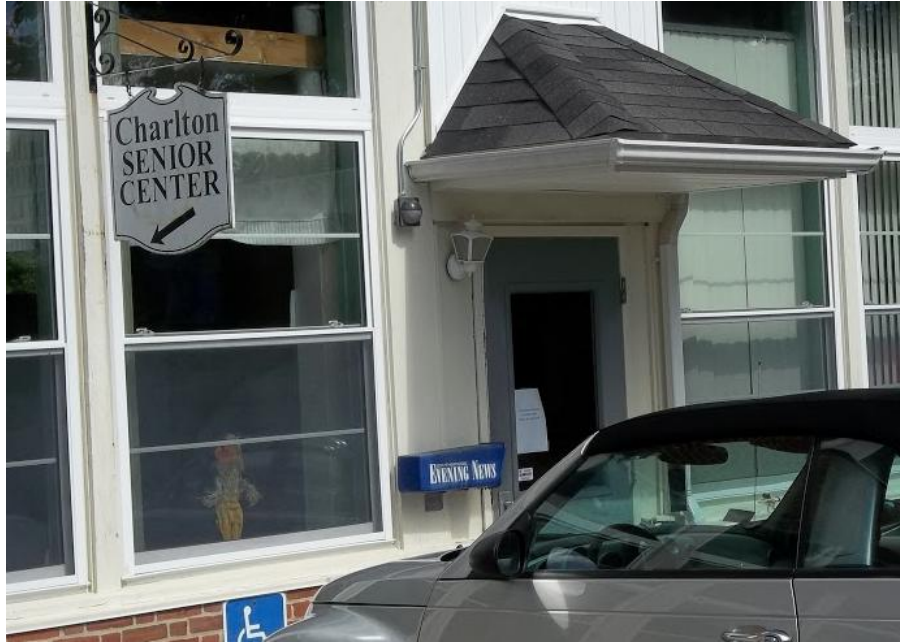
Figure 18: The Exterior Senior Center Door with Obstructing Mailbox

Likewise for an ADA requirement, there must be at least 18" of clear wall space on the pull side of a door, next to the handle. The mailbox next to the exterior senior center door violates this {Adaptive Environments, 1995, ADA Title III Compliance Materials}.

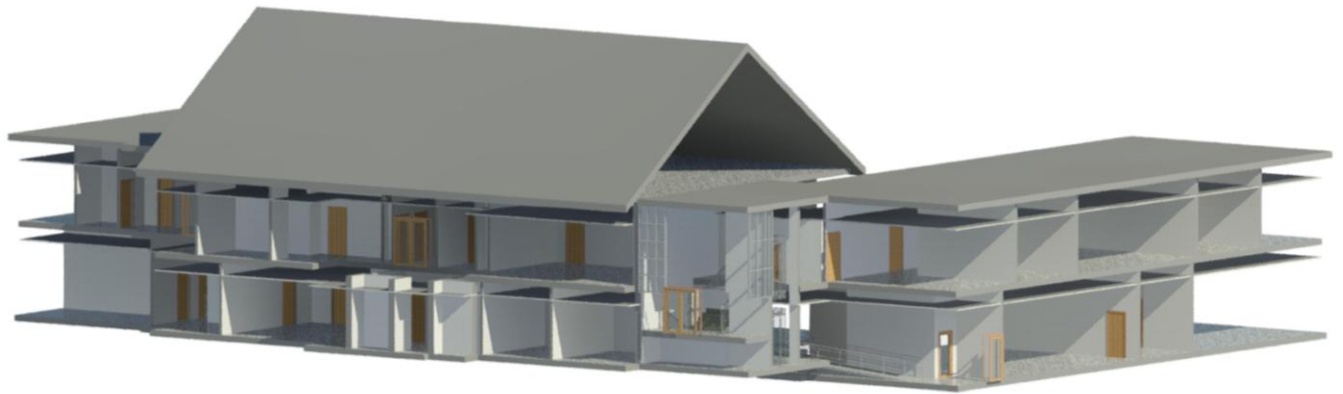
Figure 19: 3D Rendering of Town Hall with no Exterior Walls

Per the building plan, throughout the building, accessible signage will be added. All public counters and work surfaces, including computer stations, will be made accessible. Each floor will have an accessible water fountain. The stairwell next to the VA office will be removed, and stairs will be put in next to the elevator shaft. The VA office and adjacent conference area will be merged into one room. In all bathrooms, the mirrors, grab bars, and toilets will be lowered to accessible levels {Durland - Van Voorhis Architects, 2010, Charlton Town Hall Accessibility Improvements}.

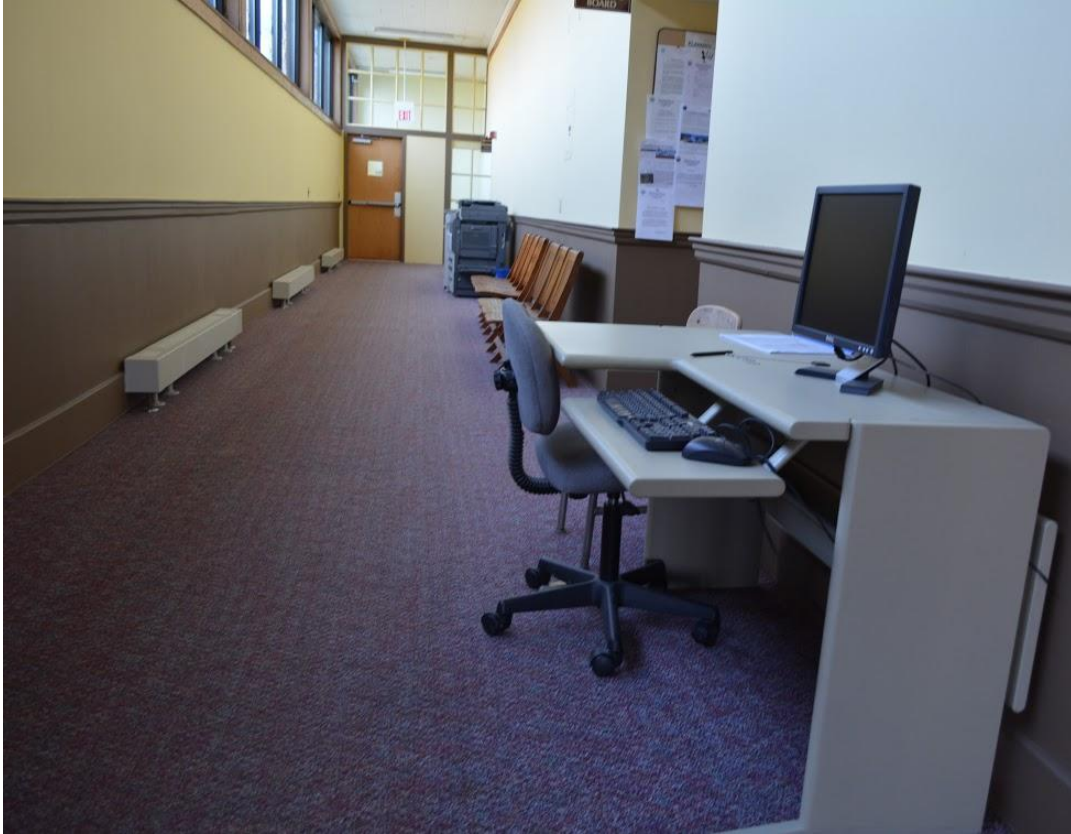
Figure 28: A Workstation that Narrows the Hallway

There is a desk in the hallway that, when the chair is not pushed in, frequently causes an obstruction. This can be an ADA problem when it makes the hallway narrower than 36".

Option 3: Replace the desk with a smaller desk, and rotate the workstation 90 degrees so that when the chair is pulled out, it does not decrease the clearance in the hallway. This desk could potentially be moved into the senior center to be used as a reception desk.
