Assessing Environmental Damage at Stream Crossings in El Yunque National Forest

Interactive Qualifying Project

Sponsoring Agency: United States Forest Service, El Yunque National Forest

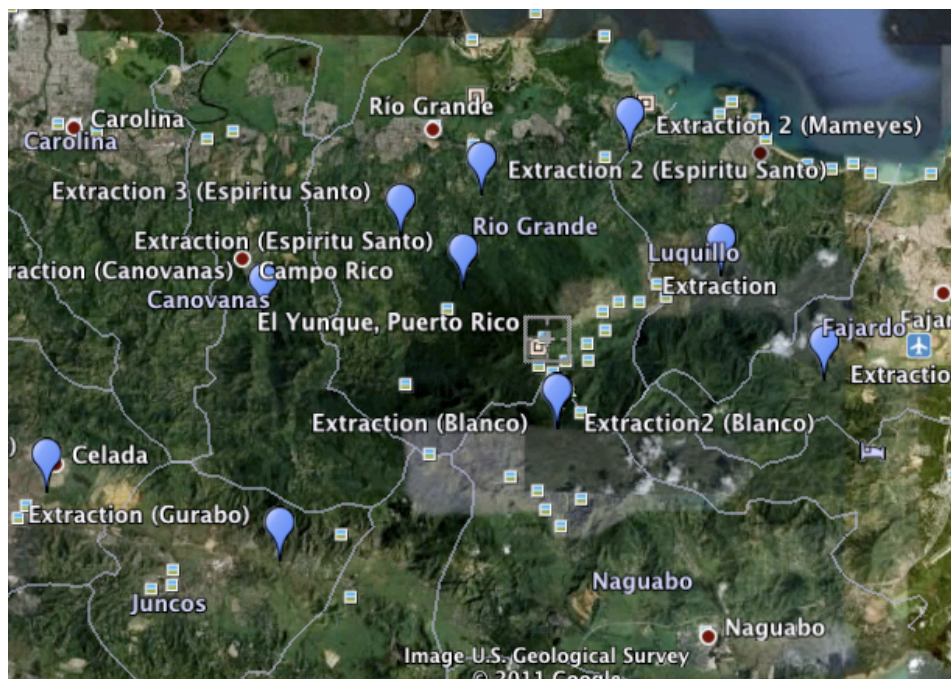
Figure 2: Extraction Sites

Stream crossings are not the only human modification that can negatively impact streams. Almost all of the twelve watersheds are dammed in multiple places. The only exception is Río Mameyes, which is not dammed anywhere along its length (Pedro Rios, personal communication March 15, 2011). However, most rivers have an extraction or withdrawal where water is piped for public use. Withdrawals come in various sizes, ranging from small to large enough to power a hydroelectric plant (Benjamin Fuentes, personal communication, March 24, 2011). Withdrawals alter the flow of the stream and often negatively affect the ecosystem. The locations of extractions (Crook et al. 2007) operating in 2002 and assumed to operate now were plotted using the Google Earth application in Figure 2. Knowing the locations of these extractions aids in determining how much the flow of the river is altered, with a potentially negative impact on the surrounding environment.

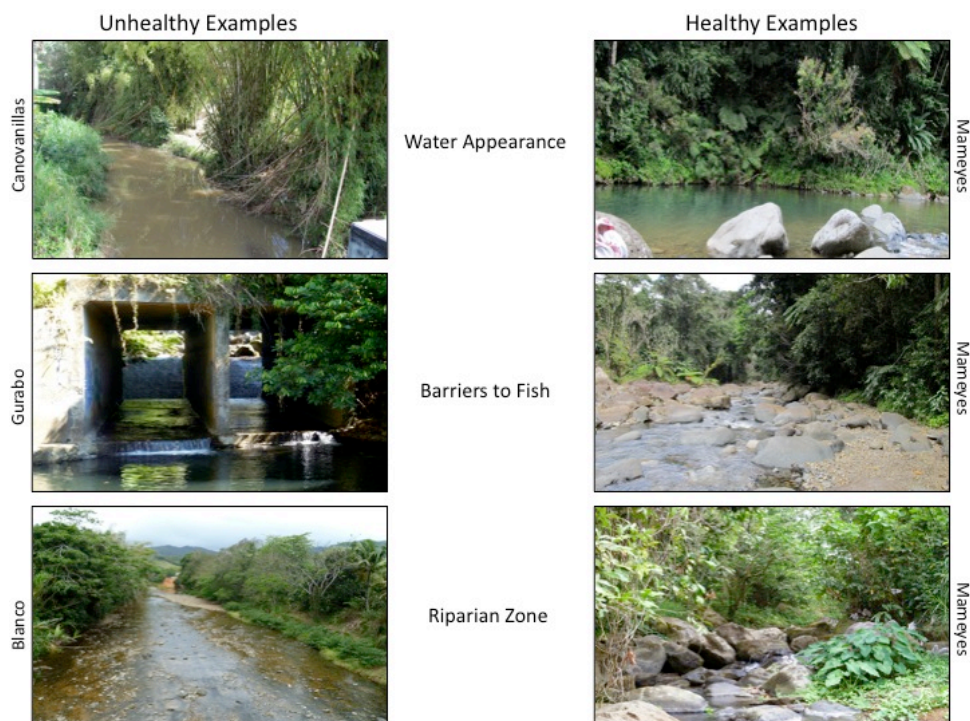
Figure 13: Visual Differences between Healthy and Unhealthy Streams

Each of the three unhealthiest rivers had one factor in which they all scored a one, the lowest score possible. For Río Canóvanillas, it was water appearance. Río Blanco scored extremely low in riparian vegetation and Río Gurabo had a barrier to fish movement (a drop culvert). The visual difference between these low scores and the perfect scores of the control (10) are shown in Figure 13.

Although the river is evaluated as a whole, sometimes one or two factors can change the overall average of the score. Even in the almost perfect controls, low scores were obtained for in-stream fish cover and nutrient enrichment. For our worst streams, all three of them were given a lower average due in major part to one score. Knowing these correlations helped us to develop better recommendations for individual streams as well as for the watersheds as a whole.
