Measurement and Analysis of Walkability in Hong Kong

An Interactive Qualifying Project Report

Though Hong Kong's Victoria Harbour is world-renowned, the harbor front districts are far from walkable. The WPI team surveyed 16 waterfront districts, four in-depth, assessing their walkability using a tool created by the research team and conducted preference surveys to understand the perceptions of Hong Kong pedestrians. Because pedestrians value the shortest, safest, least-crowded, and easiest to navigate routes, this study found that confusing routes, unsafe or indirect connections, and a lack of amenities detract from the walkability in Hong Kong. This report provides new data concerning the walkability in harbor front districts and a tool to measure it, along with recommendations for potential improvements.

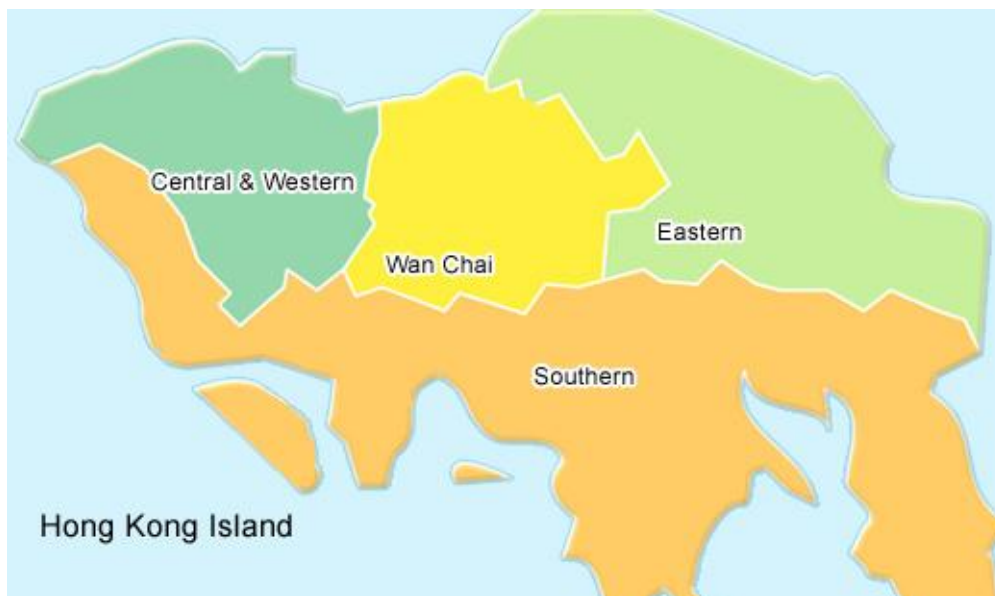
Figure 2.4-2: Districts of Hong Kong Island (Home Affairs Department, 2010)

Hong Kong Island is located south of Victoria Harbour. There are four districts of Hong Kong Island: Central and Western, Eastern, Wan Chai and Southern (Home Affairs Department, 2010). Central and Western, Eastern, and Wan Chai, will be the main focus of this report. Figure 2.4-2 highlights the boundaries of each district.

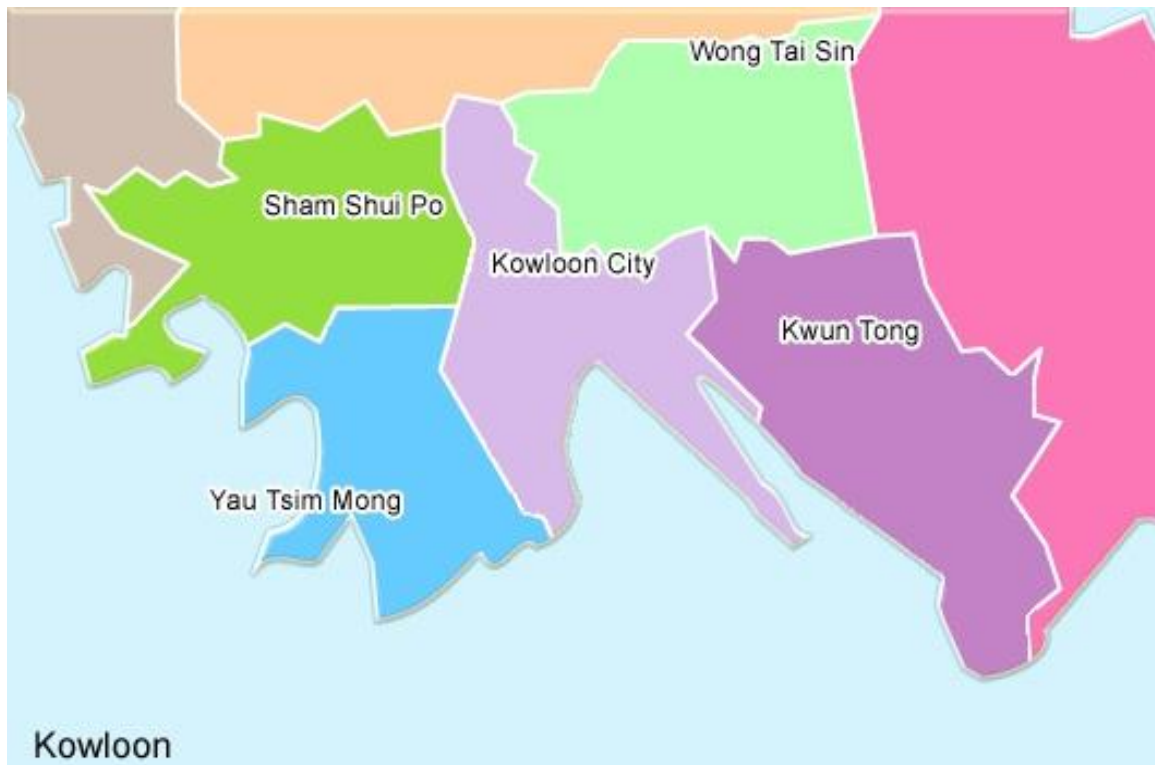
Figure 2.4-3: Map of Kowloon Administrative Districts

The Central and Western, Wan Chai, and Eastern District all run along Victoria Harbour. To the north of Victoria Harbour is Kowloon. Kowloon is comprised of fourteen action areas. Our team found it useful to cluster these action areas into the five administrative districts shown in Figure 2.4-3.

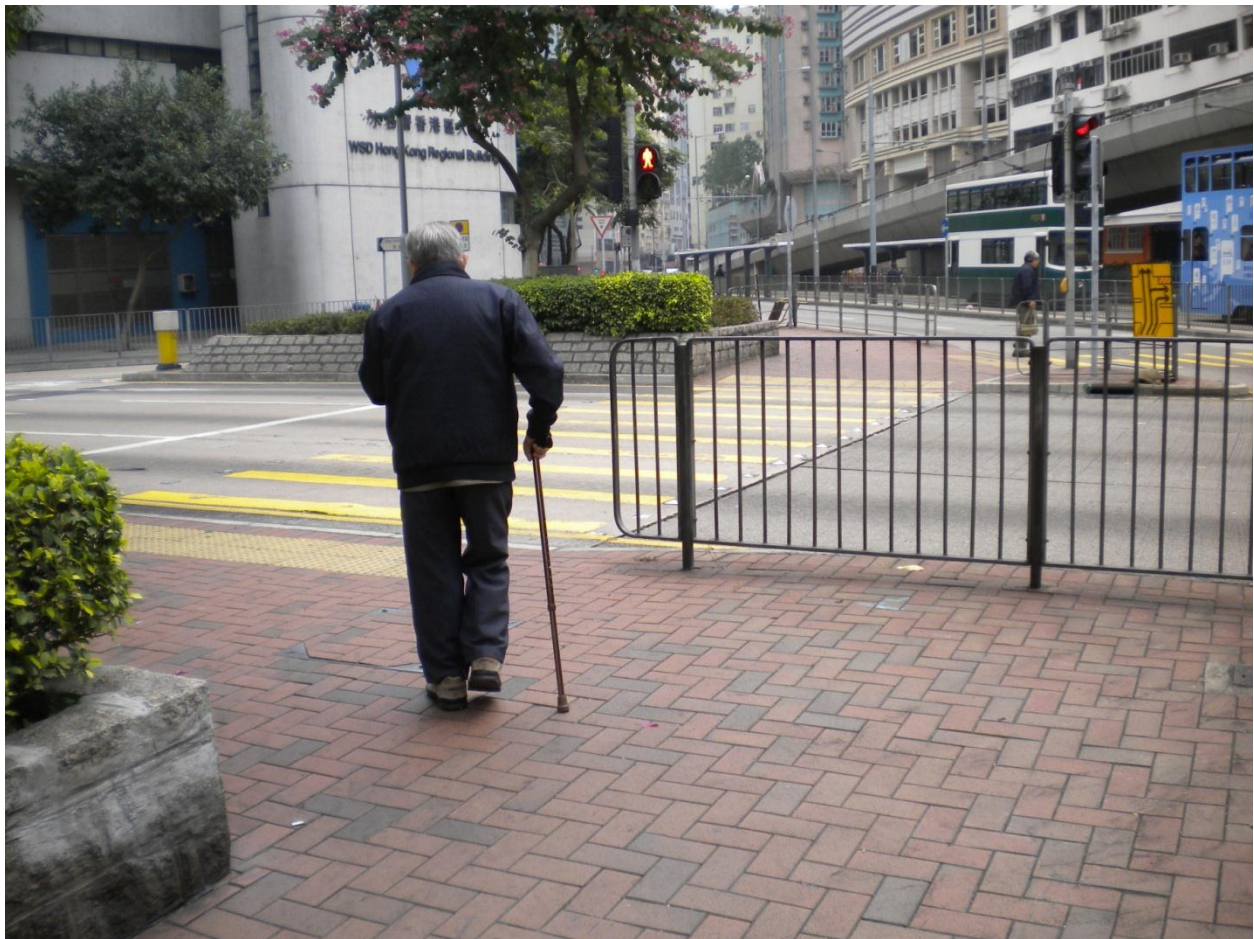
A *connection*, shown in Figure 3.1-3, is a marked crosswalk, a footbridge, or subway, including MTR tunnels. If a tunnel exits to three different streets, this is considered three different connections. However, if there are two crosswalks, but the middle crosswalk is only an island, this is considered only one connection. A place where pedestrians cross and there is only a look left or look right sign or no markings on the road is not included as a connection.

Figure 3.1-3 - Connection (Zebra Crossing)

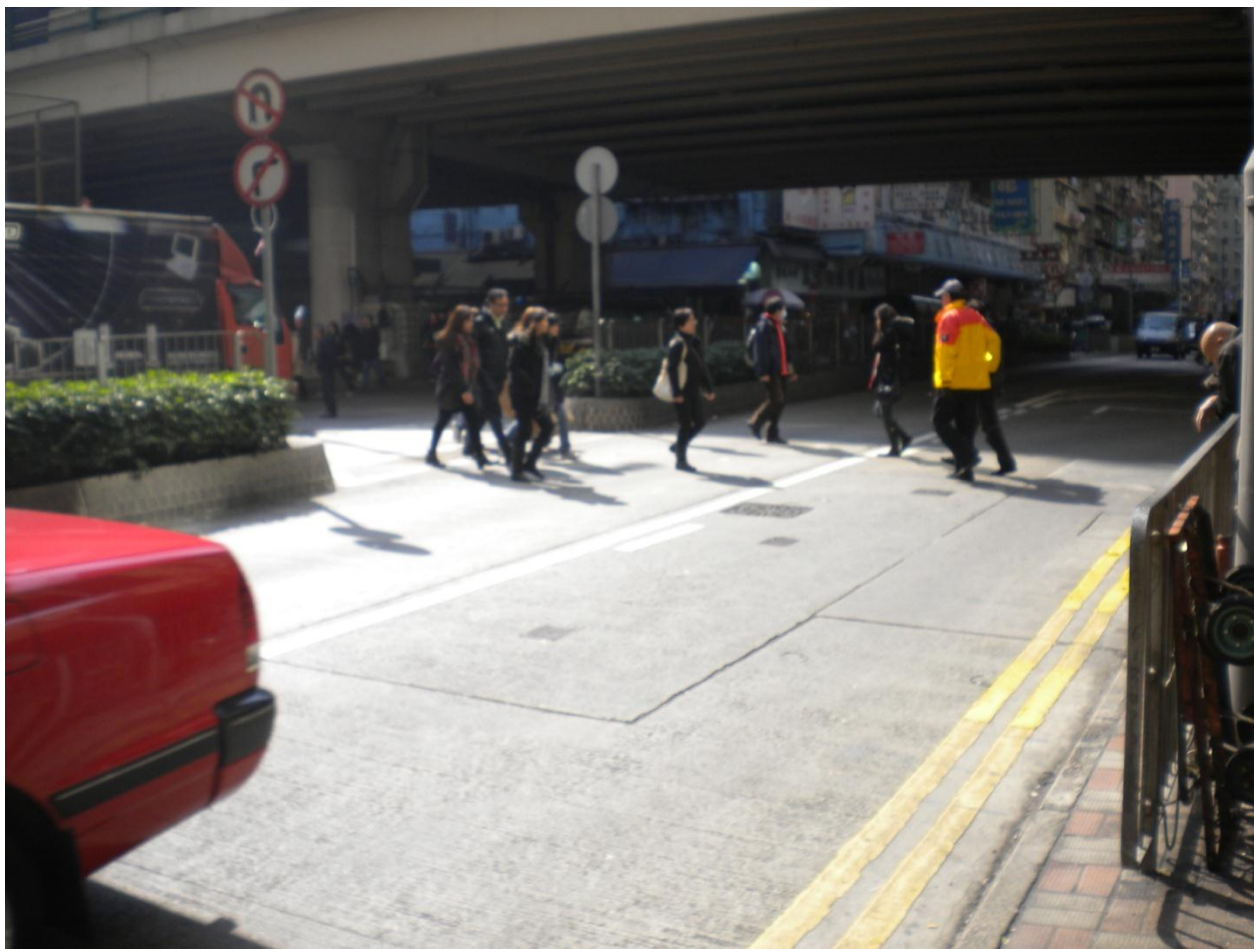
A *choke point*, shown in Figure 3.1-4, is any place where a pedestrian is forced to slow down their walking due to either a structure or barrier in the walkway, not from the congestion of people. This can include construction areas, excessive displays from shops or restaurant seating. This also includes *informal crossings*, any time a street needs to be crossed and there is no connection between streets yet pedestrians continue to cross there. Anywhere that vehicles enter or exit, such as the entrance or exit to a parking garage, can be considered a choke point. A “look left, look right” crossing or an *unmarked crossing* is also considered a choke point. A choke point is not where there is an excessive amount of people or bags of waste (as on a garbage day).

Figure 3.1-4 - Choke Point

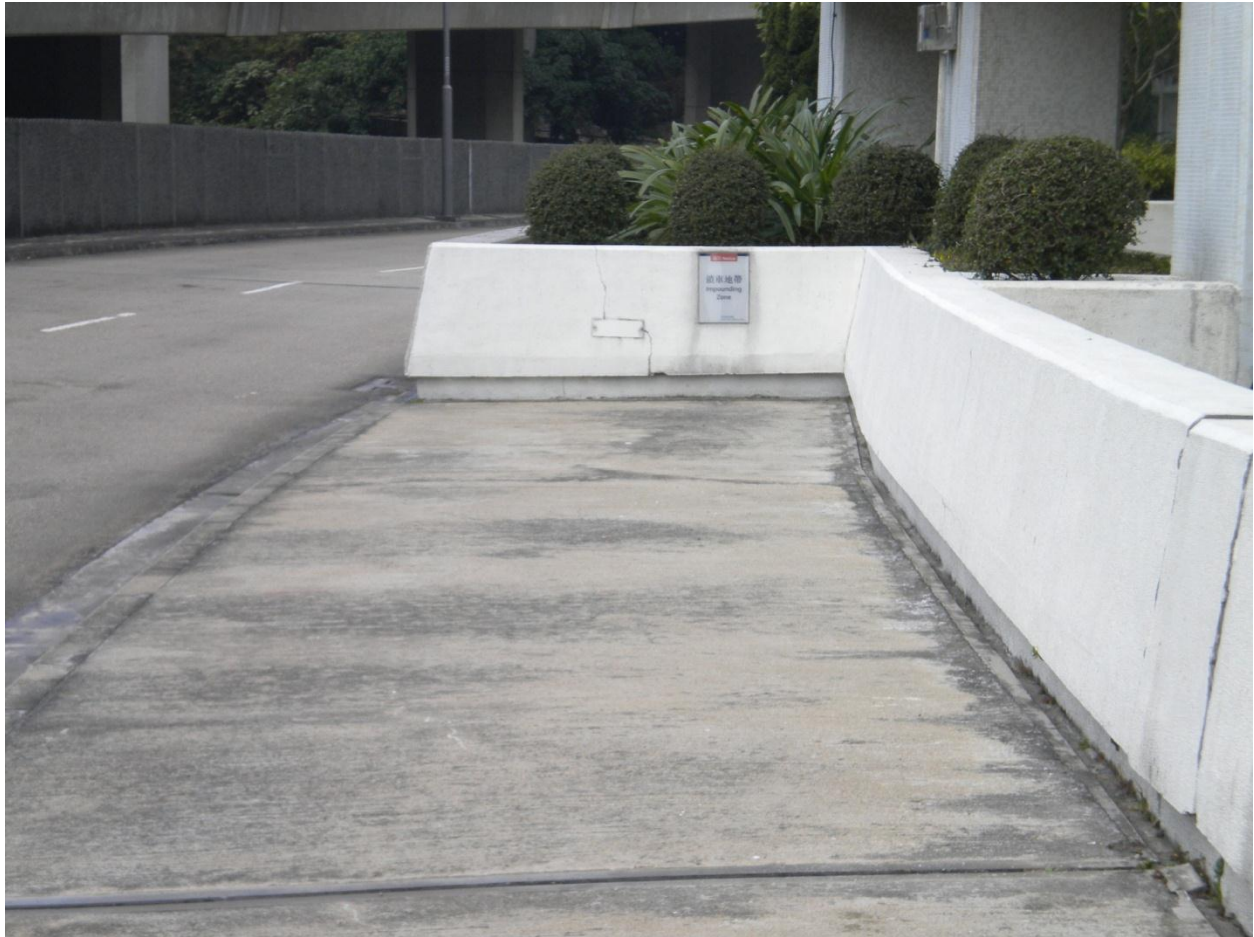
A *breakdown*, shown in Figure 3.1-5 is defined as a barrier on a path that completely obstructs a pedestrian route and forces the pedestrian to turn around and go back the way they came. A breakdown is when a street or sidewalk abruptly ends or when there is construction that blocks the path a pedestrian would like to take. A breakdown is not the end of a park or enclosure of a sitting area.

Figure 3.1-5 - Breakdown

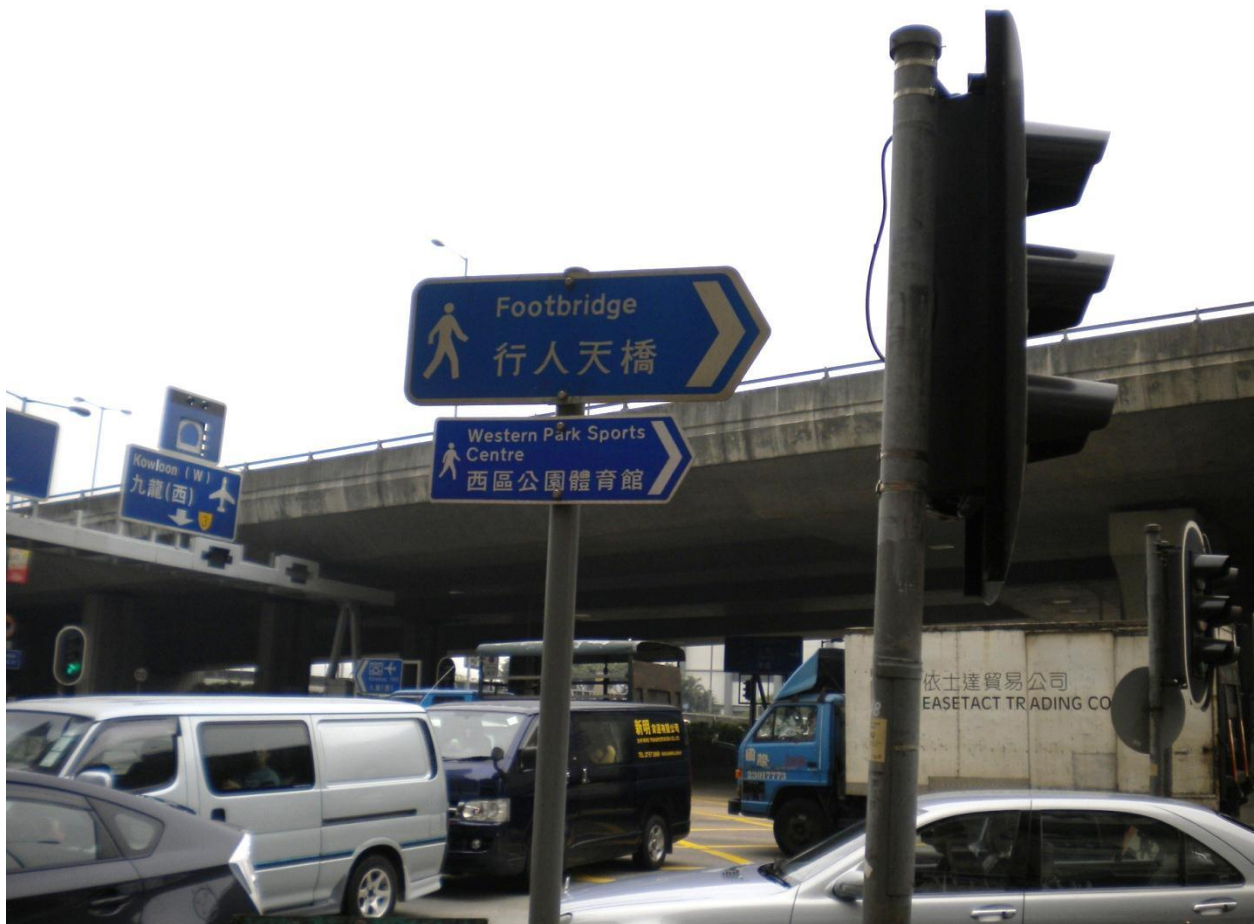
A *directional sign*, shown in Figure 3.1-6, has a directional arrow, is written in both English and Chinese, and is targeted towards pedestrians. A directional sign is also a map or any commercial sign that would help walkers find a destination such as a restaurant or shopping area. For the purpose of the preliminary evaluation, this excluded street signs showing the direction of the street. A directional sign is not one that is meant for vehicular traffic or other commercial forms of traffic, such as signs pointing to parking garages.

Figure 3.1-6 - Directional Sign

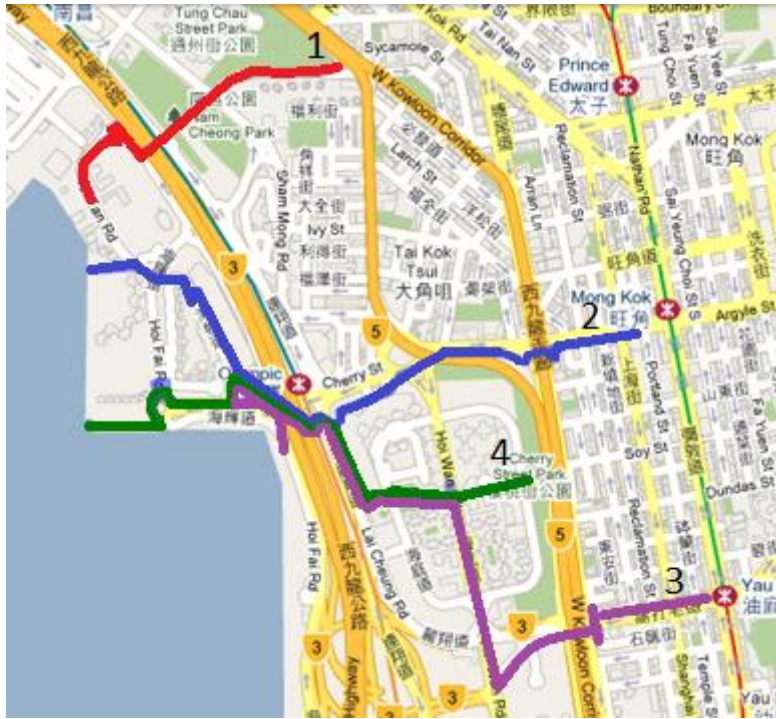
Figure 3.3 - 2 - Routes in Yau Ma Tei

A hypothesis of this investigation is that WAT can effectively evaluate the walkability of one route, between hinterland and harbor front, in any district in Hong Kong along Victoria Harbour. After walking a route and completing the rubric, WAT provides focus areas of improvement for the specific route based on the information entered into the rubric. The user completes the rubric while walking a pre-planned route from hinterland to harbor front in one district. Based on the preliminary evaluations, the team selected four different districts to evaluate: Wan Chai, Sai Ying Pun, Yau Ma Tei and Tsim Sha Tsui. The team used these four districts to evaluate the quality and accuracy of the criteria as well as to determine recommendation plans for improvement. The team decided to test the rubric on 16 routes, four routes per final district. These four routes were approximately evenly spaced throughout the district with the ideal routes leading from main transit stations, large recreational areas, or residential blocks to the different areas along the harbor front. The following four maps (Figures 3.3-2 to 3.3-5) show the final districts, Wan Chai, Sai Ying Pun, Yau Ma Tei and Tsim Sha Tsui, and the four routes taken, noted in various colors, in each district.

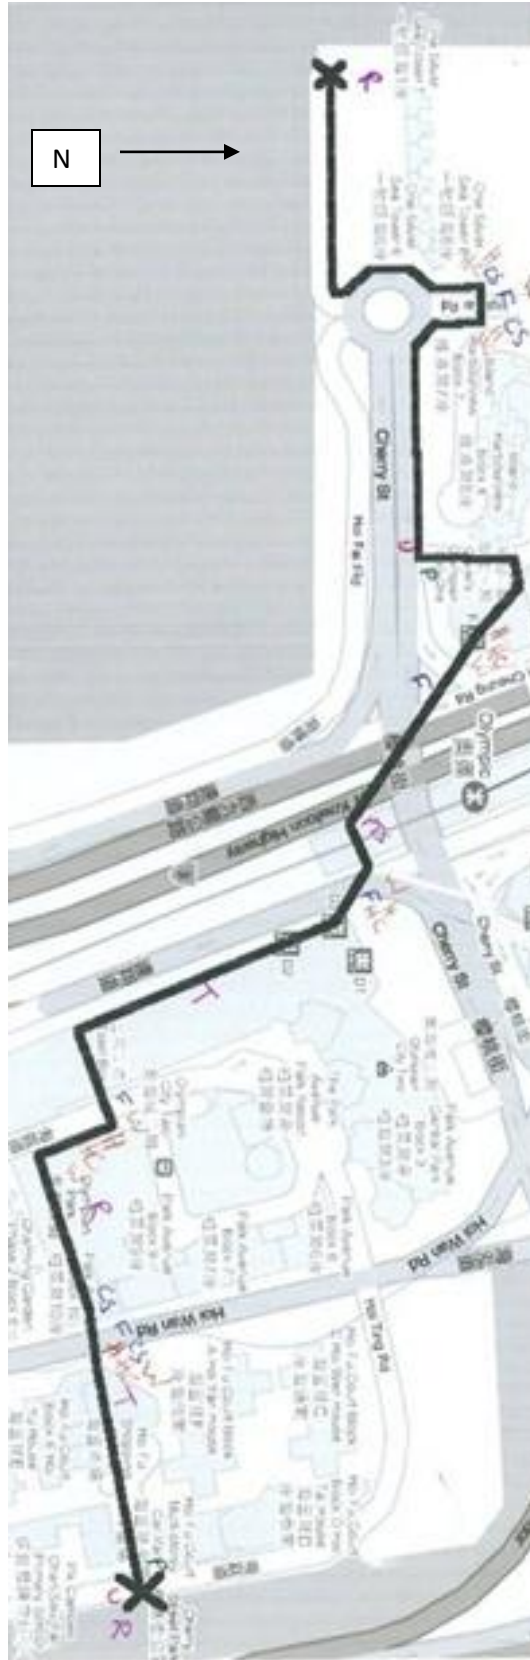
Five colors and 15 letter codes indicated different types of criteria and made the maps easier to read for later reference. For example, whenever the team crossed a footbridge connection, a blue line was drawn on the map with the letter F next to it. Also written in blue was CS (connection sign) if the footbridge was missing a connection sign. As seen in the map in Figure 3.3-1, other connections and amenities were noted on the map as well. Additionally, team members noted and commented on areas under construction, confusing pathways, or any other characteristics that they encountered while walking each route. Adjustments to the route from the pre-determined path were noted on the map as well. Each walking map is a visual of the connectivity, convenience and amenities of the route. The purpose of the walking maps was to provide visuals for the team to use when creating recommendation plans for each route. Due to the time constraints of this study, the team did not have enough time to re-walk each route to verify the focus areas of the WAT. The maps gave a very simple visual of where problems occurred and where small changes can be implemented to improve walkability in Hong Kong. The results chapter shows and discusses all of the maps in further detail.

Figure 3.3-1- - Walking Map of Yau Ma Tei

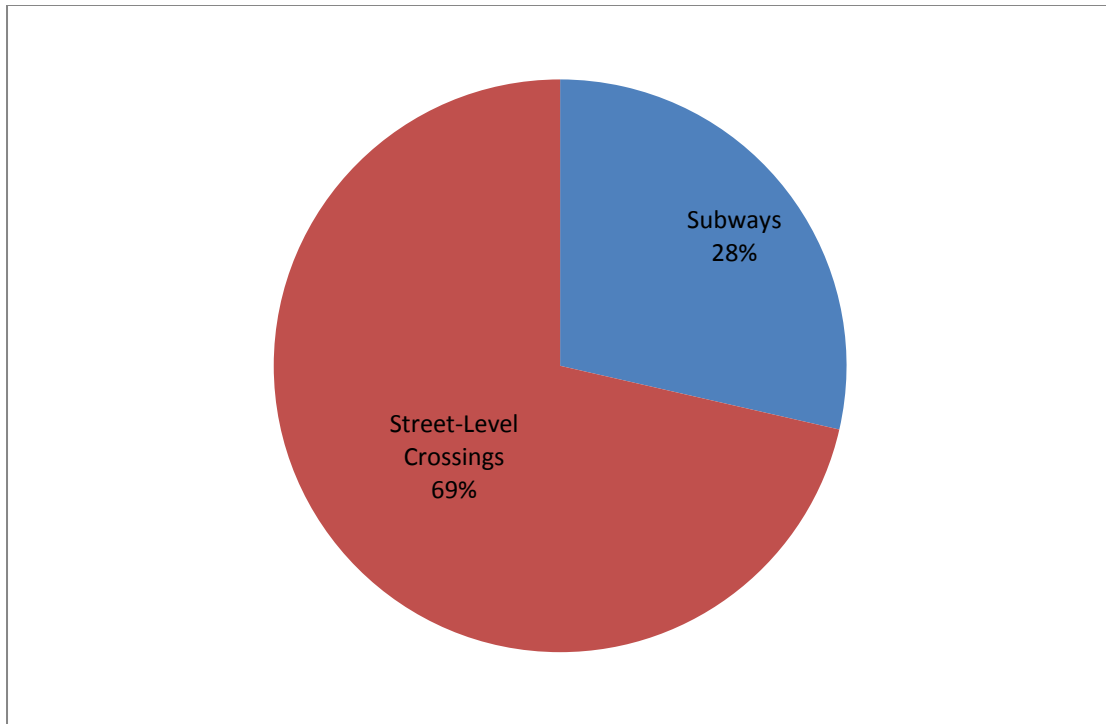
The survey sought pedestrians’ preferences related to the type of route choice, given a specific route with only two options: the subway under Salisbury Road or a reinstated street-level zebra crossing across Salisbury Road. The first question asked participants to make a normal route choice, excluding weather conditions. Figure 4.2-2 depicts 69% of participants selecting the reinstated zebra crossing.

Figure 4.2-2 – Pedestrian Route Selection at Tsim Sha Tsui Harbor Front Survey Route Preference under Normal Conditions

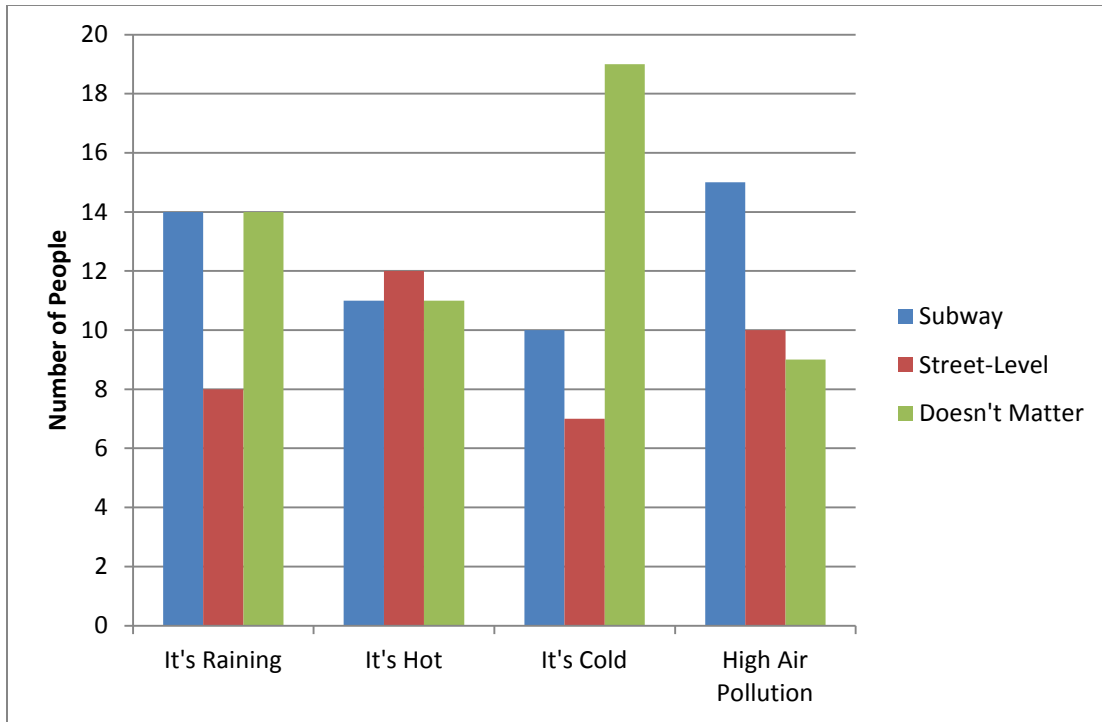
The survey asked for preference dependent on the type of weather condition. The participants' options for selection were: street-level crossings, subways or no preference. Figure 4.2 -3 suggests that weather is not a big factor when selecting route with the exception of a slight preference for subways when the air pollution is bad or it is raining.

Figure 4.2-3 – Route Preference under Different Weather Conditions

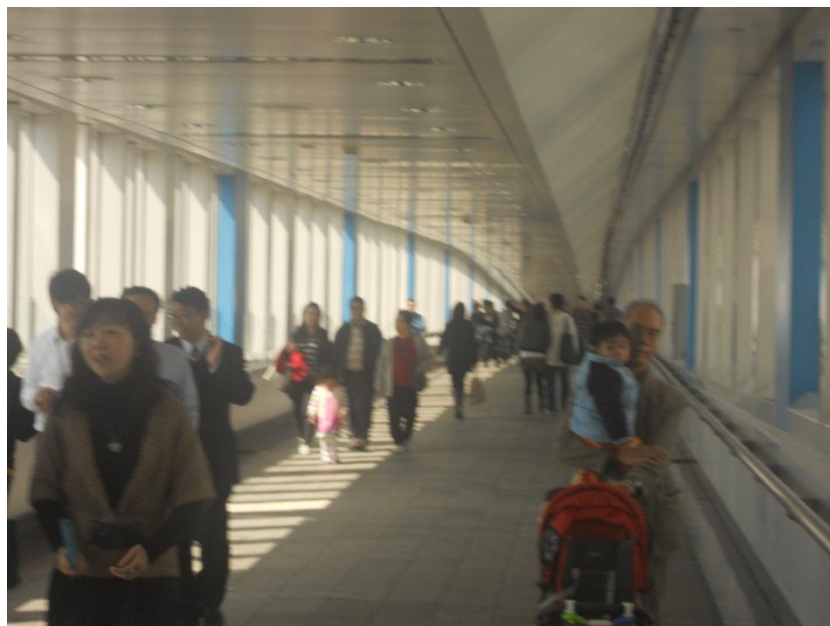
Overall, this district has few direct routes to the waterfront and needs more accessible, developed waterfronts. In addition, signage is needed for everything except public transit stations. The picture below (Figure 4.4-5) shows the pedestrian congestion at lunchtime, around 1:00pm. This picture was taken in the MTR Exit E footbridge that connects Olympic Station to Olympic City I. As three of the four routes pass through this footbridge, it is the main connection between the harbor front and the hinterland in Yau Ma Tei. The congestion at lunchtime is high because this is one of the few connections, forcing people to use it rather than spread out.

Figure 4.4-5 - MTR Exit E Footbridge in Yau Ma Tei

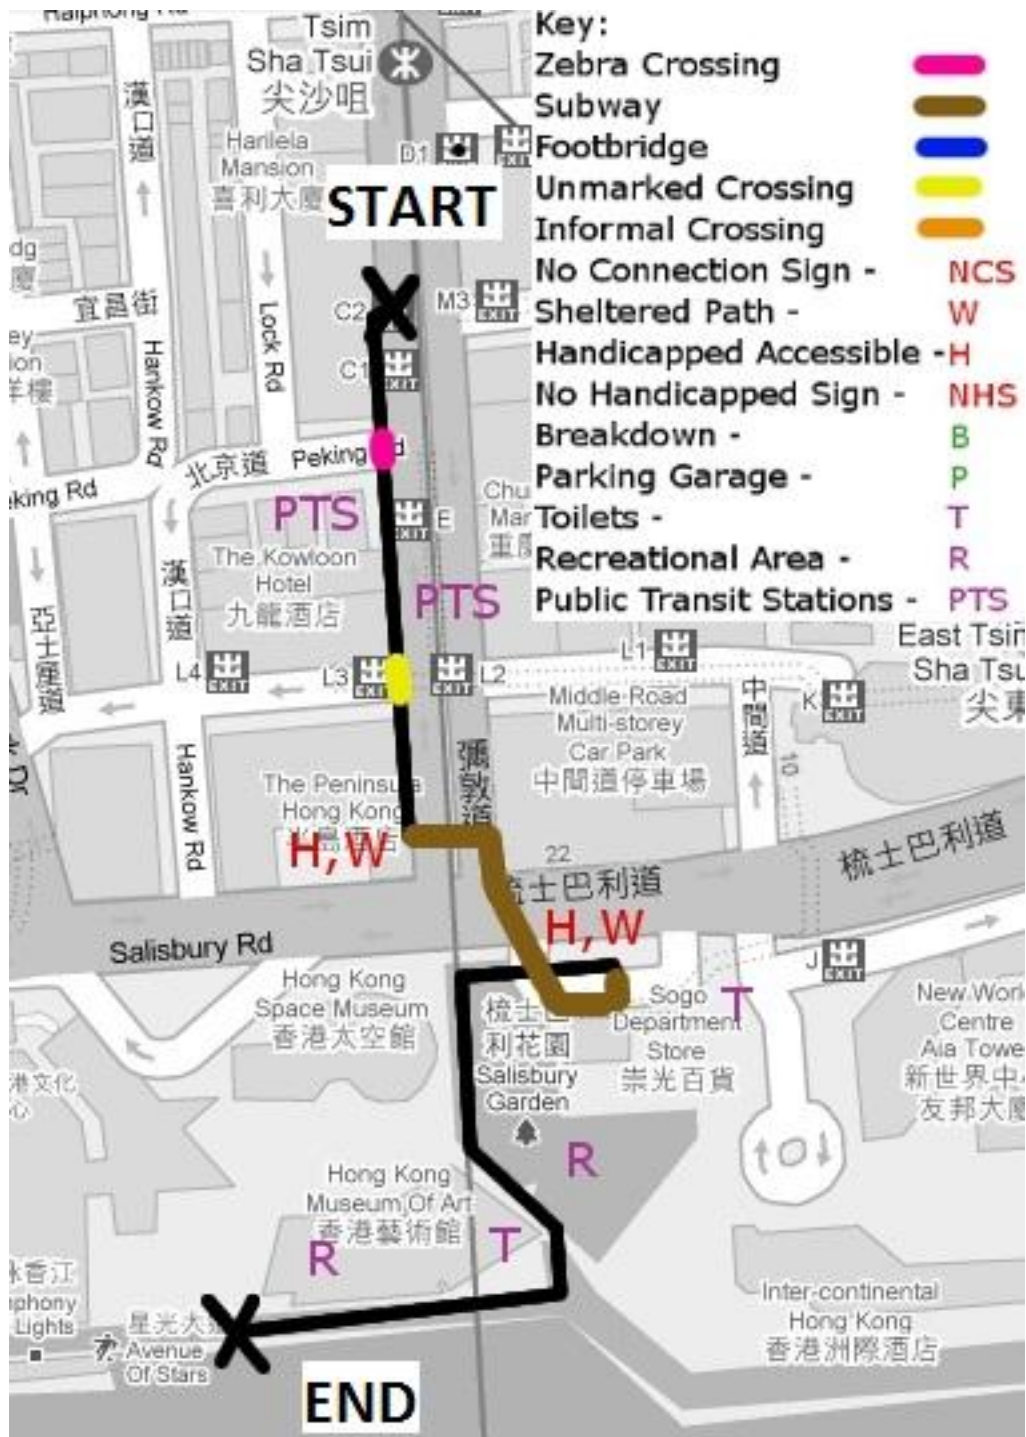
Figure 4.4-7 Route 2 Tsim Sha Tsui MTR exit C2 to Symphony of Lights Waterfront Walking Map

This route (shown in Figure 4.4-7) leads south down Nathan Road towards the harbor. Both the pedestrian and vehicular traffic on Nathan Road is very loud and busy. Next to the Peninsula Hotel, the route leads down a subway into the SOGO underground mall and exits near Salisbury Garden, a small park with some seating. Though the mall area has shopping and food, it is almost impossible for a first-time visitor to find their way through as the signage is either nonexistent or confusing. From Salisbury Gardens, the route turns right down the promenade towards the Hong Kong Art Museum and the Hong Kong Cultural Centre. This promenade and plaza are very large and beautiful and both are popular with tourists.

The Tsim Sha Tsui Route 2 table suggests that the quality of the route and the visual aesthetics need to be improved. The number of seating areas and the unmarked crossings could also be improved. Overall, the route had excellent signage and was completely handicapped accessible.

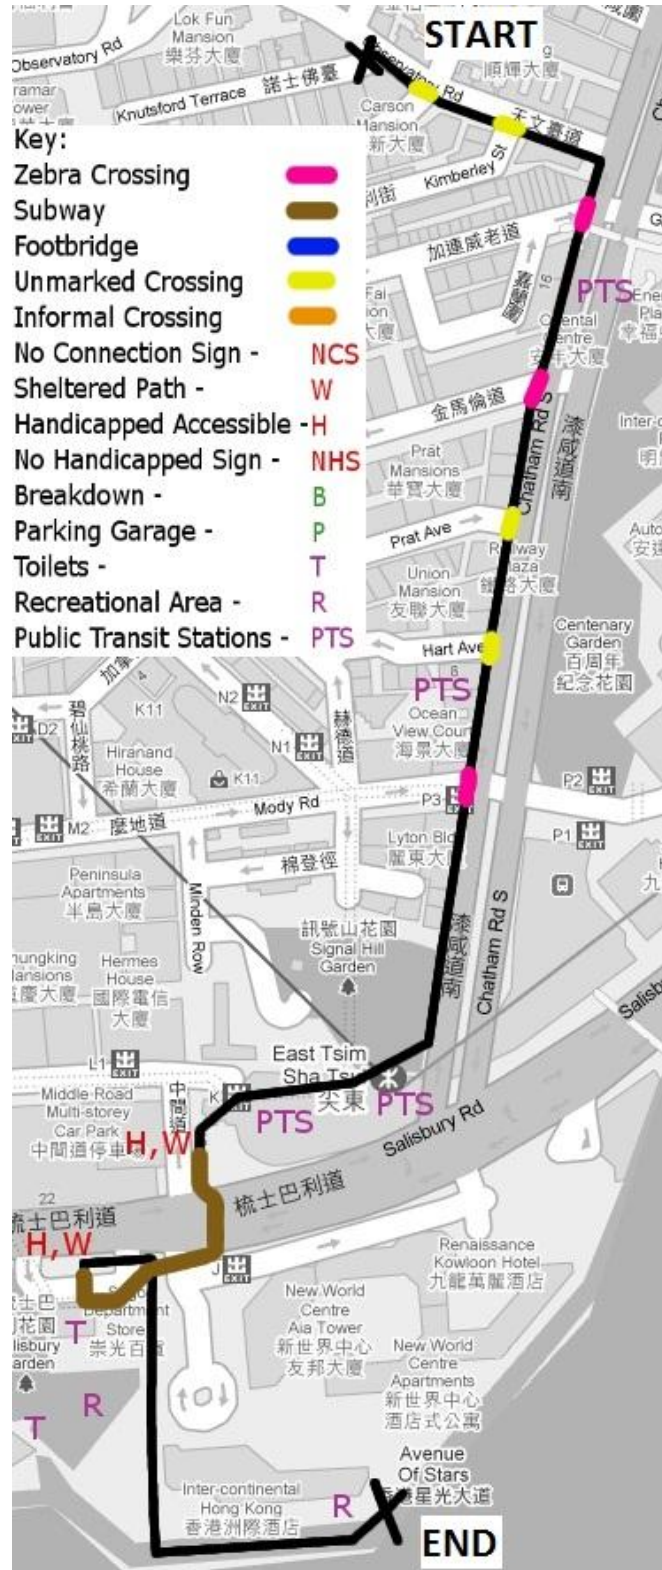
Figure 4.4-8 Route 3 Knutsford Terrace to Avenue of Stars Promenade Walking Map

This route (shown in Figure 4.4-8) led from Knutsford Terrace, a popular eating destination, south on Chatham Road South crossing several marked and unmarked crosswalks until it reached Salisbury Road. The sidewalk turned at the end of Chatham Road and passed a café seating area and a children’s playground. The path then enters the subway through the SOGO underground mall and exits near Salisbury Garden, a small park with some seating. Though the mall area has shopping and food, it is almost impossible for a first-time visitor to find their way through as the signage is either nonexistent or confusing. From Salisbury Gardens, it is easy to find the entrance to the Avenue of Stars, the beginning of a popular promenade always crowded with tourists. This promenade is very pleasant and well-maintained with seating areas and concession stands open at night.

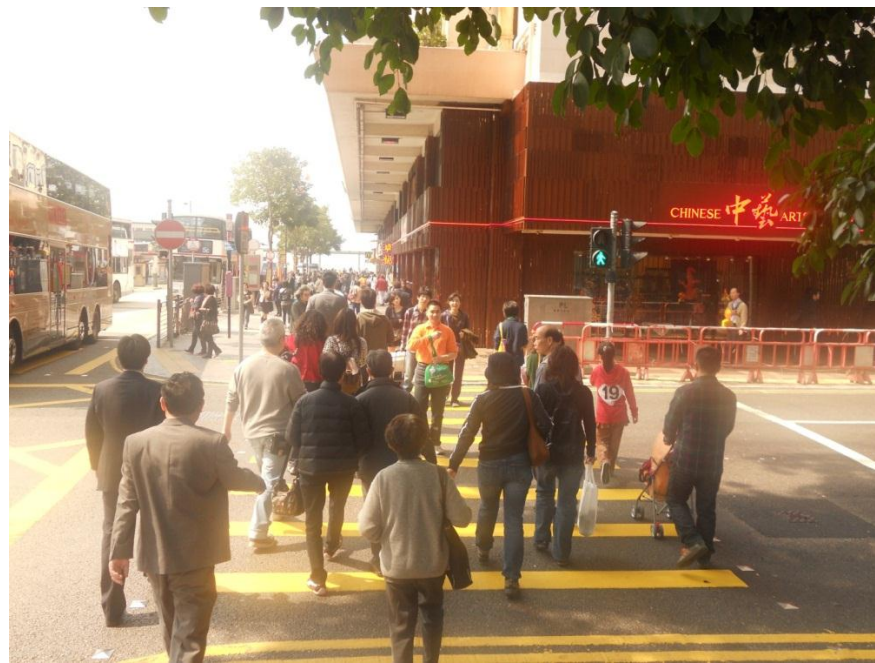
Overall, this district has too many modal conflicts such as parking garages and unmarked crosswalks. In addition, the quality of the route generally needs to be improved. The picture below (Figure 4.4-10) shows the pedestrian congestion at lunchtime, around 1:00pm. This picture was taken at the zebra crossing across Canton Road at the corner of Canton Road and Salisbury Road. As this is on the route from the exit to the MTR subways and the waterfront, it is one of the main connections between the harbor front and the hinterland in Tsim Sha Tsui. The congestion at lunchtime is high because this is a very high traffic district that is always crowded with pedestrians, busses and cars.

Figure 4.4-10 - Zebra Crossing at the End of Canton Road

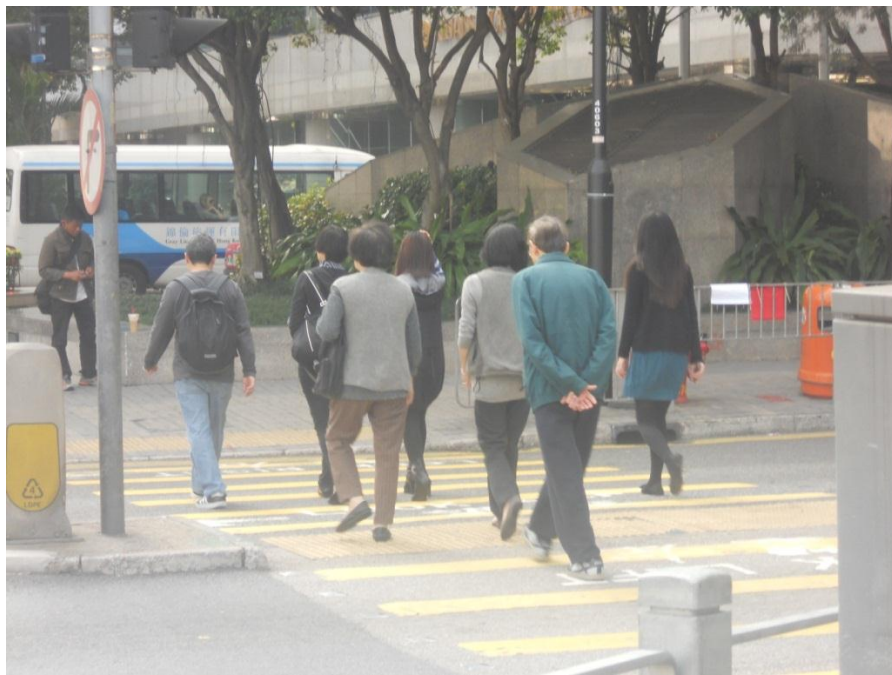
Overall, this district has too many modal conflicts such as parking garages and unmarked or informal connections. In addition, the quality of the route generally needs to be improved because of the multitude of construction sites. The picture below (Figure 4.4-15) shows the pedestrian congestion at lunchtime, around 1:00pm. This picture was taken at the zebra crossing across Convention Avenue near the Hong Kong Convention and Expo Centre. As this crossing is on the route from the MTR to the Expo Centre promenade, it is one of the main connections between the harbor front and the hinterland in Wan Chai. The congestion at lunchtime is moderate because, though this is a very high traffic area, many tourists arrive to the Expo Centre via tour bus while locals can arrive via the Star Ferry.

4.4-15 - Zebra Crossing at Convention Ave near the Expo Centre

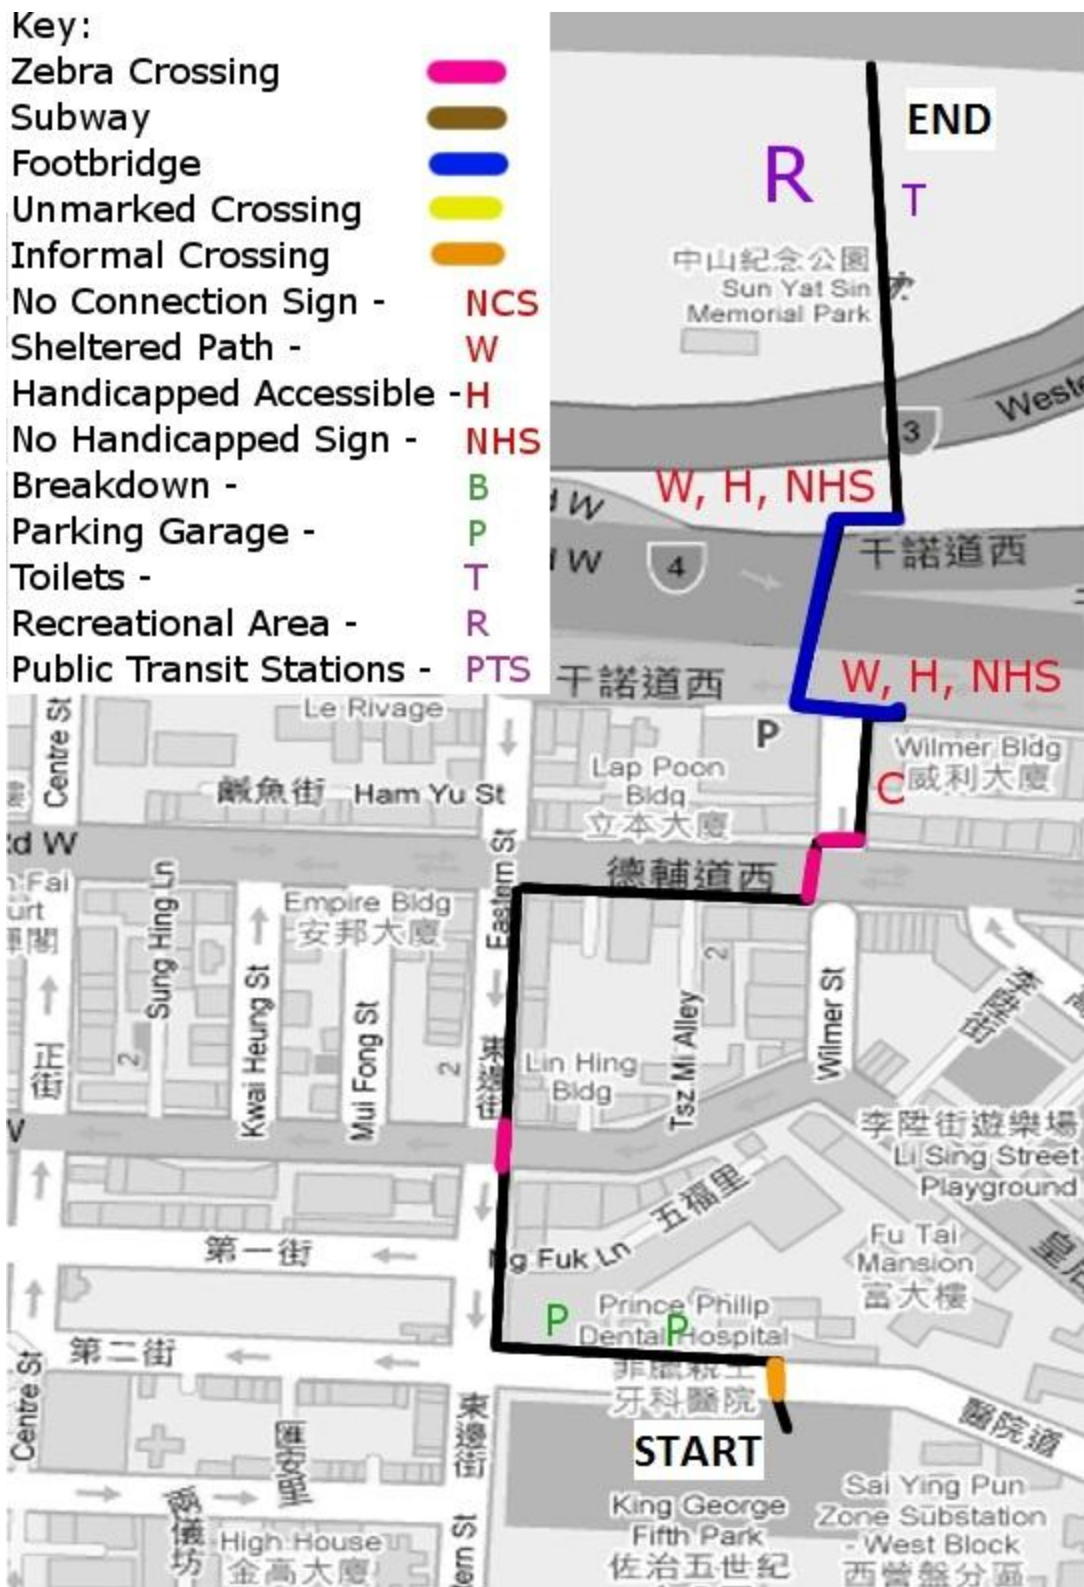
Figure 4.4-18 Route 3 King George Park to Sun Yat Sin Park Walking Map

This route (shown in Figure 4.4-18) started at the north entrance of King George Fifth Park along Hospital Road. The team started at grade and both sides of the road were not very visually pleasing. On the park side of the street was a plain concrete wall and across the street were two parking garages. There was also an informal crossing from the park to the other side of the street. The route then followed Hospital Road to Eastern Street and then it was a direct route north on Eastern Street passing shops and markets to Des Voeux Road West. Des Voeux Road West was crowded with people and dried fish markets that were overflowing onto the sidewalks, making it hard to walk around people. The team crossed Wilmer Street and took the covered footbridge into the park. There were no signs that the footbridge was handicapped but there were signs that stated where the footbridge went. The footbridge led into Sun Yat Sin Memorial Park. The park lead directly to the harbor front and included a promenade with seating. There were only a few construction projects along the entire route and they did not interfere with pedestrian pathways.

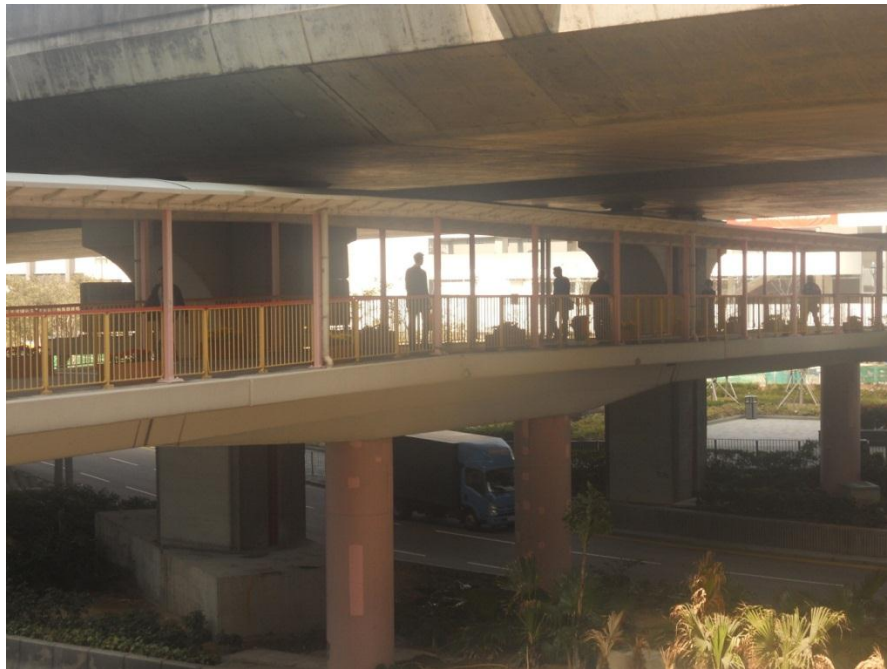
1:00pm. This picture was taken at the footbridge leading to Sun Yat Sin Park. As this park is the main waterfront promenade in the district, it is one of the main connections between the harbor front and the hinterland in Sai Ying Pun. The congestion at lunchtime is low because this is a low traffic district in which fewer people seem to visit the waterfront.

Figure 4.4-20 - Footbridge to Sun Yat Sin Park in Sai Ying Pun

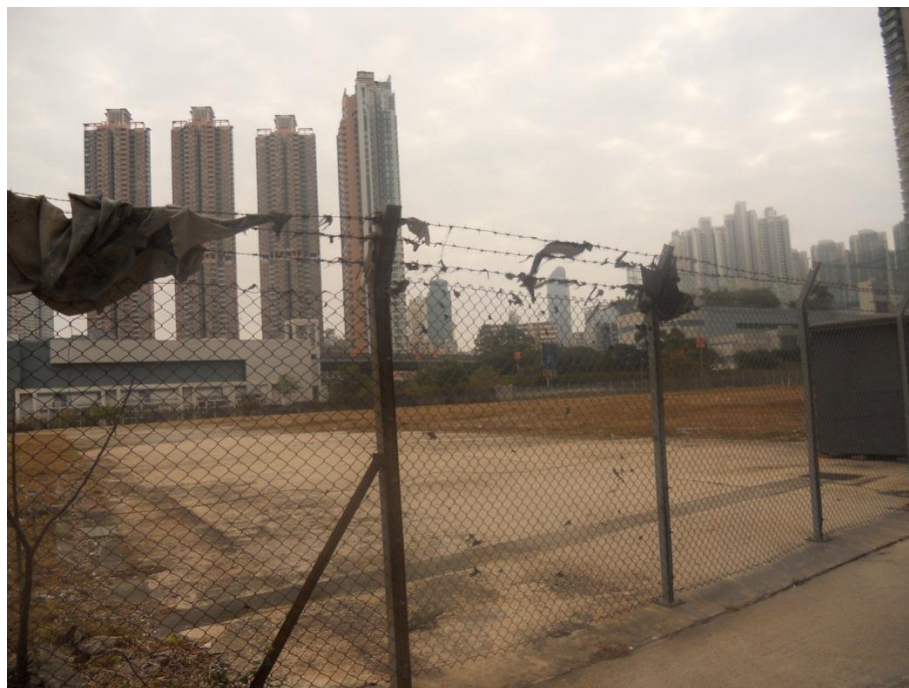
This route ended in a breakdown in front of the Marine Police Operational Base. There was nowhere to reach the waterfront within 100 m. A solution is to extend the promenade in front of the Long Beach north to in front of Hampton Place and create another access point to the waterfront on the northern side of Hampton Place. To reach this access point from the other side of the street, a connection is needed. Because this is a low traffic street, a street-level connection such as a zebra or at least an unmarked crossing is sufficient. This promenade needs seating areas and nice landscaping to mesh with the Long Beach promenade. The general attractiveness and aesthetics of the route also needs to be improved as there are several empty lots and parking lots. More trees or planters should be placed along the sidewalk and the empty lots should either be developed or cleaned up.

Figure 5.1-1 Empty Lot near Waterfront in Yau Ma Tei

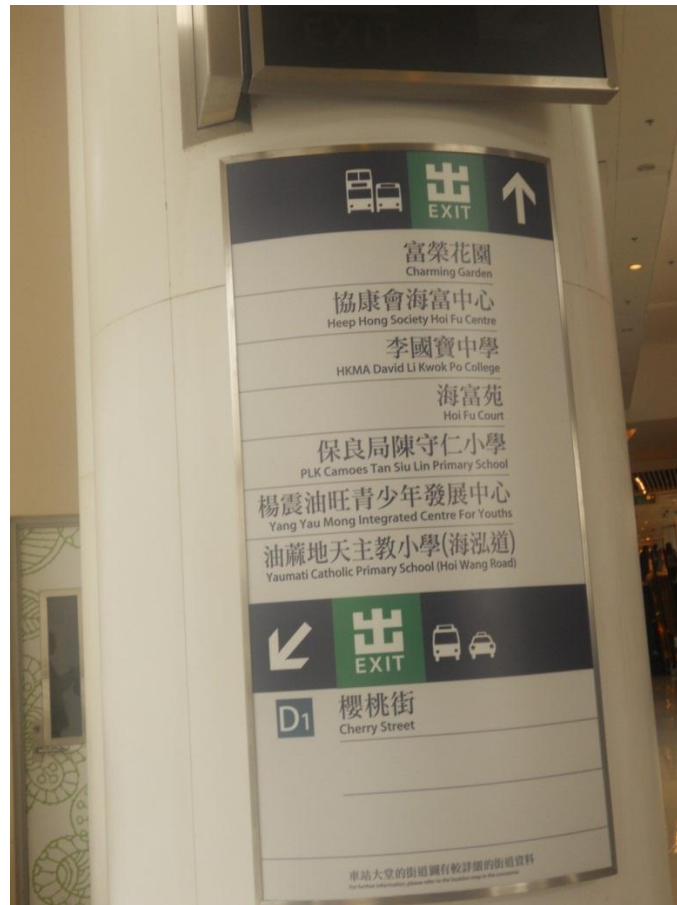
The main issue with this route is signage. The footbridges over Tong Mi Road and Hoi Fan Road both need signs for their location and to indicate whether they are handicapped or not. The D1 Exit from the MTR station is not handicapped accessible but there is another route through Olympian City II that is handicapped accessible. However, this route is not labeled nor is it indicated that Exit D1 is not handicapped accessible. It is simple for either the MTR or Olympian City to post a sign for the elevator near the exit from the MTR Exit D footbridge.

Figure 5.1-2 MTR Exit D1 Sign

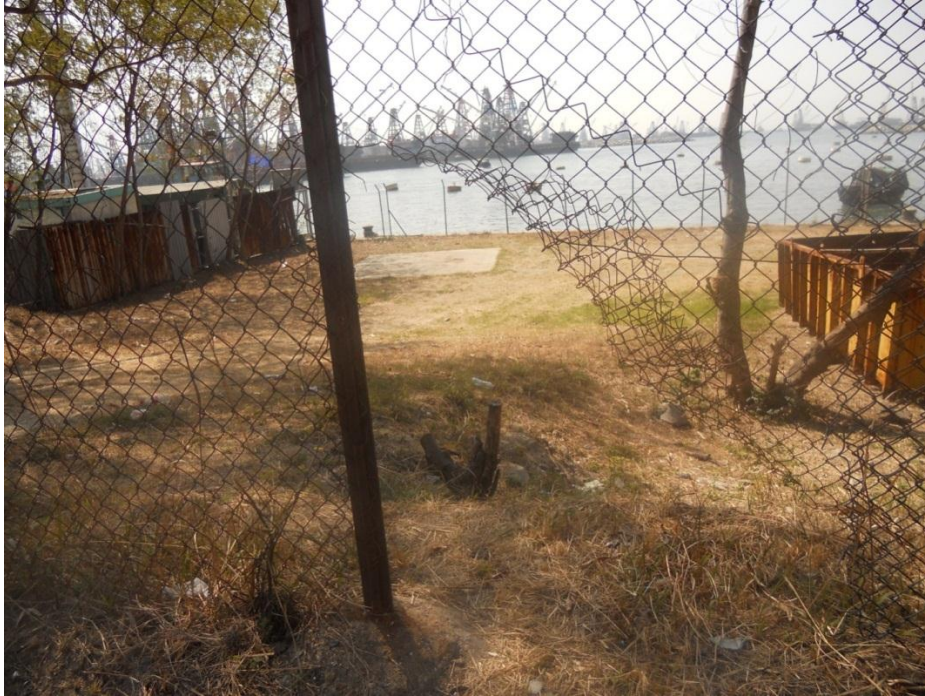
This route ended in a breakdown on Hoi Fai Road. There was no access to the waterfront for over 200 m in either direction. A solution is to extend the promenade that is in front of the Silversea east and south around the Typhoon Shelter and create access points to the waterfront along Hoi Fai Road. To reach these access points from the other side of the street, a connection is needed. Because this is a low traffic street, a street-level connection such as a zebra or at least an unmarked crossing would suffice. This promenade would need seating areas and nice landscaping to mesh with the Silversea promenade. The current solution to this lack of waterfront is to simply cut through a hole in the fence, pictured below in Figure 5.1-3.

Figure 5.1-3 Hole in Fence for Waterfront Access

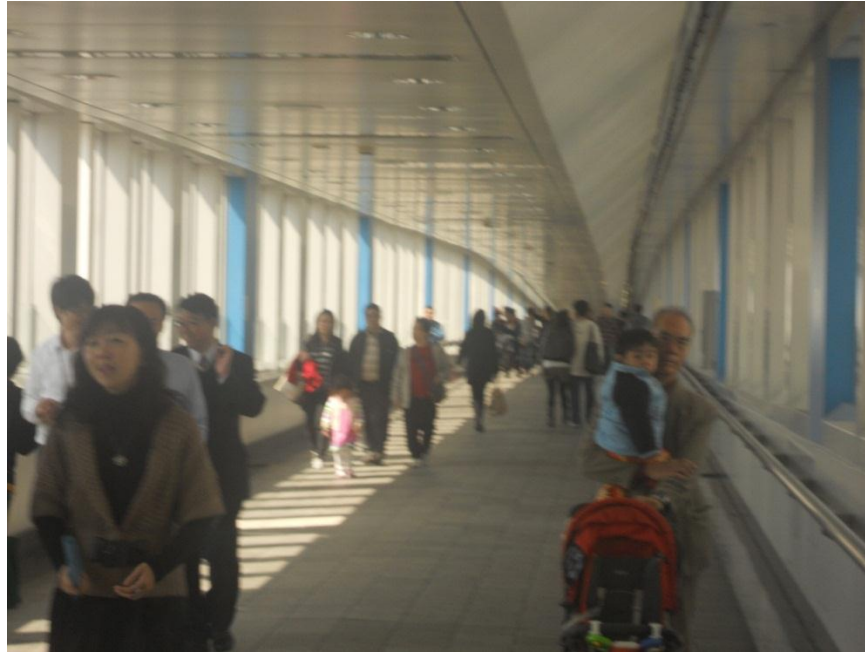
The main issue along this route is the signage. The footbridge through Olympian Park needs a sign at the edge of Hoi Wan Road showing its location and that it is handicapped accessible. The MTR Exit E footbridge on the inside of the mall needs a sign indicating that it is handicap accessible. The footbridge across Hoi Fai Road needs signs on both ends showing the location of the footbridge and

indicating that it is handicap accessible. In addition, there are no signs for the harbor front anywhere along the route. A suggestion is to place one inside the Olympian City I mall and another just outside the exit pointing towards the Silversea Promenade.

Figure 5.1-4 MTR Exit E Footbridge
