Measurement and Analysis of Walkability in Hong Kong

An Interactive Qualifying Project Report

Though Hong Kong's Victoria Harbour is world-renowned, the harbor front districts are far from walkable. The WPI team surveyed 16 waterfront districts, four in-depth, assessing their walkability using a tool created by the research team and conducted preference surveys to understand the perceptions of Hong Kong pedestrians. Because pedestrians value the shortest, safest, least-crowded, and easiest to navigate routes, this study found that confusing routes, unsafe or indirect connections, and a lack of amenities detract from the walkability in Hong Kong. This report provides new data concerning the walkability in harbor front districts and a tool to measure it, along with recommendations for potential improvements.

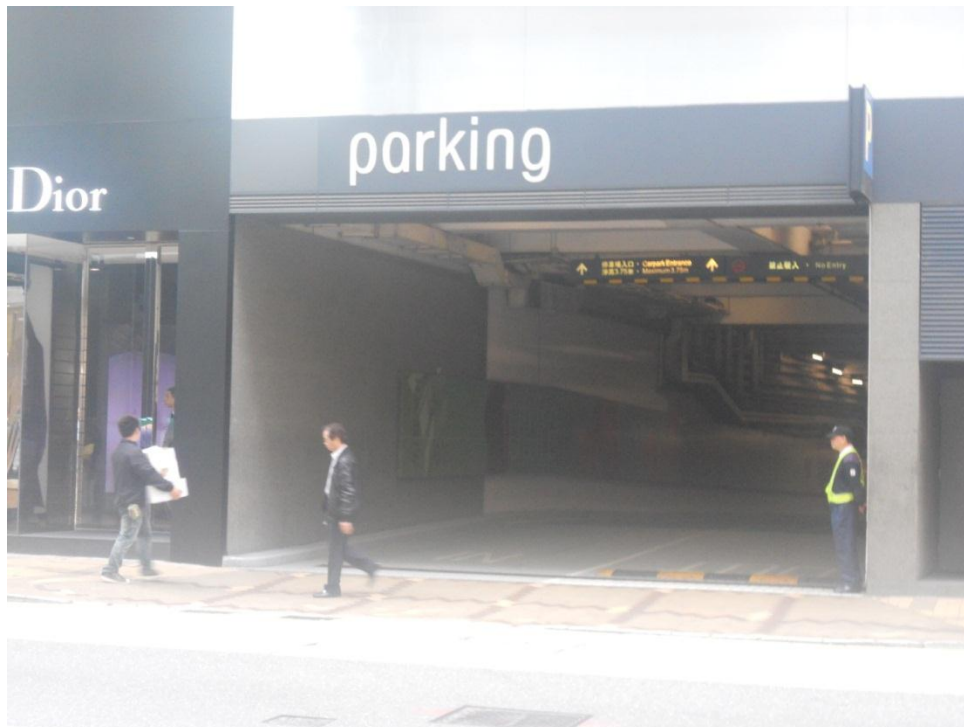
The main concern when walking down Canton Road from Kowloon Park to the Star Ferry is choke points. There are a few areas where the path changes widths, thereby restricting pedestrian flow. However, the main issue is the parking garages (see Figure 5.1-5). The parking garages are modal conflict areas; this is dangerous to both pedestrians and vehicles. The parking garages have guards directing traffic because Tsim Sha Tsui is a high traffic area. This increases the safety of these garages, but the pedestrian traffic flow is significantly diminished. To increase both the safety and traffic flow rate of pedestrians and vehicles, a separate connection should be placed along Canton Road. Canton Road is lined with upscale shopping centers so the installation of a subway would detract from the shopping

Figure 5.1-5 Parking Garage on Canton Road

experience. However, if a footbridge was installed, every shop would need a second floor access point. There is not an easy solution for this problem, yet this needs to be addressed. The recommendation proposed is to use Gateway Boulevard as an access road for the parking garages, therefore removing the entrances on Canton Road. This would significantly improve the pedestrian flow and the safety along Canton Road, a famous shopping area.

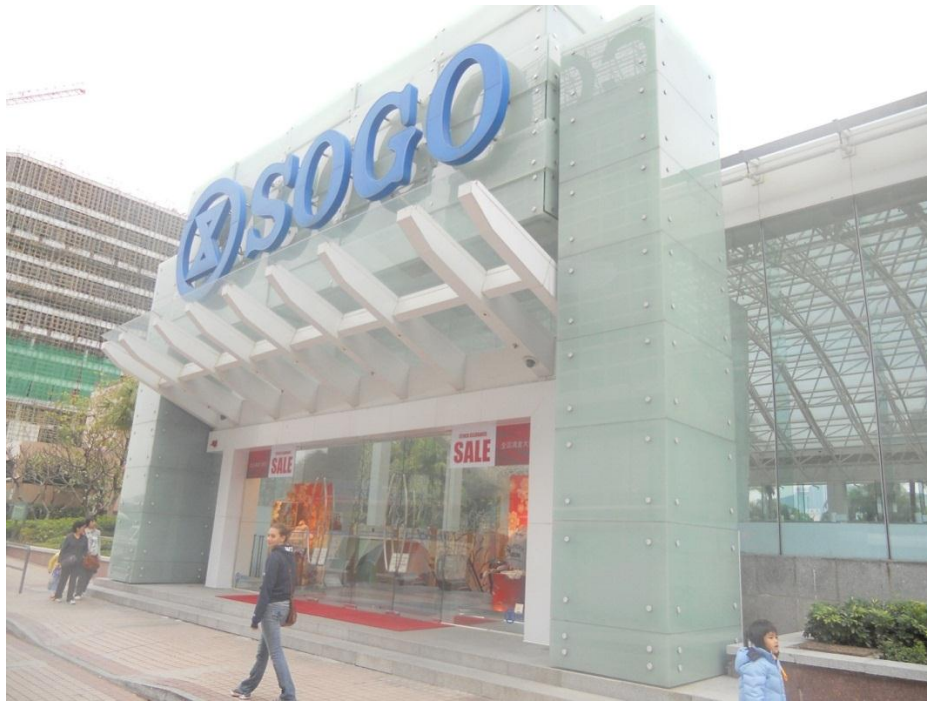
The route's quality scored low because of the confusion involved with navigating the SOGO mall (see Figure 5.1-6). The connection is used often by both residents and visitors because there are only a few connections across Salisbury Road. The connection winds through the mall to connect both sides of the street; this causes the route to be far from intuitive. To solve this problem, there are several options, each with varying results. The first option would be to install more useful directional signage in the subway. One solution would be to lay colored paths or a very frequent series of signs within the subway system for people to follow. While this would be an easier solution to the problem, the impact would be limited. The path already has very good signage in one section so it would only be a small improvement. Also, these signs would have less of an effect on the quality of the route because people tend to follow signs after becoming lost or confused rather than before. The second option would be to add a secondary path in the tunnel, a direct path for pedestrians who prefer not to walk through the SOGO mall. This option increases intuitive navigation by having a single straight line path, yet the creation of one is an expensive, time-consuming project. The final option would be to install a zebra crossing on Salisbury Road connecting Nathan Road to the harbor front. This direct path is the most intuitive path and therefore the easiest to navigate. Pedestrians can see their destination and are allowed to walk straight to it. This would greatly increase the pedestrian flow rates for minimal costs; however, doing so would disrupt vehicular traffic flow and place priority on pedestrian flow. The quality of this route needs to be addressed because it is a highly traveled path that involves too much confusion.

Figure 5.1-6 Entrance to SOGO Underground Mall

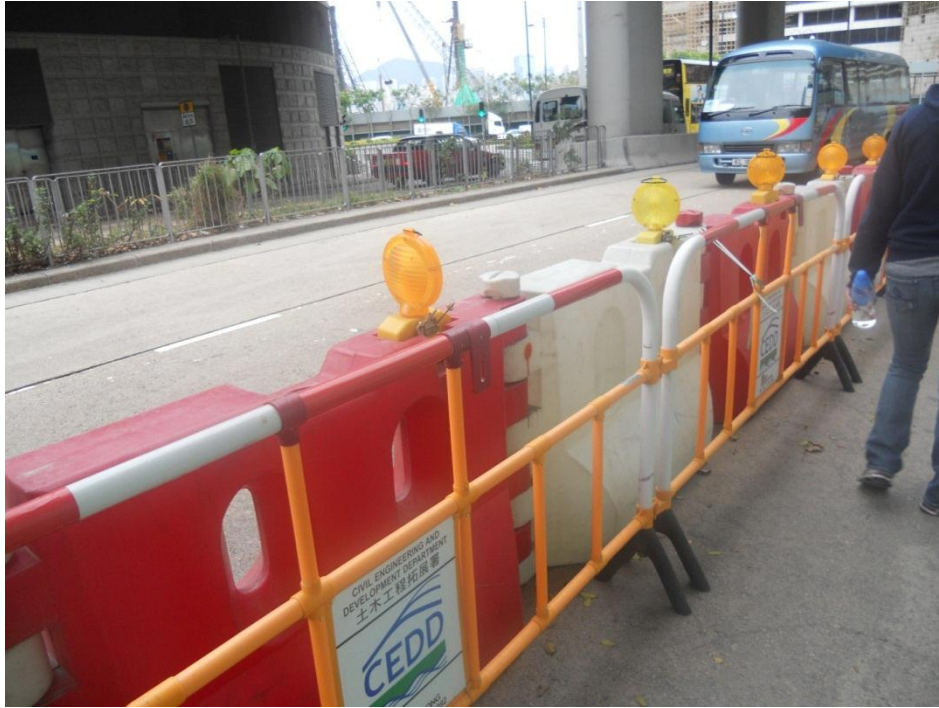
Finally, there was a large section of construction through the middle of the path. The construction zone had a detour for safety but the detour put the pedestrians in the road, very close to the vehicular traffic, with minimal safety barriers (see Figure 5.1-7 below). This needs to be reinforced and the safety double-checked to make sure that no one will be injured. This route, as popular as it is, could use significant improvements to enhance its walkability.

Figure 5.1-7 Construction Detour on Chatham Road South

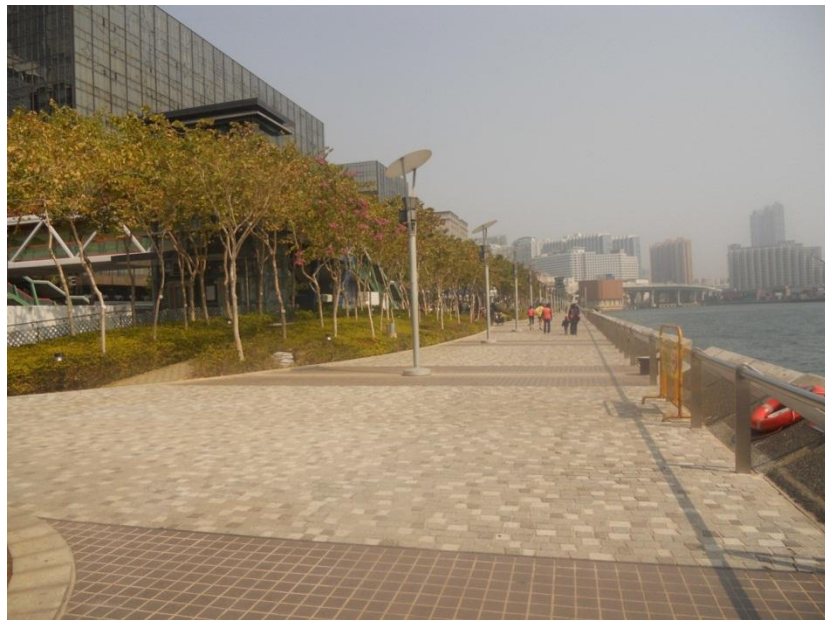
alongside. There is not enough seating along the route, specifically at the end. The Tsim Sha Tsui promenade is one of the best in Hong Kong and is popular all times of the day; therefore, it needs more seating on the east Tsim Sha Tsui side where this route ends. The seating at the East Tsim Sha Tsui Promenade, Figure 5.1-8, has to be extended further along the promenade. Because of the number of people traveling this route, there needs to be at least one if not two toilets installed along the route. An improvement to these aspects will improve the pedestrian convenience and comfort, which will inevitably increase the number of people who walk this already popular route.

Figure 5.1-8 East Tsim Sha Tsui Promenade and Seating Area Under Trees

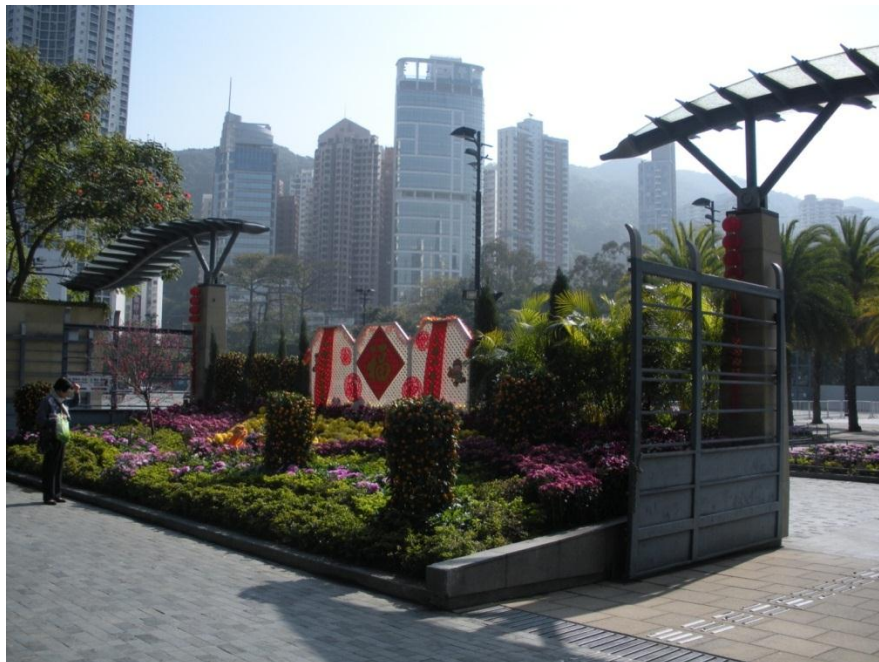
Figure 5.1-9 - Victoria Park Entrance

The connections along this route are excellent. However, the signage for the connections is not good. There needs to be signage near the Hong Kong Central Library pointing to the footbridge and on the harbor front pointing to the footbridge. In addition to direction, these signs and the existing footbridge signs inside of Victoria Park also need to note that these footbridges are handicap accessible. Though the aesthetics, shown in the figure below and the route's seating areas are great, having great greenery and several areas to sit. The signage along the route needs improvement. The signs within Victoria Park were smaller and not spread out. Signs need to be placed more often in the park, making navigation towards the harbor front much easier. There should also be a public toilet along the harbor with signage pointing to it. The final improvement is to place a bus stop in front of the starting point, the Hong Kong Central Library, making the route easier to access.

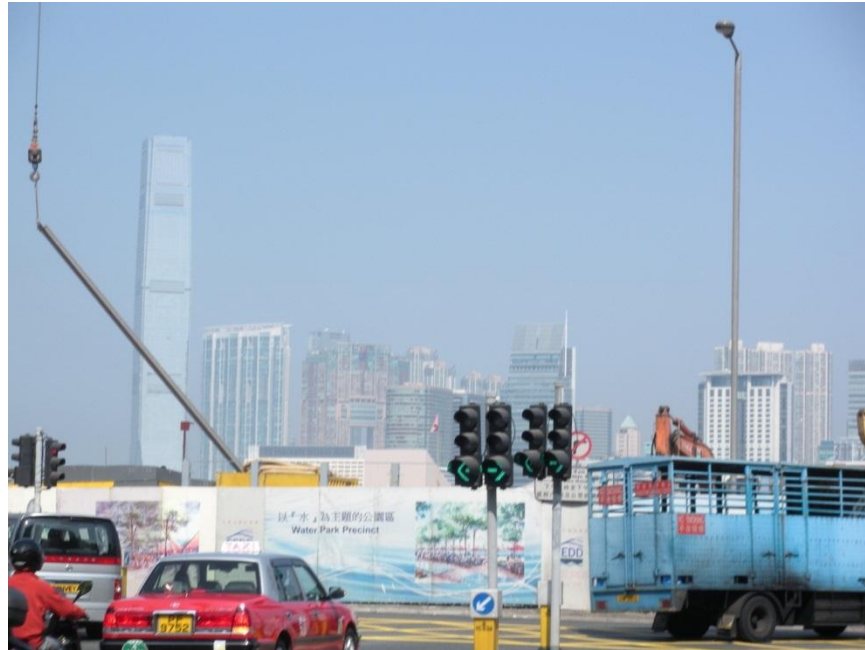
Figure 5.1-10 - Construction Breakdown Point in Wan Chai

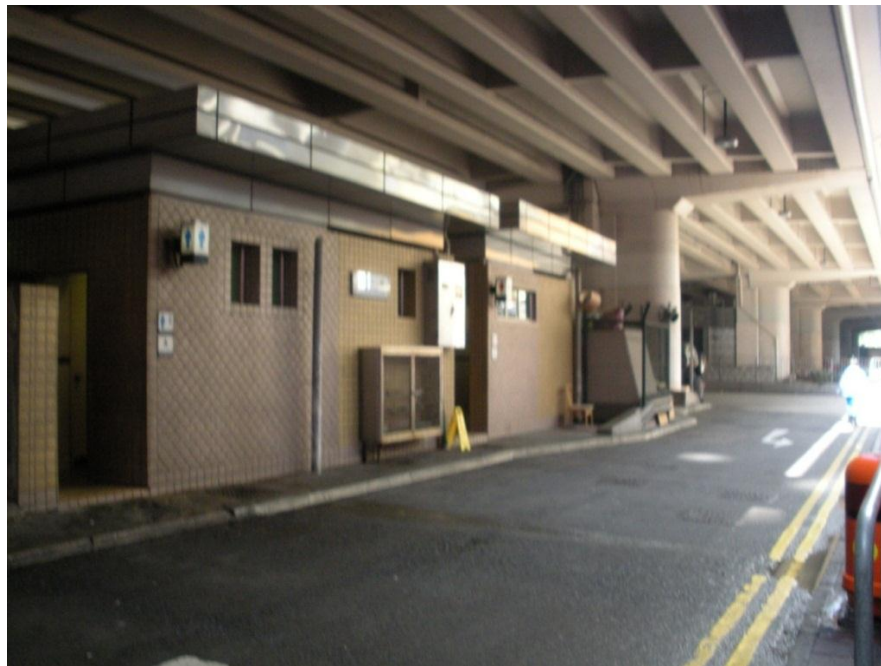
Figure 5.1-11 - Poor Aesthetics along Route in Wan Chai

The visual aesthetics along the route are minimal, as seen in the figure below. A seating area with some plants needs to be placed along Fleming Road to increase the aesthetics. The seating at the Expo Centre, before the waterfront, needs improvement. More benches need to be added because of the high volume of visitors to this area. Finally, the completion of the construction will allow pedestrians to cross the road. This means that a zebra crossing will be necessary to cross Expo Drive East. This zebra crossing will increase pedestrian safety as well as reduce problems with tour busses.

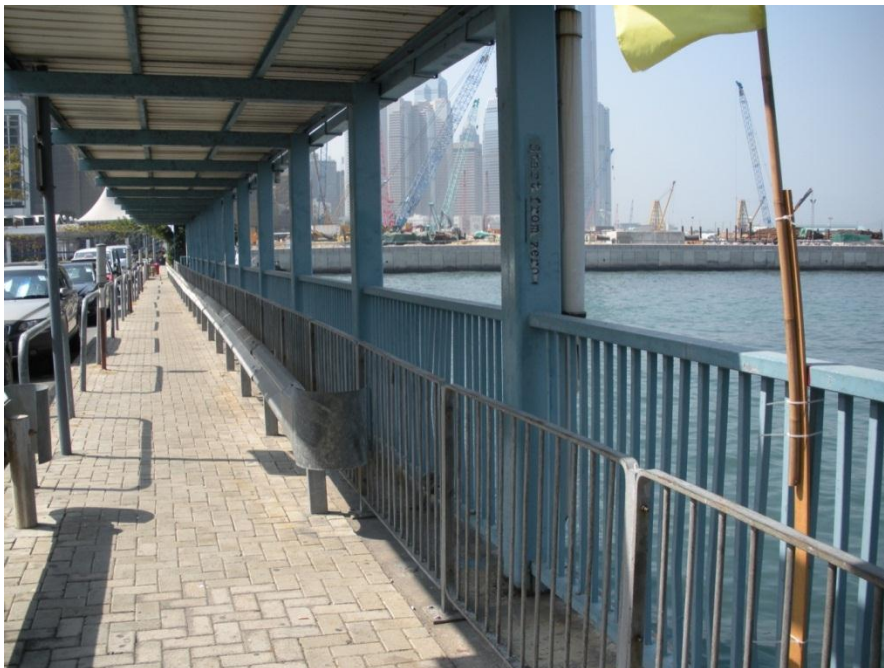
Figure 5.1-12 - Waterfront near Fenwick Pier

The connections along this route are good. The footbridge across Convention Avenue and Harbour Road needs to be handicap accessible and signage indicating this should be added to both sides of the footbridge. Connection and handicap accessibility signage need to be added to both sides of the footbridge over Gloucester Road. This route is direct and has good connectivity, but lacks in the pedestrian experience section. There need to be several amenities added to the route. A public toilet needs to be added in the middle of the route, near the Harbourview. A bus stop in this same area will increase the convenience of the route. Once construction is finished, more seating should be added and a larger promenade added to the waterfront. The overhanging shelter overlooking the water, seen in the figure below, should remain because it provides weather and sun protection; however, more benches can be added in this area until the construction is completed.

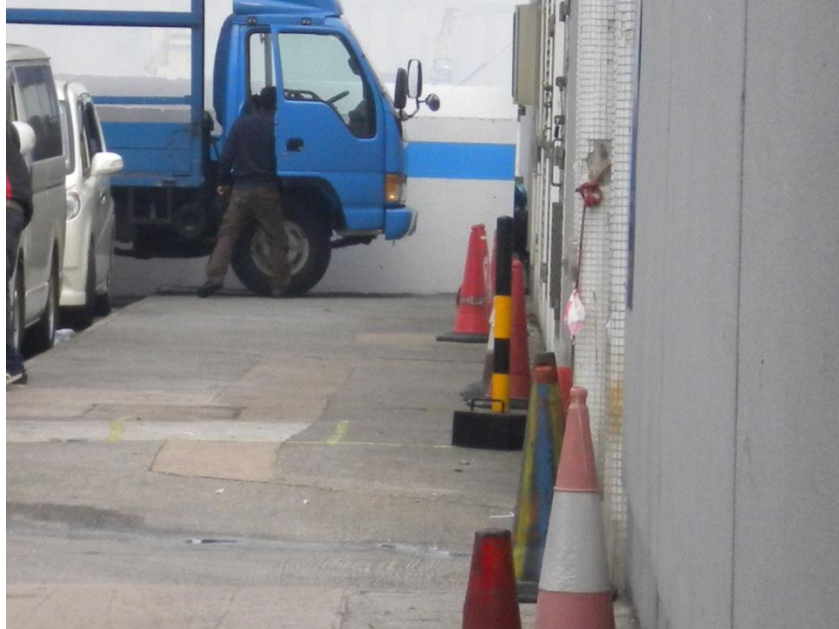
Figure 5.1-13 Breakdown at the End of Hill Road

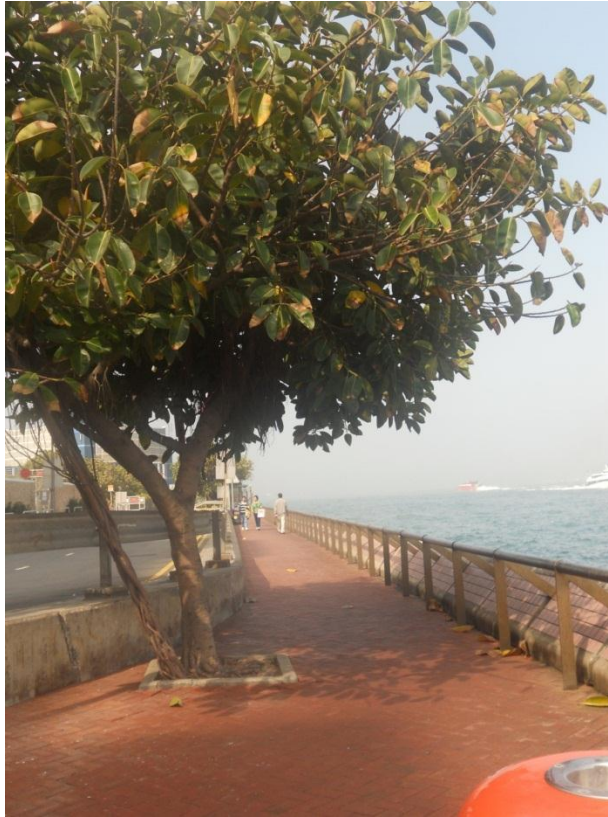
Figure 5.1-14 Existing Harbor Front at the End of Western Fire Services Street

Overall, the pedestrian experience can use improvements. To improve mobility around the area, a suggestion is to place a public transit stop at the intersection of Connaught Road West and Sutherland Street. This location will be convenient because there is a bus station at the beginning of the route and a MTR and Ferry Terminal to the east of the harbor front. This new location will provide another way of getting closer to the harbor but also will be conveniently located near Sun Yat Sin Memorial Park. To improve visual aesthetics along the route, small planters or greenery can be placed on the sidewalks. The streets are already overflowing with dried seafood shops and some color added to the streets will improve the aesthetics. There are a lot of small construction projects around which the safety and signage needs be checked. The signage for public transit stations and harbor front is lacking and installing signs at the intersections of roads will be very beneficial to the pedestrian. The seating areas along the route and harbor front promenade need to be increased. Figure 5.1-14 below shows the existing harbor front access with no seating areas. The harbor front promenade also needs to be built up more to include seating areas, greenery and a public toilet.

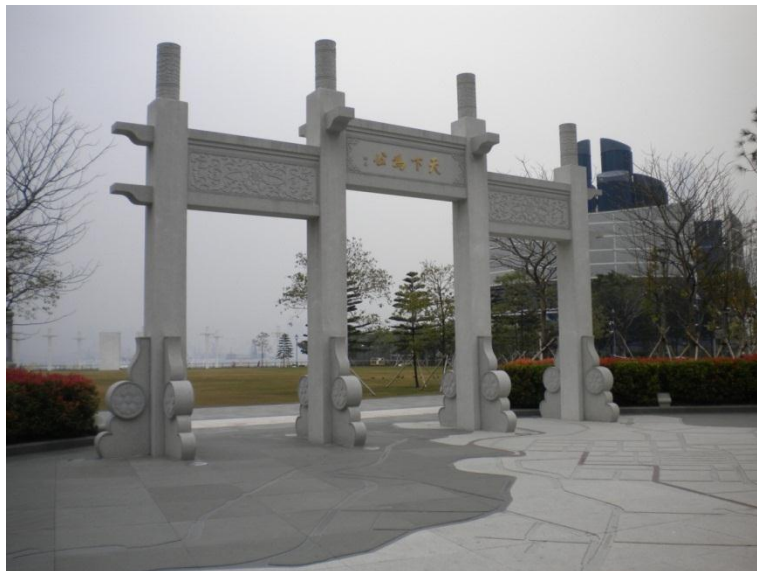
Figure 5.1-15 Sun Yat Sin Memorial Park

The pedestrian experience needs a lot of improvements. Even though one of the focus areas is parks and recreation, the beginning and end points along the route are parks and there really isn't a need for another one. However, there are no public transit stops. This needs to be remedied because Sun Yat Sin Memorial Park, shown in Figure 5.1-15, is a popular destination in this district. If a public

transit station was placed at the intersection of Connaught Road West and Sutherland Street, it would be convenient for two of the surveyed routes and within 400 meters of both destinations. To improve the visual aesthetics, more greenery and plants need to be placed along the route, in addition to a seating area near the middle of route. The seating area will provide a resting point for pedestrians who are unable to walk the whole route at once. Another public toilet can be placed along the route. One located in the beginning or middle is the most convenient because there is already one located at the end.

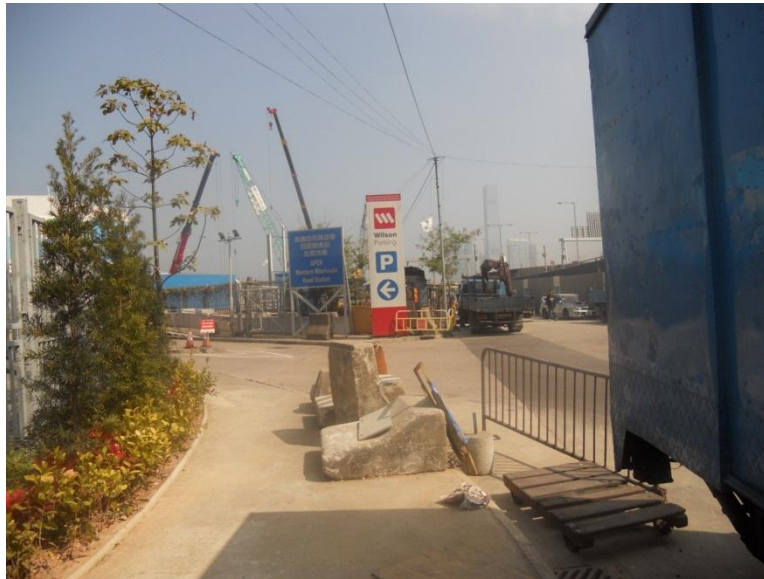
Figure 5.1-16 Breakdown at the End of Fung Mat Road
