Evaluation of the Erosion Control Methods Implemented by the Panama Canal Expansion Program

Major Qualifying Project

Autoridad del Canal de Panamá

January 12, 2012

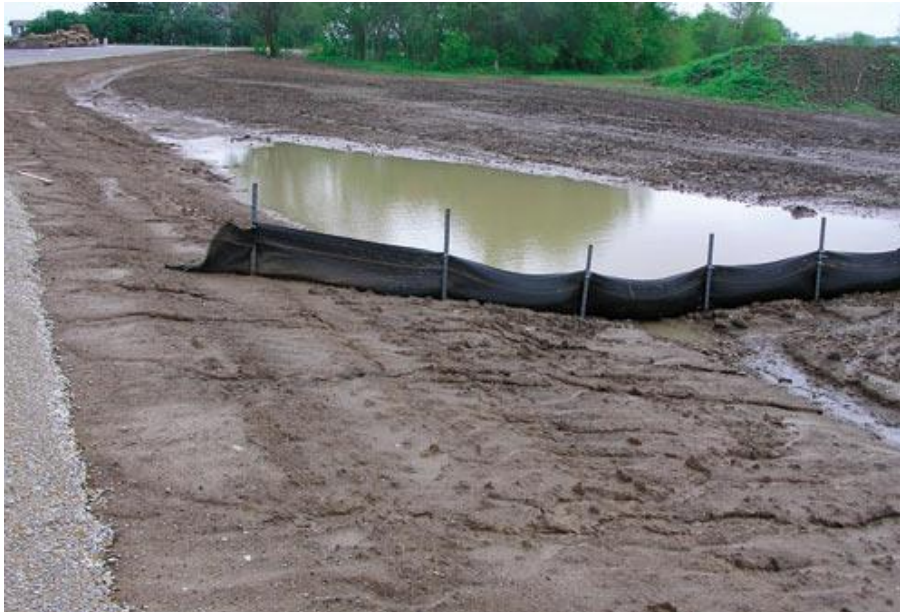
Figure 6 - A properly installed silt fence retaining run-off for sedimentation and filtration to occur (Carpenter, 2006)

which results in ponding of the water, as illustrated in Figure 6. As the water percolates through the silt fence fabric, much of the suspended sediment is filtered out. Silt fences and sediment traps are most effective when combined with other erosion controls, but they are suitable for applications at the bottom of exposed and erodible slopes, above hydroseeding, along stream and channel banks, around temporary spoil areas and stockpiles, and in ditches. They may be made of many different materials, of which straw bales and filter fabric are most common. The filter fabric is usually entrenched, attached to supporting poles and backed by a plastic or wire mesh for support (California Stormwater Quality Association, 2003; Novotny, 2003).

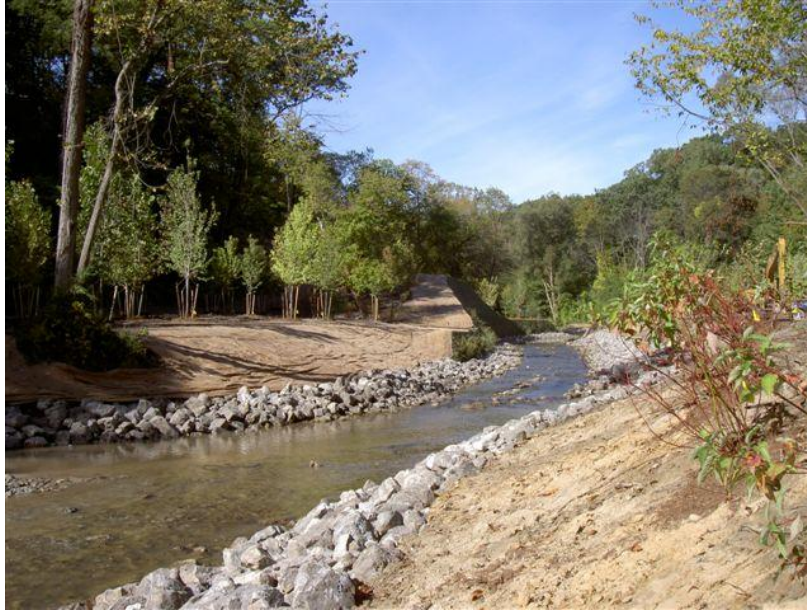
Figure 8 - Stream bank showing the use of riprap for erosion control (Michigan Department of Water Resources, 2011)

erosion. Riprap is used in areas of concentrated flow, turbulence or wave energy as shown in Figure 8. The effectiveness of the riprap depends on the mass and size of the materials that are used. The gaps between the rocks trap and slow the flow of water, reducing its ability cause erosion. A well-graded mixture of rocks is recommended, with predominantly larger stones and sufficient smaller sizes to fill the voids. Channel riprap applies where design flow velocity exceeds 1.21 m/sec (4 ft/sec) and conditions are unsuitable for grass-lined channels (Metropolitan Council/Barr Engineering Co., 2001).

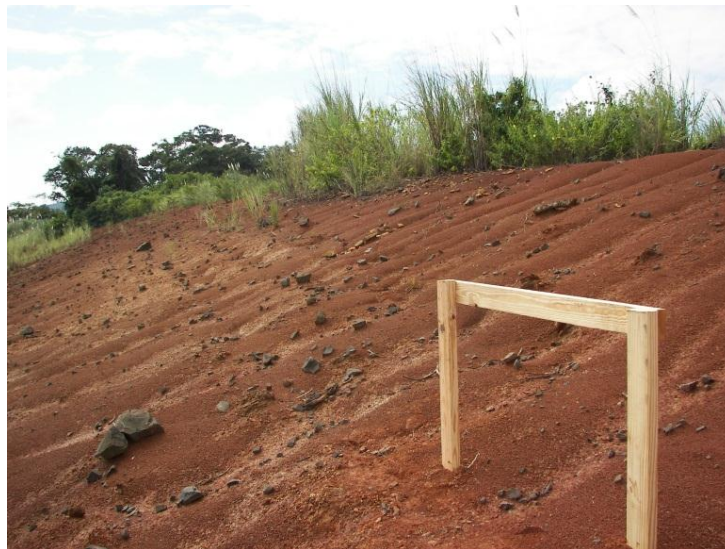
Figure 21 - Soil erosion bridge located at site 6 showing clay, basalt pebbles and rill erosion (Photo Credit: Bryan Lee, 2011)

Site 6 was on the opposite side of the hill from site 5. This area was chosen due to its soil type. As shown in Figure 21, the site had clay as well as basalt pebbles and rocks of up to 3 inches in diameter. Soil erosion was present as demonstrated by rill formations and the outline of the drainage pattern over the area. The slope in the area was calculated to be 28.1% or 15.7 degrees (see Appendix D).
