Improvements to the weak-post W-beam guardrail

IMPROVEMENTS TO THE WEAK - POST W-BEAM GUARDRAIL

Civil Engineering

Klas Erik Engstrand
June 2000

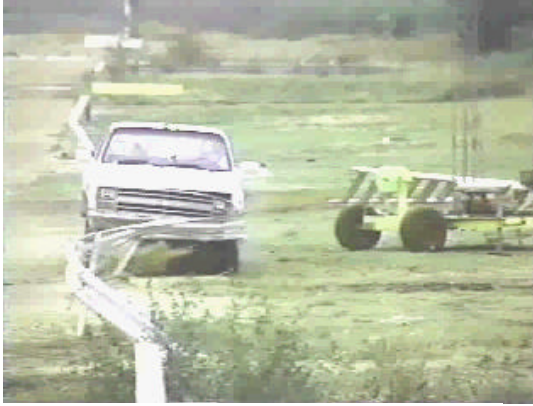
Figure 2: Cash sequence at time » 0.3 sec (TTI 7147-21).

What is happening here is that the vehicle straddled the guardrail as can be seen in figure 2 to 5. The authors explain that “as the vehicle was being redirected, the W-beam rail element dropped and began to dig into the ground at 0.732 second. At 0.768 second, the left front tire began to mount the guardrail and was on top of the rail by 0.895 second.”(3) The maximum deflection before failure was 2.4 m. The pictures of the collision show that the rail starts to drop just a little bit, which at this large deflection is enough to let the rail come in contact with the front right wheel and the vehicle starts to climb the rail.

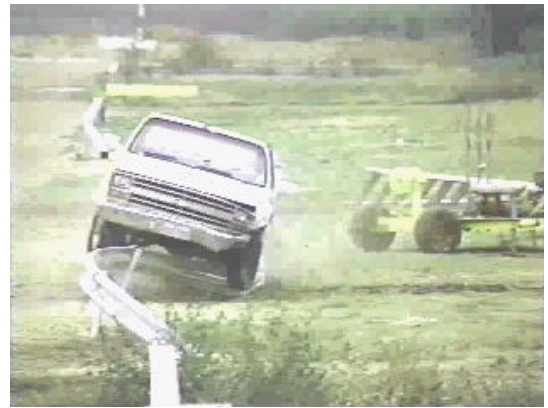
Figure 5: Cash sequence at time » 0.8 sec (TTI 7147-21).

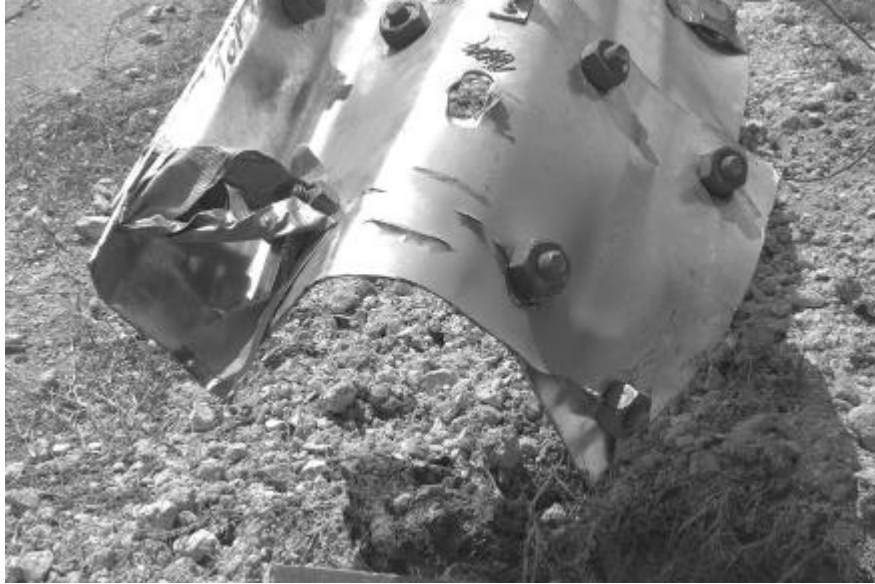
Figure 6: Ruptured rail element at splice in TTI Test 405421-2. (16)

Buth, Zimmer and Menges present a full-scale crash test (TTI 405421-2) with a modified G4(1S)-system.(16) Stronger W150X17.9 steel block-outs were used instead of the standard W150X12.6. The test was performed at NCHRP Report 350 test designation 3-11 conditions. The vehicle impacted the installation 672 mm upstream of post 17. The authors describe the impact scenario as: “The vehicle began to redirect at 0.065s, the left front tire contacted post 18 at 0.087 s, and the tire began to turn toward the guardrail. By 0.192 s, the W-beam rail element ruptured near the splice at post 19 as the vehicle was at a 14.30 degree angle to the rail. The maximum deflection of the rail element before rupture occurred was 1.00 m.”(16) The vehicle penetrated the barrier and rolled over behind the guardrail. The failed guardrail element is shown in figure 6. A “strength analysis (ASTM A370) were performed on three specimens taken from the torn rail segment near the tear. Yield strength was 436 Mpa, tensile strength 514 MPa, and the percent elongation in 51-mm gauge length was 25 percent.”(16) The rail tension was obtained at three locations, between post 15 and 16, between post 18 and 19 and between post 22 and 23, from strain gauge bridges. The tension in the rail between post 18 and 19 was about 130 KN when the splice failure occurred. Worth mentioning is that the post-rail connection bolt tension was measured at post 17 and 18 and the splice displacement was measured at post 15, 19 and 23. The splice displacement was measured with splice

displacement transducers. The splice displacement at post 19 was about 50 mm at maximum and 35 mm when the splice failure occurred.

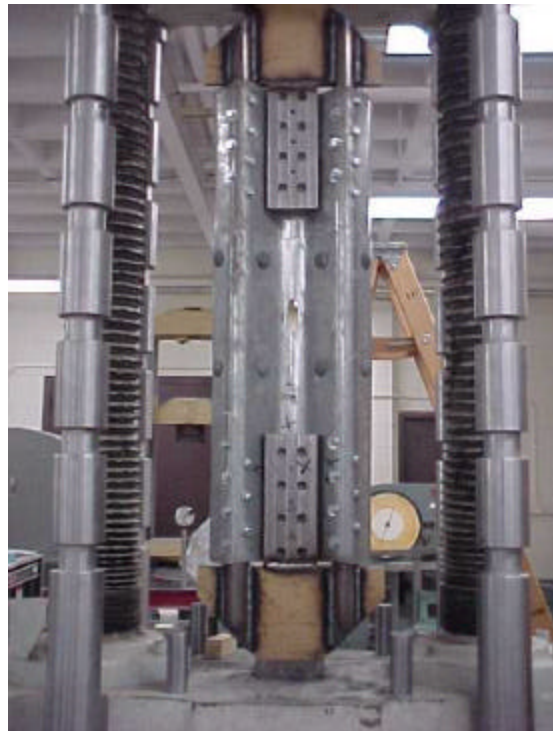
Figure 8: Uniaxial tensile test setup.

Three uniaxial tensile tests were performed with this setup. The first test was interrupted since the bolts used for the grips failed at around 390 kN. Weaker, 9.5-mm diameter bolts and small round washers were used to clamp the rail to the grips in the original design. The grips were improved by using stronger 12.7-mm diameter bolts and long plate washers between nuts and rail. The same test was continued and completed successfully. Two more tests were then performed successfully. The failure mechanism and maximum pulling force were considered consistent through out the tests.

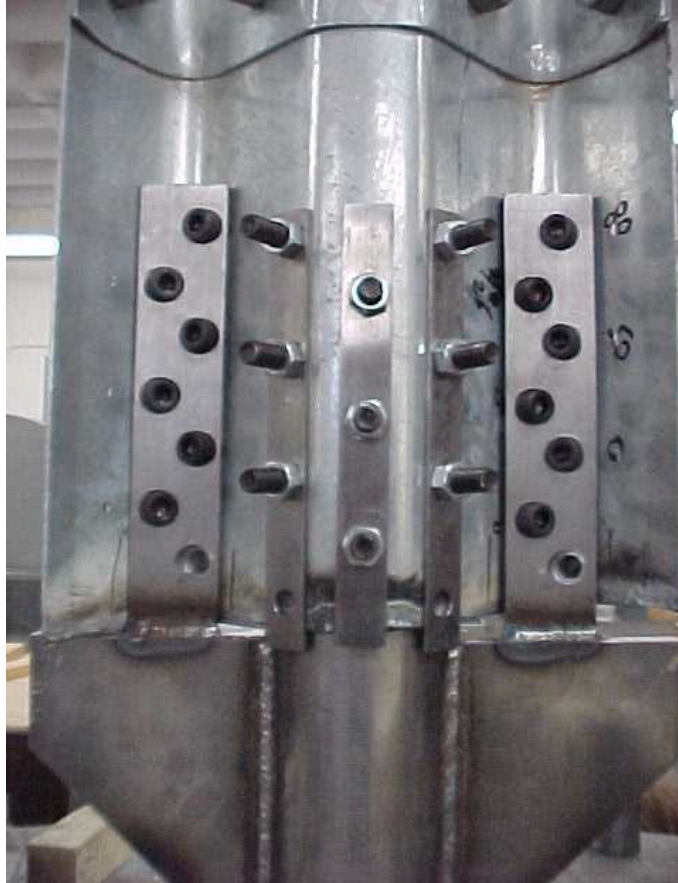
Figure 9: Test grips.

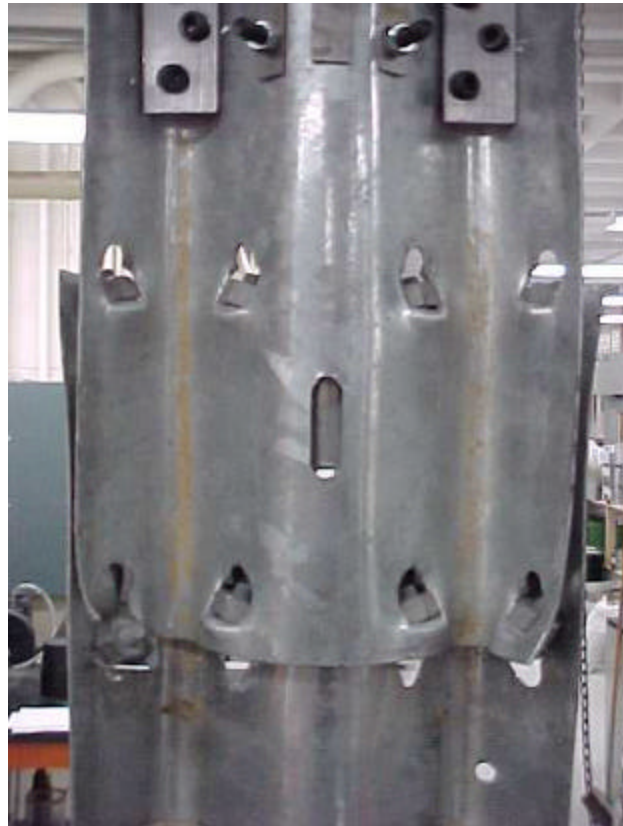
Figure 10: Failed splice connection.

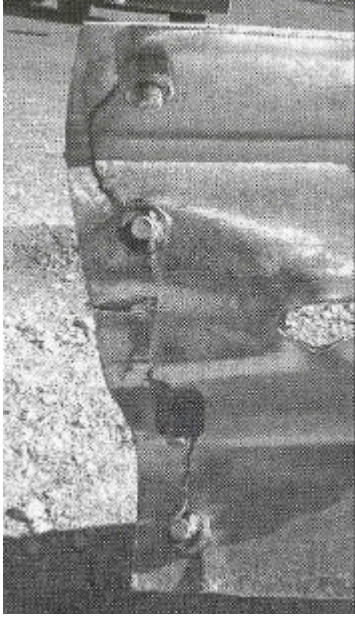
Figure 35: Close-up view on ruptured rail.(17)

Figures 35 and 36 shows a typical splice failure. These figures are from a test where a 1500-kg Chevrolet Lumina impacted a G4-system between post 13 and 14.(17) The authors describe the rail rupture as follows: “At 0.112 s, a tear appeared at the lower edge of the W-beam rail at post 15... The W-beam rail element ruptured at 0.122 s.”(17) Figure 36 shows the location of the study post where the rail tore and also the posts between which the vehicle impacted the system. Figure 35 shows a close-up view of the ruptured rail element. The back layer of W-beam at post 15 tore at the downstream column of splice holes. The tear was initiated at the lower edge of the W-beam and followed a path through all four splice holes. The failure corresponded to the prediction.

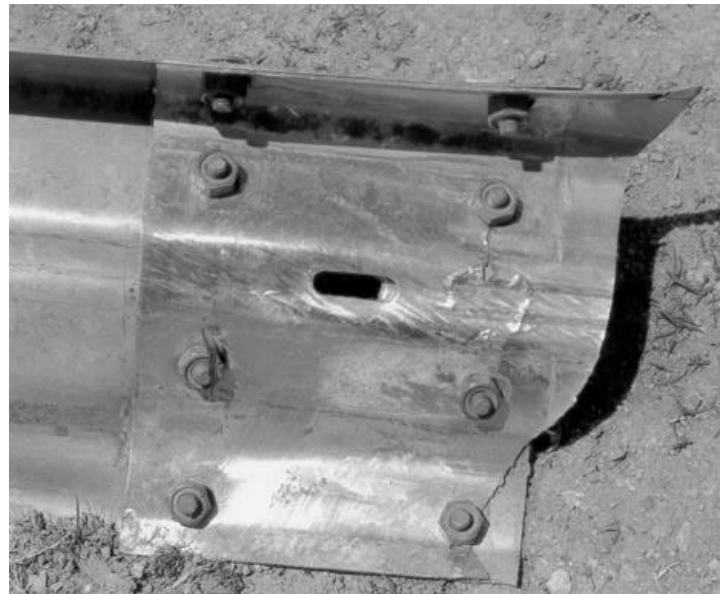
Figure 37: Ruptured rail element in TTI test 405541-4.(18)

Figure 37 shows the ruptured rail element in TTI test 405541-4.(18) The back layer of W-beam tore at the downstream column of splice bolts as predicted from the FE-simulation. The tear was initiated at the lower post hole and followed a path very similar to figure 34.

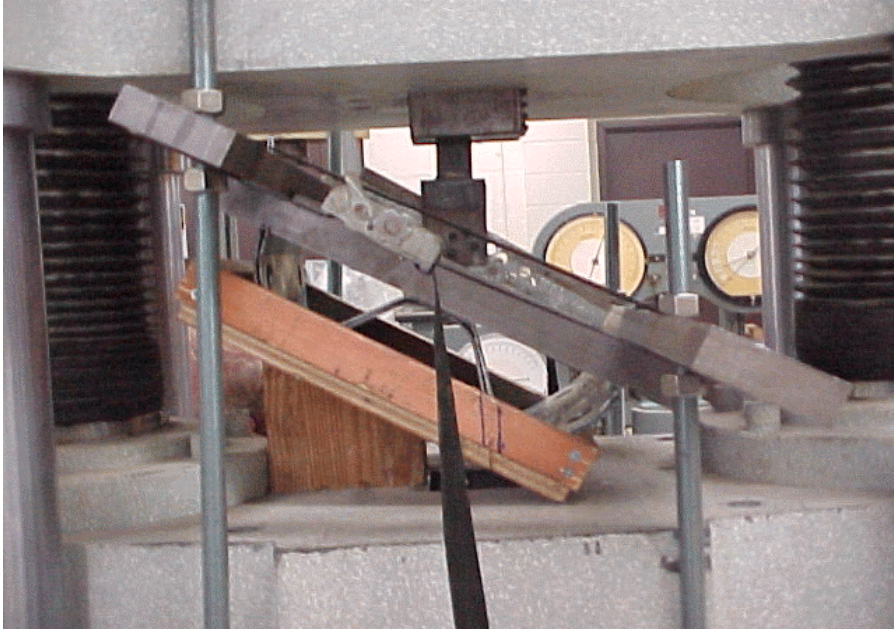
Figure 38: Test setup for the 30/0 degree load test.

Two different support setups were used: (1) the guardrail mounted at a 30 degree slope about the rail axis (figure 38) and (2) the guardrail mounted at both 30 degrees from the guardrail axis and 15 degrees from the post axis (figure 39). These orientations were selected to represent the loading experienced by the connection as the post is bent back and twisted during an impact. The post bolt was positioned in two different positions of the guardrail slot, centered or at the edge. The ends of the rail section were anchored to the test machine base and the test machine grips were used to pull on the web of the post. This resulted in the loading being applied to the bolt in a manner similar to what would be experienced in a full-scale crash test but quasi-static instead of dynamic. The loading was applied at a rate of 89,000 N/minute.

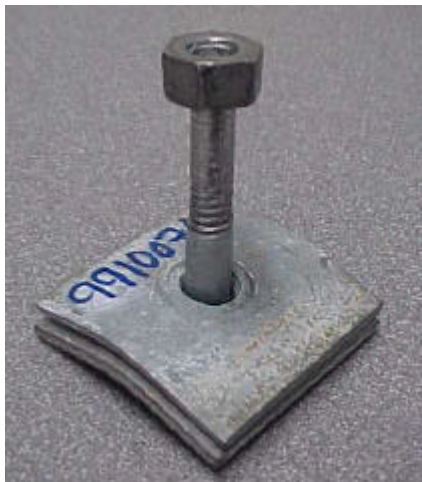
Figure 42: The result of test 99100701 showing the failed components.

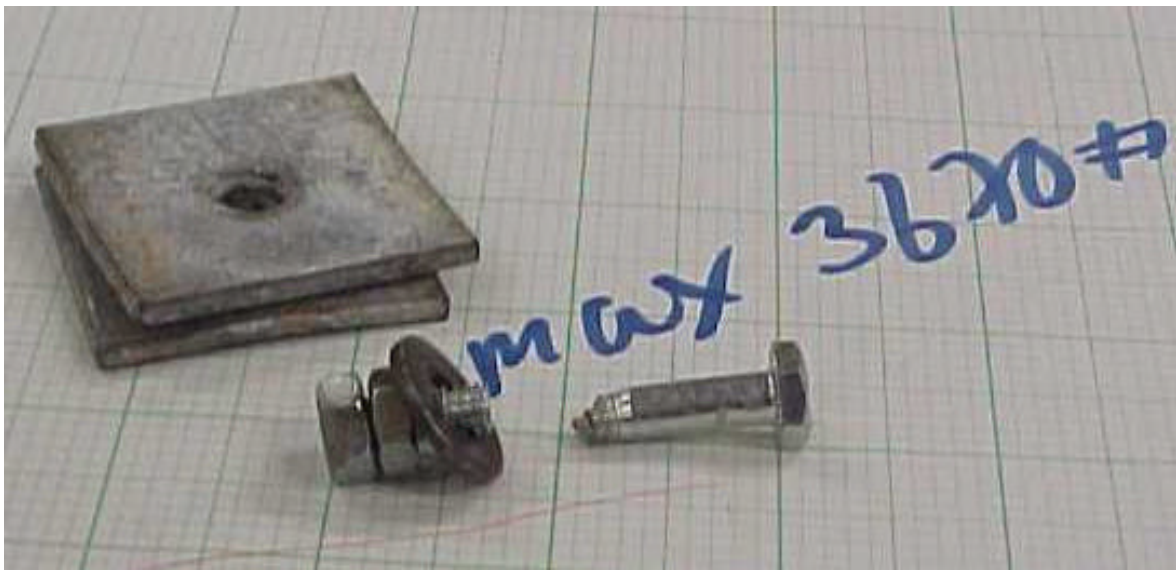
Figure 45: Result of test 99101102 shows the failed components.

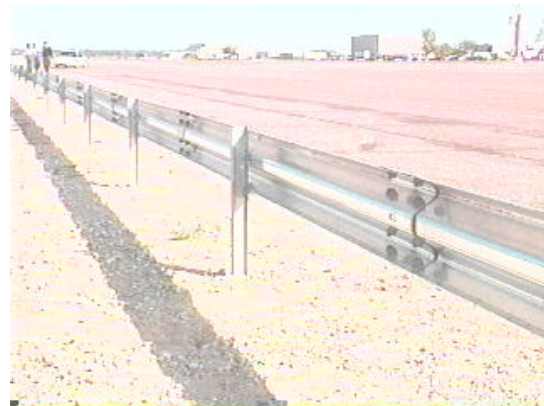
Figure 49: Guardrail installation of a modified G2-system with splice connection between posts.

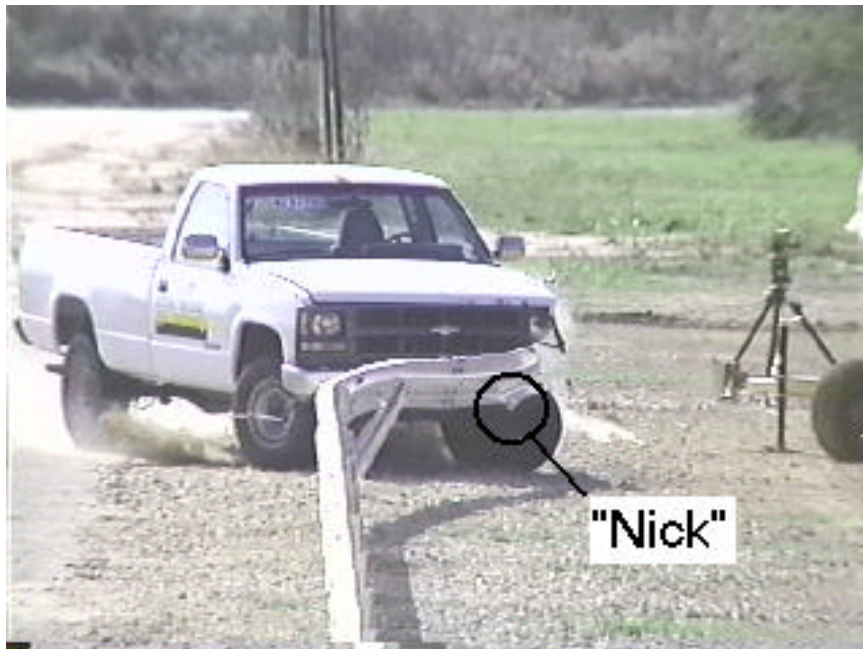
Figure 50: Crash sequence just before rail rupture (TTI 473750-1).

As shown in figure 50 to 52, the rail unexpectedly tore and the vehicle penetrated the barrier. The failed guardrail end can be seen in figure 53.

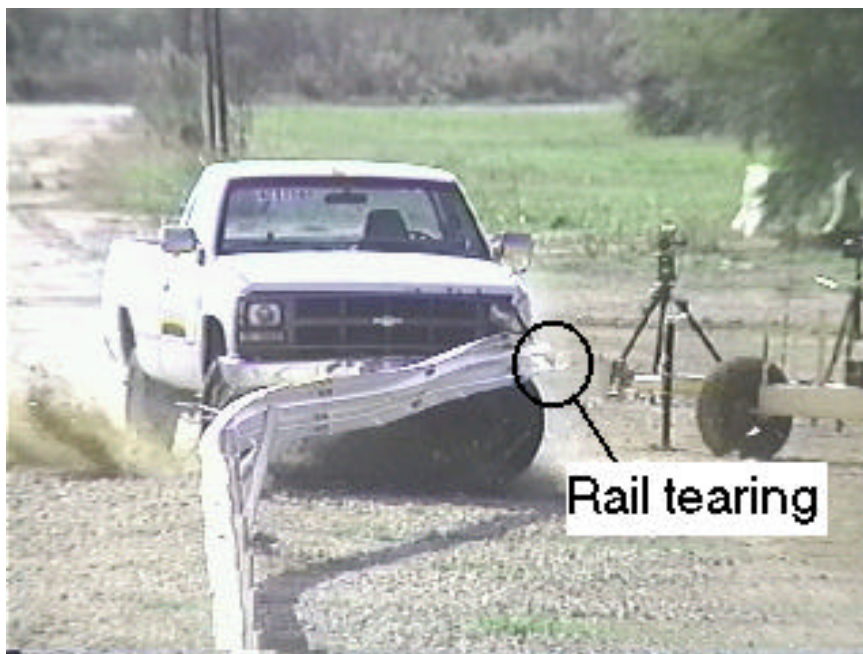
Figure 51: Crash sequence at rail rupture (TTI 473750-1).

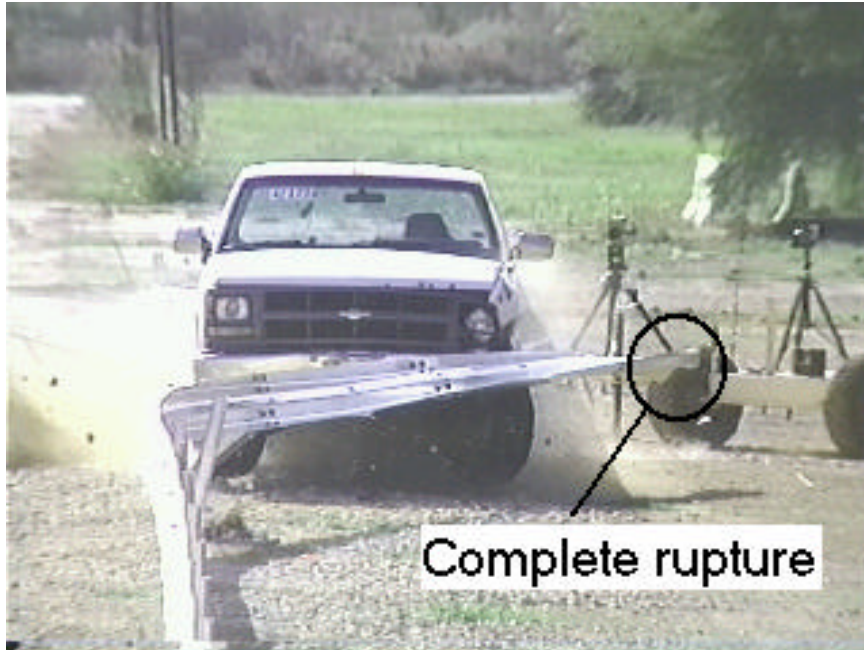
Figure 52: Crash sequence after rail rupture (TTI 473750-1).

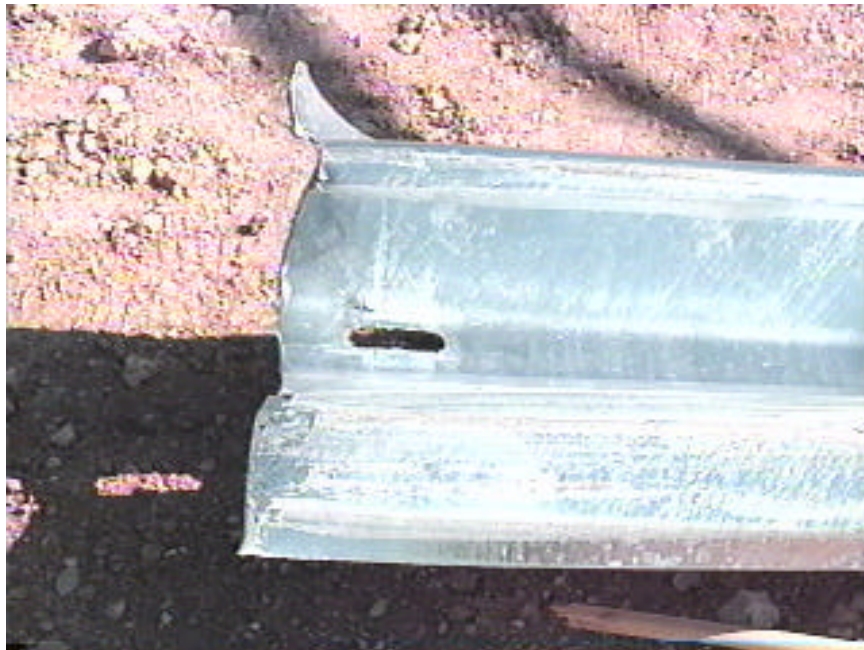
Figure 53: Torn guardrail.

It was difficult to observe the actual guardrail fracture in the full-scale crash test. The fractured guardrail segment shown in figure 53 was positioned at post 8. It appears, from viewing high-speed videotapes of the crash test, that the tear initiated when the rail was pulled over the top of post 8 creating a nick at the lower edge of the rail. This nick is shown in figure 50. The rail ruptured completely when the nick came to the tension side of the vehicle as shown in figures 51 and 52. The maximum tensile rail force upstream from impact point, as obtained from strain gauges, was 275 kN, and the maximum tensile strain downstream of the impact point was 151 kN.(9) The combination of a small cut and significant tension in the guardrail caused the crack to propagate through the cross-section of the rail and resulted in complete rupture of the rail. The rail was also fractured at other posts. Figures 56 and 57 show that tearing was initiated at the lower edge of the W-beam at other posts as well. These damages were similar to the nick that finally ruptured the rail. However, the tension in the rail at these other locations was never high enough to propagate the tear through the cross-section of the W-beam and rupture the guardrail completely. The conclusion is that the nicking and tearing of the rail is not a random phenomena but happens at every post as the rail is released from the post and pulled over it.

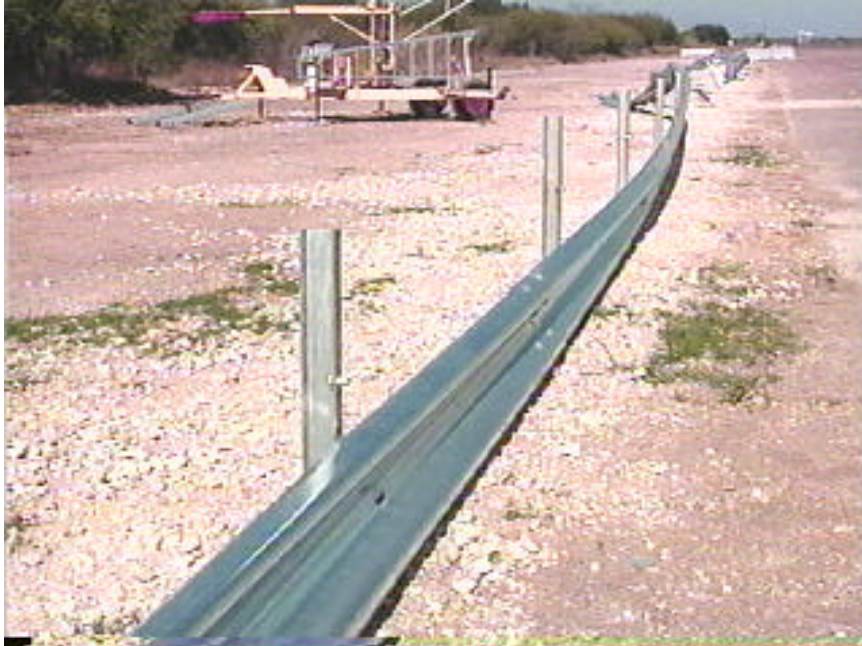
Figure 54: Damage looking up-stream from the impact point.

A more positive result from this test was that the post-rail connection work properly. Figure 54 shows that the rail was released upstream from impact point, which indicates that the connection fails easily. Figure 55 shows that the bolt failed without stripping nuts or pulling the washers through the slots.

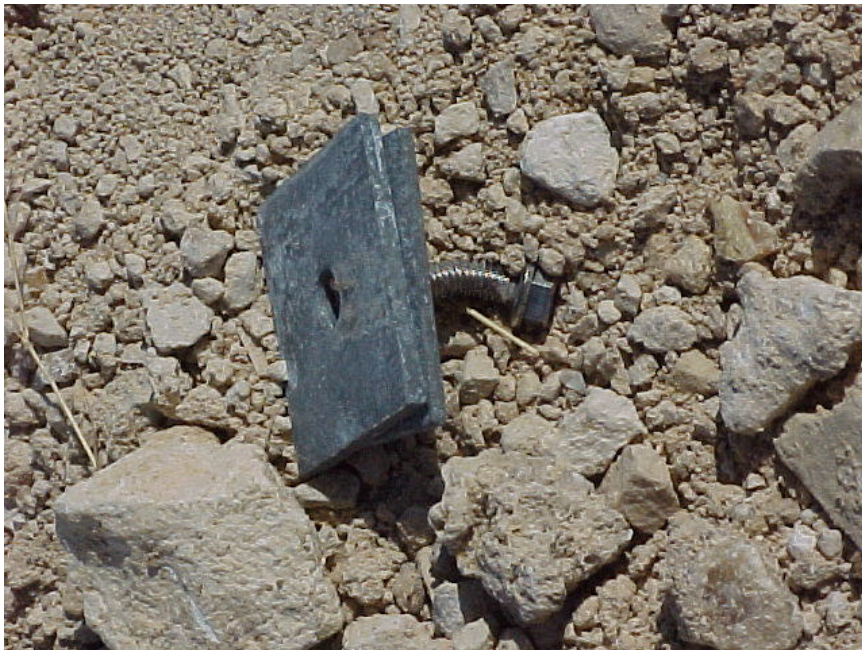
Figure 55: Post-test view of connection components.(9)

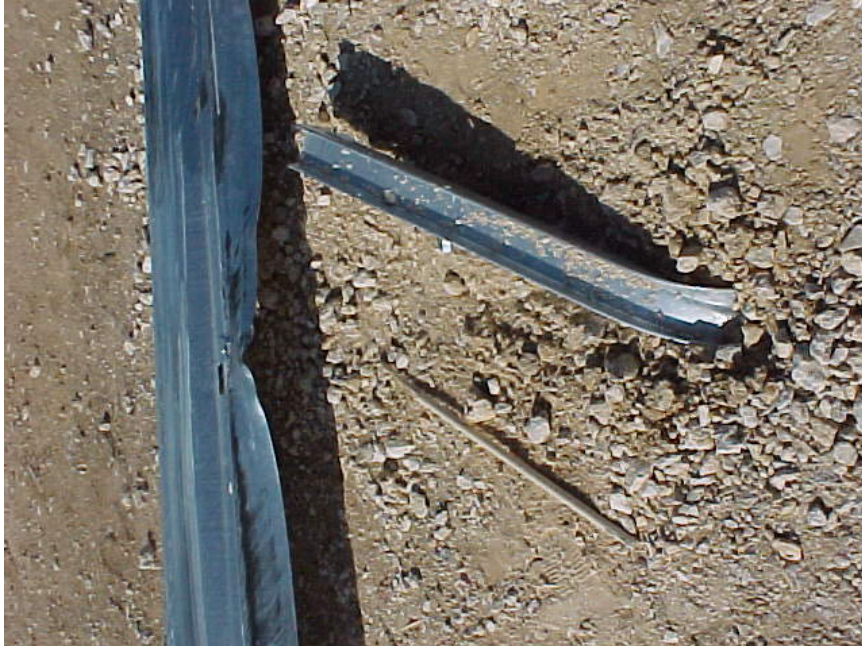
Figure 56: Guardrail tear initiated at a post.(9)

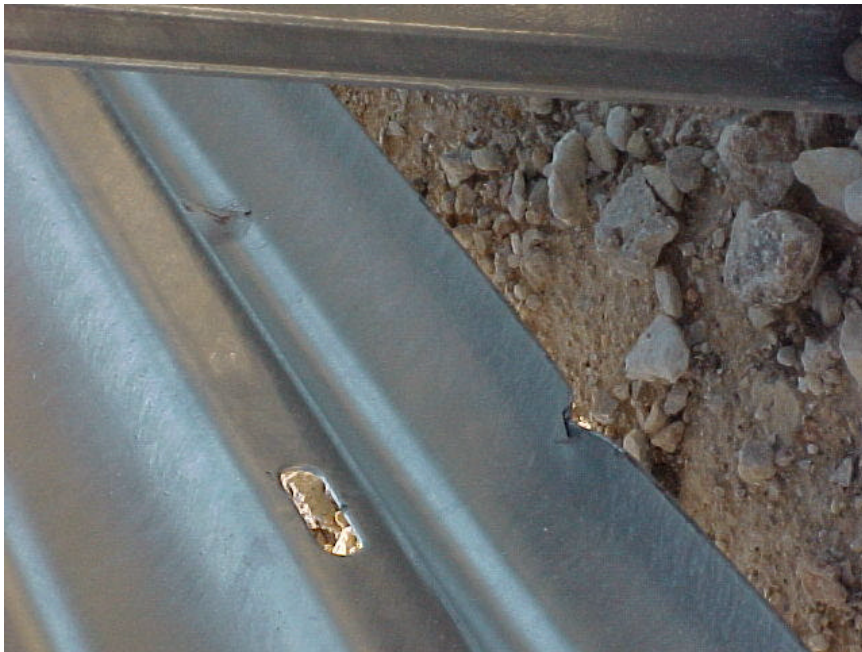
Figure 57: Rail deformation at a post.(9)

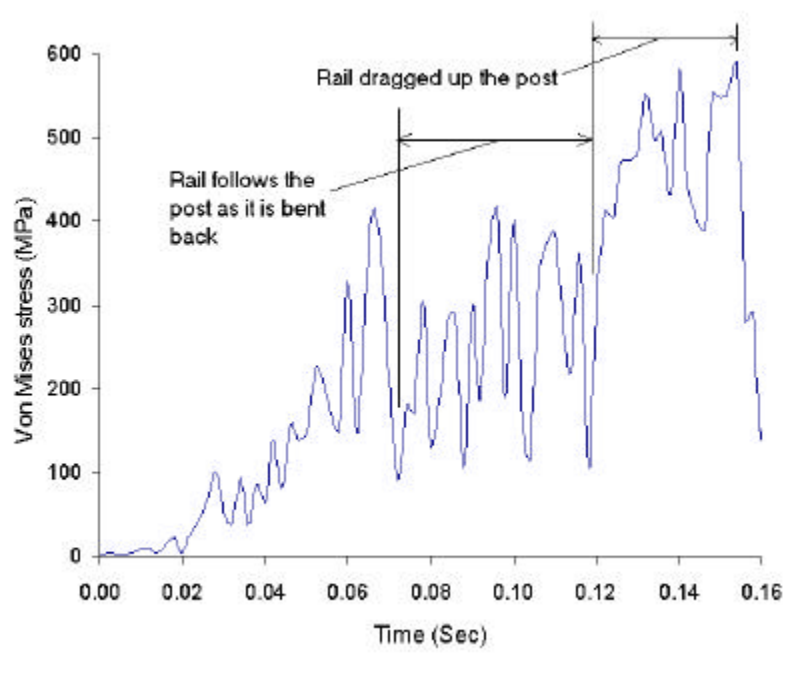
Figure 66: Von Mises stress verses time graph for shell element No. 5449.

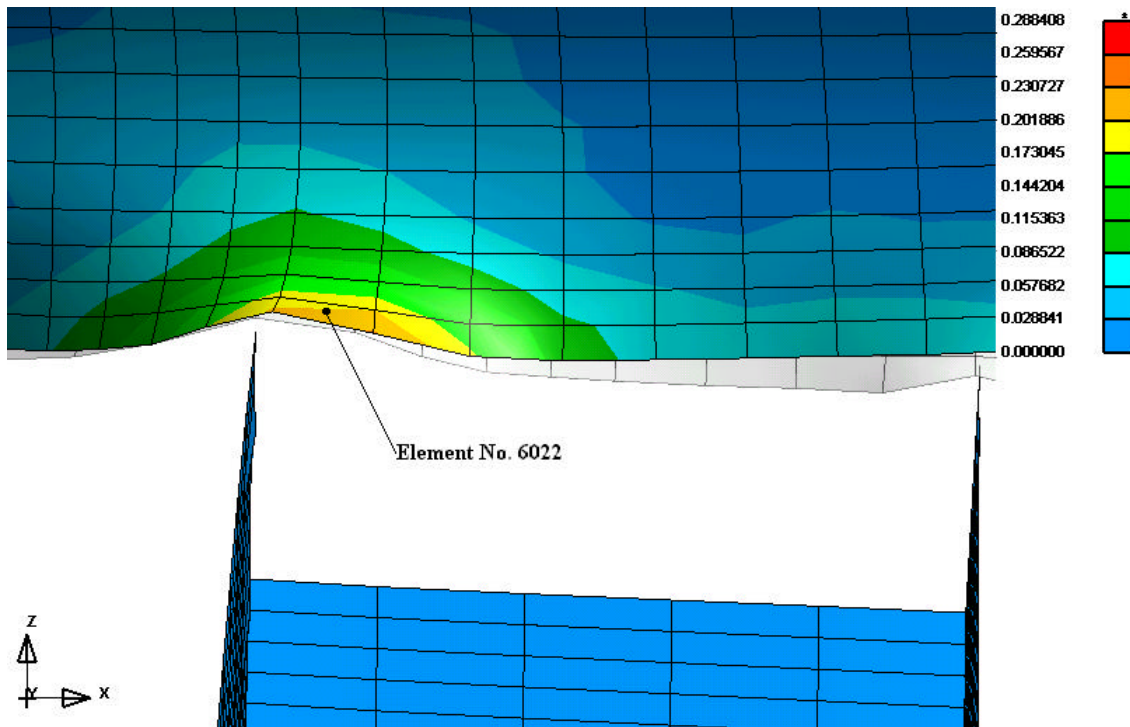
Figure 74: Effective plastic strain contour plot.

The contour plot of the effective plastic strain in figure 74 shows a concentration where the dent was formed. An element was selected in this region (element 6022) and the effective plastic strain time history was plotted (figure 75). As observed in the simulation without the backup plate behind the rail the material at the lower edge of the W-beam formed a kink/dent as the rail moved up the post. This can be observed following the Von Mises time history curve from 0.12 to 0.16 seconds. The effective plastic strain reached 0.23 as the rail was pulled over the top of the flange. This was the maximum effective plastic strain in the model. Adding the backup plate to the model reduced the effective plastic strain by 38 percent.

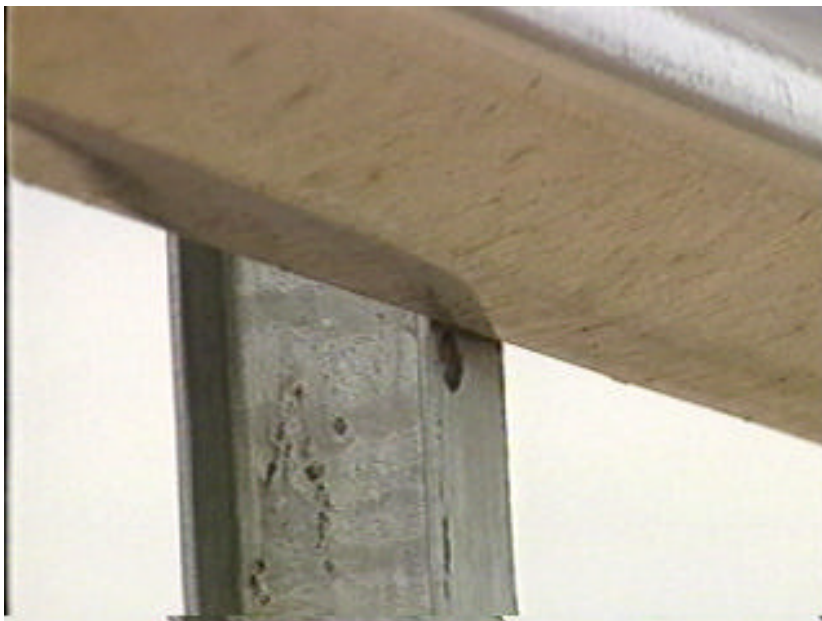
Figure 79: Eliminated shelf bolt.

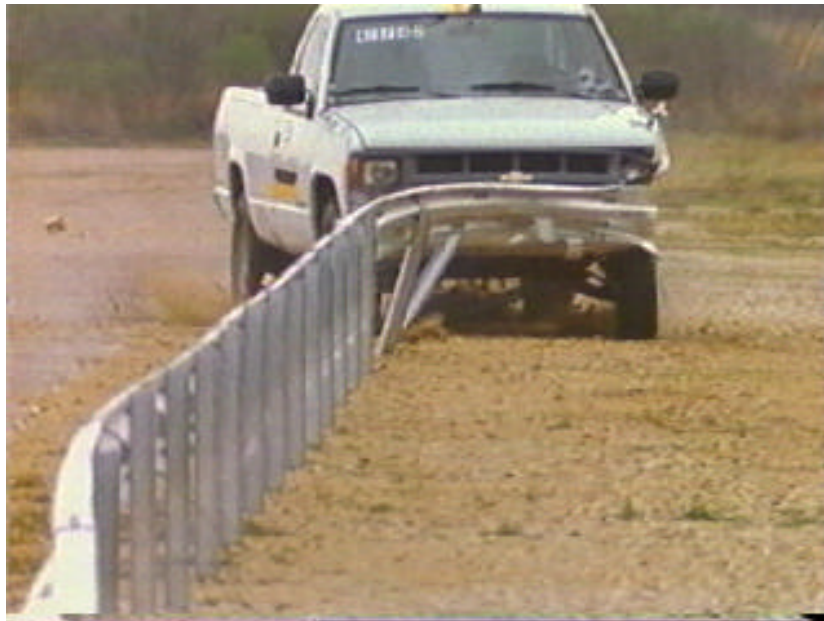
Figure 80: Crash sequence at time » 0.2 sec (TTI 473750-2).

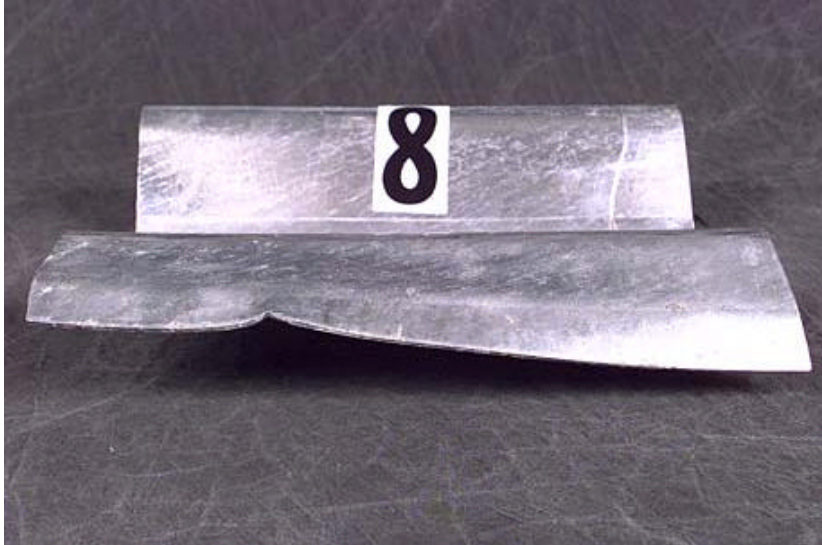
Figure 86: Typical backup plate damage.(17)

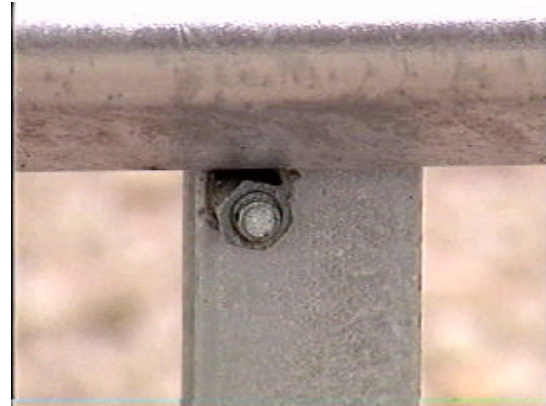
Figure 97: Shelf bolt.

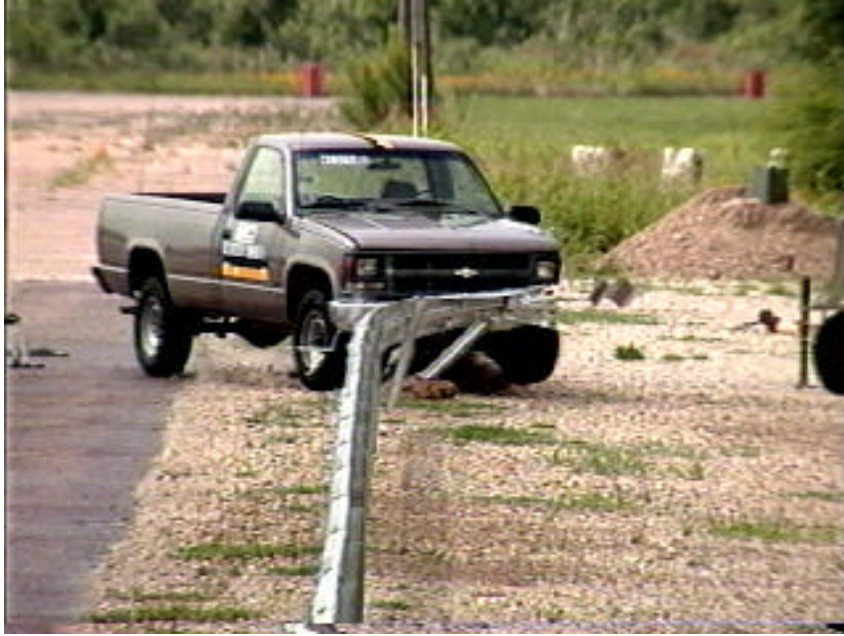
Figure 98: Crash sequence at time » 0.18 sec (TTI 473750-3).

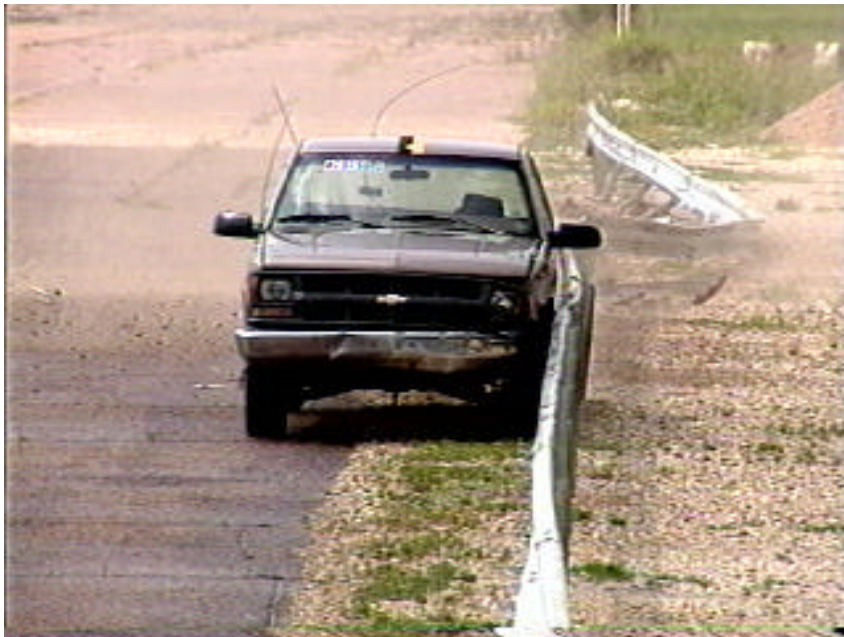
Figure 103: Crash sequence at time » 2.73 sec (TTI 473750-3).

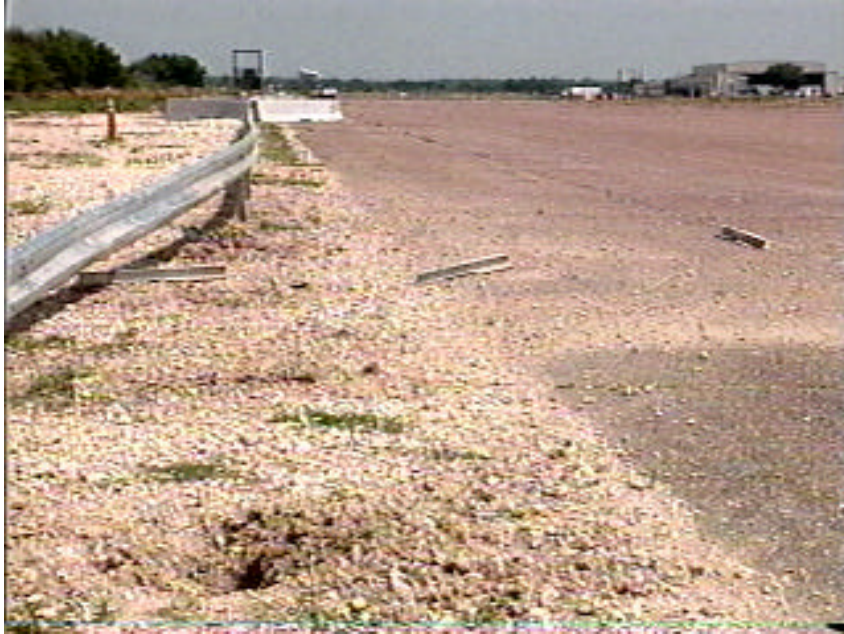
Figure 104: Posts pulled out from the ground.
