Complete Mouth Rehabilitation and Gastroesophageal Reflux Disease: Conventional and Contemporary Treatment Approaches

Accepted version. *The Journal of Prosthetic Dentistry*, Vol. 117, No. 1 (January 2017): 1-7. [DOI](#). ©
2016 Editorial Council for The Journal of Prosthetic Dentistry. Used with permission.

Abstract: This report describes the diagnosis and prosthodontic management of 2 patients with a history of chronic gastroesophageal reflux disease and worn dentition. Different treatment approaches were used for oral rehabilitation. Use of conventional and contemporary restorative materials resulted in functional and esthetic prosthodontic rehabilitation with a favorable prognosis.

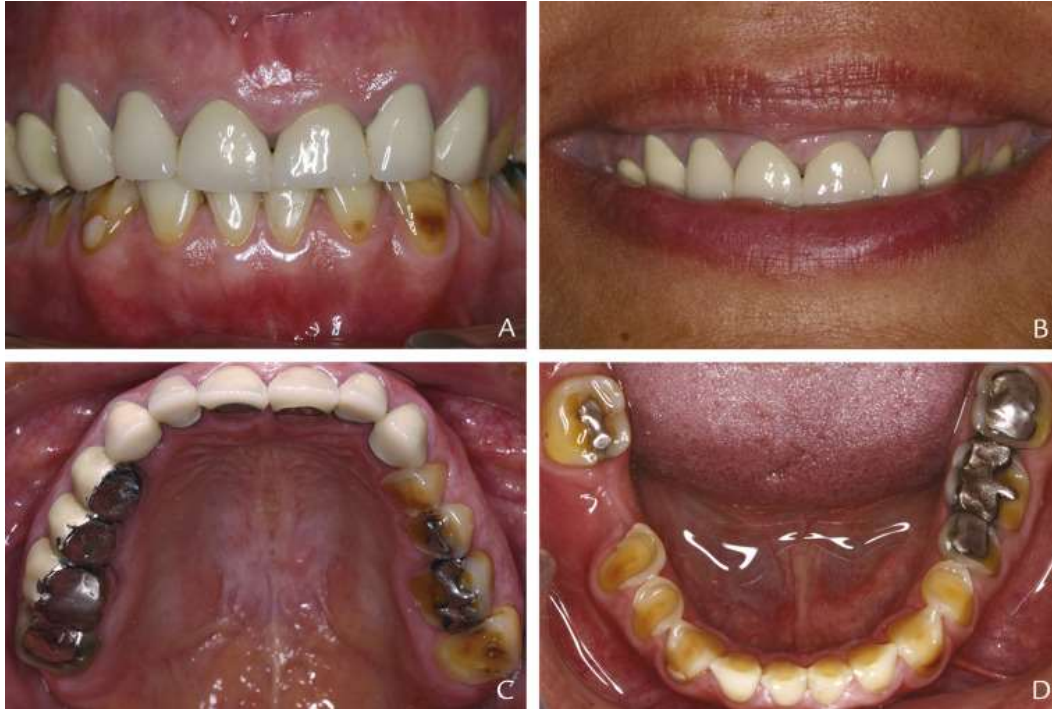
Figure 1. Patient 1 pretreatment. A, Maximum intercuspation position frontal view. B, Exaggerated smile. Note nonideal gingival display. C, Maxillary occlusal view. Note condition of existing restorations. D, Mandibular occlusal view. Note ridge defect at post extraction site of mandibular right first molar and formation of amalgam islands on left posterior teeth.

A 47-year-old woman presented complaining that her "teeth have worn out over time." Her medical history included mild chronic GERD, controlled with diet. Clinical and radiographic examinations revealed multiple root canal treatments (RCTs), amalgam restorations,

and metal ceramic (MC) restorations (Fig. 1). Her last dental appointment was 2 months before the prosthodontic evaluation for extraction of the mandibular right first molar (Fig. 2). The patient underwent monitored occlusal device therapy before any treatment.

The problems identified were moderate to severe dental wear, defective restorations, inadequate tooth structure on several maxillary and mandibular teeth, inadequate anterior guidance, nonideal gingival

display in an exaggerated smile, loss of attached mucosa, and presence of a mandibular right bone defect (Fig. 1). The definitive diagnosis included worn dentition caused primarily by erosion^{9, 10, 11 and 12} and occlusal instability. Her caries risk was low.¹³ The patient was characterized as category 2 relative to the occlusal vertical dimension associated with a treatment plan¹⁴ and as prosthodontic diagnostic index (PDI) class IV for partial edentulism.¹⁵ The treatment objectives were to control GERD, to maintain periodontal and dental health, and to provide functional and esthetic restorations. Significant treatment modifiers were the GERD and finances. The patient declined bone/soft tissue augmentation and implant placement.

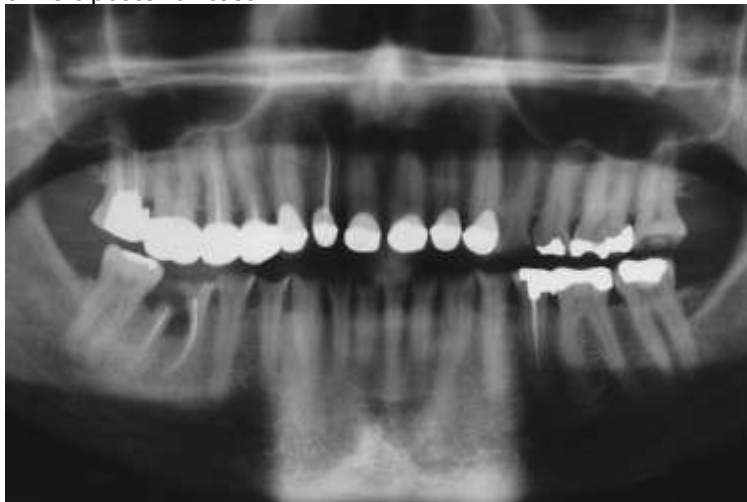
Figure 2. Panoramic radiograph, pretreatment.

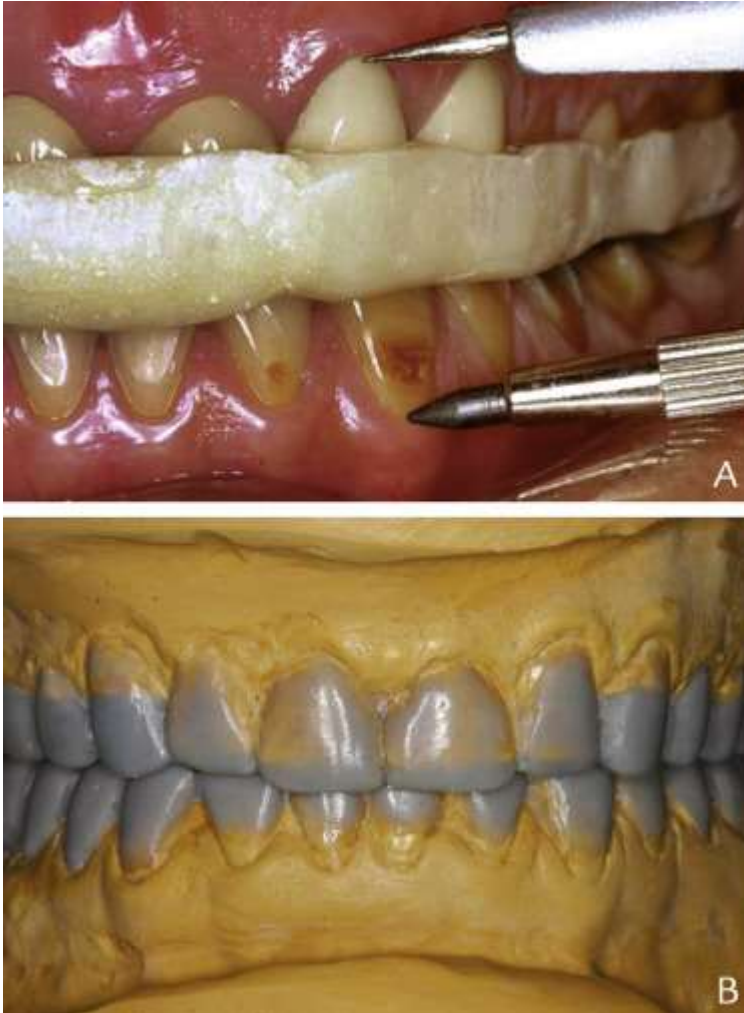
Figure 3. A, Occlusal vertical dimension evaluated with gingival height of left canines as reference. Monitored splint therapy was executed at proposed occlusal vertical dimension to locate musculoskeletally stable treatment position and evaluate patient's adaptation to new vertical dimension. B, Diagnostic waxing at proposed occlusal vertical dimension.

Diagnostic casts were obtained and mounted (Denar Mark II; Whip Mix Corp) using a facebow (Denar Slidematic; Whip Mix Corp) and centric relation records. The occlusal vertical dimension was evaluated, and a 3-mm increase was determined to allow adequate restorative space. A diagnostic waxing was used to evaluate esthetics and function and to fabricate interim prostheses (Fig. 3).

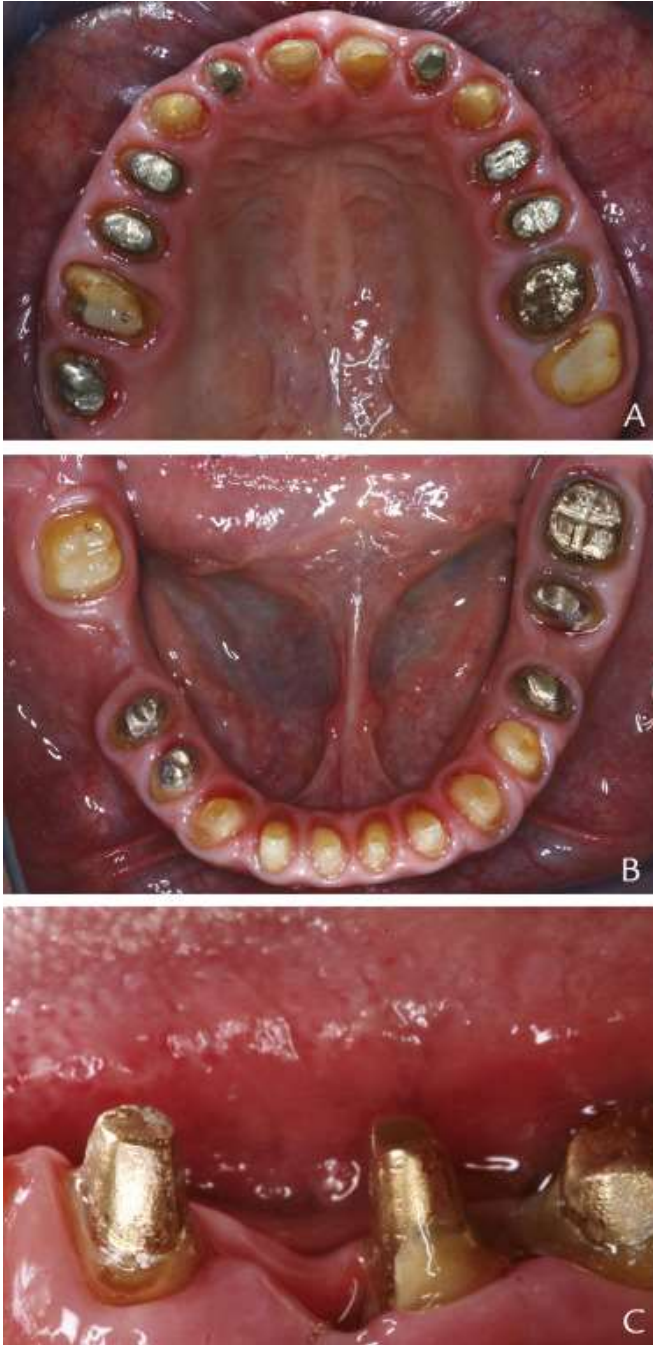
Figure 4. Tooth preparations. A, Maxillary. B, Mandibular. C, Cemented cast post/core on root-resected mandibular left first molar.

The inadequate tooth structure was managed by crown lengthening and/or cast post and cores after RCT. The maxillary central incisors were lengthened to improve gingival architecture. Strip perforation at the mesiobuccal canal of the mandibular left first molar occurred during RCT. After evaluating the tooth, resection of the mesial root was proposed,¹⁶ as the patient refused extraction and implant placement (Fig. 4). The occlusal scheme established with the interim prostheses was mutually protected articulation. The patient was monitored for 4 months to evaluate esthetics, function, oral hygiene, and soft tissue healing. Definitive impressions were made with custom trays and polyvinyl siloxane material (Aquasil Ultra; Dentsply Intl). Casts of interim prostheses were made to facilitate cross mounting of definitive casts and to fabricate a custom incisal guide table.¹⁷ The interim prostheses were used to communicate the established esthetics (incisal edge position, contours, occlusal plane) and function (occlusal scheme, envelope of function, palatal contours of maxillary anterior teeth). The patient received MC fixed dental prostheses (FDPs) on all maxillary and mandibular teeth. All prostheses were cemented with resin-modified glass ionomer cement (Fuji Plus; GC Corp).

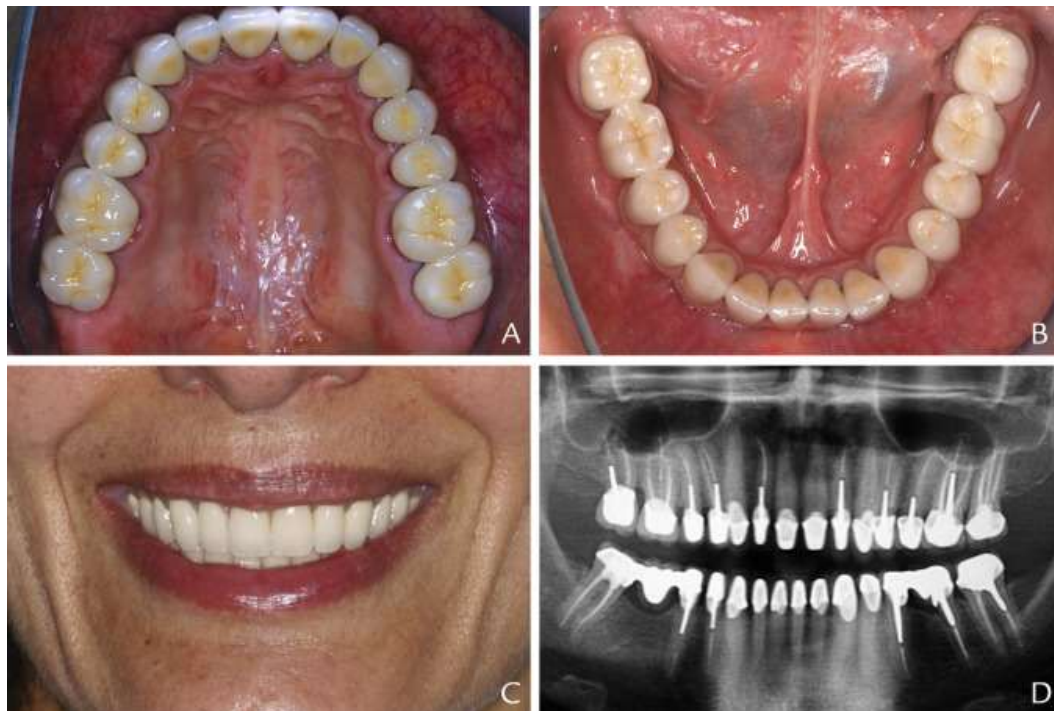
Figure 5. Patient 1. Inserted definitive prostheses. A, B, Occlusal views. C, Exaggerated smile. D, Panoramic radiograph 3 years after insertion.

The patient received follow-up examination 1 week after insertion and was excited with her rehabilitation. A maxillary occlusal device was fabricated to protect the prostheses. The patient entered a 6-month recall maintenance program with favorable long-term

prognosis. After 3 years, she was still satisfied with her prostheses (Fig. 5).

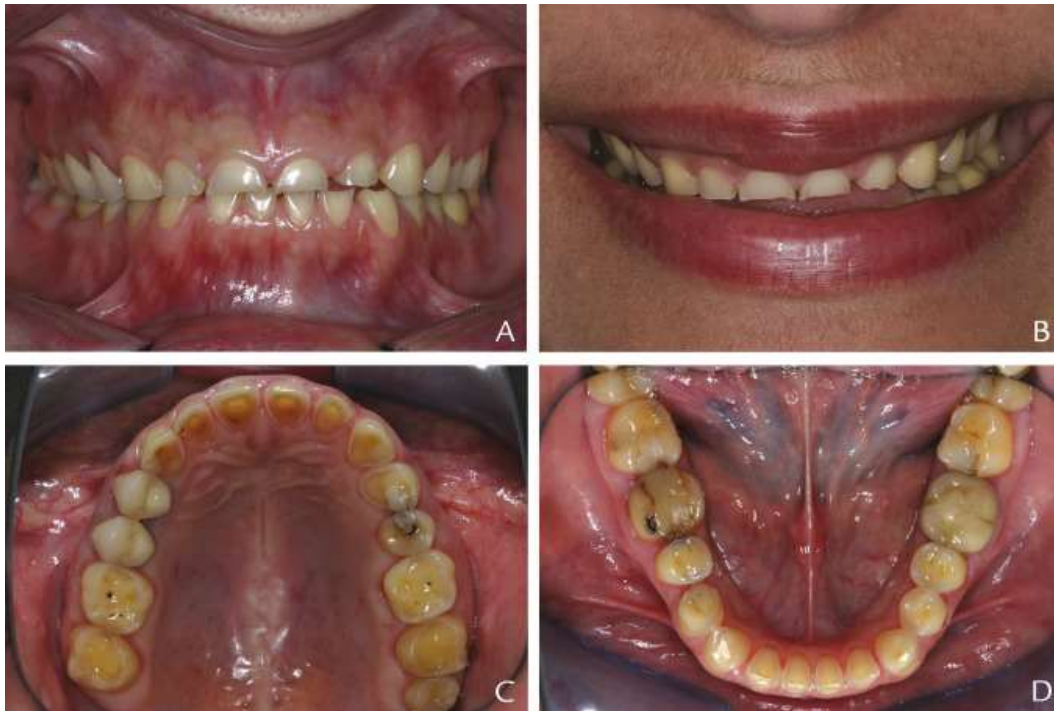
Figure 6. Patient 2 pretreatment. A, Maximum intercuspation position frontal view. B, Exaggerated smile. C, D, Occlusal views.

A 42-year-old woman complained of her “short and ugly teeth.” Her medical history included chronic GERD, controlled with a histamine-2 receptor antagonist. The patient had high esthetic expectations. Clinical and radiographic examination revealed existing RCTs, composite resin restorations, and MC restorations (Figs. 6, 7). The temporomandibular joint examination revealed clicking sounds on both joints but a normal range of motion and no pain. The patient admitted nocturnal bruxism. An occlusal device was fabricated and monitored for 6 weeks to allow the condyles to assume a stable treatment position.¹⁸ Diagnostic casts were mounted (Denar Mark II; Whip Mix Corp) using a facebow (Denar Slidematic; Whip Mix Corp) and centric relation records. The occlusal vertical dimension was evaluated, and an increase of 1 mm was determined to allow space for the restorative materials. Dual-polymerizing composite resin

The problems identified were moderate dental wear, recurrent caries on several teeth, periapical pathosis on the mandibular first molars, inadequate tooth structure on the maxillary right second premolar, nonrestorable maxillary right first premolar and mandibular

left first molar, occlusal interferences, no anterior guidance in maximum intercuspation position, and uneven gingival display in an exaggerated smile (Fig. 6). The definitive diagnosis included worn dentition due to erosion and attrition,^{9, 10, 11 and 12} caries, and occlusal instability. There was no periodontal pathosis, and her caries risk was high.¹³ The patient was characterized as category 2 relative to occlusal vertical dimension associated with a treatment plan¹⁴ and as PDI class IV for completely dentate patients.¹⁹ Treatment objectives were to control GERD, to manage caries by risk assessment, to maintain periodontal health, and to perform functional and esthetic restorations. Important treatment modifiers were GERD, bruxism, and the patient's esthetic demands. Possible options to restore teeth with poor prognosis were discussed, and the patient rejected 3-unit FDPs as definitive prostheses.

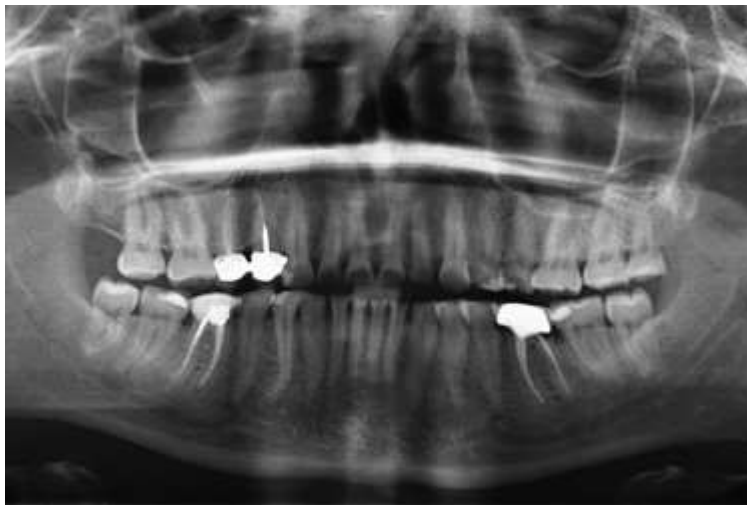
Figure 7. Panoramic radiograph, pretreatment.

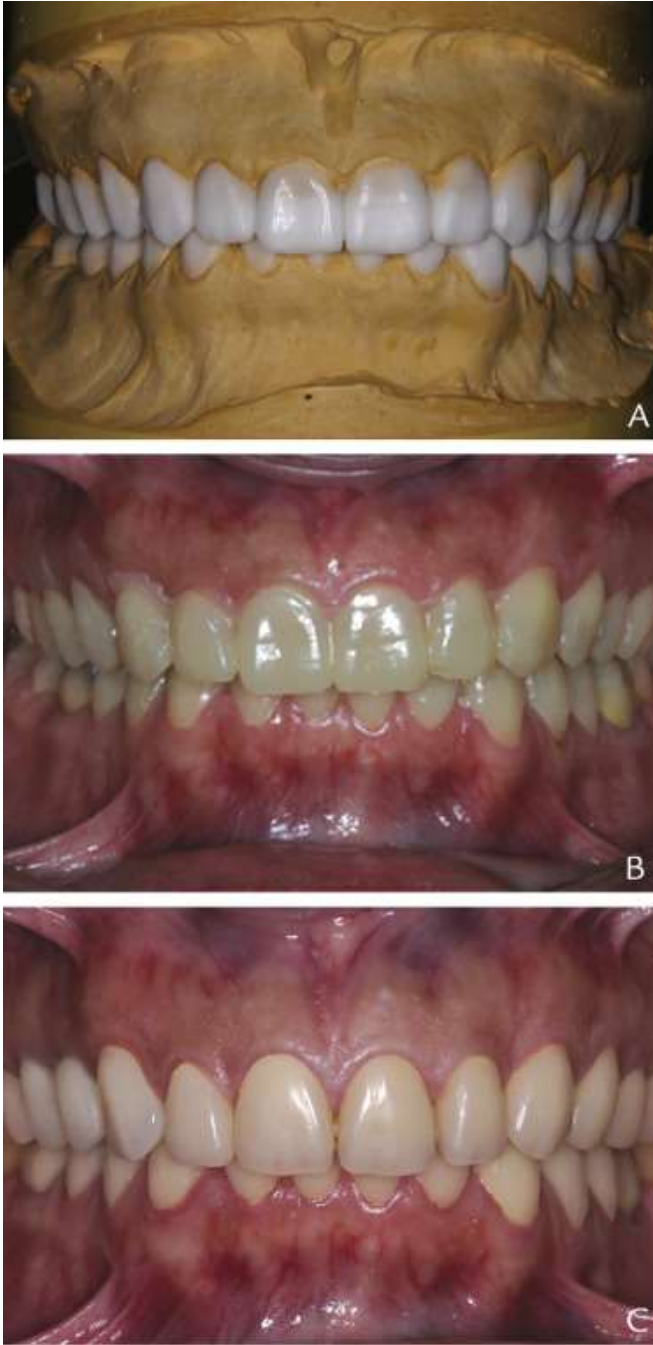
Figure 8. A, Diagnostic waxing at proposed occlusal vertical dimension. B, Intraoral evaluation of trial restorations from diagnostic waxing. C, Interim prostheses.

(Integrity; Dentsply Intl) was used as a trial restoration to evaluate the diagnostic waxing intraorally (Fig. 8).

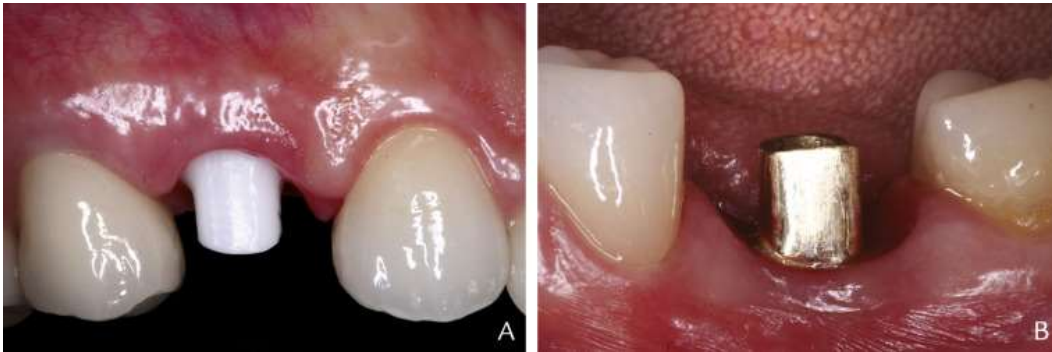
Figure 9. Implant custom abutments. A, Computer-aided designed and computer-aided manufactured (CAD-CAM) custom zirconia abutment on implant at maxillary right first premolar site. B, Custom cast gold abutment on implant at mandibular left first molar site.

Nonrestorable teeth were extracted. At the maxillary right second premolar extraction site, a ridge preservation technique was performed with freeze-dried bone allograft (RegenerOss Allograft; Biomet 3i LLC) and resorbable collagen membrane (OsseoGuard; Biomet 3i LLC). After 6 months of healing, an implant was placed with the aid of a surgical guide (Replace Select RP; Nobel Biocare). At the mandibular left first molar extraction site, implant placement and grafting were performed simultaneously (Replace Select RP; Nobel Biocare). Teeth with inadequate tooth structure were restored with composite resin core foundation material (FluoroCore 2; Dentsply Intl) after RCT. The crowns of the maxillary anterior teeth were lengthened to improve the uneven gingival display. After 4 months of healing, the implants were loaded with interim prostheses, which were fabricated based on the diagnostic waxing and which established a mutually protected occlusion scheme (Fig. 8). Esthetics, function, oral hygiene, and soft tissue maturation were monitored for 6 months. Definitive impressions and a definitive cast mounting were made as described in patient 1. A custom-made zirconia abutment (NobelProcera Abutment Zirconia; Nobel Biocare) was fabricated for the maxillary implant, and a custom-made gold alloy abutment for the mandibular implant (Fig. 9). All teeth received lithium disilicate (IPS e.max Press; Ivoclar Vivadent AG) crowns, which were adhesively cemented (Calibra; Dentsply Intl). Layered zirconia crowns were fabricated on custom abutments and cemented with resin-modified glass ionomer cement (Fuji Plus, GC Corp) (Fig. 10).

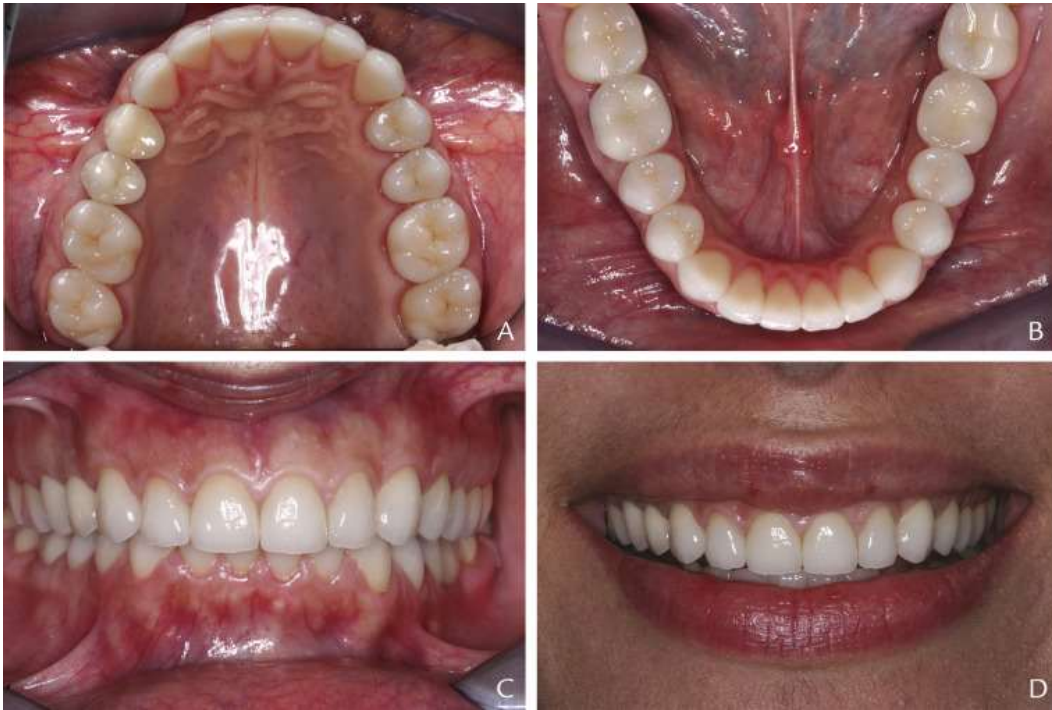
Figure 10. Inserted definitive prostheses. A, B, Occlusal views. C, Maximum intercuspation position frontal view. D, Exaggerated smile.
