# Bond–slip Behavior of Fiber-Reinforced Polymer/Concrete Interface in Single Shear Pull-Out and Beam Tests

**Abstract:** It has been assumed that the fiber-reinforced polymer/concrete interface is subjected to in-plane shear condition when intermediate crack debonding failure occurs. Therefore, the single shear pull-out test results are often used to predict the intermediate crack debonding failure in beams. In this study, the behavior of fiber-reinforced polymer-strengthened concrete beams and single shear pull-out specimens were studied experimentally and numerically. The bond-slip behavior of the fiber-reinforced polymer/concrete interface was obtained by single shear pull-out and beam tests. In all beam specimens, a concrete wedge located at the edge of the notch detached with the fiber-reinforced polymer debonding failure. This phenomenon shows that the initiation of debonding is due to a diagonal crack formation close to the major flexural/shear crack inside the concrete. The diagonal crack formation is due to a local moment at the tip of the notch. This causes the different stress state and slip of the fiber-reinforced polymer/concrete interface of beam specimens from that

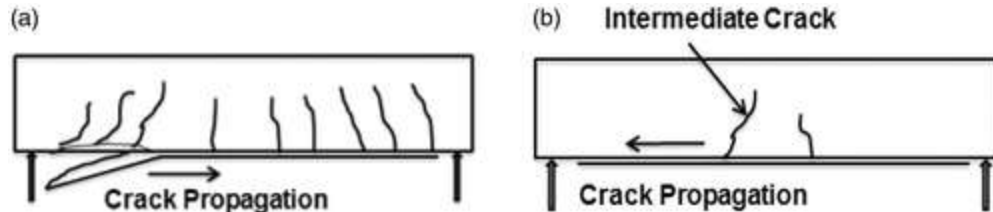
When a concrete beam is strengthened with bonded FRP composite materials, FRP debonding along the FRP/concrete interface can be categorized into two main failure modes<sup>1</sup> as shown in [Figure 1](#). The first failure mode is plate-end (PE) debonding ([Figure 1\(a\)](#)) which initiates at the ends of the FRP plate and propagates in the direction of increasing moment. Many studies have been carried out to investigate and predict this type of debonding failure mode.<sup>2-4</sup> End wrapping and mechanical anchorage have been found to be efficient methods of mitigating the PE debonding failure in FRP repaired or retrofitted concrete beams.<sup>5</sup> The second failure mode is the intermediate crack induced debonding (IC debonding) which initiates at a flexural/shear

crack (intermediate crack) in the concrete within the shear span and propagates toward the plate end in the direction of decreasing moment as shown schematically in [Figure 1b](#). This type of FRP debonding failure, unlike PE debonding, is difficult to prevent. Therefore, it must be explicitly taken into consideration in the design process and addressed as a limit state.

**Figure 1.** FRP debonding failure: (a) PE debonding and (b) IC debonding.

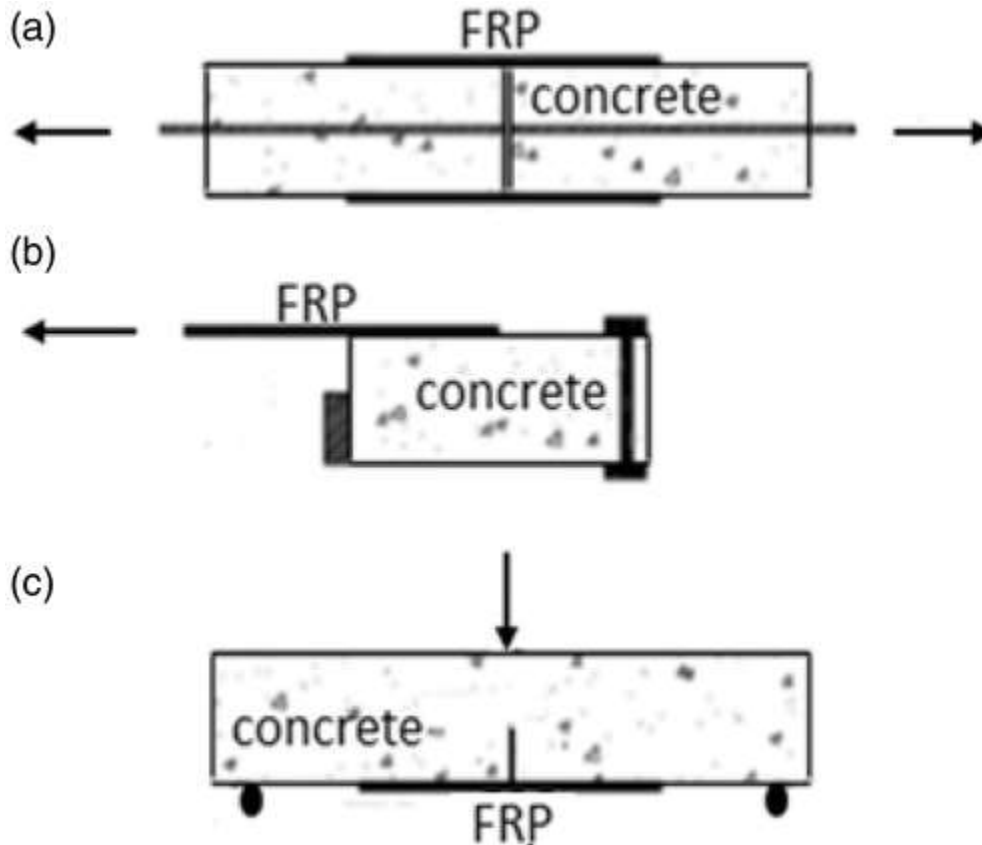
**Figure 2.** FRP/concrete bond test methods: (a) double pull-out test, (b) single pull-out test, and (c) beam test.

There are no universally accepted standards for determining bond capacity between FRP and concrete. Normally, the bond between FRP and concrete is tested by applying shear stress to the FRP/concrete interface of a FRP bonded concrete specimen. According to Chen and Teng<sup>6</sup> and Chen et al.,<sup>7</sup> general test methods include double shear pull-out tests,<sup>8-11</sup> single shear pull-out tests,<sup>12-16</sup> and beam tests.<sup>17-19</sup> These test methods are presented in [Figure 2\(a\)](#) through (c), respectively. There are a number of variations in the beam tests as summarized by Harries et al.<sup>20</sup> Besides of the test methods applying shear stresses, normal stresses,<sup>21-23</sup> and mixed normal and shear stresses<sup>24,25</sup> are also applied to the FRP/concrete interface to evaluate the bond capacity between FRP and concrete.

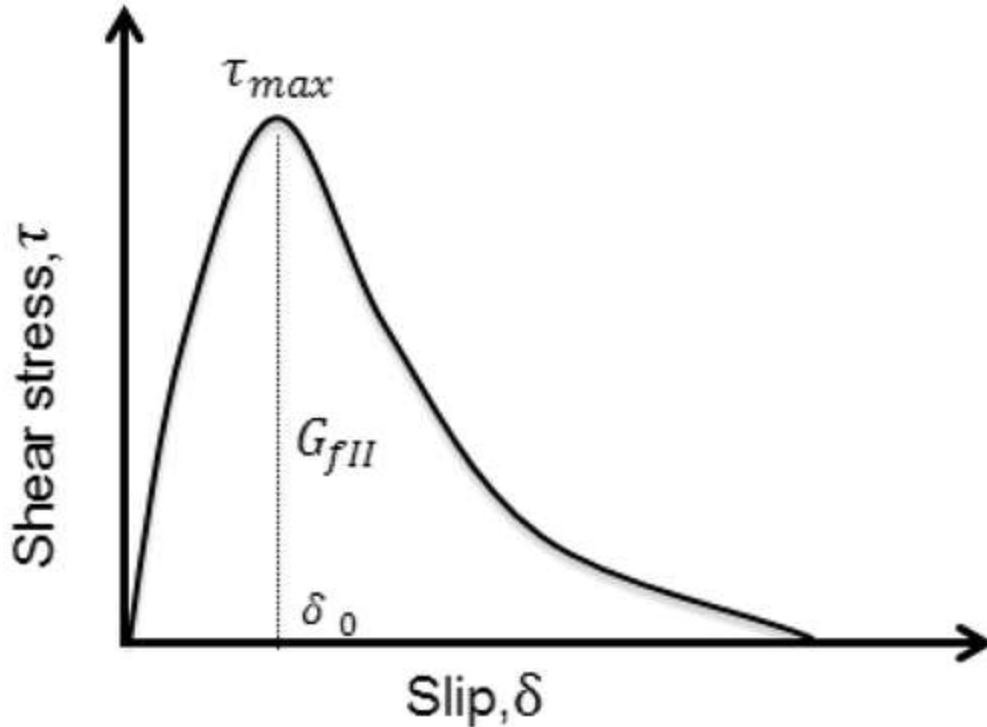
**Figure 3.** Typical bond-slip curve of a FRP/concrete interface.

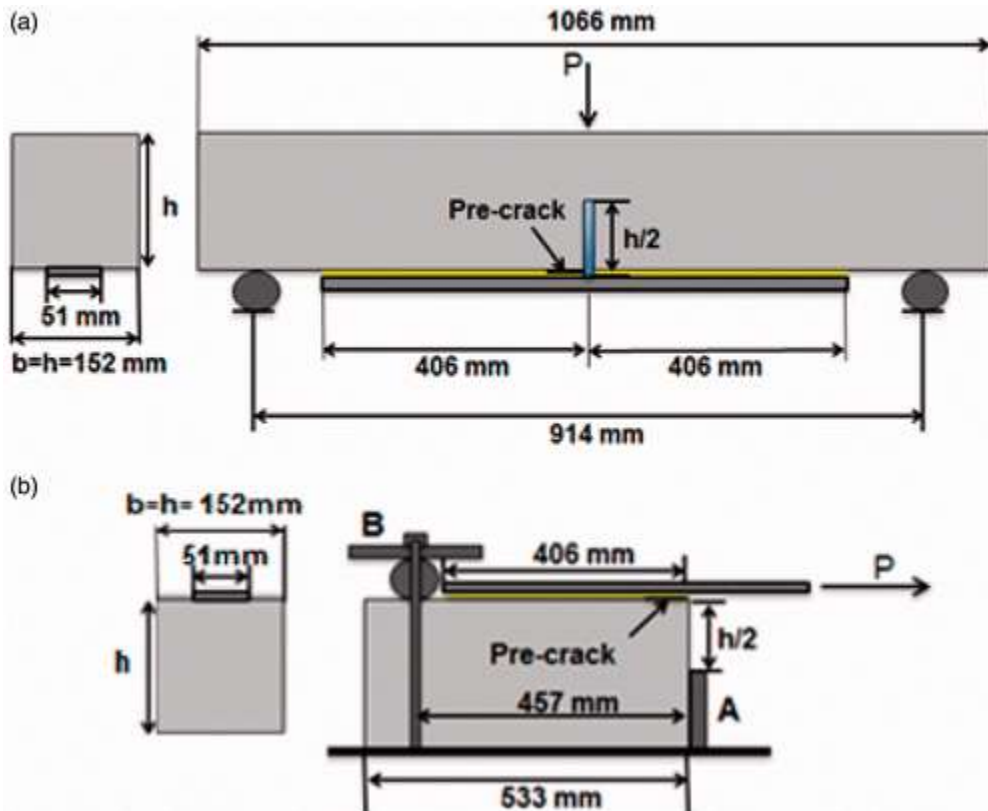
Five single shear pull-out specimens (CS1-CS5) and six beam specimens (CMC0-1 to CMC0-6) were tested in the experimental program. Since the main purpose of carrying out the pull-out test in this study was to compare the bond–slip behavior of the pull-out specimens to the bond–slip behavior of the FRP-strengthened beam specimens, the pull-out specimens were made to represent one half of the beam specimens both in terms of dimensions and boundary conditions. The beam test specimens and the pull-out specimens are shown schematically in [Figure 4](#). As shown in the figure, the length of the concrete block and the FRP plate of the pull-out specimen represent one half of the beam specimen. The cross section of the concrete substrate and FRP width were also same in both specimens. In the beam specimens, a half-depth saw-cut notch was located at mid-span to simulate a pre-existing flexural crack. A recent study<sup>33</sup> shows that the boundary condition of the concrete block has a significant effect on the bond–slip behavior in single shear pull-out tests. To mimic the same boundary conditions of beam specimens in the pull-out specimens, the concrete block was positioned on a rigid frame with two steel reaction elements as shown in [Figure 4\(b\)](#).

Element A in Figure 4(b) provides the horizontal reactions to simulate the un-cracked part of the beam at the top of the notch, and element B provides the vertical reactions to simulate the support forces in the beam specimens. A 25-mm horizontal precrack (unbonded FRP length) between FRP and concrete was provided in the single shear pull-out specimens and only at one side of the notch in the beam specimens. The bonding length of FRP plate was 406 mm, which is larger than the effective length (192 mm calculated by using the method recommended by FIB<sup>34</sup>).

**Figure 4.** Experimental specimens: (a) beam specimens and (b) single shear pull-out specimens.

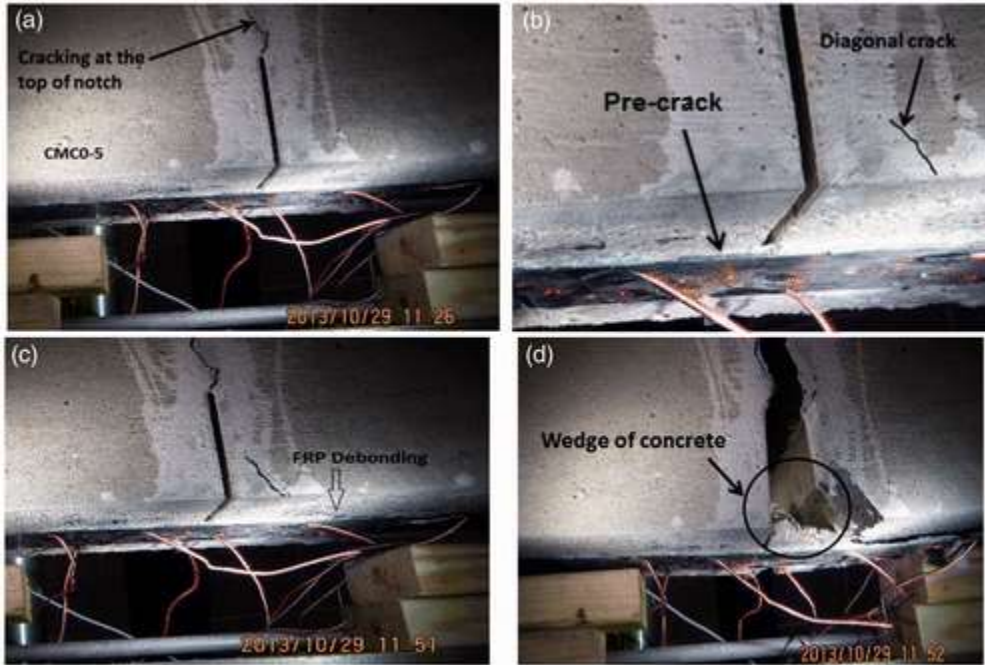
1. Flexural cracking initiated at the top of the notch ([Figure 5\(a\)](#)).
2. A diagonal flexural/shear crack started close to the notch, about 25 mm from the notch ([Figure 5\(b\)](#)) at one or other side of the notch, or occasionally both sides.
3. FRP debonding along the FRP/concrete interface initiated at the tip of the diagonal crack and propagated toward the support ([Figure 5\(c\)](#)).

4. Sudden, essentially instantaneous failure steps included: the diagonal crack merging with the notch, the crack at the top of the notch propagating to the loading point, and FRP debonding continuing to the end of the FRP plate (Figure 5(d)).

**Figure 5.** IC debonding failure processes of beam CMC0-5.

In all specimens, there was a wedge of concrete attached to the FRP plate (Figure 5(d)) that shows diagonal cracking inside the concrete. In all cases, the debonding cracking did not start at the tip of the precrack. Instead, it started at the tip of the diagonal crack to either side of the notch. Therefore, the applied precrack did not work as the initiation point of the FRP debonding and it did not control to which side of the notch FRP debonding would occur.

Figure 11 shows the FE-predicted FRP debonding failures. In the single shear pull-out test specimens (Figure 11(a)), the debonding started at the tip of precrack and propagated along the FRP/concrete interface to the end of the plate in a manner similar to the experimental observations (Figure 7). In the beam specimens shown in Figure 11(b), the applied method is able to predict the cracking at the top of the notch and also the diagonal crack about 25 mm from the notch. After the diagonal crack formation, the FRP debonding started at the tip of the diagonal cracks parallel to the interface. In the FE analysis, when the strain energy in the element at the top of the notch (Figure 11(b)) reached the critical fracture energy of concrete, this element was no longer able to transfer stress. At this stage, the behavior of concrete and the whole model became unstable. Therefore, the analysis was terminated and this stage was considered to be the final failure step of the FE analysis. Because of the symmetry of the FE model, the diagonal crack and partial FRP debonding were seen at both sides of the notch. The FE-predicted debonding processes of the beam specimens are in a very good agreement with the experimental observations (Figure 5(a)–(d)).

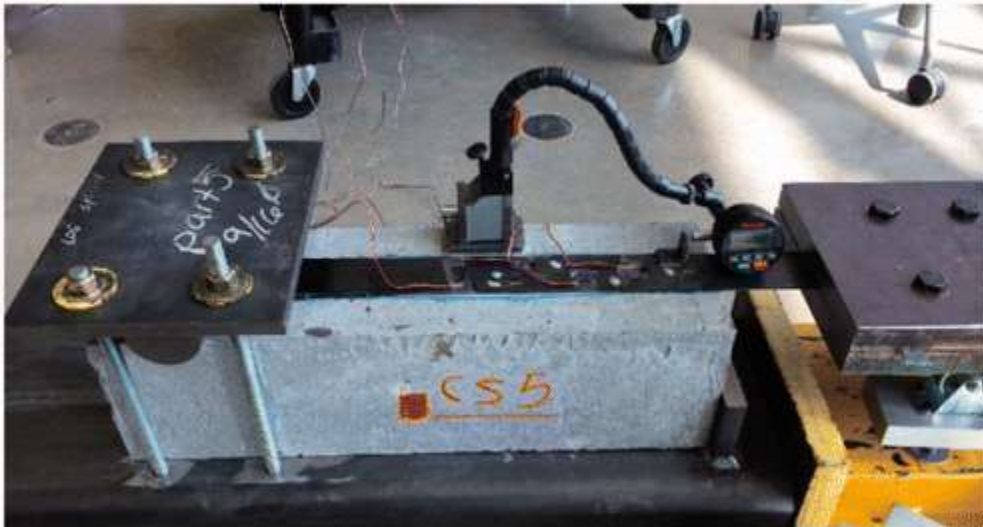
relative slip between the concrete and FRP at the precrack tip as shown in [Figure 6](#).

**Figure 6.** Application of digital dial gauge to obtain the relative slip at the precrack tip.

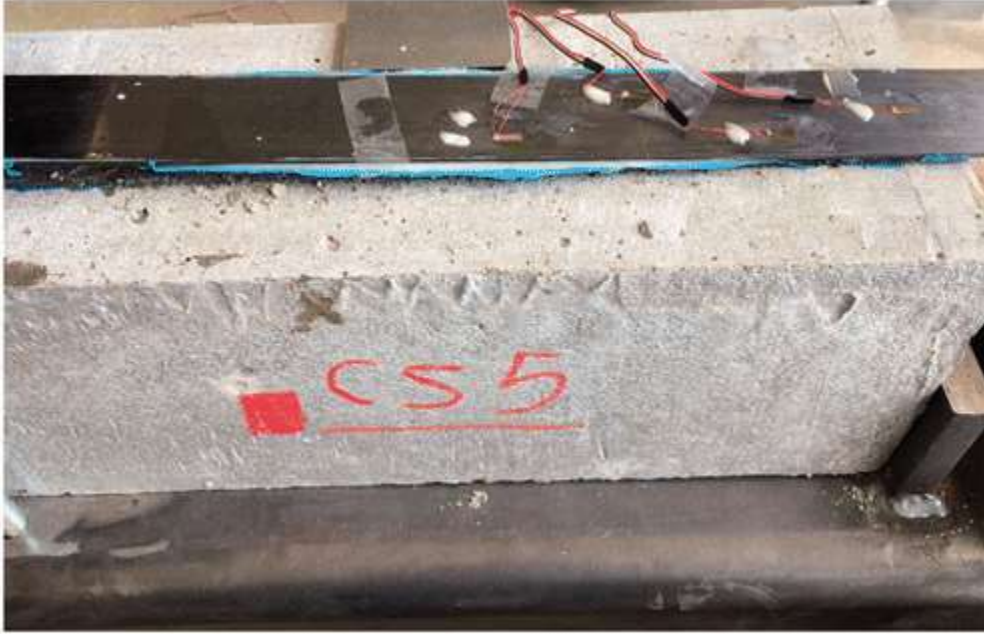
[Figure 7](#) shows the FRP debonding failure in specimen CS5, which is typical for the single-shear pull-out tests. The debonding initiated at the tip of the precrack and propagated along the FRP plate to the end of the specimen. The failure plane was in the concrete a few millimeters (1–2 mm) away from the FRP/concrete interface.

**Figure 7.** FRP debonding failure of pull-out specimen CS5.

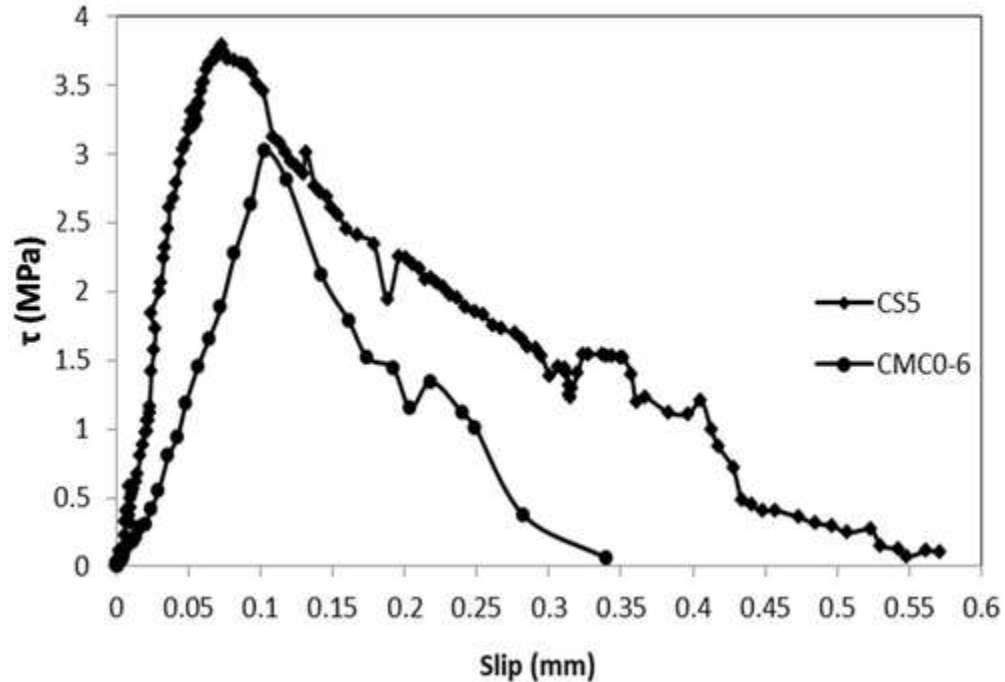
where  $\tau_i$  is the average interfacial bond stress in the increment  $i$  having length  $\Delta x$  between strain gage data  $\varepsilon_i$  and  $\varepsilon_{i-1}$  representing the  $i$ th and  $(i-1)$ th gauges arranged along the FRP plate;  $E_f$  and  $t_f$  are the elastic modulus and thickness of the FRP plate, respectively;  $\delta_i$  is the local slip between the FRP plate and concrete at the section  $i$ ;  $\varepsilon_0$  is the strain in the FRP plate at the free end of bonded area; and  $\varepsilon_j$  is the strain value of the  $j$ th gauge. Figure 8 shows a representative bond–slip curve of the beam test (specimen CMC0-6) and the single shear pull-out test (specimen CS5) for comparison.

**Figure 8.** Bond–slip curves of beam specimen CMC0-6 and single shear pull-out specimen CS5.

By comparing the experimental bond–slip curves ([Figure 8](#)), it can be seen that the slips at the tip of the diagonal crack close to the notch (i.e., the mid-span flexural/shear crack) in the beams are smaller than the slips of the FRP plate at the tip of the precrack in the pull-out specimens. The slip is largely affected by the modulus of the adhesive layer which is smaller by a factor of 3.7 in the single shear pull-out specimens ([Table 2](#)). Therefore, the slip of the shear specimens is greater than that of the beams specimens. Since the bond strength of the beam specimens is also smaller than that of the pull-out specimens, the interfacial fracture energy of the bond (the area under the bond–slip curve) in the beams is less than that in the pull-out specimens. However, the FE analyses show that the fracture energy value of the bond–slip relationship does not control the final failure of the beam specimens. As explained in the section of finite element analysis, the final failure of the beam occurs when the fracture energy in the element at the top of the notch ([Figure 11\(b\)](#)) meets the critical fracture energy of the plain concrete. Therefore, the plain concrete fracture energy, which is considerable less than the FRP/concrete interfacial fracture energy, plays the key role for the beam failure.

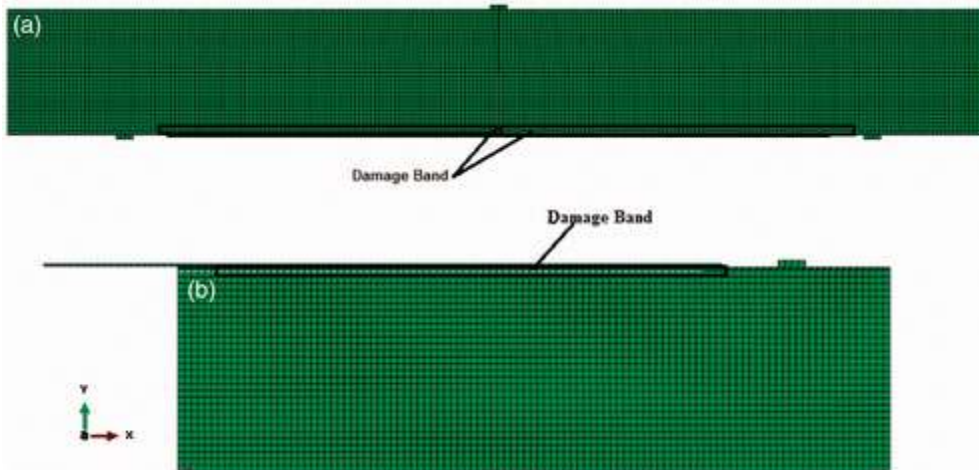
The commercial software ABAQUS/standard 6.13 was used for the FE analysis. The plane stress 4-node bilinear 2D elements (CPS4R) were applied for the modelling of all materials. Figure 9 shows the typical FE meshes of the beam and the single shear pull-out specimens.

Figure 9. Typical finite element mesh: (a) beam specimen and (b) pull-out specimen.

strength of a thin layer of mortar adjacent to the interface and provides significant mechanical beyond in this region.<sup>36</sup> Secondly, the concrete substrate is the weakest component in the FRP/epoxy/concrete interface with a relatively small tensile strength. Based on this experimental observation, a thin damage band of 2 mm thicknesses was modeled along the interface as shown in [Figure 9](#). Although a 25-mm long precrack was made in one side of the notch in the beam specimens, the debonding did not start from the precrack tip, but from the diagonal crack tips at either sides of the notch as discussed previously in the experimental program. Therefore, the applied precrack did not work as the initiation point of the FRP debonding and it did not control to which side of the notch FRP debonding would occur. In the finite element analysis, in order to capture the diagonal cracking, the damage band was included along the whole FRP length for the beam specimens as shown in [Figure 9\(a\)](#).

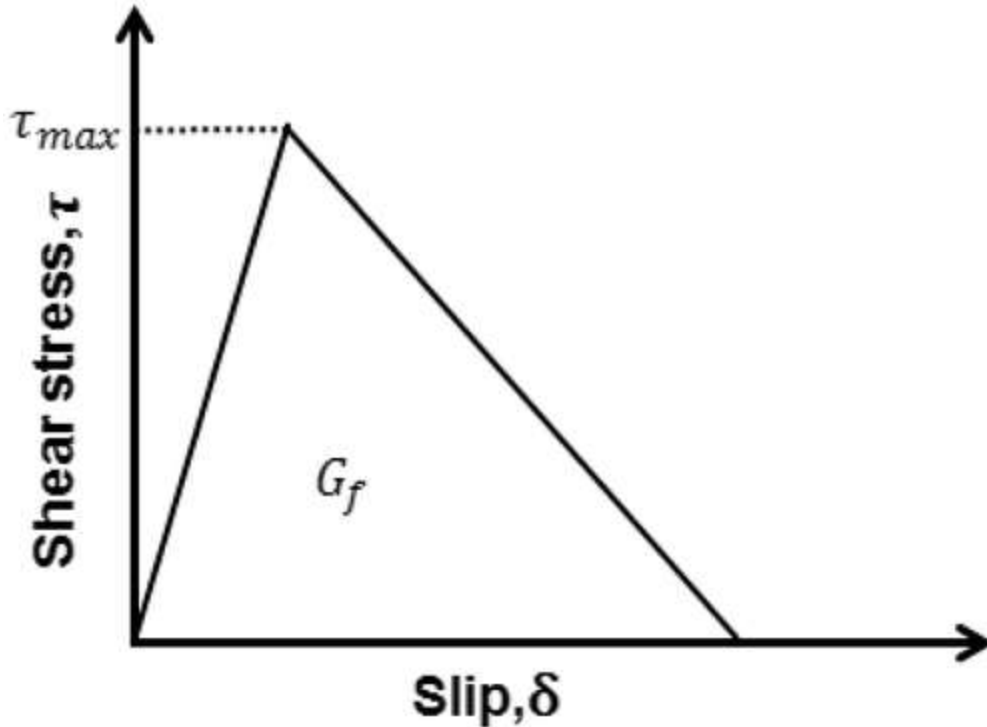
To model the FRP/concrete interface, the cohesive zone method was applied. This method models the debonding behavior using the bond–slip curve of the interface. In this study, the constitutive response of the damage band was defined by a bilinear bond–slip relationship as shown in [Figure 10](#). According to this figure, the stress–slip curve was assumed linear up to the bond strength and debonding was initiated. The postcracking behavior was presented by a descending linear damage law using the fracture energy value,  $G_f$ , that is equal to the area under the bond–slip curve. In the present numerical analysis, the fracture energy and bond strength were assumed equal to the experimentally obtained results presented in the previous section.

**Figure 10.** Bilinear bond-slip curve.

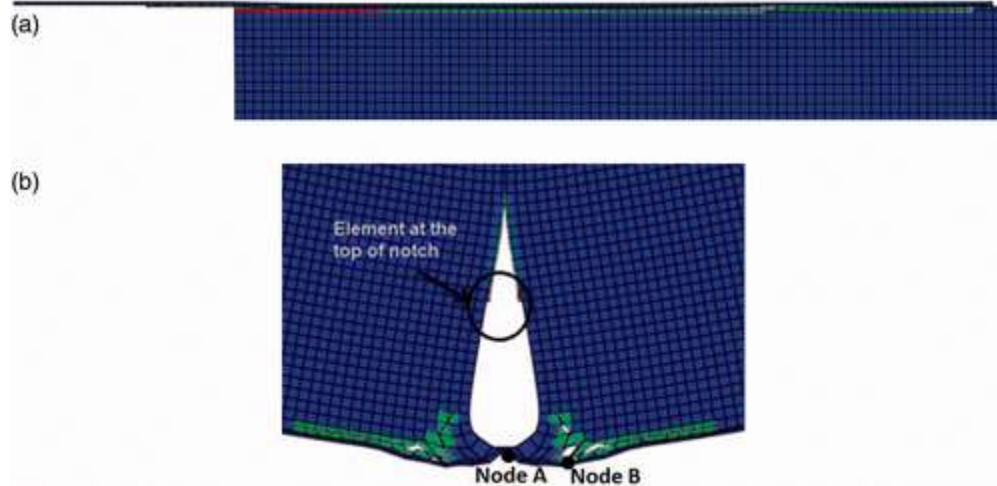
**Figure 11.** FRP debonding failure predicted by FE analysis: (a) single shear pull-out test and (b) beam test.

It can be seen in [Figure 11\(b\)](#) that the vertical displacement of FRP element below the notch (node A) is less than the displacement of the element at the tip of diagonal crack (node B). [Figure 13](#) presents the vertical displacement of node B relative to that of node A indicating that node B deflects a greater amount and shows that this relative deflection is proportional to the applied load. This deflection behavior is due to a local moment created by the tension force in the FRP plate by the vertical downward displacement of the concrete, and causes a different stress state at the FRP/concrete interface in the beam specimens from that in the single shear pull-out specimens. [Figure 14](#)

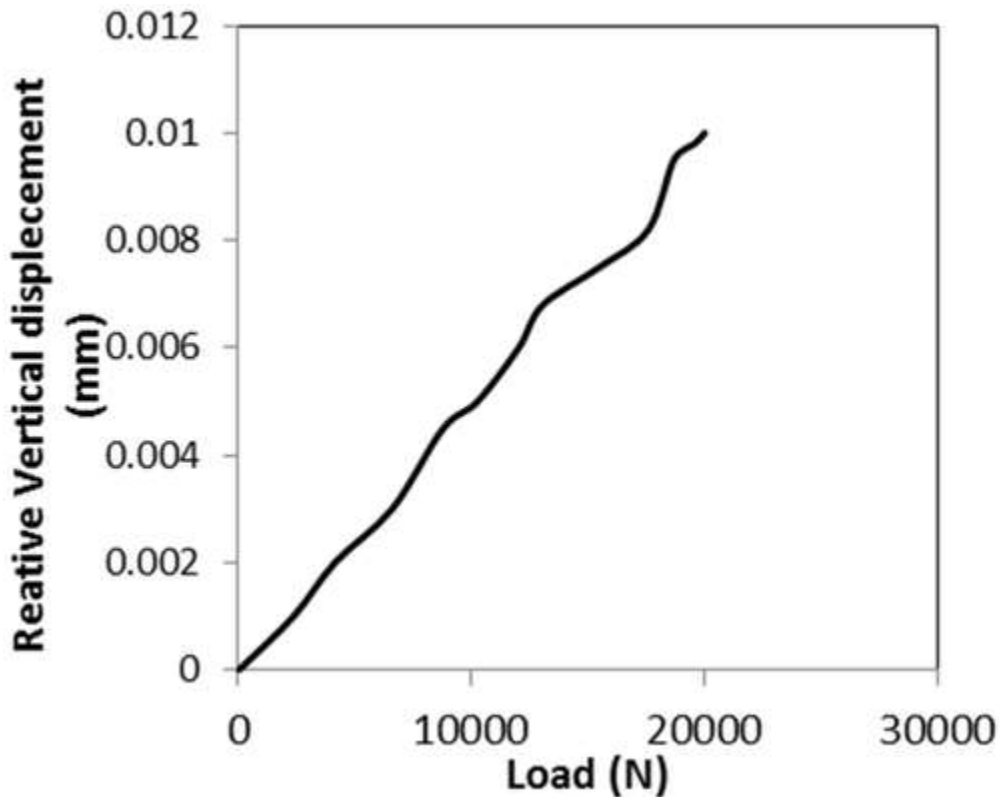
Figure 13. Relative vertical displacement of node B to node A.

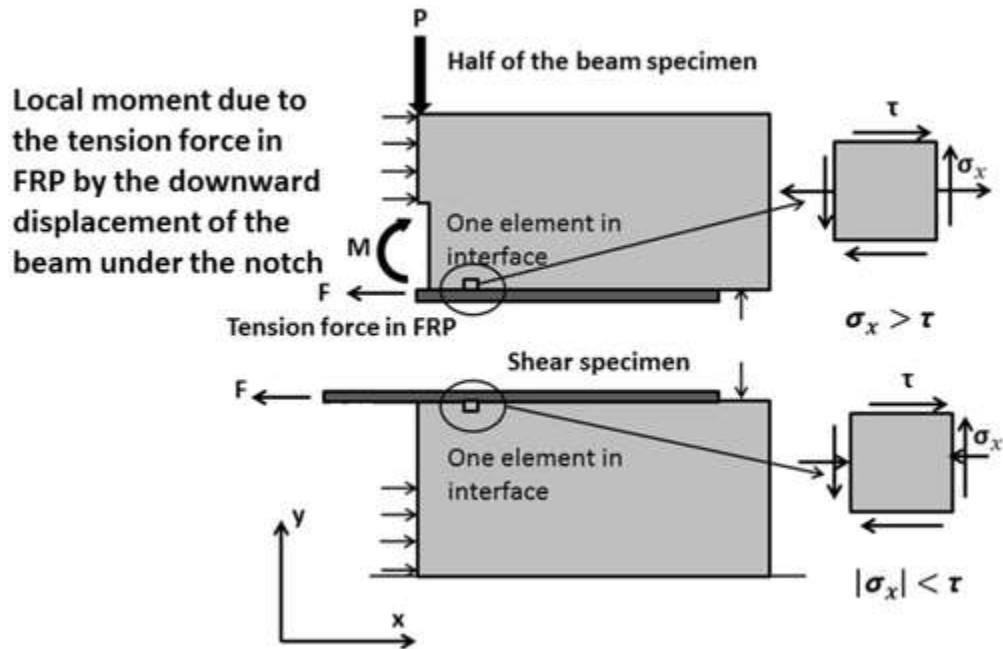
shows the numerically obtained stress state of an element at the FRP/concrete interface in the beam and the single shear pull-out specimens. In the beam specimens, the concrete element attached to the FRP/concrete interface is under shear stress,  $\tau$ , and longitudinal tension stress,  $\sigma_x > 0$ . The magnitude of longitudinal tension stress is larger than shear stress,  $\sigma_x > \tau$ . In the single shear pull-out specimens, the concrete element at the tip of the precrack is under shear stress,  $\tau$ , and longitudinal compression stress,  $\sigma_x < 0$ , while the absolute value of  $\sigma_x$  is smaller than shear stress,  $|\sigma_x| < |\tau|$ .

**Figure 14.** Comparison of the stress states at the FRP/concrete interface between beam and single shear pull-out beam specimens.
