Accepted version. 2011 *International Reliability Physics Symposium* (April 10-14, 2011). DOI. © 2011 Institute of Electrical and Electronic Engineers (IEEE). Used with permission.

Reliability Testing of AlGa_N/Ga_N HEMTs Under Multiple Stressors

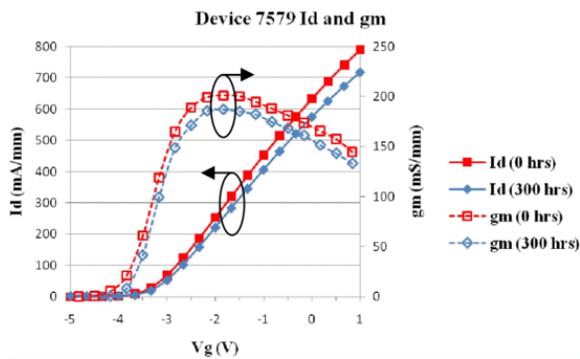
Figure 2. Transfer and transconductance curves at 0 and 300 hours of typical high-voltage-tested device. Device 7579 was tested at Condition 5.

Fig. 2 shows the transfer and transconductance curves of a typical (meaning, following the general trends in I_{Dmax} , I_{DSS} , and V_T) high-voltage-tested device. Fig. 3 shows the transfer and transconductance curves of one of the two exceptional high-voltage-tested devices. Figs. 2 and 3 illustrate the variability in the performance of the tested HEMTs. Although discovering the cause of the negative threshold voltage shift in Fig. 3 was not an objective of this study, a possible explanation is a trapping phenomenon near the gate [10], [11]. The transfer and transconductance curves of Fig. 4 are representative of the power-tested devices. Figs. 3 and 4 contain the transfer and transconductance curves from testing subsequent to the initial 300 hours; these curves show little change after 300 hours.

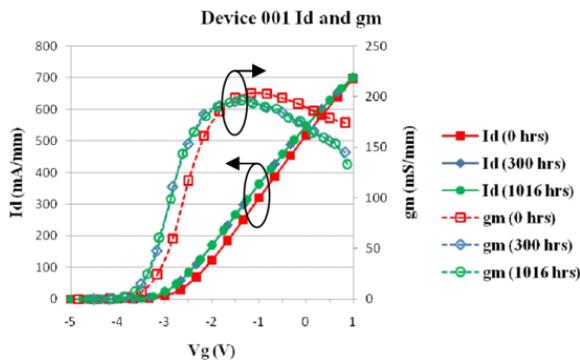
Figure 3. Transfer and transconductance curves at 0, 300, and 1016 hours of exceptional high-voltage-tested device. Device 001 was tested at Condition 5.

Condition 5 exhibited increases in I_{DSS} and negative threshold voltage V_T shifts. The same device at Condition 5 also exhibited an increase in I_{Dmax} (see Fig. 3). All devices experienced decreases in peak transconductance g_{mp} and increases in R_{on} . The other general trends were positive threshold voltage shifts and decreases in I_{Dmax} and I_{DSS} .

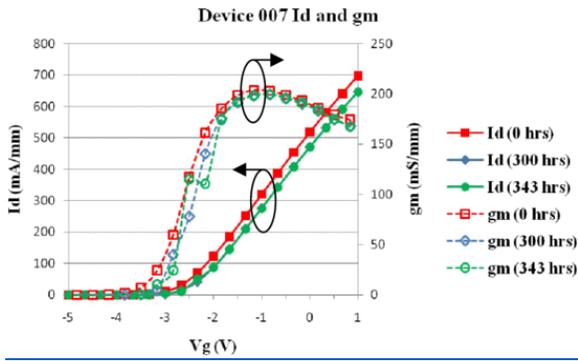
Figure 4. Representative transfer and transconductance curves at 0, 300, and 343 hours of high-power-tested device. Device 007 was tested at Condition 1.

After stress testing, we investigated the four select devices by thermal and photoemission imaging in a Quantum Focus Instruments InfraScope™. In three of the four devices, hot spots corresponded with bright spots. We delivered these four devices to NanoTEM for transmission electron microscope (TEM) imaging at the hot and bright spots. Although Device 001 is exceptional (with a negative V_T shift and increases in I_{Dmax} and I_{DSS}), its transfer and transconductance curves and its infrared (IR), photoemission (PE), and TEM images are shown since it had notable IR and PE images, whereas the other imaged high-voltage-tested device did not. Fig. 5 contains IR (radiance) and PE images for the high-voltage-tested Device 001 whose transfer and transconductance curves are in Fig. 3. (An insufficient number of samples were imaged by IR and PE to determine whether the features of Fig. 5 correlate to the negative threshold voltage shift of Fig. 3.) The IR (radiance) and PE images in Fig. 6 are those of the power-tested Device 007 whose transfer and transconductance curves are in Fig. 4.

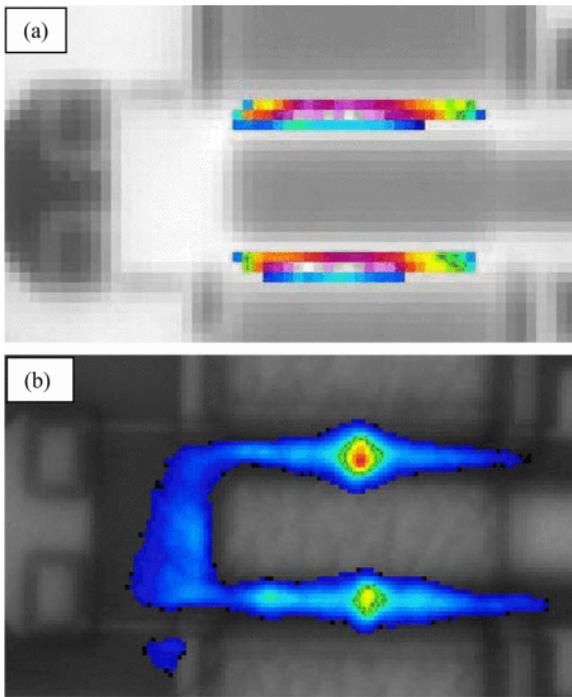
Figure 5. Device 001 (high-voltage-tested) at a baseplate of 85°C. The upper middle spot was targeted for TEM imaging. (a) IR (radiance) image at 15X magnification. $V_{DS} = 40V, I_D = 10mA, V_{GS} = -2.42V, I_G = -5\mu A$ (b) PE image at 20X magnification. $V_{DS} = 100V, I_D = 11\mu A, V_{GS} = -10$.

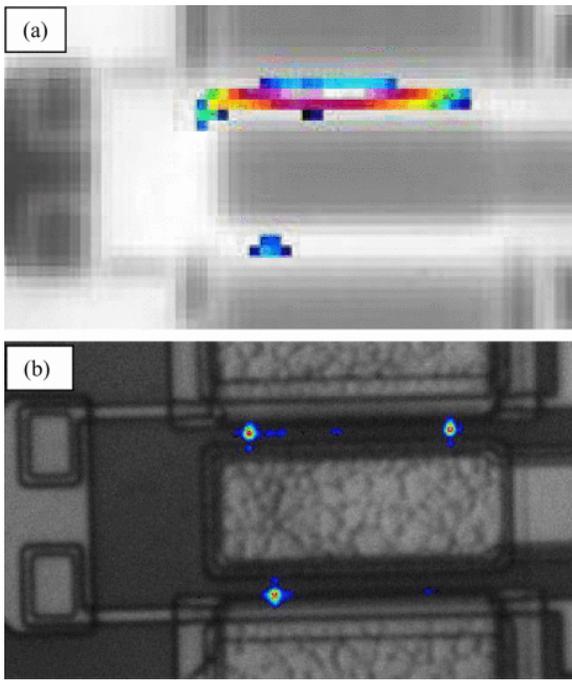
Figure 6. Device 007 (high-power-tested) at a baseplate of 85°C. The lower left spot was targeted for TEM imaging. (a) IR (radiance) image at 15X magnification. $V_{DS} = 28V, I_D = 10mA, V_{GS} = -1.69V, I_G = -3.3\mu A$, (b) PE image at 50X magnification. $V_{DS} = 10V, I_D = 3.2mA, V_{GS} = -1V, I_G$ in nA range.

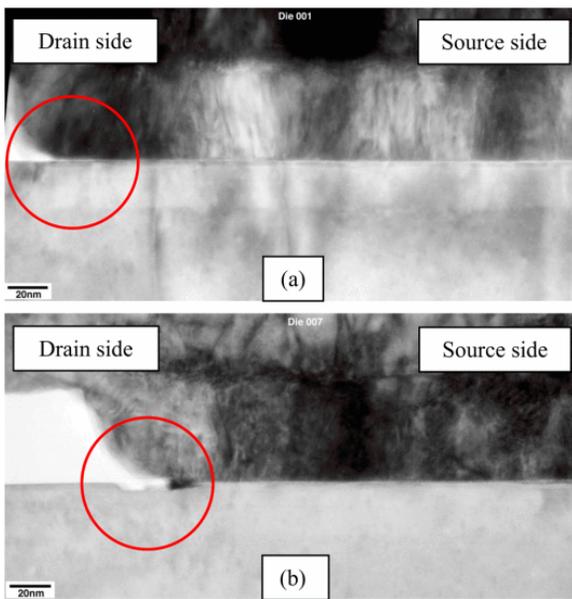
Figure 7. TEM images of (a) Device 001 (high-voltage-tested) and (b) Device 007 (high-power-tested). Notice absence of a pit or crack in Device 001 and the presence of a pit in Device 007.

The TEM images of Devices 001 and 007 are in Fig. 7. As in the TEM image of Device 001 (stressed at Condition 5), the other high-voltage-tested part that was imaged by TEM, Device 7632 (stressed at Condition 4), does not exhibit a crack or pit at the drain edge of the gate. This is contrary to the findings reported in [4]. However, in the TEM images of the two high-power-tested devices, Devices 007 and 008 (not shown), that were both stressed at Condition 1, small pits have formed at the drain edge of the gate. Thus, current appears necessary to create the pits in the AlGaIn layer.
