# RAPID MACROCELL TESTS OF ASTM A775, A615, and A1035 REINFORCING BARS

A Report on Research Sponsored by the  
EPOXY INTEREST GROUP  
OF THE CONCRETE REINFORCING STEEL INSTITUTE

Structural Engineering and Engineering Materials  
SL Report 10-4  
November 2010

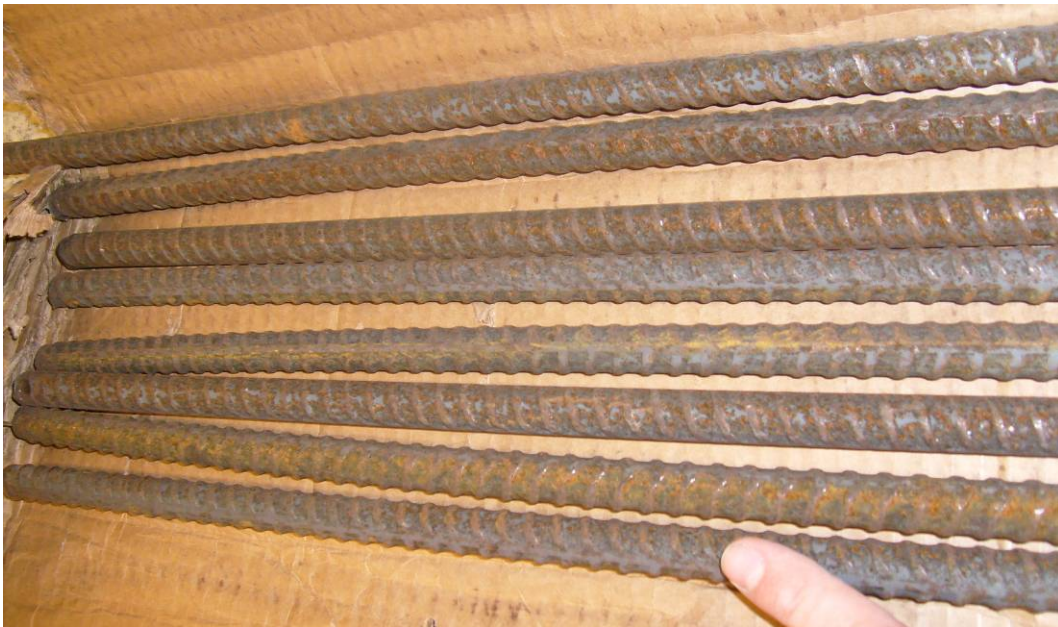
**Figure 1:** A1035 steel in the as-received condition exhibit corrosion on the surface of the bars.

The bars were inspected upon receipt, and the conventional steel and ECR were found to be in good condition. The A1035 exhibited significant corrosion, as shown in Figure 1. As a result, macrocell tests were performed on the A1035 bars after pickling, as well as in the as-received condition.

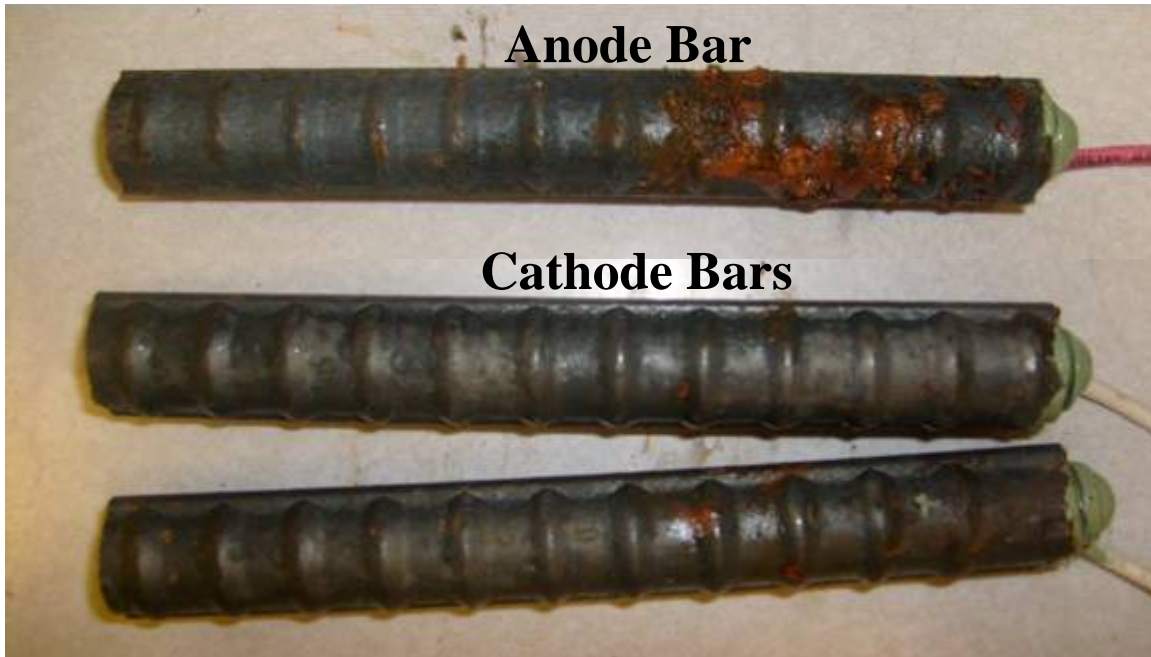
**Figure 20:** Conventional steel. Specimen 3, side A one week after removal from solution, after rinsing. Specimen exhibits significant corrosion above the liquid level.

All conventional, as-received A1035, and pickled A1035 steel specimens exhibit corrosion during the test, with the corrosion products forming at or above the liquid level. The conventional and as-received A1035 specimens exhibit significant corrosion products, such as shown for conventional steel in Figures 20 and 21, respectively. The pickled A1035 bars exhibited somewhat more limited corrosion products, as shown in Figures 22 and 23. The “grooves” along the length of the pickled specimens seem to provide a crevice at which corrosion initiates, with the corrosion products distributed along the length of the bar above the liquid level (Figures 22 and 23). This was not observed with the as-received bars, most likely due to the initial, corroded state of those specimens.

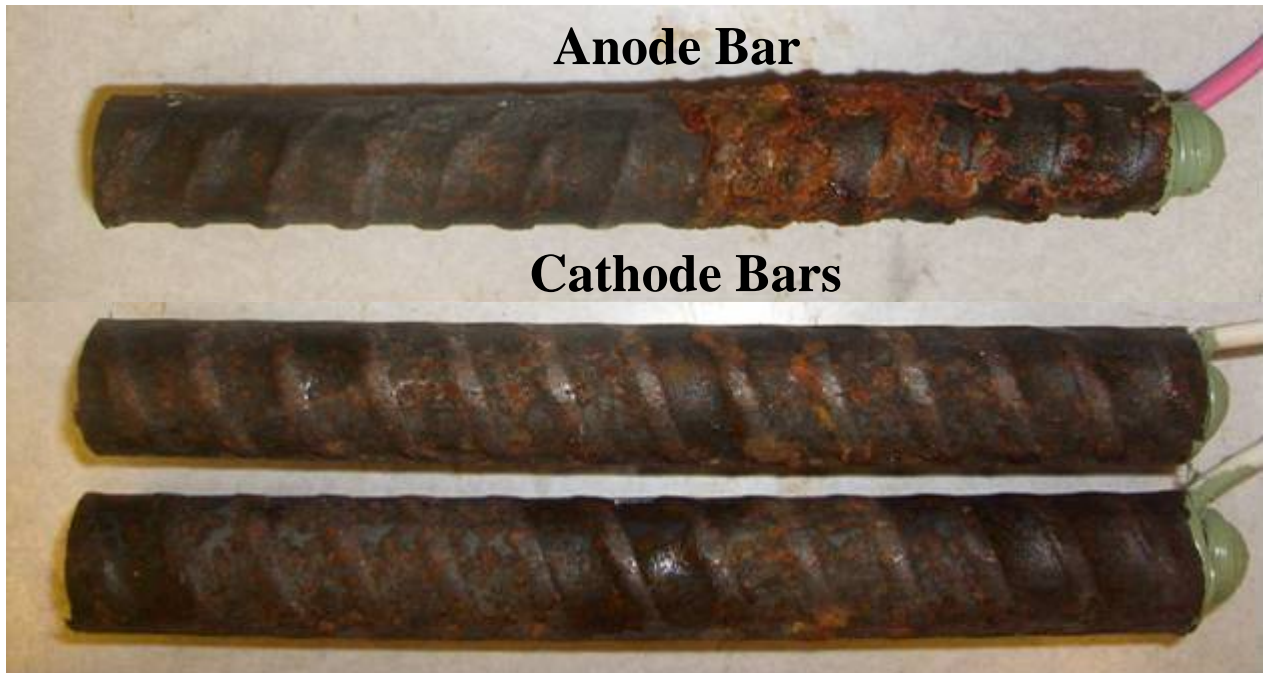
**Figure 21:** A1035 steel. Specimen 3, side B one week after removal from solution, after rinsing. Specimen exhibits significant corrosion above the liquid level.

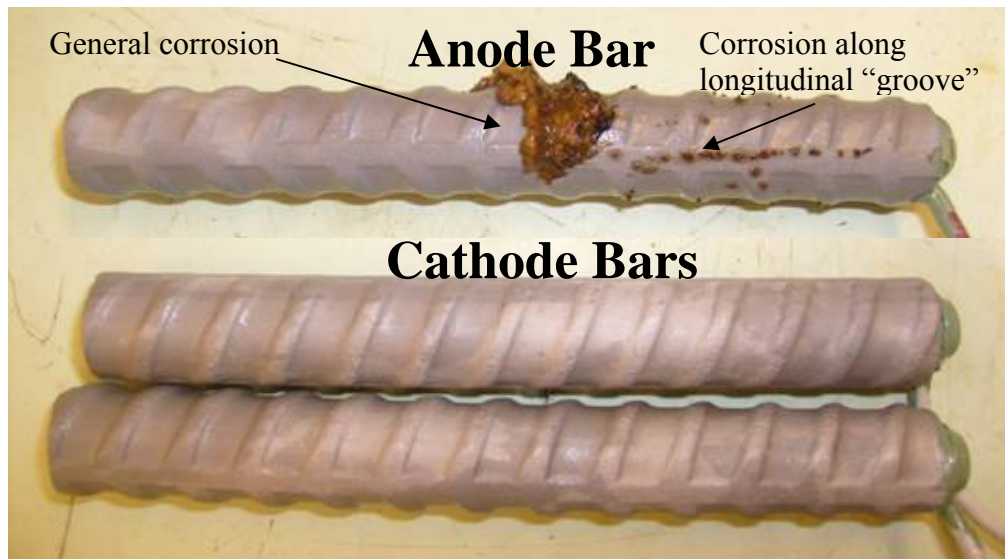
**Figure 23:** Pickled A1035 steel. Specimen 3, side A after removal from solution and rinsing.

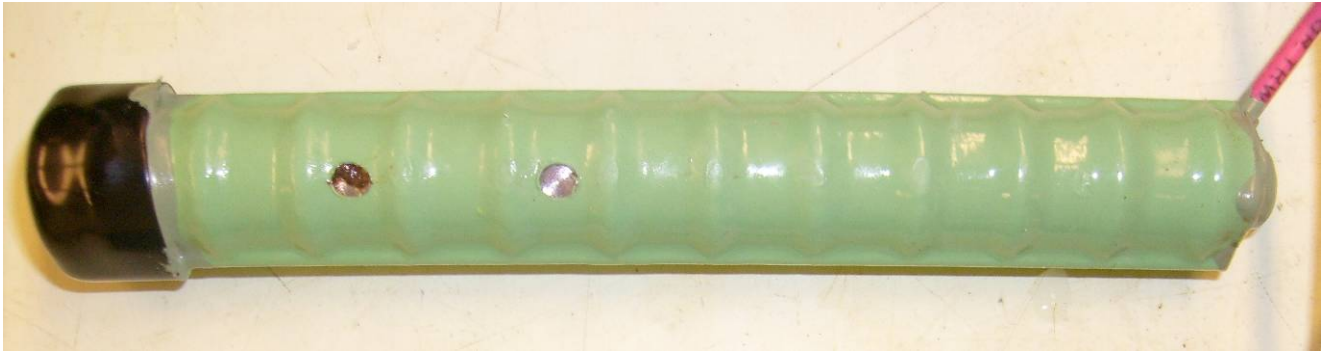
**Figure 38:** Corrosion typical of that seen on 0.83% damaged area ECR at conclusion of the test. Specimen 5, side A.

At the end of the test, the ECR specimens are inspected for corrosion and a disbondment test is performed on the anode bars. The results of the disbondment tests are covered in Appendix A. Figure 38 shows the deposition of corrosion products that is typical of that observed on the 0.83% damaged area ECR specimens at the conclusion of the test. Some damaged areas exhibited corrosion and some did not. In all cases, the epoxy remained intact. Corrosion was observed on some bars at the electrical connection with the copper wire, where the bar is coated with the two-part epoxy patch material. Examples are shown in Appendix A.

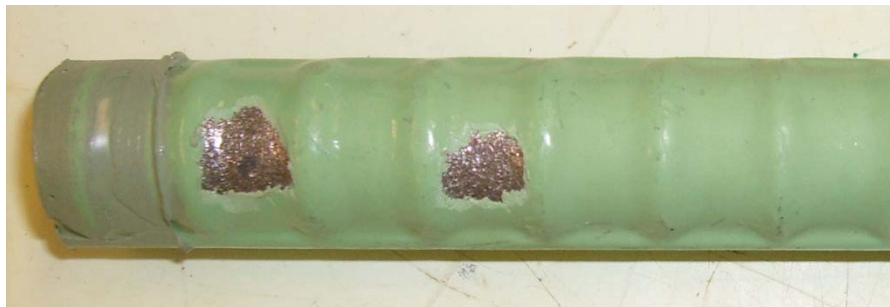
**Figure A3:** 0.04% ECR, specimen 2, side B. After disbondment. Disbonded areas close to the average ( $42 \text{ mm}^2$ ) for 0.04% ECR specimens (see Table A1a).

As shown in the Table A1a, the undamaged ECR specimens exhibit disbondment at only one site (site 2 on specimen 6). The disbondment occurred at a previously undetected holiday in the specimen. This also accounts for the negative anode corrosion potential ( $\sim -0.600$  V) for that specimen. As mentioned in the report, this specimen is not included in the average corrosion rate and corrosion potential plots, but indicates that the presence of holidays can reduce corrosion performance. As shown in Tables A1b and c, the 0.04% damaged area ECR exhibits more limited disbondment than the 0.83% damaged area ECR, with respective average disbonded areas of 42 mm<sup>2</sup> and 155 mm<sup>2</sup>. On both the 0.04% and 0.83% damaged area specimens, unintentional damage to the coating from the drilling process plays a role in the disbondment results. On occasion, the coating that was compressed by the grips during drilling of the anode bars provided additional sites for possible corrosion initiation. In particular, 0.04% damaged ECR specimen 1 (site 3), specimen 2 (site 2), and specimen 5 (site 5) exhibit increased disbondment due to this type of damage. Side 1 of specimen 1 is shown below in Figures A1 and A2. The relatively high disbondment shown in Figure A2 is in contrast to that which is more typical of 0.04% damaged ECR specimens, such as shown in Figure A3 for side 2 of specimen 2.

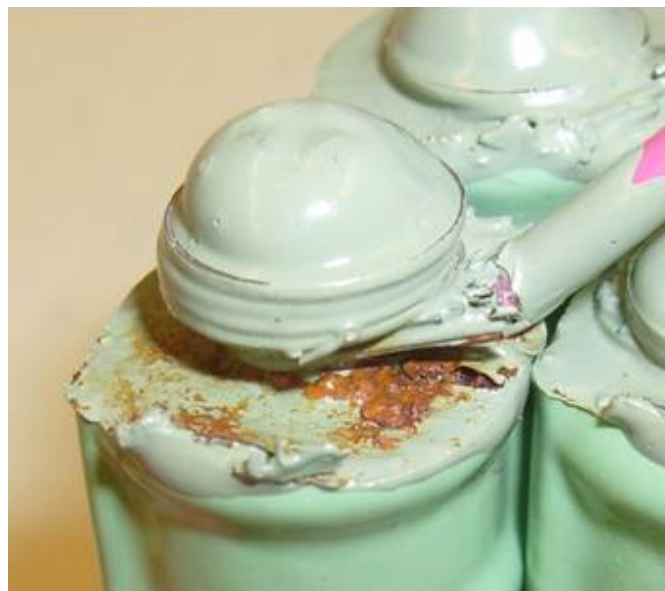
**Figure A7:** Undamaged ECR, specimen 4 anode exhibits significant steel corrosion at the electrical connection.

A6. Despite this local corrosion at the connection, the undamaged ECR performed very well. For example, undamaged ECR specimen 4 exhibits significant corrosion of the steel at the connection due to inadequate epoxy cover (Figure A7), but this corrosion has no appreciable effect on corrosion rate or potential, as shown in Figures 23 and 29.
