RAPID MACROCELL TESTS OF ENDURAMET[®] 2304 STAINLESS STEEL BARS

A Report on Research Sponsored by
TALLEY METALS

Structural Engineering and Engineering Materials
SL Report 10-3
September 2010

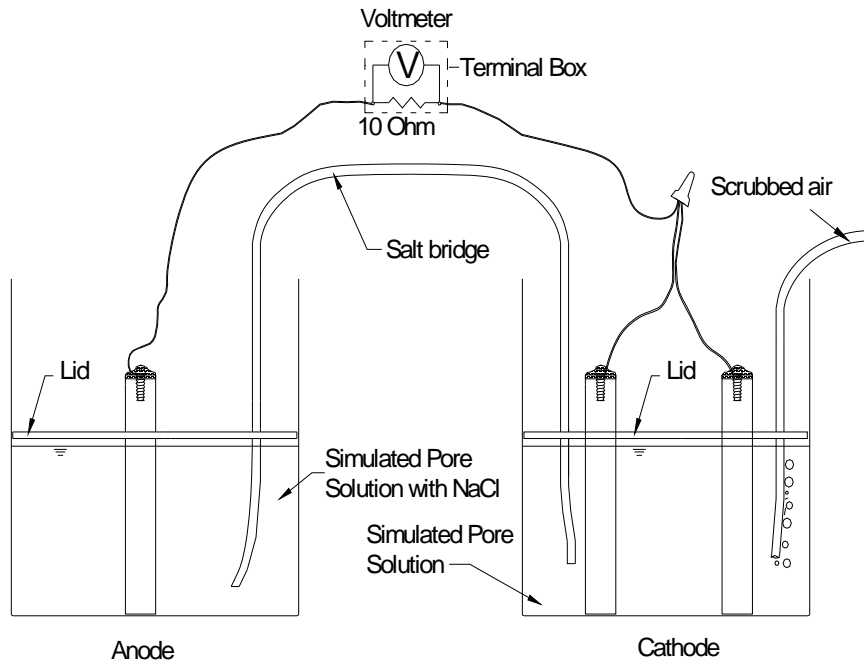
Figure 1: Rapid Macrocell Test Setup

Six specimens were tested in accordance with the rapid macrocell test outlined in Annexes A1 and A2 of ASTM A955/A955M-10 and detailed in Figure 1. Each bar used

in the rapid macrocell is 5 in. long and is drilled and tapped at one end to accept a 0.5-in., 10-24, stainless steel machine screw. Bars are cleaned prior to testing with acetone to remove oil and surface contaminants introduced by machining. A length of 16-gauge insulated copper wire is attached to each bar via the machine screw. The electrical connection is coated with an epoxy to protect the wire from corrosion.

A single rapid macrocell specimen consists of an anode and a cathode. The cathode consists of two bars submerged in simulated pore solution in a plastic container, as shown in Figure 1. One liter of pore solution consists of 974.8 g of distilled water, 18.81 g of potassium hydroxide (KOH), and 17.87 g of sodium hydroxide (NaOH). The solution has a pH of about 13.4. Air, scrubbed to remove carbon dioxide, is bubbled into the cathode solution. The anode consists of a single bar submerged in a solution consisting of simulated pore solution and 15 percent sodium chloride (NaCl). The “salt” solution is prepared by adding 176.5 g of NaCl to one liter of pore solution. The

solutions are changed every five weeks to limit the effects of carbonation. The anode and cathode are connected electrically across a 10-ohm resistor. A potassium chloride (KCl) salt bridge provides an ionic connection between the anode and the cathode (Figure 1).

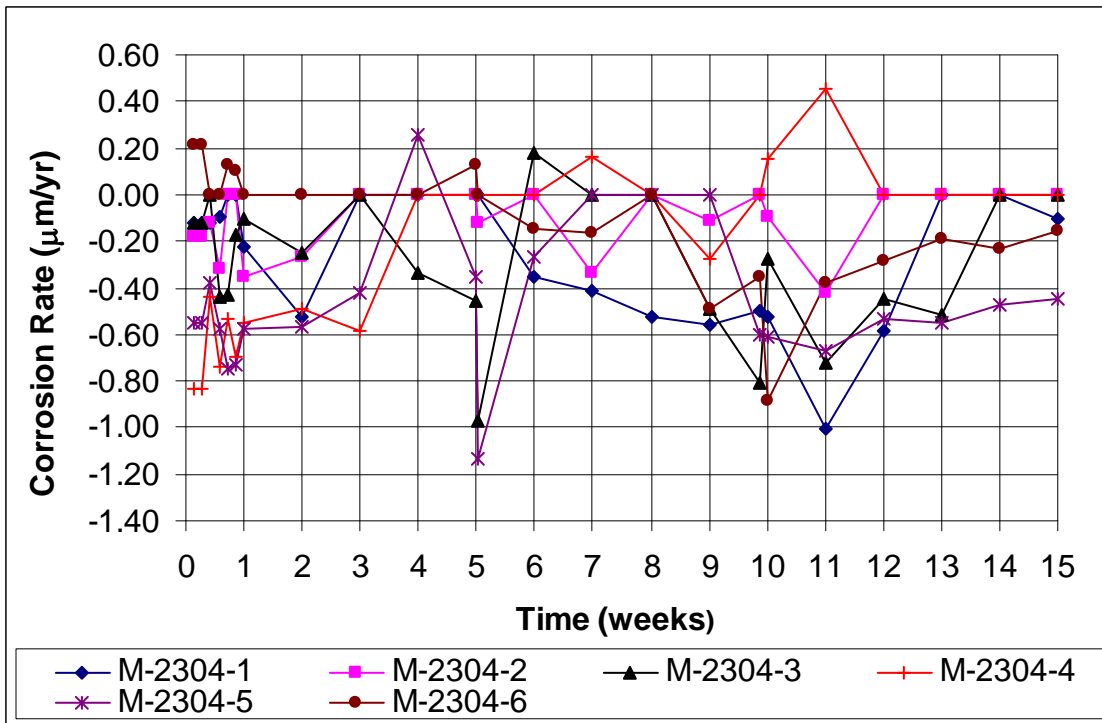
Figure 2: Individual Corrosion Rate of 2304 Stainless Steel, Specimens 1-6.

The individual corrosion rates of the six specimens tested are shown in Figure 2, and the overall average corrosion rate for all six specimens is shown in Figure 3. As shown in Figure 2, specimen 4 exhibited the highest corrosion rate by an individual specimen, $0.445 \mu\text{m}/\text{yr}$ at week 11. As shown in Figure 3, the maximum average corrosion rate was, in fact, negative, $-0.014 \mu\text{m}/\text{yr}$ at week 4. “Negative” corrosion is caused by minor differences in oxidation rate between the single anode bar and the two cathode bars. Thus, no individual specimen exhibited a corrosion rate above the allowable maximum of $0.50 \mu\text{m}/\text{yr}$, and the average corrosion rate was well below the allowable maximum of $0.25 \mu\text{m}/\text{yr}$.

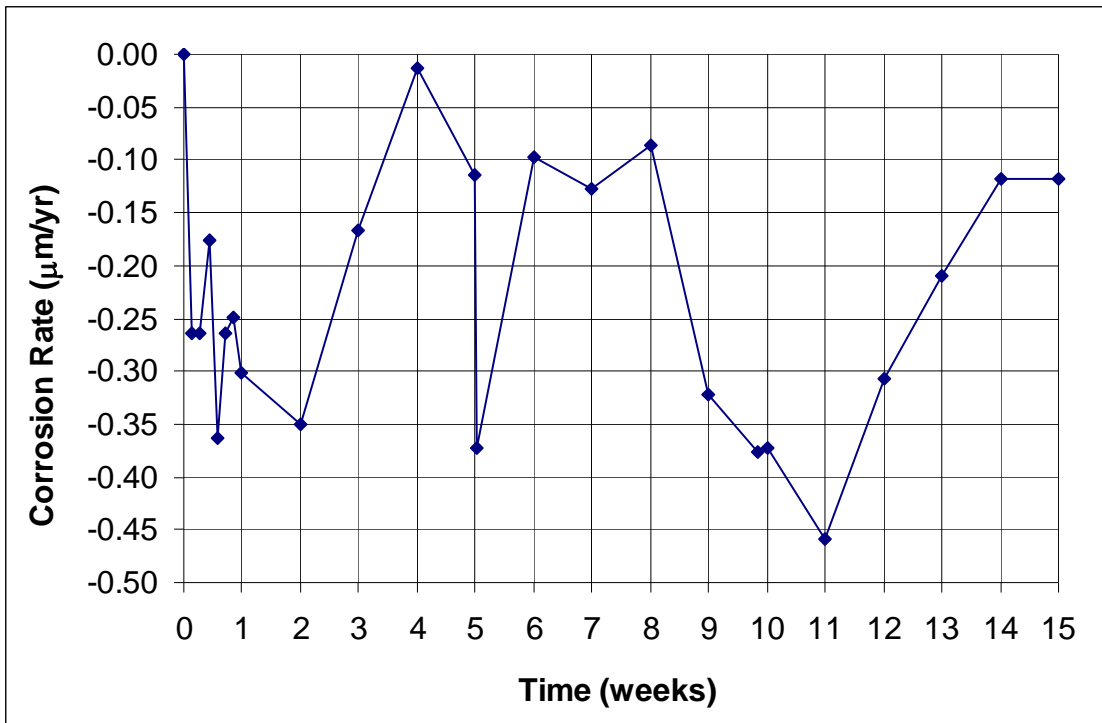
Figure 3: Average Corrosion Rate of 2304 Stainless Steel, Specimens 1-6.

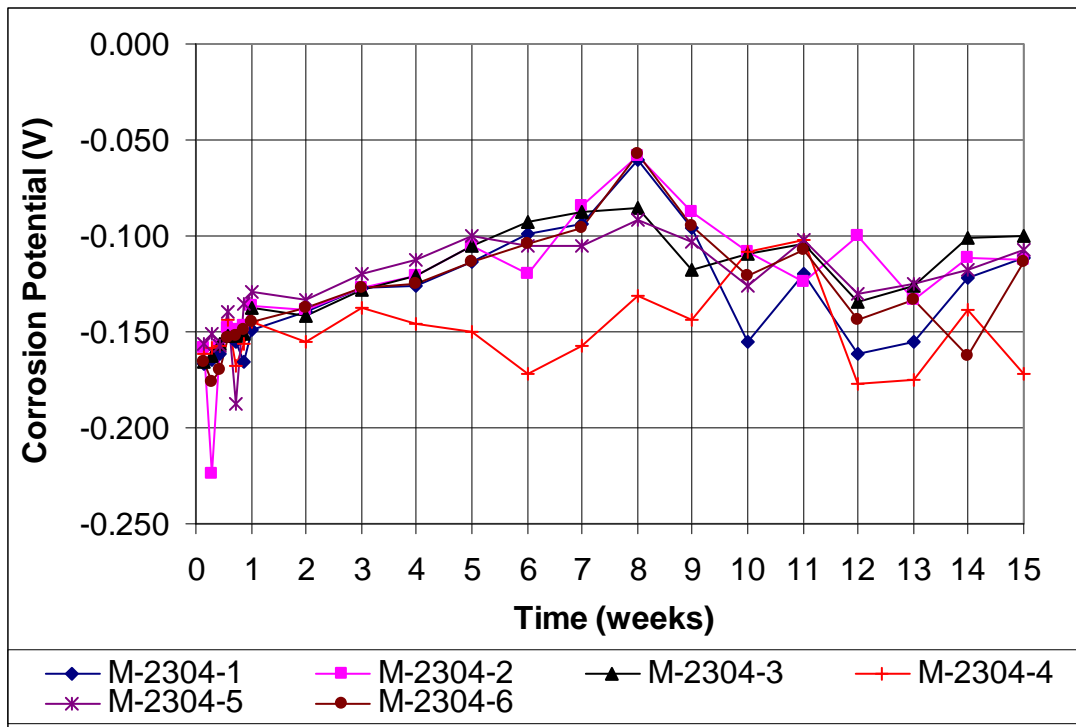
Figure 4: Individual corrosion potential with respect to SCE. 2304 stainless steel bars in salt solution (anode), specimens 1-6.

Individual corrosion potential data taken with respect to a saturated calomel electrode (SCE) for the bars in pore solution with salt (anode) and bars in pore solution (cathode) are shown in Figures 4 and 5, respectively. As shown in Figure 4, the bars in pore solution plus salt show potentials ranging from -0.050 to -0.225 V versus the SCE. The bars in pore solution have potentials, shown in Figure 5, within the range of -0.100 to -0.200 V. ASTM C876 states that a potential more negative than -0.275 V with respect to an SCE (-0.350 with respect to a copper/copper sulfate electrode) indicates a 90% probability that corrosion is occurring. Two important differences between this macrocell test and ASTM C876 prevent a direct comparison of this test to ASTM C876:

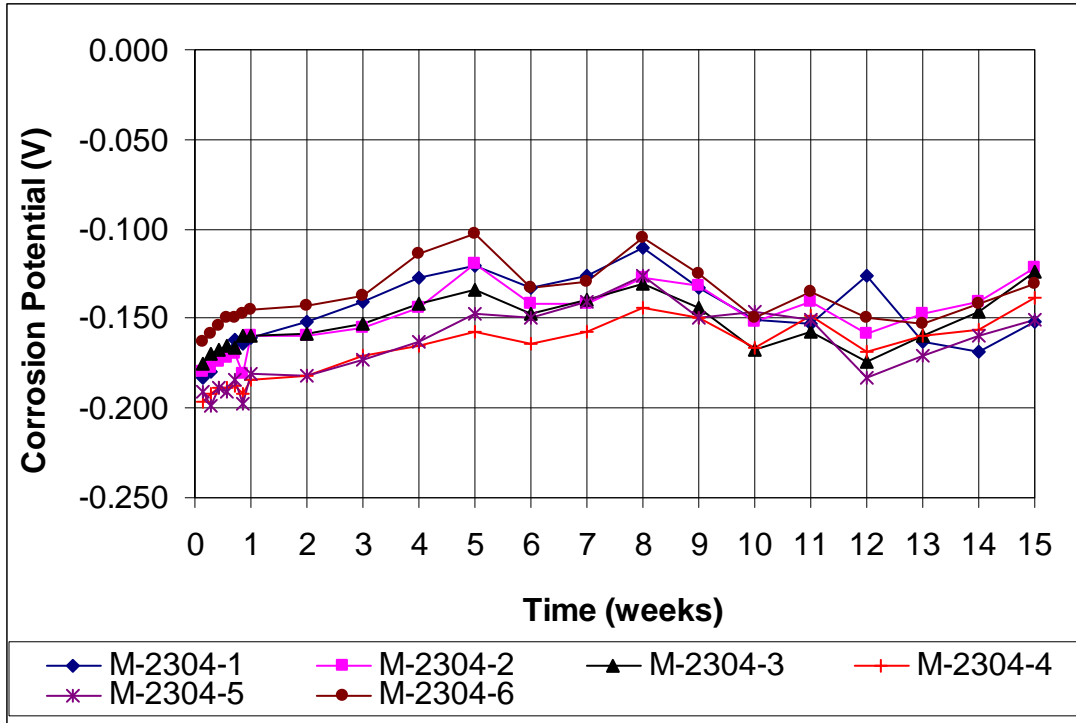
Figure 5: Individual corrosion potential with respect to SCE. 2304 stainless steel bars in pore solution (cathode), specimens 1-6.

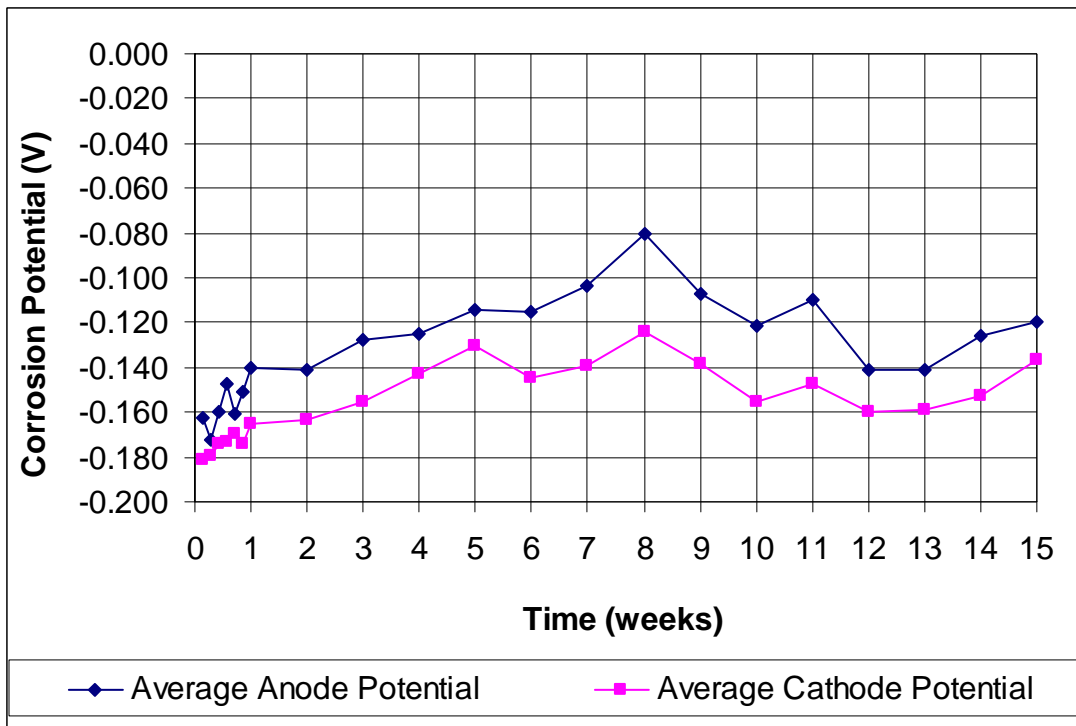
Figure 6: Average corrosion potential with respect to SCE. 2304 stainless steel bars, specimens 1-6.

the steel used is a stainless steel alloy instead of conventional steel, and the bars were placed in a pore solution, not concrete. Overall, the average potential, shown in Figure 6, was more negative for bars in pore solution than for bars in pore solution plus salt by 0.020 to 0.040 V throughout the test. This would further explain the apparent negative corrosion values.

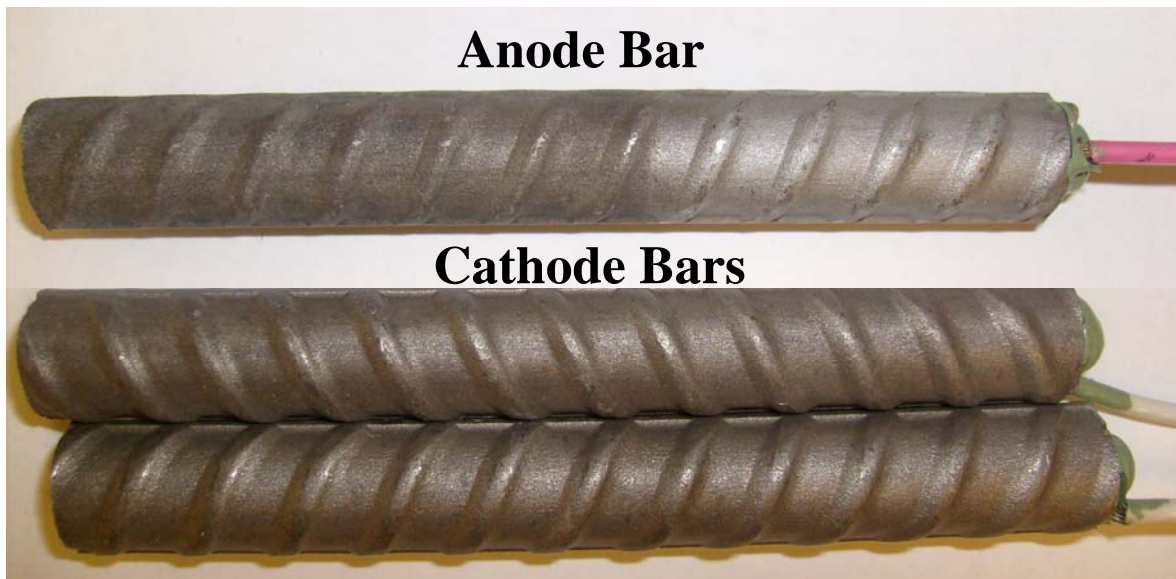
Figure 7: Specimen 3 one week after removal from solution, after brushing. Anode bar exhibits discoloration below the liquid level

Once the specimens reached week 15, the test was terminated, and the specimens were removed from solution, lightly scrubbed with a soft brush for removal of residual salt, and examined for corrosion. Photographs were taken at each stage. All six specimens showed a discoloration on the anode bars below the liquid level. An example of the discoloration is shown in Figure 7.

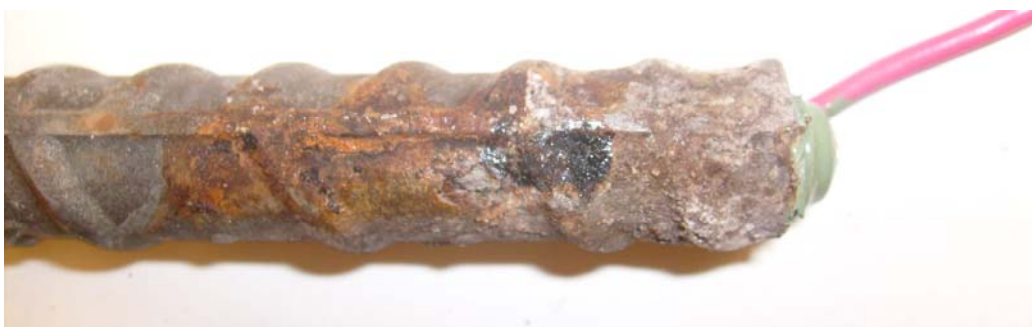
Figure 8: Specimen 4 (opposite site from that shown in Figure 7) one week after removal from solution. Significant corrosion appears on the top third of the anode bar.

Of the six 2304 specimens tested, corrosion products were observed on specimens 3, 4, 5, and 6 before brushing. The most severe corrosion was observed on the top third of the specimen 4 anode bar (Figure 8). Much of the corrosion product and staining on this bar was removed during brushing, providing a clearer picture of the corrosion initiation site, which was located about one inch from the top of the bar (Figure 9). The corrosion products are most likely caused by crevice corrosion at the point where the bar was occasionally in contact with the supporting lid. Crevice corrosion is a function of the test configuration, not macrocell corrosion.

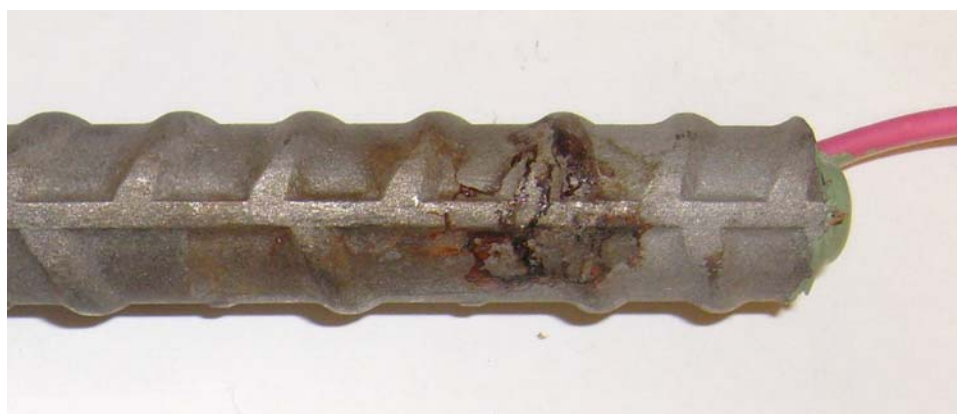
Figure 9: Specimen 4 one week after removal from solution, after brushing. A clear corrosion initiation site is evident, caused by crevice corrosion.

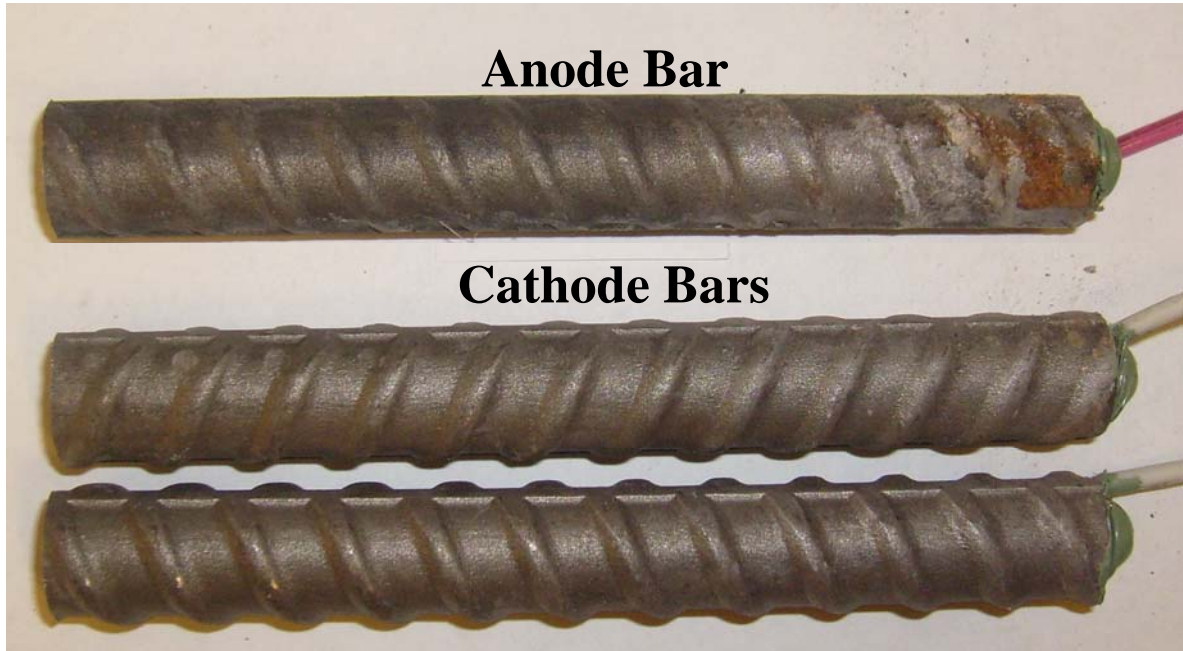
Figure 10: Specimen 3 one week after removal from solution, prior to brushing.

Specimens 3 and 5 exhibited moderate and slight corrosion, respectively, at the top of the bar near the epoxy-coated connection (Figures 10 and 11). Brushing removed much of the corrosion product from the bars, which proved to be staining, deposited from corrosion under the epoxy (Figures 12 and 13). In all likelihood, a galvanic couple formed between the bar and the copper wires under the epoxy. Specimen 6 showed slight staining of the anode along the longitudinal rib 1.5 to 2 in. from the top of the bar (Figure 14) – this was removed with brushing and was possibly caused by staining at a crevice

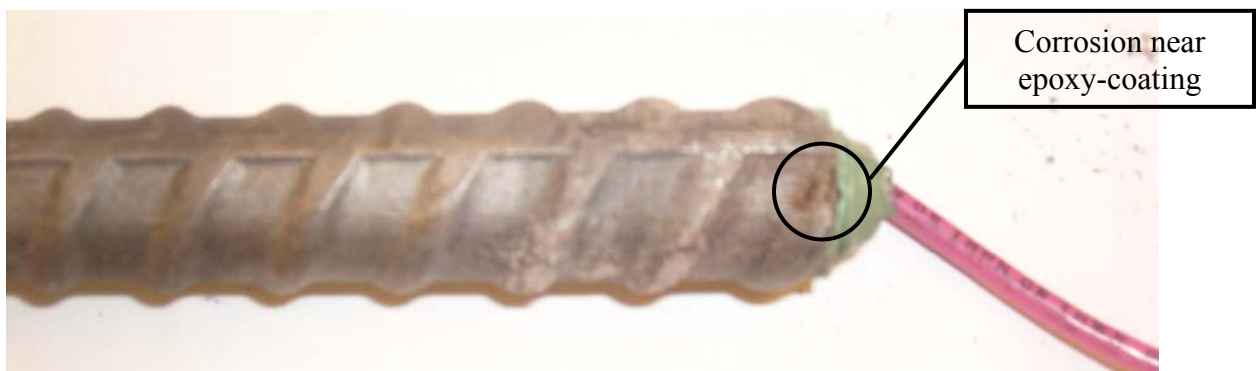
Figure 11: Specimen 5 anode one week after removal from solution, prior to brushing.

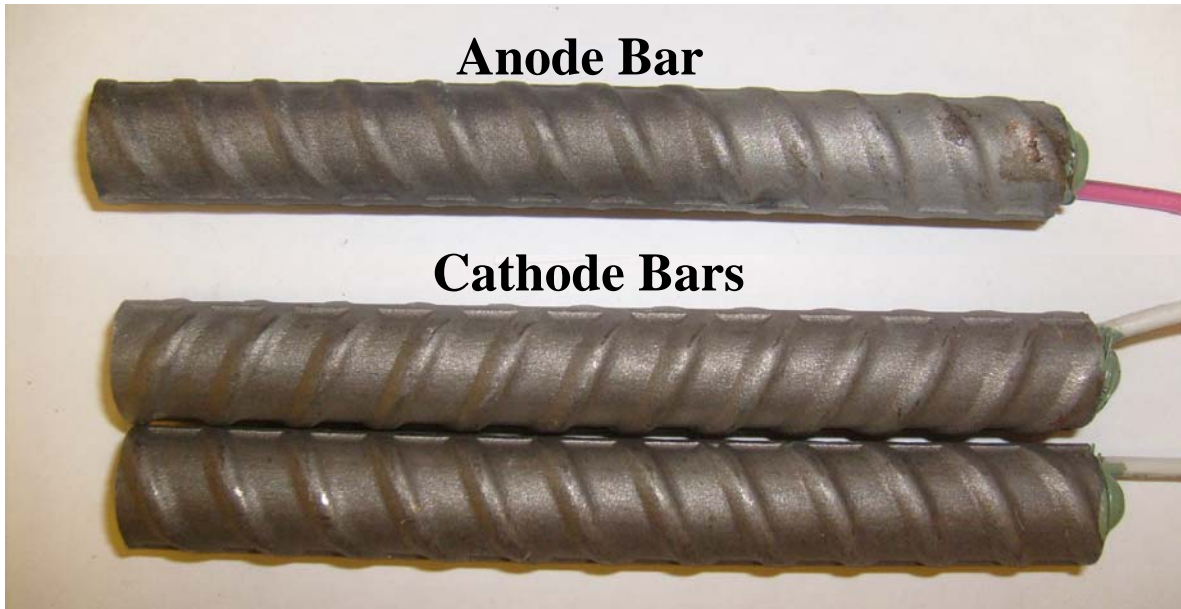
Figure 12: Specimen 3 one week after removal from solution, after brushing. Moderate corrosion occurred at the top of the bar.

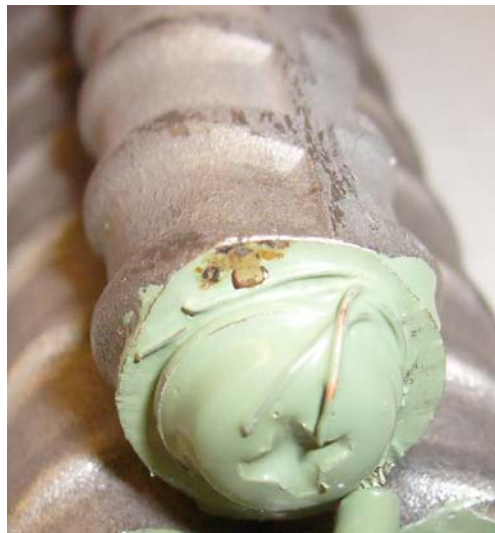
Figure 13: Specimen 5 anode one week after removal from solution, after brushing.

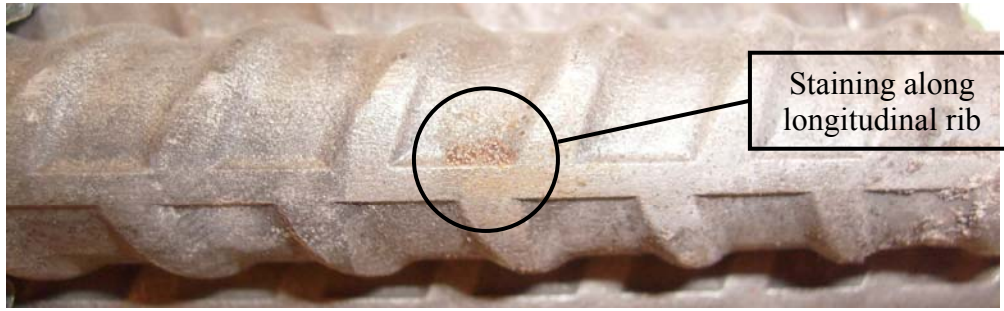
Figure 14: Specimen 6 anode one week after removal from solution, prior to brushing. The stain was removed by brushing.

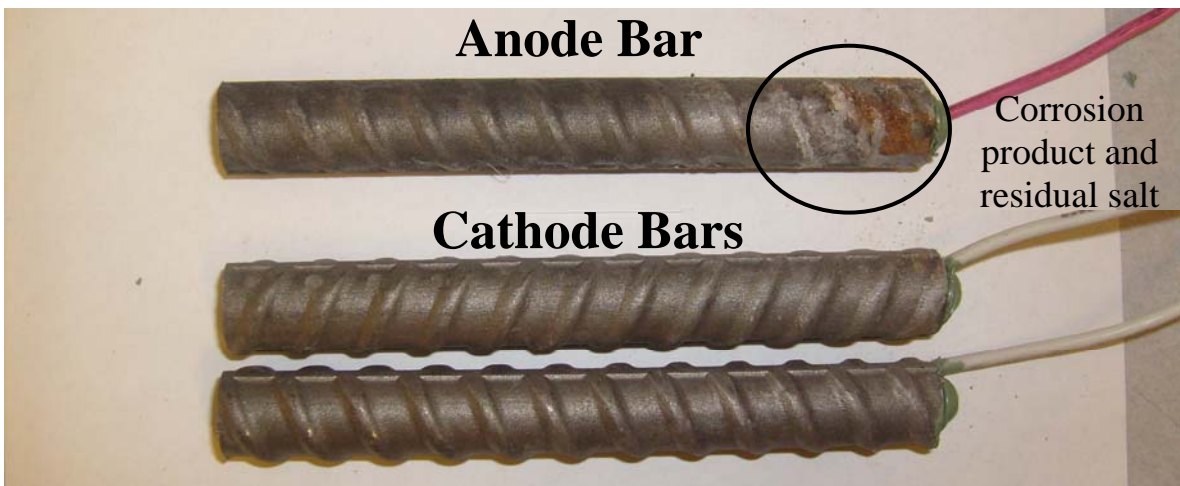
Figure A.5b: Specimen 3, Side A, eight days after removal from solution. Corrosion product from under epoxy collects at the top of the bar is exhibited as well as residual salt.

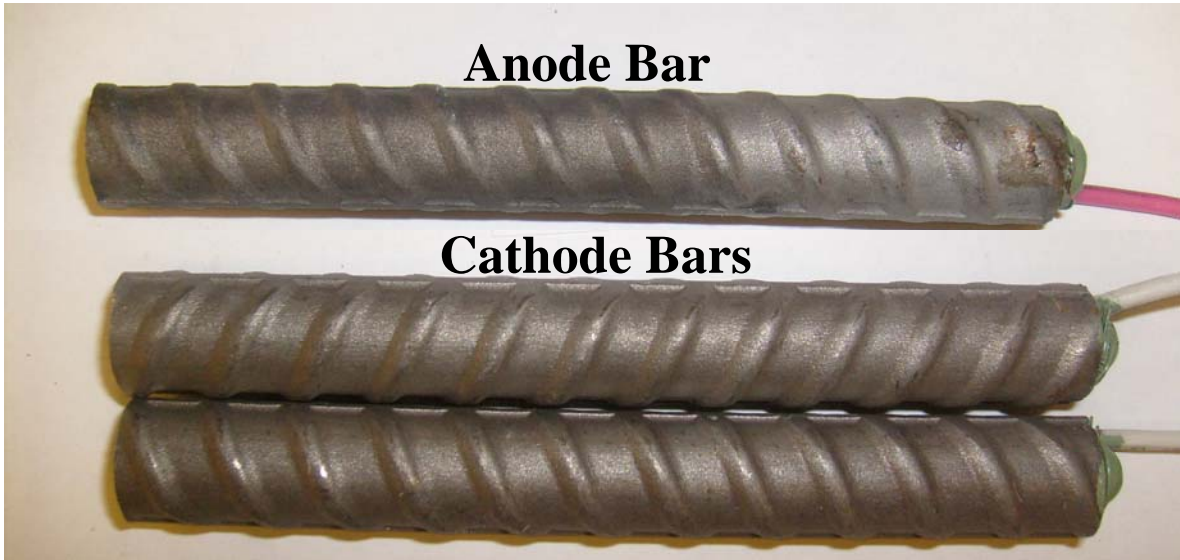
Figure A.5c: Specimen 3, Side A, eight days after removal from solution, after brushing. Much of the corrosion residue is removed with brushing.

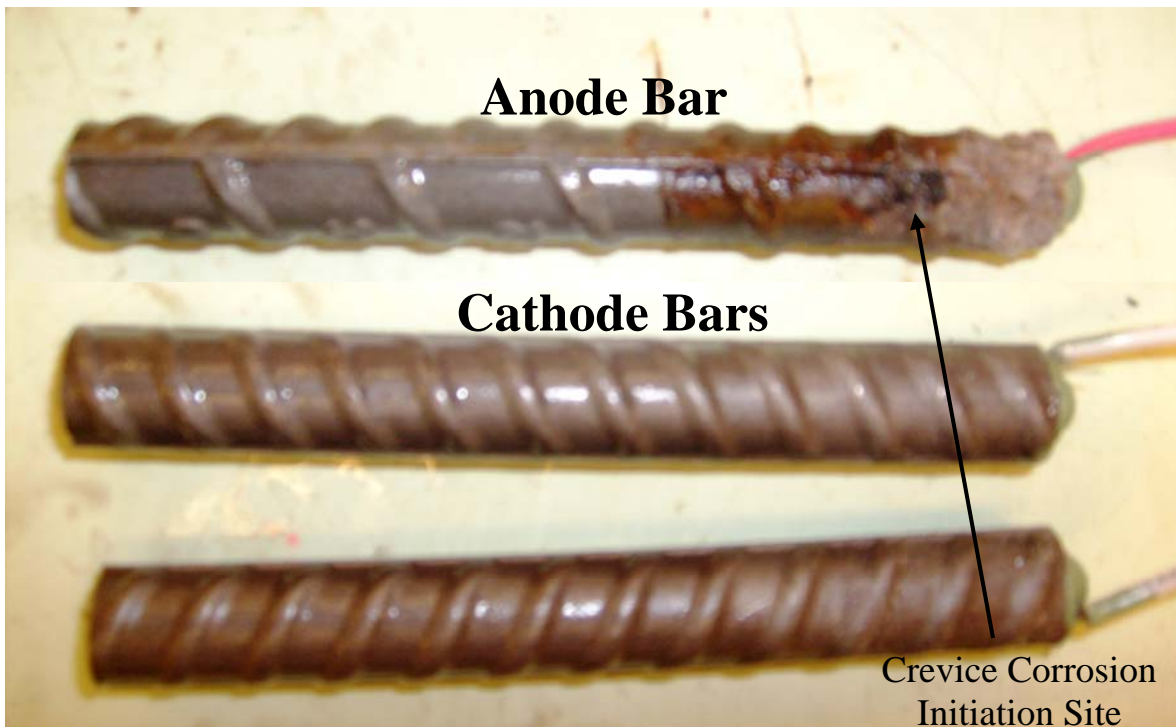
Figure A.8a: Specimen 4, Side B, immediately after removal from solution. Crevice corrosion caused by test configuration; it does not reflect on the corrosion resistance of the steel

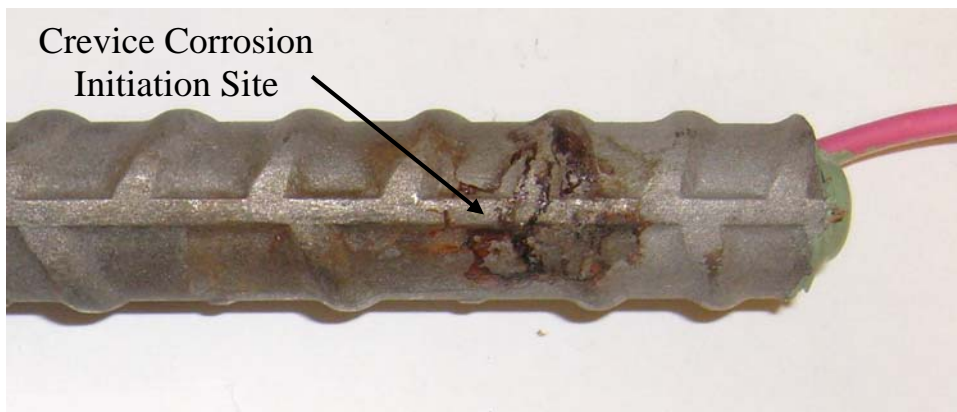
Figure A.8d: Specimen 4 anode bar, eight days after removal from solution, after brushing. Crevice corrosion caused by test configuration; it does not reflect on the corrosion resistance of the steel.
