# **Local Applications of Fluvial Geomorphology**

**CE 890 / Special Problem / Dr. Alfred David Parr  
Fall 2009**

This study proposed a method for developing regional curves based solely on hydraulic modeling. Regional curves relate bankfull channel geometry and discharge to drainage area and are typically used to design channel reaches in natural stream systems at locations where stream modifications are required. Such modifications may result from the following projects - highway improvement, bank stabilization, flood control, etc. There are simply situations where modifications must be made to reaches of natural streams in order to accommodate improved drainage structures or to address flooding, scour or erosion problems.

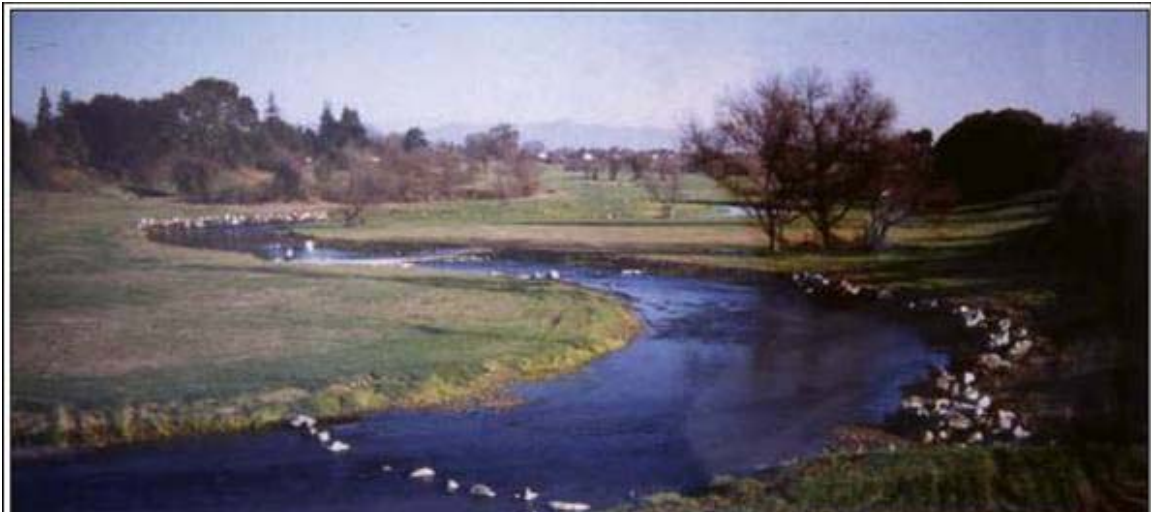
**Figure 1: Rock Weirs Placed during the Restoration of Uvas Creek  
(Photo credit, Kondolf, et. al, 2001)**

The failure of the Uvas Creek restoration project is thought to be due to a misapplication or oversimplification of Rosgen's methods. All of the rock weirs placed in Uvas Creek were washed out after about three months (Kondolf, Smeltzer, Railsback, 2001).

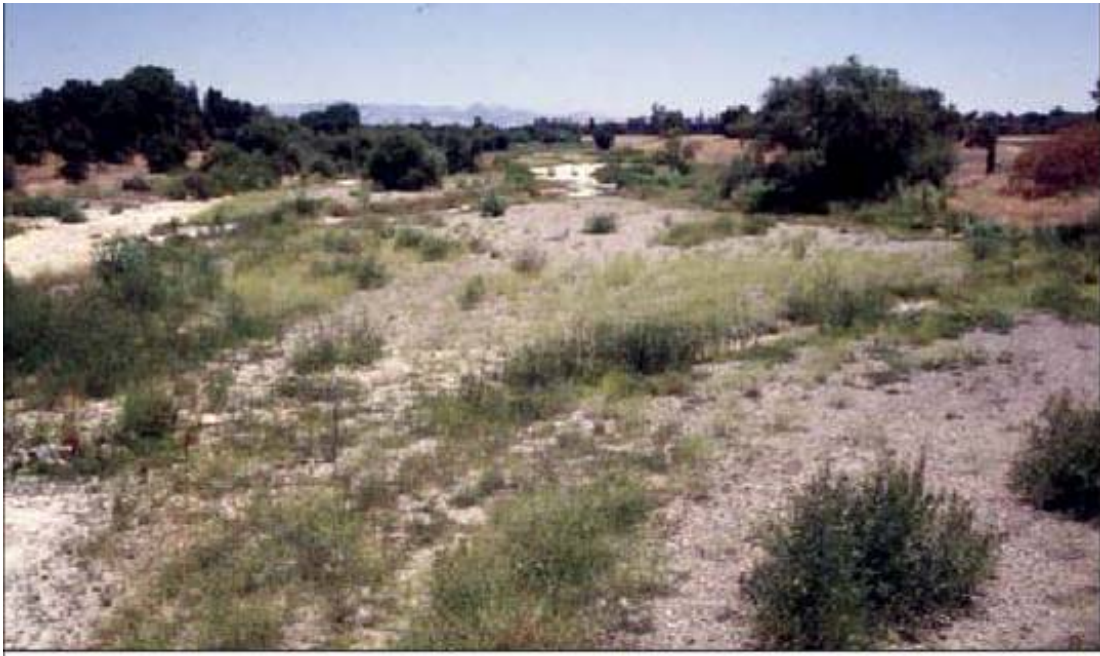
**Figure 2: Restoration Efforts Washed Out of Uvas Creek  
(Photo credit, Kondolf, et. al, 2001).**

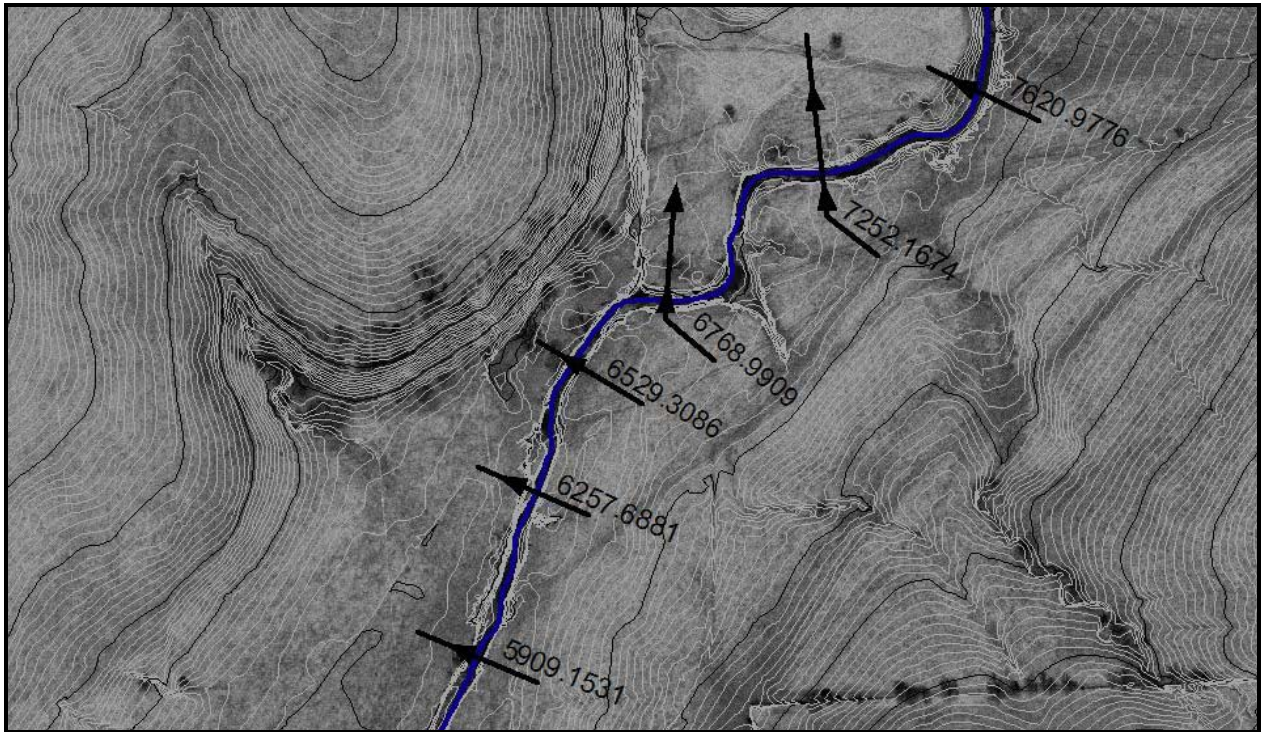
**Figure 4: Cross Section Locations for Bankfull Discharge on Lower Bain Creek**

representative stretches of each reach. Guidance on selecting cross-sections was taken from the USDA's Stream Channel Reference Sites: an Illustrated Guide to Field Technique, 1994. An aerial view of cross-sections taken for Lower Bain Creek appears in the figure below.

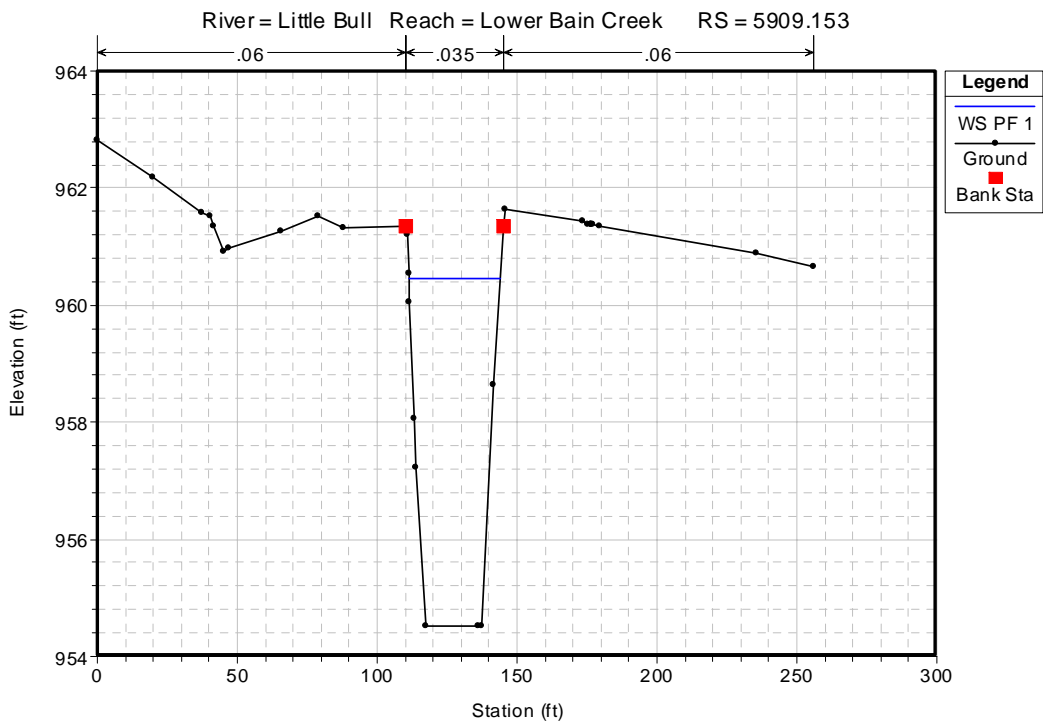
**Figure 10: Determination of Bankfull Elevation at River Station 5909.153 on Lower Bain Creek.**

The Manning's 'n' values that appear in Figures 6-10 were based on values used in a recent flood study conducted by Johnson County and verified using aerial photography.

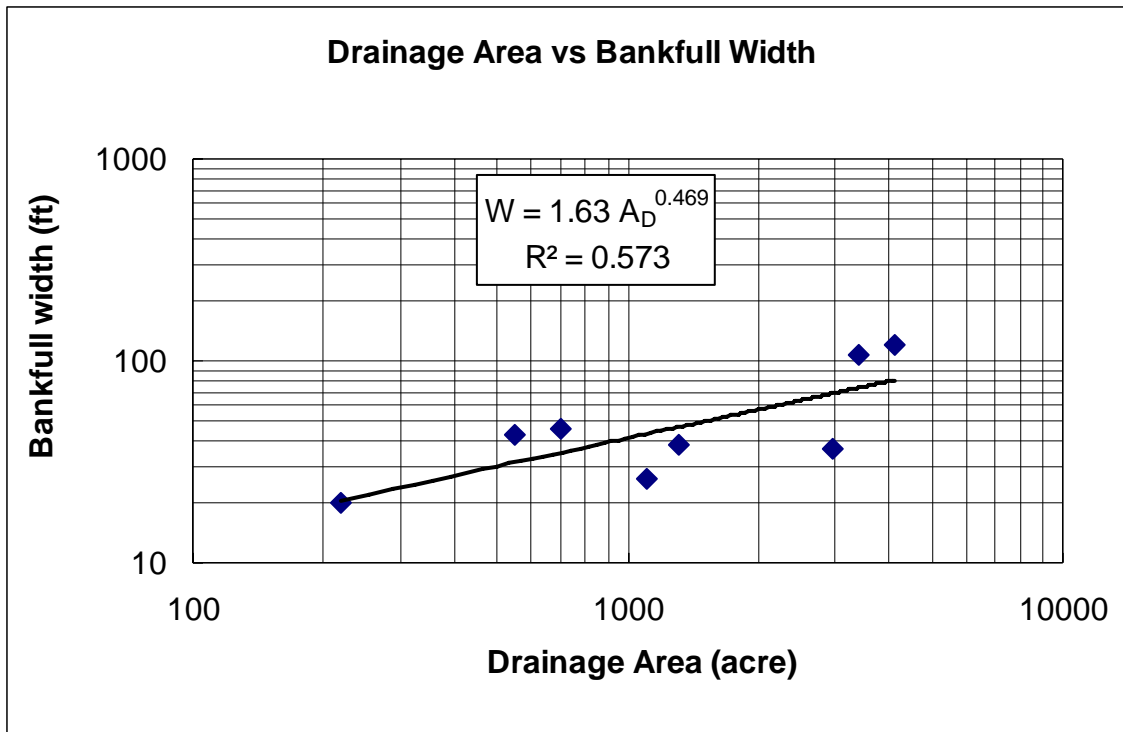
**Figure 13: Drainage Area vs. Bankfull Width**

As indicated in Figure 13, the bankfull width varies considerably as the stream gets larger. This brings into question the utility of plan form ratios as required for stream analysis in APWA 5600. The standard acknowledges that streams are variable, and ratios outside of the typical range do not necessarily indicate problems. The ratios are intended to qualitatively evaluate bank stability, and not for use as a target for stream ‘rehabilitation.’

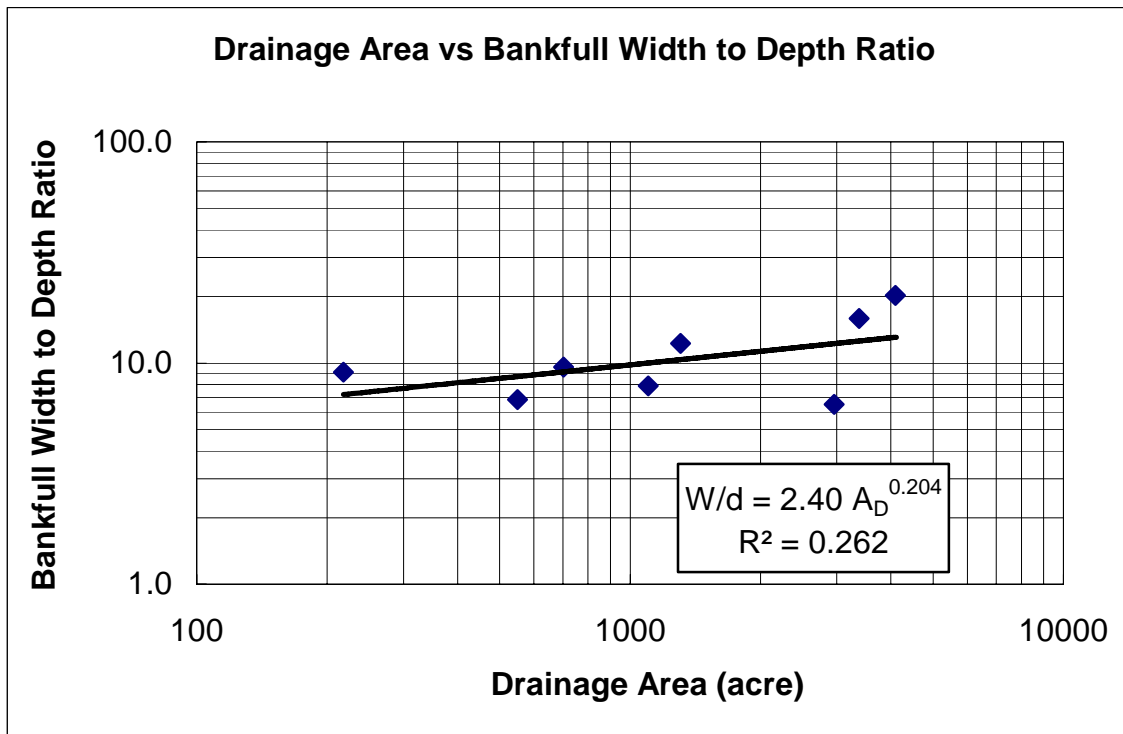
**Figure 14: Drainage Area vs. Bankfull Width to Depth Ratio**

The width-to-depth ratios shown above vary widely, considering that only one person was involved in determining bankfull elevation. Using a numerical model, Simon et al. found equilibrium width-to-depth ratios varying by as much as 200% (Simon, Doyle, Kondolf, Shields, Rhoads, McPhillips, 2007). Although changes in width are often treated as an indicator of bank and/or channel instability, if the width is considered continuously and compared to stream power, it can be correlated to the combination of slope and discharge (Doyle, et. al., 1999).

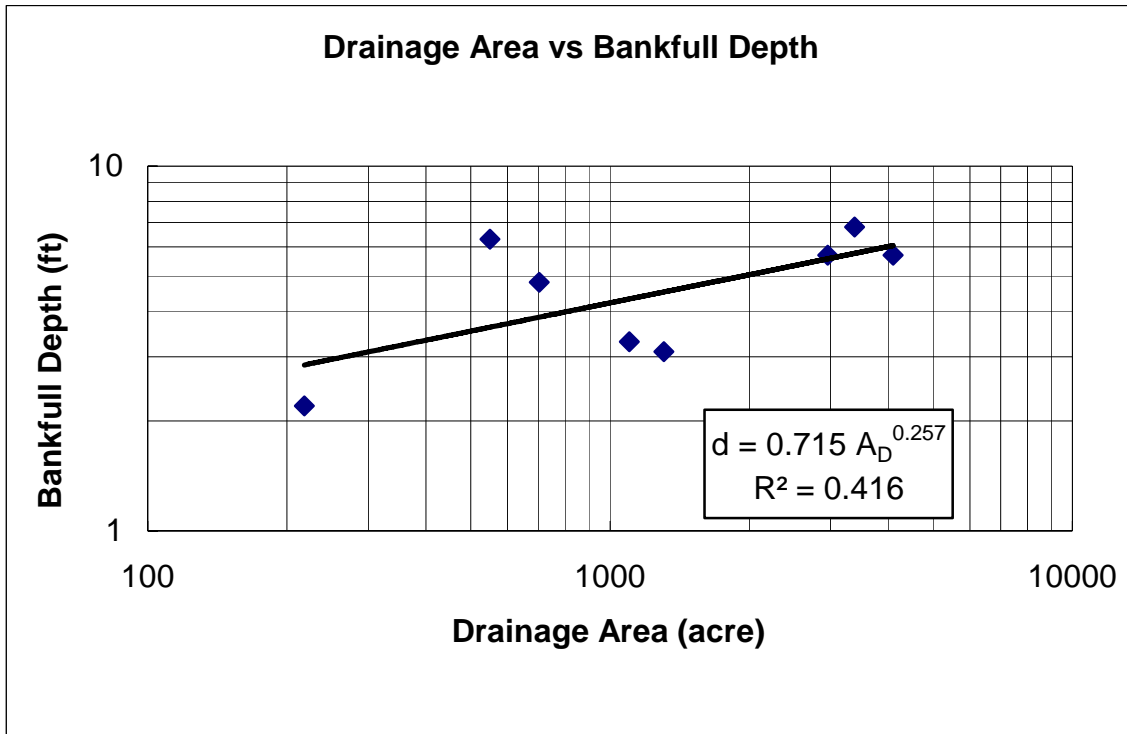
Figure 15: Drainage Area vs. Bankfull Depth

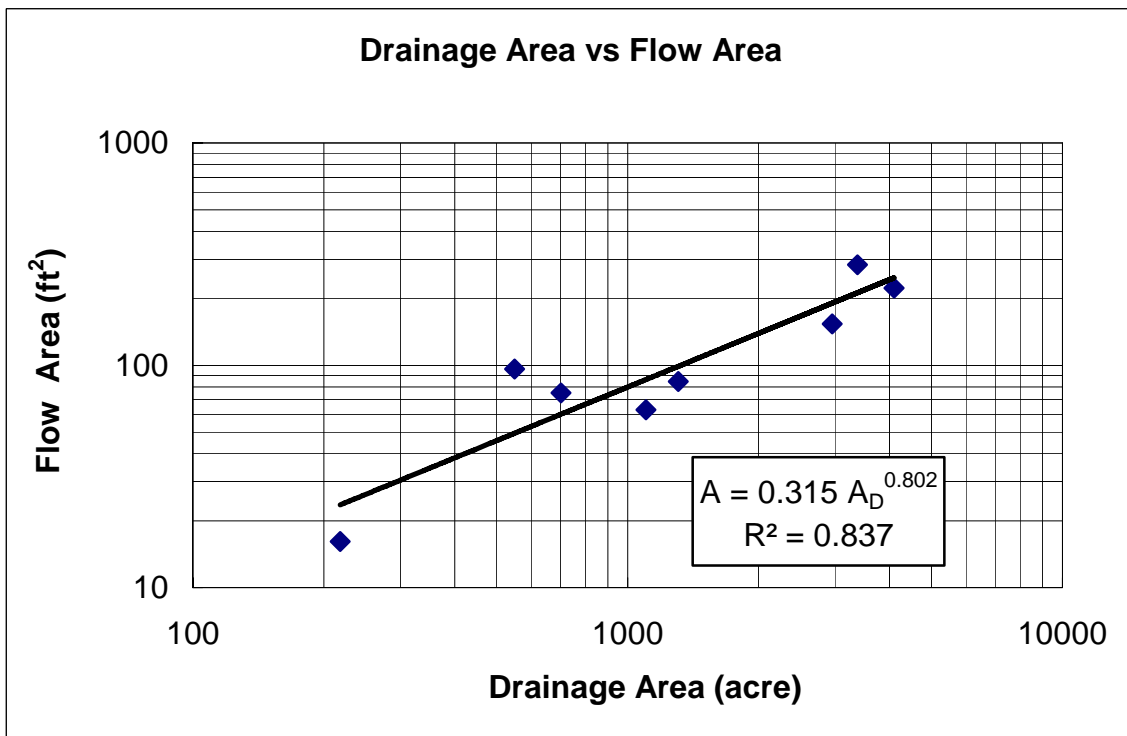
Figure 16: Drainage Area vs. Flow Area

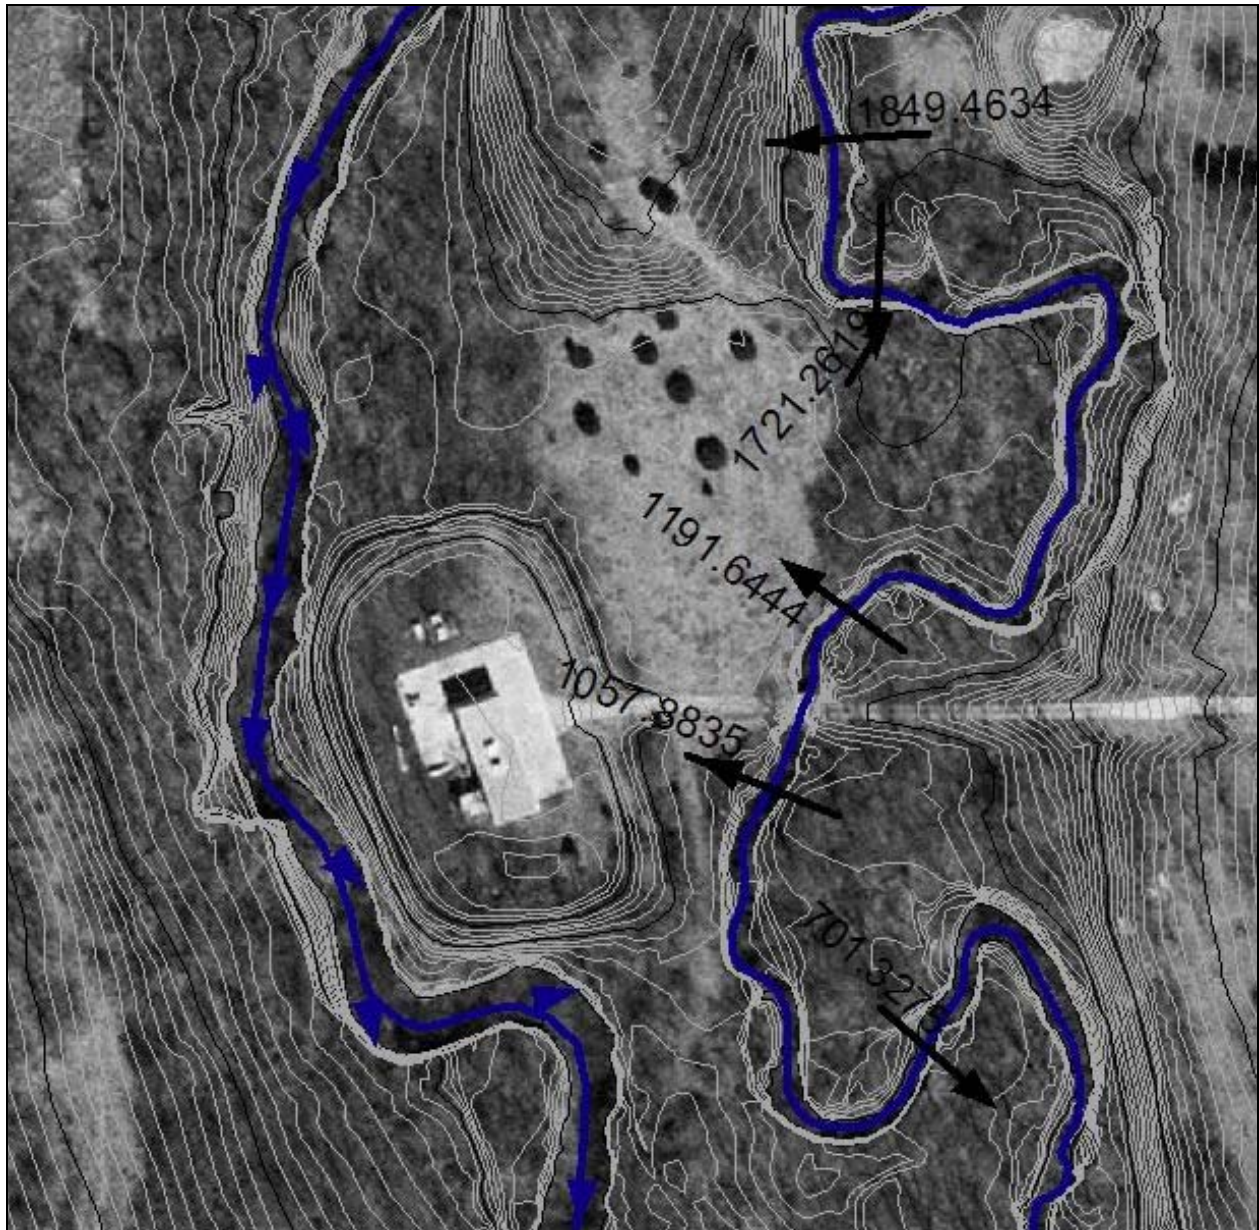
**Exhibit 4: Aerial Photograph, Contours and Cross-section Locations for LBNC1.**

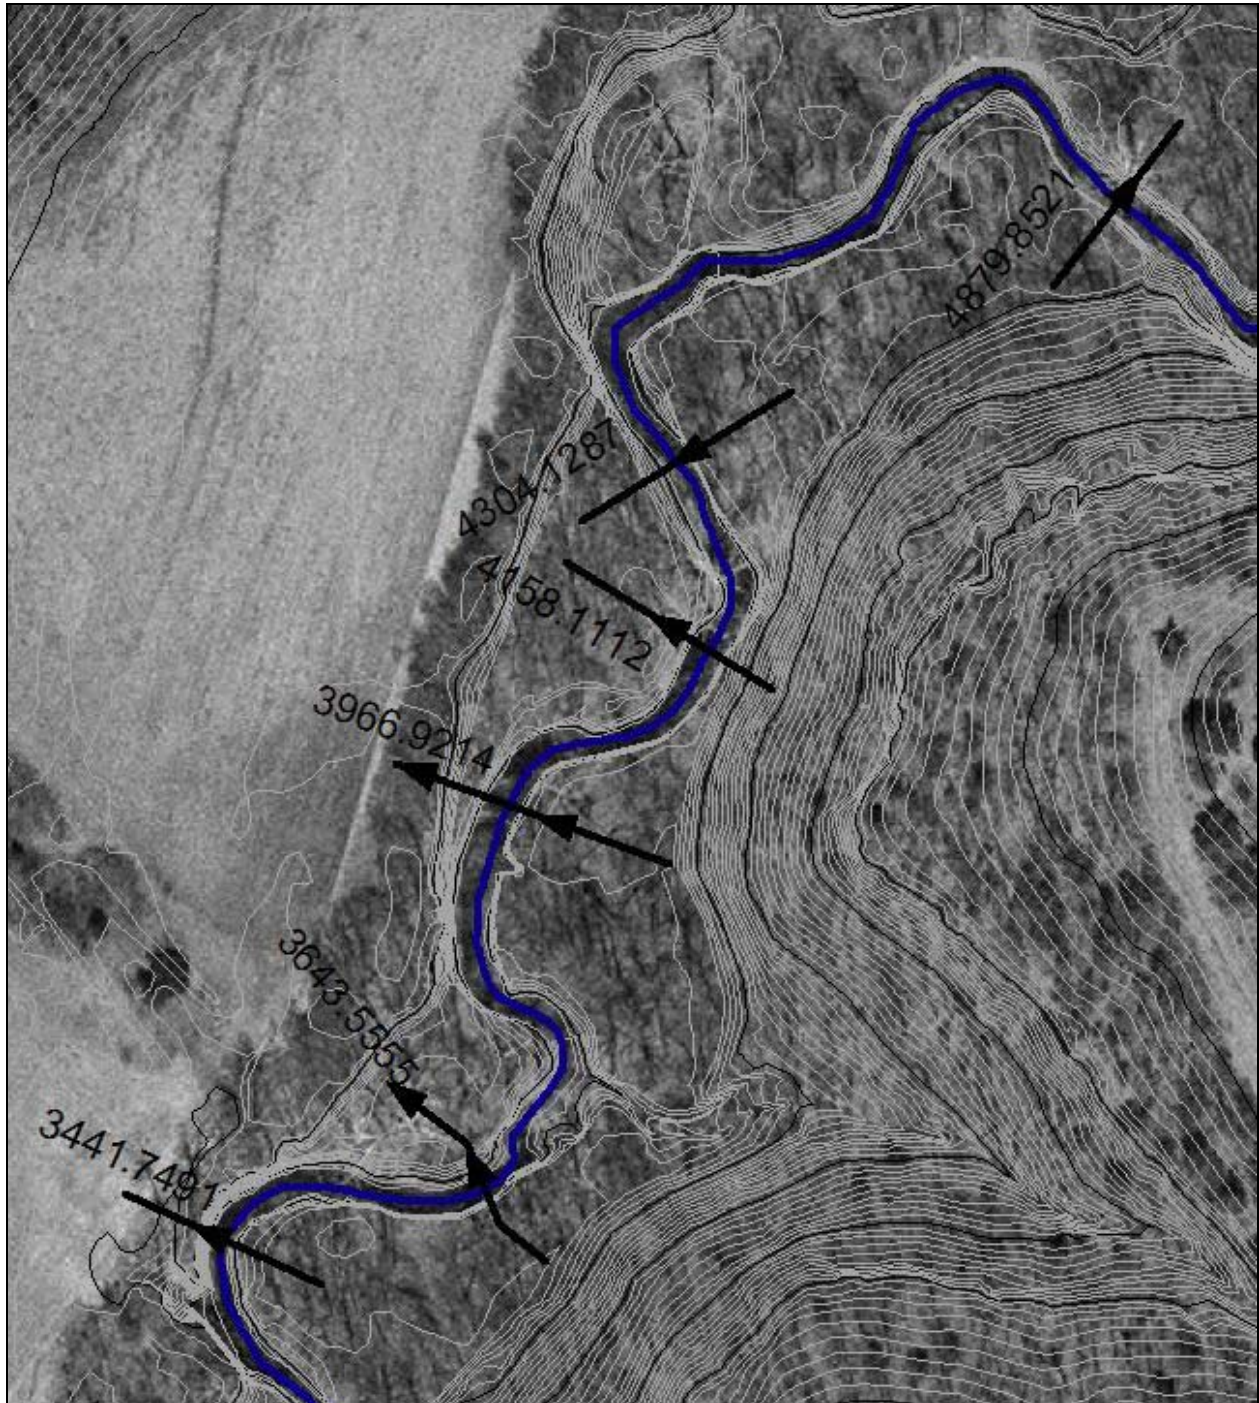
**Exhibit 6: Aerial Photograph, Contours and Cross-section Locations for Spring Creek**

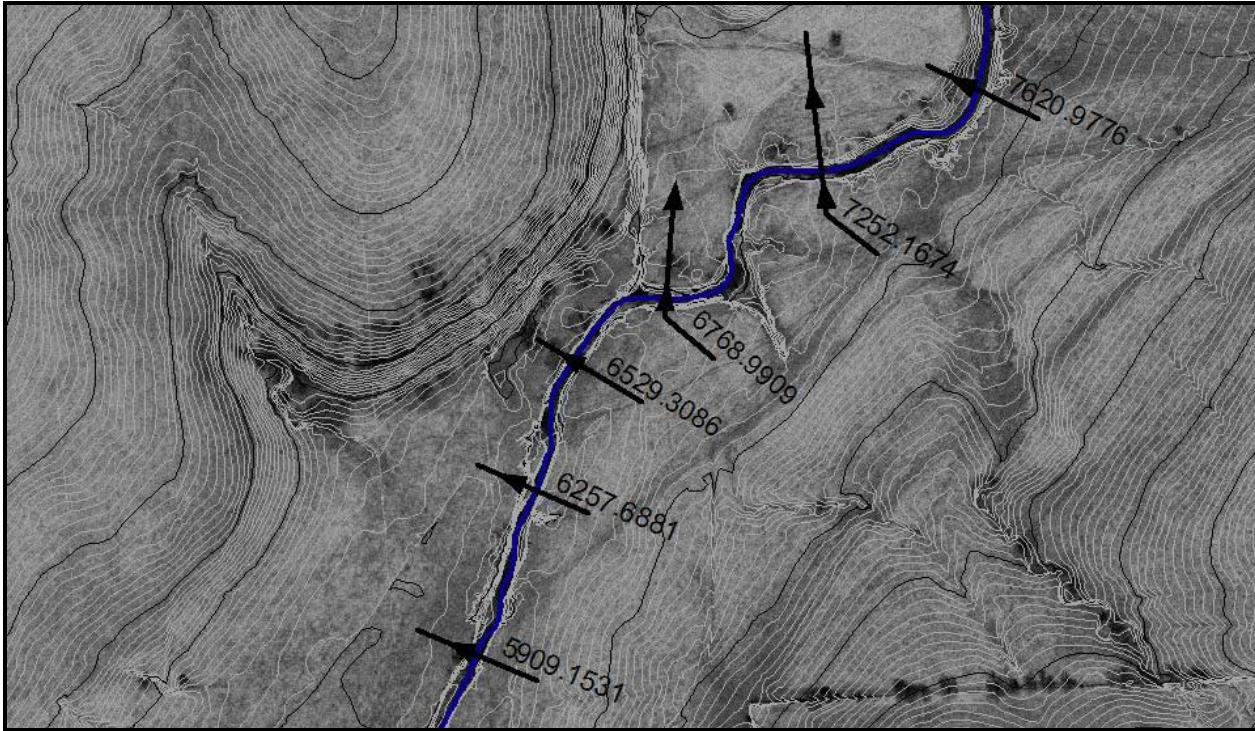
Exhibit 8: Aerial Photograph, Contours, and Cross-section Locations for Lower Bain Creek.
