# **GRAFFITI RESISTANCE OF WAX-BASED AND EPOXY-BASED COATINGS ON STEEL AND CONCRETE SUBSTRATES**

**A Report on Research Sponsored by  
MicroCor Technologies, Inc.**

**Structural Engineering and Engineering Materials  
SL Report 16-1**

**THE UNIVERSITY OF KANSAS CENTER FOR RESEARCH, INC.  
LAWRENCE, KANSAS  
January 2016**

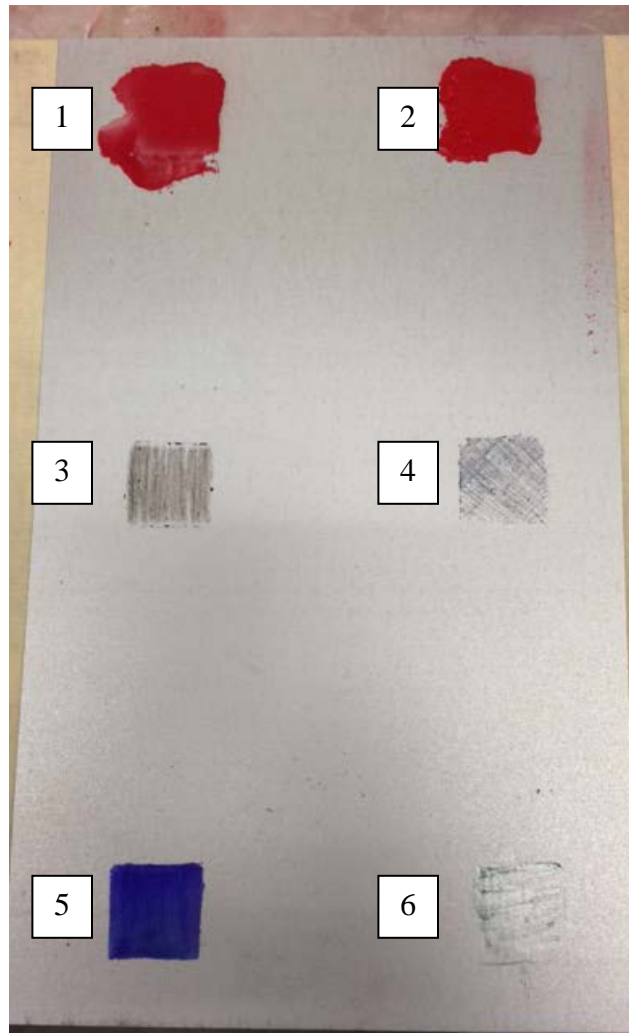
**Figure 1:** Chemical Testing Graffiti Application

A 6 in. × 12 in. template was constructed with a 0.5 in. perimeter and 1 in. × 1 in. square holes equally spaced for the application of designated graffiti markings as shown in Figure 1; (1) red solvent-based acrylic spray paint, (2) red solvent-based alkyd spray paint, (3) black wax crayon, (4) ballpoint ink pen, (5) blue solvent-based permanent ink marker, and (6) black water-based ink marker. The graffiti marking was classified as “repellant” if the marking material did not uniformly cover or adhere to the test area. After graffiti application, specimens were stored for 24 hours before removal was attempted.

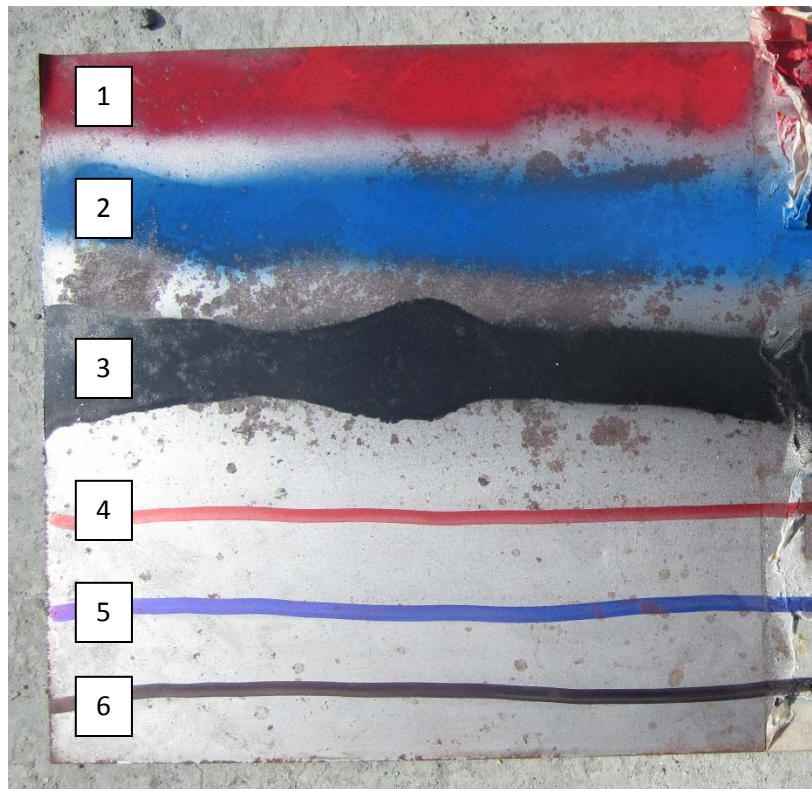
**Figure 2:** Pressure Washer Test Graffiti Application

The graffiti application for pressure washing specimens consisted of a series of six parallel lines as shown in Figure 2; (1) red, (2) blue, and (3) black acrylic spray paint and (4) red, (5) blue, and (6) black solvent based permanent markers. The graffiti was allowed to cure for five days before the graffiti removal process was attempted. A commercial pressure washer at 4 GPM and 1500 psi with a 15 degree nozzle was utilized to remove the graffiti. Evaluation of the level of cleanability is shown in Table 2.

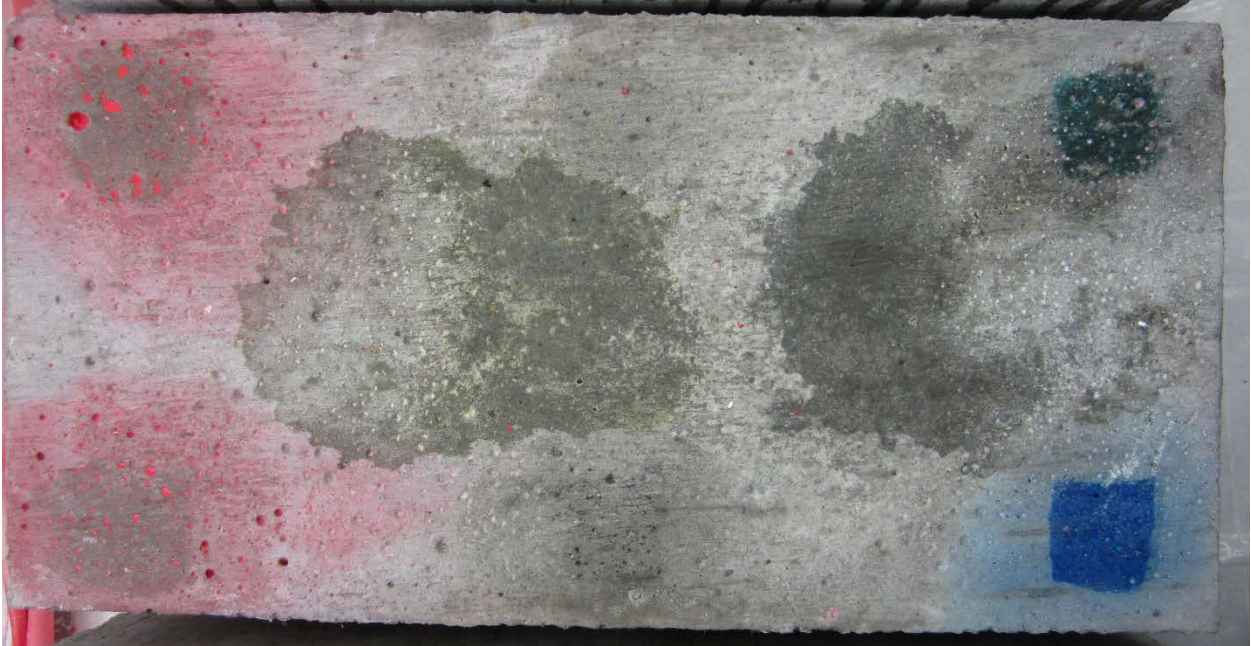
**Figure 3:** Chemical Resistance Test - MC-300 on concrete exposed to paint thinner and gasoline. Some adhesion loss.

When exposed to selected reagents, paint thinner and gasoline, the MC-300 coating experienced some adhesion loss on the concrete surface (Figure 3) and complete adhesion loss on the steel surface (Figure 4); however, the MC-500 coating did not experience any blistering, discoloration, swelling, or other alterations on concrete (Figure 5) or steel (Figure 6) surfaces.

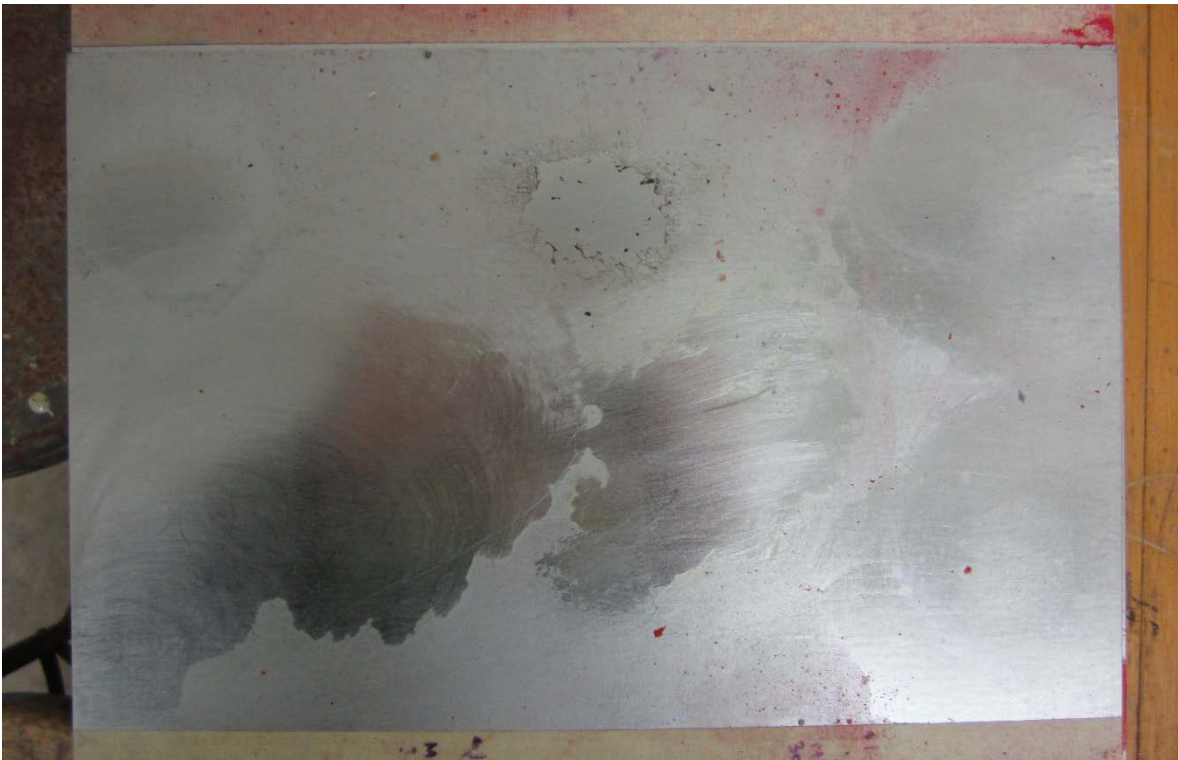
**Figure 4:** Chemical Resistance Test - MC-300 on steel exposed to paint thinner and gasoline. Complete adhesion loss.

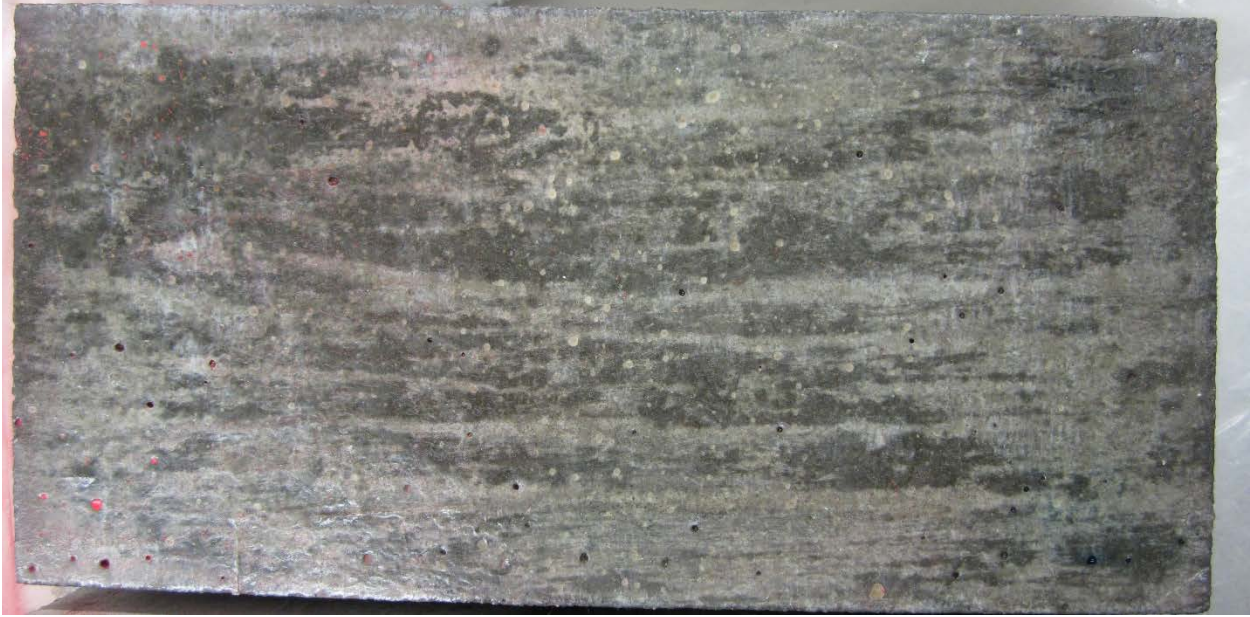
**Figure 5:** Chemical Resistance Test - MC-500 on concrete exposed to paint thinner and gasoline. No alterations.

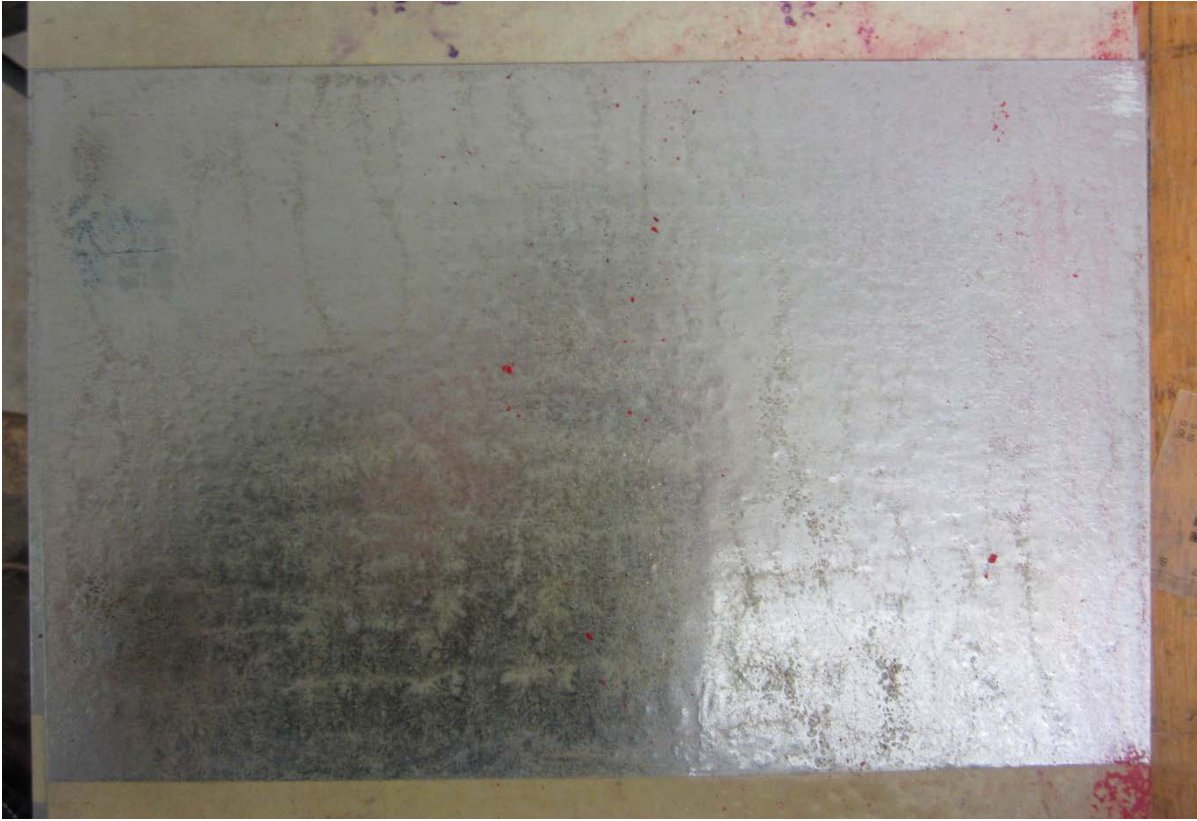
**Figure 6:** Chemical Resistance Test - MC-500 on steel exposed to paint thinner and gasoline. No alterations.

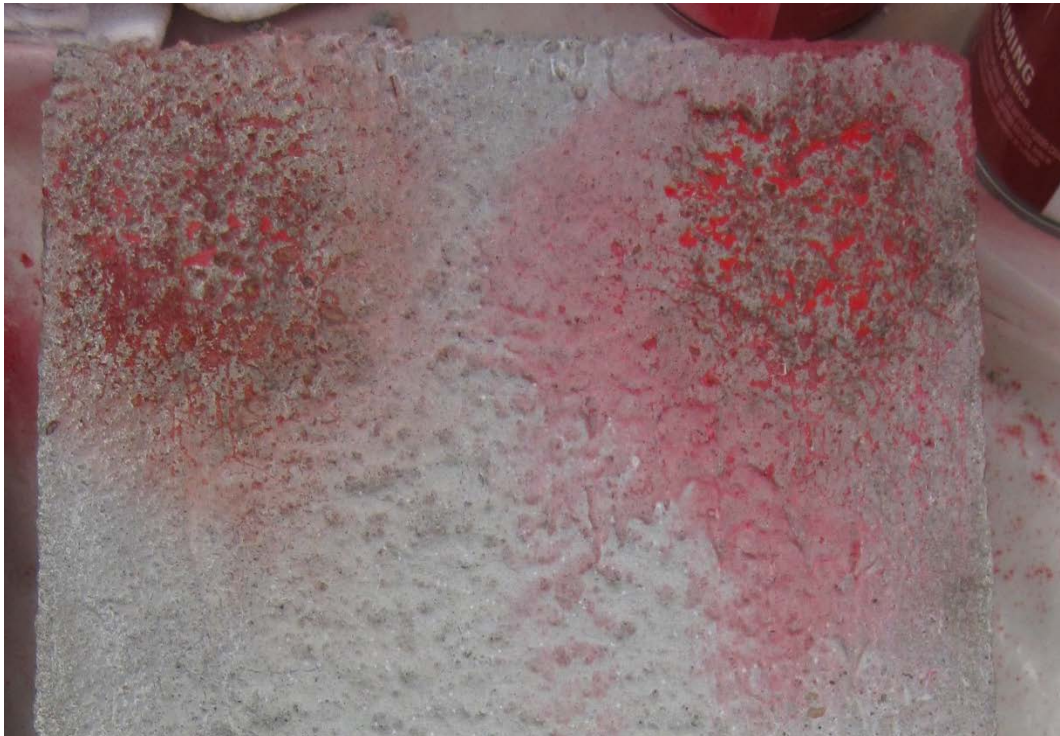
During the procedure, it was noticed that the rough surface of the concrete provided several crevices and voids for graffiti to reside as well as staining of the concrete surrounding the test square for various types of graffiti (Figure 7); therefore, the concrete was evaluated as clean as long as the graffiti was removed from the test square while the graffiti trapped in crevices or voids and the surrounding staining was disregarded. For clarification, the two test areas (acrylic spray paint-left, oil spray paint-right) shown in Figure 7 were considered to be cleanable.

**Figure 7:** Concrete crevices, voids, and surrounding stains

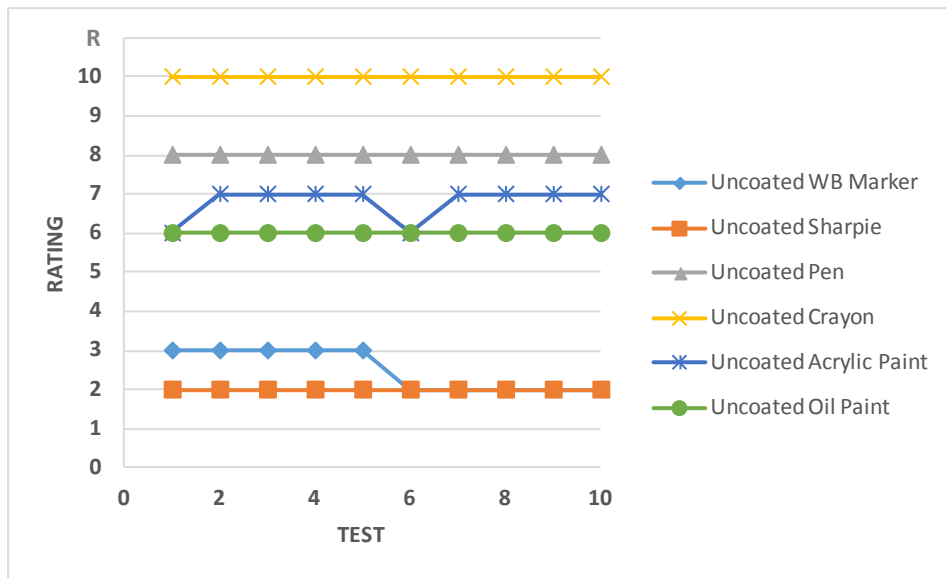
**Figure 8:** Performance of Uncoated Concrete Specimens

Figures 8 through 11 show the performance of uncoated, MC-300, recoated MC-300, and MC-500 concrete specimens, respectively. As shown in Figure 8, the uncoated concrete specimens had consistent results for removal of all graffiti types over all ten cycles. Crayon was the most readily removed graffiti type using a dry rag followed by ball point pen removed by isopropyl alcohol. The acrylic paint was typically able to be removed with mineral spirits, and oil paint was removed by xylene. The water-based and permanent markers were unable to be fully removed from the surface of the concrete for all cycles.

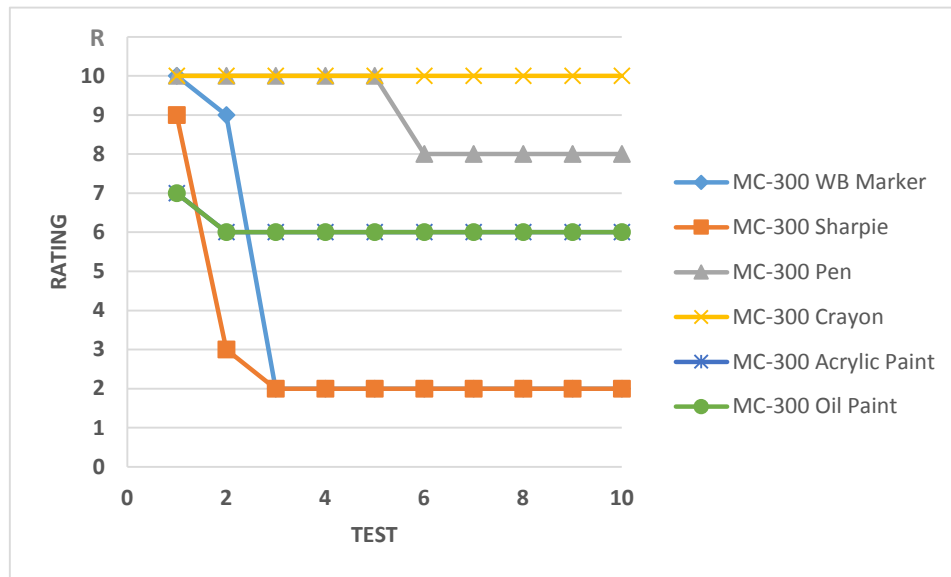
**Figure 9:** Performance of MC-300 Coated Concrete Specimens

Figure 9 displays the performance of MC-300 coated concrete specimens. MC-300 specimens showed excellent cleanability for the first cycle; however, the abrasive action of rubbing the marks removed some of the coating. This resulted in a drastic drop in performance on subsequent cycles, particularly on the marks that required more effort to remove, such as permanent marker. Based on the figure, crayon and pen were the most readily removed types of graffiti. Crayon was consistently removed by a dry rag for all cycles while pen could be removed

via dry rag for five cycles before requiring isopropyl alcohol to remove the remaining ink. Oil and acrylic spray paint were both able to be removed with mineral spirits for one cycle before consistently needing xylene to remove those types of graffiti for the outstanding cycles. The MC-300 coating allowed for removal of water-based marker and permanent marker for two cycles and one cycle, respectively, before they stained the concrete surface and were no longer cleanable. In general, the MC-300 was beneficial for one cycle before performance degraded to that of the uncoated specimens.

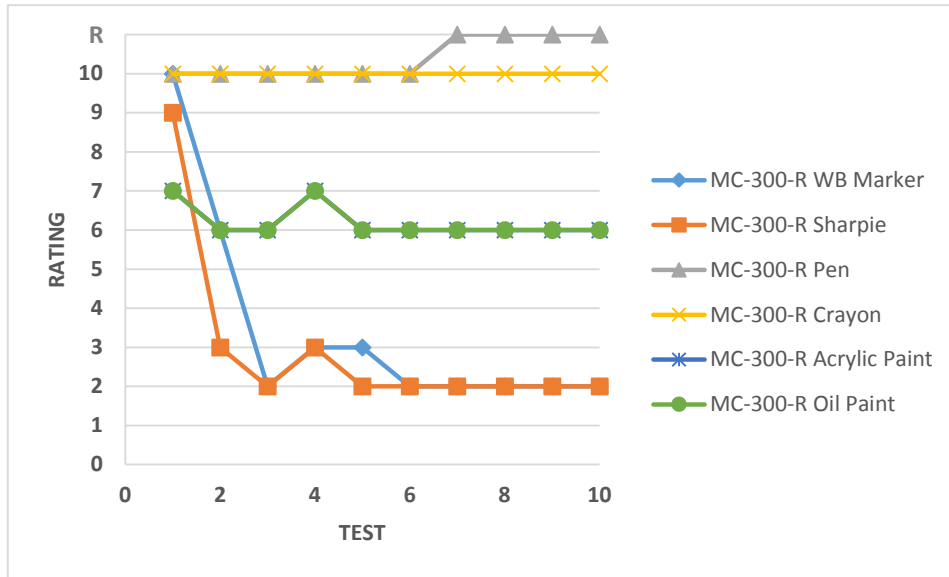
**Figure 10:** Performance of MC-300 Recoated Concrete Specimen

One concrete specimen was coated with MC-300 before the first test and reapplied prior to tests 4 and 7. The results shown in Figure 10 indicate that reapplication had minimal effect on the graffiti resistant qualities. Recoating the specimen was the most beneficial for protection against ball point pen, allowing removal via dry rag for several cycles and repelling the ink for the last four cycles. It also allowed oil and acrylic spray paint to be cleaned with mineral spirits for one cycle before performance declined. Crayon was removed with a dry rag for all cycles

regardless of the coating. The permanent and water-based markers were not able to be cleaned at all once they stained the concrete surface. Based on these results, MC-300 would need to be reapplied after each cleaning to provide complete protection.

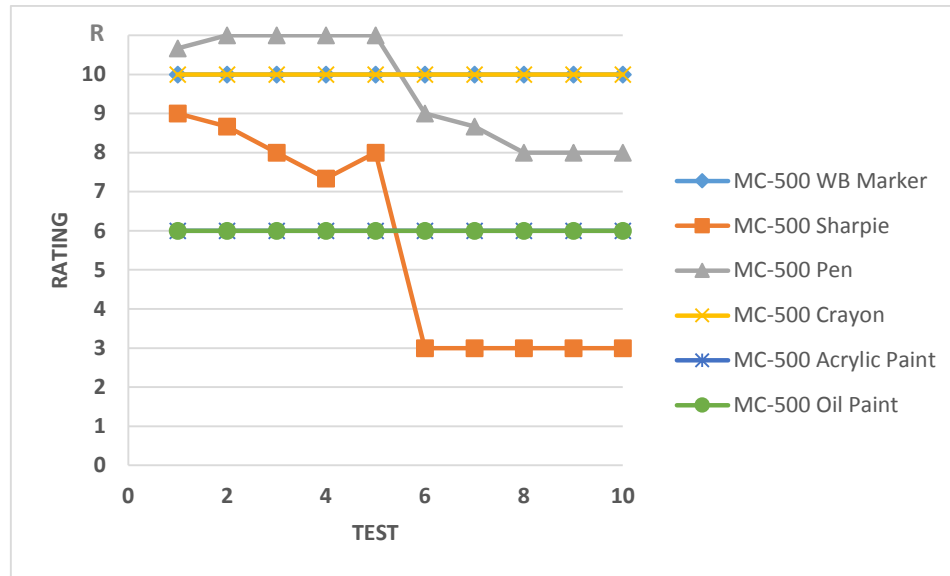
**Figure 11: Performance of MC-500 Coated Concrete Specimens**

Figure 11 displays the average performance of MC-500 coated concrete specimens. Crayon and water-based marker were most readily removed using a dry rag for all cycles. Ball-point pen was repellent for five cycles before declining for the remaining cycles requiring isopropyl alcohol for removal. Oil and acrylic spray paint were cleanable with xylene for all ten cycles. Sharpie was cleanable with a variety of cleaning agents until the sixth cycle, after which it was no longer cleanable.

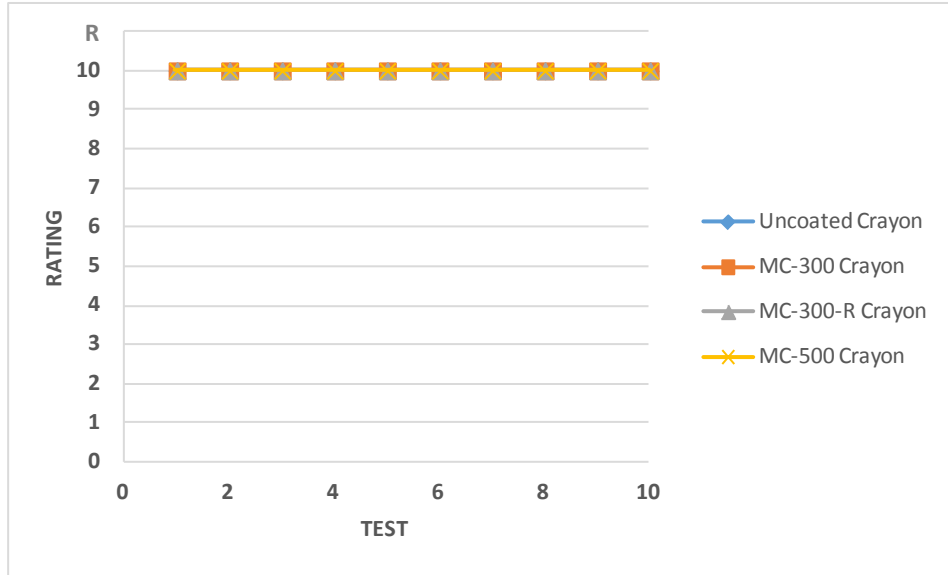
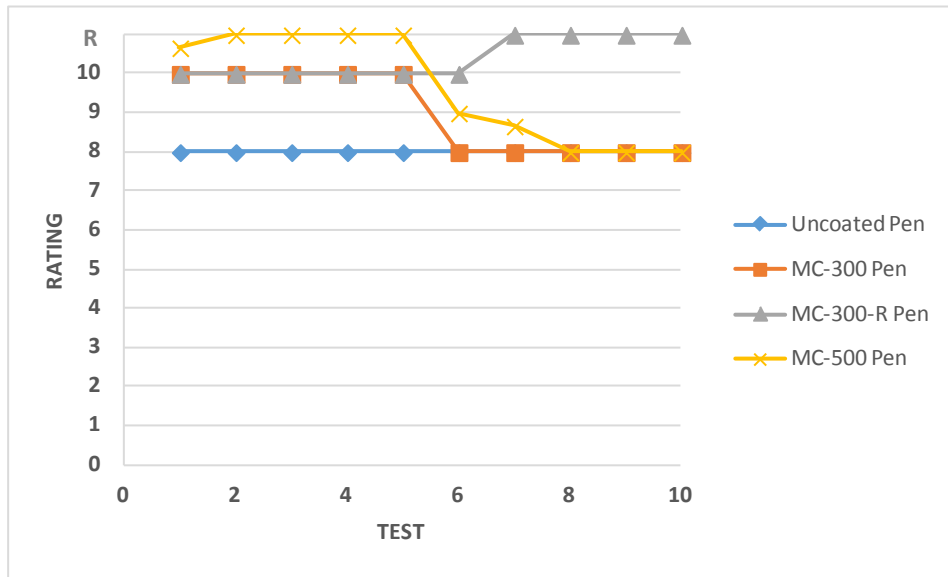
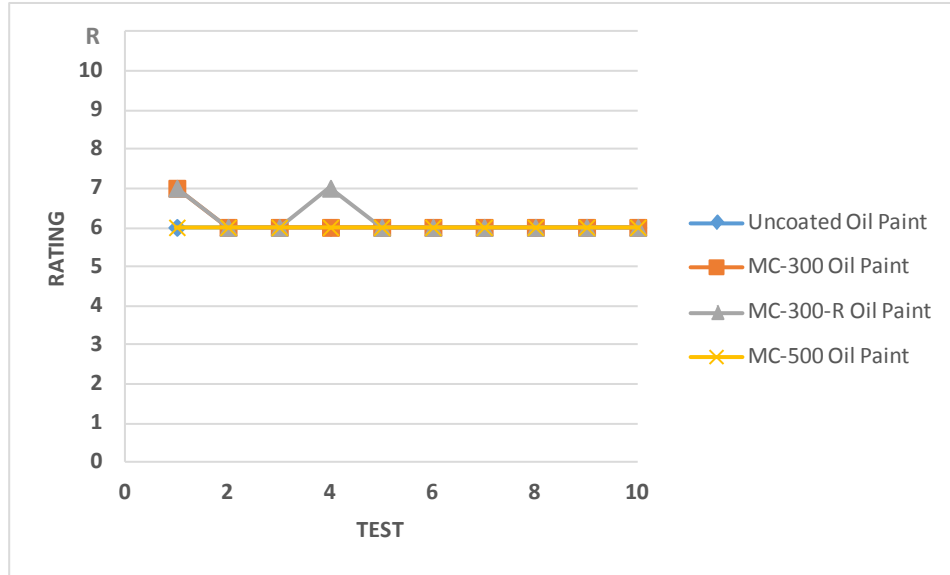
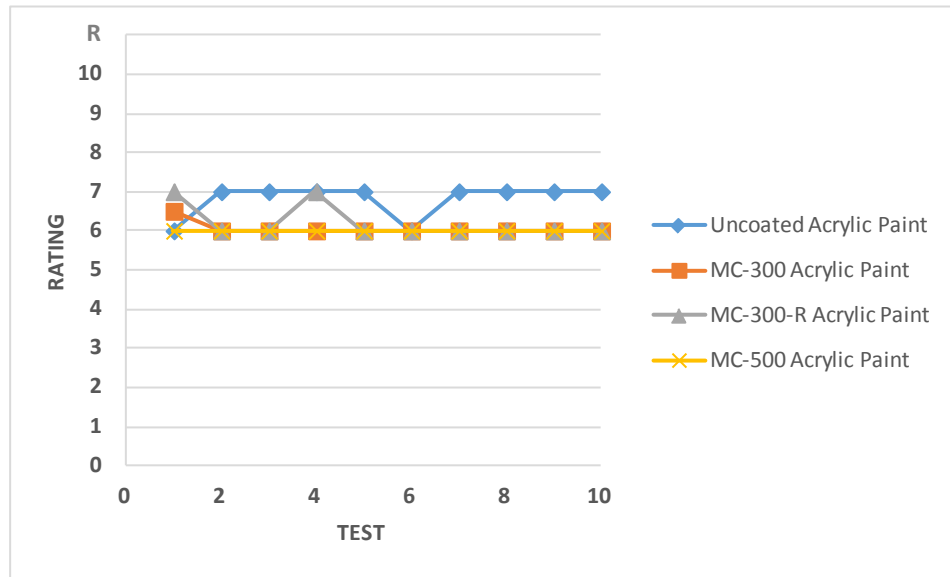
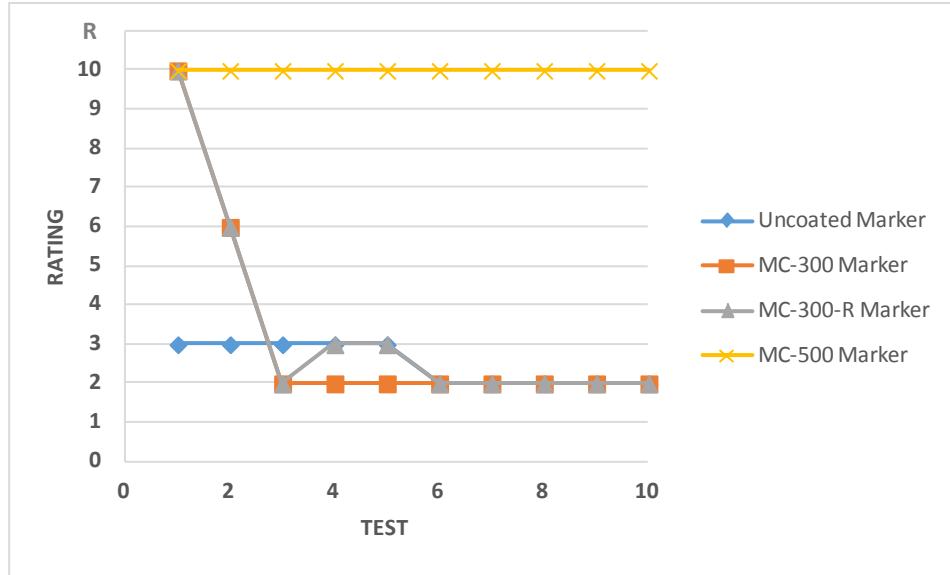
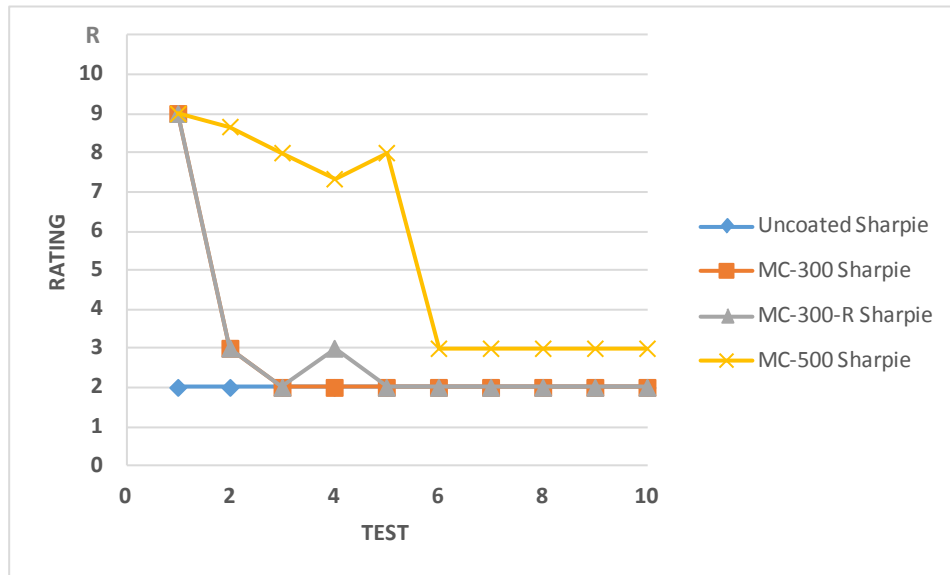
A comparison of coating resistance to individual types of graffiti is shown in Figures 12-17. As shown in Figure 12, crayon was removable via dry rag for all cycles regardless of coating type. Based on Figure 13, MC-500 performed the best against pen for seven cycles where it was repellant for the first five tests; however, pen was able to be cleaned with a dry rag on the MC-300 coated specimens for five cycles, and recoating the specimen created a repellant barrier for the remaining four cycles. Oil paint was slightly easier to remove using mineral spirits when applied to the MC-300 coated and MC-300 recoated concrete specimens for one cycle (Figure 14). After one cycle, all concrete specimens required xylene to remove oil paint. Figure 15 displays uncoated specimens had the best performance against acrylic spray paint. Figure 16 depicts MC-500 coated specimens were the only specimens where water-based marker was cleanable for all cycles. In addition, MC-500 coated specimens had high resistance to permanent marker which was cleanable for five cycles (Figure 17). In general, the MC-500 coating had the best performance for graffiti removal using solvents on concrete specimens.

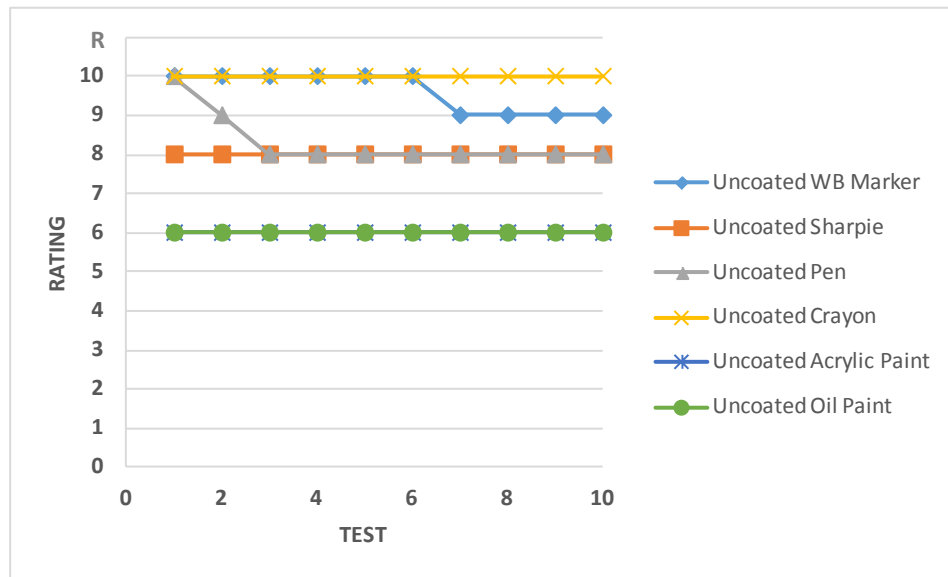
**Figure 18:** Performance of Uncoated Steel Specimens

Figures 18 through 22 show the performance of uncoated, MC-300, recoated MC-300, and MC-500 steel specimens, respectively. Based on Figure 18, every type of graffiti was consistently cleanable for all cycles. Crayon was the most readily cleanable using only a dry rag. Water-based marker was cleanable with a dry rag for six cycles before declining slightly to removal via detergent. Sharpie and pen were removed using isopropyl alcohol for all cycles. Acrylic and oil spray paint were removed by xylene.

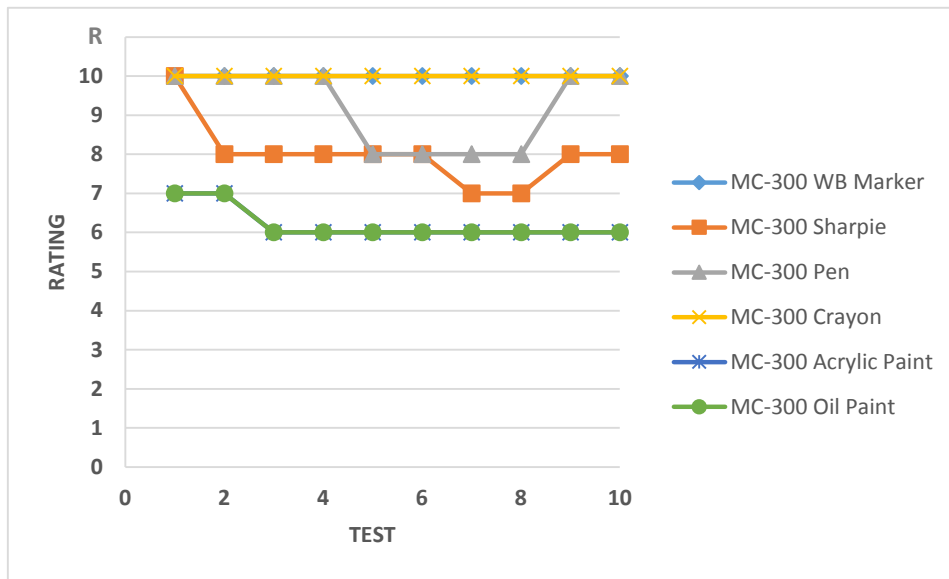
**Figure 19:** Performance of MC-300 Coated Steel Specimens

Figure 19 displays the performance of MC-300 coated specimens. From the figure, it can be seen that crayon and water-based marker were removed via dry rag for all ten cycles. Pen was able to be removed with a dry rag for four cycles before declining to removal using isopropyl alcohol. Sharpie was removed with a dry rag for one cycle and then was only removed by isopropyl alcohol and even mineral spirits for the remaining cycles. Oil and acrylic paint were removed with mineral spirits for two cycles, and then resembled uncoated specimen performance

for the remaining cycles. During the procedure, the aggressive scrubbing of the graffiti and various chemicals, such as mineral spirits and xylene, removed the MC-300 from the surface of the steel. Once the coating wore off, the performance was similar to an uncoated specimen. An example of the wear can be seen in Figure 20.

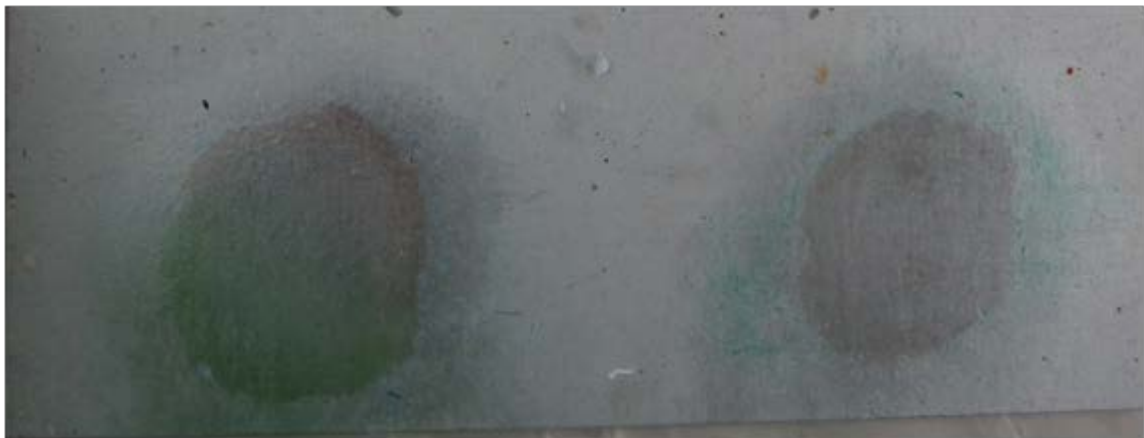
**Figure 20:** Wear on MC-300 coating after 10 cycles

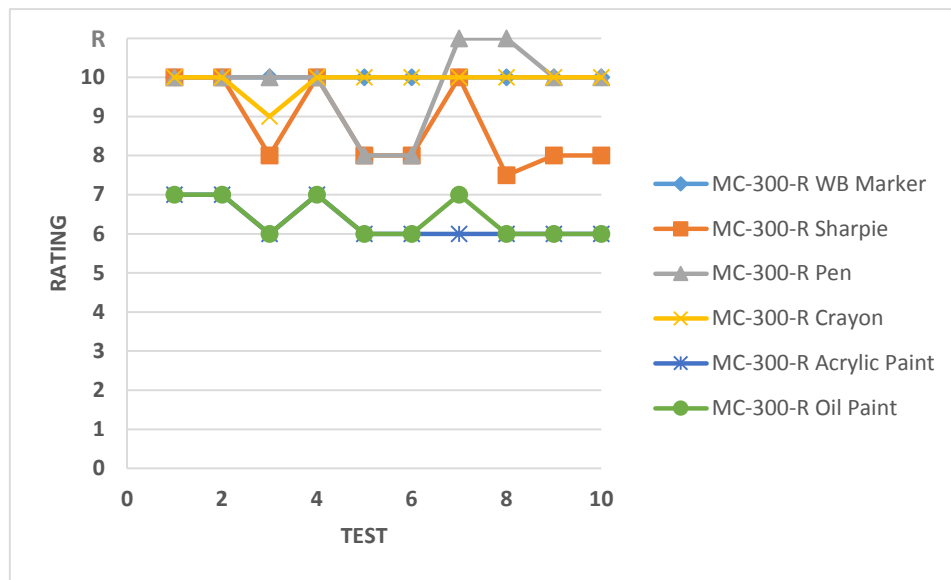
**Figure 21:** Performance of MC-300 Recoated Steel Specimens

Due to the excessive wear of the MC-300 coating, two steel specimens were coated with MC-300 before the first test and recoated prior to tests 2, 4, and 7. The results shown in Figure 21 indicate that reapplication restored most of the graffiti resistant qualities. Recoating the specimen was the most beneficial for protection against permanent marker, allowing removal via dry rag for the cycle after reapplication. Resistance against ball-point pen was also restored by every reapplication of the coating. Oil and acrylic spray paint were able to be cleaned with mineral spirits for one cycle after reapplication before declining back to performance comparable to uncoated specimens. Crayon and water-based marker were removed with a dry rag regardless of the coating. Based on these results, MC-300 would need to be reapplied after each cleaning to maintain full graffiti resistance.

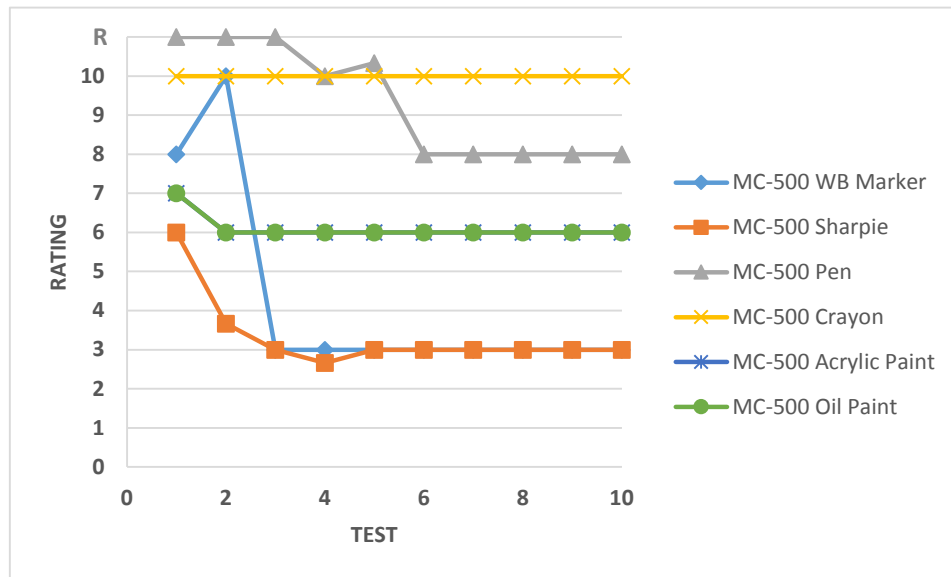
**Figure 22:** Performance of MC-500 Coated Steel Specimens

Figure 22 shows the performance of MC-500 coated steel specimens. As displayed in the figure, crayon was removable with a dry rag for all ten cycles. Pen was repellent for three cycles before it made a continuous mark, which was removable with a dry rag, for two cycles. After

that, isopropyl alcohol was needed to remove the pen. Oil and acrylic paint were both removable with mineral spirits for one cycle; xylene was needed to remove those types of graffiti for subsequent cycles. The water-based marker was removable for two cycles before it stained the MC-500 coating and was no longer removable. Permanent marker was only cleanable with xylene for one cycle. Although the MC-500 coating was more durable than the MC-300 coating, it was noticed that the harsher chemicals such as xylene and methyl ethyl ketone combined with abrasive scrubbing of the graffiti broke down and thinned the MC-500 coating.

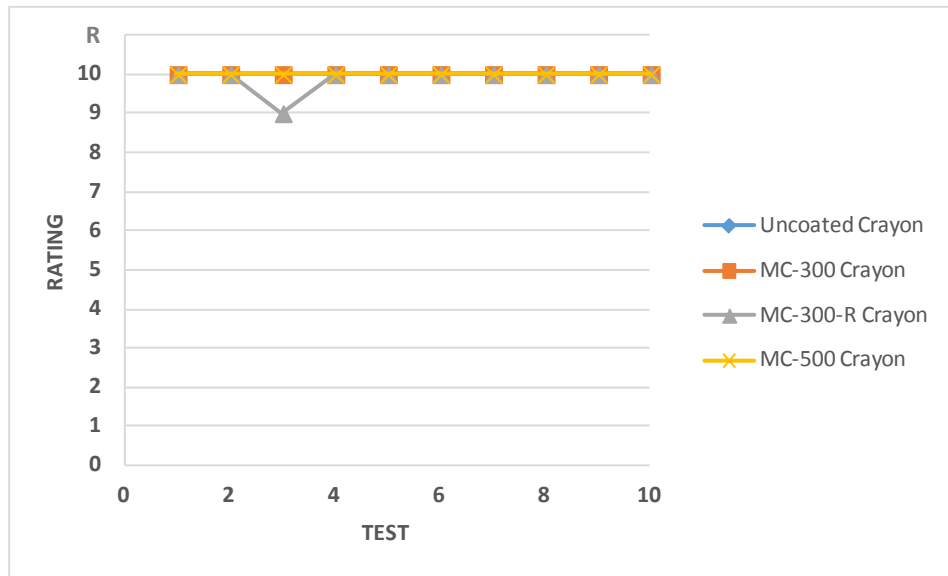
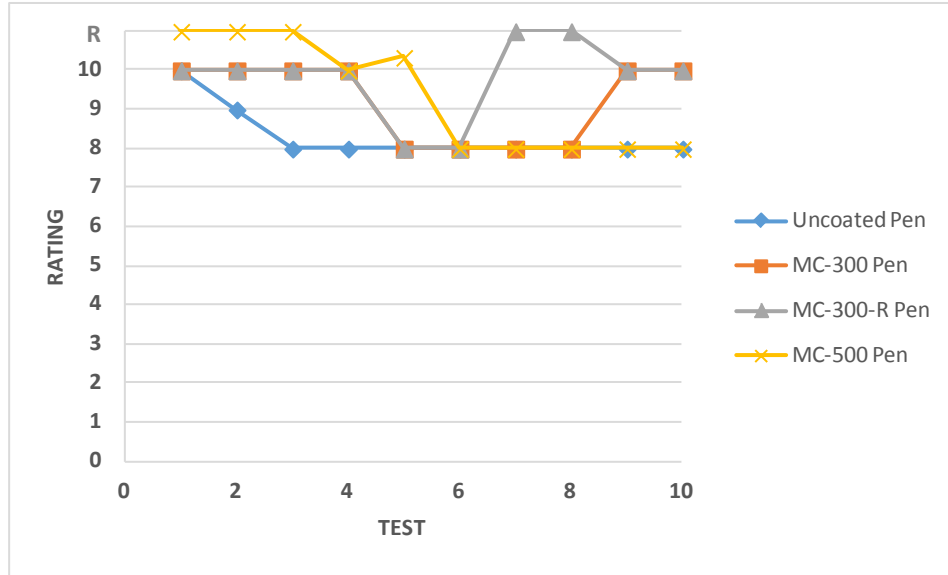
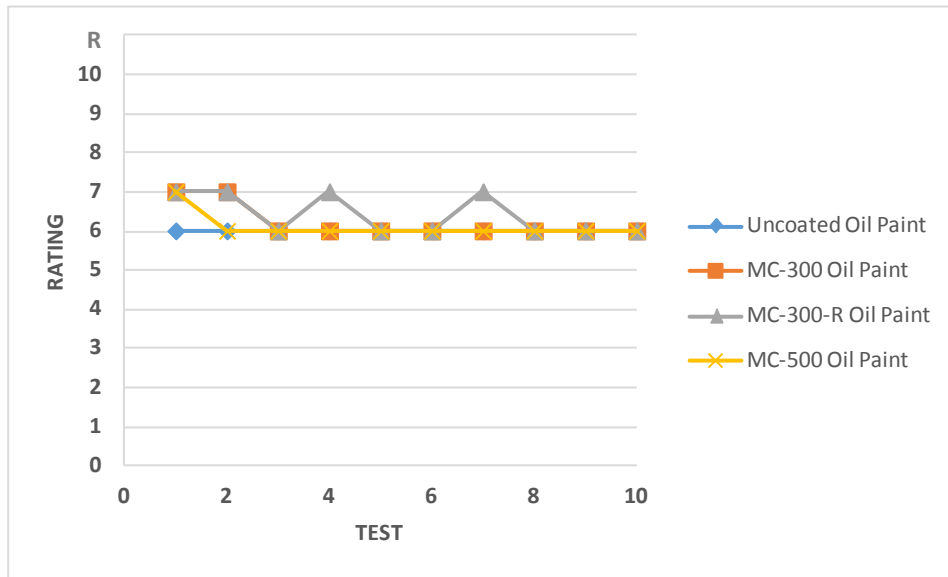
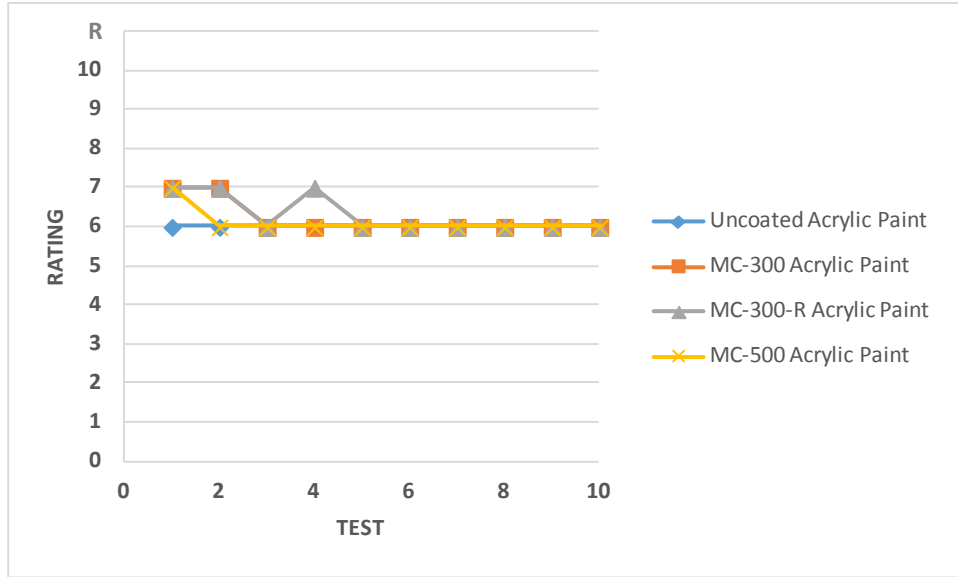
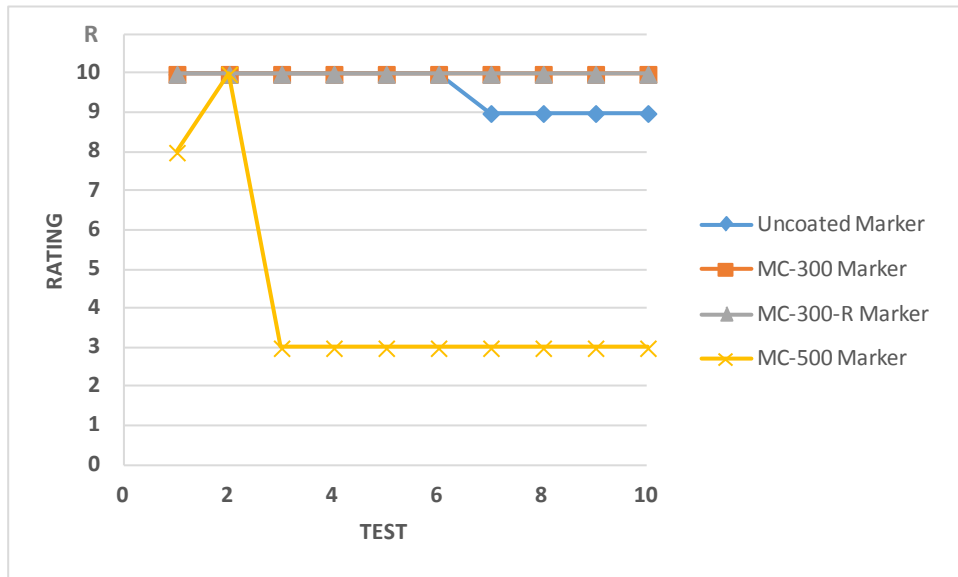
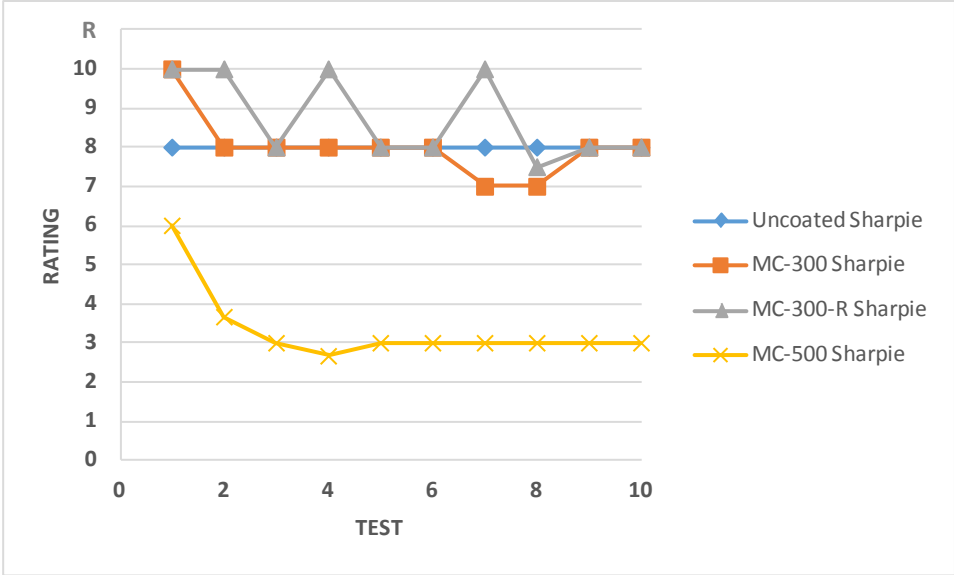
A comparison of coating resistance to individual types of graffiti is shown in Figures 23-28. As shown in Figure 23, crayon was removable from the steel specimens via dry rag for all cycles regardless of any type of coating. Based on Figure 24, in comparison to uncoated steel specimens, both MC-300 and MC-500 enhanced graffiti resistance against pen. MC-500 performed the best against pen for the first three cycles where it was repellent; however after three cycles, a dry rag was used to clean the pen marking for an additional two cycles before performance declined resembling uncoated specimen performance. Pen was cleanable with a dry

rag on the MC-300 coating for four cycles before declining to cleanability similar to uncoated specimens. Figures 25 and 26 display that both oil and acrylic spray paint were slightly easier to remove when applied to the MC-300 and MC-500 coated steel specimens. Oil and acrylic paint applied to MC-300 coated steel were cleanable with mineral spirits for two cycles, whereas oil and acrylic paint applied to MC-500 coated steel were cleanable with mineral spirits for one cycle. After that, all steel specimens required xylene to remove oil paint. Figure 27 depicts MC-300 coated specimens performed somewhat better than uncoated specimens against water-based marker, cleanable with only a dry rag for all ten cycles. Additionally, MC-300 coated specimens improved resistance to permanent marker where the sharpie was cleanable for one cycle with a dry rag before isopropyl alcohol was needed (Figure 28). In summary, even though MC-300 had the best graffiti resistance of the three systems tested, the MC-300 coating on steel only performed slightly better than uncoated steel, though reapplying the coating could improve performance.

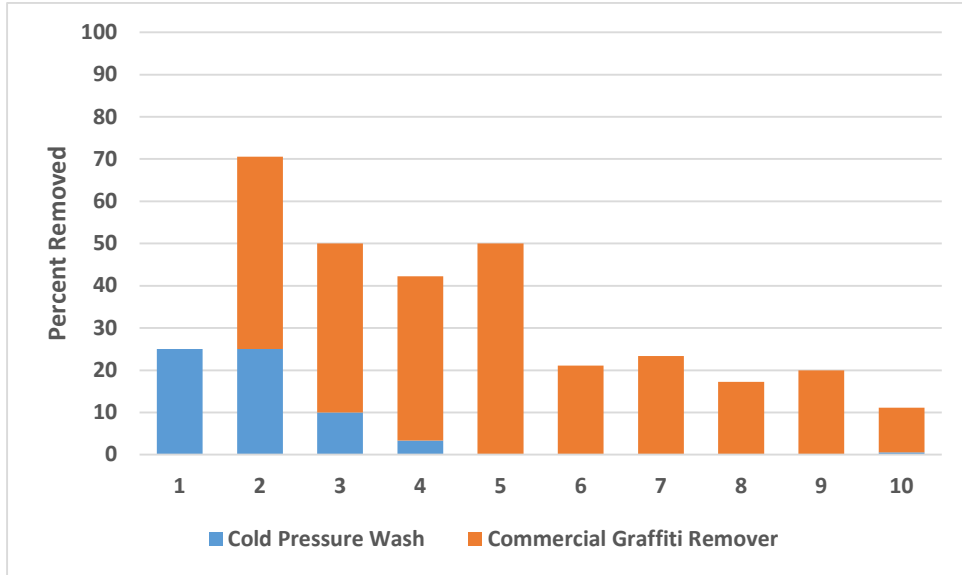
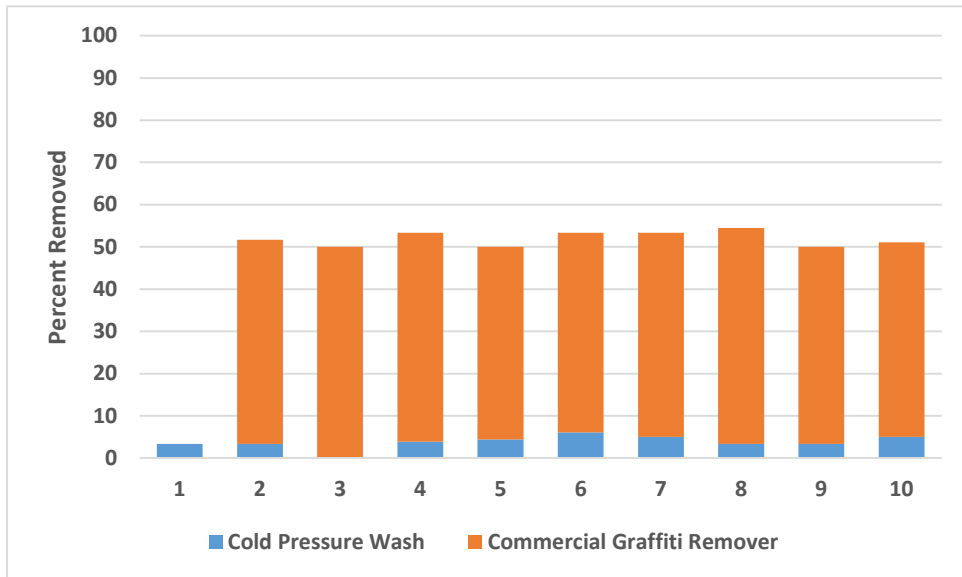
Figures 29 to 32 show the average performance of uncoated, MC-300, recoated MC-300, and MC-500 specimens, respectively. As a note, commercial graffiti remover was not utilized on the concrete specimens until the second test cycle; therefore, the first cycle of the concrete

pressure washing specimens do not have the orange column. Based on Figure 29, the uncoated specimens were unable to be fully cleaned, either with the pressure washer alone or the commercial graffiti remover. Performance against spray paint (Figure 29a) declined as the number of cycles of testing increased; however, the performance against permanent marker remained consistent removing a total of approximately 50% of the permanent marker for the remaining cycles (Figure 29b). Based on the performance for both types of graffiti, uncoated concrete specimens did not meet requirements of Cleanability Level 1 or 2 for either type of graffiti and were rated as not cleanable for all cycles.
