# **GRAFFITI RESISTANCE OF WAX-BASED AND EPOXY-BASED COATINGS ON STEEL AND CONCRETE SUBSTRATES**

**A Report on Research Sponsored by  
MicroCor Technologies, Inc.**

**Structural Engineering and Engineering Materials  
SL Report 16-1**

**THE UNIVERSITY OF KANSAS CENTER FOR RESEARCH, INC.  
LAWRENCE, KANSAS  
January 2016**

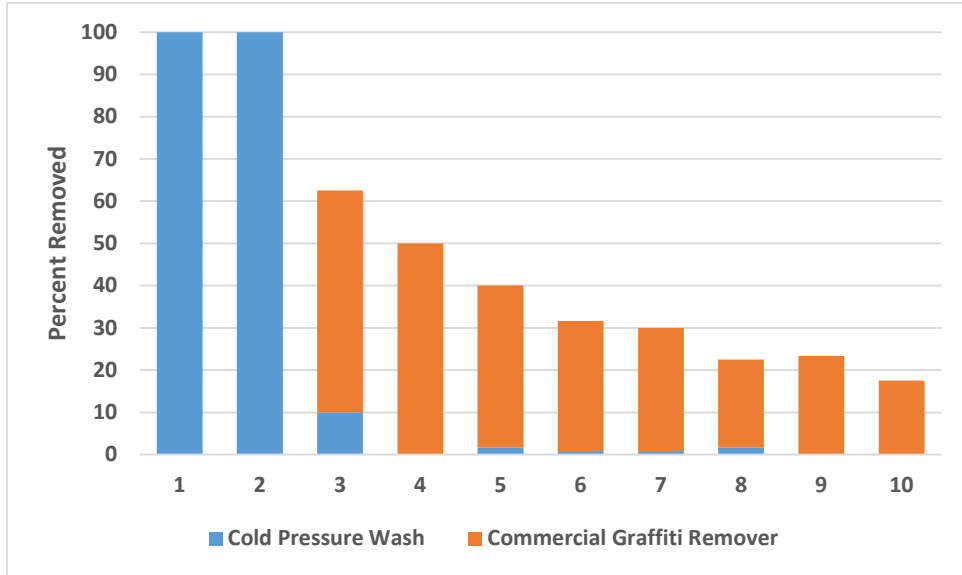
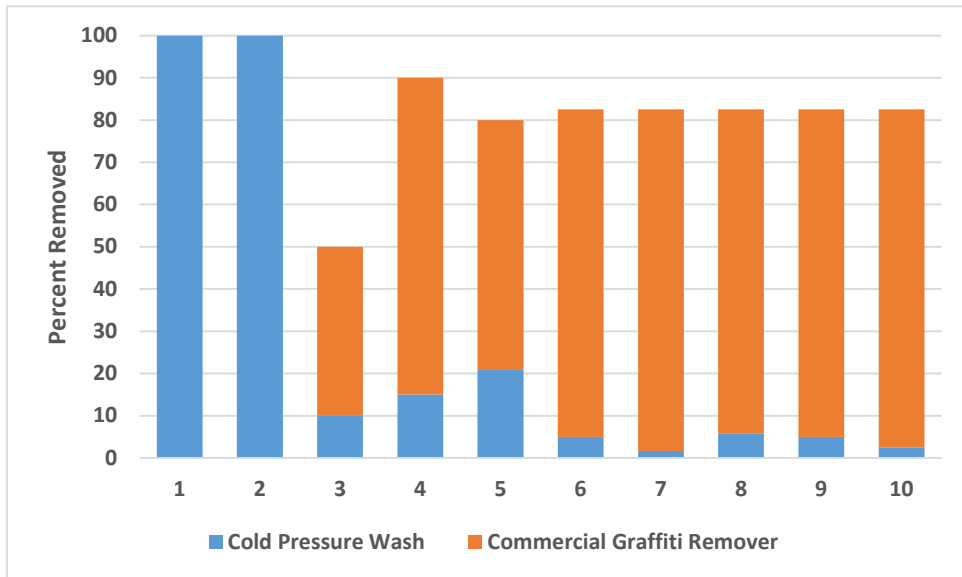
MC-300 specimens that were not recoated (Figure 30) were able to be fully cleaned with the cold-water pressure wash; however, the coating was partially removed by this process. After two cycles, the coating was sufficiently removed resulting in declination of performance. The MC-300 coating performance against spray paint (Figure 30a) after two cycles resembled the results obtained for uncoated specimens of the same magnitude and trend. The MC-300 performance against permanent marker (Figure 30b) after two cycles remained consistent removing a total of approximately 80% for the remaining cycles. For both types of graffiti, the MC-300 coated concrete specimens were rated as Cleanability Level 1 for two cycles.

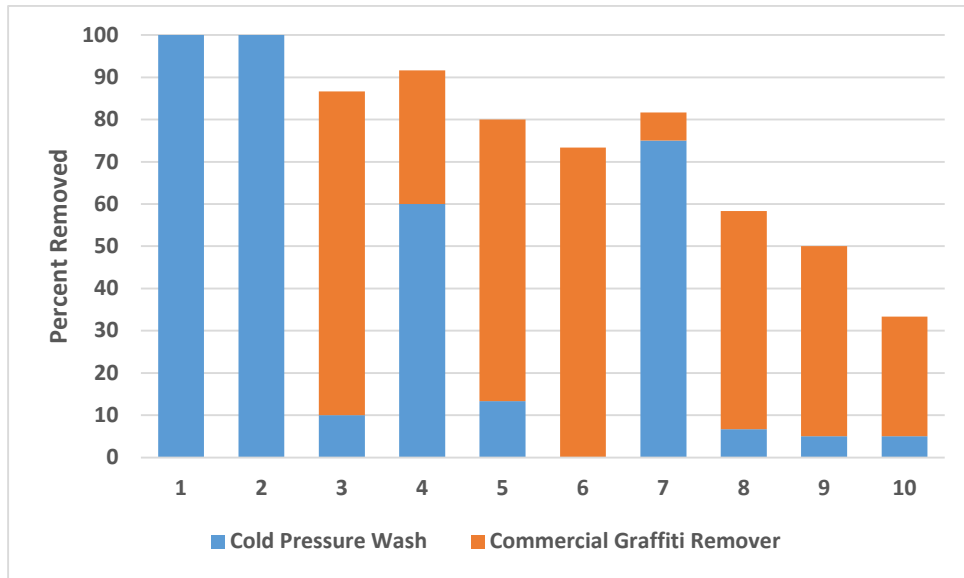
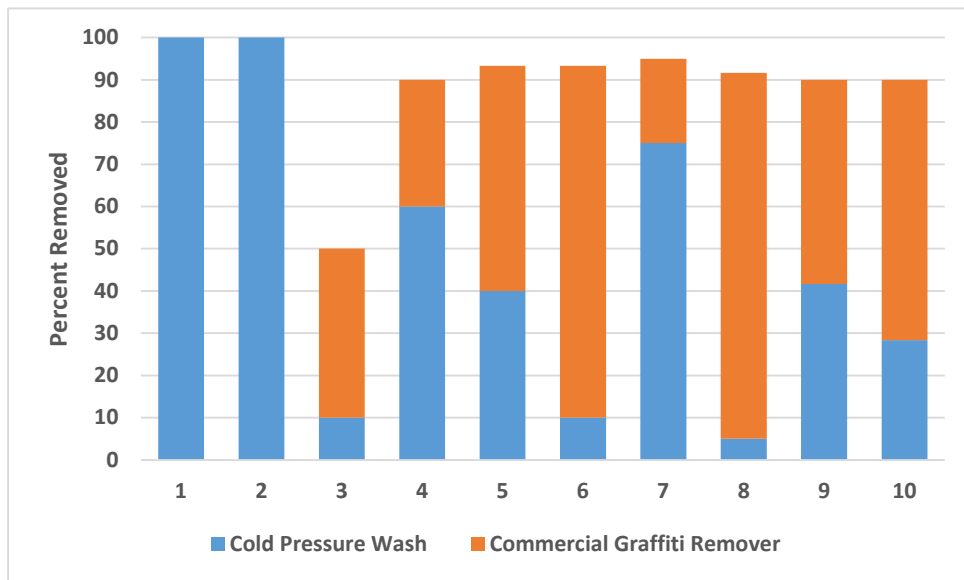
One MC-300 specimen was coated before the first test and then recoated prior to cycles 4 and 7 to assess the effects of reapplication. Although the results shown in Figures 31a and 31b indicate that reapplication of the MC-300 coating restored most of the graffiti resistant capabilities, especially for the cold-pressure wash alone, reapplication does not fully restore those capabilities. The recoated MC-300 concrete specimen was evaluated as Cleanability Level 1 for the first two cycles only.

There are a few possible reasons as to why graffiti resistant capabilities were not fully restored. First, the pressure washer partially removed the MC-300 coating which allowed for graffiti of subsequent cycles to adhere to the concrete itself, resulting in performance similar to uncoated specimens. Second, the MC-300 coating was reapplied over the leftover graffiti from previous cycles, which would prevent the removal of old graffiti in subsequent cycles. Last, the pressure washer removed cement paste at the surface of the specimen. This could result in cavities where it is difficult to get a full and even coating of the MC-300 and also provide areas that are difficult to remove graffiti from on subsequent cleanings.

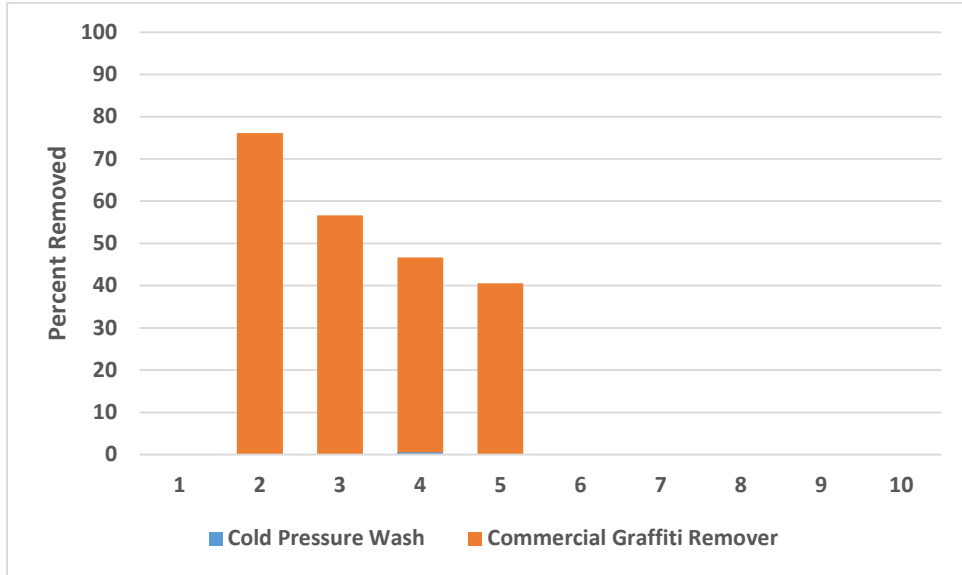
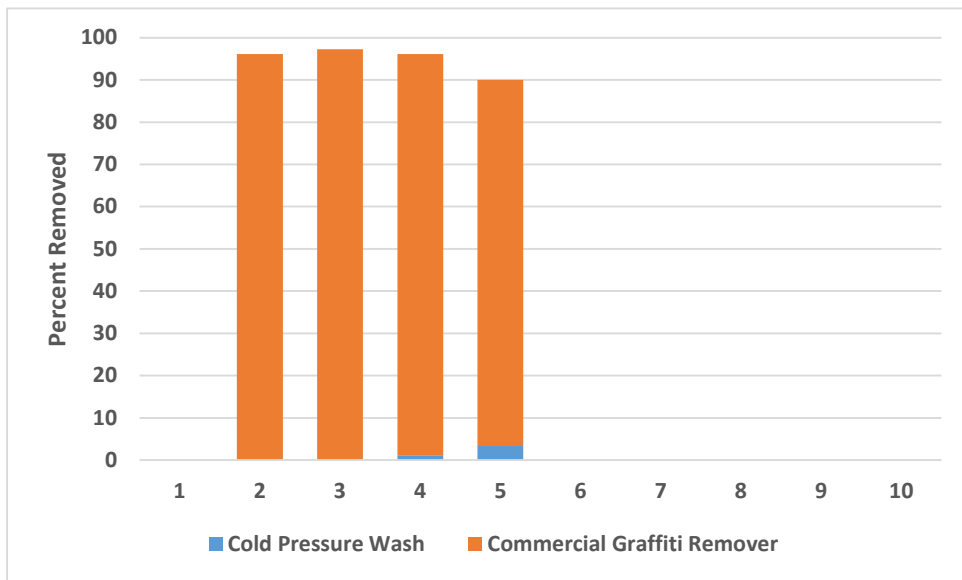
The performance of MC-500 coated concrete specimens are shown in Figure 32. As stated, the first cycle did not utilize the commercial graffiti remover as indicated by the orange column. Additionally, the MC-300 coated specimens were not able to be cleaned with the cold-water wash alone, resulting in a blank column for the first cycle. It was observed that utilizing the commercial graffiti remover on subsequent cycles resulted in spray paint removal comparable to the uncoated specimens and near complete removal of the permanent marker. Testing was discontinued after the fifth cycle due to the MC-500 coating consistently performing worse than the uncoated specimens after cold-water wash alone. The MC-500 coating was more durable than the MC-300; however, moderate wear was noticed after five cycles including thinning of the MC-500 coating and appearance of holes on the surface. The MC-500 coated concrete specimens were rated as not cleanable for spray paint (Figure 32a) and Cleanability Level 2 for five cycles for permanent marker (Figure 32b).

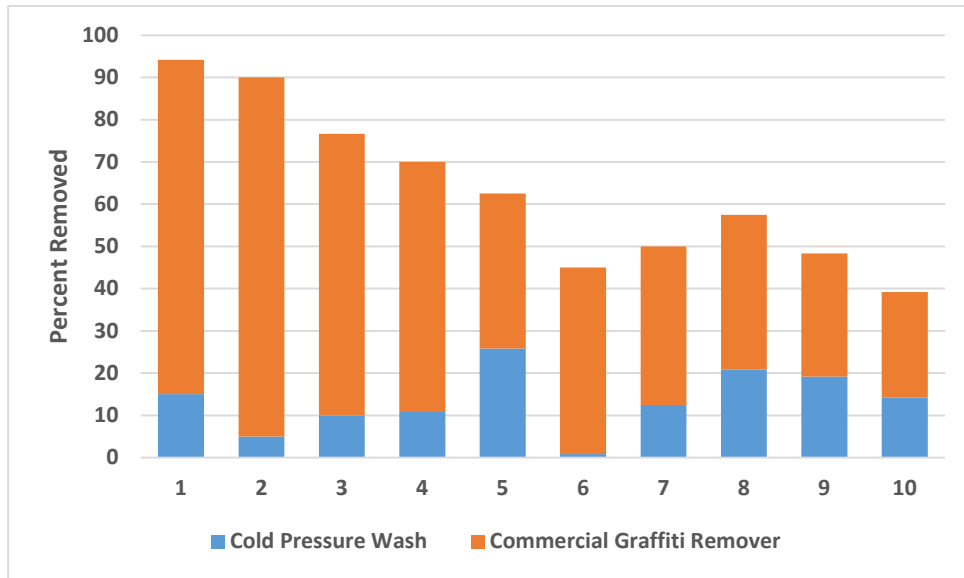
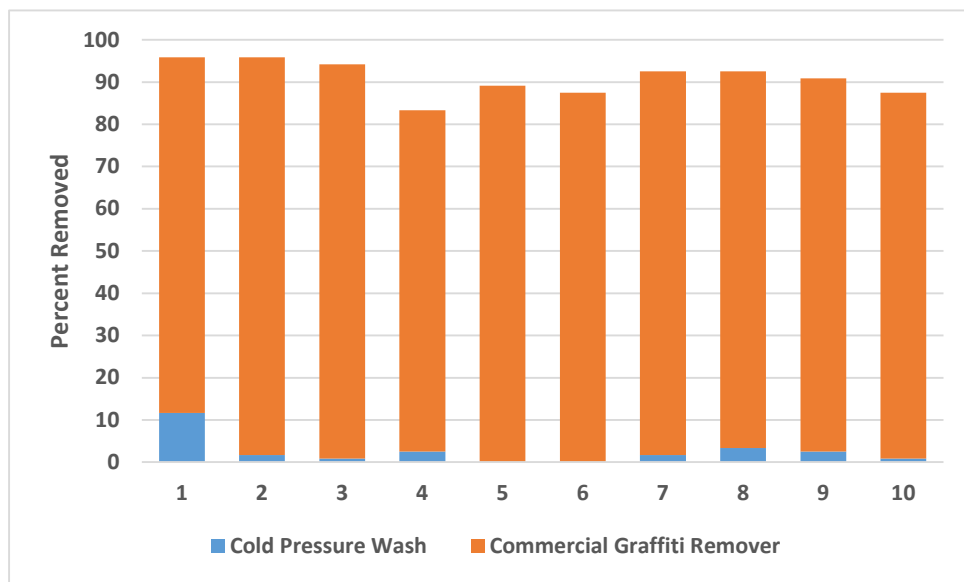
Figures 33 and 34 show the performance of uncoated and MC-300 specimens as a function of number of test cycles. Uncoated specimens (Figure 33) were unable to be fully cleaned with the pressure washer alone; near complete removal was obtained with the commercial graffiti remover, although the effectiveness decreased as the number of test cycles increased. As was observed on the concrete specimens, performance against spray paint (Figure 33a) declined as the number of cycles of testing increased; the performance against permanent marker (Figure 33b) remained consistent resulting in approximately 90% of total graffiti removal through the duration of the test cycles. The uncoated steel specimens were rated as Cleanability Level 2 for two cycles of spray paint and Cleanability Level 2 for three cycles of permanent marker.

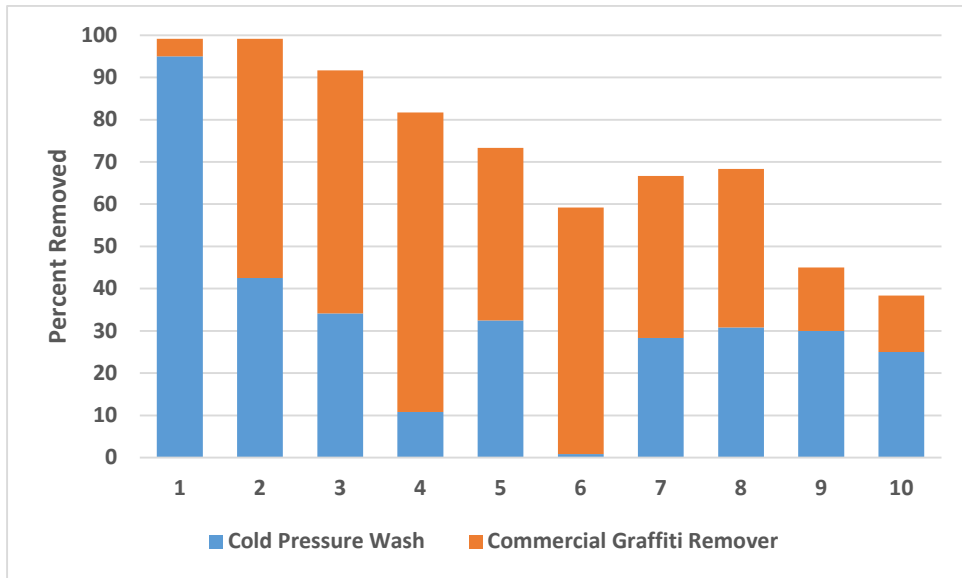
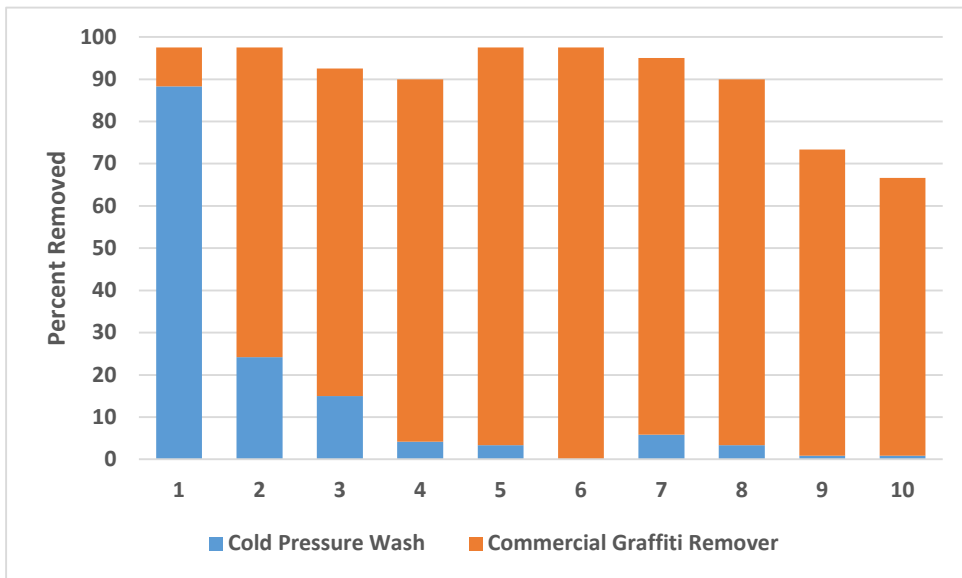
MC-300 specimens (Figure 34) were able to be fully cleaned with the cold-water pressure wash; however, the coating was partially removed by this process. After one cycle, the coating was sufficiently removed that performance declined. After three cycles, the MC-300 specimens performed comparably to uncoated specimens. Based on Figure 34a, the MC-300 coated steel specimens were rated as Cleanability Level 1 for one cycle and Cleanability Level 2 for an additional two cycles of spray paint. As depicted in Figure 34b, the MC-300 coated steel specimens were rated as Cleanability Level 2 for eight cycles of permanent marker. A photo comparison of uncoated and MC-300 specimens during the second and tenth cycle of the pressure-wash test are shown in Figures 35a and 35b, respectively.

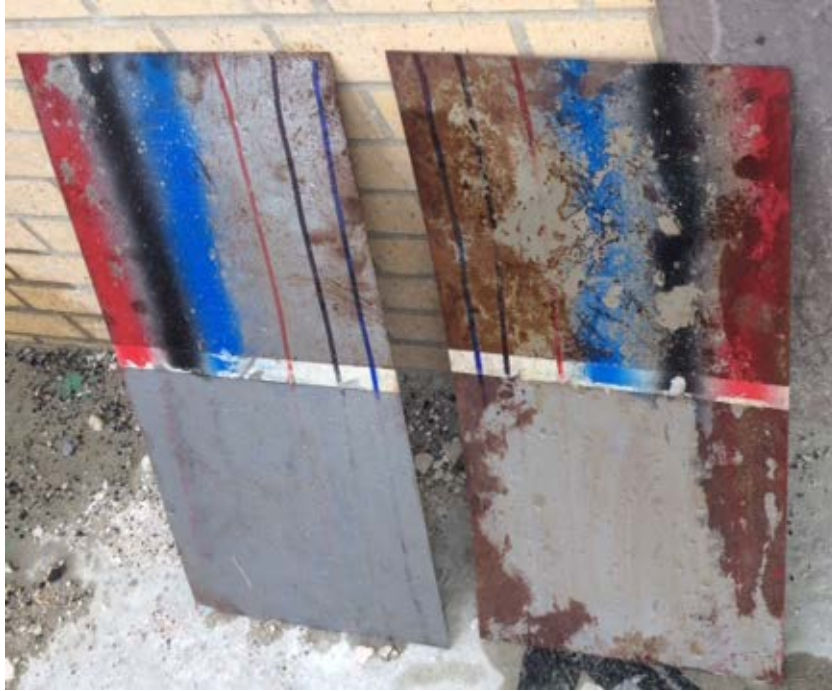
**Figure 31a:** Pressure Washer Test - 2nd Cycle. Uncoated steel (top) and steel coated with MC-300 (bottom).

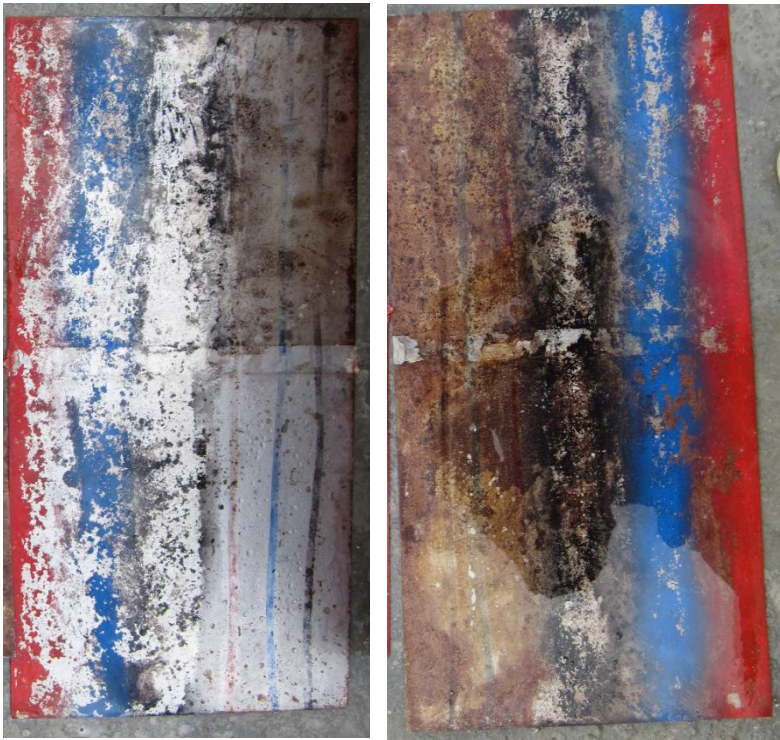
**Figure 35b32:** Pressure Washer Test - 10th Cycle. Uncoated steel (top) and steel coated with MC-300 (bottom).
