Title No. 113-S69

# Effect of Preexisting Cracks on Lap Splice Strength of Reinforcing Bars

by Jiqiu Yuan, Matthew O'Reilly, Adolfo Matamoros, and David Darwin

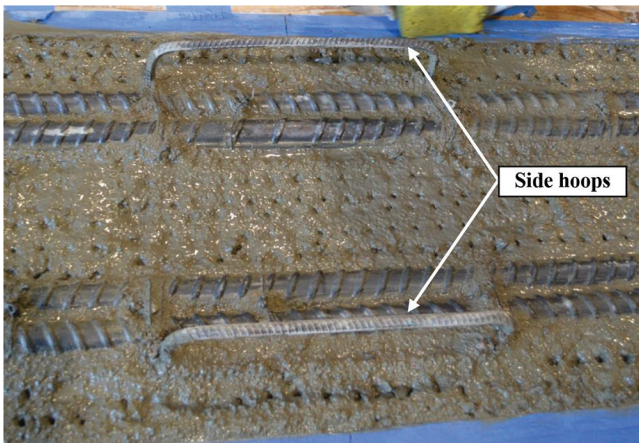
Fig. 2—Side hoops crossing plane of cold joint in Beams 5 through 10, outside spliced bars, at center of specimen.

(Fig. 2). Beams 5 through 7 had a splice length of 79 in. (2007 mm). Beams 6 and 7 had a 20 ft (6096 mm) long cold joint. Beams 8 through 10 had a splice length of 120 in. (3048 mm) and a 23 ft (7010 mm) long cold joint.

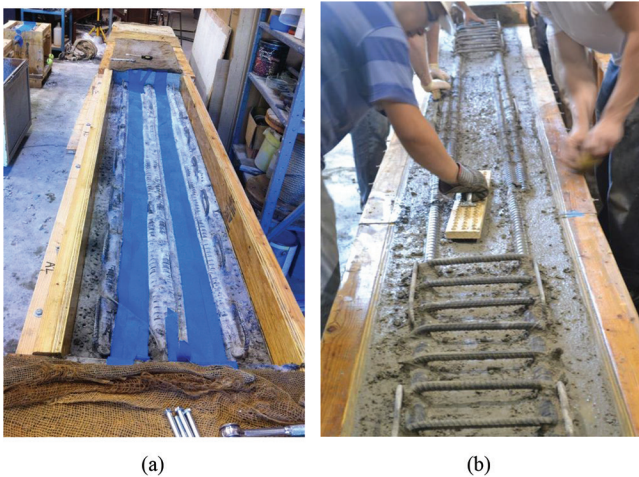
Fig. 3—(a) Painter’s tape placed adjacent to spliced bars to serve as crack initiator for Beams 1 and 2; and (b) roughening of concrete surface at plane of cold joint; used for Beams 3 through 10.

Specimens with cold joints were cast using two placements. In the first placement, concrete was cast up to the center of the top layer of reinforcement. Beams 1 and 2 were cast with two layers of painter's tape within the cold joint to serve as crack initiators. The painter's tape was placed adjacent to the spliced bars (Fig. 3(a)). The rest of the beams were cast without painter's tape in the cold joint. To simulate the roughness of a natural crack in Beams 3 through 10, the surface of the cold joint was treated by introducing indentations while the concrete remained plastic (Fig. 3(b)). The exposed reinforcing steel was cleaned using sponges

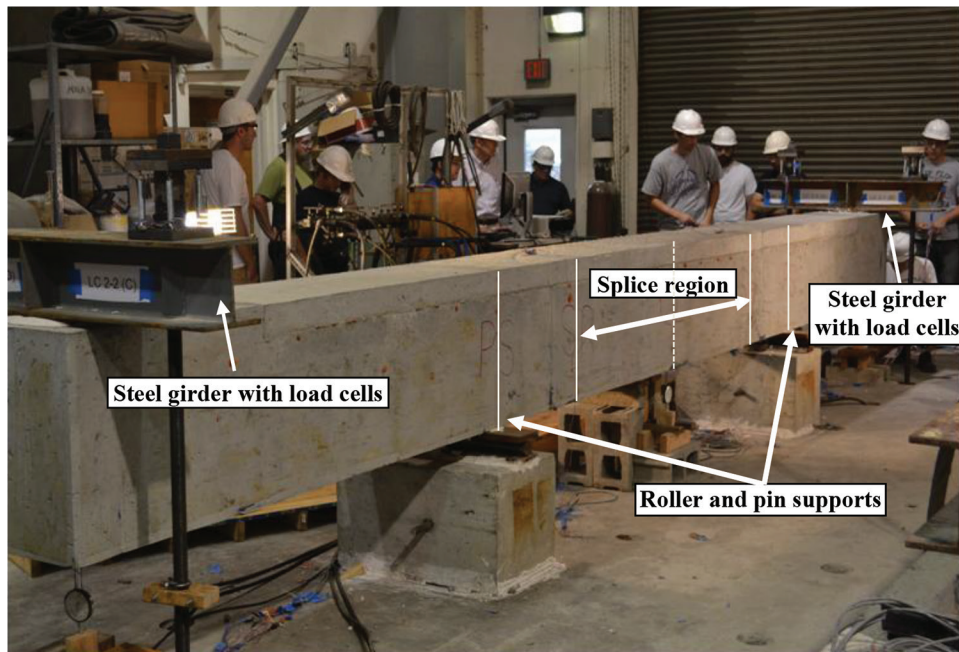
Fig. 4—Four-point loading configuration.

The splice specimens were tested using a four-point loading configuration (Fig. 4). Loads were applied in the downward direction, with the main flexural reinforcement located at the top of the beam, to facilitate safe inspection of cracks in the area surrounding the splices. Forces were induced using hydraulic rams mounted under the laboratory floor and connected to threaded load rods. Steel girders spanning two load rods were used to transfer the load at each end

of the beams (Fig. 4). Hydraulic pressure was applied to the rams through a manifold while the force was recorded in load cells mounted on each of the load rods. The magnitude of the forces was closely monitored to ensure that equal-magnitude loads were applied on both ends of the beam. The splice region was located between the two supports, in the constant moment region of the beam. The beams were instrumented to measure the displacement at the ends and at midspan.

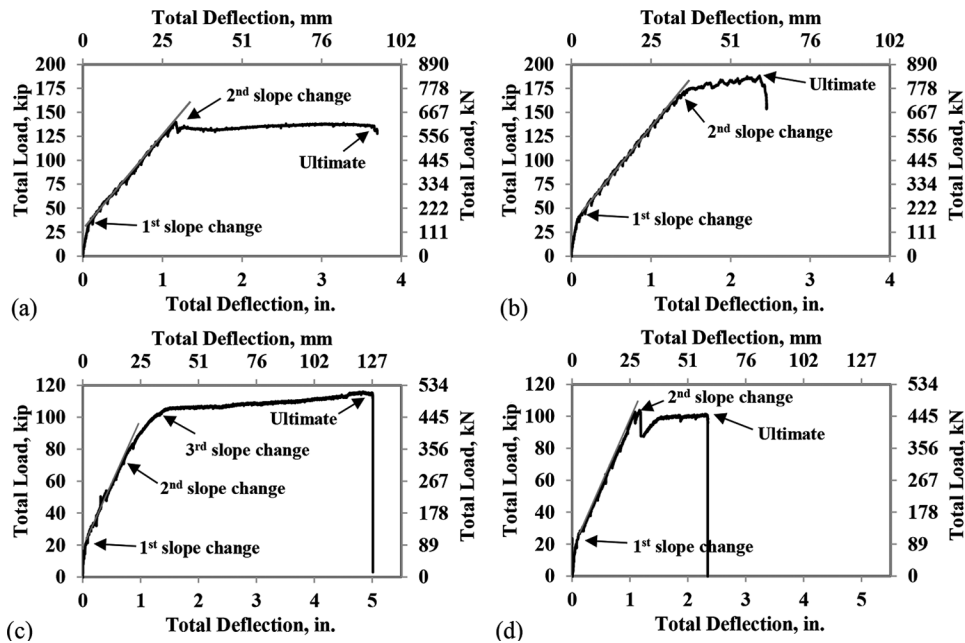
Fig. 5—Total load versus total deflection for: (a) Beam 1 (16 side hoops, 33 in. [838 mm] splice length); (b) Beam 2 (16 side hoops, 79 in. [2007 mm] splice length); (c) Beam 3 (without side hoops, 33 in. [838 mm] splice length); and (d) Beam 4 (without side hoops, 79 in. [2007 mm] splice length).

Load-deflection curves are presented for each beam (for example, Fig. 5 for Beams 1 through 4). The load shown in the figures corresponds to the total load applied to the beam; the deflection was calculated by adding the average of the two end point displacements and the displacement at the center of the beam. Points corresponding to changes in stiffness (changes in slope of the load-deflection diagram) and failure are shown in each figure. Loads and corresponding bar stresses at different stages of loading, including the load at which horizontal splitting cracks were first observed, are summarized in Table 3. The first reduction in stiffness in the load-deflection diagram correlated closely with the point at which flexural cracks were observed for the first time, in all instances, at a calculated bar stress based on cracked section properties of approximately 16 ksi (110 MPa). Subsequent reductions in stiffness in the load-deflection diagram are attributed to either splice failure or yielding of the flexural reinforcement. A detailed description of measurements recorded during the tests is presented by Yuan et al. (2012). Key observations about the mode of failure of each beam are presented in the following.

*Beam 1*—The load-deflection curve for Beam 1 (splice length of 33 in. [838 mm]) is presented in Fig. 5(a). The

post-flexural cracking proportional limit was observed at a total load of 140 kip (623 kN) and a total deflection of 1.14 in. (29 mm) (Fig. 5(a)). At this point, the calculated bar stress based on moment-curvature analysis was 54 ksi (372 MPa) (Table 3). This value correlates very closely with the bar stress at failure of a 33 in. (838 mm) splice in monolithic concrete (53 ksi [365 MPa]), as shown in Table 1)

The shape of the load-deflection curve for Beam 3 (Fig. 5(c)) was noticeably different from that of Beam 1. For Beam 3, there was a very gradual reduction in stiffness starting at a load of approximately 70 kip (311 kN), and continuing up to a load of 102 kip (454 kN), where the tangent stiffness became almost zero. Horizontal splitting cracks in the splice region were first observed at the cold joints at a load of approximately 60 kip (267 kN). Assuming equal force in the three longitudinal bars, the calculated bar stresses corresponding to loads of 60 and 70 kip (267 and 311 kN) are 30 and 34 ksi (207 and 234 MPa), respectively (Table 3). The bar stress corresponding to a load of 102 kip (454 kN), assuming that the splice had failed and the tensile force was carried entirely by the two continuous bars, is 71 ksi (490 MPa), which is slightly above the measured yield stress for the reinforcing bars (67 ksi [462 MPa]). Based on the load readings, the shape of the load-deflection curve, and the observed crack pattern, it is concluded that failure of the splice initiated at a bar stress of 34 ksi (324 MPa), which corresponds to 64% of the calculated capacity of the splice in monolithic concrete (53 ksi [365 MPa]), and that the force in the spliced bar was gradually transmitted to the two continuous bars until they reached yielding at a total load of 102 kip (454 kN). As displacement increased beyond the yield point, the load-carrying capacity increased due to strain hardening of the reinforcement. The test was finally halted at a total load of 113 kip (503 kN) due to the presence of large flexural cracks. The widest cracks in Beam 3 developed through the cold joint (Fig. 6(b)), which is indicative of splice failure through the plane of the cold joint. The location of the splitting cracks observed in Beam 3 was different from that observed in Beams 1 and 2, in which the splitting cracks propagated vertically through the top cover.

**Beam 4**—Beam 4 (splice length of 79 in. [2007 mm]) exhibited a sudden drop in load at the post-flexural cracking proportional limit, which is indicative of a sudden splice failure (Fig. 5(d)). The measured load at the proportional limit was 102 kip (454 kN), corresponding to an average bar stress in the three bars of 50 ksi (345 MPa) (Table 3), approximately 51% of the calculated failure stress of a similar splice in monolithic concrete (98 ksi [676 MPa], per

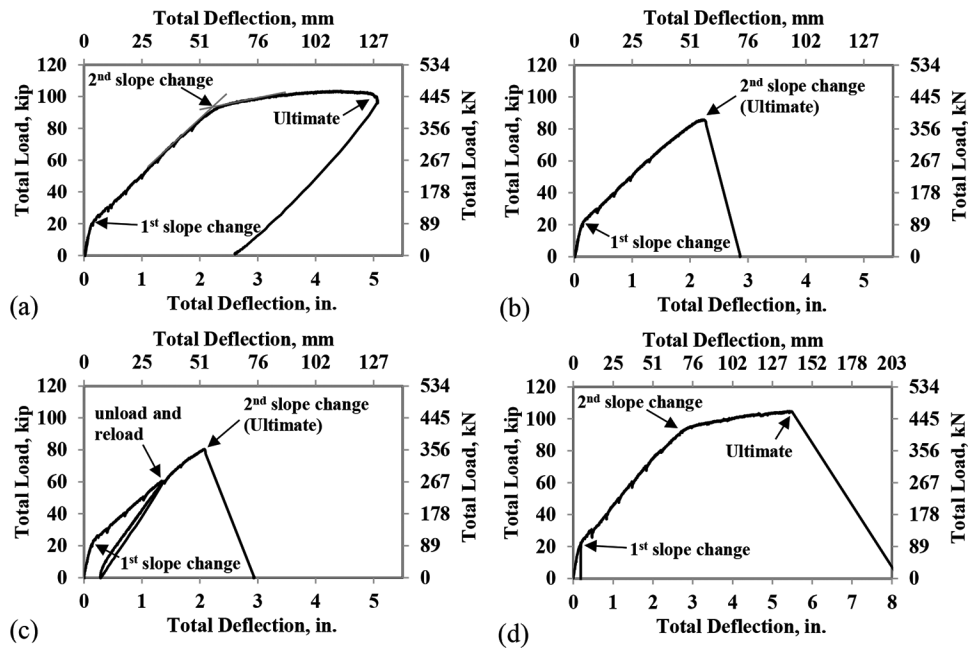
Fig. 7—Total load versus total deflection for: (a) Beam 5 (79 in. [2007 mm] splice length, cast monolithically Loading Protocol A); (b) Beam 6 (two side hoops, 79 in. [2007 mm] splice length, cold joint, and Loading Protocol A); (c) Beam 7 (two side hoops, 79 in. [2007 mm] splice length, cold joint, and Loading Protocol B), and (d) Beam 8 (two side hoops, 120 in. [3048 mm] splice length, cold joint, and Loading Protocol A).

**Beam 5**—As stated earlier, calculations showed that the bars in this beam were expected to yield prior to failure of the splice. The load-deflection relationship for Beam 5, shown in Fig. 7(a), had a tri-linear shape. Horizontal splitting cracks were observed during the test, as shown in Fig. 8(a), although the dimensions of the cracks were not indicative

The load-deflection curves for Beams 6 and 7 are shown in Fig. 7(b) and (c). The first horizontal splitting cracks within the splice region of Beams 6 and 7 were observed at total loads of 40 and 30 kip (178 and 133 kN), respectively, corresponding to inferred bars stresses of 29 and 22 ksi (200 and

The load-deflection relationships for Beams 8, 9, and 10 are shown in Fig. 7(d), 11(a), and 11(b), respectively. All three beams exhibited similar behavior during loading. The first horizontal splitting cracks within the splice region were observed at total loads of 40, 30, and 40 kip (178, 133, and 178 kN) for Beams 8, 9, and 10, respectively. The corre-

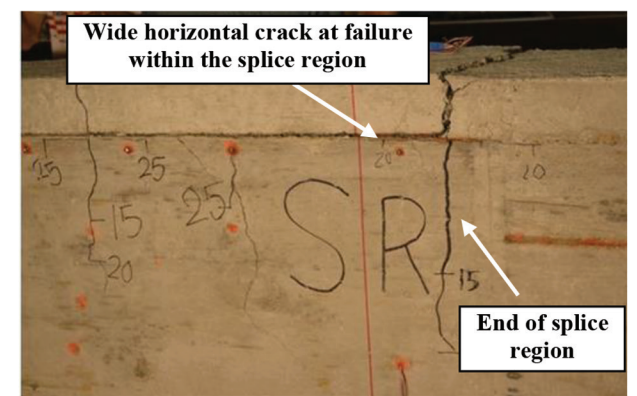
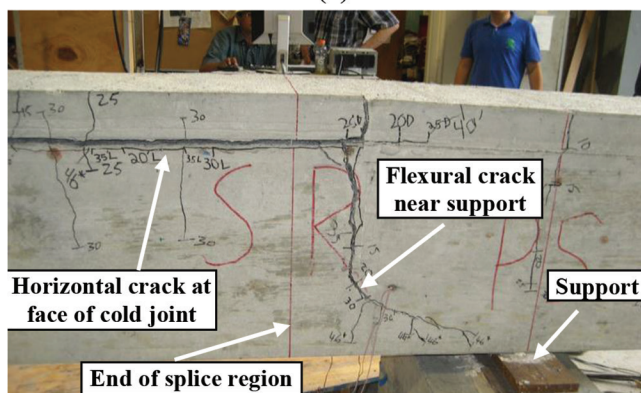
Fig. 9—Failure mode for: (a) Beam 6 with wide horizontal crack along the cold joint; and (b) Beam 8 with horizontal crack along plane of reinforcing steel and flexural cracks near the support.

Beams 6 and 7 failed due to sudden splitting of the concrete along the cold joint in the splice region (Fig. 9(a)). The loads at failure for Beams 6 and 7 were 85 and 80 kip (378 and 552 kN), respectively, which correspond to calculated bars stresses of 62 and 57 ksi (427 and 393 MPa), both below the measured yield stress of 67 ksi (462 MPa). Based on the shape of the load-deflection curves and the observed behavior during the tests, it is concluded that Beams 6 and 7 had splice failures. This mode of failure was confirmed by direct observation of bar slip at the ends of the lap splice, after the cover was removed for final inspection (Fig. 10).

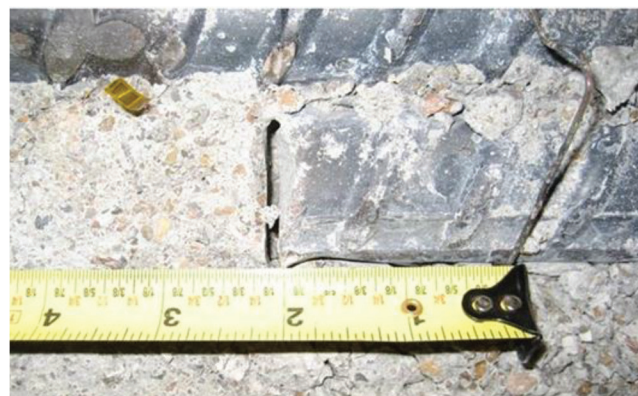
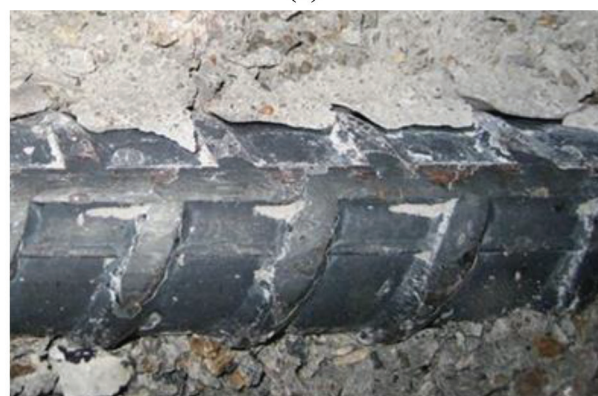
Fig. 10—Splice condition during post-test inspection of Beam 6: (a) bar slip; and (b) separated concrete around spliced bar.

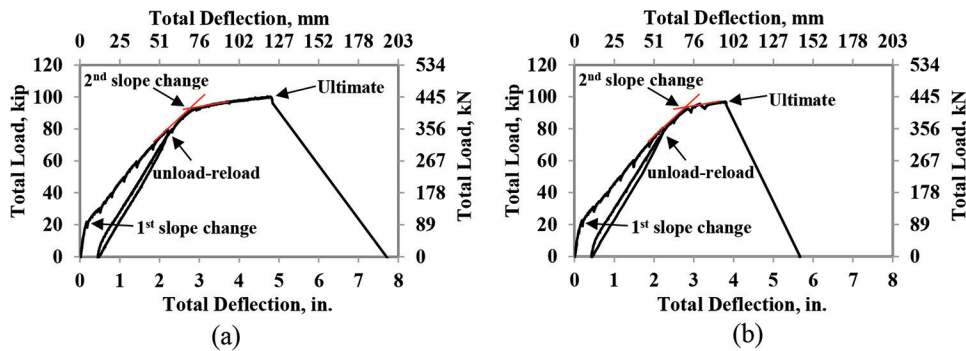
Fig. 11—Total load versus total deflection for: (a) Beam 9 (two side hoops, 120 in. [3048 mm] splice length, cold joint, and Loading Protocol B); and (b) Beam 10 (two side hoops, 120 in. [3048 mm] splice length, cold joint, and Loading Protocol B).

The post-flexural cracking proportional limit of the three load-deflection relationships was observed at total loads of 95, 91, and 92 kip (423, 405, and 409 kN) for Beams 8, 9 and 10, respectively. Based on moment-curvature analyses, the calculated bar stresses associated with those loads were 68, 66, and 66 ksi (469, 323, and 323 MPa), respectively, which are nearly equal to the yield stress of the reinforcement (67 ksi [462 MPa]). As deformation increased beyond the post-flexural cracking proportional limit, the slope of the load-deflection relationship remained positive, which is attributed to strain hardening of the reinforcement. All three beams failed in a sudden manner with wide horizontal cracks in the plane of the cold joint and flexural cracks near the support (the latter shown in Fig. 9(b)). The loads at failure for Beams 8, 9, and 10 were 105, 96, and 100 kip (467, 427, and 445 kN), corresponding to bar stresses of 72, 68, and 69 ksi (496, 469, and 476 MPa), respectively. Based on these measurements and the shape of the load-deflection relationships, it is concluded that in all three cases the splices failed after yielding of the bars. Bar slip was observed in the three beams after removal of the concrete cover for final inspection.
