Composite Action in Prestressed NU I-Girder
Bridge Deck Systems Constructed with
Bond Breakers to Facilitate Deck Removal

Submitted to the graduate degree program in Civil, Environmental, and Architectural
Engineering and the Graduate Faculty of the University of Kansas in partial fulfillment of the
requirements for the degree of Doctor of Philosophy.

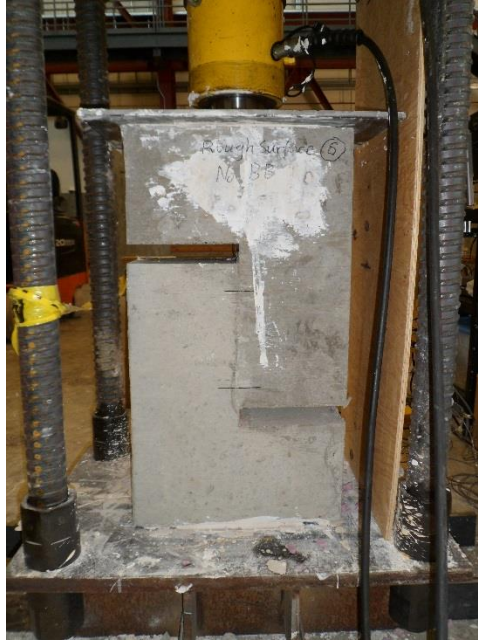
Figure 2.1: Typical Push-off Specimen

This mechanism of horizontal shear transfer has been studied extensively through push-off tests of specimens similar to that shown in Figure 2.1. Since the 1960s, a significant amount of work has been done in this area. The following summarizes key contributions in chronological order.

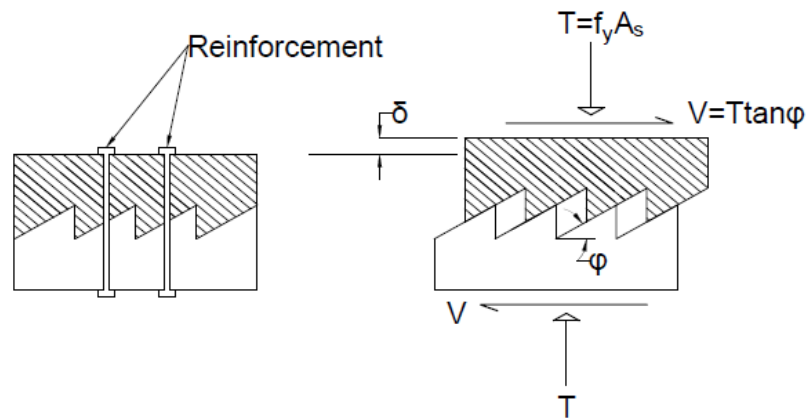
Figure 2.2: Saw-Tooth Model (adapted from Birkeland and Birkeland,1966)

Birkeland and Birkeland (1966) were the first to propose the “shear friction” theory wherein reinforcement crossing a shear plane is assumed to provide a clamping force that induces friction across the interface. A saw-tooth model (Figure 2.2) was proposed to describe the behavior across a cracked interface. Equation 2-1 was proposed to calculate shear transfer strength.

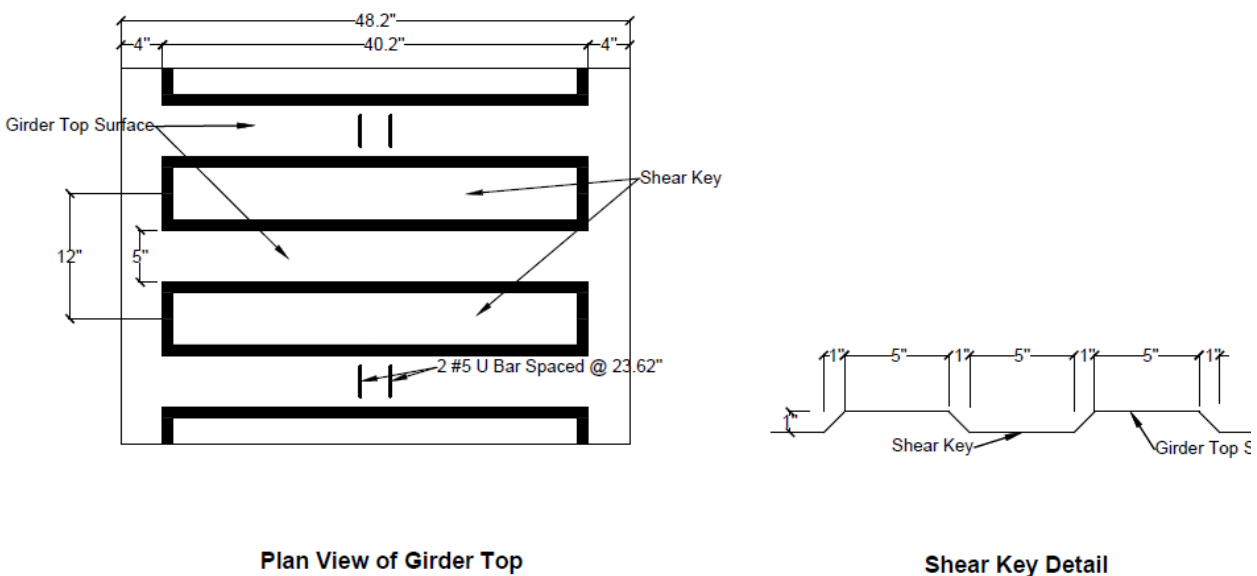
Figure 2.3: Connection Detail

Kamel (1996) proposed a concrete girder-to-deck connection system to facilitate deck replacement and provide sufficient strength for full composite action. The proposed connection detail consisted of an unbonded interface with formed shear keys protruding from the top surface of the girder as illustrated in Figure 2.3. U-shaped epoxy-coated shear connector bars, separate from girder vertical shear reinforcement, extended 6 in. into the concrete deck from the girder. In the study, both push-off tests and full-scale girder tests were performed. Different surface preparations (smooth, rough, and shear key), steel connectors (using 100 ksi high-strength threaded bars or Grade 60 normal-strength reinforcing bars), and bond condition were the main variables.

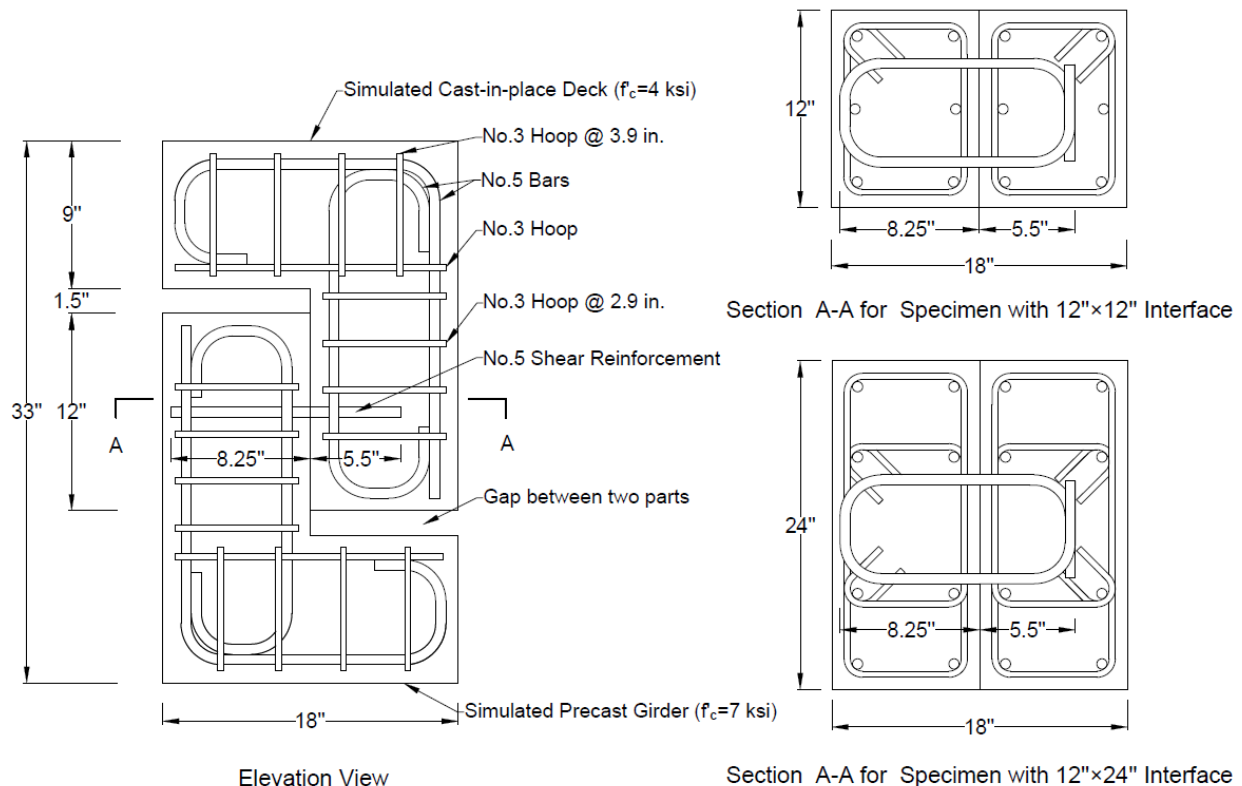
Figure 3.1: Push-off Specimen Detail

Push-off specimen dimensions and reinforcement layouts are shown in Figure 3.1. Each specimen was composed of two antisymmetric L-shaped parts connected across a 12 in. long interface that was either 12 or 24 in. wide, depending on the specimen. The bottommost L-section, which was cast first using 7 ksi concrete, was meant to represent the top flange of a precast concrete bridge girder. The topmost L-section represented the cast-in-place concrete deck. This section was cast several days after the first using 4 ksi concrete. A pair of 1.5 in. wide gaps were formed between the two concrete parts above and below the 12 in. long interface.

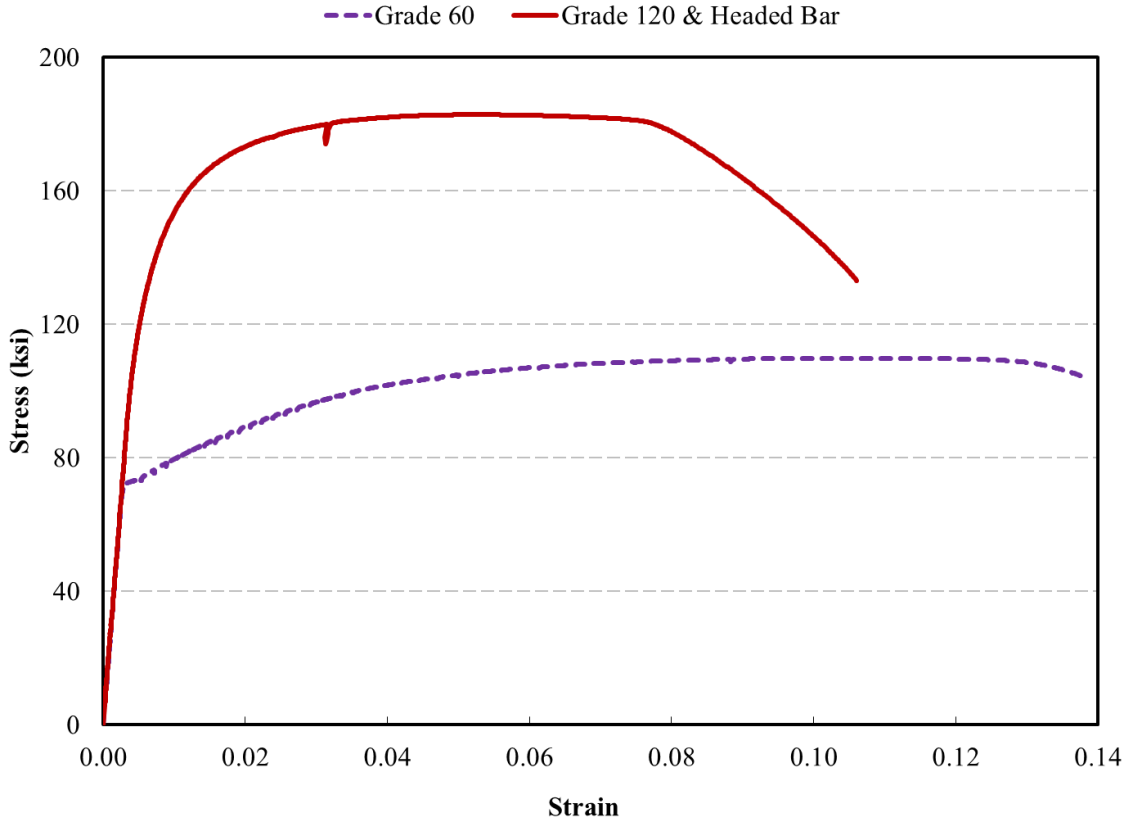
Figure 3.2: Stress-strain Curves for No. 5 bars Used as Interface Shear Reinforcement

For each reinforcing bar grade used to fabricate the specimens, at least two samples were tested under direct tension. The average steel properties determined from tests are listed in Table 3.4 and sample plots of stress versus strain are shown in Figure 3.2 (plots of stress versus strain are provided for all steel in Appendix B). The interface shear reinforcement consisted of normal-strength (ASTM A615/A615M-16 Grade 60) or high-strength (ASTM A1035/A1035M-16 Grade 120) reinforcing bars. Grade 60 ASTM A615 steel was used for all of the ancillary reinforcement.

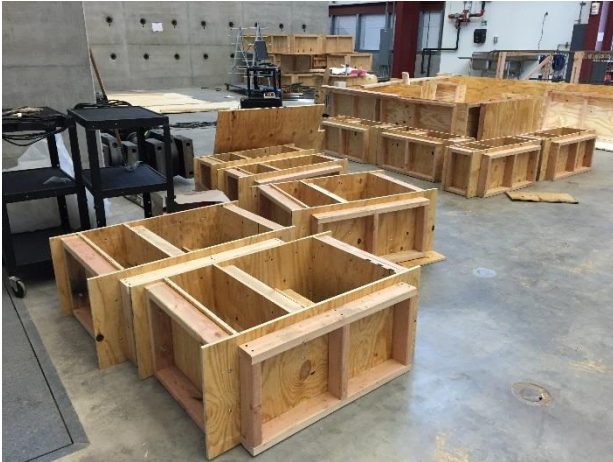
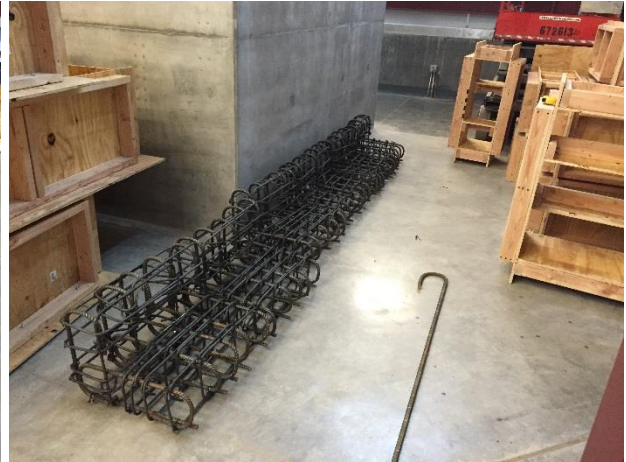
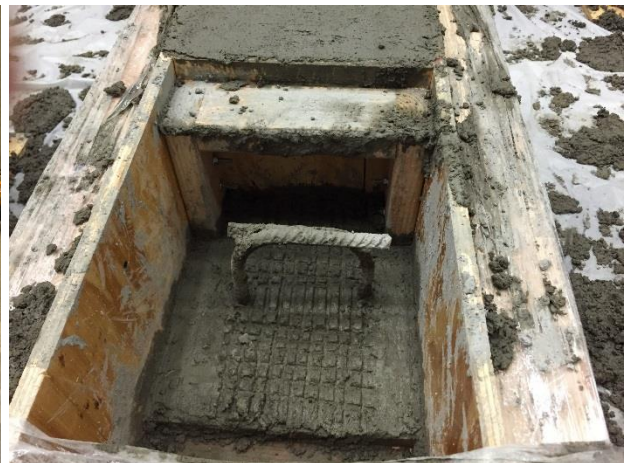
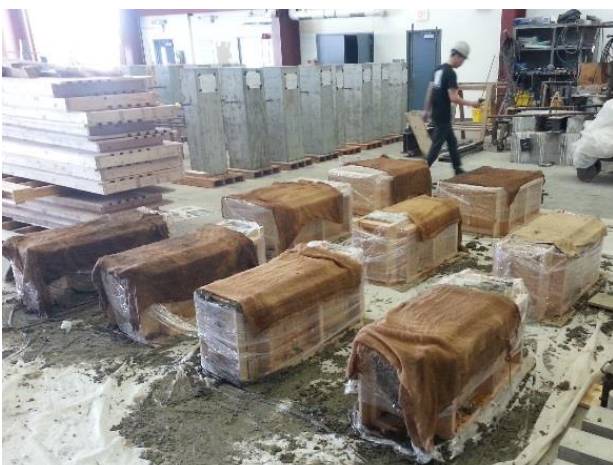
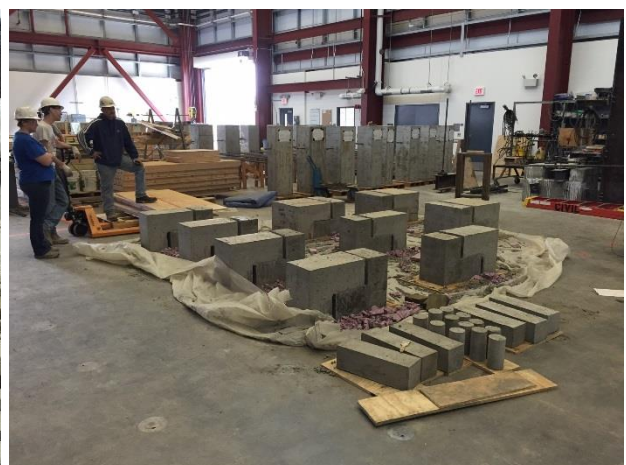
Figure 3.3: Fabrication of Push-off Specimens

(a) Formwork

(b) Reinforcement Cages

(d) Finished Rough Middle Surface

(e) Concrete Curing

(f) Push-off Specimens after Demolding

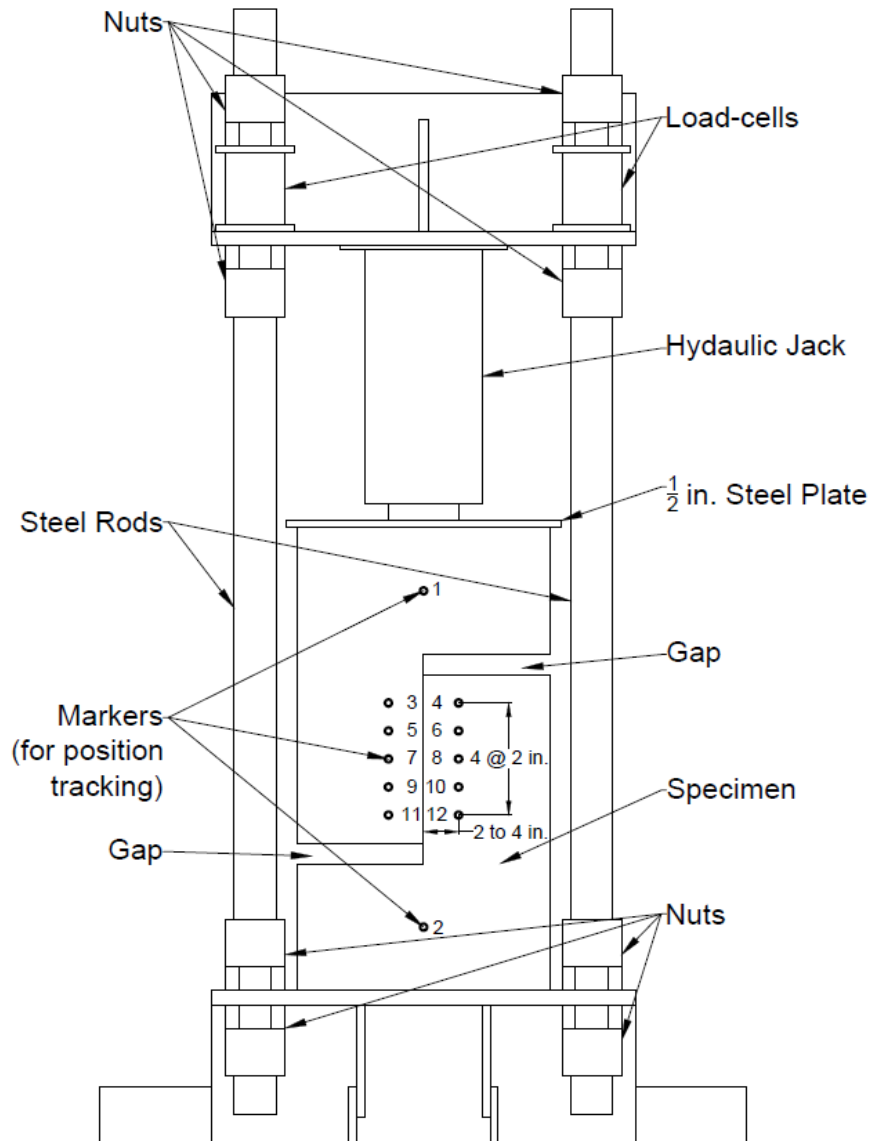
Figure 3.4: Elevation View of the Test Setup

A non-contact infrared-based 3D position tracking system was used to collect data on the location of 12 high-speed markers (placed as shown in Figure 3.4) throughout the tests. These data were then used to calculate deformations of the specimen under load, including crack width, rotation, and relative slip at the interface.

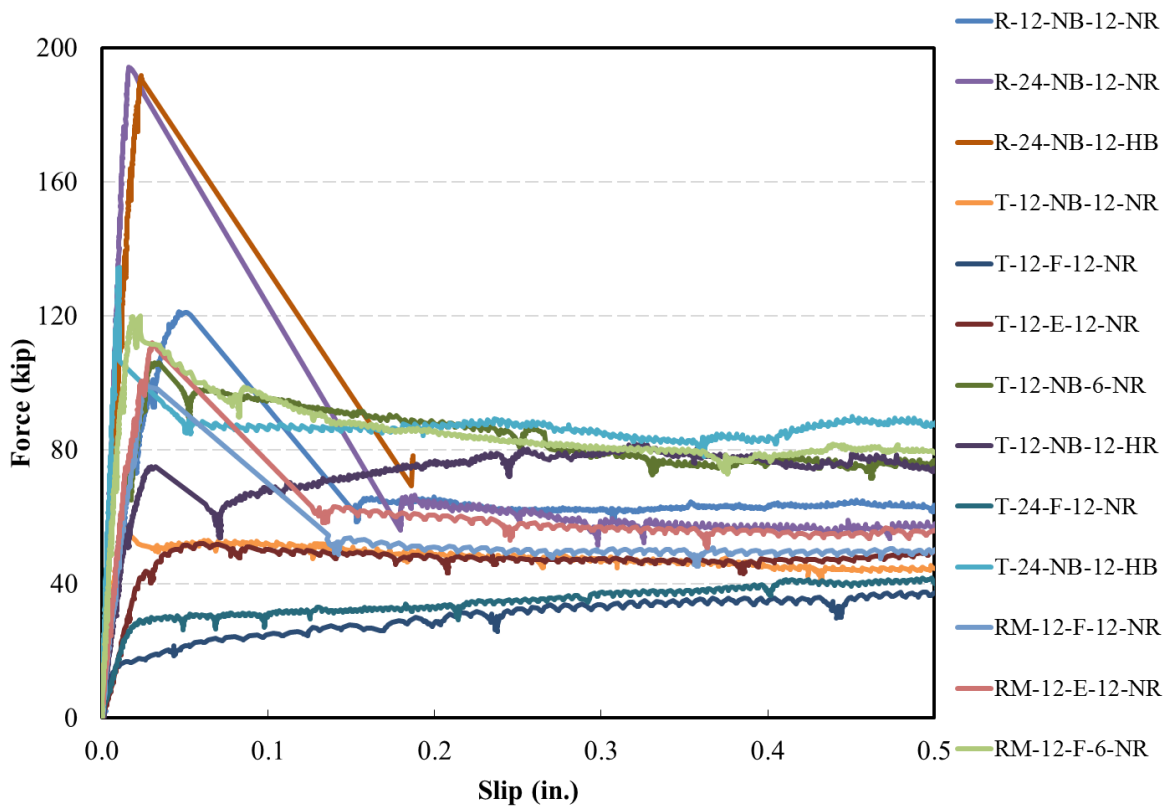
Figure 3.7: Force versus Slip (Specimens Affected by Rotation are Omitted)

horizontal line, where the imposed force was maintained (or slightly increased) as slip increased. For these specimens, the peak force was reached at large values of slip (Table 3.5). For the rest of the specimens, the linear ascending branch continued until the peak force (or initial peak force) was reached at slip values between 0.01 and 0.05 in. (Table 3.5). Upon reaching peak strength, a sudden drop in force was observed in conjunction with a sudden increase in slip. After the sudden drop in force, the specimens continued to support a nearly constant force as the slip was increased similar to the behavior observed in the fully debonded specimens. In all specimens, the force resisted by the specimen at large slips (greater than approximately 0.1 in.) was strongly influenced by reinforcement area and grade and not by interface preparation, suggesting that dowel action dominated at this stage of testing.

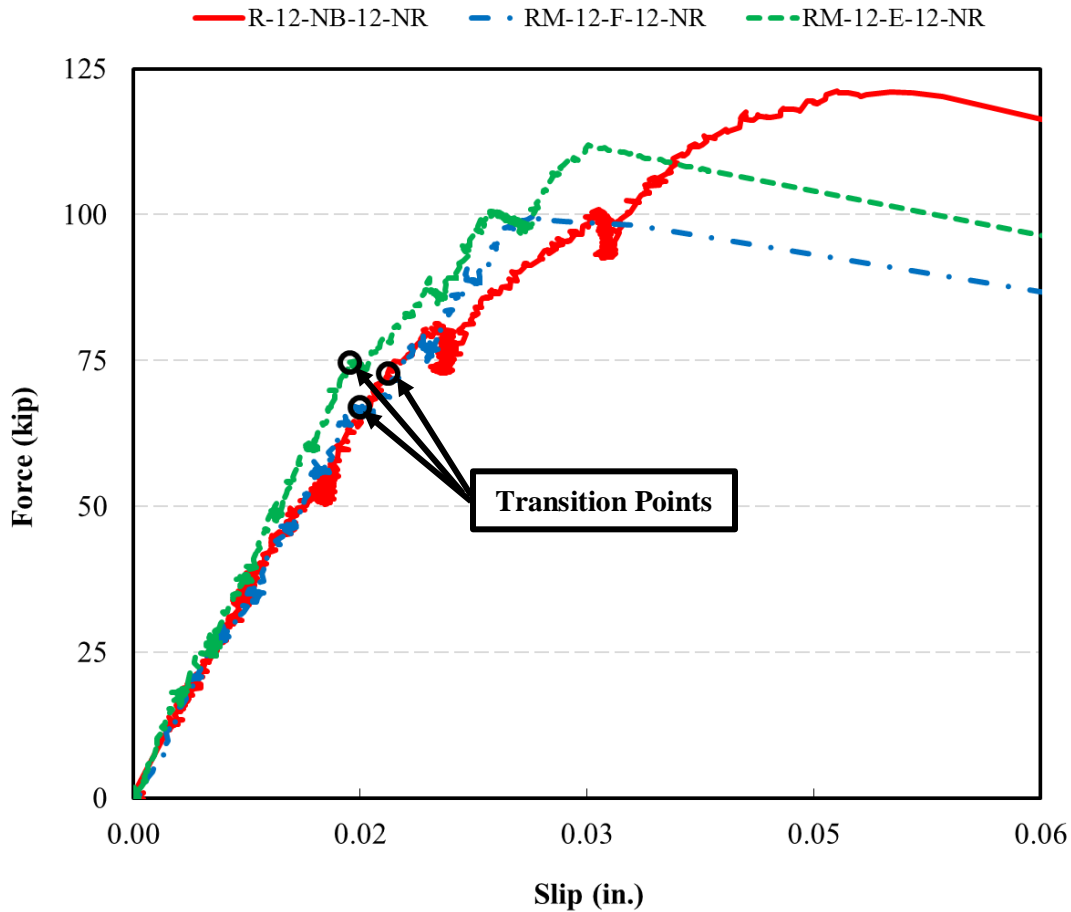
Figure 3.8: Force versus Slip up to a Slip of 0.06 in.

specimens. It appears that reduction of stiffness is related to surface roughness after cracking. Also, the initial stiffness is related to the area of interface shear reinforcement. As the area of reinforcement doubled, the initial stiffness increased for all bonded specimens.

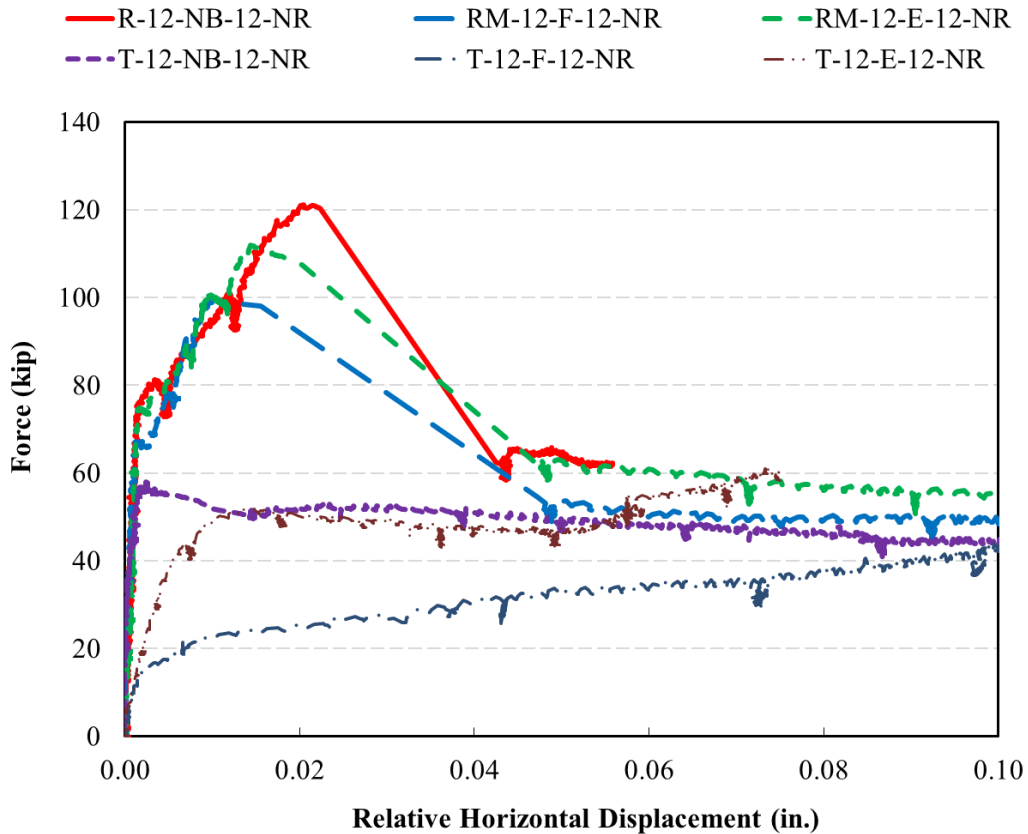
Figure 3.9 Force versus Relative Horizontal Displacement for Selected Specimens

compromised the data collected for a given marker. Figure 3.9 shows force plotted versus relative displacement for a subset of specimens. For the two unbonded specimens (T-12-E-12-NR and T-12-F-12-NR), the plotted results start with an approximately linear initial portion followed by a transition to an approximately horizontal segment. This behavior is very similar to the force versus slip relationships in Figure 3.7. For the specimens with some or all of the interface intentionally roughened (R-12-NB-12-NR, RM-12-E-12-NR, RM-12-F-12-NR), the relationship prior to peak strength is clearly composed of two segments with markedly different slopes. The transition point between the initial and secondary loading segments is the same as for the force versus slip relationships and coincides with cracking at the interface. After this transition point (cracking), relative displacements increased with load at a much greater rate than before. Although not visible in Figure 3.9, the initial ascending branch for T-12-NB-12-NR was also approximately bi-linear.

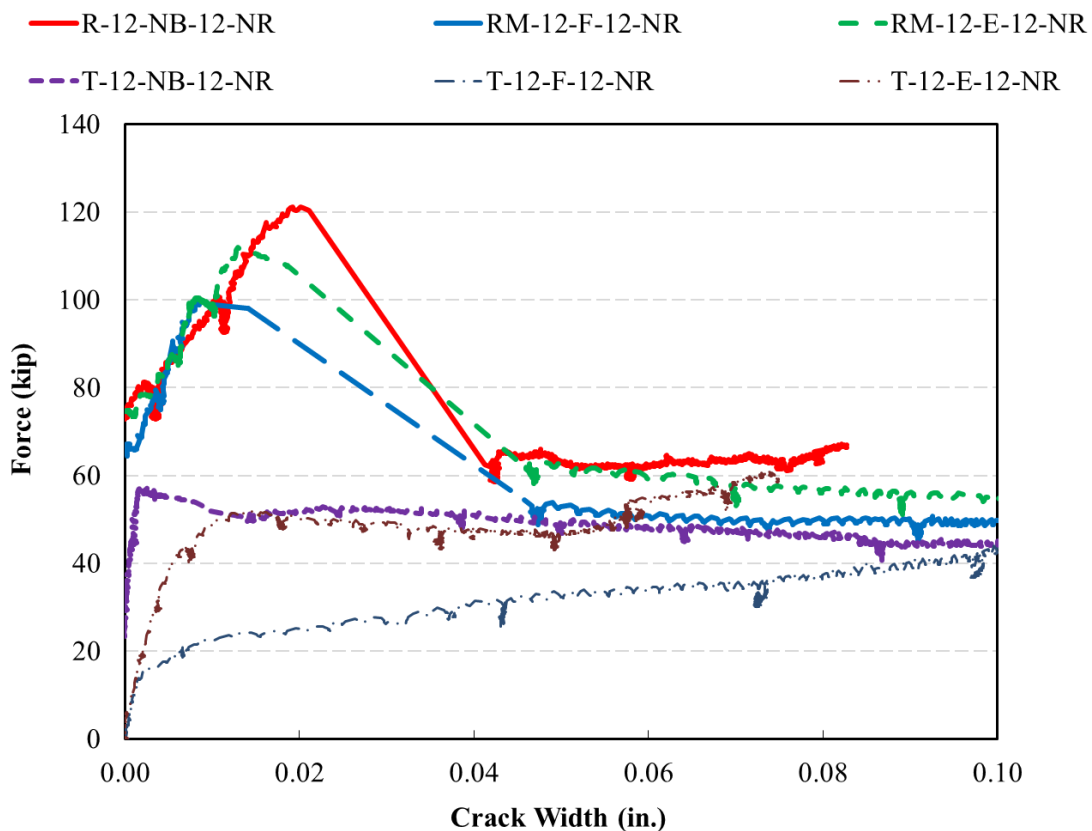
Figure 3.10 Force versus Crack Width

To estimate crack width in specimens with some portion of the interface that was initially bonded, it was assumed that crack width was zero until first cracking and that crack width after cracking was equal to the calculated relative horizontal displacement between markers minus the relative horizontal displacement at first cracking. This method does not account for any rebound of strains that might occur within the concrete between the markers and the interface after cracking, but it is believed that inaccuracies due to this omission are minor. For specimens with a fully debonded interface, it was assumed that calculated relative horizontal displacements were entirely attributable to separation of the surfaces (a “crack”). For these specimens, crack width was set equal to relative horizontal displacement. Force is plotted versus crack width in Figure 3.10 for the same specimens shown in Figure 3.9.

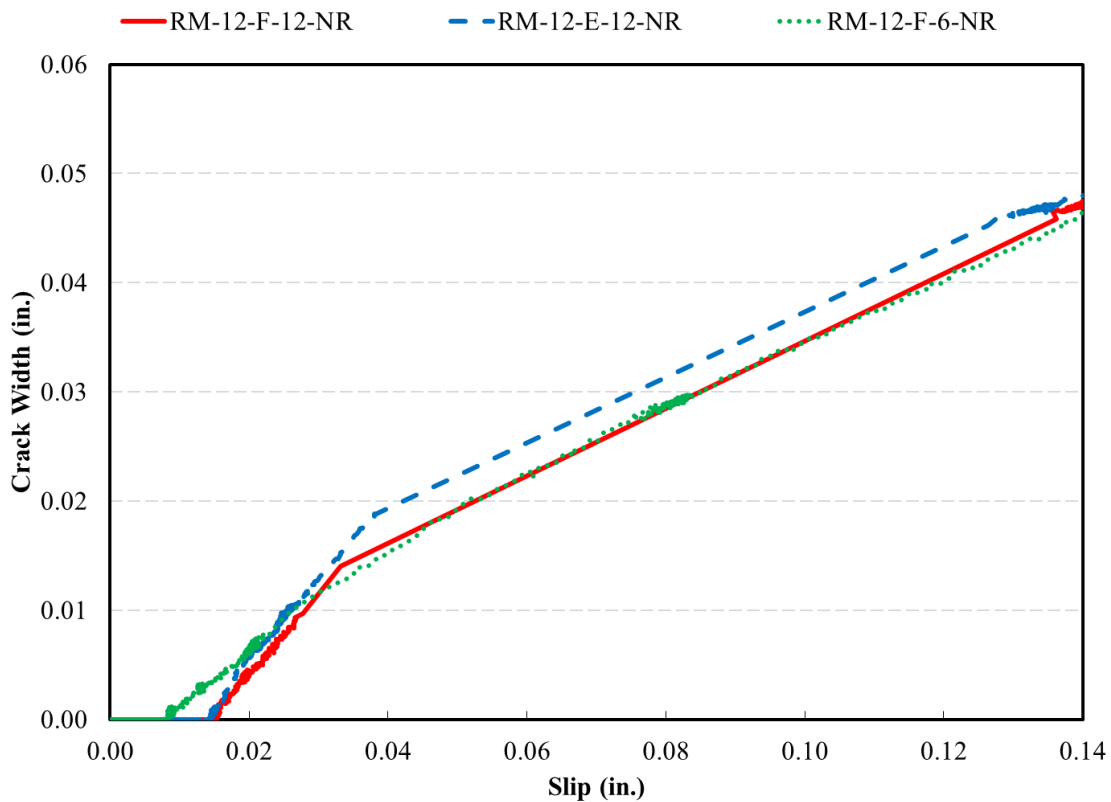
Figure 3.11: Crack Width versus Slip for Rough Middle Specimens

Crack width is plotted versus slip for most specimens in Figures 3.11 through 3.14 (individual plots are provided in Appendix D). Results for rough middle (RM-12-F-12-NR, RM-12-E-12-NR, and RM-12-F-6-NR) and rough specimens (R-12-NB-12-NR, R-24-NB-12-NR, and R-24-NB-12-HB) are shown in Figures 3.11 and 3.12. Both figures show that the specimens typically exhibited some slip (up to approximately 0.015 in.) prior to cracking. After cracking, crack width and slip increased somewhat proportionally, although the slope varied among the specimens. This post-cracking but pre-peak region of behavior is what most researchers refer to as shear friction – where slip requires a proportional increase in crack width and, therefore, strain in the reinforcement crossing the interface. For most specimens included in Figures 3.11 and 3.12, the proportional region of behavior clearly transitioned to one with a reduced slope, where increasing slip was associated with a smaller change in crack width. This transition coincided with the peak strength shown in Figure 3.7. Therefore, after the specimens reached peak strength, slip increased rapidly while crack width increased slowly.

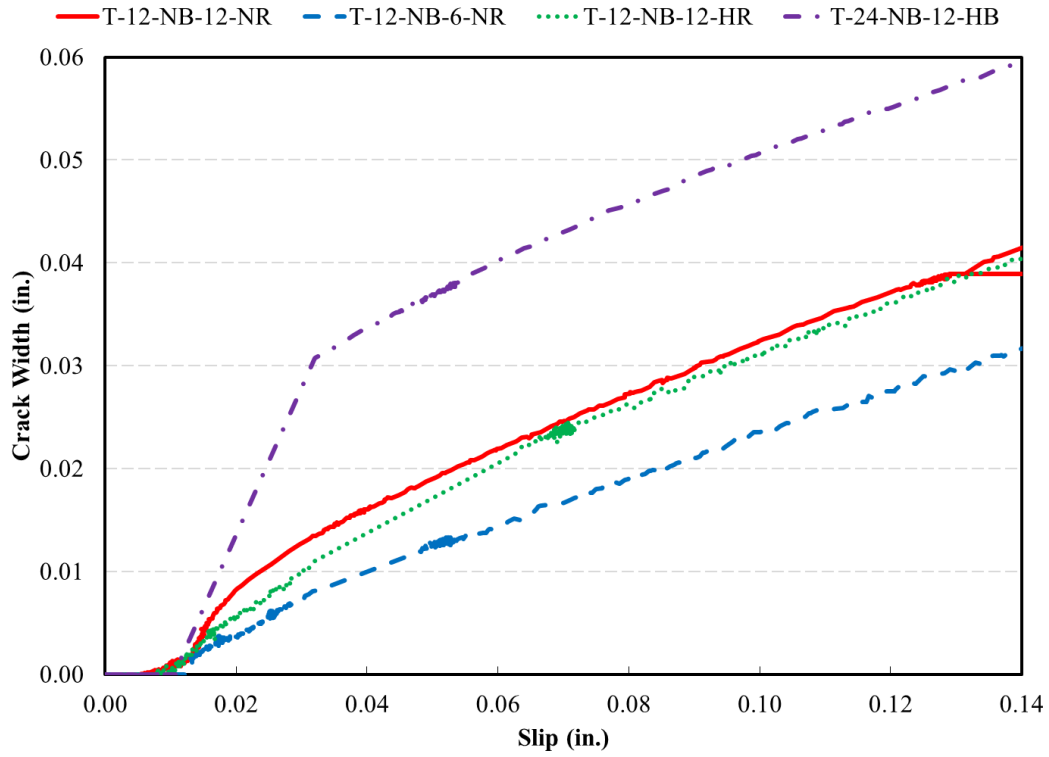
Figure 3.13: Crack Width versus Slip for Troweled Specimens without Bond Breakers

Crack width is plotted versus slip in Figure 3.13 for bonded troweled specimens (T-12-NB-12-NR, T-12-NB-6-NR, T-12-NB-12-NR and T-24-NB-12-NR) and in Figure 3.14 for debonded troweled specimens (T-12-F-12-NR, T-12-E-12-NR, T-24-F-12-NR). All of the bonded troweled specimens exhibited slip (of approximately 0.01 in.) prior to cracking. After cracking, three of the four bonded troweled specimens (T-12-NB-12-NR, T-12-NB-6-NR, T-12-NB-12-NR) exhibited the approximately bi-linear post-cracking response typical of roughened specimens. However, the slope of the post-cracking region for the three specimens was much less than that of typical roughened specimens and the transition between peak and post-peak is not very obvious in these figures. Only T-24-NB-12-NR did not exhibit the bi-linear post-cracking response typical of roughened specimens; instead it exhibited a sudden transition after reaching first cracking (the peak strength of the specimen coincided with first cracking of the section). The difference in observed behavior among the bonded troweled specimens could be due to minor (and unintended) differences in the surface condition prior to casting. The surface condition of the three specimens

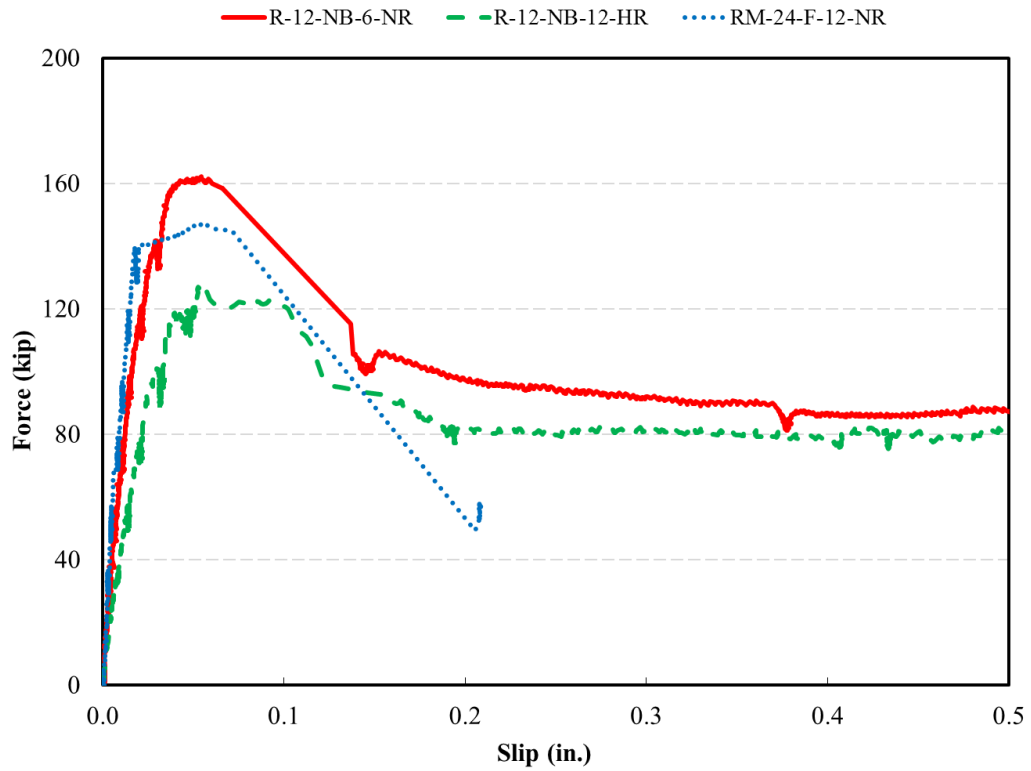
Figure 3.17: Force versus Slip for Specimens Affected by Rotation

In Figure 3.17, force is plotted versus slip for R-12-NB-6-NR, R-12-NB-12-HR and RM-24-F-12-NR; the specimens influenced by rotation. All three specimens exhibited a truncated peak that was not exhibited by other specimens (Figure 3.7). The truncated peak is attributable to the large θ_x and θ_z values. This unintended relative rotation is not representative of bridge structures in practice and is believed to have influenced the force, slip, and crack width near peak strength. Throughout this report, results from these tests are reported when they are not impacted by this rotation (e.g. initial stiffness, force at cracking). Any result that may have been influenced by rotation is not reported.

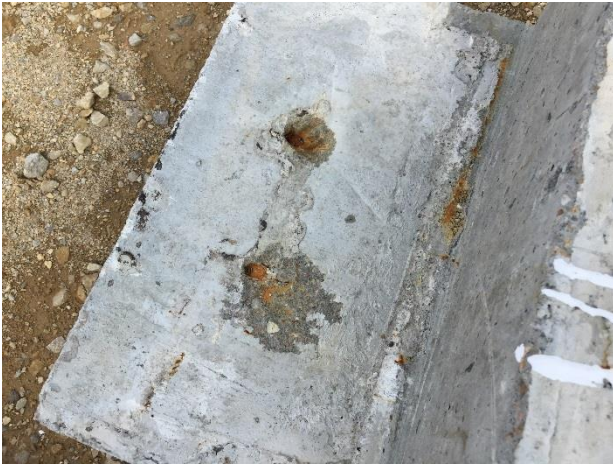
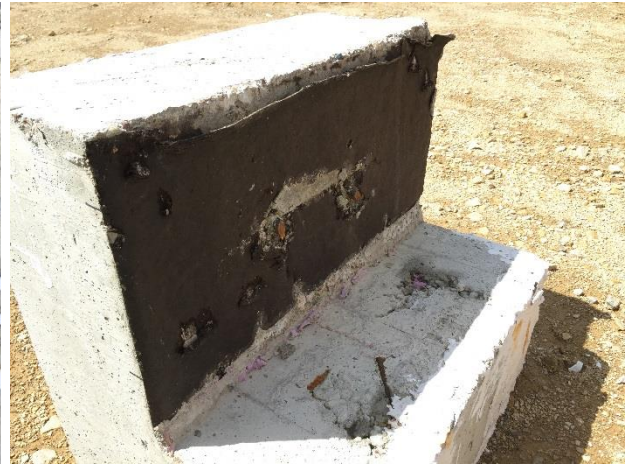
Figure 3.18: Interface of T-24-F-12-NR after Testing

4 ksi Section

7 ksi Section

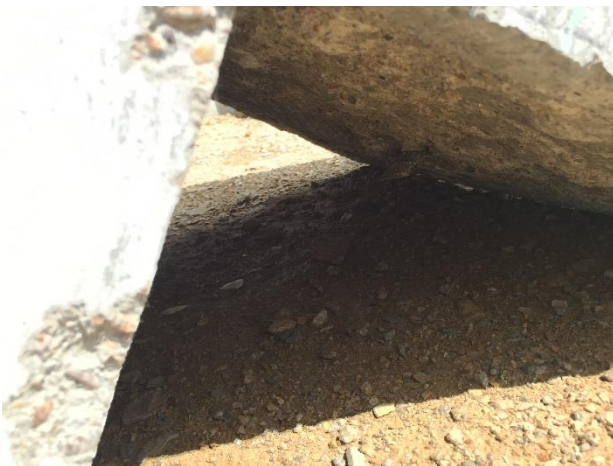
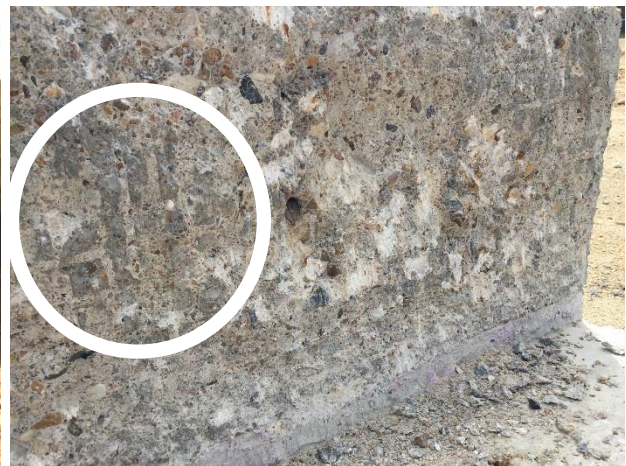
Figure 3.19: Interface of R-24-NB-12-NR after Testing

4 ksi Section

7 ksi Section

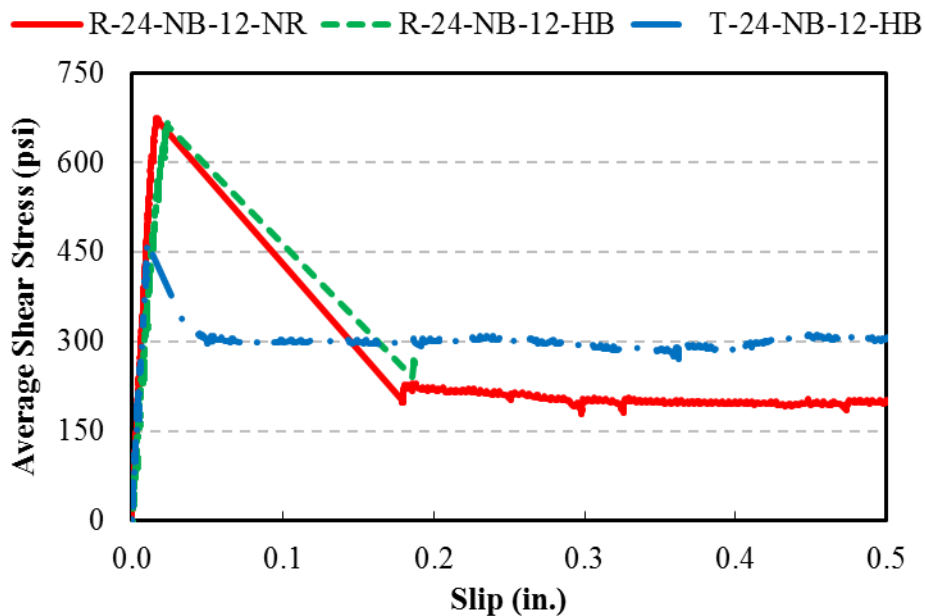
Figure 3.25: Average Shear Stress versus Slip for 24 in. Wide Specimens

Increasing the yield strength of the interface shear reinforcement by 100% had no clear effect on the cracking stress and increased peak strength by only approximately 30%. This is based on comparisons between two pairs of roughened specimens (R-12-NB-12-HR and R-12-NB-12-NR as well as R-24-NB-12-HB and R-24-NB-12-NR) and one pair of troweled specimens (T-12-NB-12-HR and T-12-NB-12-NR). Among roughened specimens, the specimen with a higher reinforcement grade had a 30% lower cracking strength (which is likely unrelated to use of high-strength steel) and approximately equal peak strength. Among the troweled specimens, cracking stress and peak stress increased by 38 and 31%, respectively. When specimens with high-strength steel were compared to specimens with an increased area of interface shear reinforcement (e.g. R-12-NB-12-HR and R-12-NB-6-NR, where either grade or reinforcement area were doubled relative to the control, R-12-NB-12-NR) increasing reinforcement area was a more effective means of increasing interface shear strength than increasing reinforcement grade. Although based on very limited data, this finding is consistent with findings from other research groups (Harries and Zeno, 2012). It is possible this is attributable to the short anchorage length provided that may not have allowed for the higher grade bars to fully develop their capacity. Additional investigation is necessary if high-strength steel is to be used in shear friction applications.

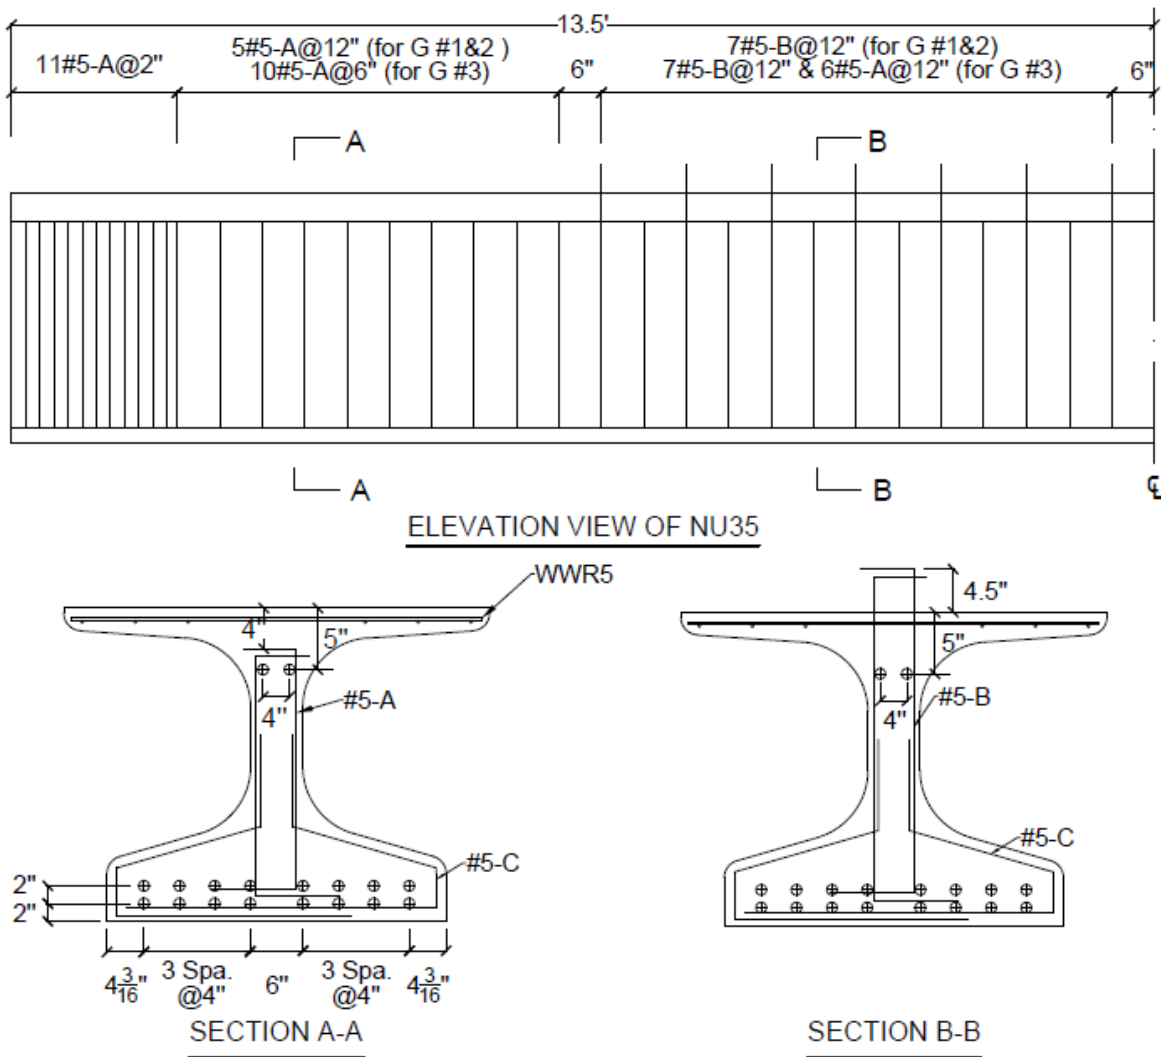
Figure 4.2: Elevation and Cross Sectional Views of NU35 Girder Specimens

Figure 4.2 shows elevation and cross-sectional views of the NU35 girders. Girders #1 and #2 were designed so that the flexural and transverse shear strengths of the composite girder were large enough to ensure that the horizontal shear strength of the girder-to-deck connection could be evaluated. Girder #3 was instead designed to fail in a flexural mode because it was not possible to design it to fail at the interface without first exceeding the maximum permitted web shear stress (i.e. the girder would likely exhibit a web compression failure).

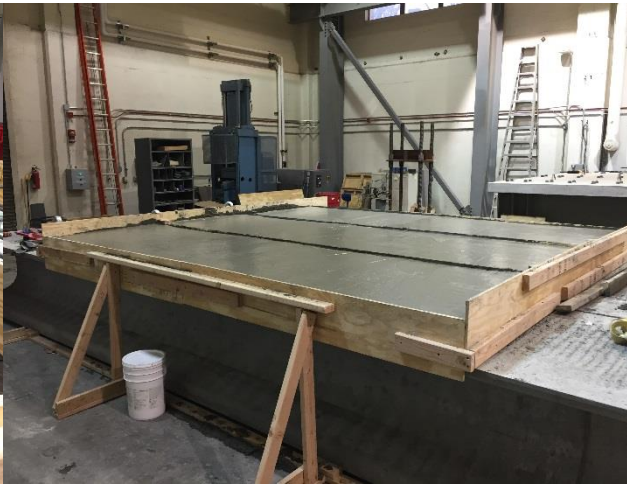
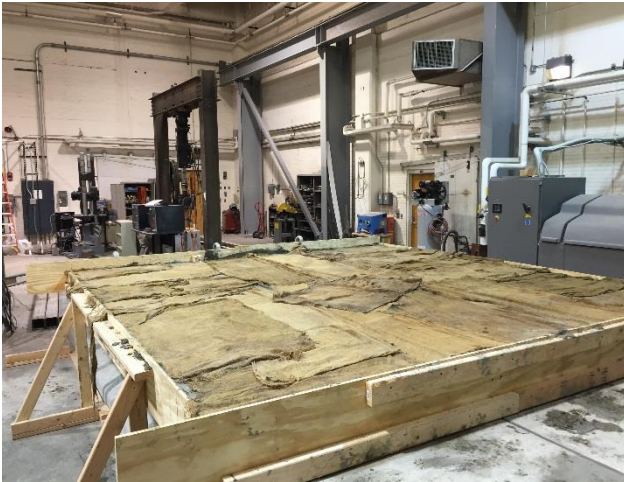
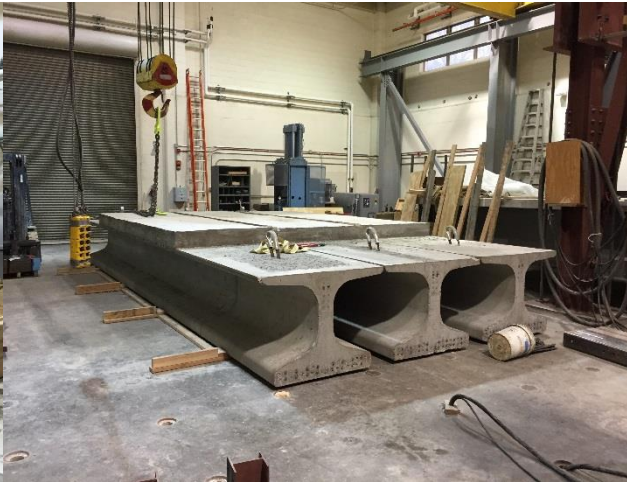
Figure 4.6: Deck Casting Procedures

(b) Concrete Deck after Finishing

(c) Concrete Deck Curing

(d) Demolded Concrete Deck

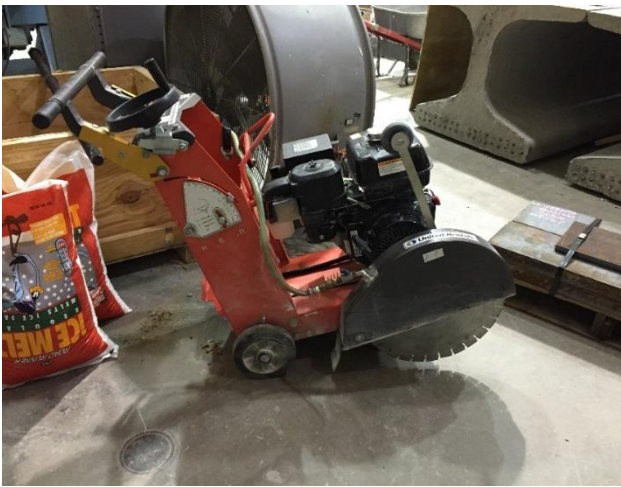
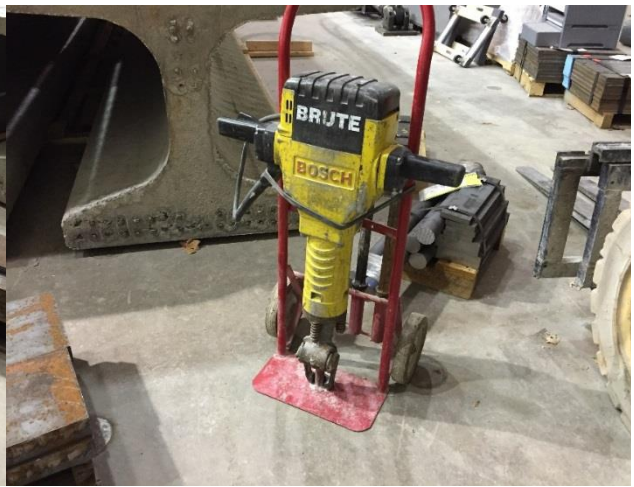
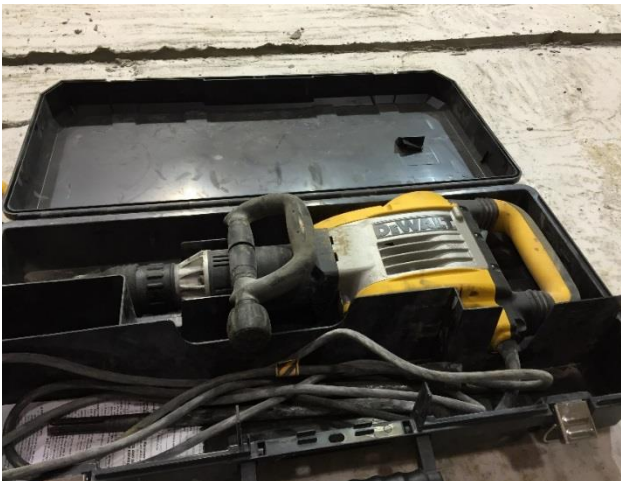
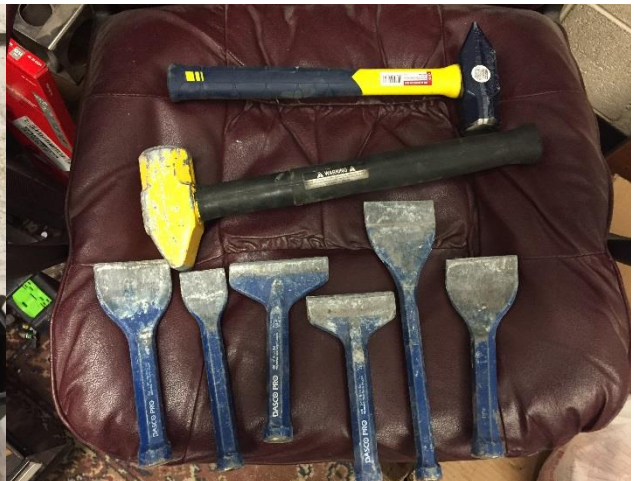
Figure 4.7: Primary Tools Used for Deck Removal

(a) Walk-Behind Concrete Saw

(b) 65 lb Electric Jackhammer

(c) Variable Impact Demolition Hammer

(d) Hammers and Chisels

The primary tools used for deck removal are shown in Figure 4.7. These included the walk-behind concrete saw shown in Figure 4.7(a), 65 lb electric jackhammer shown in Figure 4.7(b) that was operated with a 1-1/8 in. bit, demolition hammer shown in Figure 4.7(c) that had an adjustable power output from 3.7 to 18.5 foot-pounds of impact energy, and various hammers and chisels shown in Figure 4.7(d). Although the demolition hammer had a weight of 23 lbs, the power output was set to approximately mid-range, or approximately 12 ft-pounds of impact energy, when chipping around the rebar and close to the deck. This was done to simulate the use of a 15 lb demolition hammer, which is typically required for such tasks.

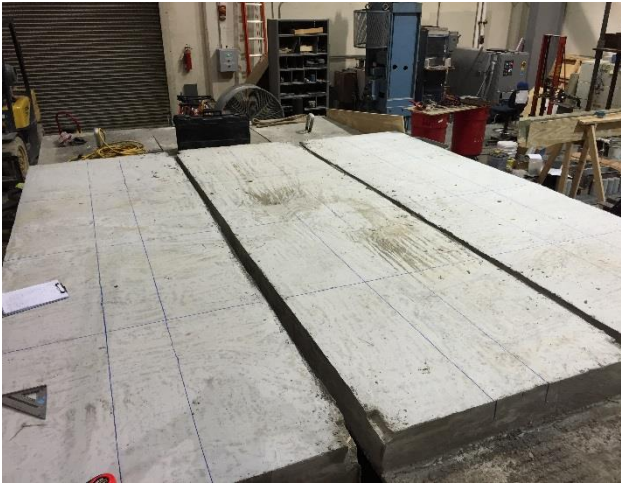
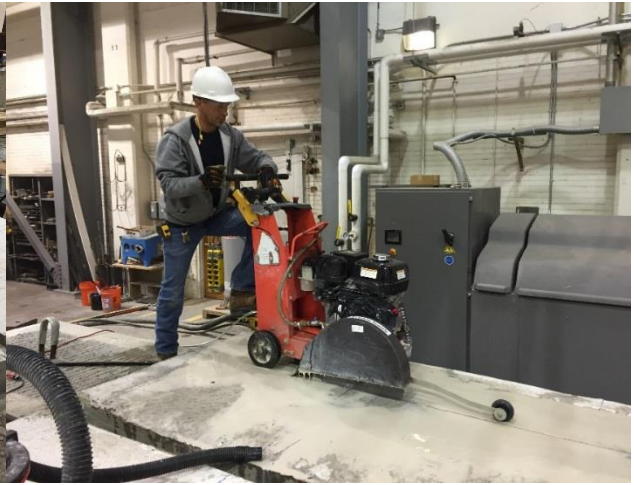
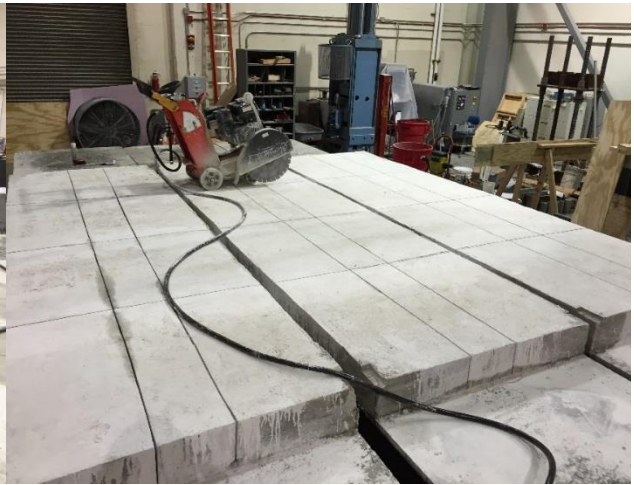
Figure 4.8: Saw-Cutting Procedures

(a) Chalk Lines Indicating the Location of Saw-Cuts

(b) Longitudinal Saw-Cuts

(d) Decks after Saw-Cutting

The first step of the demolition process was to saw-cut the concrete deck into 12 sections (Figure 4.8). For each deck, two longitudinal cuts were made 4 in. from the centerline of the girder (near to but not interfering with the horizontal shear transfer reinforcement) and three transverse cuts were made at regular intervals (spaced at 42.5 in.). As shown in Figure 4.8(a), chalk-lines were first set on the top surface of the concrete deck to guide the operator of the saw. The walk-behind saw was then used to make the longitudinal and transverse cuts (as shown in Figures 4.8(b) and 4.8(c)). The depth of cut was set to 6.75 in. to avoid contacting the girder top flange (the deck thickness was 7 in.). The saw-cut decks are shown in Figure 4.8(d).

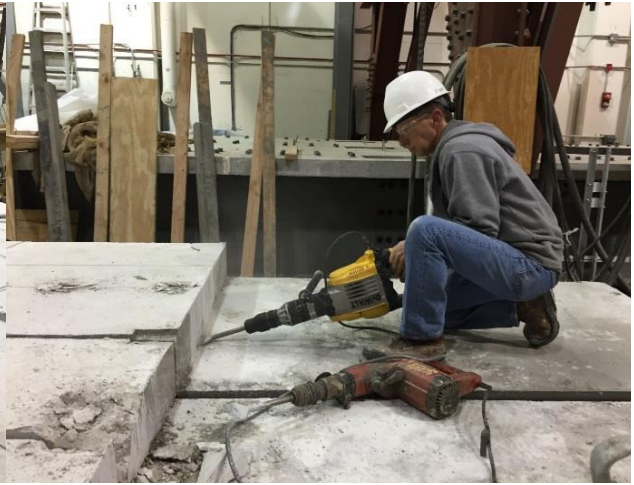
(b) Use of Demolition Hammer at a Low Angle to Break Deck Sections Free
