Composite Action in Prestressed NU I-Girder
Bridge Deck Systems Constructed with
Bond Breakers to Facilitate Deck Removal

Submitted to the graduate degree program in Civil, Environmental, and Architectural
Engineering and the Graduate Faculty of the University of Kansas in partial fulfillment of the
requirements for the degree of Doctor of Philosophy.

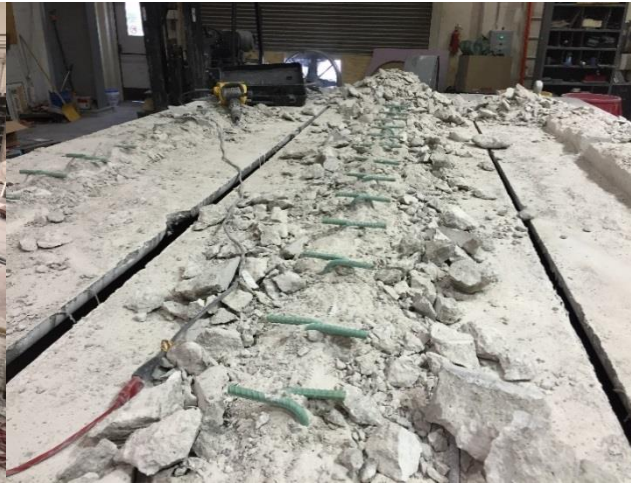
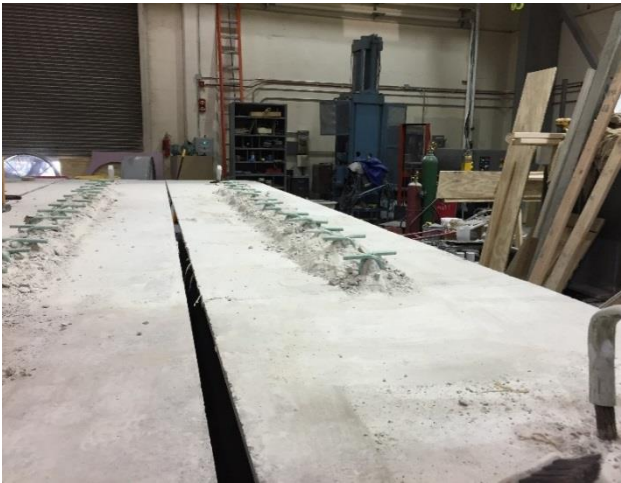
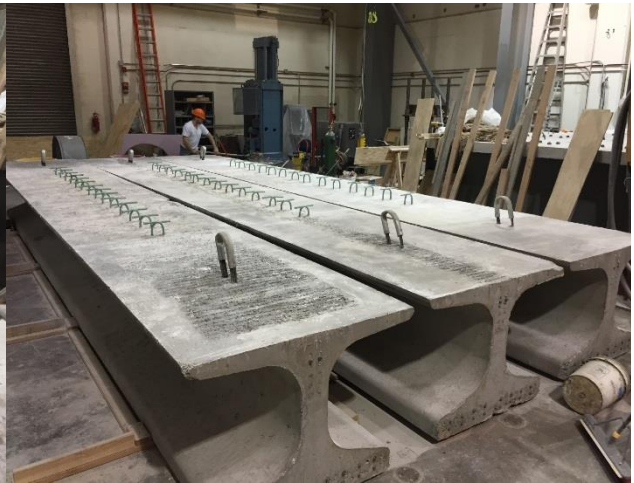
Figure 4.10: Removal of Deck Concrete over Girder Webs

(b) Deck Condition After Use of the 65 lb Jackhammer

(c) Prior to use of Variable Impact Demolition Hammer

(d) After Deck Removal

After removal of the edge sections of the deck, the middle portions of the deck located over the beam webs were removed. The steps of the process are shown in Figure 4.10. As shown in Figure 4.10(a), a 65 lb jackhammer was first used to break apart the middle sections down to the level of the interface reinforcement. Although hammers larger than 30 lbs are generally not permitted by Kansas Department of Transportation specifications, the larger hammers were used here on a limited basis with no negative impacts. Use of such large hammers must, however, be well controlled and any contact with or near the girder must be avoided. In practice, it would be prudent to limit hammer sizes to 30 lbs, as currently done in typical KDOT specifications (2015) and recommended by Manning (1991) and the American Concrete Pavement Association (1998). After exposing the interface shear reinforcement, the variable impact demolition hammer, set to a moderate impact energy level consistent with a 15 lb demolition hammer, was used to remove the remaining concrete down to the top of the girder flange as shown in Figures 4.10(c) and 4.10(d).

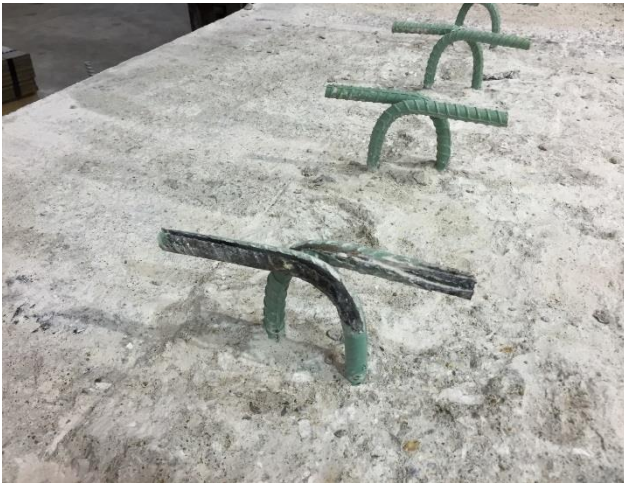
(a) Saw-Cut Damage to Rebar (Girder #3)

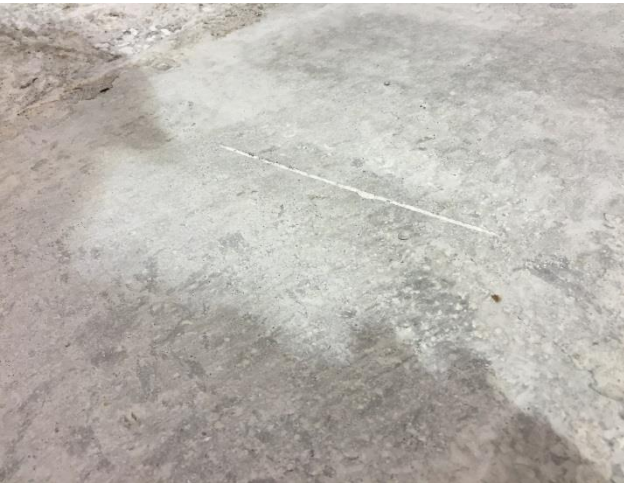
(b) Saw-Cut Damage to the Girder Top Flange (Girder #2)

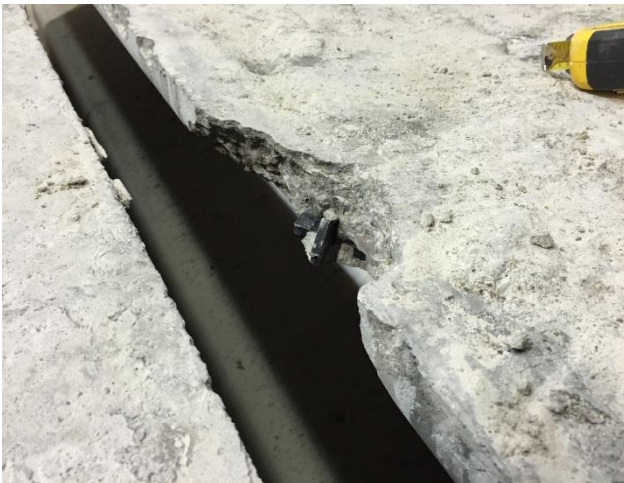
(c) Broken Flange Tip (Girder #3)

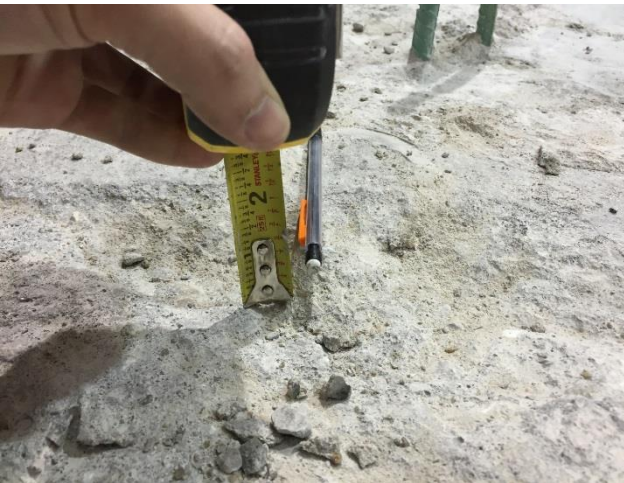
is an indication of the difficulty with which bridge deck concrete is separated from a troweled girder flange. Additional complications may develop if the crater is deep enough to expose reinforcement or, worse, dislodge concrete from the bottom face of the top flange.

(d) Crater in Girder Top Flange (Girder #1)

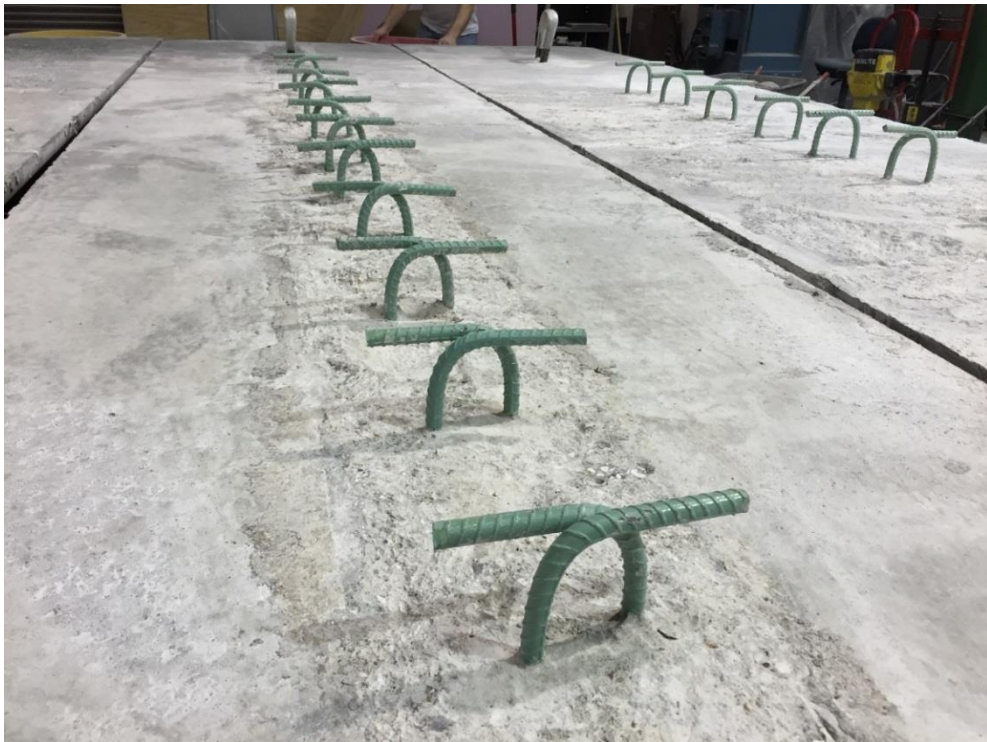
Figure 4.13: Girder #2 Surface after Deck Removal (Originally Partially Roughened with Roofing Felt over the Flange Tips)

For Girder #2, which originally had a roughened strip of concrete over the beam web and roofing felt over the remainder of the flange, the roughened girder surface over the web was similar to the surface of Girder #3 (Figure 4.12). Where roofing felt had been placed, the girder surface was as smooth as it had been prior to casting of the bridge deck (except for the minor saw-cut damage shown in Figure 4.11(b)). The roofing felt effectively prevented the cast-in-place bridge deck from interacting with the girder flange during the casting process and reduced the risk of damage to the girder during deck removal.

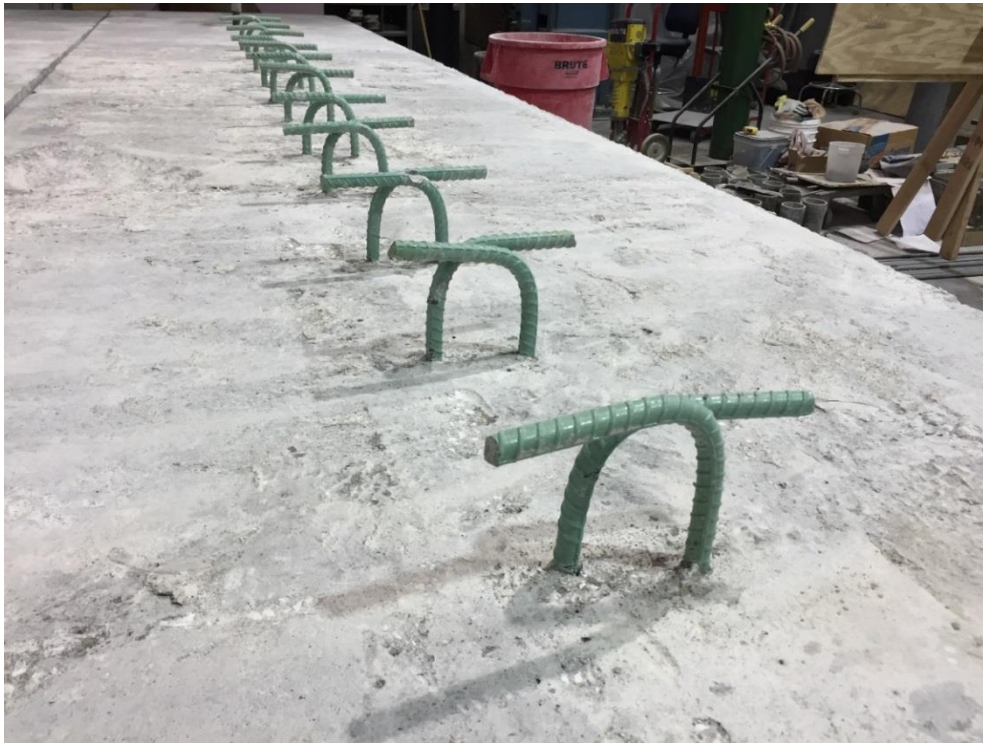
roughness of the Girder #1 surface was between that of the other two girders. For calculation of composite action, it would be prudent to consider the surface of Girder #1 to be troweled.

Figure 4.14: Girder #1 Surface after Deck Removal (Originally Fully Troweled)

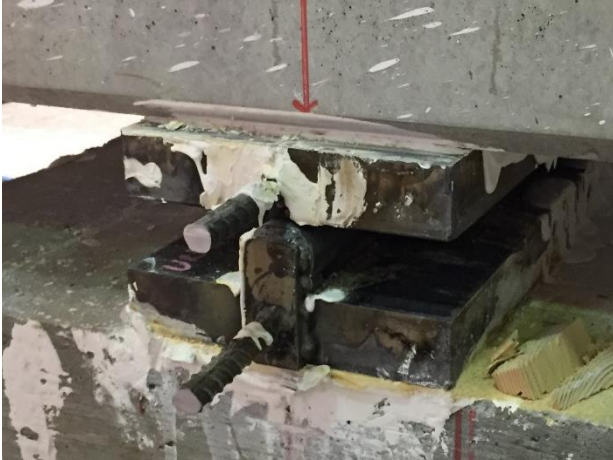
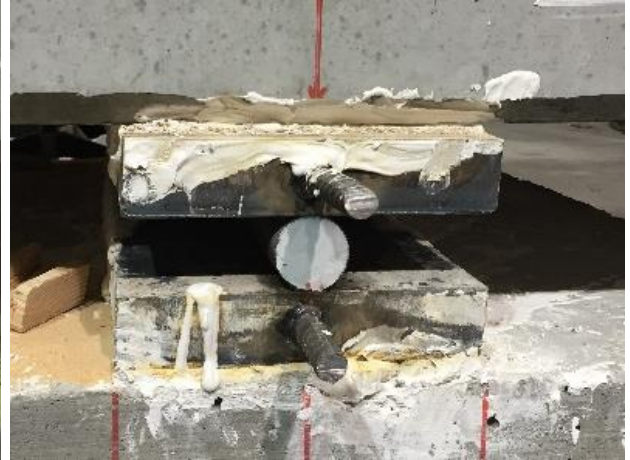
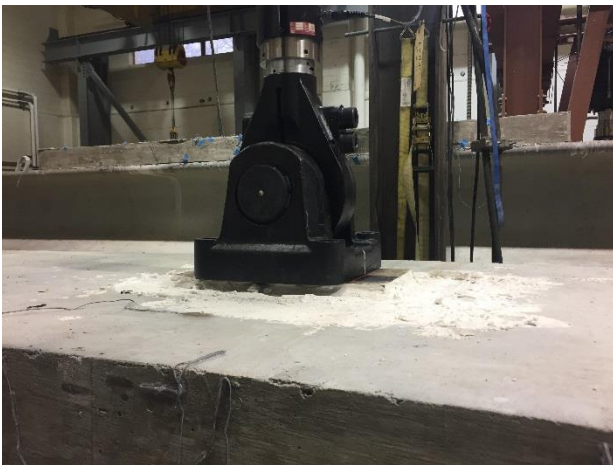
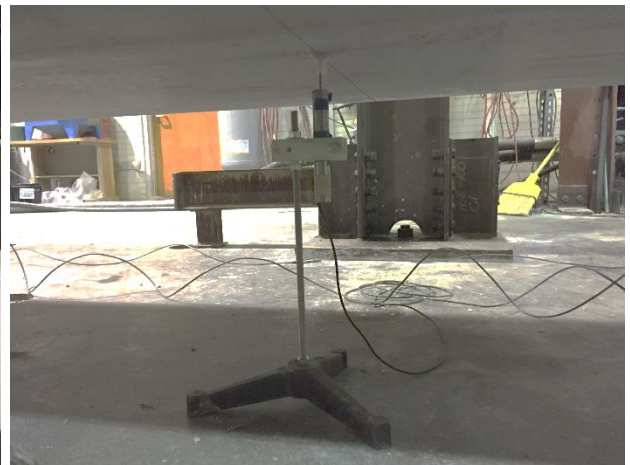
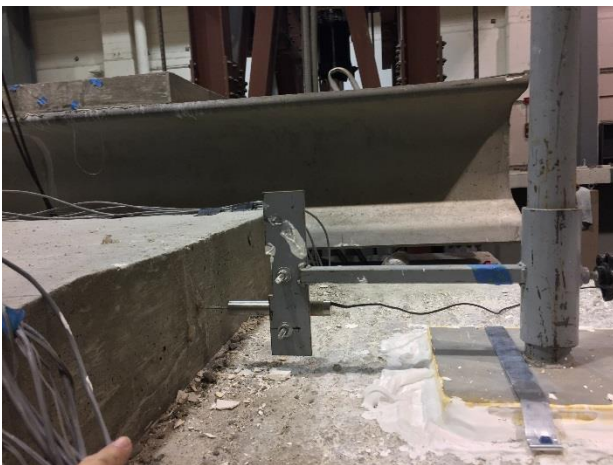
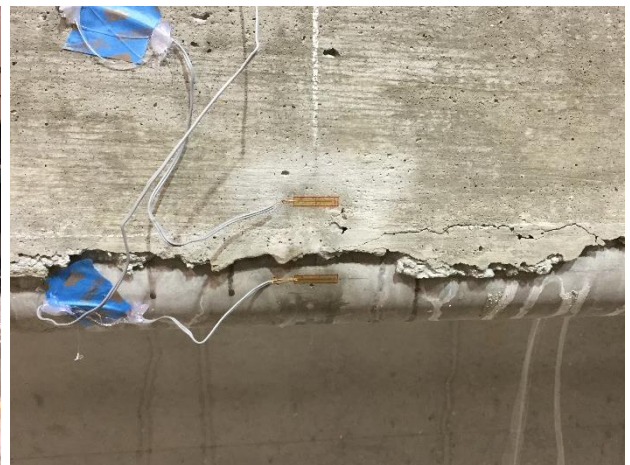
Figure 4.17: Details of Test Setup and Instrumentation

(a) Pin Support

(b) Roller Support

(c) Bearing of Actuator on Bridge Deck

(d) LVDT Below Girder at Midspan

(e) LVDT at End of Deck

(f) Strain Gauges

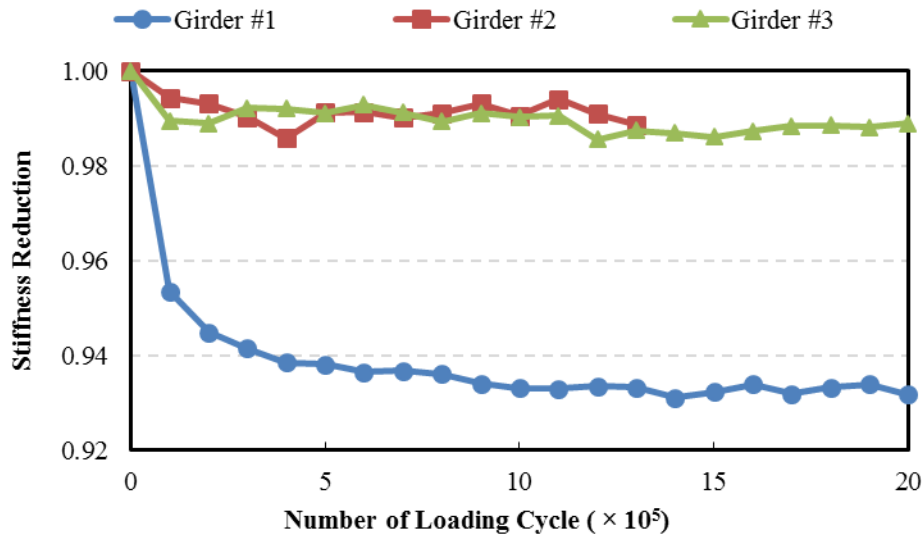
Figure 4.22: Ratio of Girder Stiffness to Initial Girder Stiffness

Results are not plotted for Girder #2 after 13×10^5 cycles in Figure 4.22 and will not be reported herein. This is because approximately 46,000 cycles into the phase 14 loading, the servo-valve of the actuator being used to load the specimen malfunctioned. Repair of the actuator took 5 months, resulting in a 5 month pause in testing that the other specimens were not subjected to. After the actuator was fixed, the specimen was loaded up to the same 2×10^6 cycles imposed on the other specimens to provide parity among specimens before testing them to failure. The long pause, however, allowed for time-dependent effects such as shrinkage and prestress force losses to slightly skew the fatigue test results after the test was resumed.

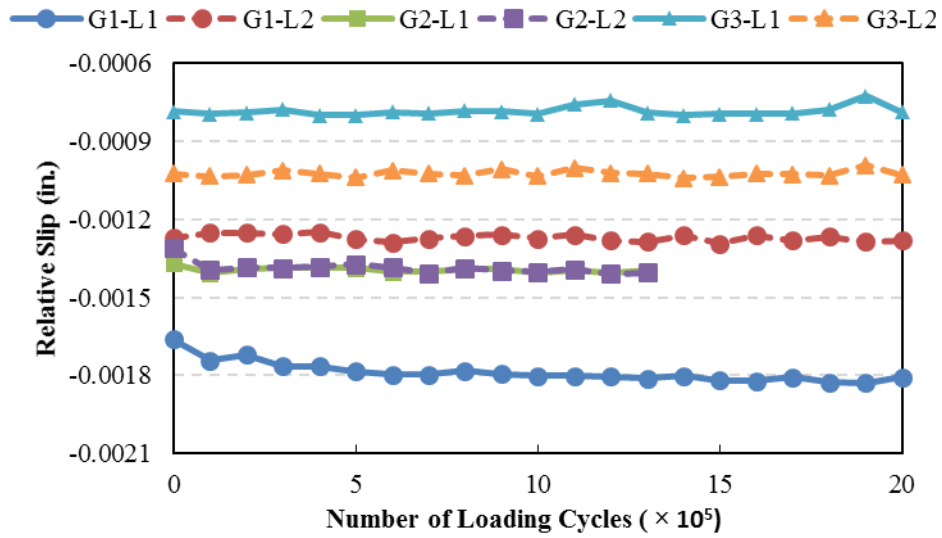
Figure 4.23: Relative Slip at 80 kips throughout Fatigue Tests

The slip measured by each LVDT at 80 kips of force during the slow ramp loading is plotted versus loading cycle number in Figure 4.23 for all three specimens. Measured relative slip was between 0.00072 and 0.0019 in., which is much less than the slip at first cracking for all bonded specimens shown in Table 3.8. As expected, Girder #1 exhibited the largest relative slip and Girder #3 exhibited the smallest relative slip. Given that Girder #3 had 4.5 times more roughened area than Girder #2 (36 in. width compared to 8 in. width), it is notable that Girder #2 exhibited only approximately 50% more slip than Girder #3.

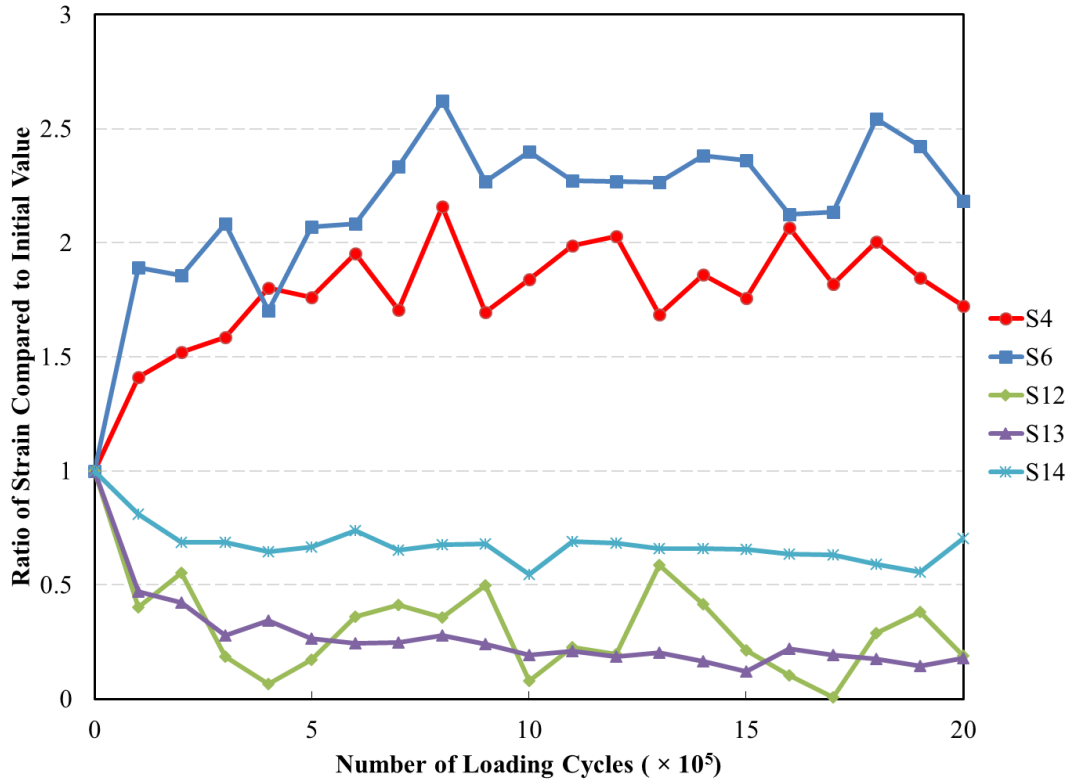
Figure 4.29: Strain Ratio for Girder #1

Of the measured strains, results from S13 and, to a lesser extent, S14 deviated most from the expected magnitudes. Results from S13 were less than expected for fully-composite action in all three specimens and S14 results were less than expected for Girders #1 and #2. It is believed this is because the deck was more fully engaged over the girder web and less so near the flange tips – especially in specimens with debonded flanges. This would be consistent with S13 recording strains near zero, as observed.

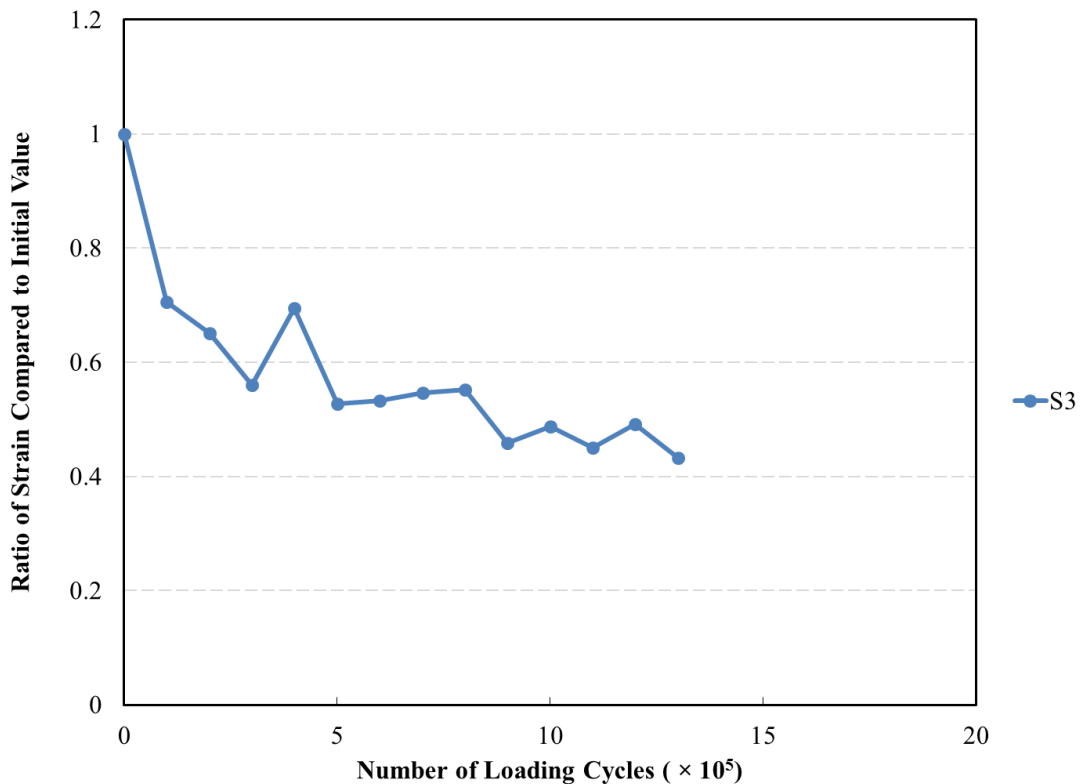
Figure 4.30: Strain Ratio for Girder #2

Strains measured with S3 dropped 30% after the first 10^5 cycles and continued to drop to approximately 50% of the initial value after 5×10^5 cycles. This isolated change in data measured with S3 in the test of Girder #2 is not clearly consistent with other measurements taken during testing. Rather than indicating a change in shear transfer mechanism, it is likely that the change in strains is instead due to development of a through-thickness shrinkage crack in the deck located approximately 3 in. from S3 that was noted after completion of 2×10^6 cycles.

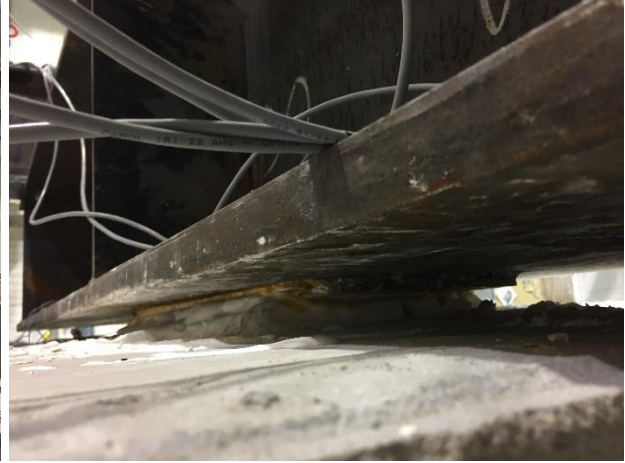
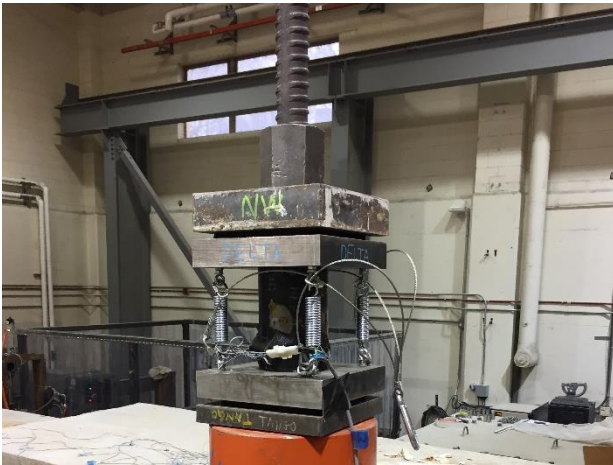
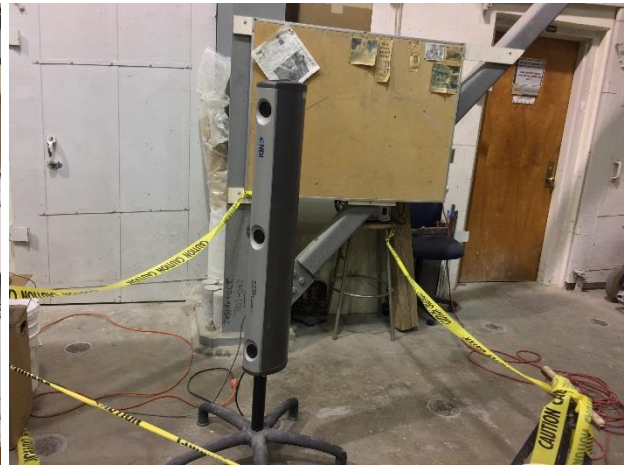
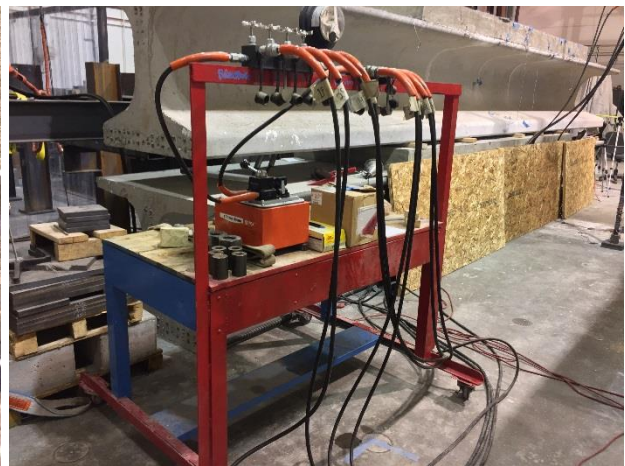
Figure 4.32: Test Setup and Instrumentation Details

(b) Steel Plate and Gypsum Cement between Loading Frame and Specimen

(c) Load Cell Arrangement

(d) Position Tracking Camera

(f) Pumping Station

The test setup is shown in Figures 4.31 through 4.33. As in the fatigue tests, the girders were placed on simple supports spaced 243 in. apart, or approximately six times the composite girder depth. The girder was monotonically loaded at midspan using the frame shown in Figure 4.32(a). The frame, which was constructed from an HP18×208 cross-beam and built-up channel beams at each end, supported four 150-ton hollow-cylinder hand-operated hydraulic jacks. The force in each jack was transmitted through a hollow-cylinder load cell and into a 1.7 in. diameter high-strength steel threaded rod (through bearing on a nut). The threaded rods passed through the laboratory strong floor and were anchored by spreader beams located below the floor. The threaded rods and load cells were therefore approximately stationary, and extension of the jacks forced the loading frame and girder downward. Bearing of the loading frame onto the top of the girder was through a 10 × 20 in. steel plate set into a bed of gypsum-cement (shown in Figure 4.32 (b)) to distribute the force on the specimen during testing.

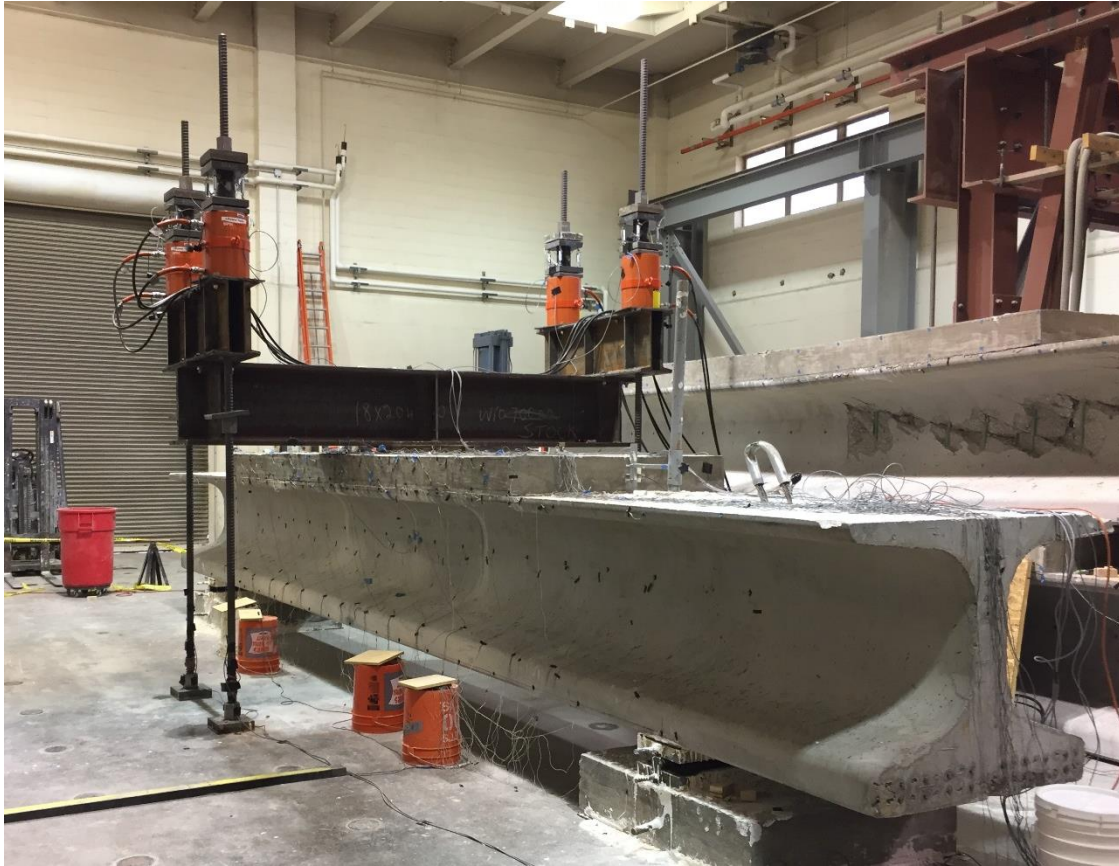
Figure 4.33: Test Setup

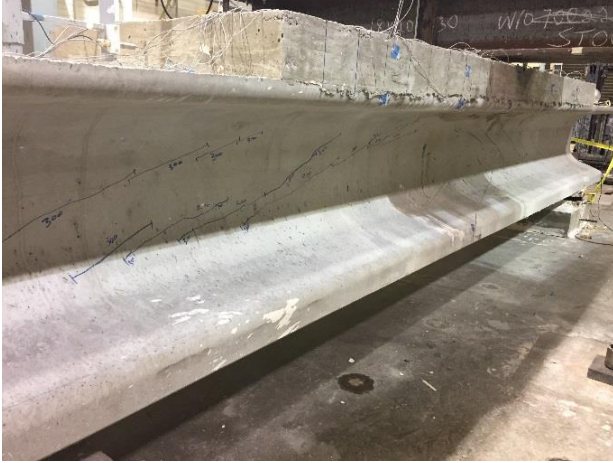
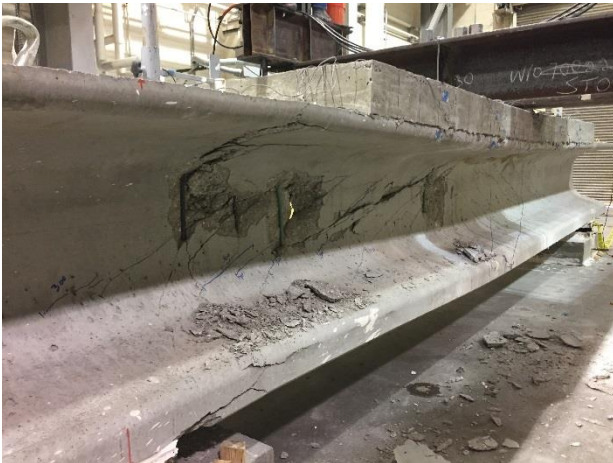
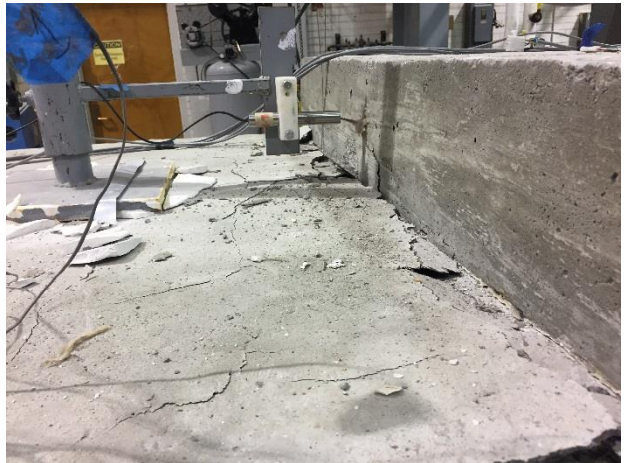
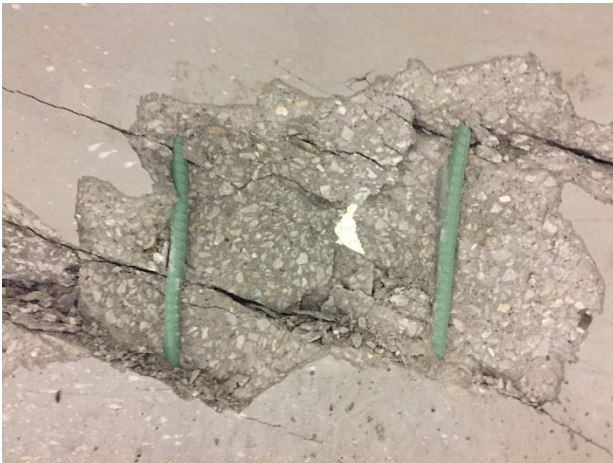
Figure 4.34: Photos of Girder #1 During and After Testing

(a) Web Shear Cracks at 205 kip

(c) Specimen after Failure

(d) Girder Top Flange Cracking after Failure

(e) Girder Web after Failure

Cracks were first observed during a pause at a force of approximately 200 kips. These cracks were inclined cracks in the girder web on both sides of midspan (Figure 4.34(a)). Further loading caused these cracks to slowly extend towards the bottom and top flanges of the girder. Flexural cracks were first observed in the bottom flange near midspan during a pause at a force of 400 kip. As loading continued, more web shear cracks and flexural cracks were observed and existing cracks propagated and widened. Slip between the deck and the girder top flange was first visible at a force of 450 kip, when approximately 1/8 in. of slip was observed on the east end.

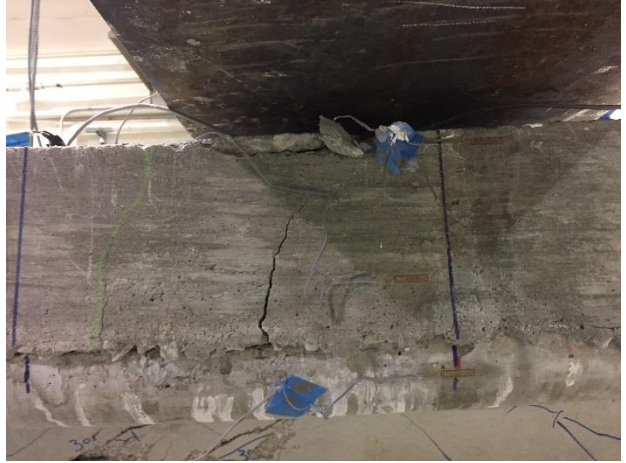
(b) Deck Cracking Below the Loading Point after Failure

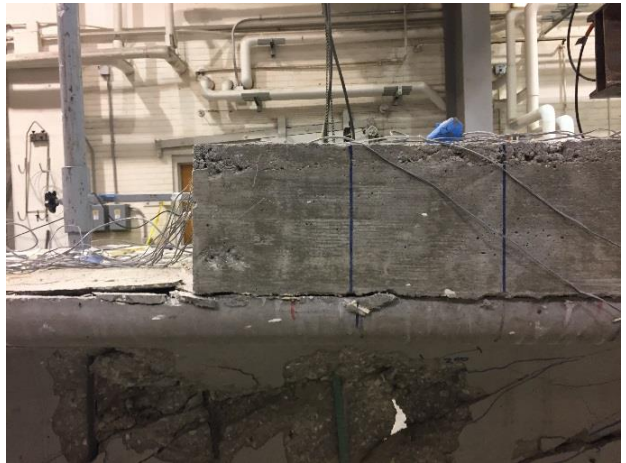
(f) Permanent Slip between Girder and Deck after Failure

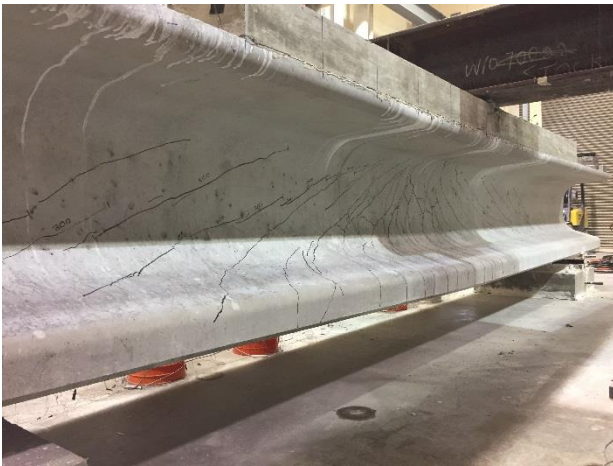
(a) Cracking at 400 kips

Photos taken during and after the test of Girder #2 are shown in Figure 4.35. The first inclined and flexural cracks were observed when the force was approximately 200 kip and 400 kip respectively (Figure 4.35(a)). Slip between the girder and deck was not observed until the force reached 450 kip, at which time approximately 0.02 in. of relative slip was observed on the west end of the specimen. The specimen reached its peak flexural strength of 577 kips at 3.04 in. of deflection. Loading of the specimen continued until a compression failure (Figure 4.35(b)) occurred in the deck at a deflection of 4 in. (Figure 4.35(c)). As Figure 4.35(b) shows, only one of the four cracks in the deck was connected with a crack from the girder; this shows that the section at midspan was not fully composite at the end of the test. A small amount of permanent slip (Figure 4.35(d)) was observed between girder and deck at both ends after failure.

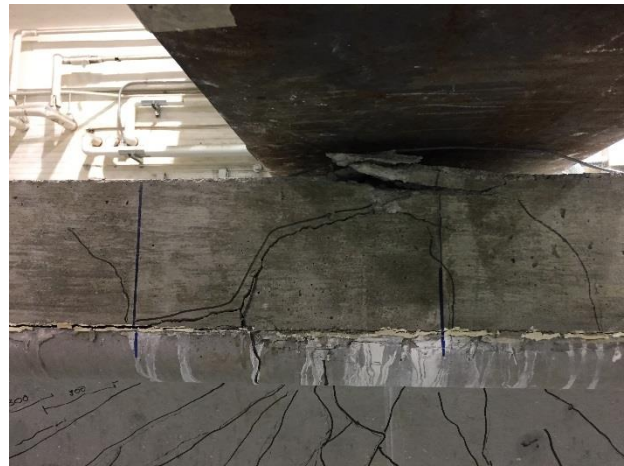
(b) Compression Zone Failure

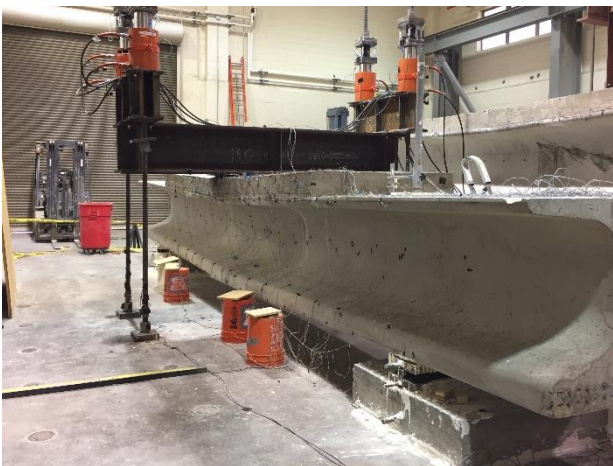
(c) Large Deformation at End of Test

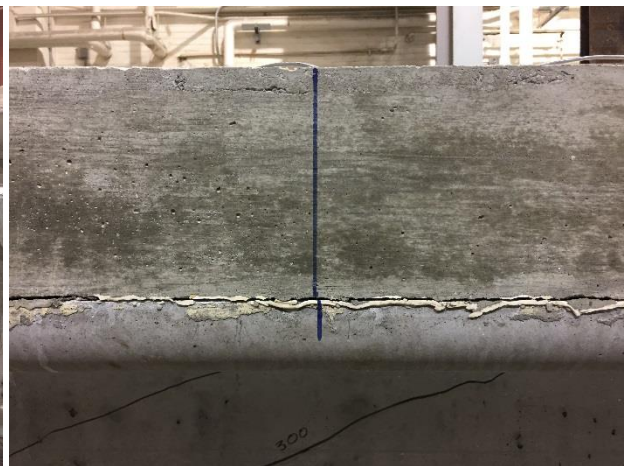
(d) Permanent Slip between Girder and Deck (East Side) after Failure

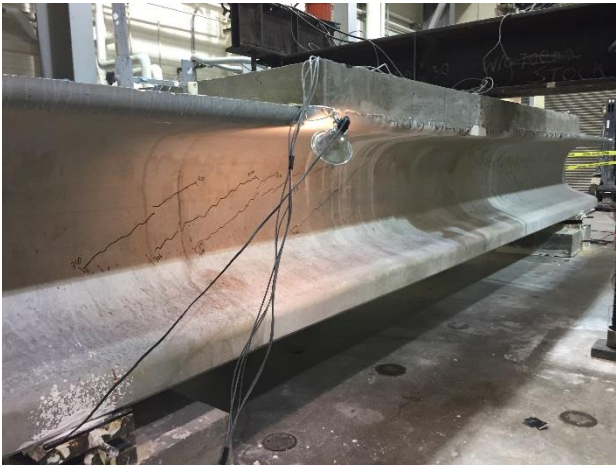
(a) Cracking at 300 kips

Photos of Girder #3 during and after testing are shown in Figure 4.36. The first inclined and flexural crack were observed during pauses at forces of approximately 300 and 400 kips respectively. The later appearance of inclined cracks is likely attributable to the tighter spacing of transverse reinforcement. The spacing of web shear cracks late in the test of Girder #3 was

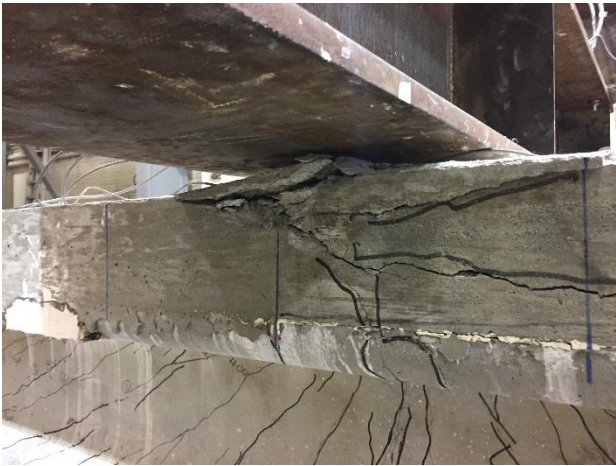
(b) Compression Zone Failure

measured to be approximately 4.5 in., a closer spacing than observed in the first two specimens (6.5 in. for Girder #1 and 6.0 in. for Girder #2). The peak strength of the specimen, 605 kips, occurred at a deflection of 2.49 in. The specimen then failed by crushing of the compression zone in the deck (Figure 4.36(b)), followed immediately by propagation of a horizontal crack near the bottom of the deck that extended from midspan to the west end of the deck (Figure 4.36(c)). A small residual slip was observed on the west end of the deck after the test as shown in Figure 4.36(d). As Figure 4.36(b) shows, vertical deck cracking near midspan was connected with underlying cracks through the girder top flange, showing that the girder was composite at the end of the test.

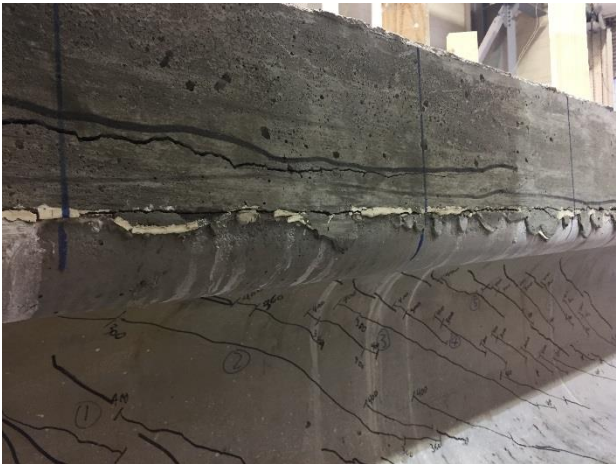
(c) Horizontal Crack Through Deck After Failure (West Side)
