MECHANICAL RESISTANCE OF CRACKED DAM MASS CONCRETE
REPAIRED BY GROUTING: AN EXPERIMENTAL STUDY

SIMON GALLAGHER

DÉPARTEMENT DES GÉNIES CIVIL, GÉOLOGIQUE ET DES MINES
ÉCOLE POLYTECHNIQUE DE MONTRÉAL

MÉMOIRE PRÉSENTÉ EN VUE DE L'OBTENTION
DU DIPLÔME DE MAÎTRISE ÈS SCIENCES APPLIQUÉES
(GÉNIE CIVIL)
DÉCEMBRE 2012

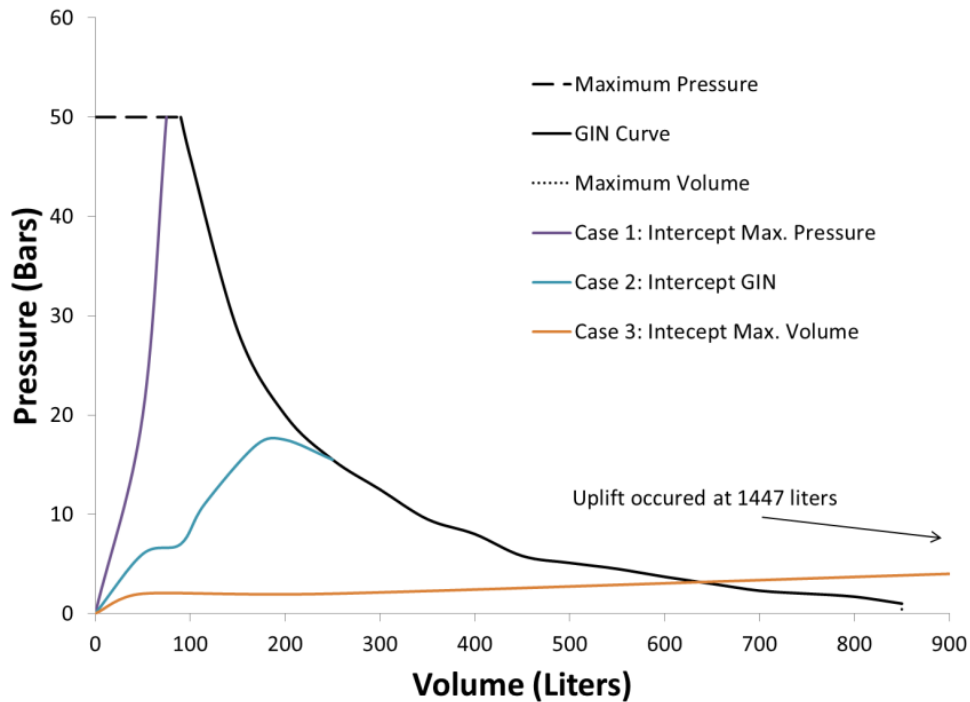
Figure 2-3: Grout Intensity Number and Injection flow paths

GIN stands for Grout Intensity Number and is represented as a curve on the injection pressure vs. volume curve as seen in Figure 2-3. The GIN method uses a single grout mix for the entire injection. This grout must be stable (w/c ratio between 0.67 and 0.8 by mass), a low-to-medium injection rate must be used, and real-time measurements of pressure and injected volume must be taken. The injection of each individual hole is stopped once the GIN line is intersected on the pressure vs. volume graph (G. Lombardi & Deere, 1993).

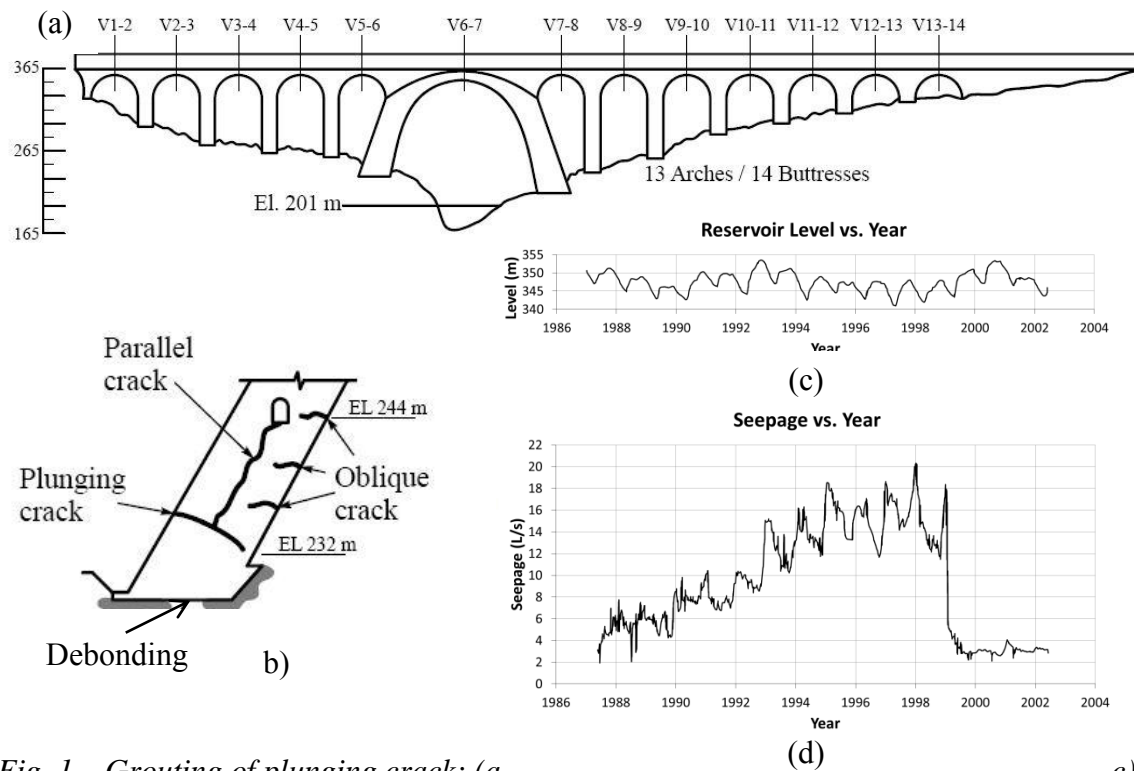
Figure 2-4: Grouting of plunging crack: (a) BDJ dam, (b) typical concrete crack pattern, (c) reservoir level, (d) seepage Arch 5-6

Debonding at the base of the dam in most arches was detected due to seepage observed at the base of the structure [Figure 2-4 (b)]. The seepage was stopped by grout injections (Bulota et al., 1991).

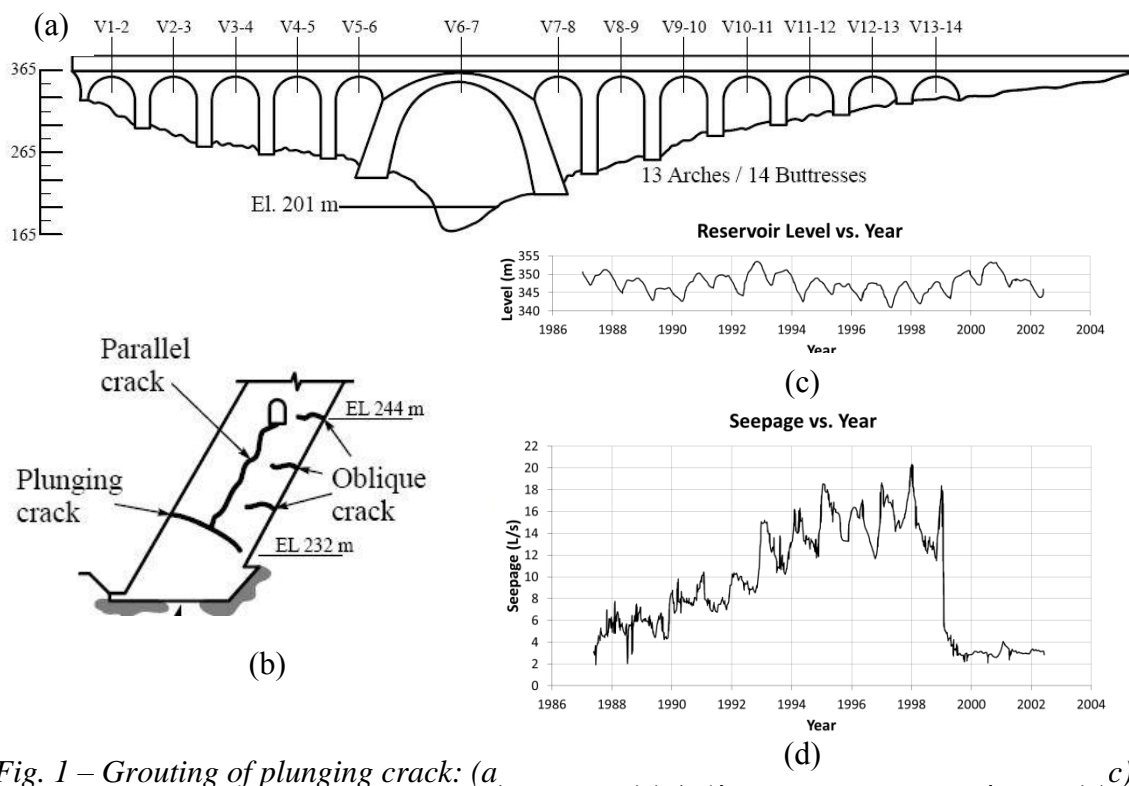
Figure 3-1: Grouting of plunging crack: (a) BDJ dam, (b) typical concrete crack pattern, (c) reservoir level, (d) seepage Arch 5-6

Since the injection, as can be seen from Figure 3-1, the water level in the reservoir has increased to above pre-repair levels without having a noticeable effect on water leakage. These results suggest that the repair increases the ability of the crack mouth in BDJ to sustain tensile stresses post-injection. In the finite element models used to assess the initiation and propagation of

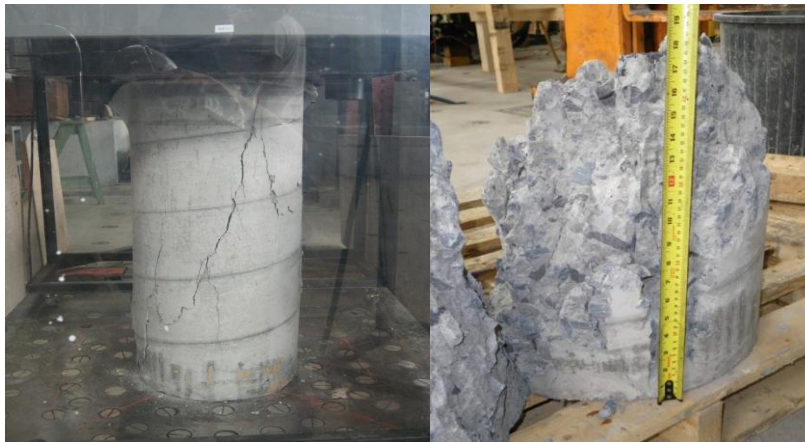
Figure 3-2: Mass concrete cylindrical specimen (400mm x 800mm)

Three cylinder specimens, seen in Figure 3-2, of 400 mm (16 in.) diameter and 800 mm (32 in.) in height, one from each batch of concrete, were poured into cardboard tubes. A modified version of ASTM C469 (to account for the larger specimens) was used to determine the compressive strength, modulus of elasticity, and Poisson's ratio of the concrete.¹⁷ The size effect for the results of the compressive strength are negligible.¹⁸

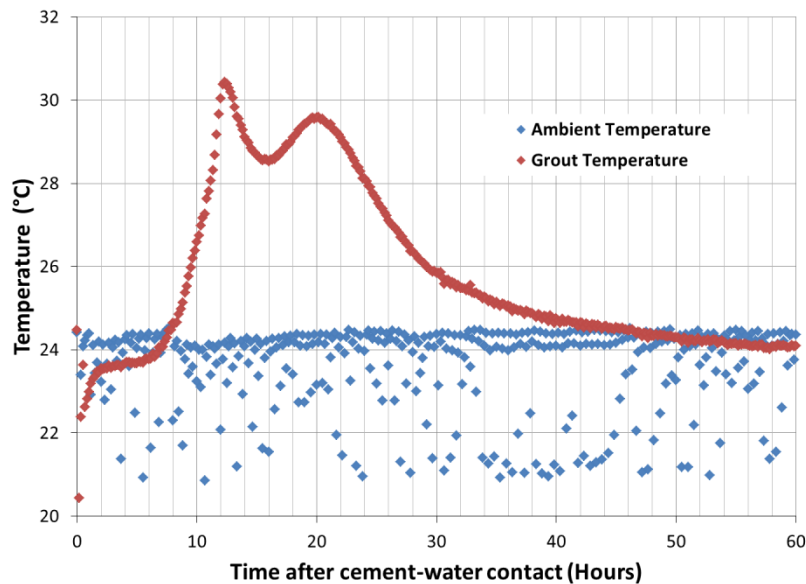
Figure 4-4: Typical Thermocouple Results

The set time test involved mounting a thermocouple, which measures the temperature every 10 minutes, at the center of a 75 x 150 mm cylinder. Once the grout was properly mixed, it was then poured into this cylinder. The ambient temperature was also measured every 10 minutes. The temperature of the grout was then plotted against the time from initial mixing of the grout. The set time was then measured as the time it took for the maximum temperature to be obtained, which is the point at which much of the hydration reaction has taken place and when the grout has reached initial set (Saleh et al., 1997). Figure 4-4 is a typical graph for the results of the set time.

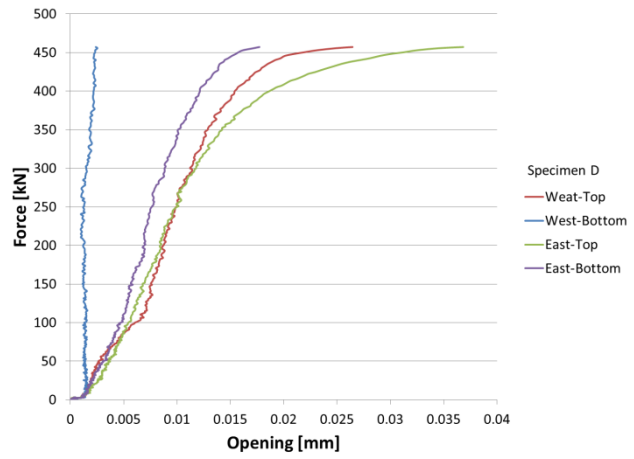
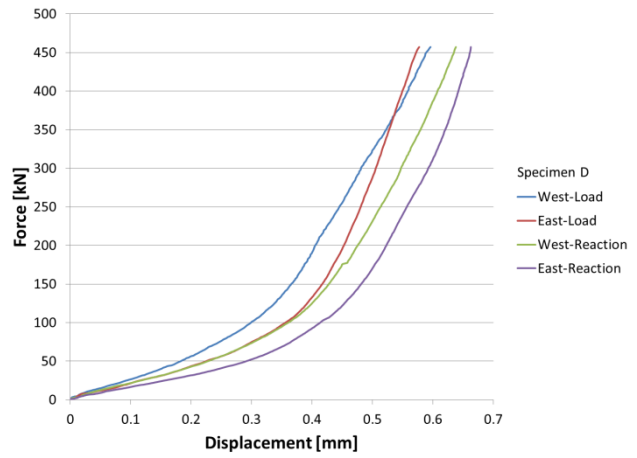
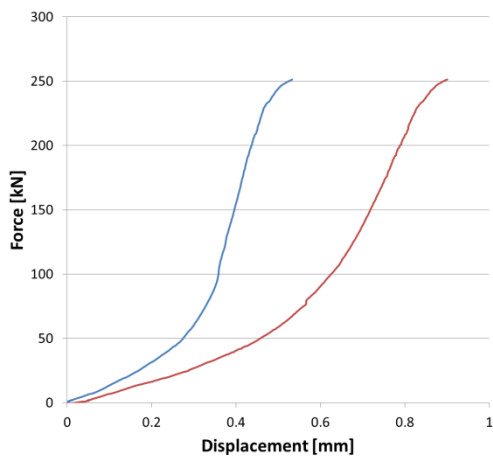
Figure 4-9: Load vs. Deformation: (a) Crack Opening B, (b) Center Deflection B, (c) Overhang B, (d) Crack Opening D, (e) Center Deflection D, (f) Overhang D

In the case of the shear test, six LVDTs were used to measure the deflection, three on either side of the specimen. Two were placed over the hanging edge, two were positioned over the reaction, and two were positioned over the applied load. Again, four LP's were used to measure crack opening however, for this test two were placed on each vertical face. The positioning of the different measurement devices can be seen in Figure 4-8. Typical load vs. measured deformation graphs for two tests can be seen in Figure 4-9.
