# Creating A Scaling Relationship Between Peak Discharge And Drainage Area To Identify Tile Drainage Inputs Into An Agricultural Stream

Ryan Plath

CREATING A SCALING RELATIONSHIP BETWEEN PEAK DISCHARGE AND  
DRAINAGE AREA TO IDENTIFY TILE DRAINAGE INPUTS INTO AN  
AGRICULTURAL STREAM

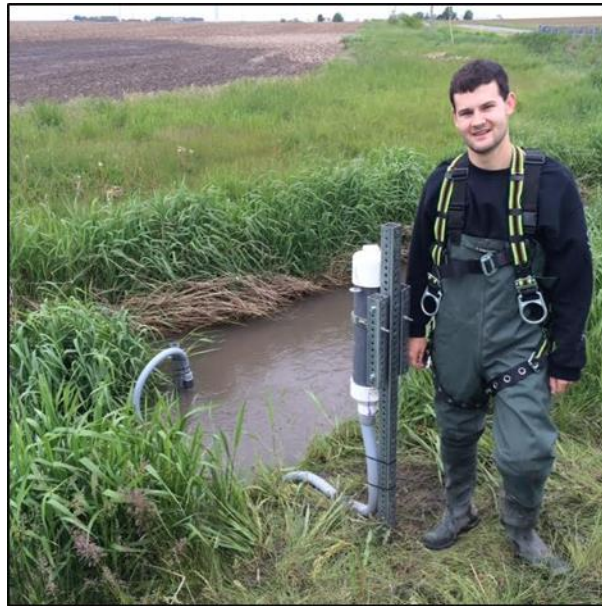
*Figure 5.* The PVC Stilling well (in the stream) connected by conduit to the onshore PVC Unit. I secured both ends to metal posts.

I installed HOBO MX pressure transducers at the eight different sampling locations along Money Creek. At each site, the sensing end of the pressure transducer was secured in a PVC stilling well. The wiring was run through conduit to an onshore PVC unit that housed the logging end of the pressure transducer and protected the electronic components from the elements (Figs. 5 & 6).

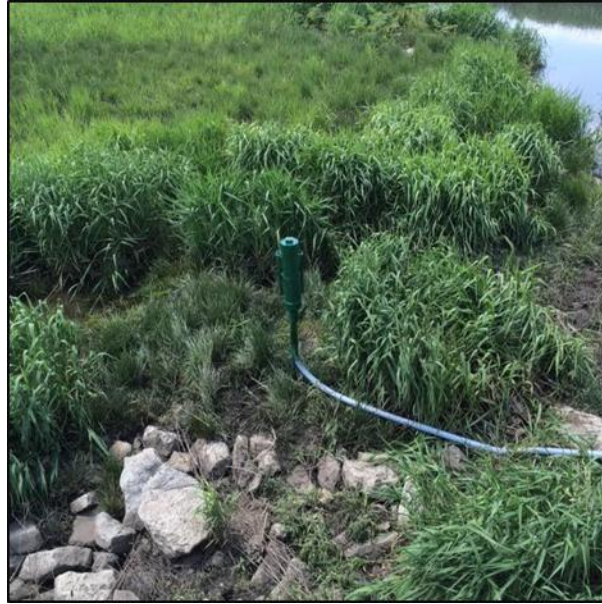
*Figure 6.* The onshore PVC Unit that houses the logging end of the pressure transducer.

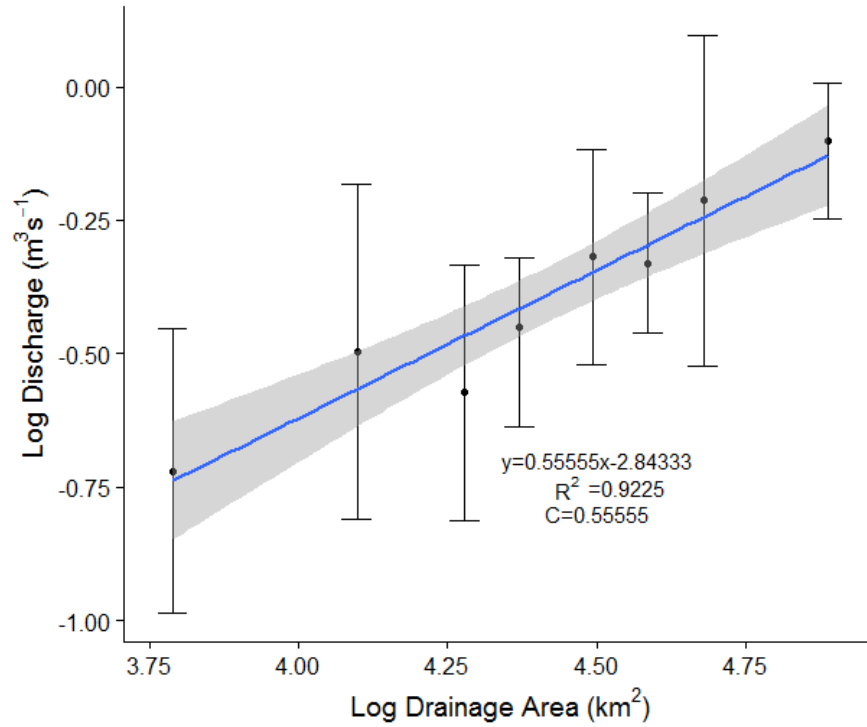
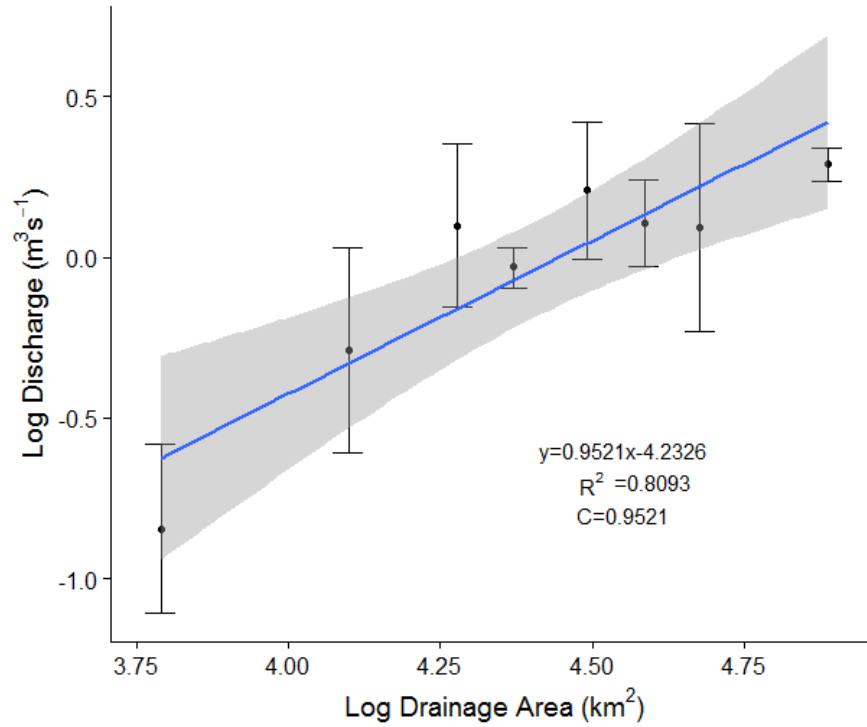
Figure 36. Peak discharge scaling relationship for Storm 1 (~ 5/29/16). Error bars represent the upper and lower limit of the 95% confidence interval for that point's calculated discharge value.

Figure 37. Peak discharge scaling relationship for Storm 3 (~ 6/14/16). Error bars represent the upper and lower limit of the 95% confidence interval for that point's calculated discharge value.

Figure 38. Peak discharge scaling relationship for Storm 4 (~ 6/22/16). Error bars represent the upper and lower limit of the 95% confidence interval for that point's calculated discharge value.

Figure 39. Peak discharge scaling relationship for Storm 5 (~ 7/6/16). Error bars represent the upper and lower limit of the 95% confidence interval for that point's calculated discharge value.

Figure 40. Peak discharge scaling relationship for Storm 6 (~ 7/14/16). Error bars represent the upper and lower limit of the 95% confidence interval for that point's calculated discharge value.

Figure 41. Peak discharge scaling relationship for Storm 7 (~ 7/14/16). Error bars represent the upper and lower limit of the 95% confidence interval for that point's calculated discharge value.

Figure 42. Peak discharge scaling relationship for Storm 8 (~ 7/25/16). Error bars represent the upper and lower limit of the 95% confidence interval for that point's calculated discharge value.

Figure 43. Peak discharge scaling relationship for Storm 9 (~ 8/16/16). Error bars represent the upper and lower limit of the 95% confidence interval for that point's calculated discharge value.

Figure 44. Peak discharge scaling relationship for Storm 10 (~ 8/21/16). Error bars represent upper and lower limit of the 95% confidence interval for that point's calculated discharge value.

Figure 45. Peak discharge scaling relationship for Storm 11 (~ 8/24/16). Error bars represent upper and lower limit of the 95% confidence interval for that point's calculated discharge value.

Figure 46. Peak discharge scaling relationship for Storm 12 (~ 8/27/16). Error bars represent upper and lower limit of the 95% confidence interval for that point's calculated discharge value.

Figure 47. Peak discharge scaling relationship for Storm 13 (~ 9/8/16). Error bars represent the upper and lower limit of the 95% confidence interval for that point's calculated discharge value.

Figure 48. Peak discharge scaling relationship for Storm 14 (~ 9/14/16). Error bars represent upper and lower limit of the 95% confidence interval for that point's calculated discharge value.

Figure 49. Peak discharge scaling relationship for Storm 15 (~ 10/6/16). Error bars represent upper and lower limit of the 95% confidence interval for that point's calculated discharge value.

Figure 50. Peak discharge scaling relationship for Storm 16 (~11/3/16). Error bars represent the upper and lower limit of the 95% confidence interval for that point's calculated discharge value.

Figure 51. Peak discharge scaling relationship for Storm 17 (11/23/16). Error bars represent upper and lower limit of the 95% confidence interval for that point's calculated discharge value.

Figure 52. Peak discharge scaling relationship for Storm 18 (~ 11/28/16). Error bars represent upper and lower limit of the 95% confidence interval for that point's calculated discharge value.

Figure 53. Peak discharge scaling relationship for Storm 19 (~ 12/26/16). Error bars represent upper and lower limit of the 95% confidence interval for that point's calculated discharge value.

Figure 54. Peak discharge scaling relationship for Storm 20 (~ 1/3/17). Error bars represent the upper and lower limit of the 95% confidence interval for that point's calculated discharge value.

Figure 55. Peak discharge scaling relationship for Storm 21 (~ 1/17/17). Error bars represent upper and lower limit of the 95% confidence interval for that point's calculated discharge value.

Figure 56. Peak discharge scaling relationship for Storm 22 (~ 1/20/17). Error bars represent upper and lower limit of the 95% confidence interval for that point's calculated discharge value.

Each scaling relationship graph displays its regression equation, R<sup>2</sup> value, and scaling exponent (c-value) (Table 5). The average R<sup>2</sup> value was 0.86. The maximum scaling exponent throughout the study was Storm 7 with a value of 1.576, while the minimum was Storm 10 with a value of 0.556. The mean scaling exponent of 11 storms from the tileflow period (both the early summer and fall/winter tileflow periods) was 1.109, while the mean from nine storms during no tileflow was 0.86 (Table 5). I excluded the scaling exponent from Storm 3 because the regression failed an F-test.

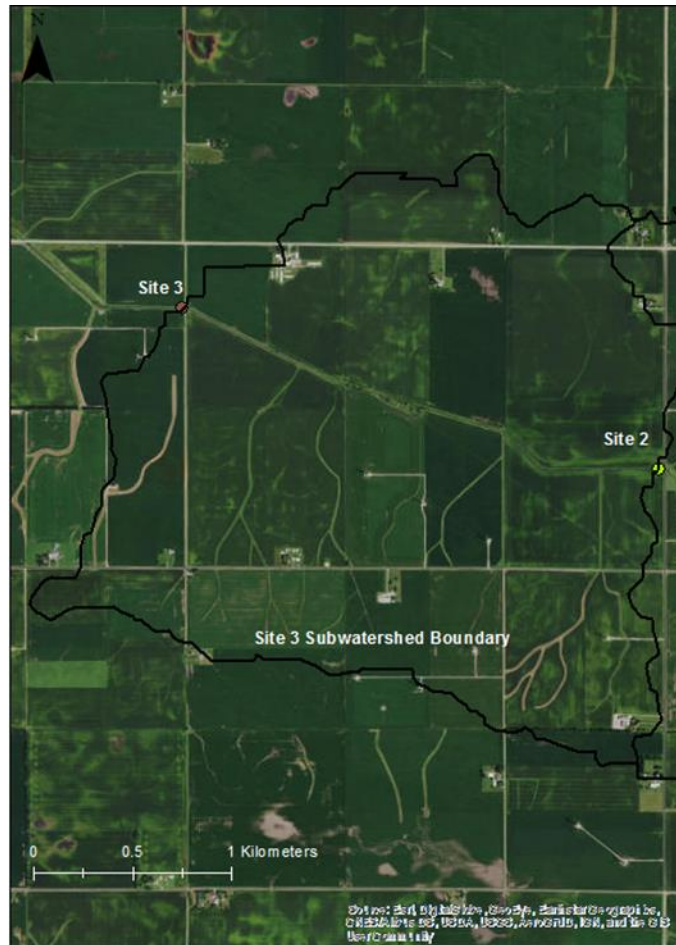
*Figure 61.* An Aerial image showing the site 3 subwatershed and the western border of the Site 2 subwatershed. The creek flows from east to west. Notice that the total area of fields that exist both within and outside of the Site 3 watershed is limited.

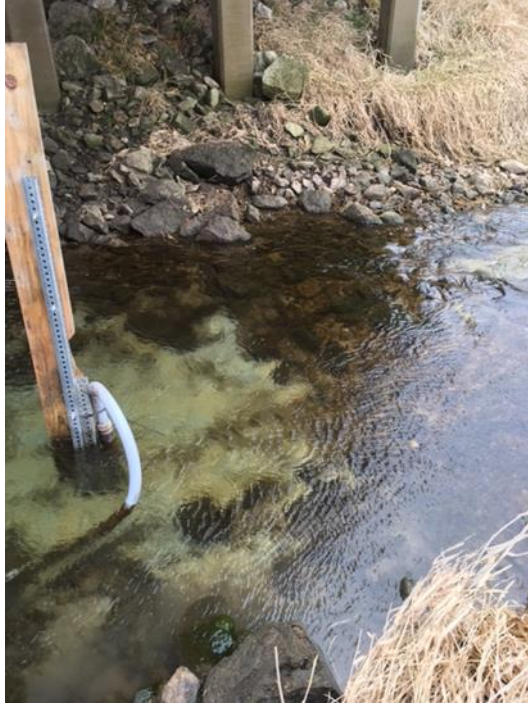
*Figure 64.* Streambed scouring and bare clay beneath the pressure transducer at Site 5 after Storm 17. Note the transition from the scoured pool section of the stream to the run with larger cobbles and boulders.

appears to have caused a sudden drop in measured stage (Fig. 62). Signs of beavers have been observed in this watershed. This sudden drop in stage could have been the result of a beaver dam that burst downstream during the storm, thus suddenly lowering stage. Upon visual examination, there appeared to be a change in channel morphology from this drop in stage. The pressure transducer, which originally was at the streambed, was now around six inches above the surface of the streambed due to scouring. Originally, the streambed had a mixture of sediment near the bottom, now the streambed is just bare clay (Fig. 63 & 64). Storm 17 converted the area just downstream of the recording station from a straight stretch of stream into a ripple section with large cobbles and boulders, much of which appears to be from limestone blocks that were used to fill the area beneath the bridge during construction (Figs. 64 & 65).

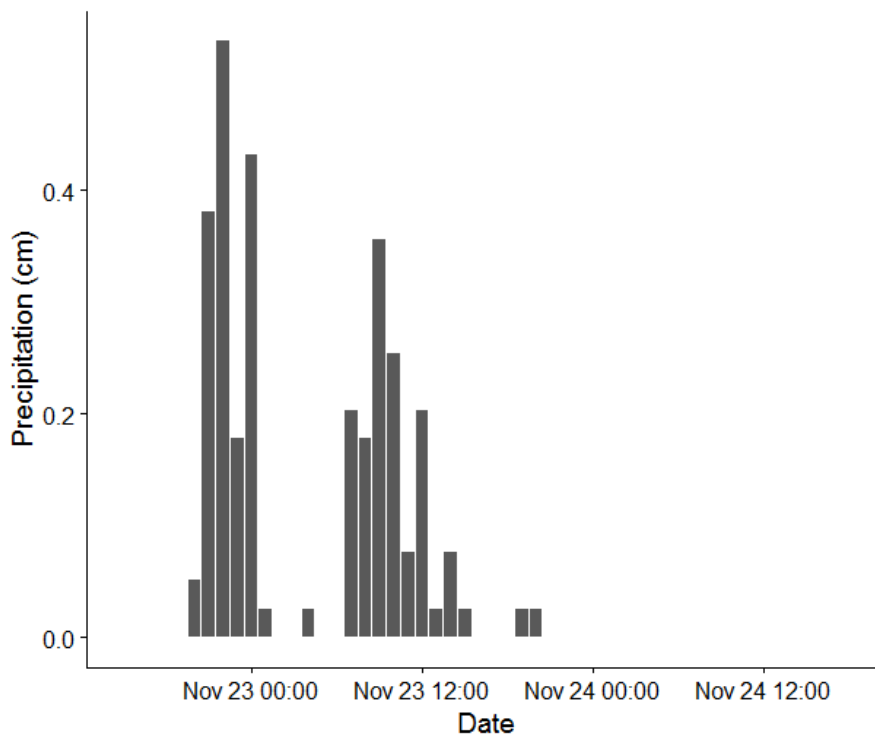
Figure 67. Hourly Precipitation data for Site 1 during Storm 17.
