Instrumentation to Monitor Bridge Foundation on the Crosstown Project

Brian Welch

Minnesota State University, Mankato

Brian Welch (Department of Mechanical and Civil Engineering)

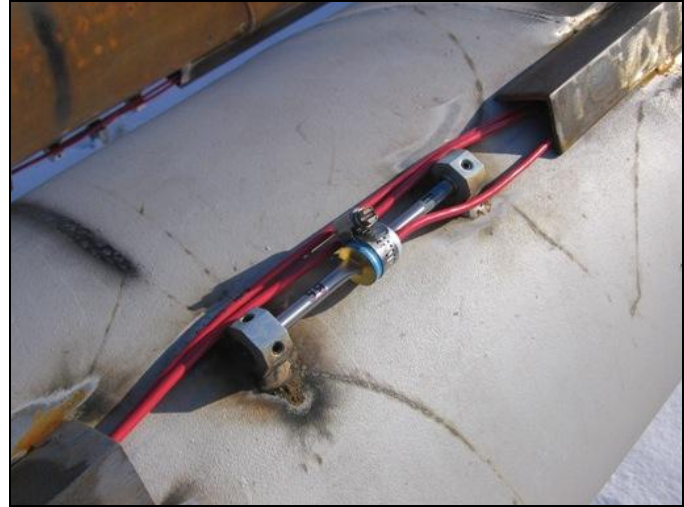
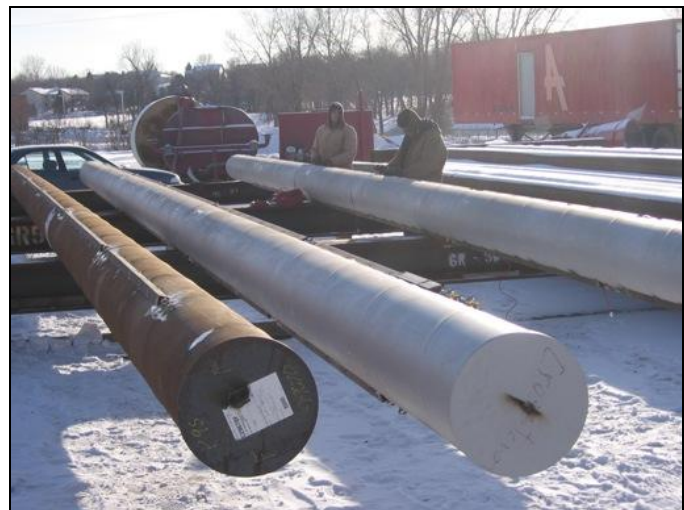
Figure 1. Placement of Strain Gages on Pipe Piles: (a) Schematic showing position of strain gage pairs, (b) Picture showing strain gages welded to pipe pile, (c) placement of strain gages on each of the three instrumented piles at the construction yard.

The project involved the placement of twelve strain gages on each of the three instrumented piles. Six pairs of diametrically opposed gages were welded to the piles, spaced out every ten feet with two sets of gages near the bottom of the pile. Identical gage placement was done for three piles, one standard steel pipe pile and two Teflon-coated steel pipe piles. The piles were 65 feet long and 16 inches in diameter. The piles were first driven to a specified resistance, and then re-struck four days later in order to measure the increase in pile resistance after driving. Data were recorded before driving, a week after driving and finally would have a continuous recording once the bridge abutment was constructed.

The next step of the project was to attach and protect the strain gages. The strain gage brackets were welded to the piles, strain gages were attached, and the cables were run the length of the piles (see Figure 1b and Figure 1c). The gages and cables are both heat sensitive, therefore heat prevention and caution were vital. After the gages were installed and the cables were pulled through the angles, they were covered by the larger protective angles and foam was inserted to hold the cables in place during pile driving. The final step of the pre-driving process was to get preliminary readings from the gages for a base reading. This would allow a comparison between the pre-driving and post-driving readings. These initial strain readings are shown in Figure 2.

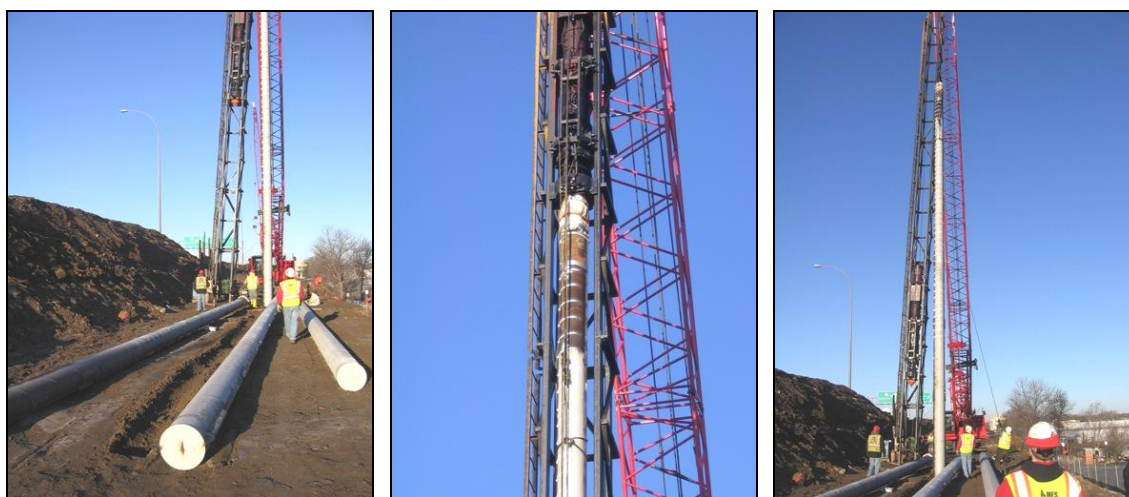
Figure 3. Instrumented Pile Mobilization and Driving on Crosstown Project: a) Three instrumented piles on the construction site, b) Cables carefully wrapped near the top of the pile, c) An instrumented pile being driven.

The final step of the pre-driving preparation was the fastening and securing of the cables to the top of the pile to hold them in place during mobilization and driving. This was one of the main concerns of the project due to the long travel of the piles and the shaking due to the pile driving hammer blows. The cables were bound and wrapped with a cloth to prevent them from shifting as they were driven. They were then bound with multiple ratchet straps to hold them in place. After this, they were ready to be transported to the site and driven into the foundation soil. Figure 3 shows the piles after mobilization to the site (Figure 3a), the carefully wrapped cables near the top of the pile (Figure 3b) and one of the piles being driven into the foundation soil (Figure 3c).

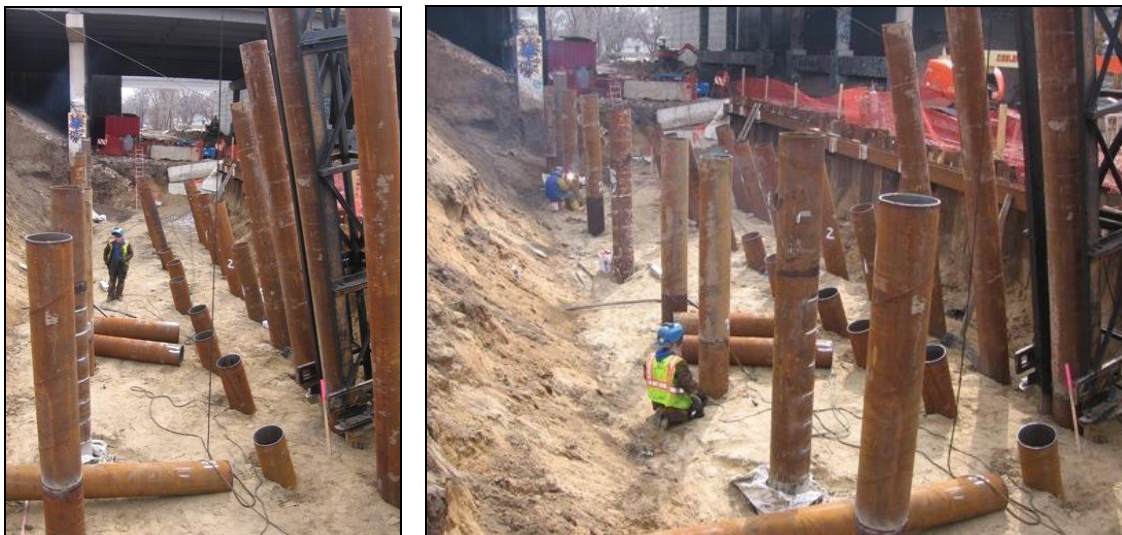
Figure 4. Pictures of Instrumented Piles and Additional Piles at Project Site.

One of the main components of the project is the piles that were to be driven. The instrumented piles were three of over 30 piles used for the northeast abutment of the bridge. The piles were 16 inches in diameter and 65 feet long. The three piles that were chosen were a standard steel pipe pile and two Teflon-coated steel pipe piles. These pipe piles were shown in Figure 1 and Figure 3. Figure 4 shows most of the piles driven for the bridge abutment discussed for this project.

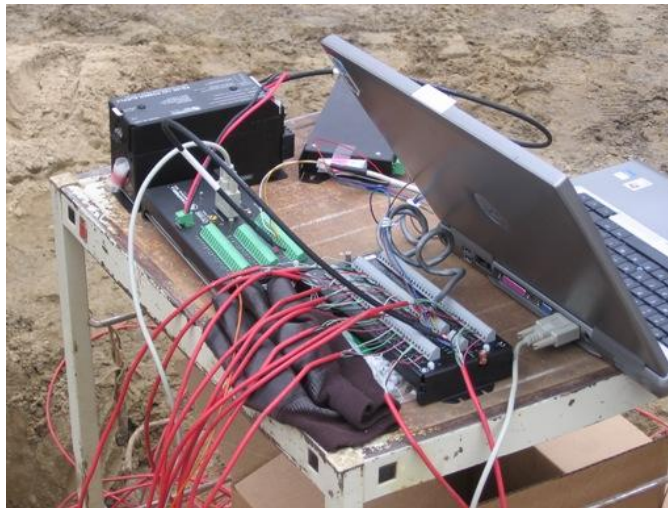
Figure 5. Data Collection Following Pile Driving

abutment is poured and will occur for a period of several years. There currently is a data collection box at the project location that will collect the strains over time and hold them until data collection is desired. Figure 5 shows the data collection system during the initial sets of readings after pile driving.
