An archaeological perspective on architectural evolution at Fort Harrison

An Archaeological Perspective on Architectural Evolution at Fort Harrison

An Honors College Project Presented to
the Faculty of the Undergraduate
College of Arts and Letters
James Madison University

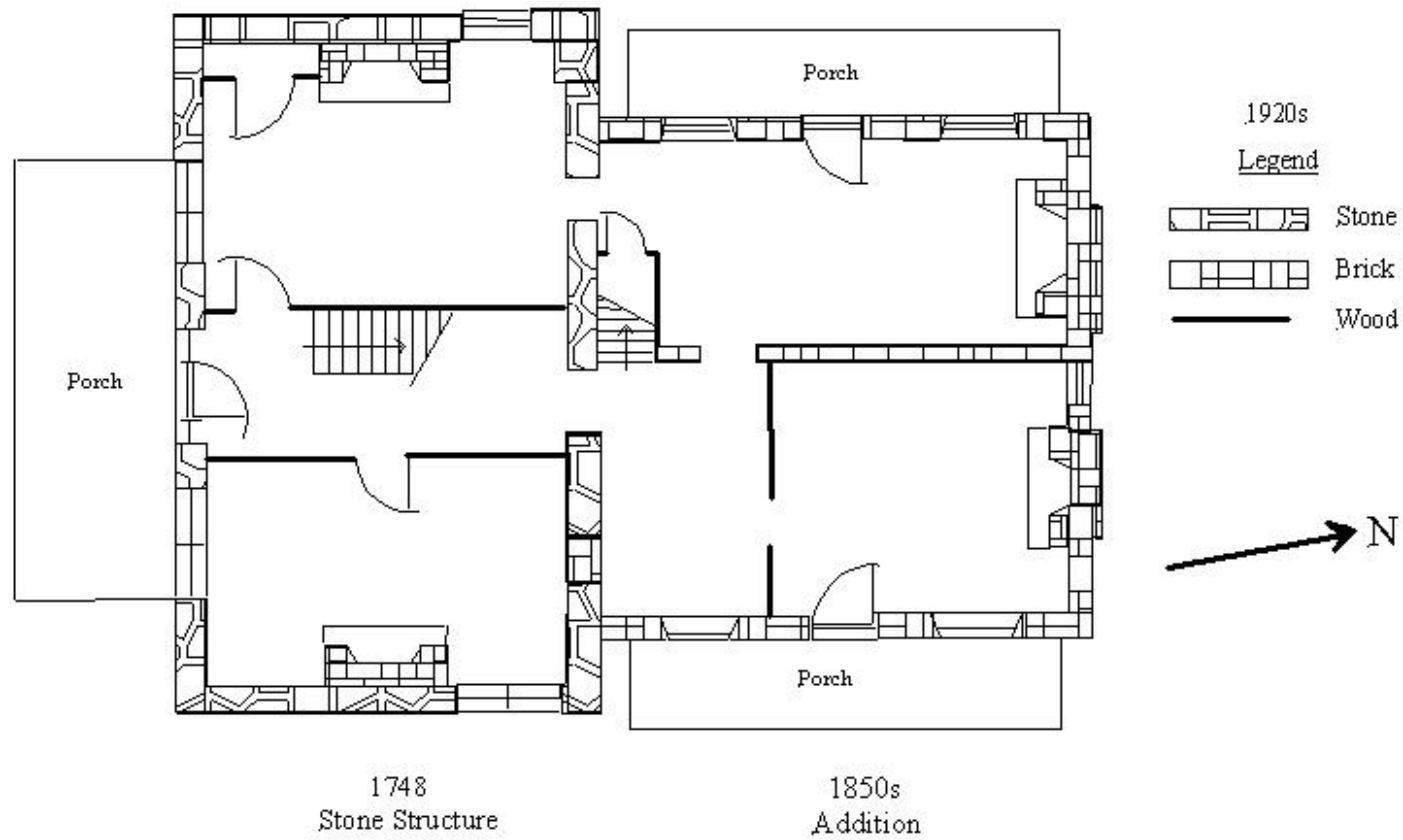
Figure 4: 1850s Addition and 1860s Renovations- First Floor Plan

In 1856, a two-story brick addition was added to the northern side of the original limestone structure by John Allebaugh (Figures 4 and 5). If the hypothesis is supported, then it was at this time that the reorientation occurred. The north wall of this addition included two chimneys, with two fireplaces on each floor. A load-bearing wall runs through the middle of the addition from north to south to support the second floor and the attic. The existing doorway on the northerly-facing side connects the original stone structure with the new brick addition. The stone arch above this doorway was kept as support for the upper stories. The second level window on the western end of the northerly-facing side was widened to function as a doorway. The other second level window on the northerly-facing side was bricked shut, while still keeping the stone arch for support. Additionally, the windows on the northerly-facing side of the first level were both widened to function as doorways, and still retained their original arches. However, the east door was later bricked shut. There is no information regarding the stairway during this period of construction.

During the 1860s there were extensive renovations by William and Solomon Burtner to the original limestone structure, including some Greek revival influence seen in the design and woodwork (Figures 4 and 5). All four window openings on the southerly-facing side were made larger to accommodate taller and wider windows. The first level front door opening was enlarged to accommodate a taller door. The second level door opening leading onto the roof of the porch was also enlarged. At this time the stone arches above the doorway and the windows were removed because the weight distribution that they created could not accommodate a larger doorway and windows. A central hall, including a stairway, was constructed on both floors of the stone structure by removing the center partitions. This created an unheated hallway that provided access into two rooms on both floors. The existing corner stairway was removed and a closet

built. A new, south side porch was constructed, which was shorter than the original. An additional window was placed on the east side of the original stone structure. The entire exterior of the structure was coated with stucco, providing a more finished look and helping to seal the walls. The original stone fireplaces and chimneys located on the east and west sides were removed and replaced with freestanding brick fireplaces and chimneys. These chimneys were not built into the wall, but were added to the inside of the room. Following these major renovations, only minor changes occurred to the architectural form of Fort Harrison.

The figure shows the first floor of both the 1856 brick addition added to the north side of the original limestone structure and the 1860s renovations completed on the original limestone structure portion of the house.

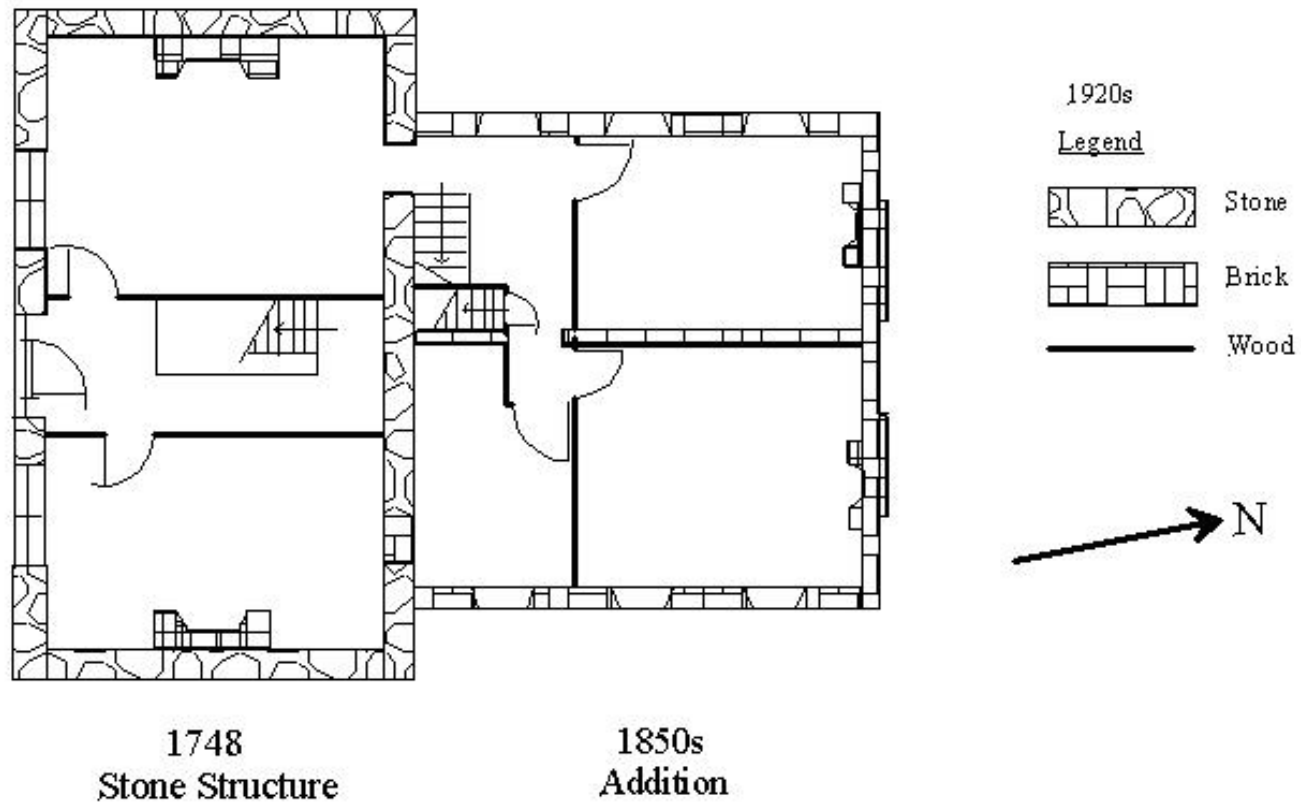
Figure 5: 1850s Addition and 1860s Renovations- Second Floor Plan
 This figure shows the second floor of both the 1856 brick addition added to the north side of the original Limestone structure and the 1860s renovations completed on the original limestone structure portion of the house.

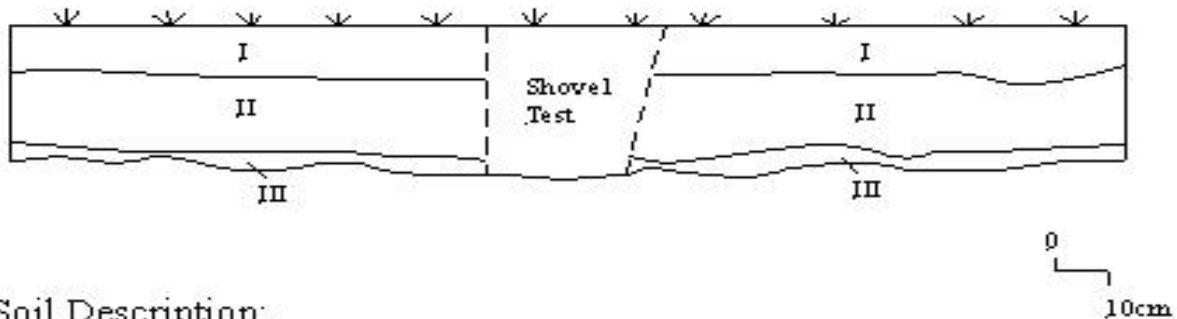
Figure 8: Unit 1 East Profile

Soil Description:

I: Fill layer - relatively blocky structure, 10 YR 4/3, silty loam

III: Subsoil - 10 YR 7/2, silty clay

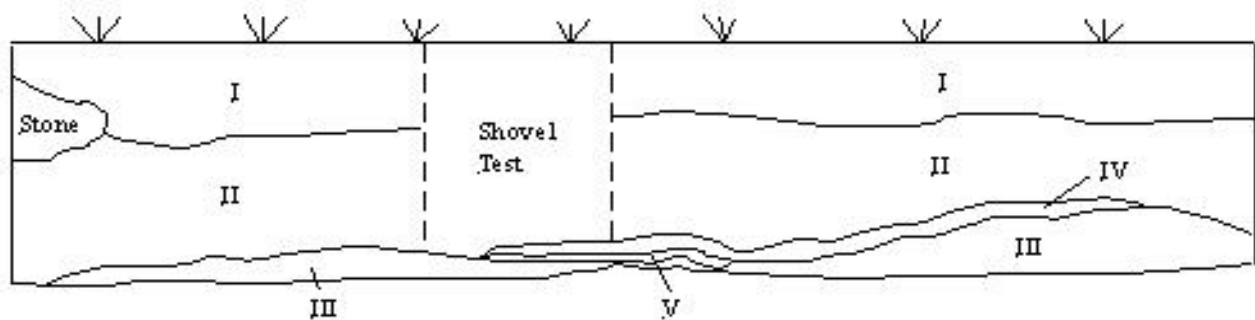
Figure 9: Unit 2 East Profile

Soil Description:

I: Humus/root zone, 10 YR 3/2, silty loam

V: Heat-altered (orange) soil

Differences in the general pattern of soil transitions from A-horizon to E-horizon to B-horizon took place when features were identified (Figures 9 and 14) and when the soil had been backfilled (Figures 8 and 10). The abundance of small pebbles and stone increased with depth within the southern pasture. Differences in depth among the shovel test pits until subsoil was reached spanned from less than 10 cm at the shallowest and around 80 cm for the deepest. Refer to the figures illustrating the unit profiles for specific information on strata, Munsell color, and soil texture.

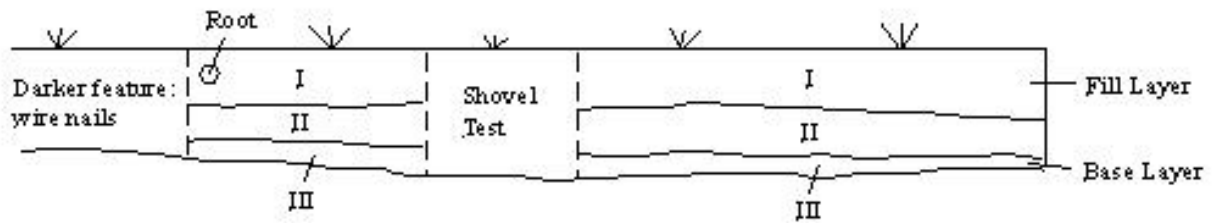
Figure 10: Unit 3 East Profile

Soil Description:

- I: Fill Layer, relatively chunky structure, 10 YR 4/3, silty loam
- II: Buried A-horizon/sheet midden, 10 YR 5/3, silty loam
- III: Subsoil, 10 YR 6/4, silty clay
- Feature: Pipe trench? Mixed soil, primarily 7.5 YR 5/6, silty clay

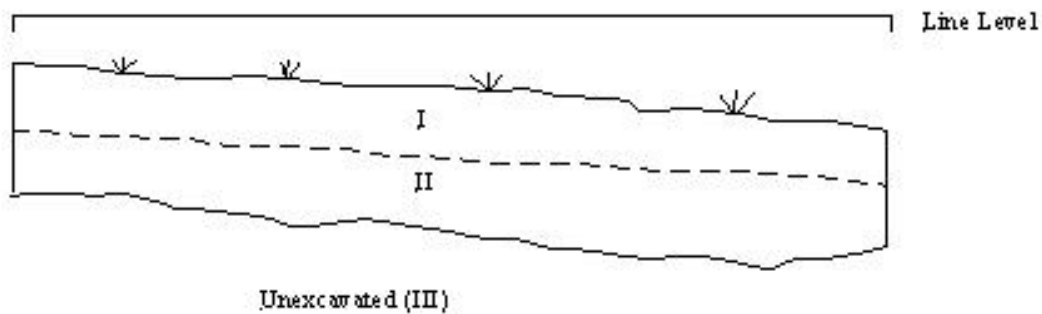
Figure 11: Unit 4 South Profile

Soil Description:

- I: A-horizon 10 YR 3/2, silty loam with occasional stone
- II: Primarily 10 YR 4/3, silty clay loam with abundant small stone
- III: Primarily 7.5 YR 4/6, silty clay loam with abundant small stones, and occasional lenses of 7.5 YR 5/6, silt clay (subsoil?)

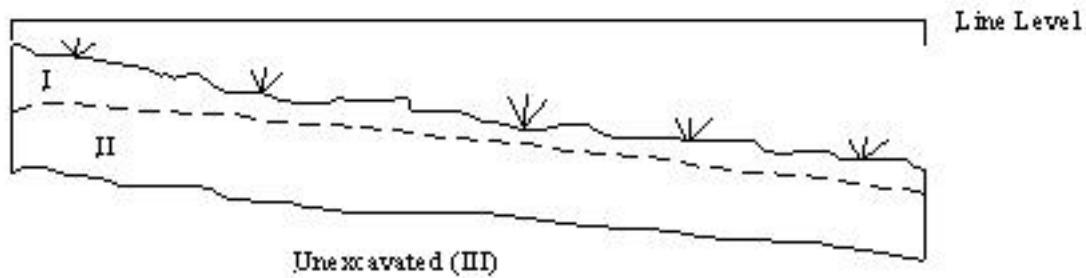
Figure 12: Unit 5 South Profile

Soil Description:

I: A-horizon 10 YR 3/2, silty loam with occasional stone

III: Primarily 7.5 YR 5/6, silty clay

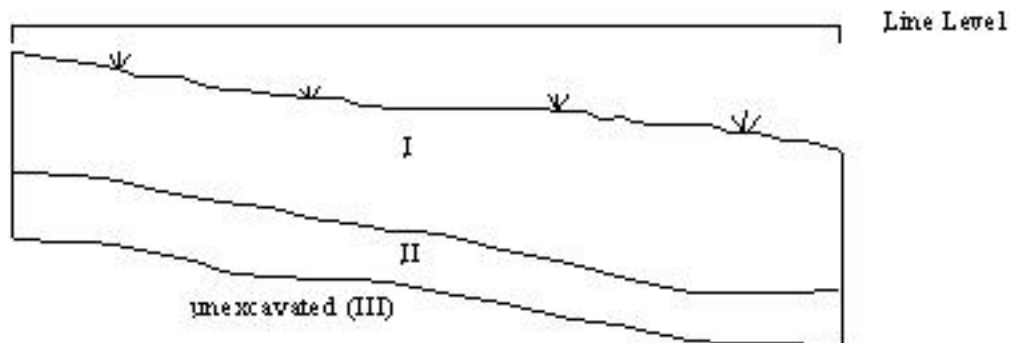
Figure 13: Unit 6 South Profile

Soil Description:

I: 10 YR 3/4 dark yellowish brown, silty loam

III: 7.5 YR 4/6 strong brown, silty clay, common to abundant small stones

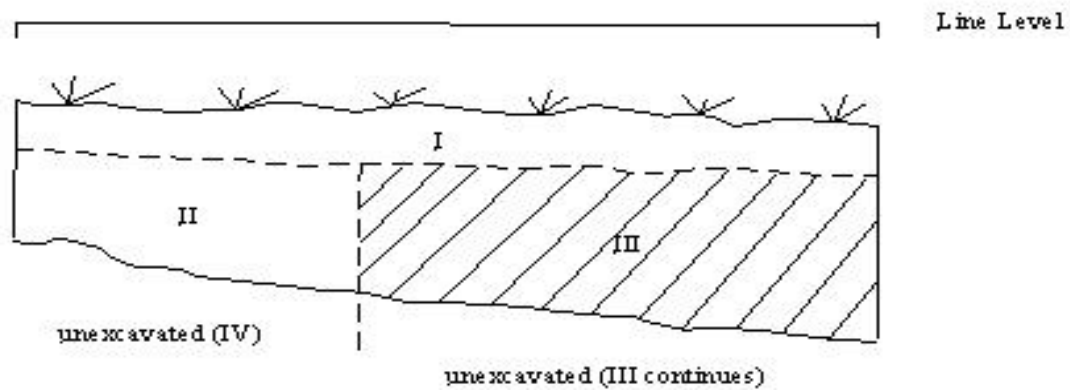
Soil Description:

- I: A-horizon 10 YR 3/2, silty loam with occasional stone
- II: Primarily 10 YR 4/3, silty clay loam with abundant small stones
- III: Feature fill/midden - 10 YR 2/2 silty clay loam with moderate quantity small stones plus common burned wood and bone (unburned)
- IV: Subsoil - 7.5 YR 4/6, silty clay loam with abundant small stones

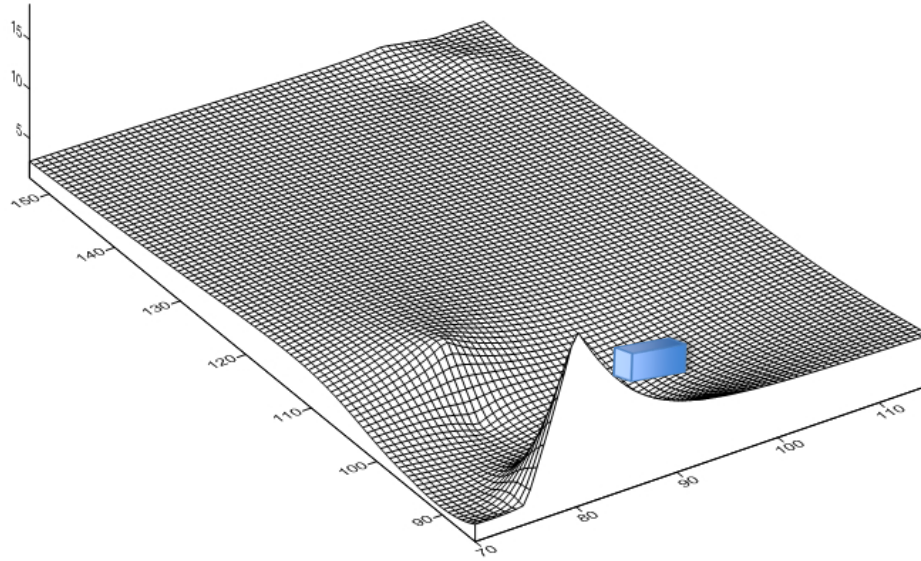
Figure 29: Shovel Test Pit Creamware Distribution

This figure shows the distribution of creamware that was recovered from the shovel test pits. The highest density of creamware is located south of the house, which is represented by the cube.

Refined earthenware can be broken into the following chronological categories: creamware (1760-1820), pearlware (1779-1830), and whiteware (1820-present). Within the southern pasture and the yard where there are the highest densities of refined earthenware, the distributions of creamware, pearlware, and whiteware are different. The distribution of creamware is more concentrated within the southern pasture to the south of the dwelling (Figure 29). The distribution of pearlware is to the west of the dwelling (Figure 30). The distribution of whiteware is to the north west of the dwelling (Figure 31). This change in refined earthenware distribution across the site, beginning in the pasture south of the dwelling and shifting north west of the dwelling, indicates that activity areas surrounding the dwelling changed over time. Creamware, the earliest manufactured refined earthenware type is densely distributed in the area south of the dwelling. Whiteware, the latest manufactured refined earthenware type is more densely distributed in the area to the north of the dwelling. Pearlware, the refined earthenware type that was manufactured between creamware and whiteware is most densely distributed in the area to the west of the dwelling. Thus, this indicates that the earlier activity areas were located to the south of the dwelling and later activity areas were shifted to a location north of the dwelling.

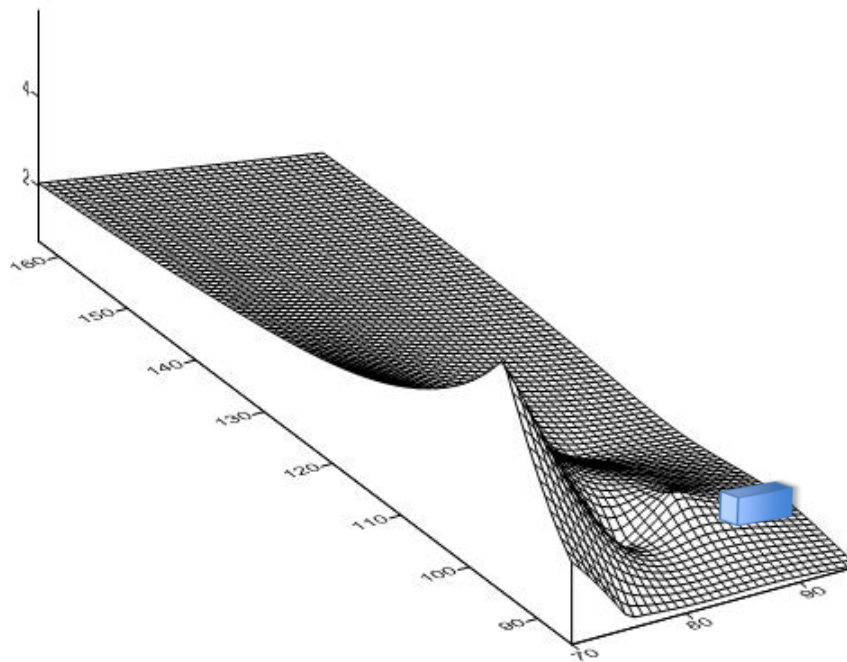
Figure 30: Shovel Test Pit Pearlware Distribution

This figure shows the distribution of pearlware that was recovered from the shovel test pits. The highest density of pearlware is located to the west of the house, which is represented by the cube.

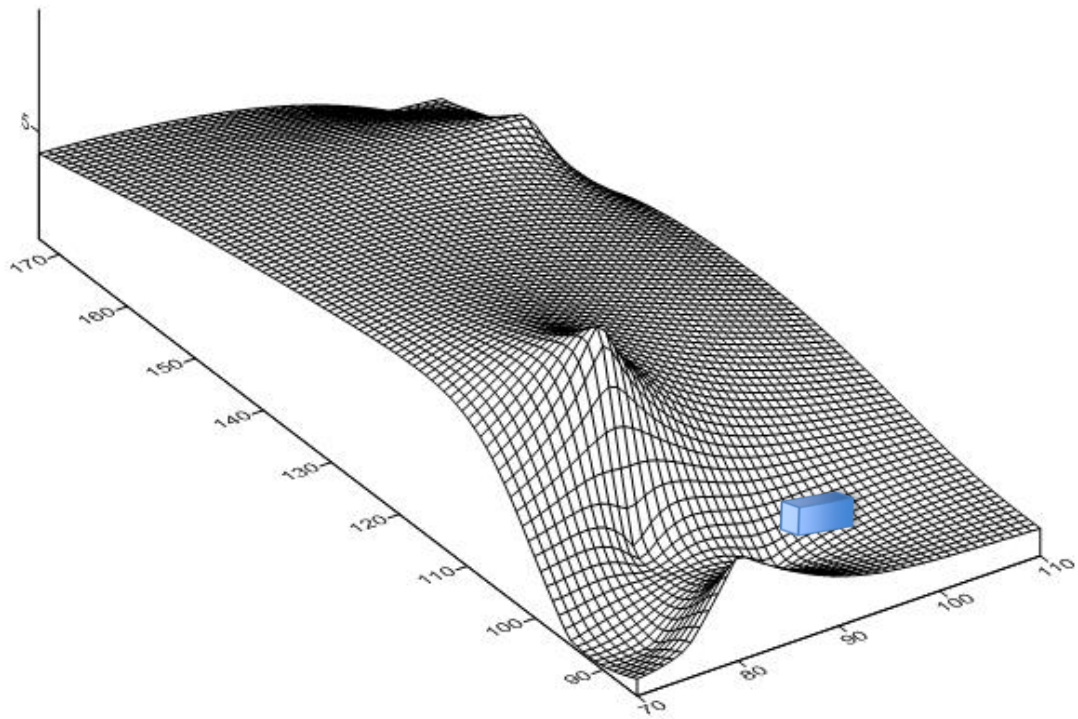
Figure 31: Shovel Test Pit Whiteware Distribution

This figure shows the distribution of whiteware that was recovered from the shovel test pits. The highest density of whiteware is located north of the house, which is represented by the cube.

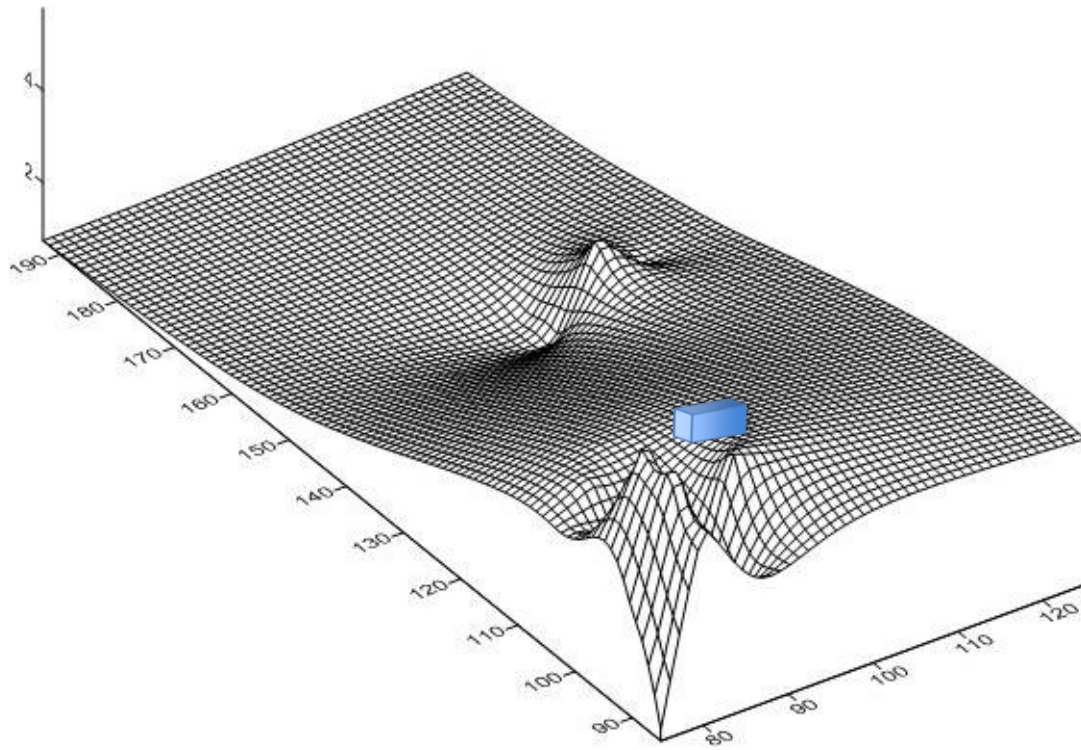
Figure 32: Shovel Test Pit Hand Wrought and Cut Nail Distribution

This figure shows the distribution of hand wrought and cut nails recovered from the shovel test pits. The highest density of nails is located to the west and south of the house, which is represented by the cube.

Nails are another artifact type that have known manufacturing dates based on specific characteristics. The nail types that were recovered were hand wrought (before 1800) and machine cut (1801-1900). The distribution of the highest concentration of both hand wrought and cut nails is within the southern pasture and the south yard (Figure 32).

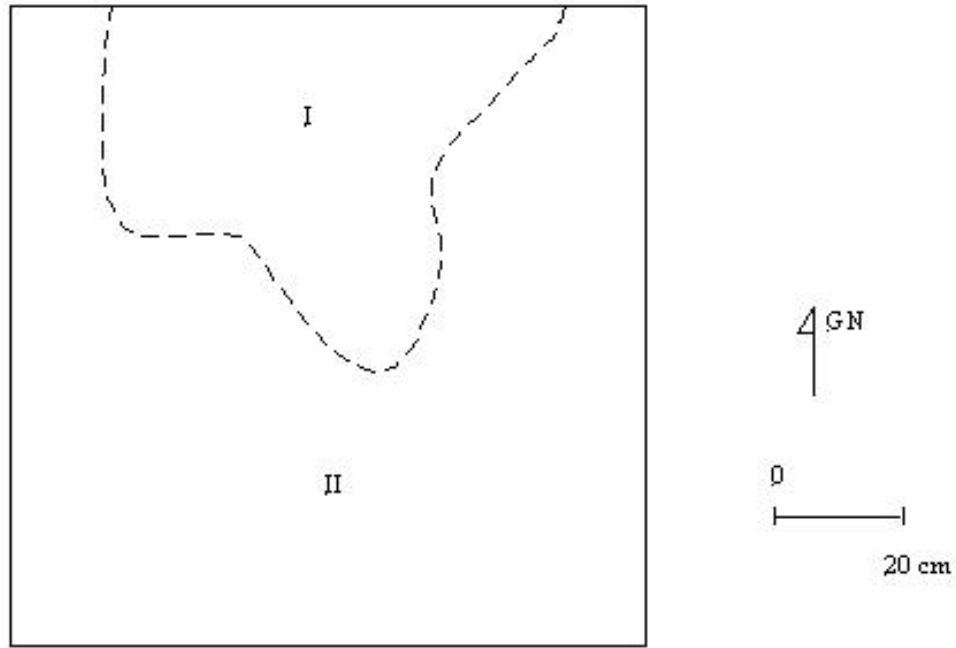
Figure 37: Unit 4 Base Stratum I Plan View

Soil Description:

I: 10 YR 6/5, clay (modern fill?)

* low to moderate gravel

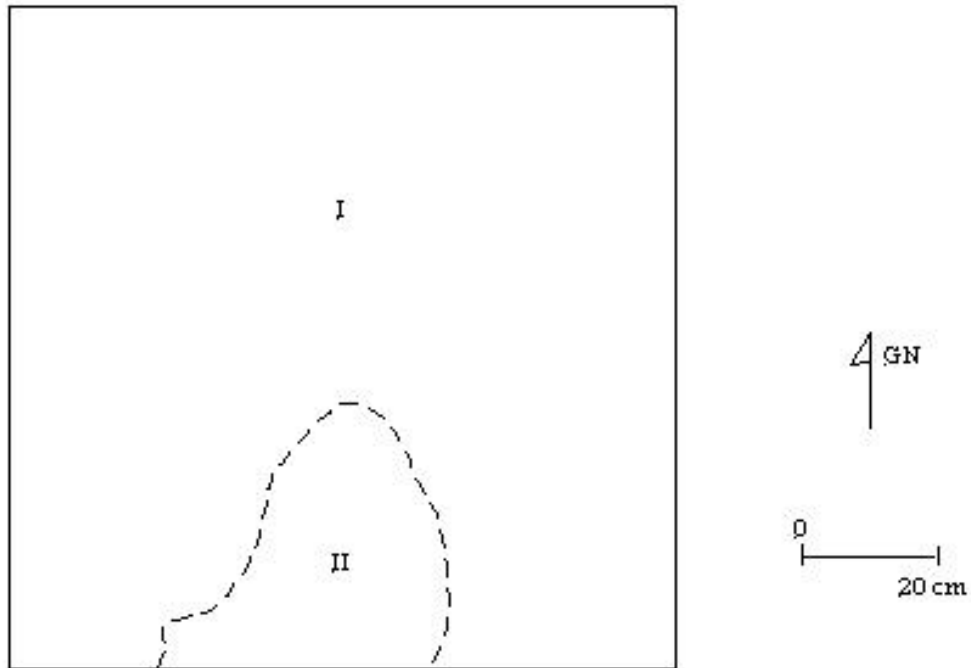
Figure 38: Unit 4 Base Stratum II Plan View

Soil Description:

- I: 10 YR 6/4, silty loam with clumps and patches of 10 YR 5/8 clay/concretions and abundant gravel
- II: Apparent feature - primarily 10 YR 4/2, silty loam with occasional artifacts, less stoney

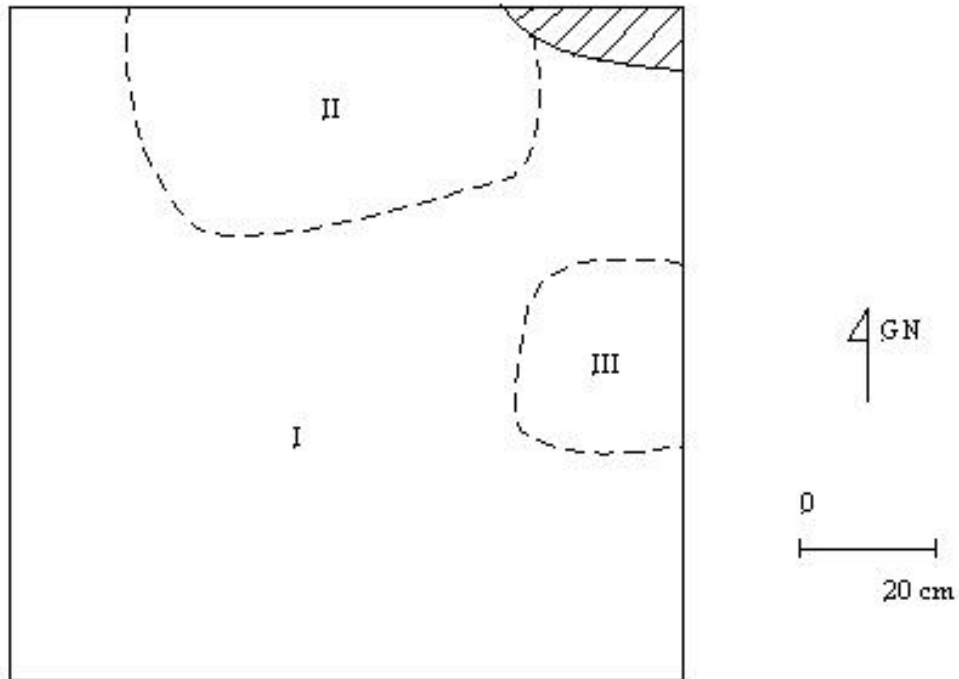
Figure 39: Unit 5 Base Stratum II Plan View

Soil Description:

- I: 7.5 YR 5/6, clay with common architectural chips, blended clay hash
- II: Apparent feature - 10 YR 3/1 silty clay loam with common artifacts
- III: Possible feature - primarily 10 YR 3/2 with some clay mottles, with common limestone chips

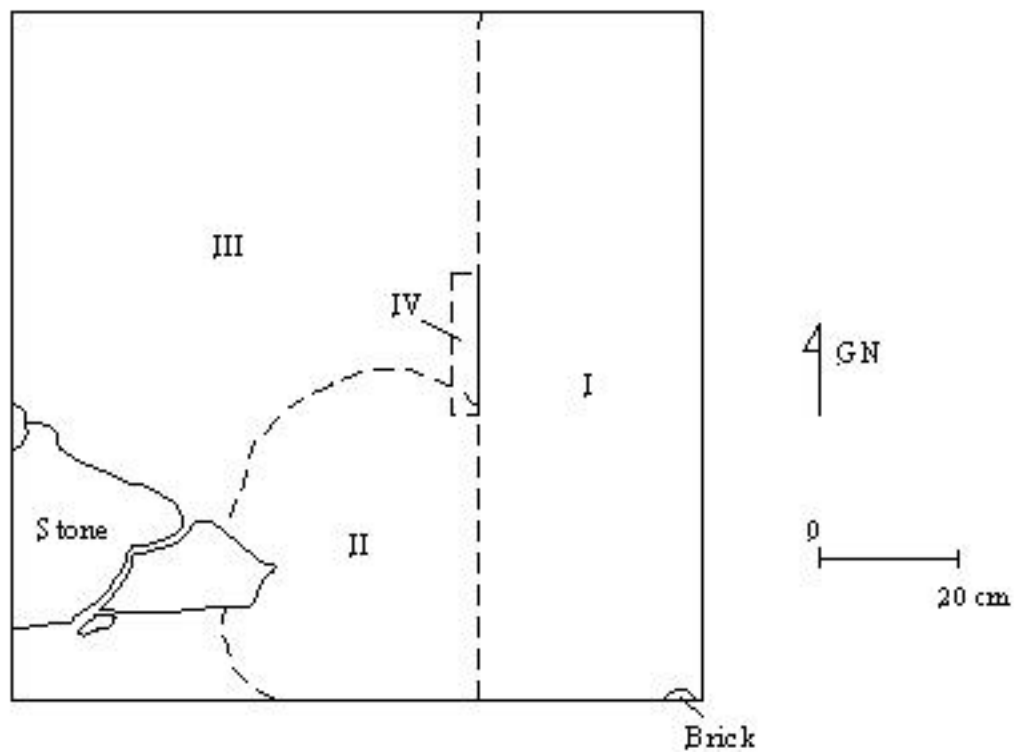
Figure 41: Unit 7 Base Stratum II Plan View

Soil Description:

I: 10 YR 6/6 brownish yellow, silty clay loam

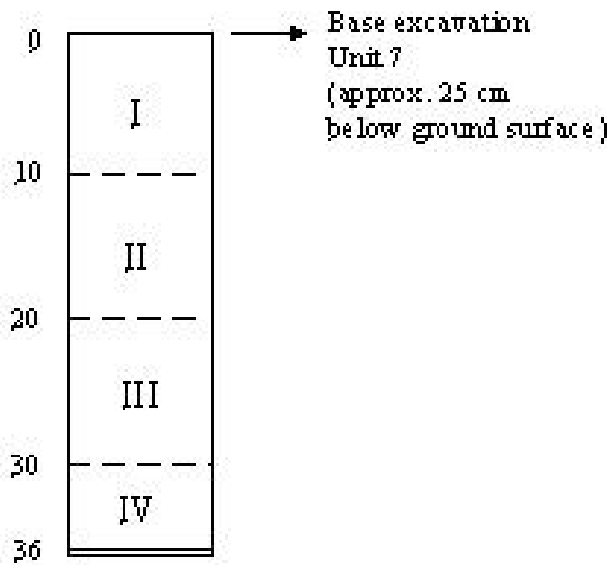
Figure 43: Oakfield Core Profile Unit 7

Soil Description

- I: Feature fill- relatively uniform dark brown, silty loam
- II: Feature fill- brown silty clay loam, with occasional mottles and charcoal flecks
- III: Feature fill- mixed brown loam and orange clay with common charcoal
- IV: Apparent orange clay subsoil

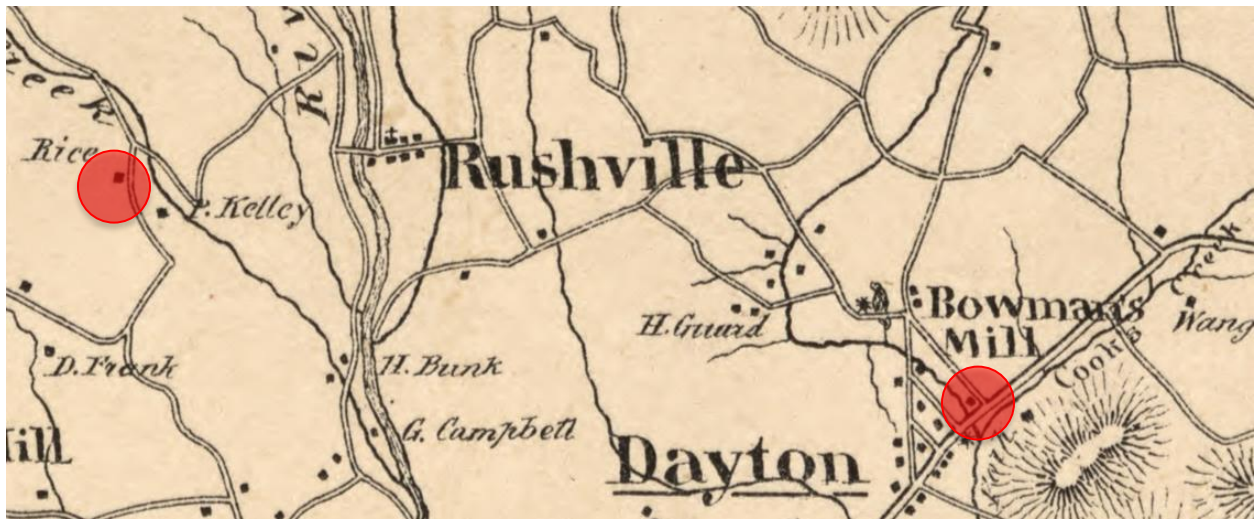
Figure 45: 1875 Map of Rockingham County- Harrison Property and Rice Property
 Harrison family property and Rice family property highlighted.

family to the property owned by Benjamin Harrison, according to the natural landscape and efficiency. When this road was first developed, it was likely oriented to the front entrance of the limestone structure because it was one of few structures on the landscape at the time. Figure 45 is an 1875 map of Rockingham County that includes Fort Harrison, the Rice property, and the roads at that time. While this map is from a later period, there is a road to the north of Fort Harrison that runs east to west and connects to the Rice's property. This road may have been one of the first to develop on the landscape and it may have initially been oriented to the northerly-facing front entrance of the original limestone structure.

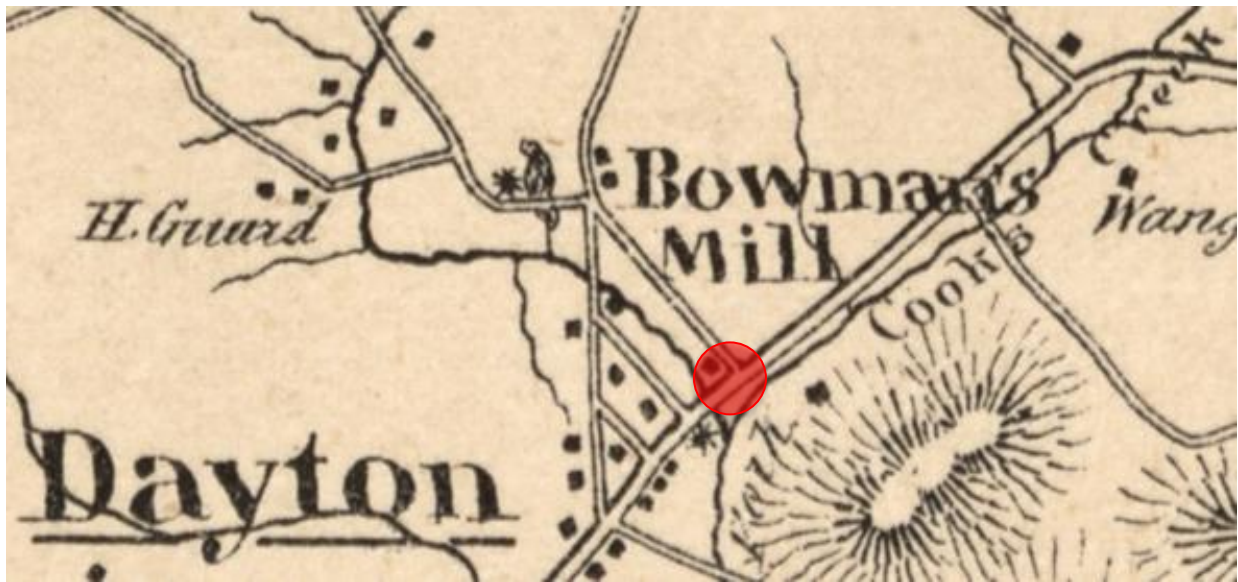
Figure 46: 1875 Map of Rockingham County- Harrison House and Adjacent Roads
 This figure shows the Harrison house highlighted and its adjacent roads. One road running east to west on the north side of the structure and one road (Main Street) running north to south on the east side of the structure.

Over time, throughout the phases of settlement within the Shenandoah Valley the town of Rifeville developed into a small center of social, political, and economic life. Rifeville or Rifetown was the previous name of the town of Dayton before it was officially established in 1833 (Wayland 1912). The city of Harrisonburg was established earlier in 1780 and was likely a larger center of social, political, and economic life in comparison to Dayton. At the time that Dayton was established in 1833 many roads were being constructed and in 1834 the Valley Turnpike Company was formed to begin construction on a road that would connect Winchester to Staunton (Wayland 1912 and Carter 2013). Dayton was a smaller community along this route in between Staunton and Harrisonburg and this road would have served as a valuable connection among many of the growing centers on the landscape. The main road running north to south through downtown Dayton today is Main Street. At the time of the construction of the Valley Turnpike in 1834, Main Street was likely already established in Dayton and it was eventually connected to the turnpike to facilitate easier travel and communication. During this time of road expansion and development in the early to middle 1800s, Main Street was expanded to pass directly to the east side of Fort Harrison (Figure 46).
