# Restoring Habitat in Densely-Populated Suburbs in the Northeast: A Demonstration Project

Mary A. Westervelt  
*University of Pennsylvania*

Master of Environmental Studies  
Resource Management/Education and Advocacy

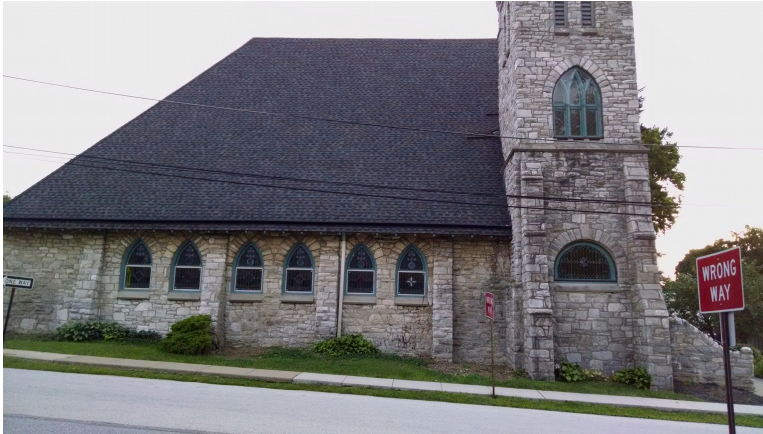
**Photo 1**

*East side of the Sanctuary in 2015 before the terracing project began. Winged euonymus shrubs had been removed. Water poured down the steep roof, bypassing the gutter and falling onto the ground; some soaked into the soil, but some ran onto the sidewalk. Two downspouts took some water into the ground, presumably intended to be dumped into the street, but exit pipes had been paved over. Photo taken August, 2015.*

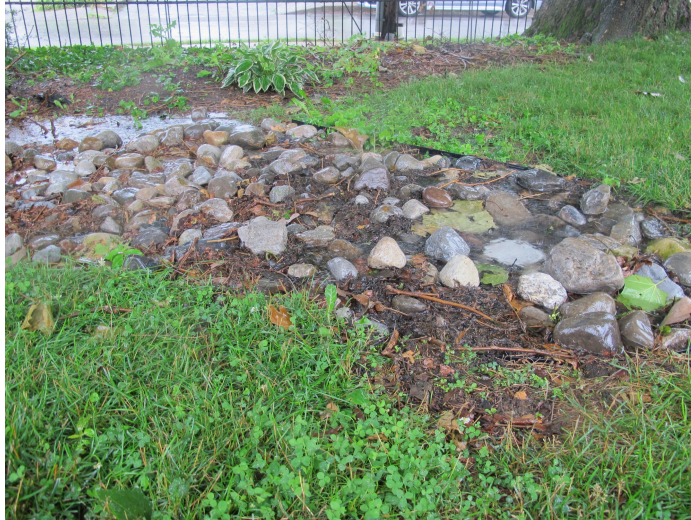
**Photo 4**

*Before the rain garden project, water bubbled up in this river-rock bed and ran to the edge of the property, often flooding the sidewalk before finding a storm sewer. Photo taken 27 June 2015.*

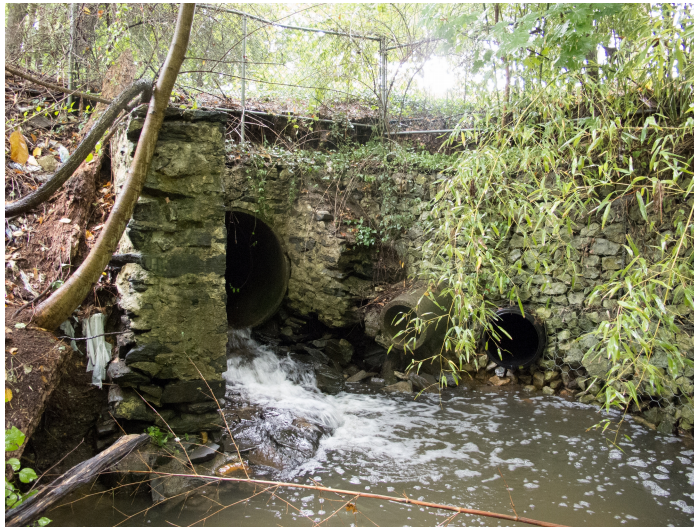
**Photo 5**

*Stormwater from the streets around Trinity Presbyterian Church enters this tributary of Darby Creek through culverts at the intersection of Midland Ave. and Eastwood Drive. Stormwater has eroded the banks and pollutes the creek near its headwaters. Photo taken 19 September 2016 after two inches of rain in two hours.*

is covered with impervious surfaces. Runoff from these surfaces has contributed to the stormwater flowing into street-side drains and from there into the local creek (**Photo 5**). This creek is a first-order tributary near the headwaters of Darby Creek, much of which is classified as 'impaired', largely because of runoff and non-point source pollution along its length, according to Kevin McAghon, Easttown Township Engineer (personal communication, 6 September 2016, substantiated by reports from the late 1990s and 2013 provided by Alan Everett at Pennsylvania Department of Environmental Protection).

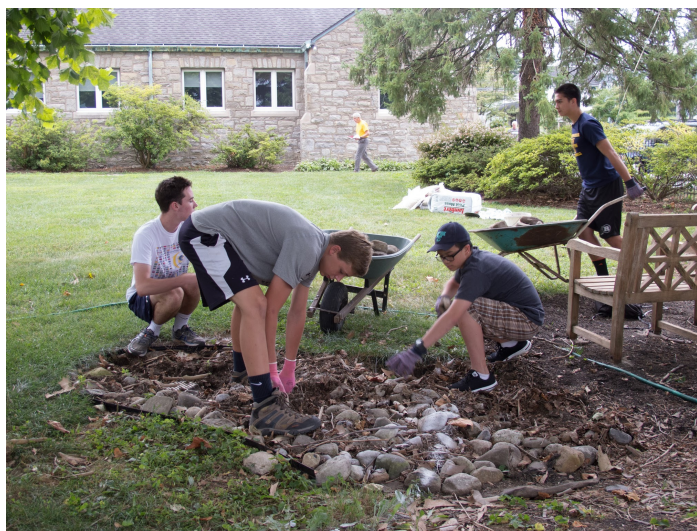
**Photo 6**

*Connor Bryan (front) and members of Boy Scout Troop 219 from Wayne, PA begin the process of installing the Courtyard rain garden by removing the river-rock around the outflow pipe that brings water across the courtyard. A hose was laid out to indicate the perimeter of the garden. The center would be dug down 20–24 in. and edges sloped to the center. Bags of peat moss (left over from earlier gardening practices on the property) and sand wait to be mixed in to the rain-garden soil.*

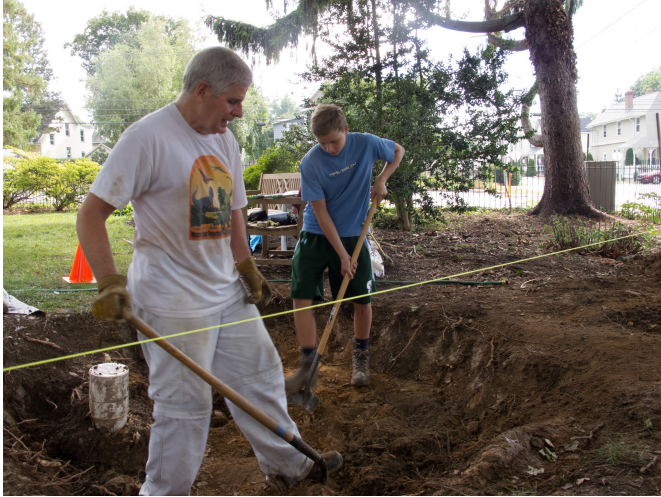
**Photo 7**

*An overnight rain made it easier for Connor and his dad Dave Bryan to dig out the compacted clay in the center portion of the rain garden area. Troop members also cleared away the English ivy, leaving a large space ready for planting. Photo 11 August 2015.*

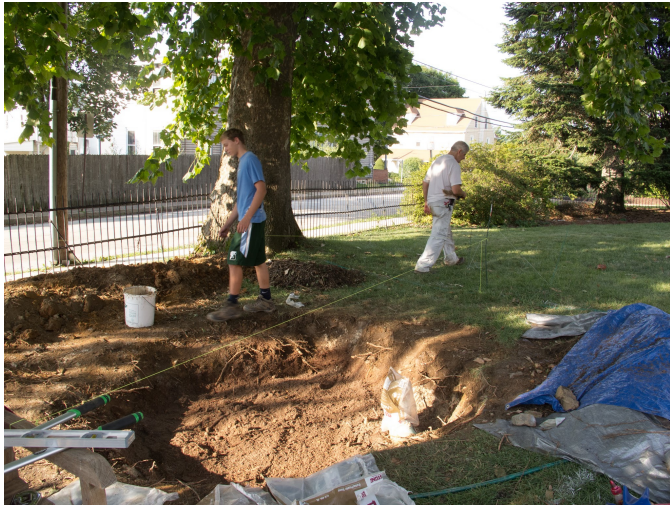
**Photo 8**

*A mix of soil, sand, and peat moss was returned to the hole leaving the surface about eight inches below grade. Photo 11 August 2015.*

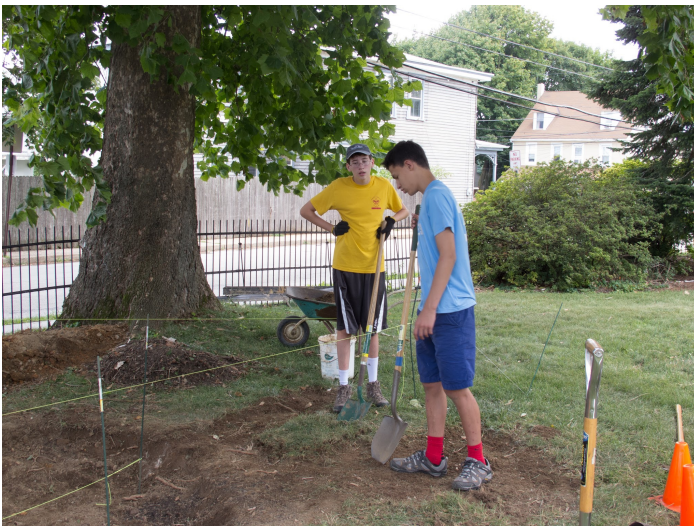
**Photo 9**

*Scouts begin the work of removing turfgrass to extend the rain garden from the center to the edge of the designated area. Soil was then dug away to slope the entire area to the center. Clay from the original excavation was used to form a berm at the outside (street) edge of the garden. Photo 12 August 2015.*

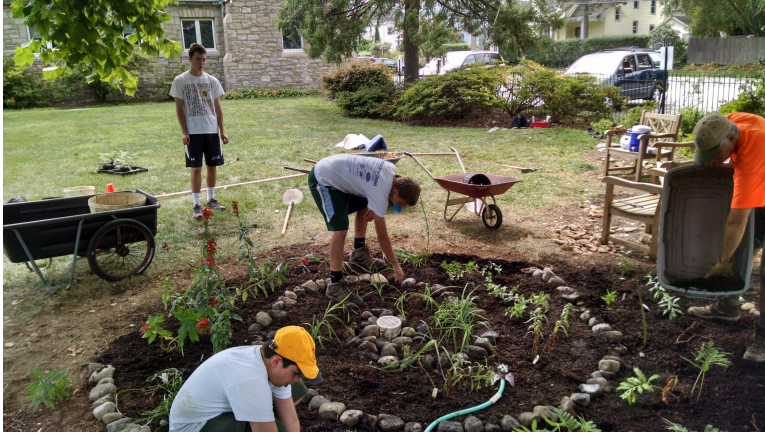
**Photo 10**

*Scouts put the final design touches on the rain garden. Plants donated from Jenkins Arboretum and Gardens were grouped with ones preferring wetter soil near the center, ones preferring full sun near the front (out of the shade of the overhanging sycamore). Scouts decided to re-use the river rock to create an artistic spiral.*

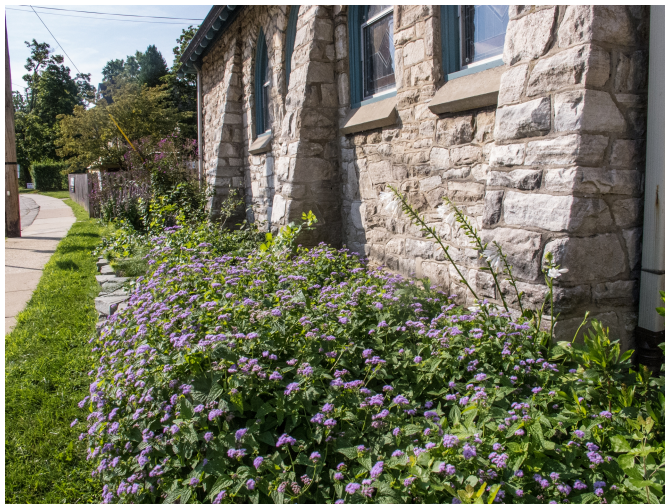
**Photo 14**

*The terraced gardens in bloom, August, 2016. Shrubs were planted all along this side of the church, but to fill in the space until they grow, flowers were added as well. Blue mist flower proved to be a show-stopper. These gardens attract the most attention of any on the church property, since they border a sidewalk that gets frequent use.*

In October of 2015, terraced beds were installed along the east side of the sanctuary where the burning bushes had been removed (**Photos 13 & 14, Appendix D**). Removing turfgrass and weeds, adding soil, and planting with native shrubs and herbaceous plants took us into December.

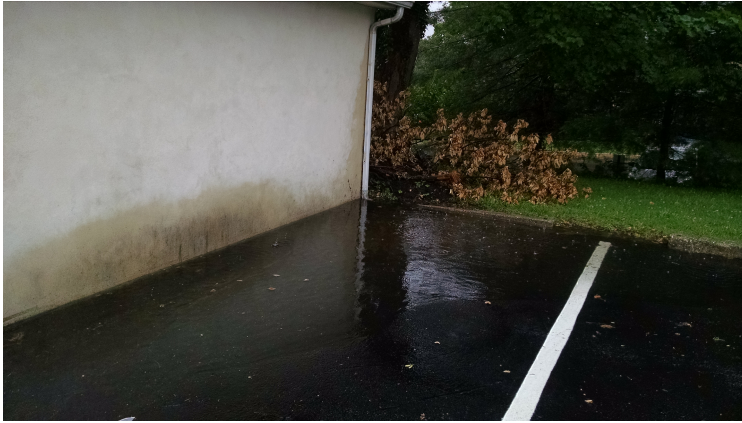
**Photo 15**

A third area where water was a problem was at the corner of the garage used as a shed at the downslope end of the east parking lot (marked SHED in Fig. 1). Rain water had been forming a lake for years. Silt had formed a thick layer at the corner. Tree roots had filled it and crawled up the downspout. Photo late summer 2015.

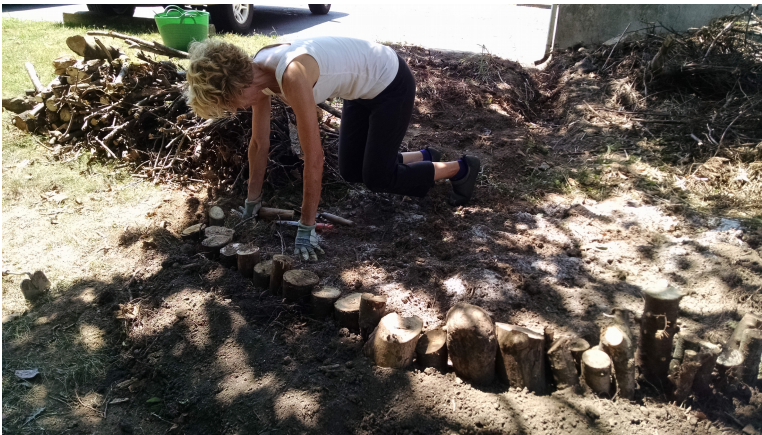
**Photo 16**

In 2016, we chopped out the roots and dug a trench. Using scrap wood that had been collecting behind the garage, we created a simple detention basin where water could collect and seep in. Here, helper Pam Koch puts the finishing touches on the whimsical retaining wall.

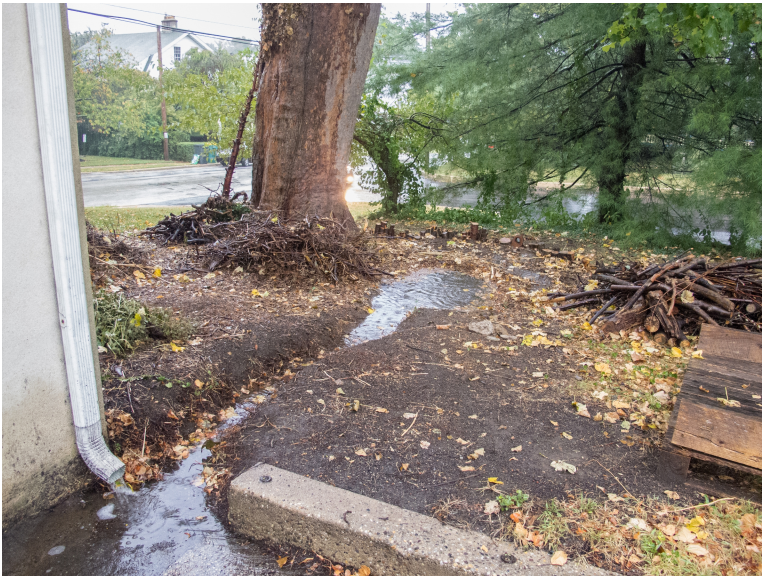
**Photo 17**

A few weeks later two inches of rain fell in two hours. The detention basin held the water, though water did sneak around the edge farthest from the tree, showing that the barrier needed to be extended. Water soaked in within two hours. Photo 19 September 2016.

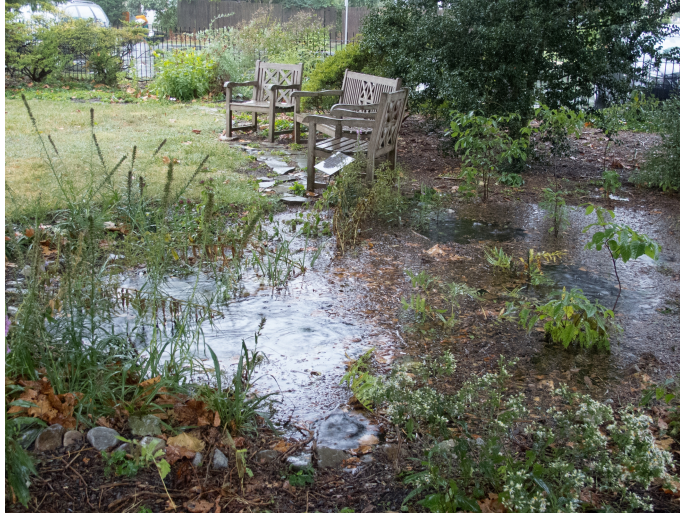
**Photo18**

*The rainstorm on 19 September, 2016 dropped two inches of rain in two hours. One hour later, the Courtyard rain garden was full of water. There was evidence that some water had escaped past the berm and had pooled by the shrubs below; that was easily repaired by extending the berm after the ground had dried.*

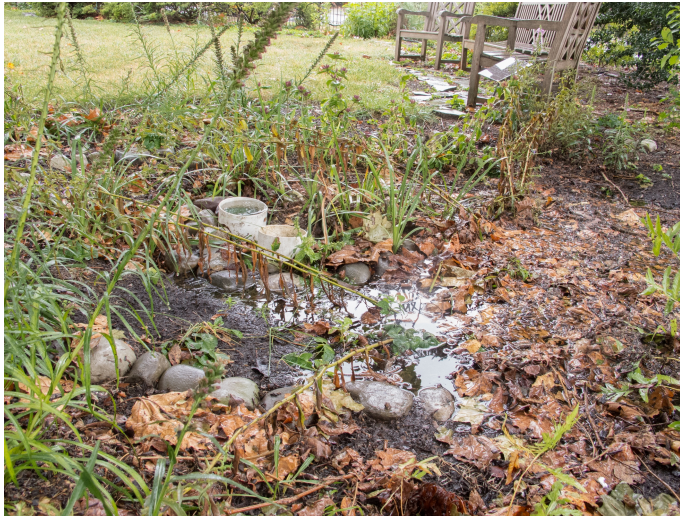
**Photo 19**

*After another hour, most of the water had sunk into the rain garden. In this photo the pipe that brings water from the church roofs is visible, with its cap blown off due to the force of the flow.*

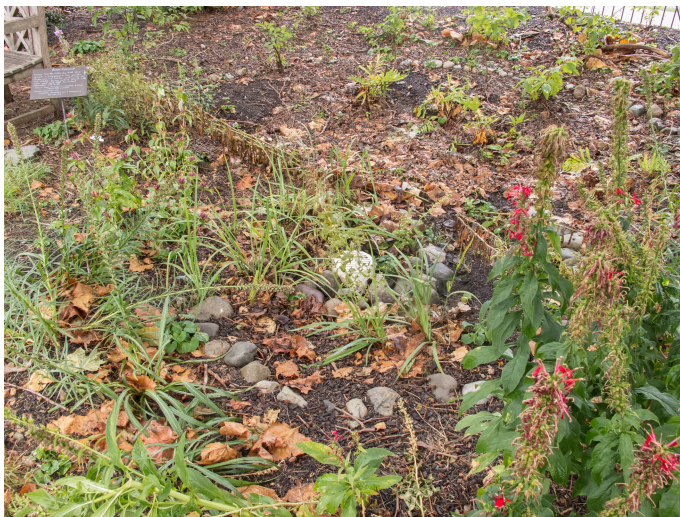
**Photo 20**

*One hour later, all the water has soaked into the soil.*
