1. Report No. FHWA/TX-10/0-6384-1		2. Government Accession No.		3. Recipient's Catalog No.	
4. Title and Subtitle ON-GOING EVALUATION OF TRAFFIC CONTROL DEVICES				5. Report Date November 2009 Published: September 2010

16. Abstract This project was established to provide a means of conducting small-scale research activities on an as needed basis so that the results could be available within months of starting the specific research. This report summarizes the small-scale research activities that were conducted between September 2008 and August 2009. There were four primary activities and two secondary activities. The four primary activities were: developing a temporary sign support with cross bracing, providing technical support on an AASHTO retroreflective sign sheeting material specification, conducting human factors research on sign sheeting materials, and monitoring lead-free pavement marking test deck performance. In addition, the researchers also provided support for hurricane evacuation routing and started a research activity focused on identifying traffic signs with supplemental light emitting diodes (LEDs).

# **ON-GOING EVALUATION OF TRAFFIC CONTROL DEVICES**

Report 0-63

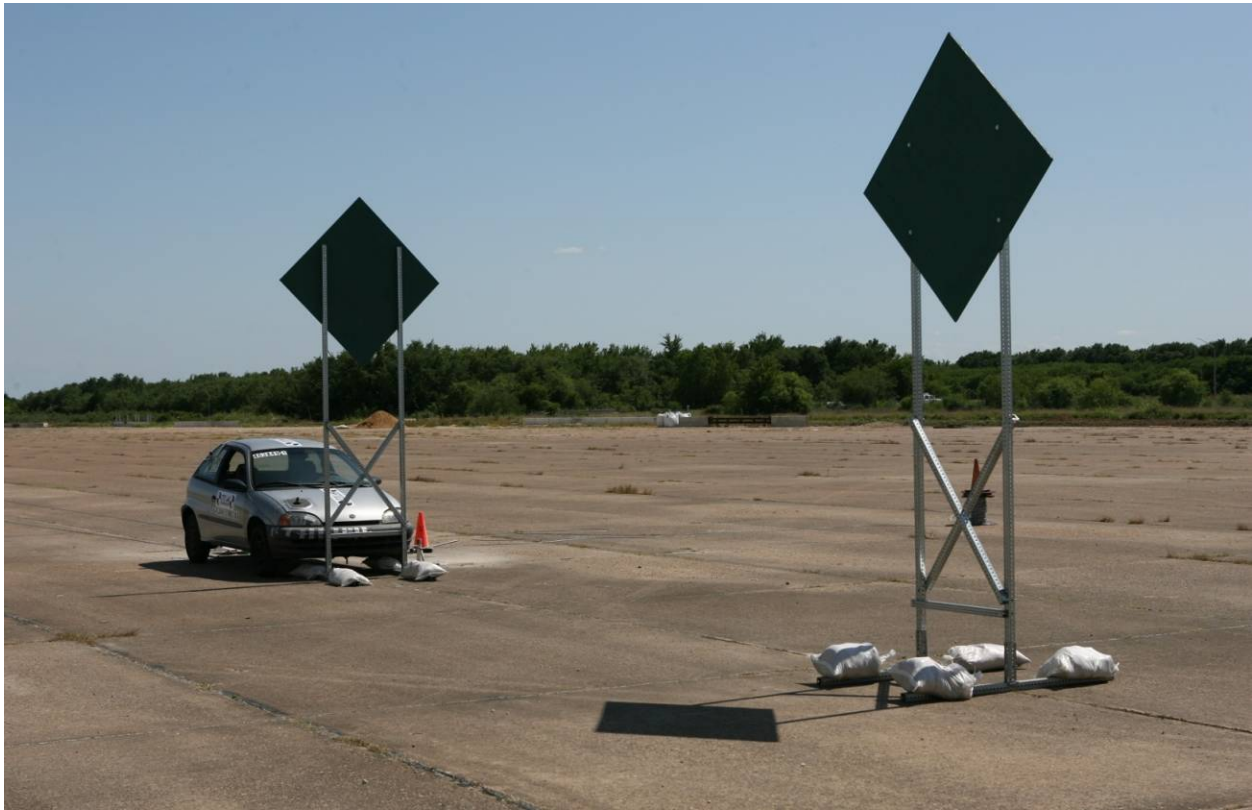
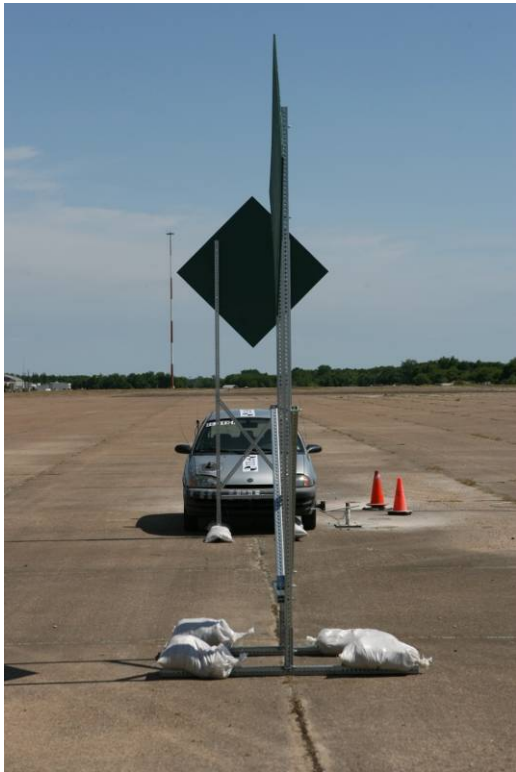
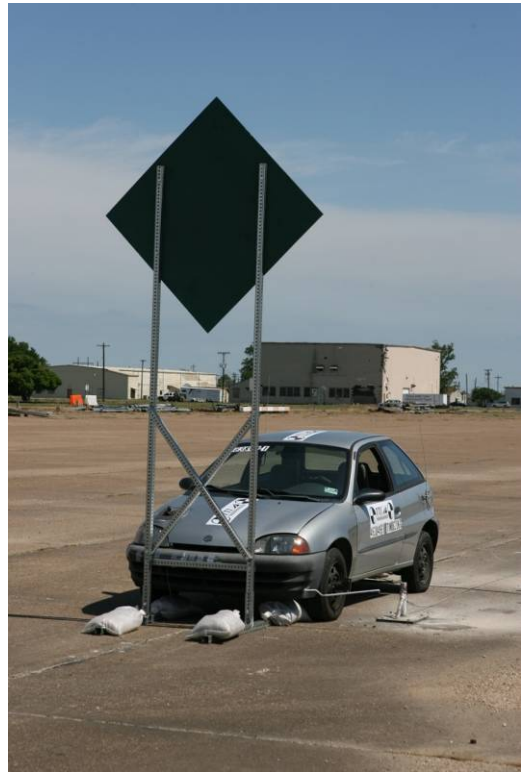
**Figure 3. Vehicle/Installation Geometrics for Test 463849-1.**

At 0.363 s, the vehicle impacted the second temporary sign support at a speed of 53.1 mi/h at an impact angle of 90 degrees. The second temporary sign support engaged the first support, pushing the first support into the windshield and then off the vehicle. As the vehicle exited the view of the high-speed cameras, the supports were still in contact with the vehicle. Figure C1 in Appendix C shows sequential photographs of the test period. Brakes on the vehicle were applied at 1.7 s after impact, and the vehicle came to rest 221 ft downstream of impact and 3.5 ft to the right of centerline of the installation.

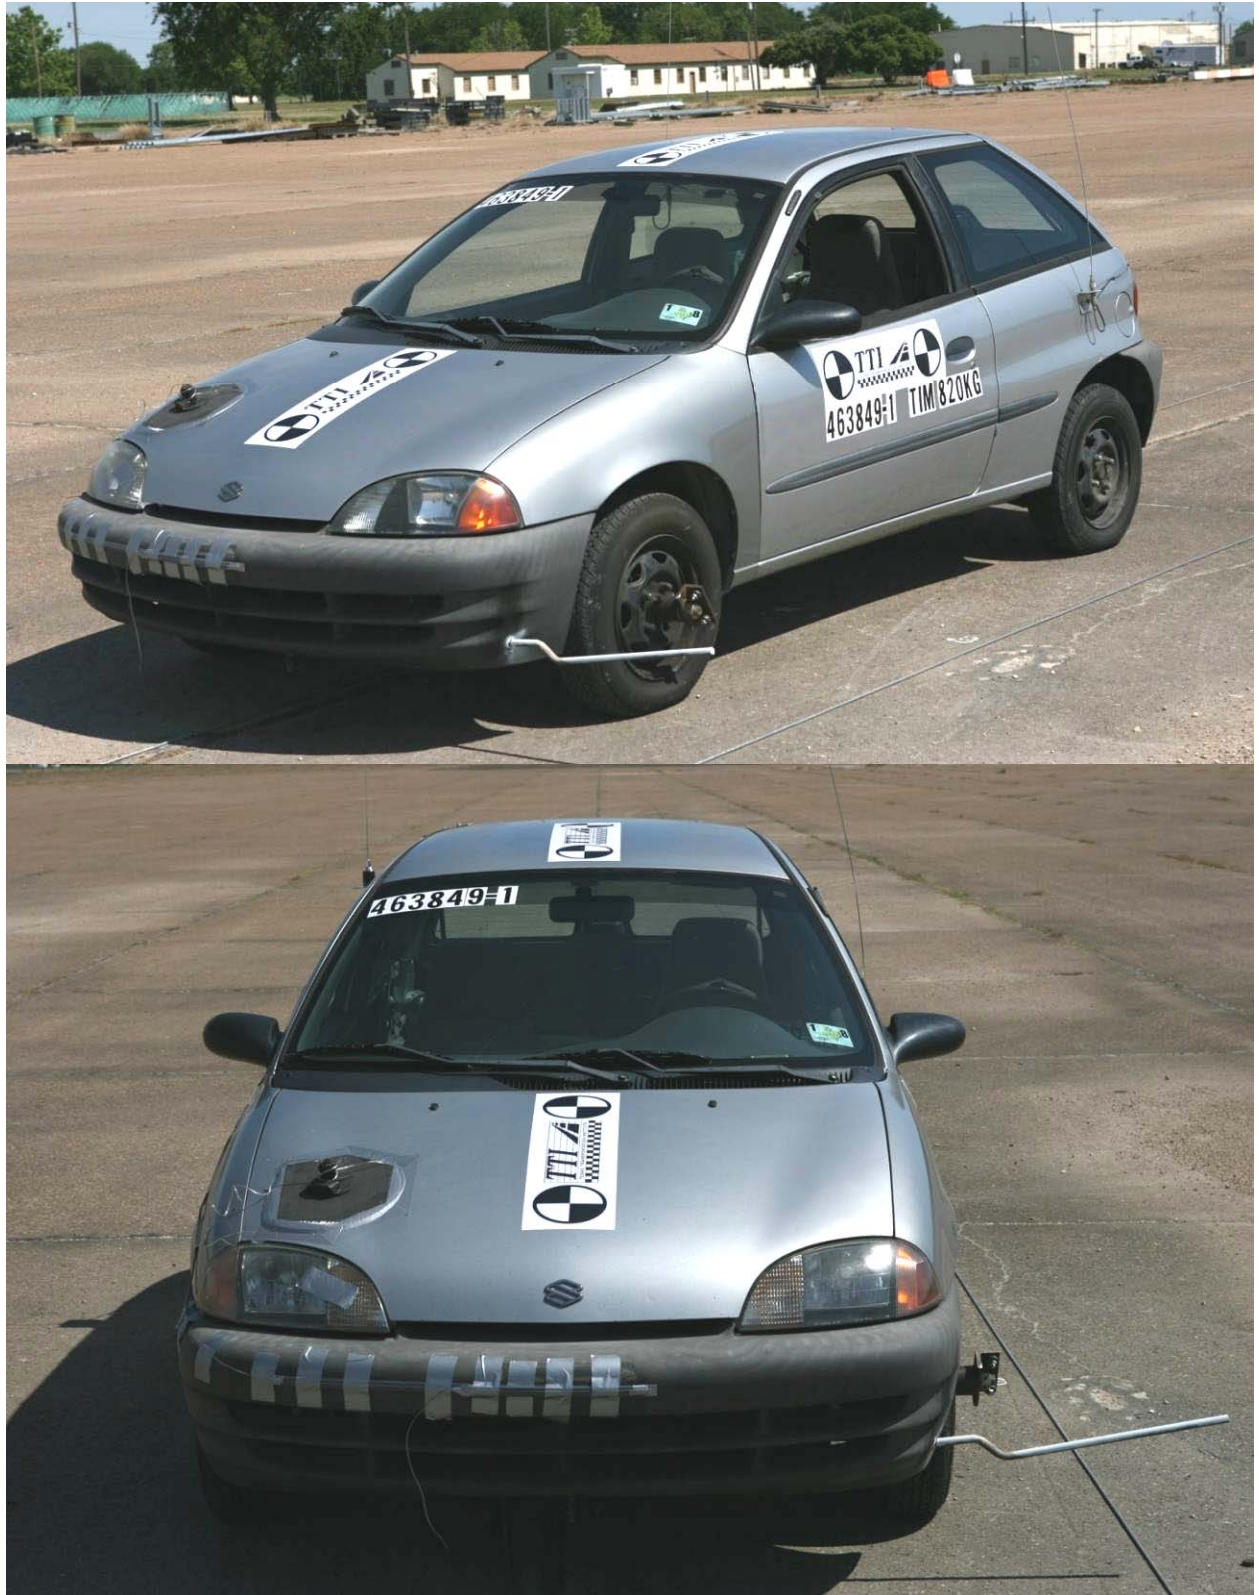
**Figure 4. Vehicle before Test 463849-1.**

A 2001 Suzuki Swift, shown in Figure 3 and Figure 4, was used for the crash test. Test inertia weight of the vehicle was 1861 lb, and its gross static weight was 2026 lb. The height to the lower edge of the vehicle front bumper was 15.75 inches, and the height to the upper edge of the front bumper it was 20.28 inches. Figure B1 in Appendix B gives additional dimensions and information on the vehicle. The vehicle was directed into the installation using the cable reverse tow and guidance system and was released to be free-wheeling and unrestrained just prior to impact.

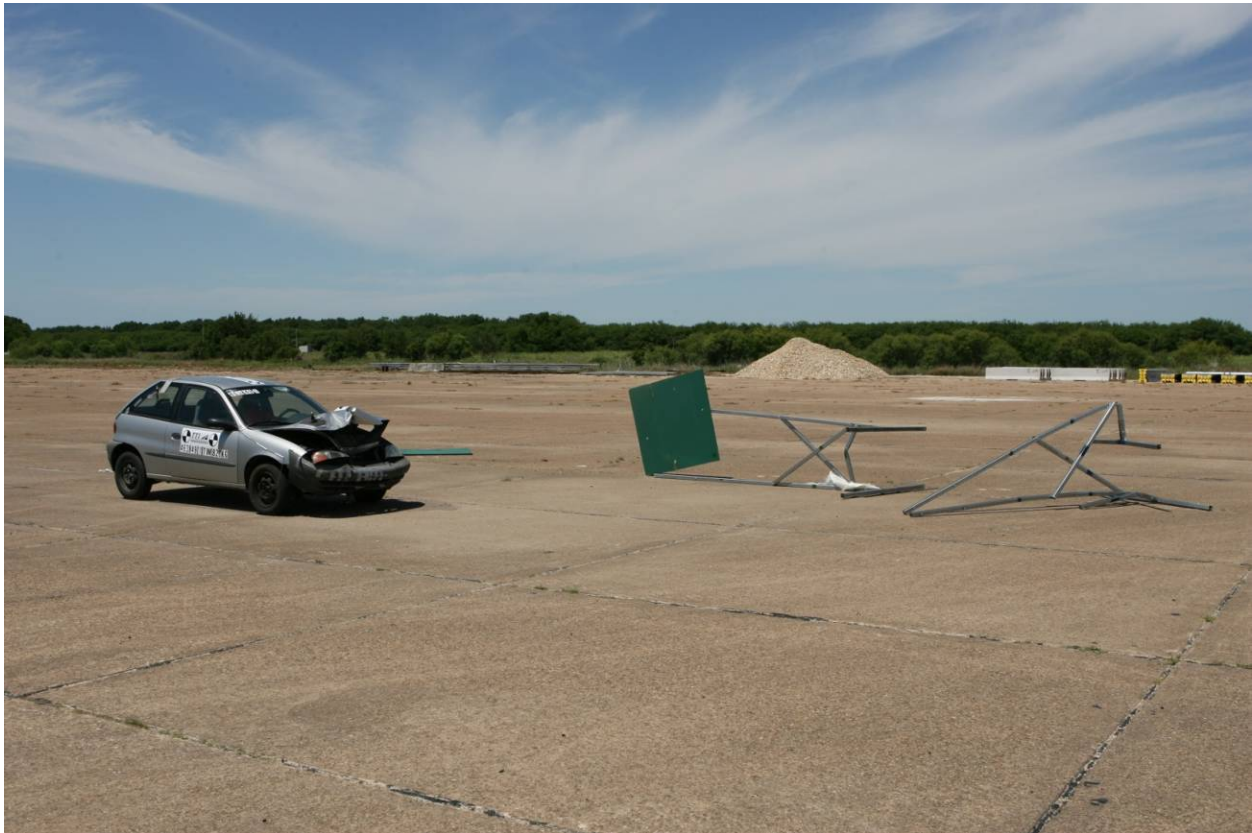
**Figure 5. After Impact Trajectory Path for Test 463849-1.**

Figure 5 and Figure 6 show the damage to the temporary sign supports. The first temporary sign support stayed together as a unit but was deformed. The support came to rest 227 ft downstream of the impact point and 12 ft to left of centerline of the installation. One of the legs of the second temporary sign support separated from the unit and rested 212 ft downstream of impact and 10 ft to the left of centerline, while the remainder of the unit rested 176 ft downstream of impact and 18 ft to the left of centerline of the installation.

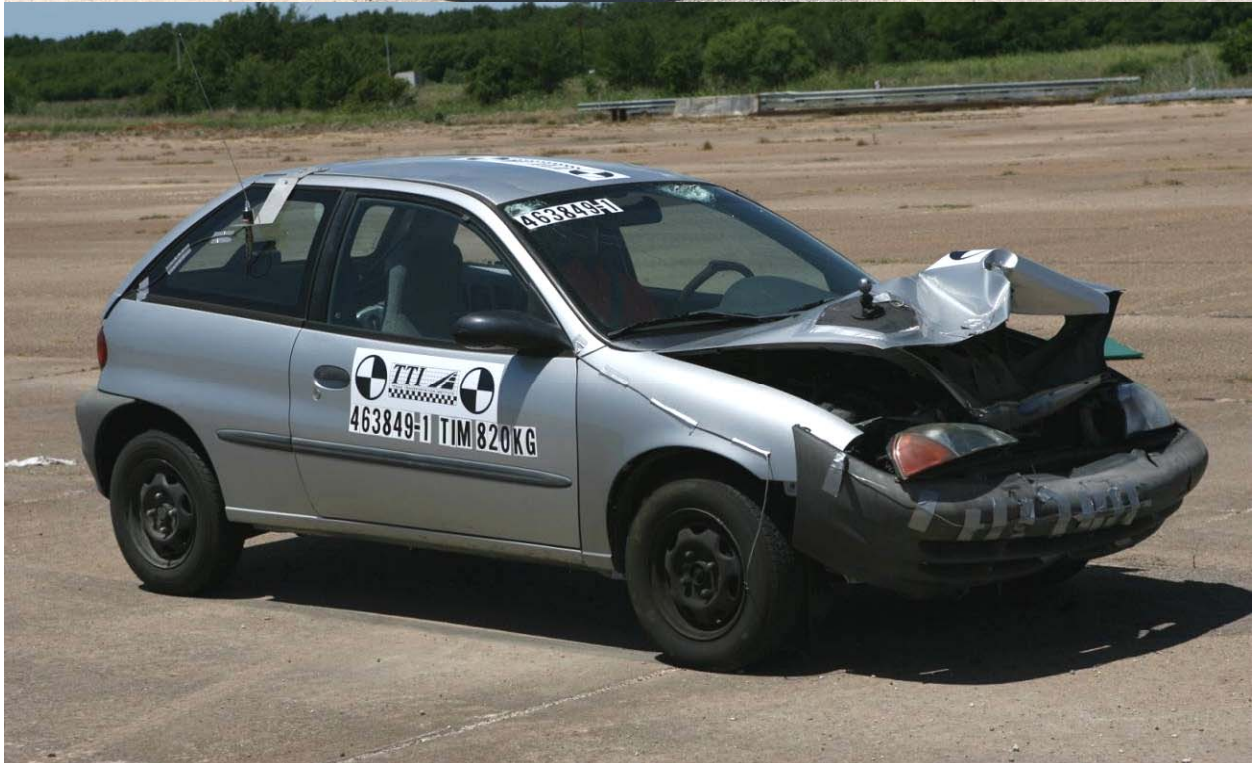
**Figure 7. Vehicle after Test 463849-1.**

Figure 7 shows the damage to the front of the vehicle, the windshield, and the roof of the vehicle. The hood was crumpled upward. Two pinprick holes were found in the windshield, one in the upper corner on the passenger side where the glass was cracked over an area measuring 6.3 inches  $\times$  5.5 inches  $\times$  0.8 inches deep, and the second in a damaged area that measured 8.3 inches  $\times$  5.7 inches  $\times$  1.2 inches deep. It is noted that the windshield damage resulted from the first sign support system being shoved into the windshield by contact with the second sign support system and was not attributable to the vehicle impacting the first sign support system. The roof had several dents, the deepest of which was 0.5-inch deep. The left rear window glass was also broken. Maximum exterior crush to the vehicle was 7.9 inches in the center front at bumper height. No occupant compartment deformation occurred. Figure 8 shows photographs of the interior of the vehicle. Exterior crush measurements and occupant compartment measurements can be found in Appendix B, Tables B1 and B2.

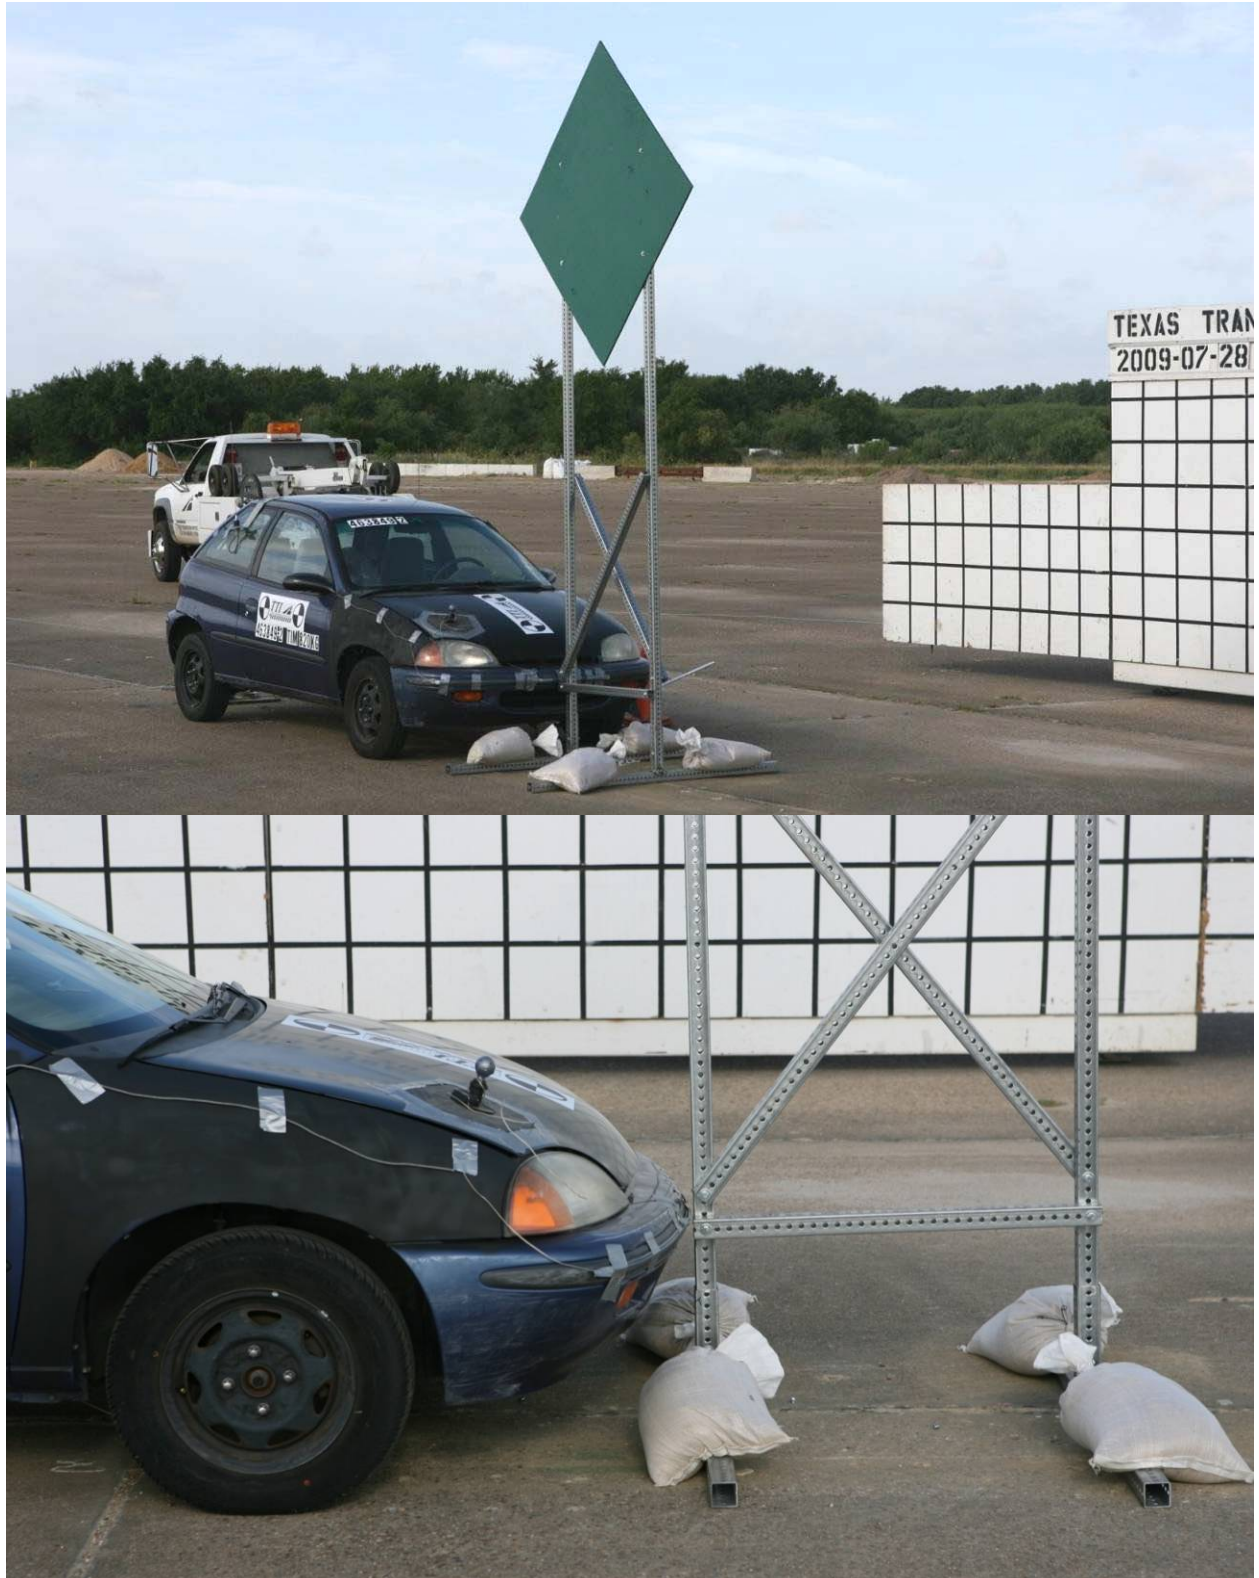
**Figure 10. Vehicle/Installation Geometrics for Test 463849-2.**

The 1996 Geo Metro, traveling at an impact speed of 62.0 mi/h, impacted both legs of the temporary sign support end-on at an impact angle of 90 degrees. Shortly after impact, the left support began to deform, and at 0.007 s after impact, the right support began to move away from the vehicle. The right support fractured at the connection to the cross brace at 0.022 s. As the vehicle continued to travel forward, the entire sign support installation rotated as a unit in front of the vehicle. At 0.115 s, the vehicle lost contact with the support while traveling at a speed of 57.3 mi/h. The rotating support structure contacted the roof at 0.197 s. At 0.275 s, the sign

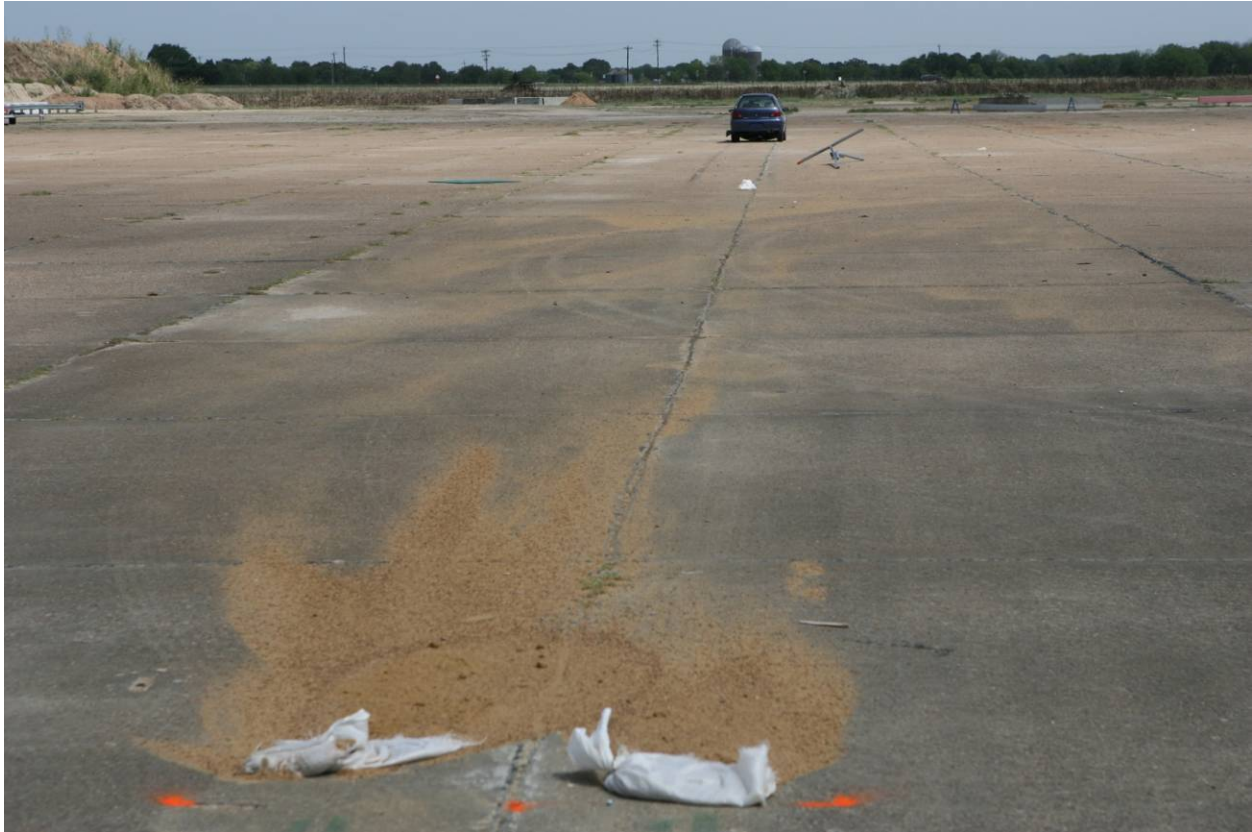
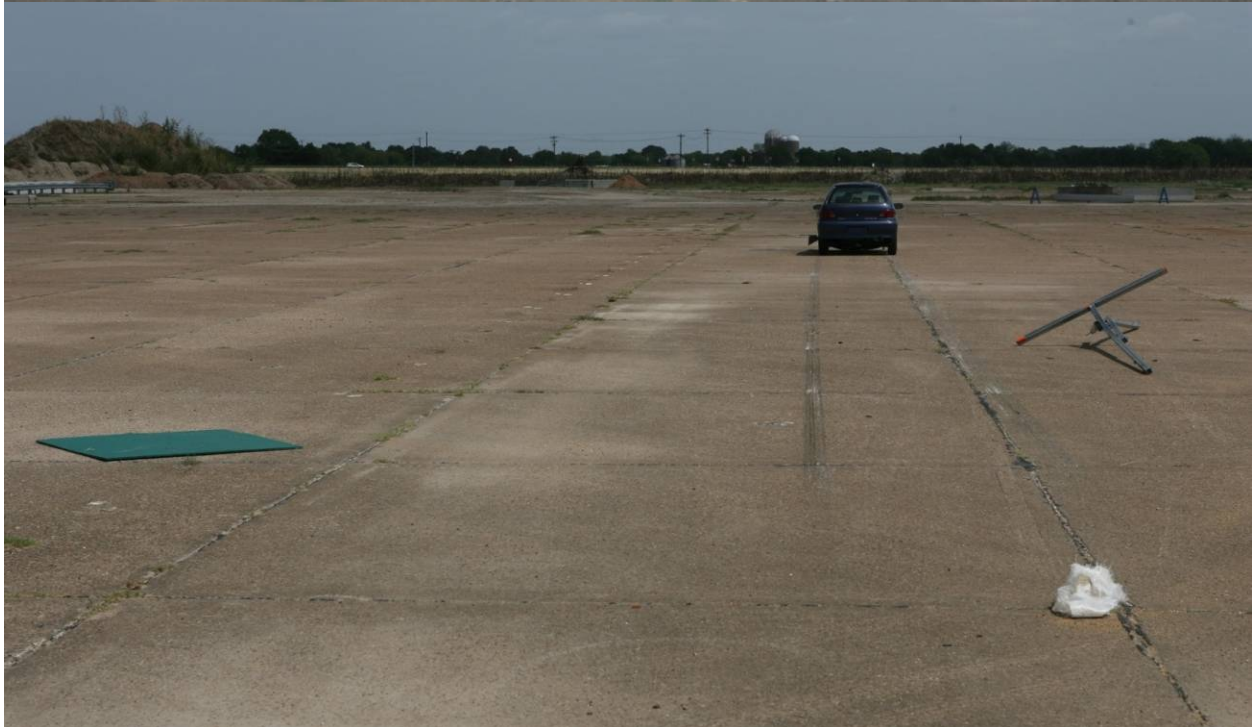
**Figure 12. After Impact Trajectory Path for Test 463849-2.**

Figure 12 and Figure 13 show the damage to the temporary sign support. The sign panel from the temporary sign support came to rest 148 ft downstream of the impact point and 15 ft to left of centerline of the installation. One of the legs and a skid of the temporary sign support separated from the unit and rested 399 ft downstream of impact and 13 ft to the right of centerline, while the remainder of the unit rested 173 ft downstream of impact and 4 ft to the right of centerline of the installation. The vehicle came to rest 272 ft downstream of the installation.

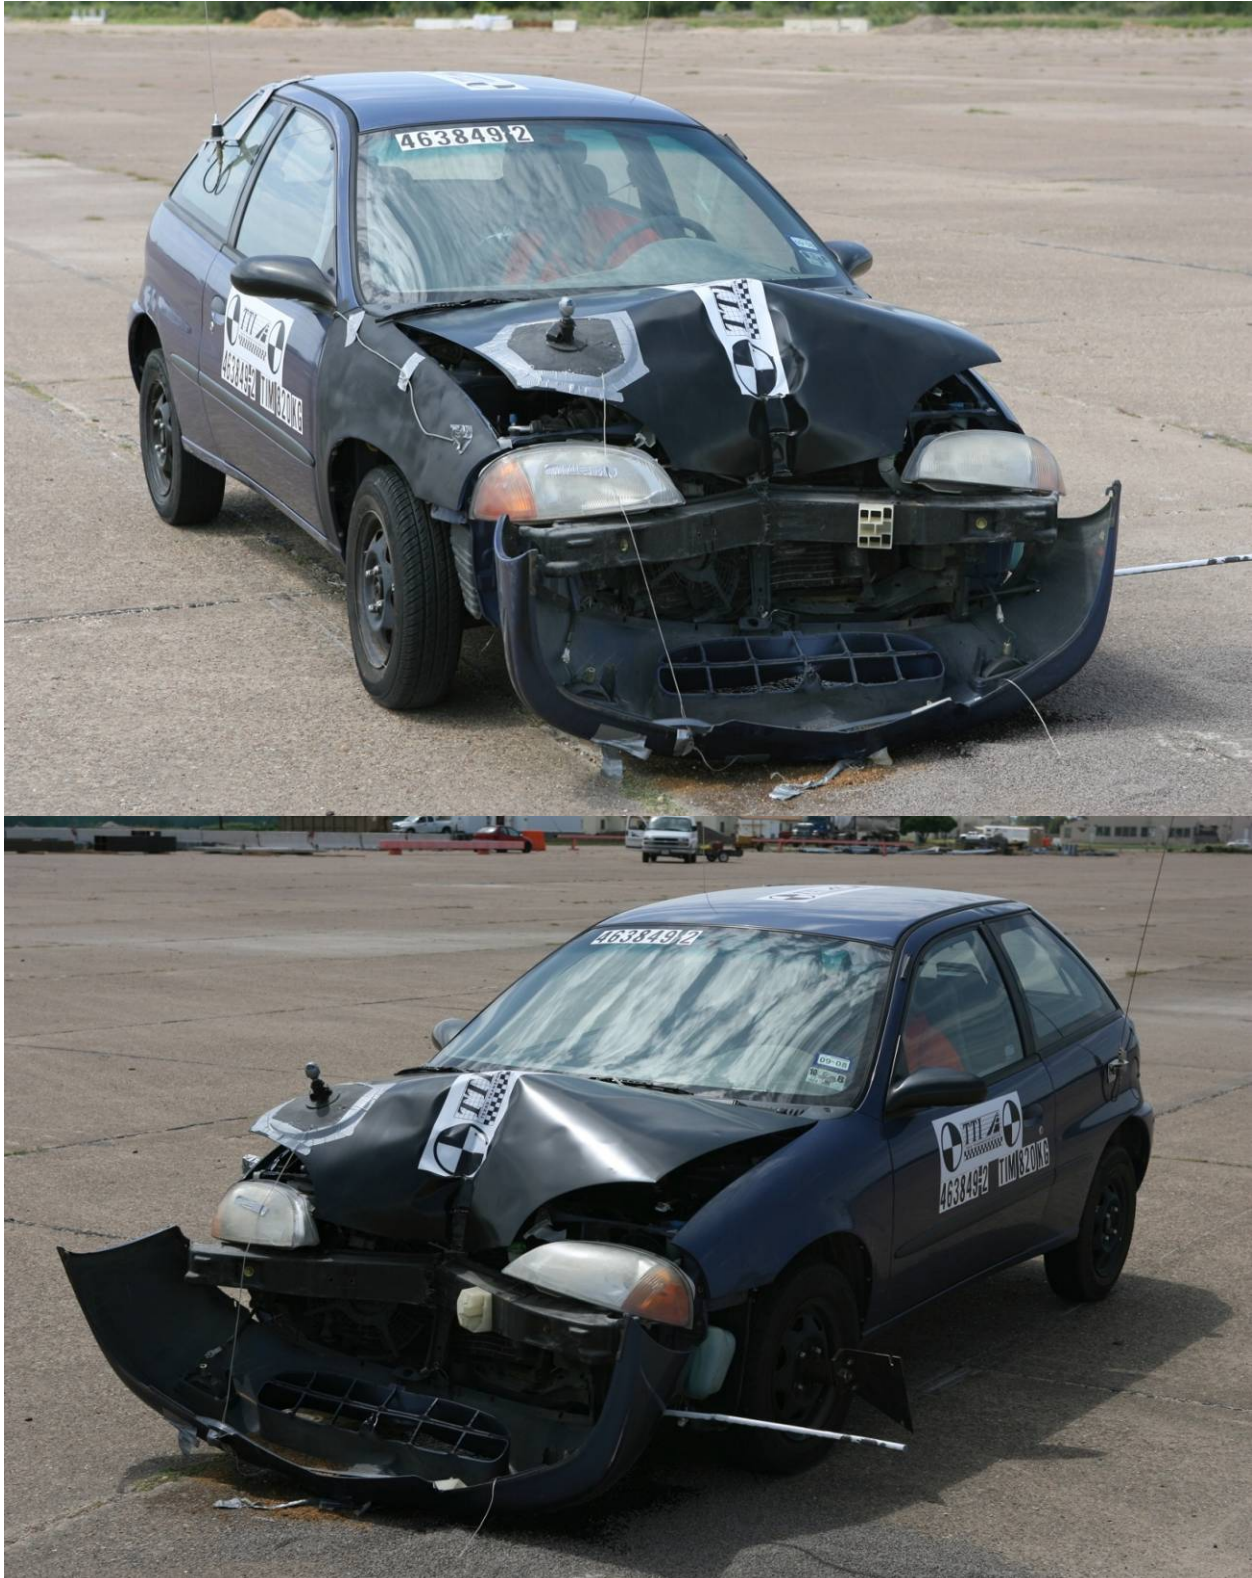
**Figure 14. Vehicle after Test 463849-2.**

Figure 14 shows the damage to the front of the vehicle, the hood and the roof of the vehicle. The hood was crumpled upward. Maximum exterior crush to the vehicle was 9.1 inches in the center front at bumper height. No occupant compartment deformation occurred. Figure 15 shows photographs of the interior of the vehicle. Exterior crush measurements and occupant compartment measurements can be found in Appendix B, Tables B3 and B4.

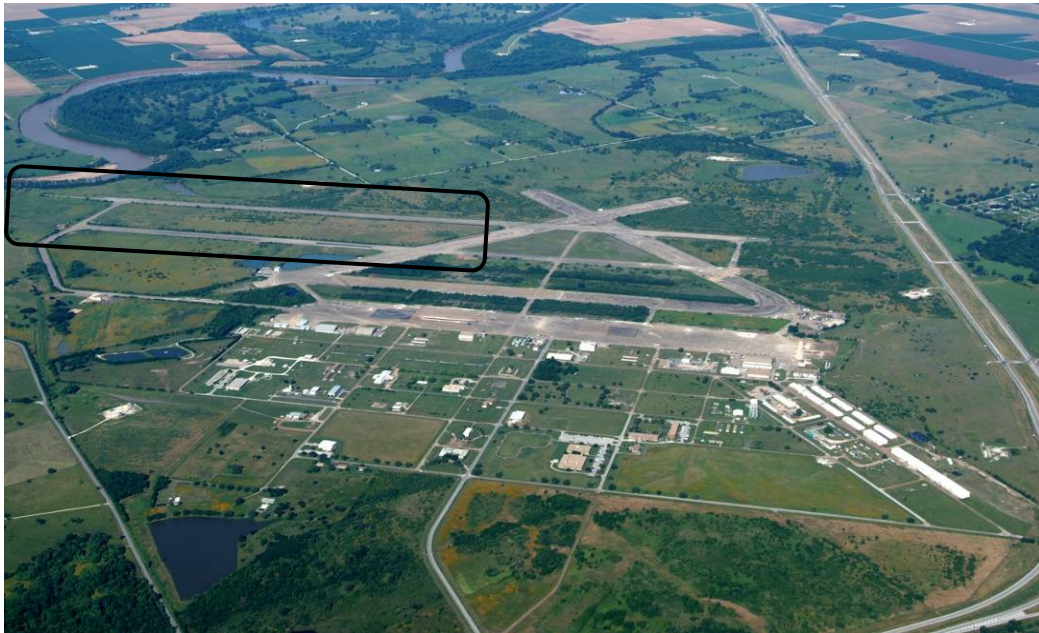
**Figure 17. Riverside Campus.**

The Phase I study was conducted on a closed course at the Texas A&M University's Riverside Campus. The course was set up along the west runway outlined in Figure 17.

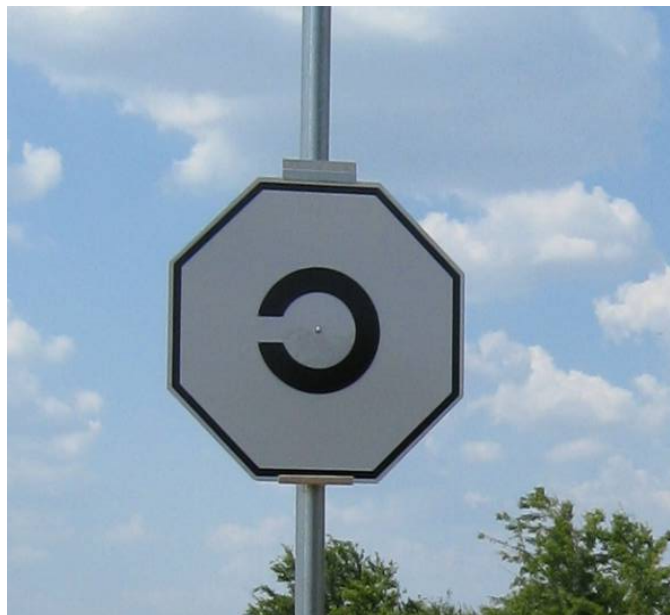
**Figure 19. Example of a Test Sign with a Landolt C**

The legend or target on each sign was a Landolt Ring, a standardized symbol used for testing vision, as shown in Figure 19. The Landolt Ring consists of a ring that has a gap, looking similar to the letter C, so the Landolt Ring has also been referred to as the Landolt C. The stroke width and the gap width are 1/5 of the diameter. The Landolt C was either 10 inches or 6 inches, and the gap was positioned at four locations (left, right, bottom, and top). A 10-inch Landolt C had a 2-inch wide stroke width with a 2-inch gap.

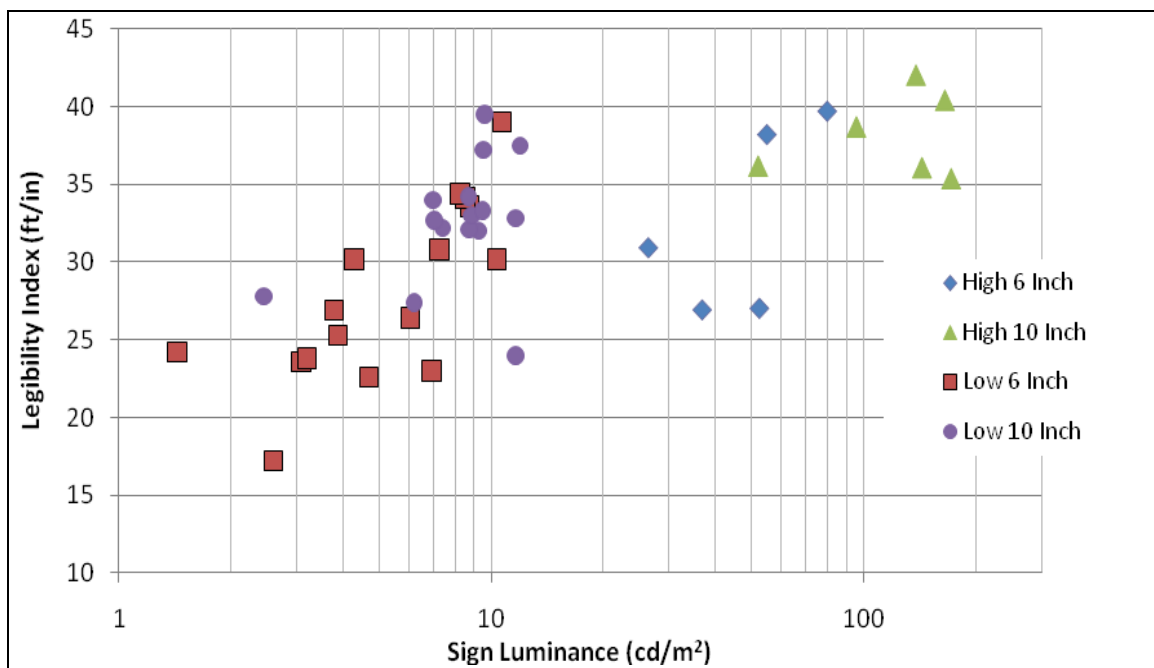
Figure 23. TxDOT Study Results.

Figure 23 displays a plot of the average legibility indices against the luminance provided by the sheeting material. As shown, the signs with the 6-inch legend were viewed at a smaller legibility index and with less luminance than the signs with the 10-inch legend for both high and low beams. Also, using high beams provides much more luminance but does not improve the legibility index, suggesting that the legibility index flattens out at a certain point and possibly begins to decline if a sign is too bright. These results should be considered preliminary as additional results will be obtained in the second phase of the study, which will be completed with white on green signs and will be conducted in the second year of the study. When all the data are available, the researchers will combine the data and complete a full analysis to establish recommendations for TxDOT's sign sheeting material specification.

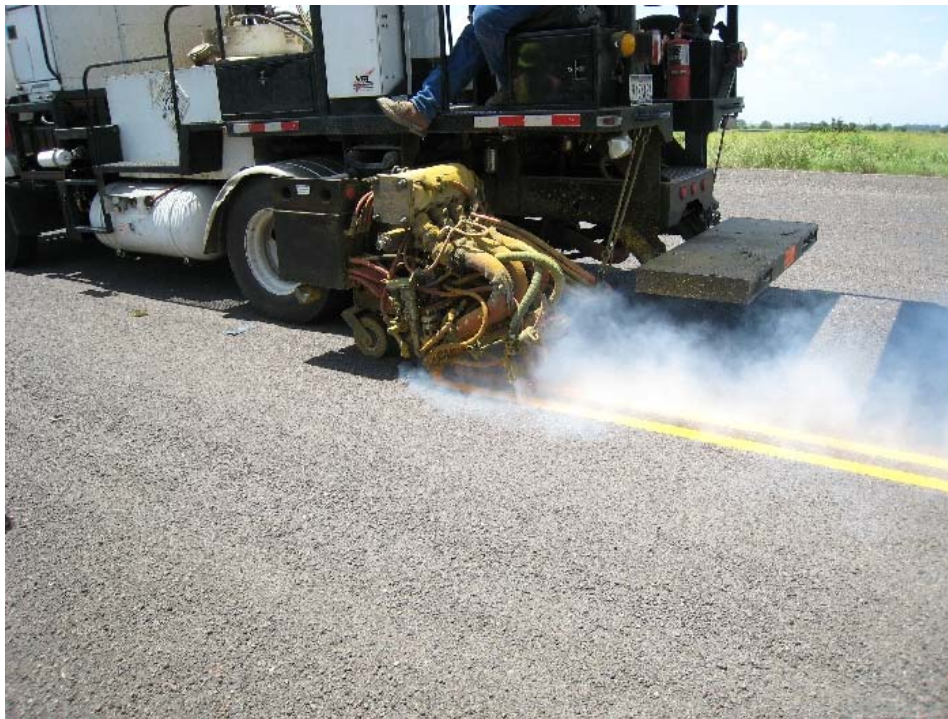
**Figure 24. SH 21 Lead-Free Thermoplastic Installation.**

The US 79 site included both lead-free and standard yellow thermoplastic materials that were installed on consecutive days in a two-way left-turn lane in the city. The SH 21 site consisted only of lead-free thermoplastic installed as the left edge line on a divided highway, transitioning to a double solid centerline on an undivided highway (see Figure 24). The US 79 section has an approximate average daily traffic (ADT) of 8000, and the SH 21 section has an approximate ADT of 12,000.

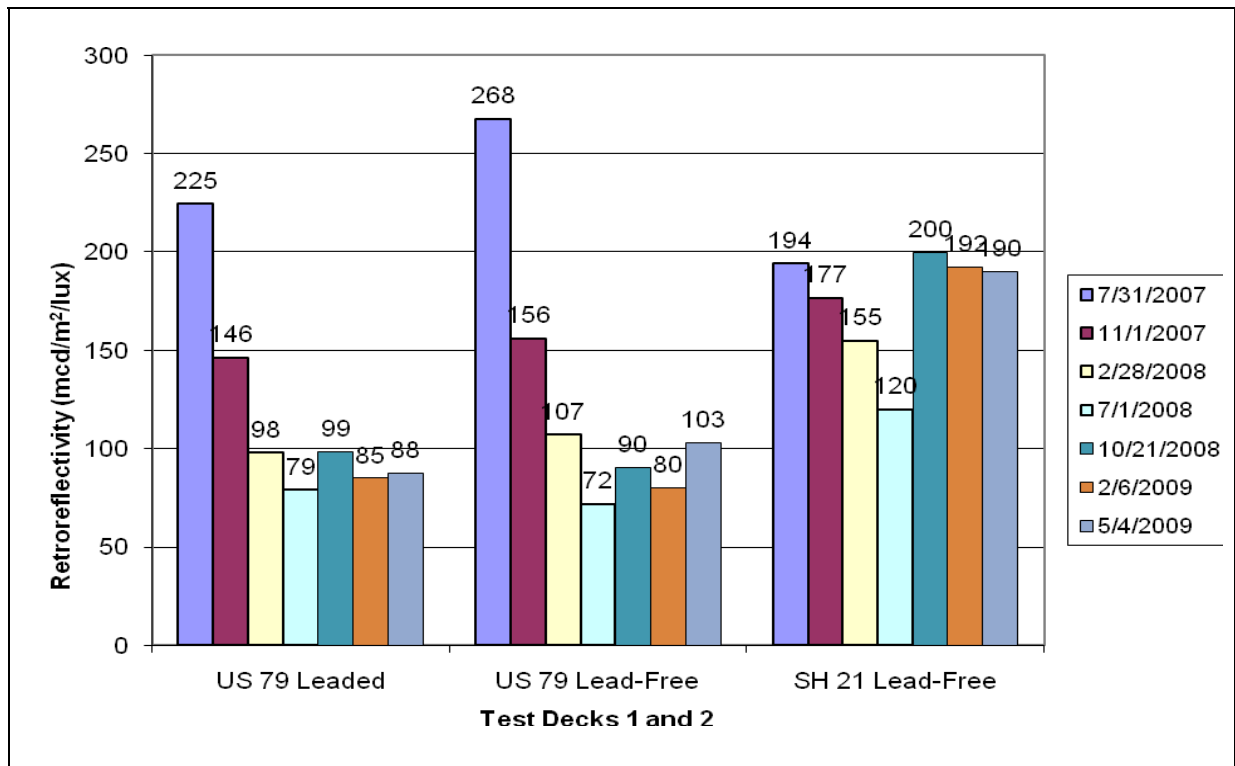
**Figure 25. Yellow Thermoplastic Retroreflectivity Summary (Decks 1 and 2).**

site than at either of the SH21 sites. The ADT on US 79 is less than that of SH 21, but since the markings form a two-way left-turn lane, it is subject to more turning movements and traffic hits than the markings on SH 21. The leaded and lead-free markings on US 79 followed similar trends as the markings aged. The biggest thing to note for test decks 1 and 2 is the change in retroreflectivity values as the measuring equipment changed. All measurement procedures and calibration processes were the same between the measurement dates. During a comparison test between the TxDOT and the FHWA LTL-2000Y it was found that the FHWA device typically resulted in a lower retroreflectivity measurement than the TxDOT device (on average about 8 percent lower) (5). The new TTI LTL-2000SY was not able to be compared to the FHWA device, but it clearly looks like it too results in measurements that are higher than the FHWA device. Comparisons were made between the TTI LTL-2000SY and other TTI pavement marking retroreflectivity devices and the resulting retroreflectivity values were similar. The resulting retroreflectivity measurements from the FHWA LTL-2000Y appear to be lower than they should be due to the equipment itself.

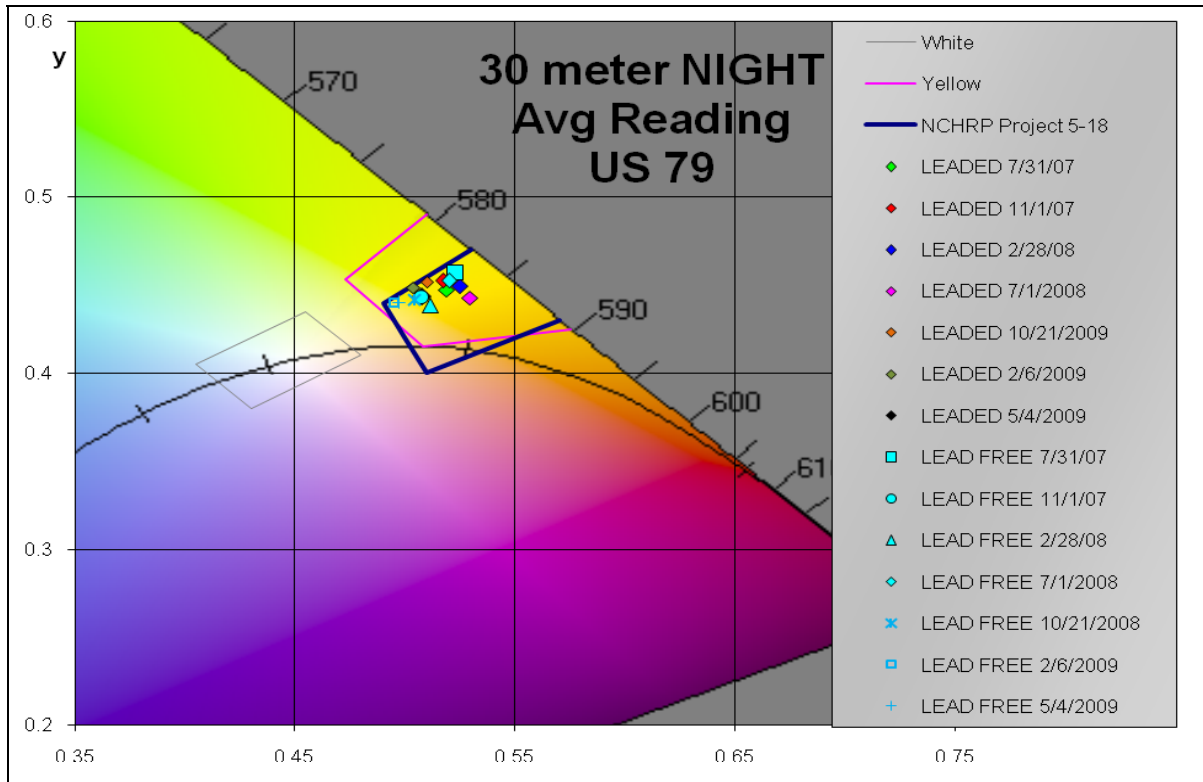
**Figure 27. Avg 30 Meter Night Color of Leaded and Lead-Free Thermoplastic at US 79 Site.**

The average 30 meter color values from each data collection period were plotted against the x-y points defining the color box from the FHWA final rule on marking color. This color box is based on Illuminant A and a viewing geometry that is the same as the 30 meter retroreflectivity geometry. The NCHRP recommended color box, which is also the 30 meter color box for TxDOT, is also illustrated to show the difference. Figure 27, Figure 28, and Figure 29 illustrate the plot of the average color points for the color measurements with the LTL-2000 devices at the three sites. Unlike the retroreflectivity measurements, 30 meter color comparisons resulted in little difference between the three different LTL-2000 devices. All of the average measurements from each data collection period on both the leaded and lead-free markings are within the FHWA color box. At sites 1 and 2 all the measurements were also within the NCHRP color box. The third site resulted in measurements that were right on the edge of the NCHRP color box. It appears from all three sites that as the markings age (both the leaded and the lead-free) they are trending toward the white area of the color box. The leaded marking at sites 1 and 3 were both more saturated in color initially and over time than were the lead-free markings.

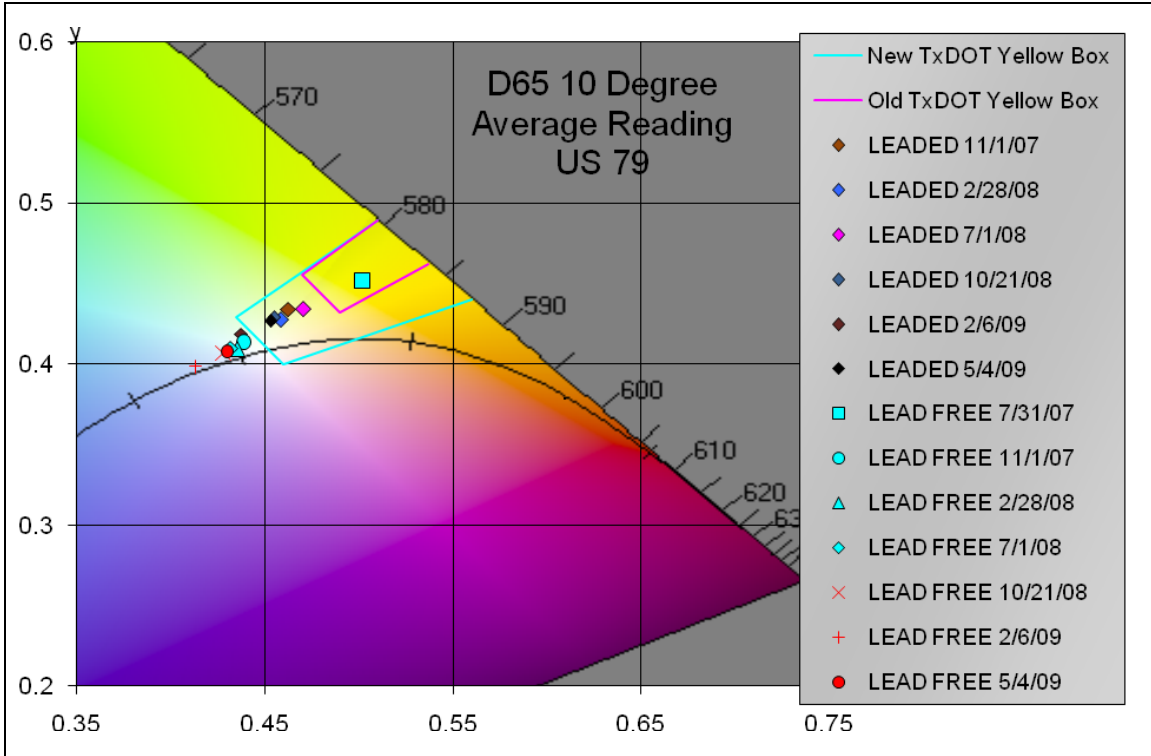
**Figure 31. Avg Daytime Color with 10 Degree Standard Observer at US 79 Site.**

measurements have fallen outside of the new TxDOT color box requirements. The D65 10° measurements of both the leaded and lead-free material at both sites fall outside of the new TxDOT color box. The leaded material was outside of the box but much closer to the box than the lead-free material was at the US 79 site. At the SH 21 site the D65 10° measurements are right at the border of the color box. The D65 2° measurements of the leaded material all fall within the FHWA color box except for one reading at the US 79 site. The majority of the lead-free material color readings at the US 79 site are outside the D65 2° color box, whereas the measurements at the SH 21 sites are within the color box. The SH 21 D65 2° color readings all fall within the FHWA color box for both leaded and lead-free materials but are less saturated in color than the initial readings. The D65 2° readings of the leaded and lead-free material at the SH 21 site do not show much of a difference between each other, compared to the large difference at the US 79 site.

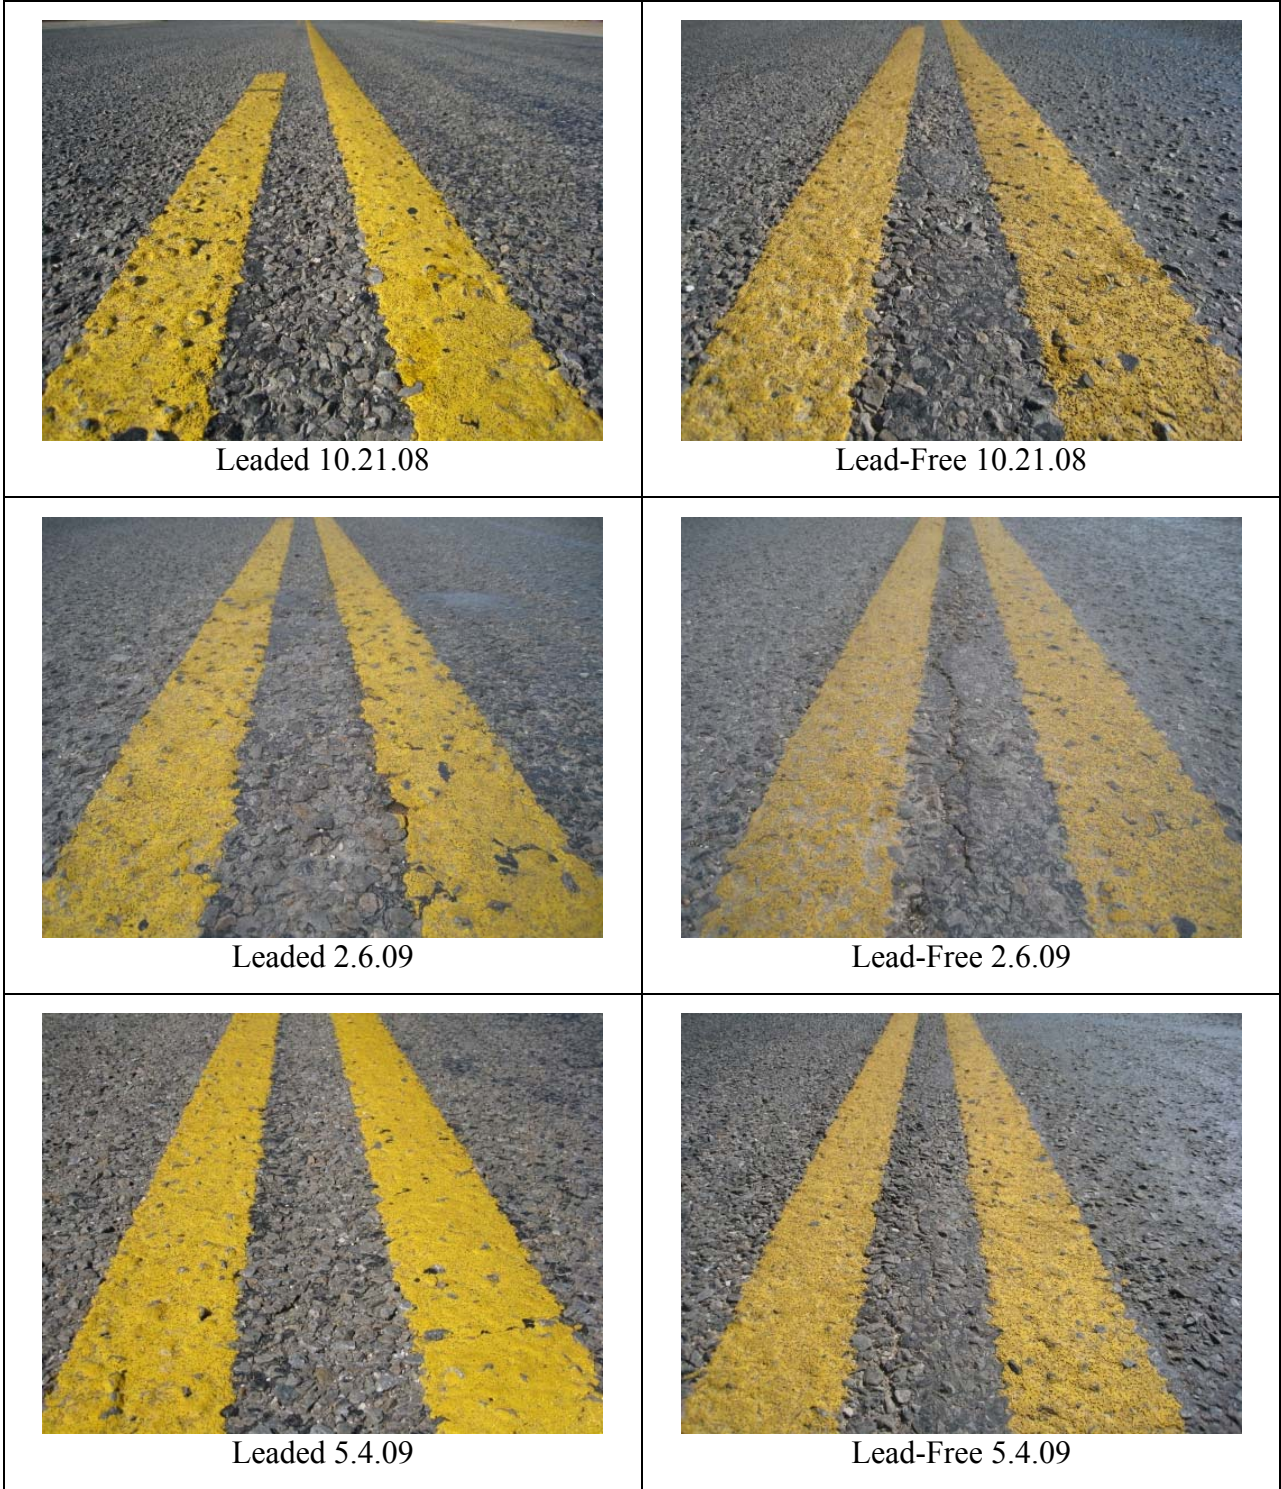
**Figure F1. Photos of US 79 Leaded and Lead-Free Thermoplastic Markings over Time (continued).**

**Figure F1. Photos of US 79 Leaded and Lead-Free Thermoplastic Markings over Time.**
