Guarding the border: watchtowers of the Nasrid Kingdom of Granada. Characterization and vulnerability assessment

Ruiz-Jaramillo, Jonathan

García-Pulido, Luis J.

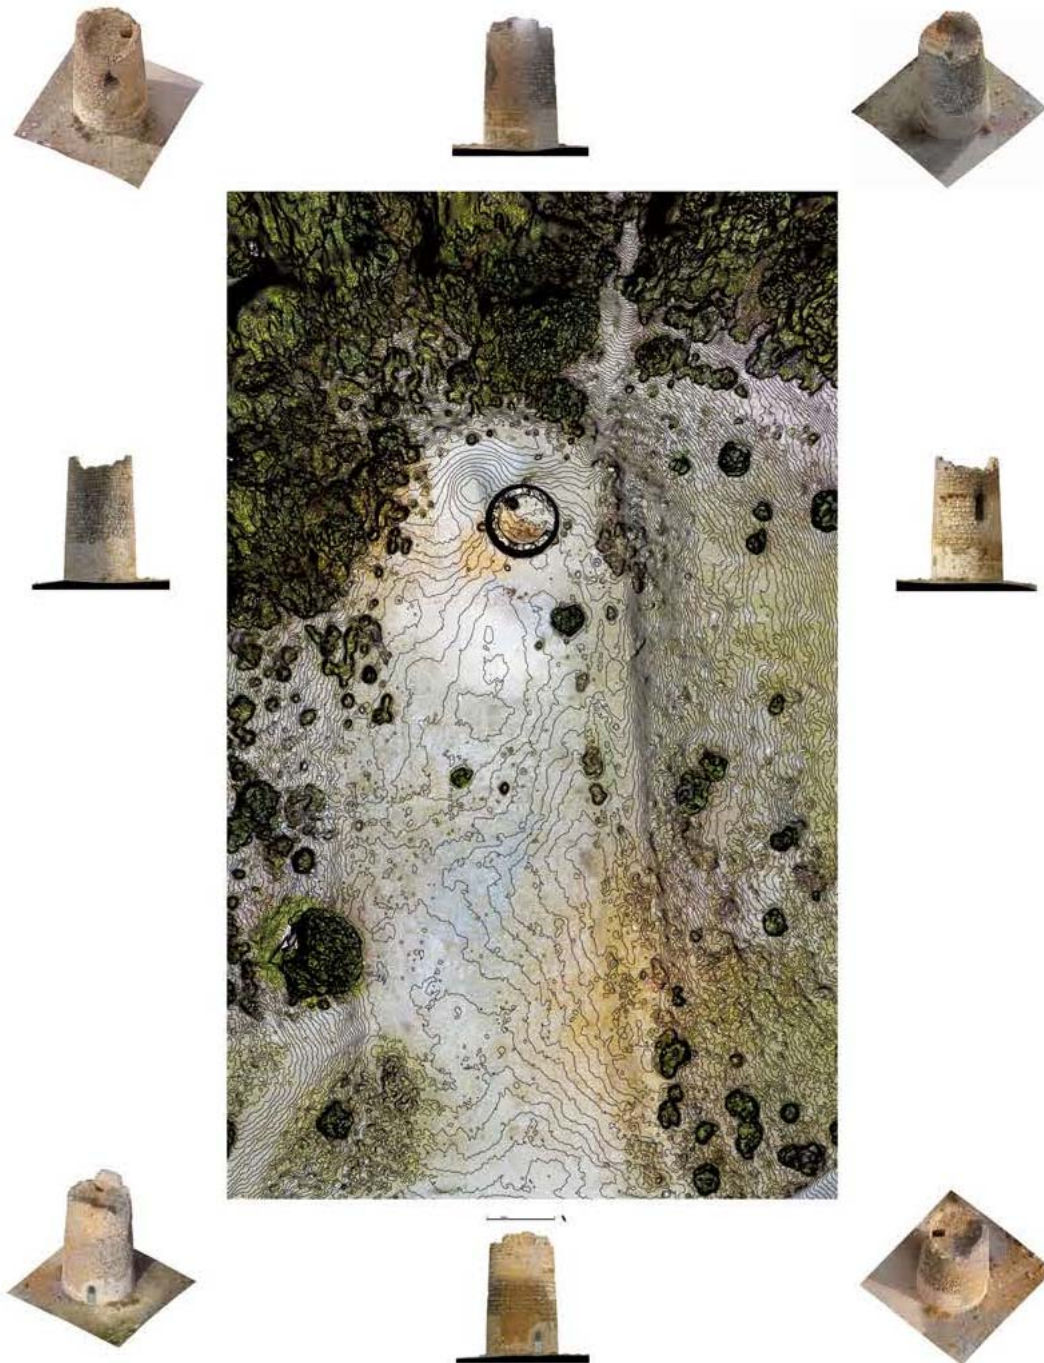
Figure 2. Planimetry of Romeral watchtower in Baza (Granada) using photogrammetry techniques

and sections) as well as elevations and external perspectives using the technique of photogrammetry. These representations have not been limited exclusively to the tower as a valuable object. Additionally, it has been included the necessary information of the surroundings (Figure 2) allowing to assess them as landscape elements capable of providing an additional value (Rössler, 2006).
