Article

Hygrothermal Performance of Worship Spaces: Preservation, Comfort, and Energy Consumption

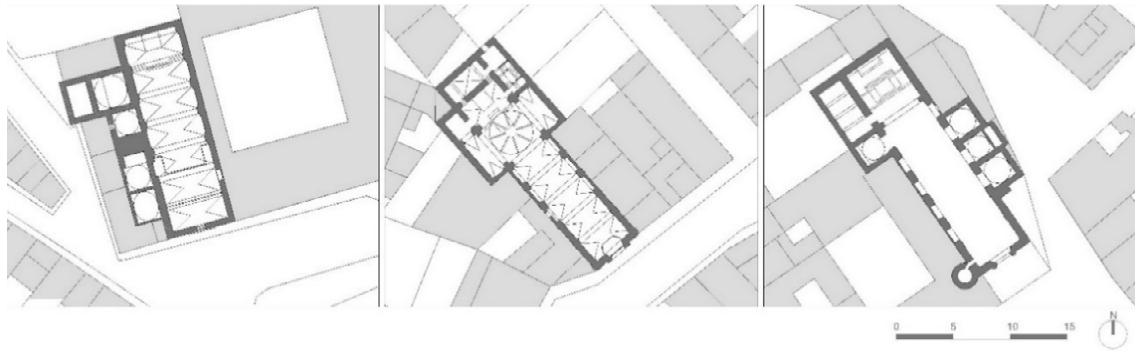
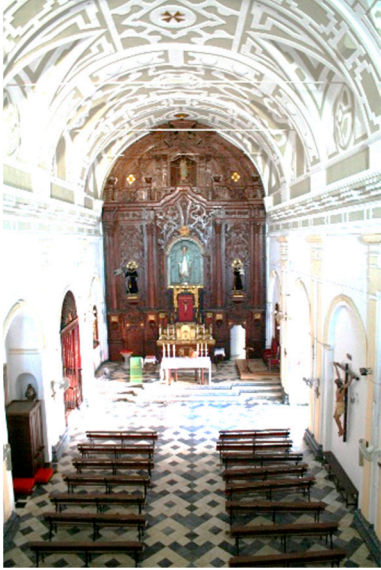
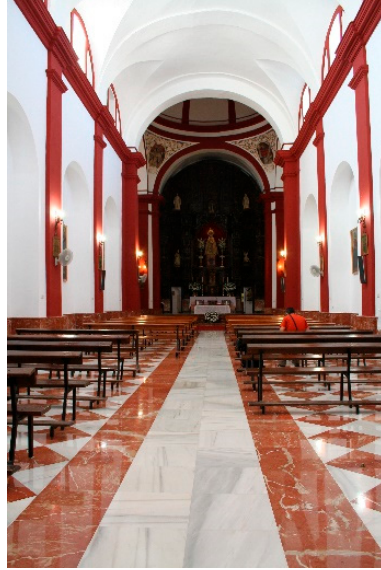
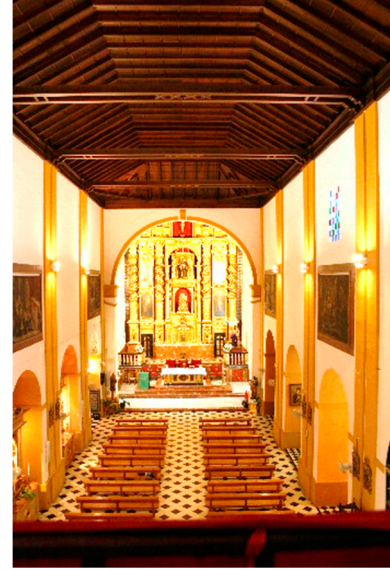
Figure 1. Interior plans and pictures for the churches studied. (SF) San Francisco de Asís Church, (M) Nª Señora de la Merced Church, and (V) Nª Señora de la Victoria church.

Although the three buildings were originally built freestanding on the outskirts of the town, various side chapels have been added over time. As a result of urban growth, these churches have now been surrounded by other buildings, some of which are adjoining to the walls of the church (Figure 1).

Two of the churches (SF and V) are composed of a single rectangular nave, while that of N^a Señora de la Merced Church (M) presents a Latin cross plan. All have thick stone and brick walls, with barrel vaults or wood panelled ceilings (Figure 1). A wide variety of artworks can be found in all three churches, including wooden altarpieces, sculptures, and frescoes. Table 4 shows the basic data for each church, as well as the composition, thickness, and thermal transmittance of the main building elements of the envelope.

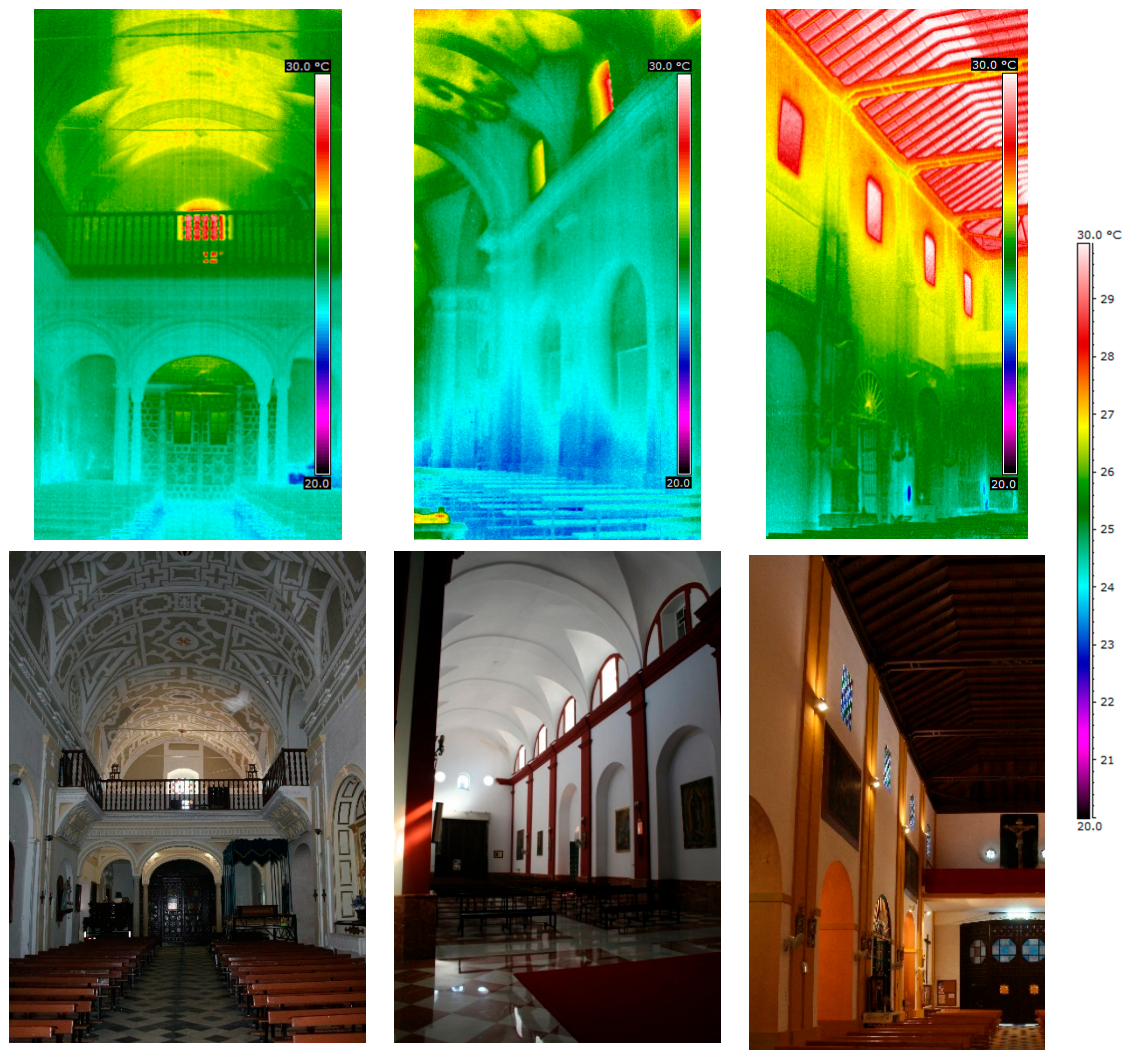
Figure 2. Surface Temperatures in June. (SF) San Francisco de Asís Church, (M) Nuestra Señora de la Merced Church, and (V) Nuestra Señora de la Victoria Church.

Sensors were placed on walls to record values of the overall behaviour of the interior space as accurately as possible. These sensors were selected according to the different orientation and height of each church. Sensors were placed at the height of a seated person (1.10 m) and thermal stratification was observed at a height of 8.5 m. Thermal images were taken at controlled intervals of time and in different seasons in order to establish the evolution of thermal processes (Figure 2).

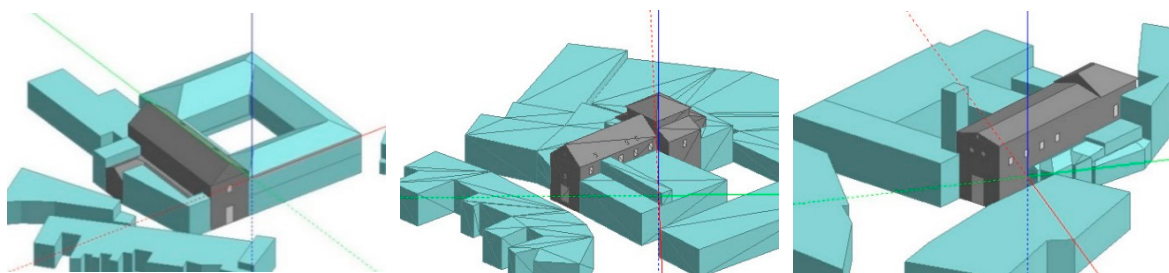
Figure 3. Simulation models. (SF) San Francisco de Asís Church, (M) Nuestra Señora de la Merced Church, and (V) Nuestra Señora de la Victoria Church.

The three-dimensional simulation models generated for each of the churches were validated using monitoring data. Each model reproduces the spatial volume of each church—including its environment and geometry—as well as its materials and climate (Figure 3). The model is validated comparing results with the temperature data (T), relative humidity (RH), and absolute humidity (AH) recorded in situ over a year. Figure 4 shows the data and values for interior average temperature.

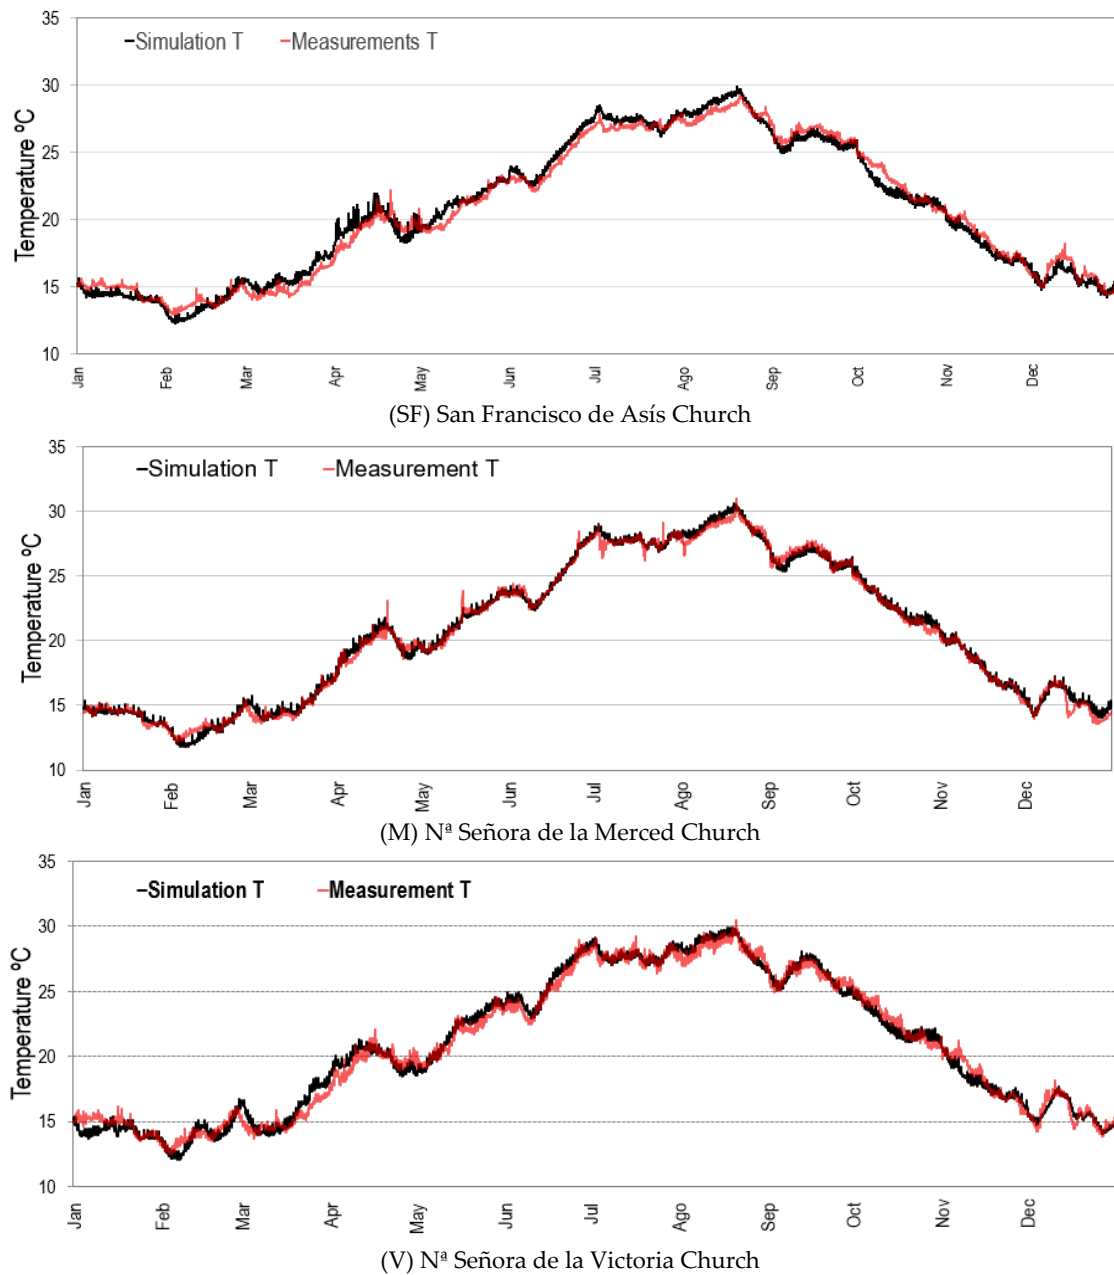
Figure 4. Validation temperature parameters.

Simulation models are considered validated when indicator Hourly Mean Bias Error MBE is $\leq 10\%$ and Coefficient of Variation of the Root Mean Square Error (CV) RMSE $\leq 30\%$. (Table 5).

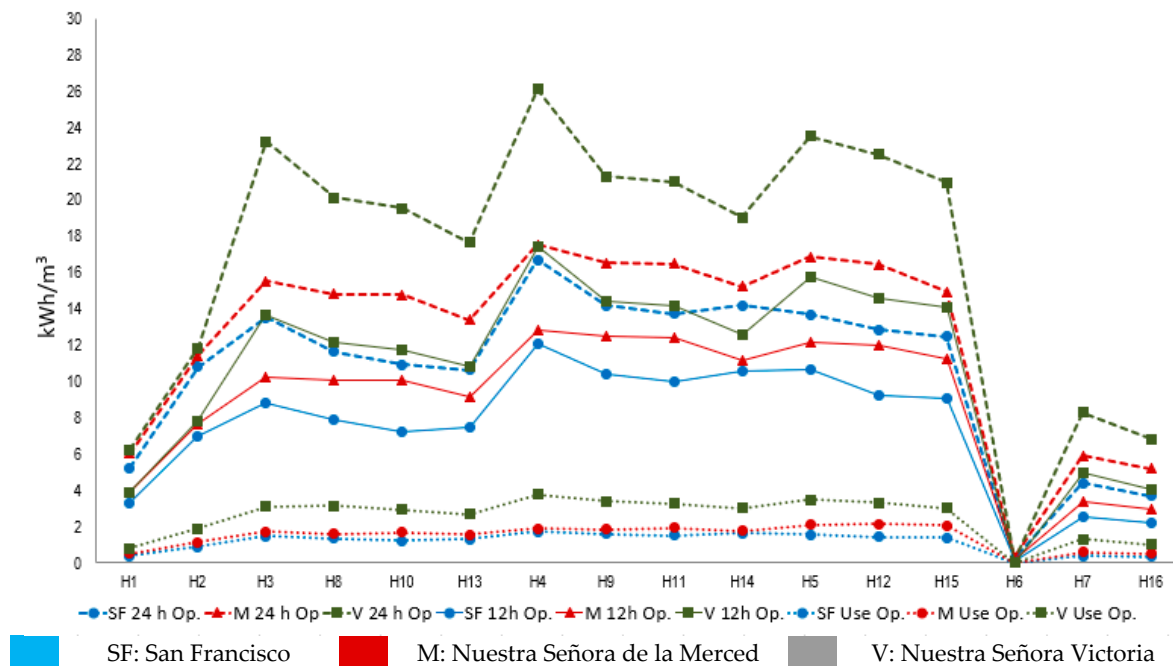
Figure 5. Annual consumption (kWh/m³).

This study has assessed the energy consumption achieved through the application of different active environmental techniques and combined them to ensure the conditions of preservation and conservation of artworks and thermal comfort. In practically all case studies, the implementation of these techniques causes generally high energy consumption due to the large size and thermal inertia of these buildings (Figure 5).

Energy consumption ranges are 139 kWh/m² (operating 24 h), 98 kWh/m² (operating 12 h), and 15 kWh/m² (operating use). According to the Basic Energy Saving Document (DB-HE) [28], energy consumption in this type of building is limited to 45–48 kWh/m².

As is to be expected, the highest consumption occurs during the period of 24-h operation, and the lowest is found when systems are in use only during the celebration of religious events. Maximum annual consumption is around 120,500 kWh (operating 24 h), while minimum consumption is about 10,000 kWh (operating when in use). These values are an average value of the three churches.
