Cable Median Barrier Failure Analysis and Remediation Phase II

CABLE MEDIAN BARRIER FAILURE ANALYSIS AND REMEDIATION PHASE II

MIDWEST ROADSIDE SAFETY FACILITY

MwRSF Research Report No. TRP-03-319-13

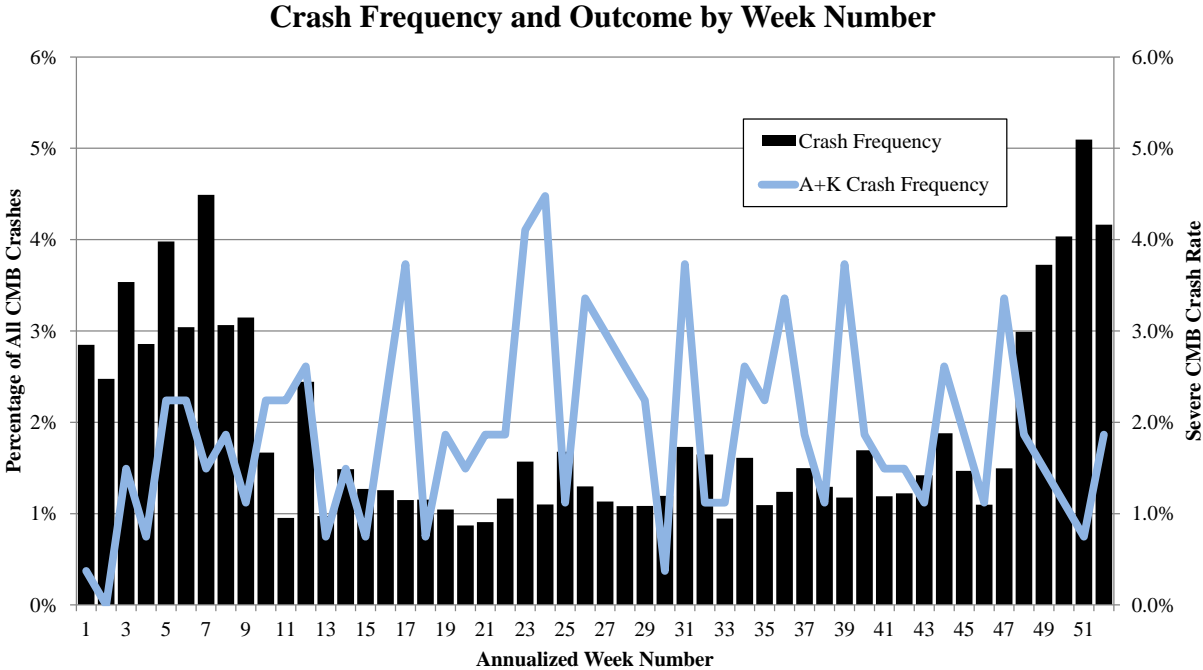
Figure 2. Crash Frequency and Severity by Week Number

The number of crashes into cable barriers was plotted with severity against week number of each crash to determine if there was any additional adverse effect from the time of year, and by extension specific weather patterns, on crash severity and frequency. The result is shown in Figure 2. A significant spike in crashes was noted between December (beginning in week 47) and February (ending week 9), which was likely related to an increase in low-severity crashes during snowy or icy conditions. Crash frequency was also largely related to cultural patterns as well. For example, the spike in crashes during week 12 corresponds to the approximate time frame for collegiate spring breaks. Between weeks 13 and 47 during the year, crash rates were relatively constant and crash frequency distributions were random. However, no distinct pattern of fatalities could be discerned except for a rise during the middle of the year, which may be due to an increased number of vehicle miles traveled.

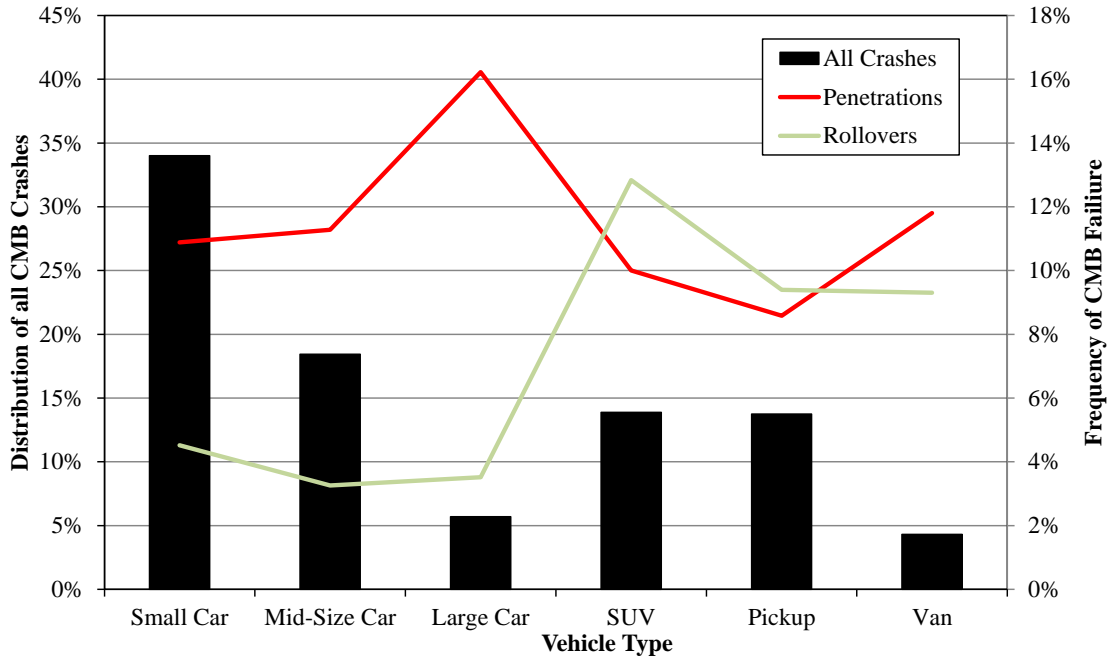
Figure 16. Frequency of Barrier Failure by Vehicle Type

By comparison, rates of vehicle penetration and rollover on a per-crash basis are shown in Figure 16. Large cars were involved in the highest frequency of penetration crashes, followed by vans, mid-size cars, and small cars. Surprisingly, pickups had the lowest rates of penetration of any vehicle type. Although some pickup models were identified which had a higher susceptibility to penetration crashes, as discussed later, generally pickups were not prone to penetrating through cable median barriers. Rollovers were infrequent with all passenger car types, but were common for larger vehicles, averaging more than 10% of all pickup, SUV, and van crashes combined.

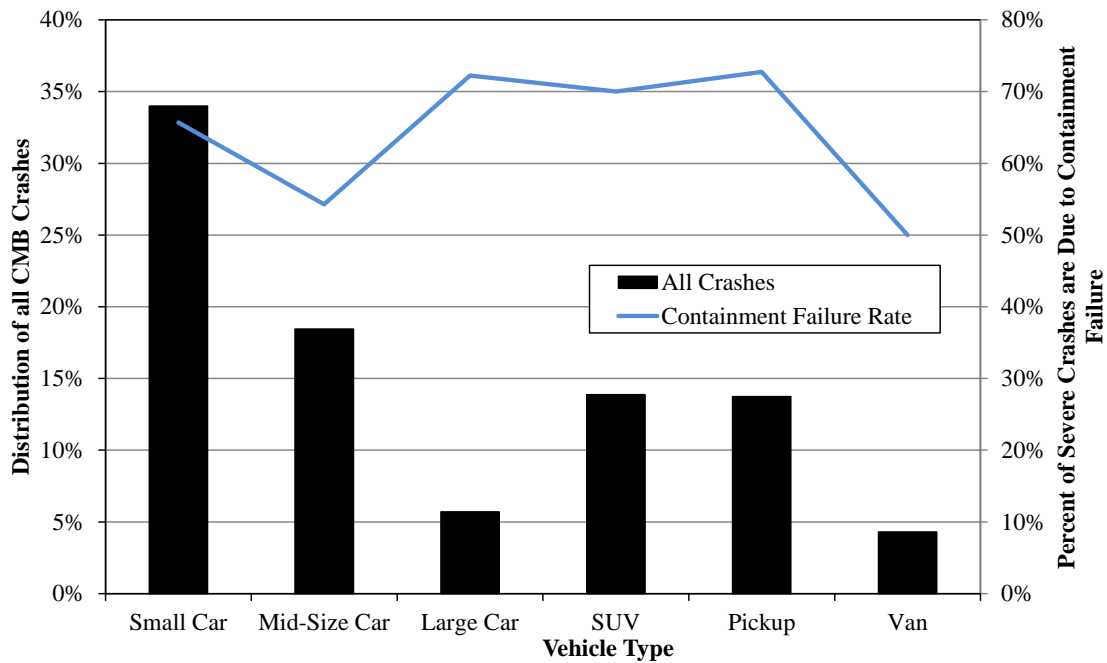
Figure 19. Percentage of Severe Crashes Related to Containment Failures

19. The highest frequencies of severe crashes based on containment failures occurred with large cars, SUVs, and pickups. Not surprisingly, vans had the lowest rate of severe injuries related to barrier containment failures, since the penetration and rollover rates for vans were not extremely high while the severe crash rate was conversely very high. Also, mid-size cars were involved in more crashes in which the vehicle became entrapped in the cables and cables crushed the hood, roof, or windshield, or penetrated into the occupant compartment of convertibles. As a result, more non-containment failure related crashes were severe involving mid-size cars than other vehicle types.

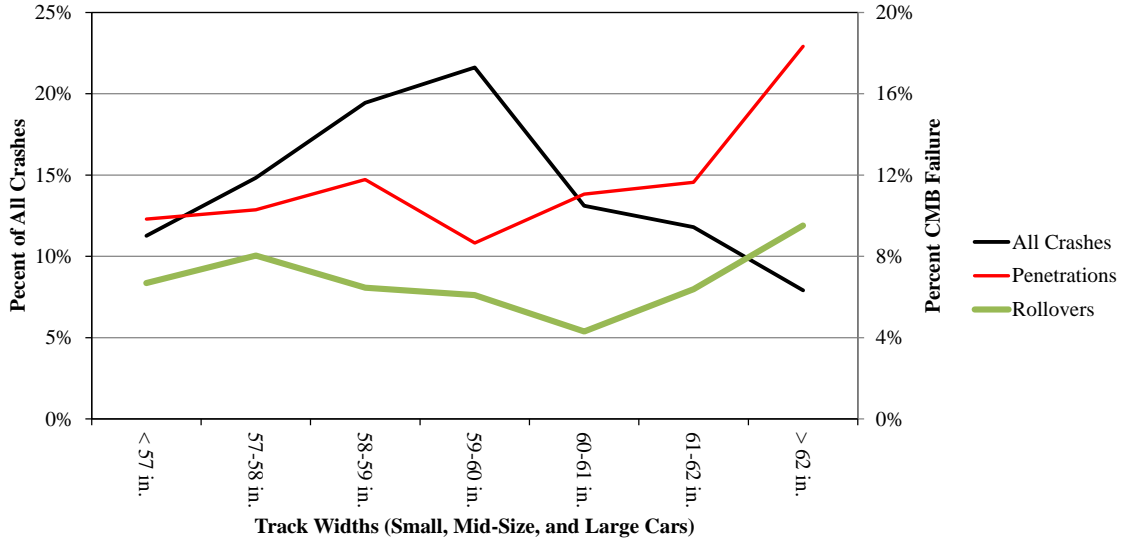
Figure 31. Crash Result Based on Track Width, Small, Mid-Size, and Large Cars

Track widths were segregated by vehicle type as shown in Figures 31 and 32. The distributions were compared by crash outcome. Segregation by vehicle type indicated a strong relationship between track width and penetration rates for passenger cars, whereas statistically significant differences in penetration rate were not observed for SUVs, pickups, and vans. Penetrations were infrequent with small track width utility vehicles, but remained relatively constant for vehicles with track widths greater than 60 in. (1,524 mm). Rollover rates were not strongly related to track width in either vehicle grouping. Further analysis of track width with respect to CG height is discussed in Section 7.3.4.

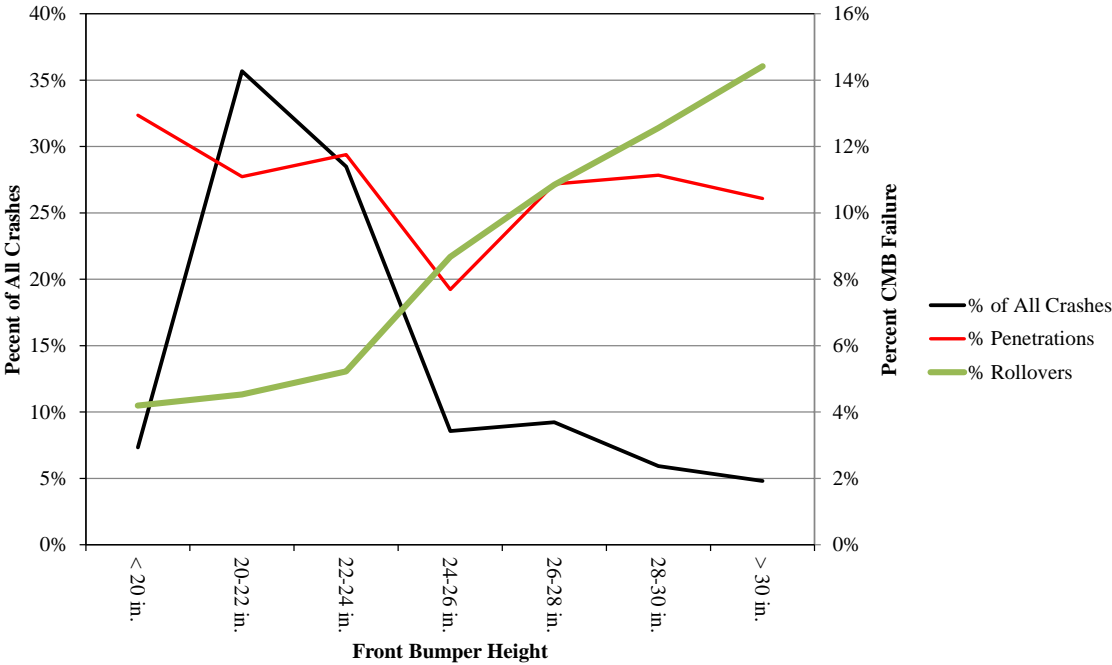
Figure 34. Crash Result Based on Top of Front Bumper Height

Crash results based on front bumper height were plotted and are shown in Figure 34. There was an unmistakable increasing trend toward higher rollover rates with increasing bumper height. Surprisingly, this correlation appeared nearly linear with bumper height. A similar relationship could not be determined for penetration crashes. The overall distribution of vehicles involved in the crashes had no discernible trend in penetration rates.

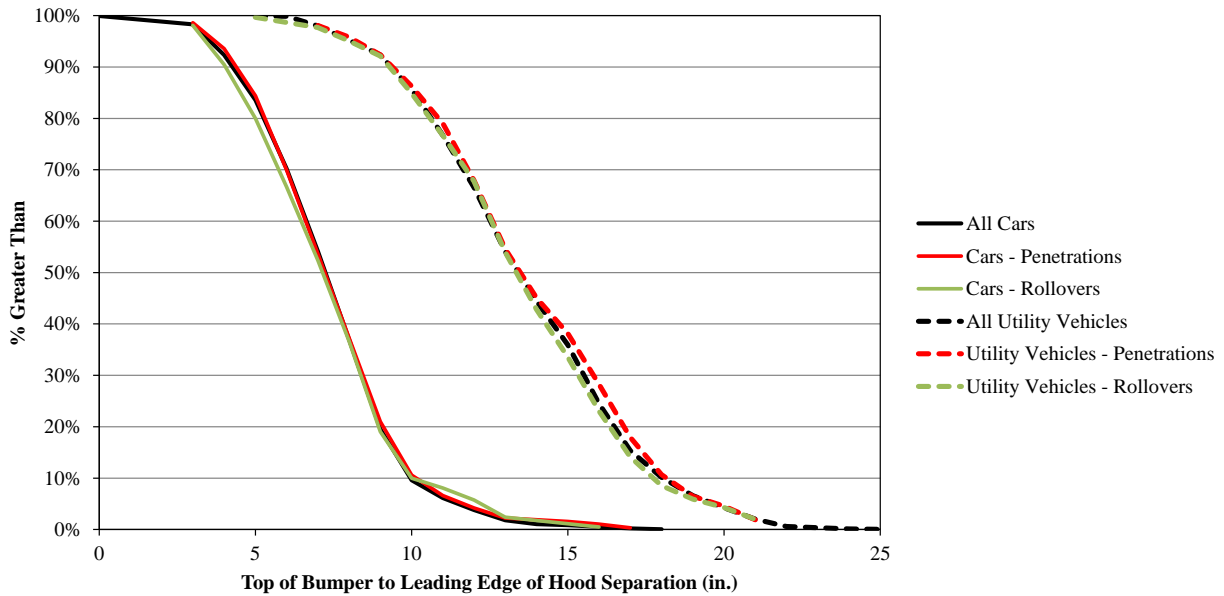
Figure 46. Smoothed Distribution of Separation Between Leading Edge of Hood and Top of Bumper by Crash Result and Vehicle Type

The top of bumper to front of hood height separation distances were plotted against crash result, but results were not statistically significant when plotted by vehicle grouping. Although statistical significance was observed with respect to the rollover database when all vehicle types were plotted together, the differences were strongly related to the types of vehicle involved in rollover crashes, and were not caused by the bumper-to-hood separation distance. Furthermore, statistical tests evaluating bumper-to-hood separation distances of passenger cars indicated a very strong statistical similarity between bumper-to-hood separation distances in rollovers and all crashes; stated differently, the two distributions were virtually indistinguishable. If there is a relationship between bumper-to-hood separation distance and penetration rates for passenger cars or utility vehicles, it was not obvious in the available database of 3,804 crashes with known vehicle types and crash outcomes, as shown in Figure 46.

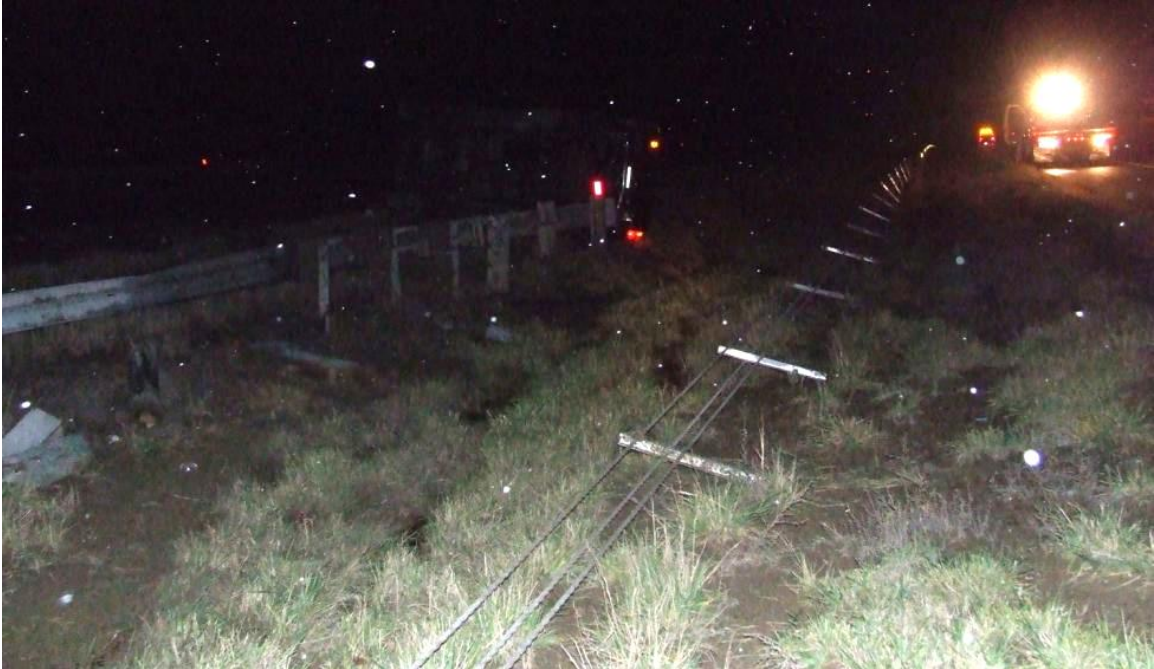
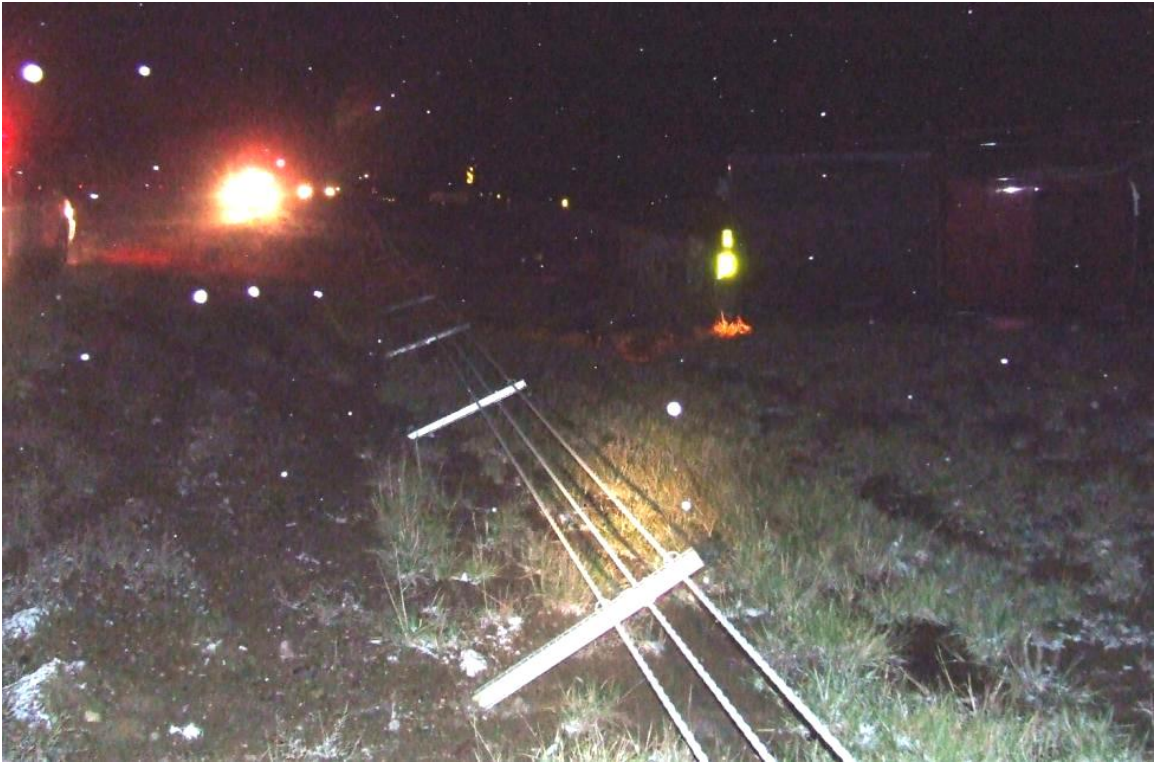
Figure 86. Penetration Crash Caused by Strong Cable-to-Post Attachment

The incident slope at the POI was 10.4:1, which was generally considered “flat” median terrain. Construction of the system was within recommended tolerance, and the vehicle bore a strong resemblance to the Dodge Ram pickup trucks used in many full-scale crash tests evaluating roadside hardware to MASH criteria. Other additional crashes occurred in which the

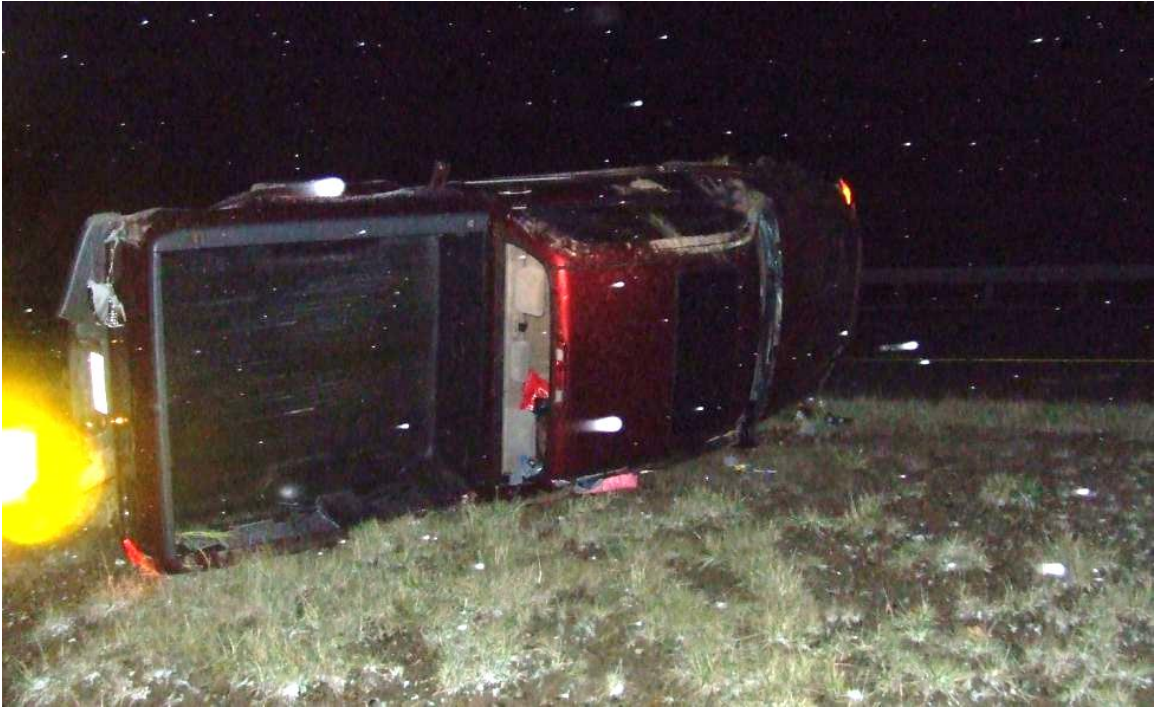
Figure 87. Crash Result Due to Strong Cable-to-Post Connection

An example of a crash in which the strong cable-to-post attachments contributed to vehicular penetration through the barrier is shown in Figures 86 and 87. In this crash, an impacting pickup truck lost control due to slick roadway conditions and departed the roadway into the median. The CG trajectory angle was approximately 24 degrees, and the orientation angle of the vehicle at impact was approximately 110 deg. The vehicle impacted the cables and began to redirect. The first few impacted posts were pulled out of the ground as the pickup was redirecting, and the strength of the cable-to-post attachments retained the posts on the cables. Due to the high orientation angle at impact, the cables did not locally crush the fender at the front of the vehicle. Fender crush promotes good cable-vehicle interaction and was commonly associated with vehicular capture or redirection. Posts downstream from impact bent backward as the pickup truck progressed into the system. Because the cables remained attached to the posts as the posts fractured and bent at the ground line, cable heights were lowered relative to the vehicle. Eventually, the vehicle overrode the cables and struck the round wood posts on the back side of a W-beam guardrail system. Due to the high orientation angle of the truck, the posts acted as a tripping mechanism and the pickup rolled five quarter-turns.

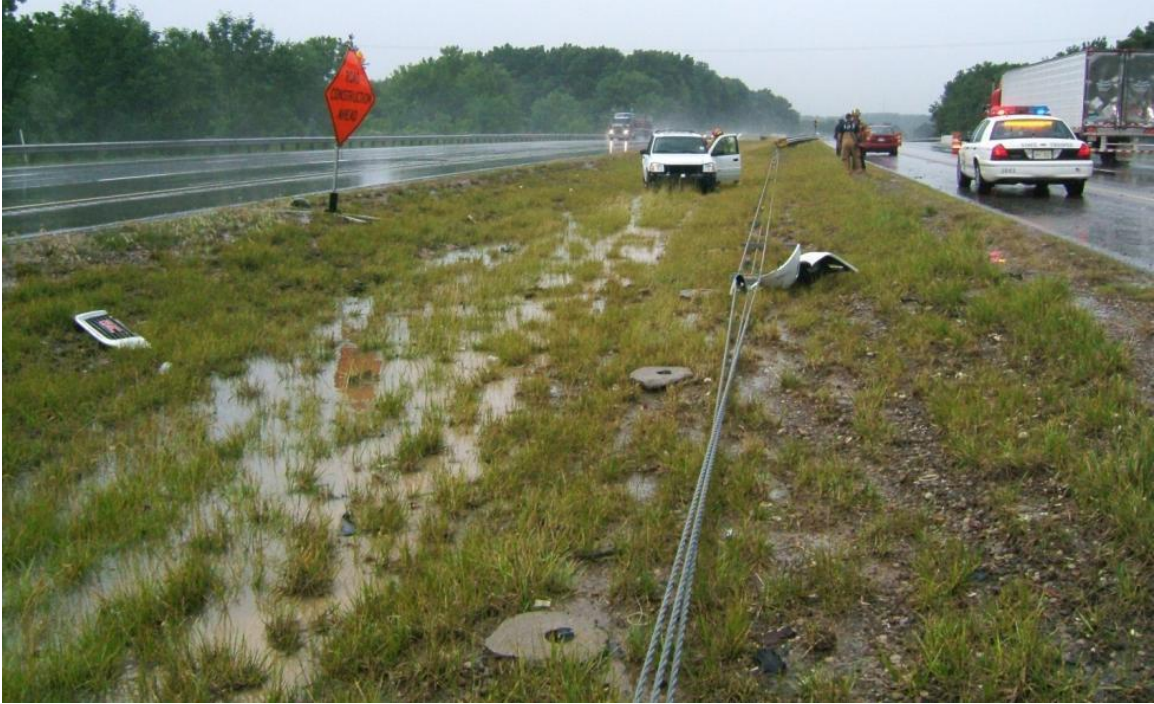
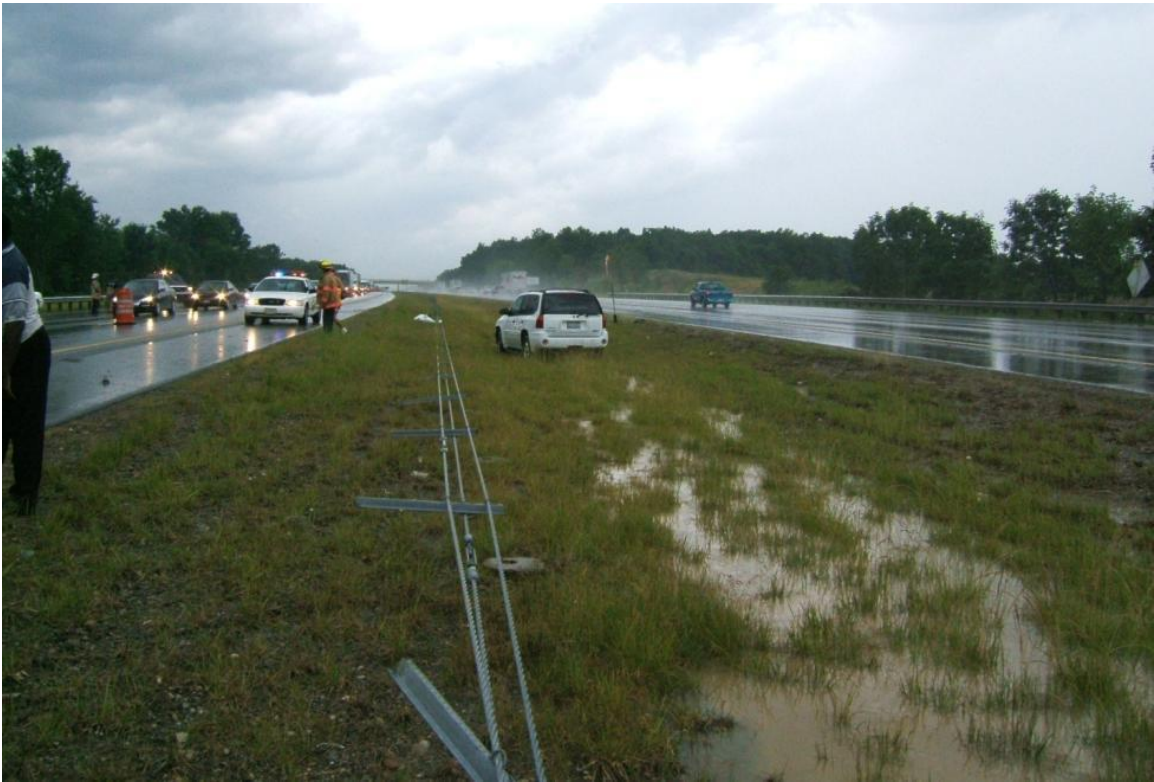
Figure 88. Override Penetration Crash Caused by Strong Cable-to-Post Attachment

Bumper cover disengagement resulting in vehicular penetration is a relatively rare event. However, the accumulation of fractured posts may be indicative of a systemic problem, because the post fractures during both redirection and penetration events, and post accumulation, were both widely observed.

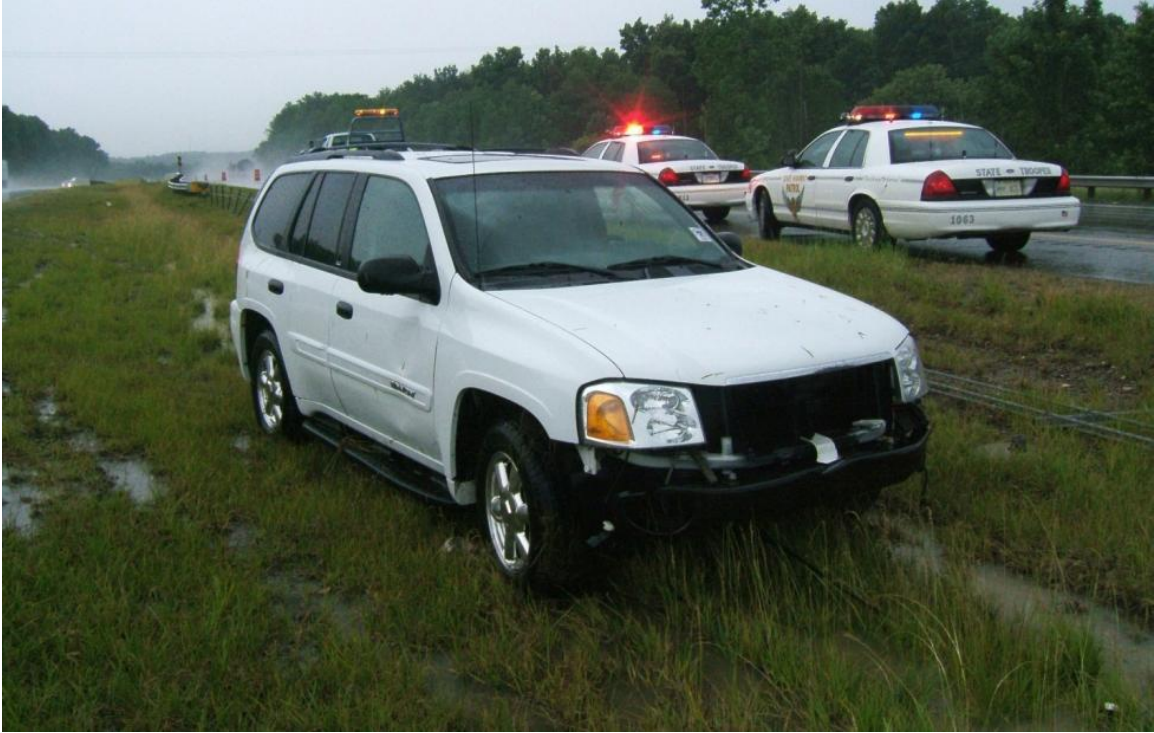
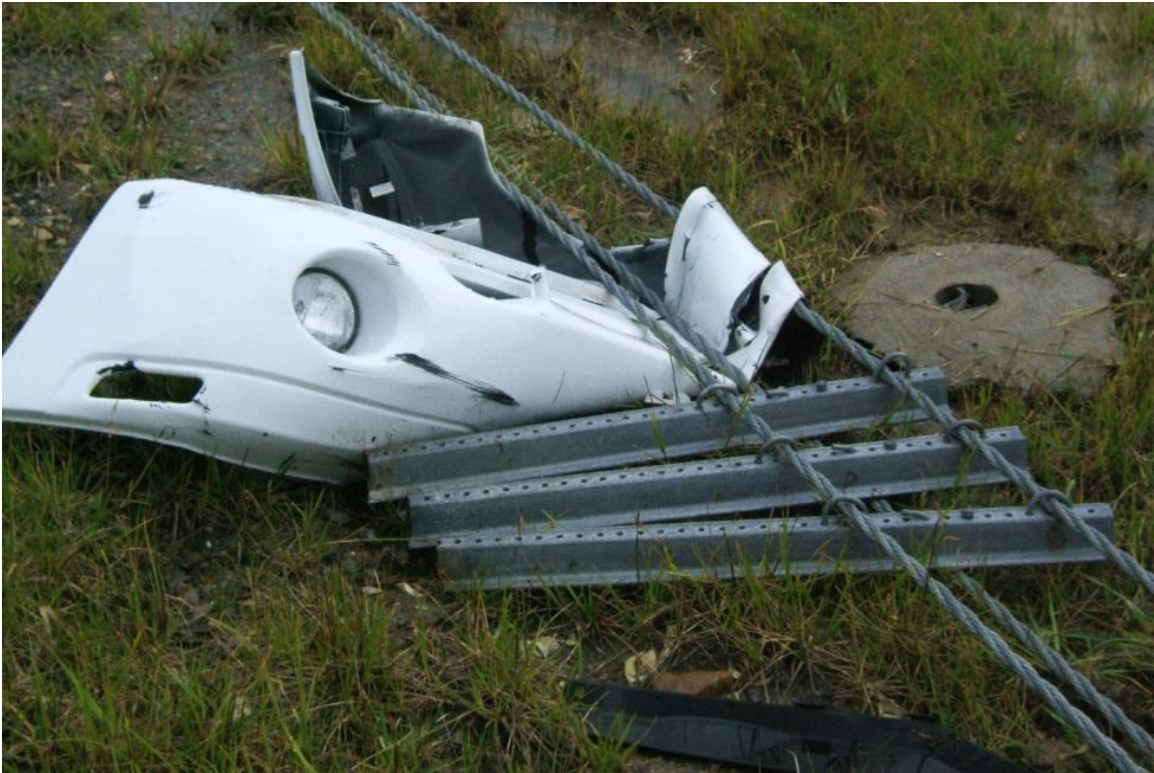
Figure 89. Override Penetration Crash Vehicle Final Position and Removed Bumper Cover

A second example of the strong cable-to-post connection consisted of a combination of several component failures which culminated in the override penetration. Vehicle no. 1 hydroplaned on the roadway and struck an adjacent vehicle. The second vehicle swerved to avoid Vehicle no. 1 but was unsuccessful. After colliding with Vehicle no. 1, Vehicle no. 2 skidded into the median and struck a cable barrier, coming to rest on the opposite side of the system. Impact CG trajectory and orientation angles of Vehicle no. 2 were in the range of 10 to 15 degrees and 20 to 30 degrees, respectively. Unfortunately, a lack of vehicle trajectory photographs prevented more accurate photogrammetric techniques from being used to calculate the encroachment angles. Final vehicle orientation was approximately 205 degrees, relative to the vehicle's original travel direction. Crash photographs are shown in Figures 88 and 89.

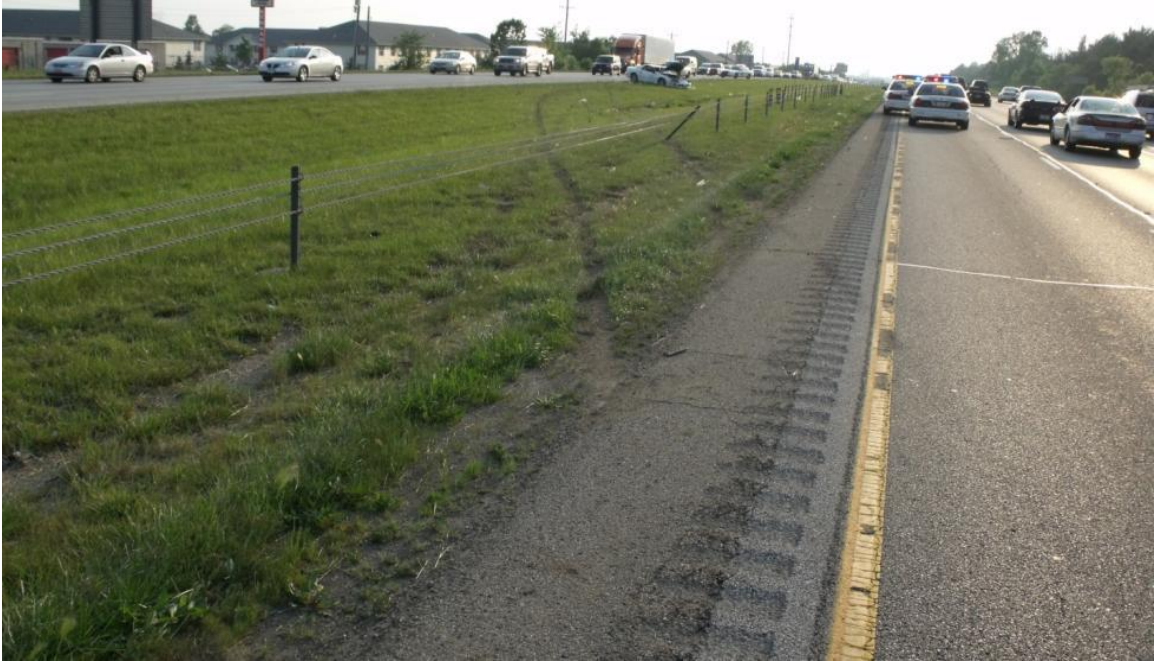
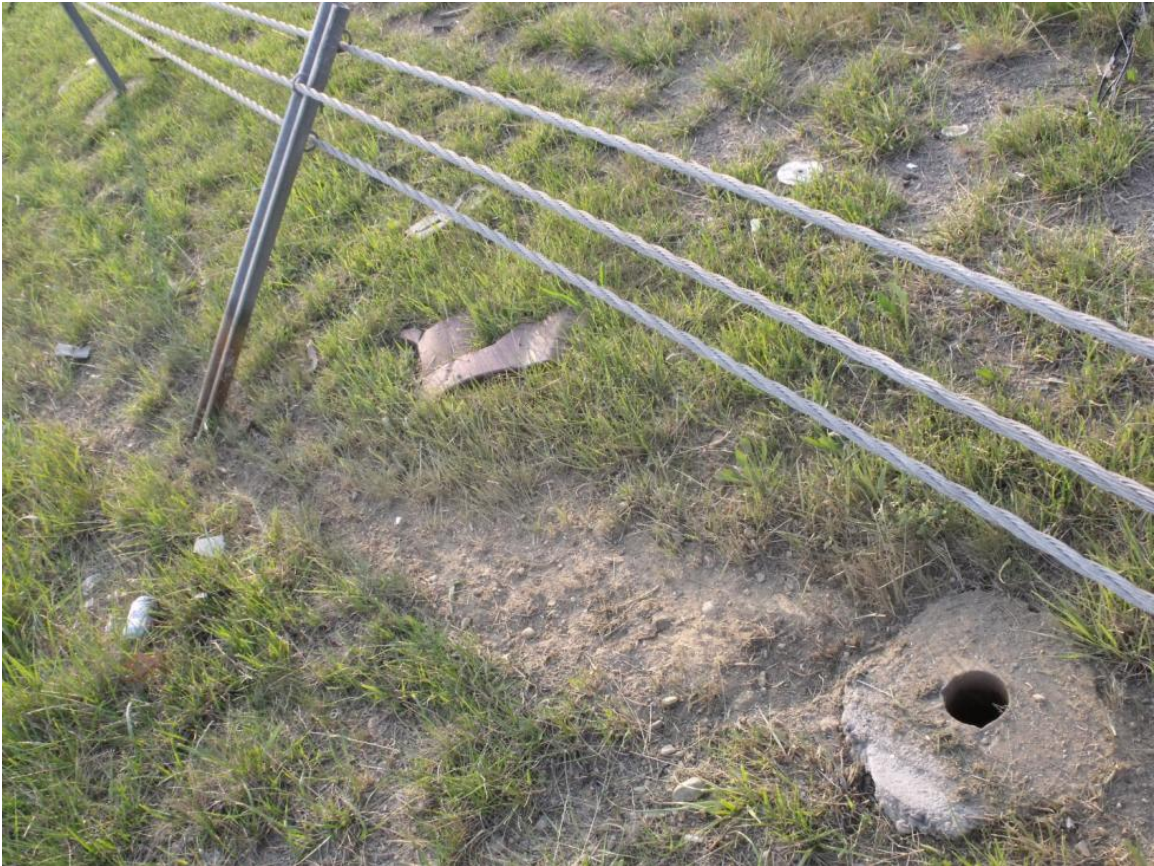
Figure 90. Prying Penetration Crash on Nucor NU-CABLE Barrier

Although the vehicle was brought to a stop in the median, the strong cable-to-post attachment could have seriously injured or killed an occupant in the back seat of the vehicle in this crash because of the retention of the post. Fortunately, no occupants were present in high-risk seat locations, and this crash resulted in only property damage.

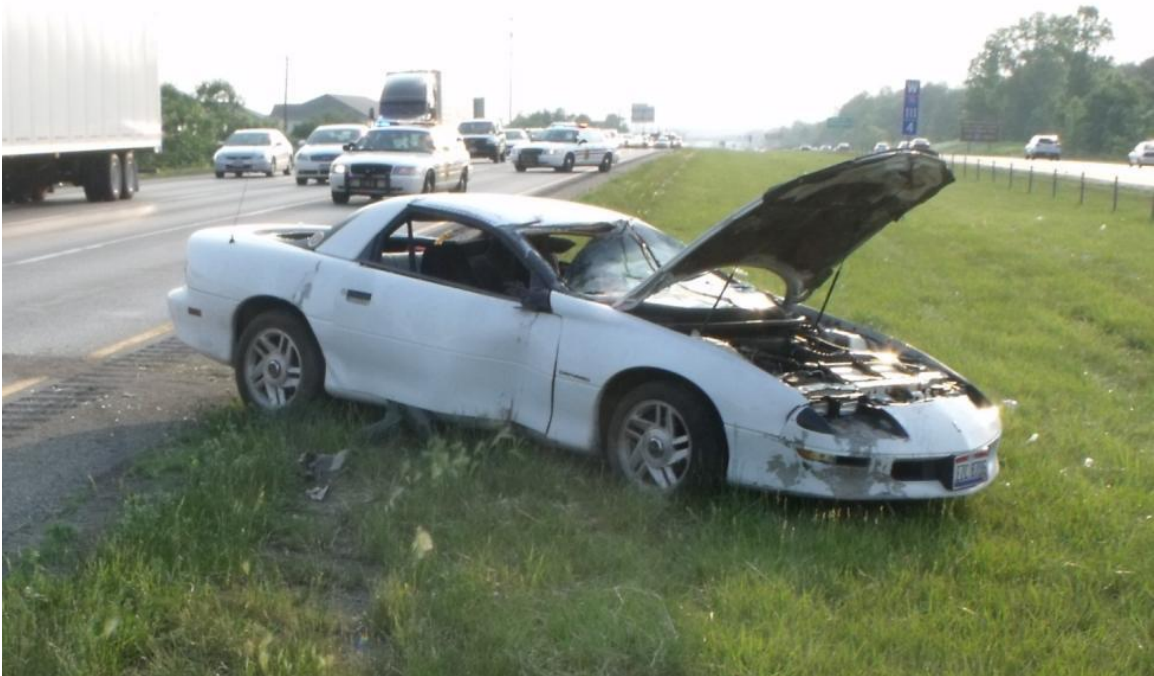
Figure 91. Prying Penetration Failure on Nucor NU-CABLE Barrier

In a second prying case, a 1994 Chevrolet Camaro impacted the Nucor system with a sideslip angle of approximately 90 degrees. Photos of the impact are shown in Figures 90 and 91. In this crash, the vehicle oversteered into the median to avoid contact with another vehicle on the road, and struck a TL-3 3-cable Nucor barrier system with 20 ft (6.1 m) post spacing. The CG trajectory angle at impact was approximately 32 degrees, and the heading angle was approximately 118 degrees. The vehicle yawed and redirected away from the opposing travel lanes, coming to rest with an orientation angle of approximately 245 degrees. The vehicle engaged one post along the right side, and pushed the post downstream. The post did not disengage from the cables as the vehicle underrode the system.

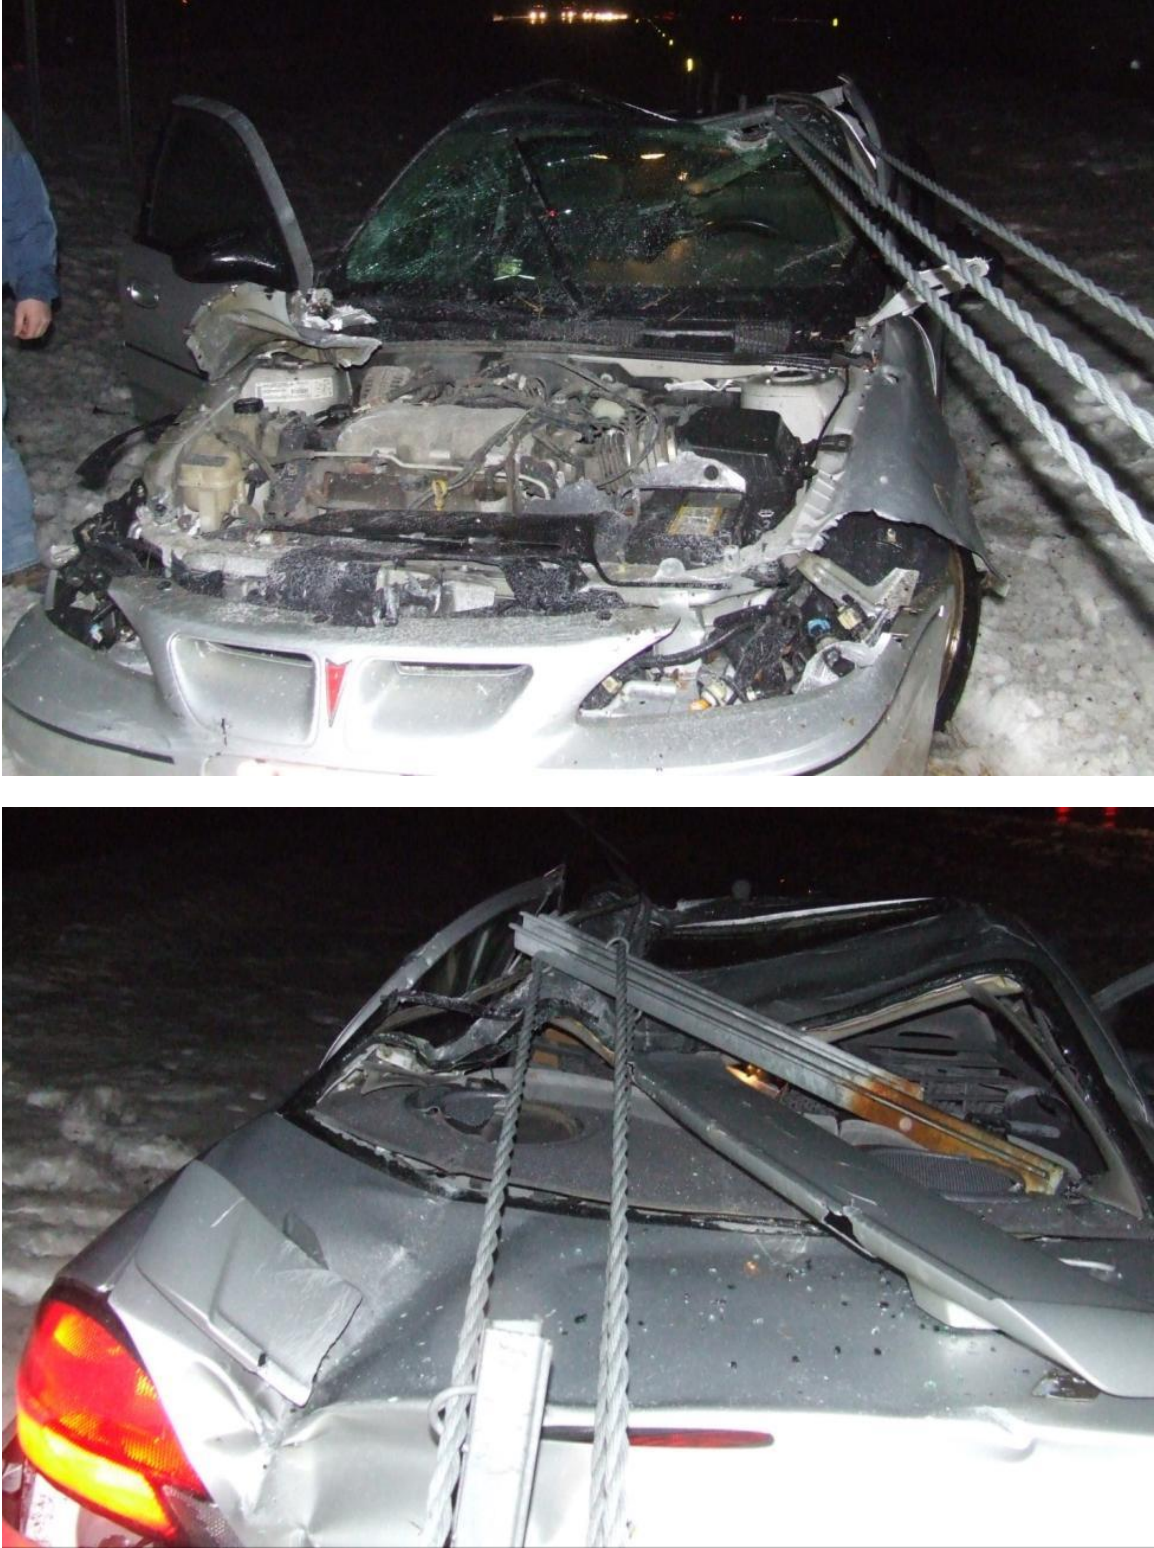
Figure 92. Potential Penetration Crash on Nucor NU-CABLE Barrier

One such potential penetration crash occurred with a 2003 Pontiac Grand Am, which struck a cable barrier with a low but unknown CG trajectory angle and an orientation angle greater than 100 degrees. Photographs of the crash are shown in Figure 92. Vehicle engagement was initially acceptable as the lower cables crushed the right-front fender panel inward and fractured the headlight housing. However, due to the slope of the leading right-front corner of the vehicle and the strength of the cable-to-post attachments, the upper cable was forced up the vehicle's A-pillar, lifting the lower cables and tearing the hood supports. The hood was removed from the vehicle and came to rest at an unknown location in the median. The force applied to the vehicle to remove the hood initiated a clockwise yaw by arresting the front of the vehicle. The second and third posts downstream from impact were struck by the rear of the vehicle and lifted out of the ground due to the prying action of the cables above the vehicle, but remained attached to the cables due to the strong cable-to-post attachments. The posts became wedged in the rear windshield, shattering the rear glass and crushing the roof inward.

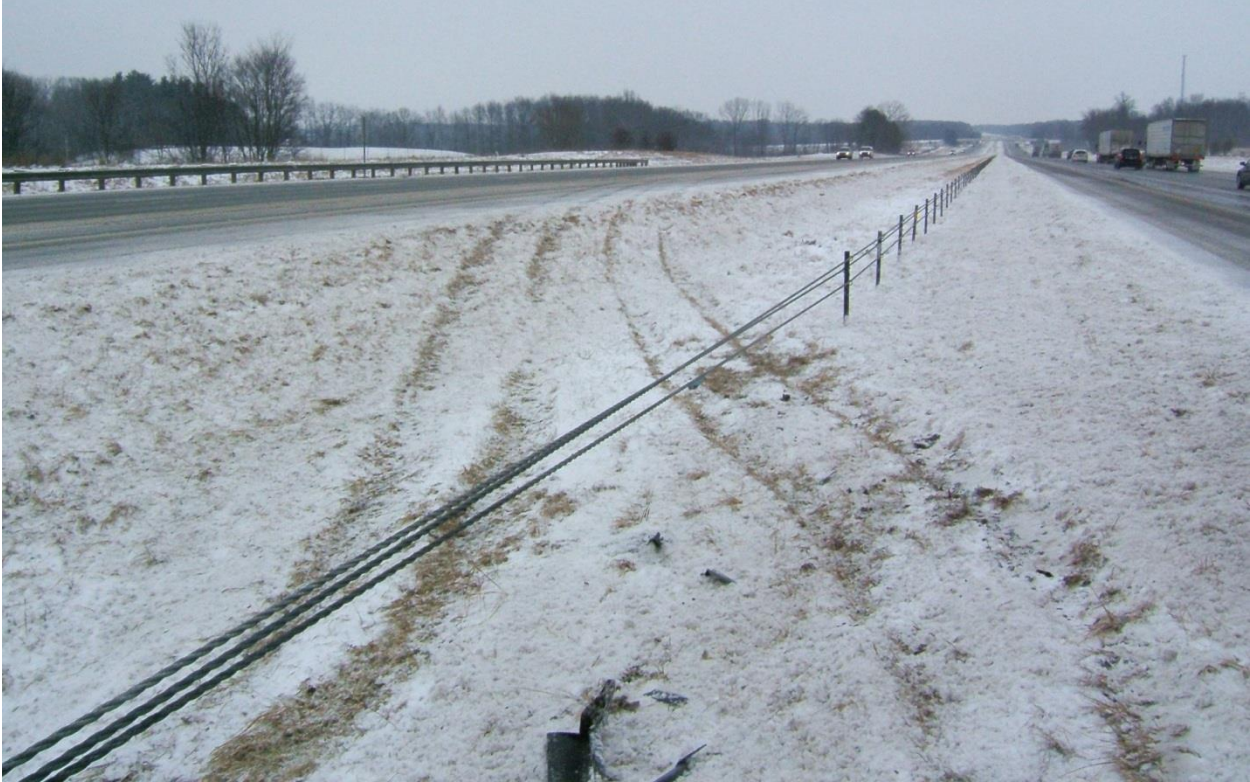
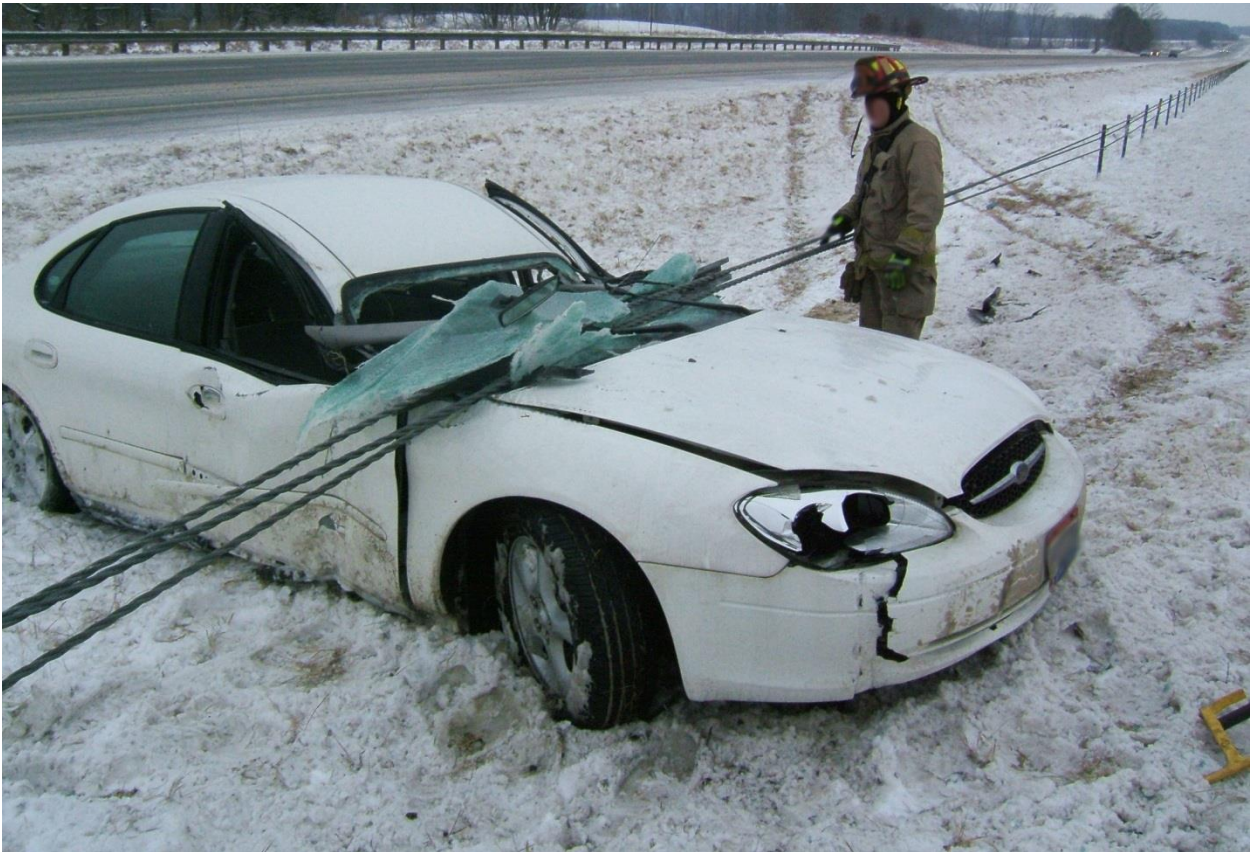
Figure 94. Diving Potential Underride Penetration Crash on Nucor NU-CABLE Barrier

A second example of a diving collision involved a 2003 Ford Taurus. Photographs from the impact are shown in Figure 94. The vehicle had lost control on the icy roadway and entered the median with an orientation angle greater than 60 degrees and a moderately-high CG trajectory angle of approximately 21 degrees. After impact, the cables slid up the bumper and grill and onto the hood without crushing or becoming "seated" in the vehicle's body. Cables adjacent to impact lifted posts out of the ground, and the posts pierced the windshield before the vehicle came to a stop. Both the windshield and roof were crushed downward by the cables.

It was determined that in addition to the smooth contour of the front end of the vehicle, suspension compression also contributed to this penetration crash. With the large orientation angle and moderately large CG trajectory angle, suspension compression and subsequent rebound had the effect of "bouncing" the cables upward and onto the hood and windshield. Significant occupant compartment deformation occurred, and the vehicle demonstrated a clear propensity for penetration since no cables were in optimum position to capture the vehicle after the vehicle came to rest; thus this crash was classified as a potential penetration and included with other penetrations in the analysis.

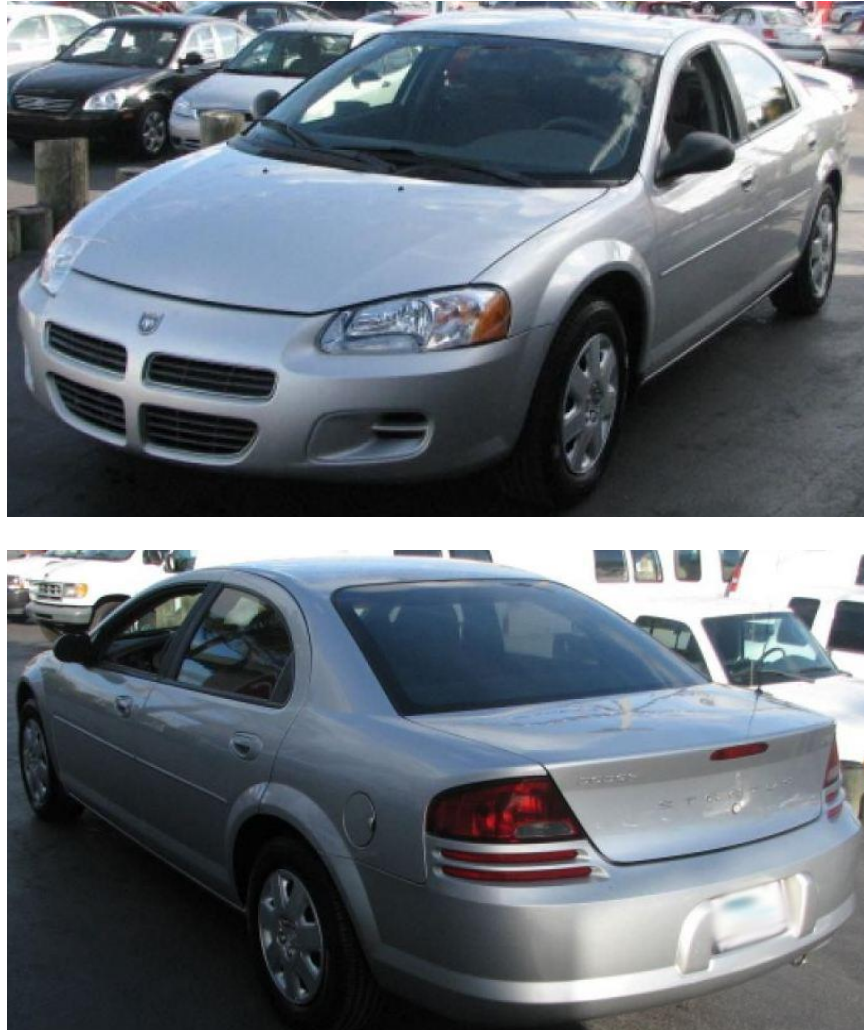
Figure 96. 2002 Dodge Stratus Similar to Vehicle Involved in High-Orientation Angle Penetration Crash [45]

The Dodge Stratus was not typically involved in penetration crashes due to some unique features. The front of the vehicle was both broad and blunt, and the sides of the vehicle were relatively flat. There were multiple locations on the vehicle which promoted interlock with the vehicle, such as cutouts around headlights, a recessed grill area, and a concave trunk area which resisted cable slippage. Typical sill heights of the windows exceed 35 in. (890 mm), whereas the ground clearance averages approximately 16 in. (406 mm). Total vehicle height averages were approximately 55 in. (1,397 mm). This height provided a large surface over which vehicle capture was possible, which also required cables to rise substantially to pass over the top of the vehicle. Thus, this vehicle was uniquely positioned to resist cable median barrier penetrations.
