Cable Median Barrier Failure Analysis and Remediation Phase II

CABLE MEDIAN BARRIER FAILURE ANALYSIS AND REMEDIATION PHASE II

MIDWEST ROADSIDE SAFETY FACILITY

MwRSF Research Report No. TRP-03-319-13

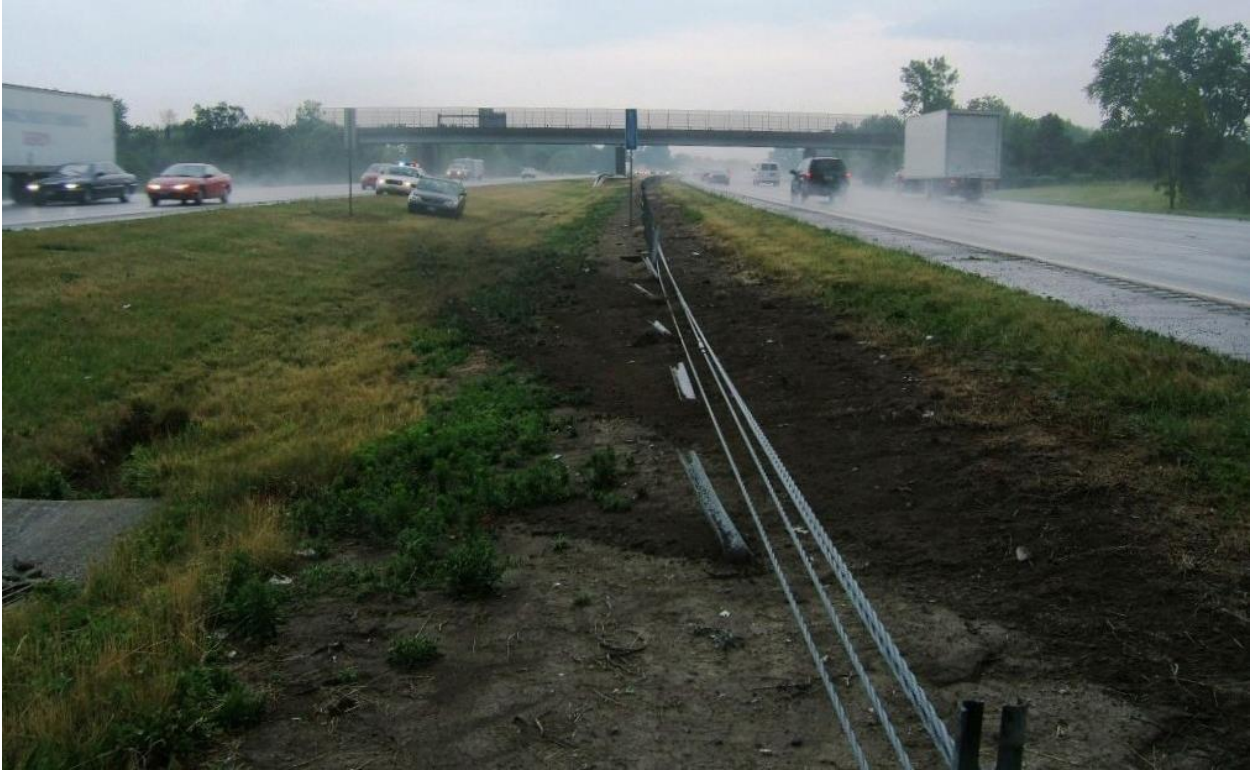
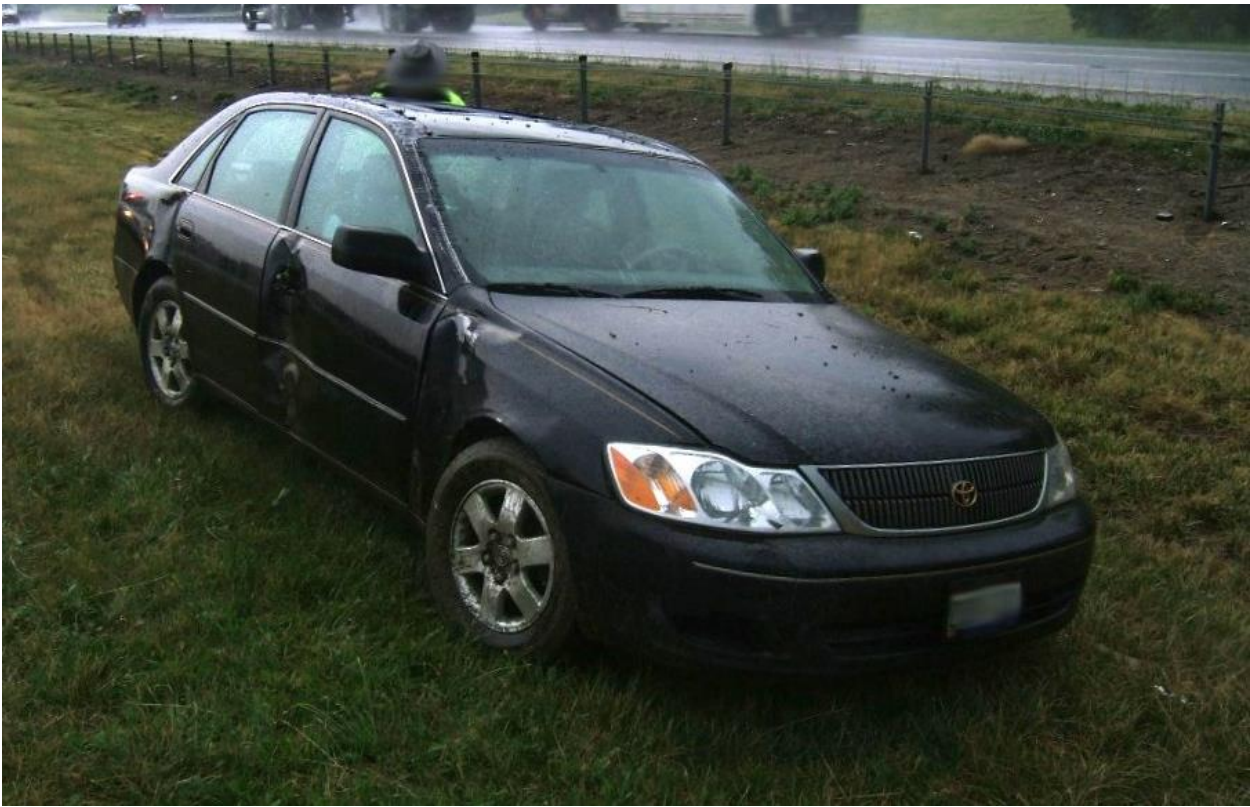
Figure 97. Prying Underride Failure on Brifen WRSF

The vehicle struck and bent four posts. One impact occurred at the front bumper, two occurred with the right-side body panels, and one occurred at the right-rear wheel, as shown in Figure 97. The vehicle occupants were not injured in this crash. The approach slope in front of the barrier was 9:1, and soil foundation tubes supporting the posts were in excellent condition.

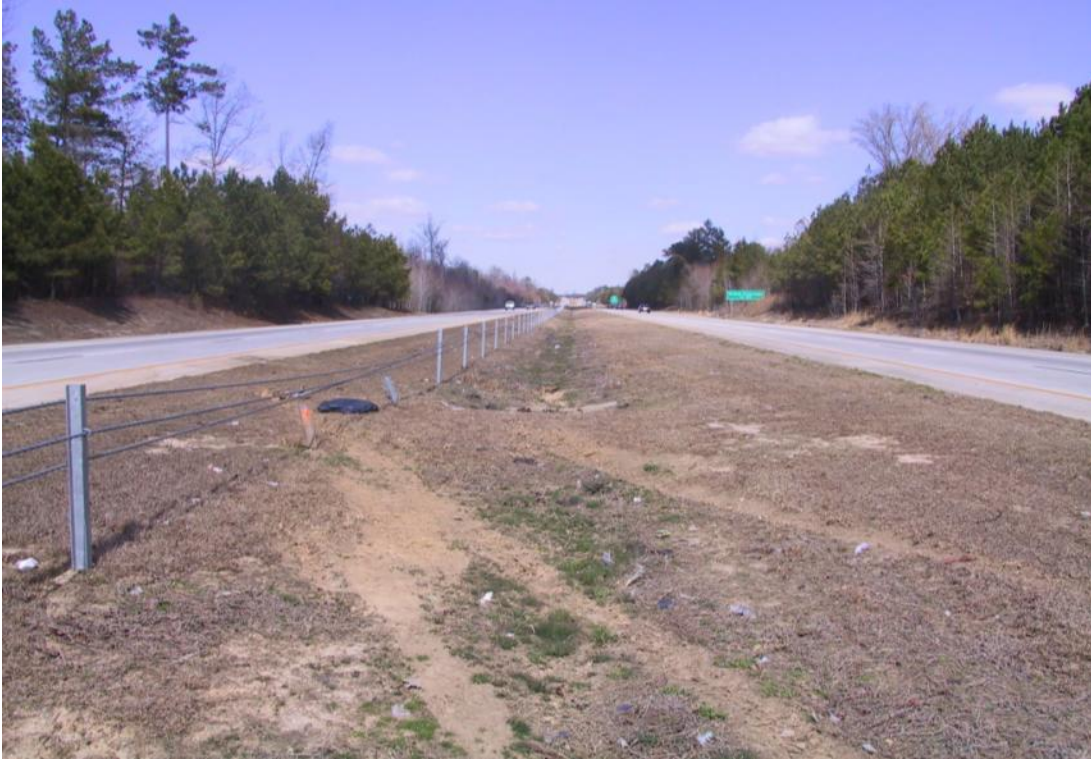
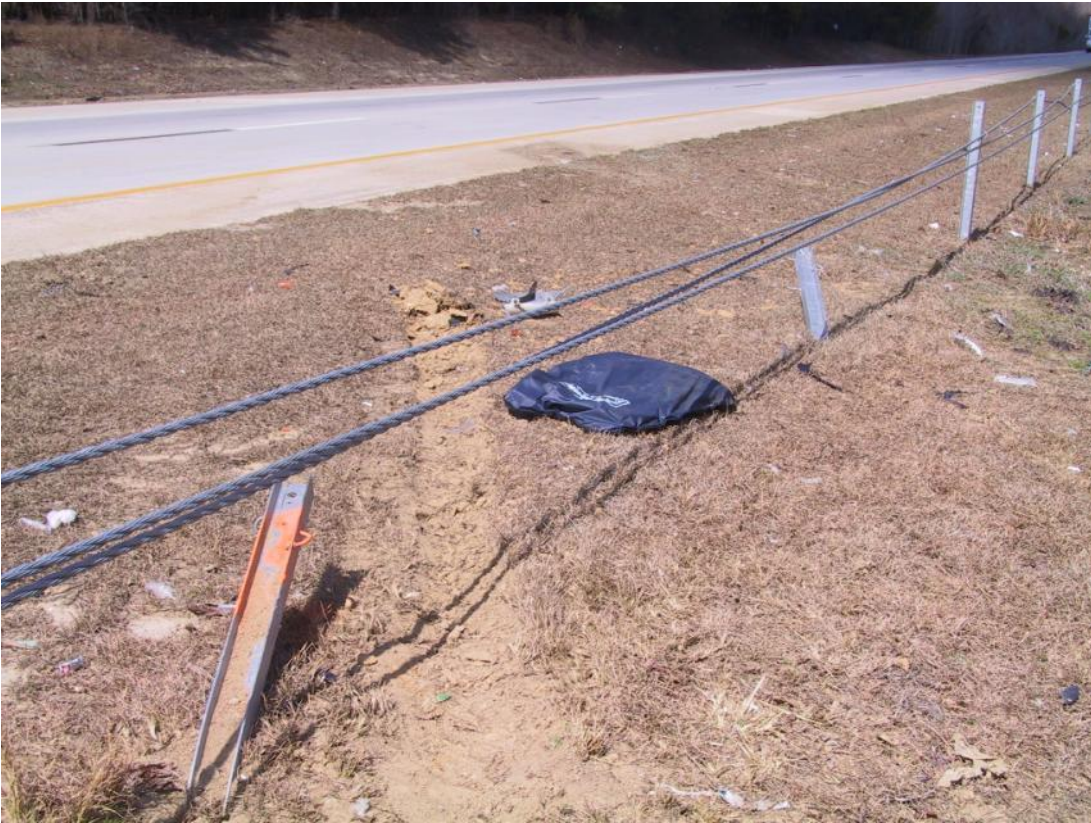
Figure 99. Diving Underride Penetration Crash in North Carolina

In general, slopes steeper than 8:1 were most susceptible to cable median barrier diving penetrations. Diving penetrations occurred less frequently if the impacting vehicle made contact with the barrier on the approach slope. The critical location to cause diving penetrations was approximately 3 to 6 ft (0.9 to 1.8 m) from the center of the V-ditch, based on analyses of ruts made in the soil in the crashes in North Carolina. This determination was supported by literature [28].

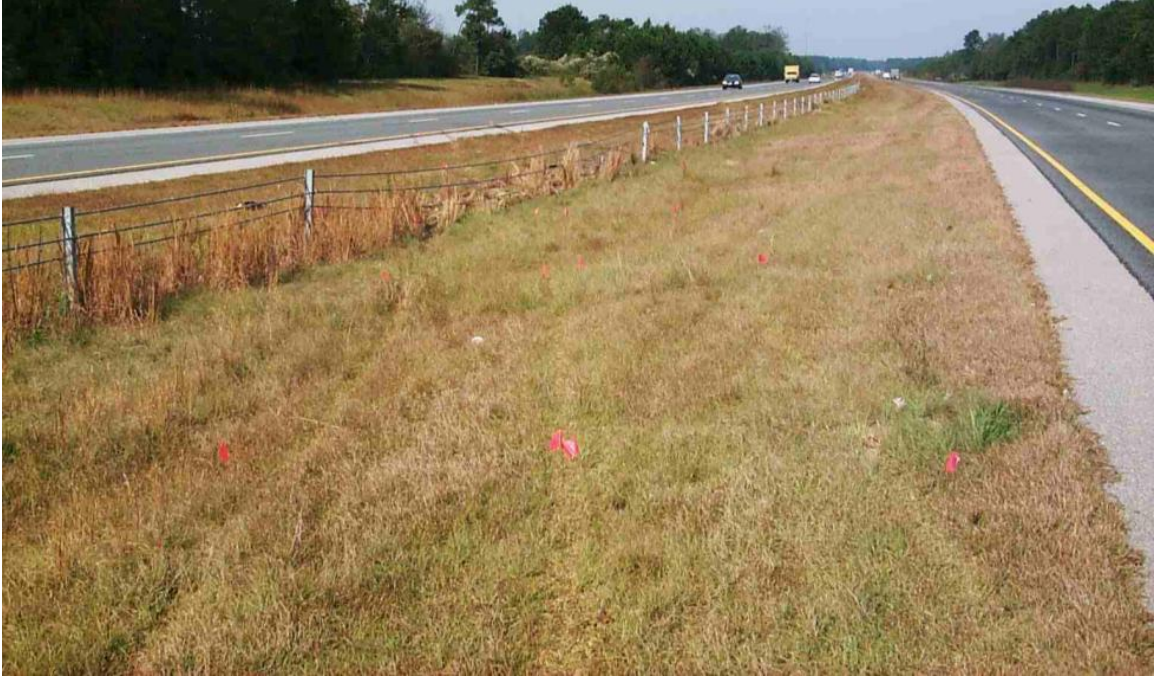
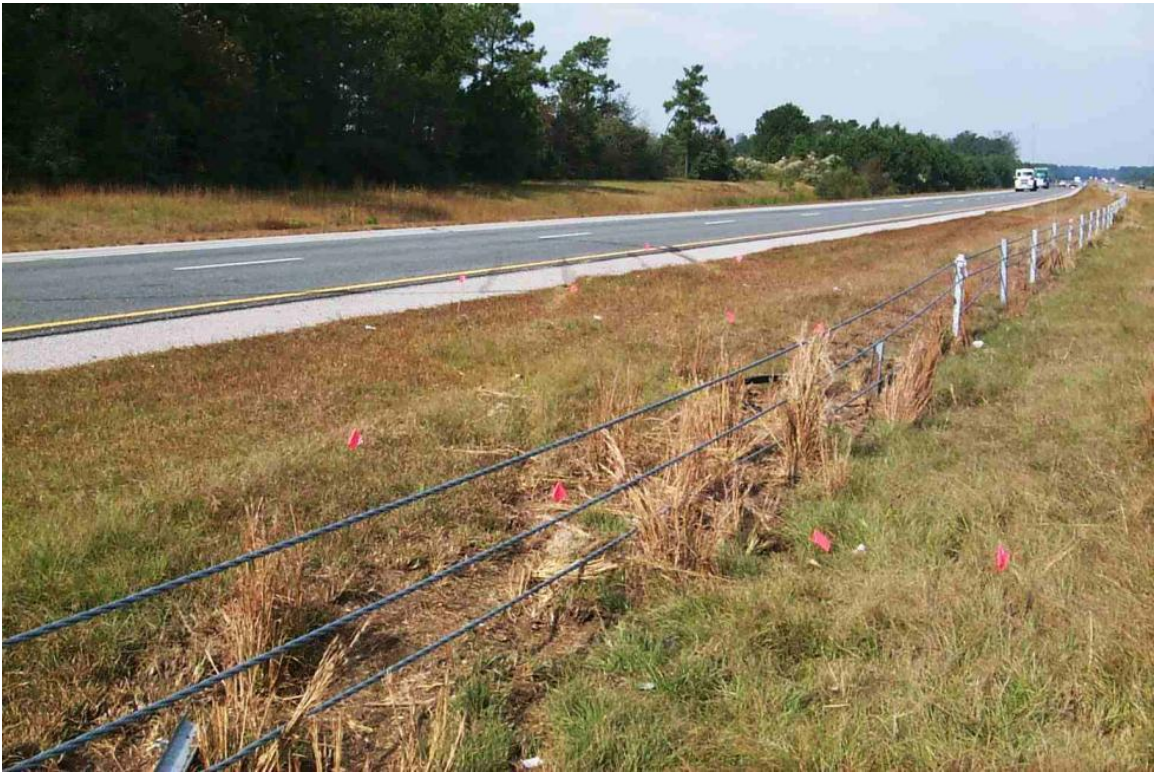
Figure 100. Additional Example of Diving Penetration Crash

Despite the effect of suspension compression on the propensity for vehicle penetration through the barrier, the weak lower cable-to-post attachments strongly increased penetration propensity. The attachments disengaged from the posts at low loads and allowed the cables to slip above or below the vehicle. It was believed that in every recorded diving cable median barrier crash in this database, the diving tendency would be significantly reduced or eliminated if the bottom cable-to-post attachment strength was increased. This could have reduced diving penetrations by as much as 50%. Increasing the release load of the bottom cable would likely increase contact forces between the impacting vehicle and bottom cable, which could result in better engagement and formation of the familiar cable crease observed on vehicles involved in successful redirections. Additional examples of diving underride crashes are shown in Figures 100 and 101.

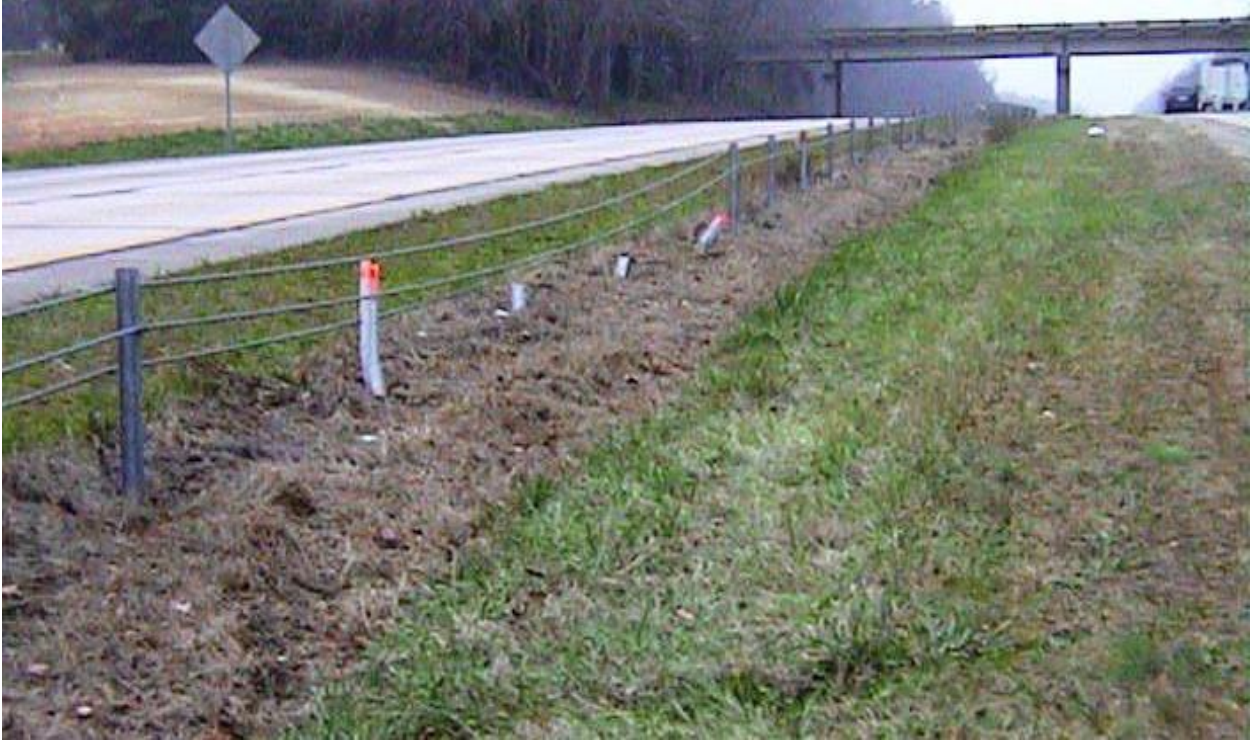
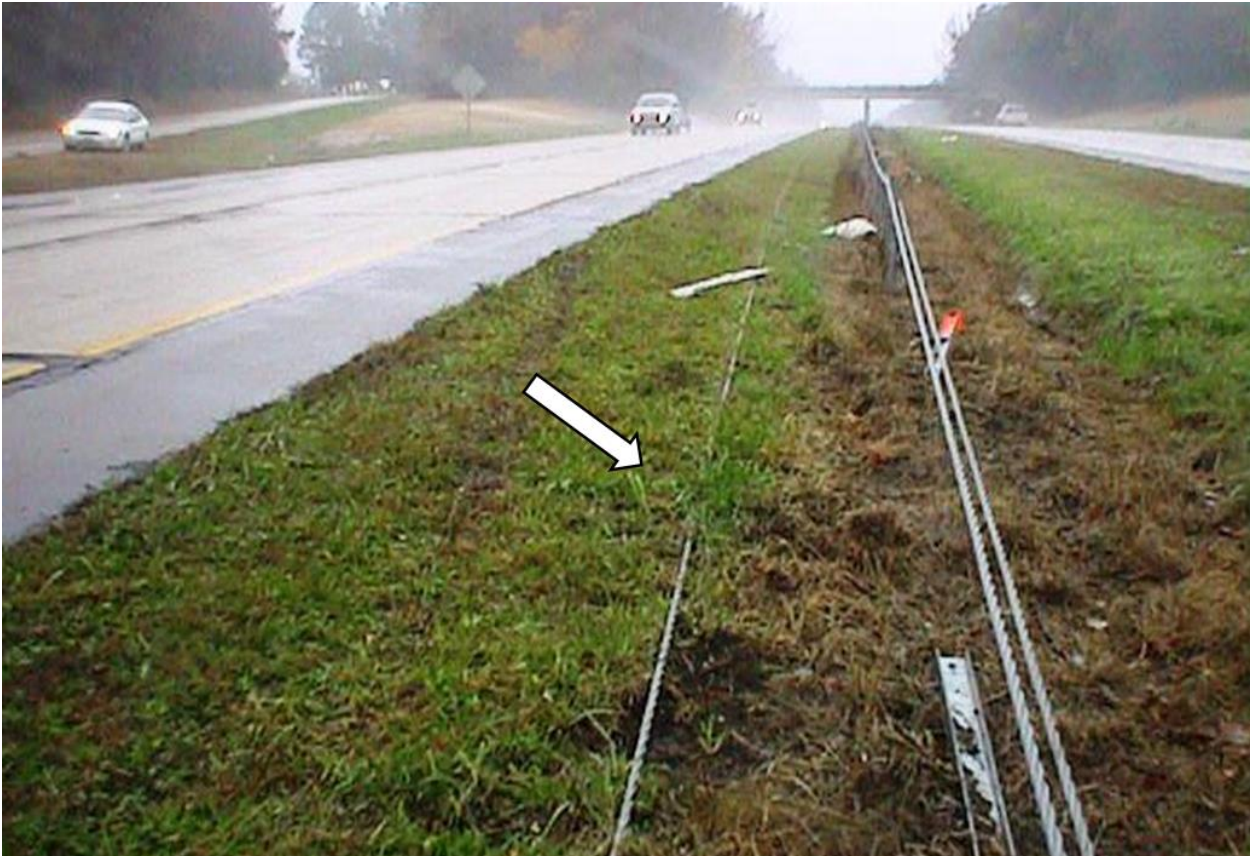
Figure 103. Back Side (Middle) Cable Release from Many Downstream Posts Resulting in Penetration

Prying penetration crashes typically occurred via a combination of the following factors: (1) cables located on the back side of the post released from many posts because lateral forces exceeded cable-to-post attachment strengths; (2) large orientation angles promoted bumper protrusion between or below the cables contributing to underride or through-cable penetration; and (3) low contact forces prevented beneficial body panel crushing or headlight fracture, causing poor cable-vehicle engagement. Back-side cable release most commonly occurred when other cables failed to adequately engage the vehicle, so the entire redirection load was applied by one back side cable. Examples of penetration crashes in which the impacted back-side cable was removed from more than 10 posts downstream from impact are shown in Figures 103 and 104.

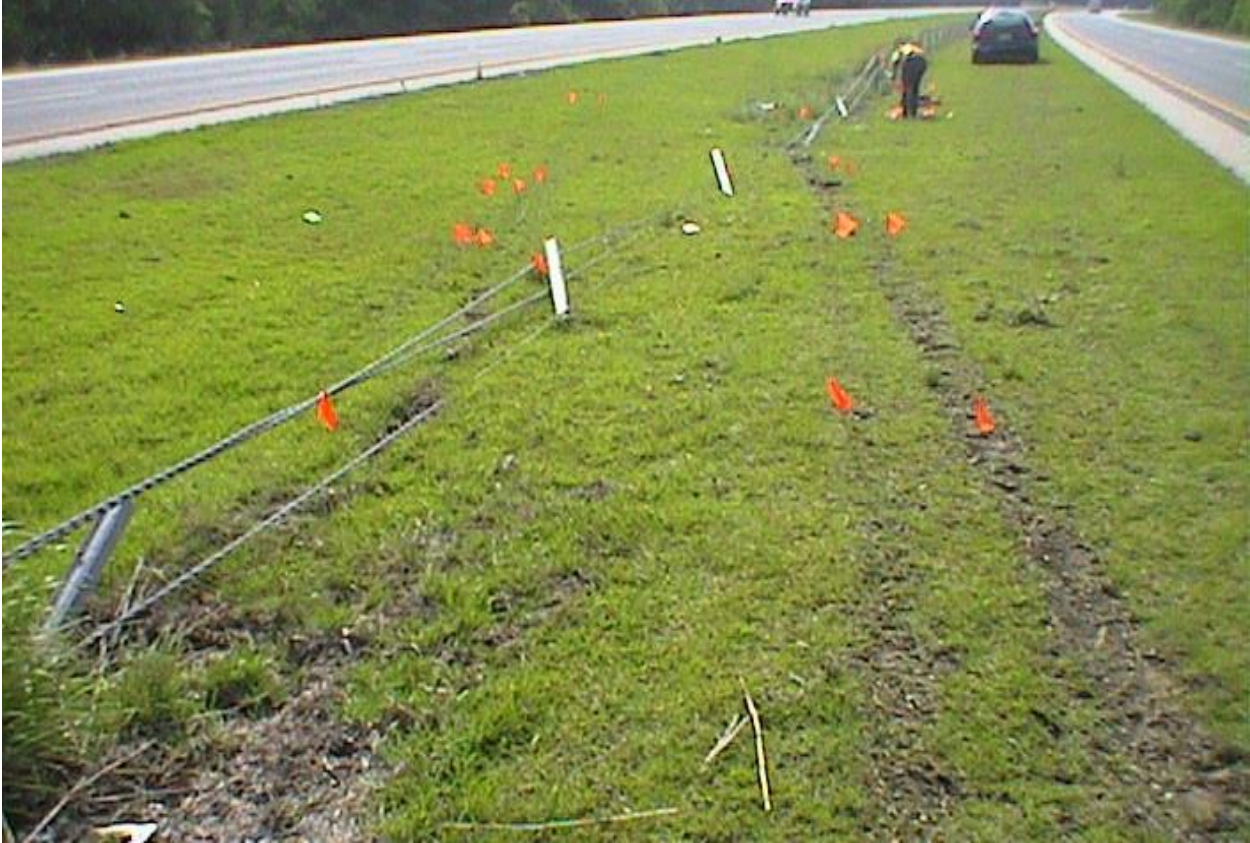
Figure 105. Prying Penetration Failure with SUV Caused by Brush Guard

One unique penetration crash involved a Mitsubishi Montero equipped with a brush guard mounted on the front bumper. Crash photographs are shown in Figures 105 and 106. The vehicle struck the cable barrier system, and the angled surface of the brush guard forced two of the cables below the front bumper and one above the hood. The cable that was lifted onto the vehicle caused minor windshield damage and scratching on the vehicle's A-pillar. However, most of the vehicle damage was due to an unrelated rollover which occurred on the roadside of the opposite travel lanes long after the barrier penetration.

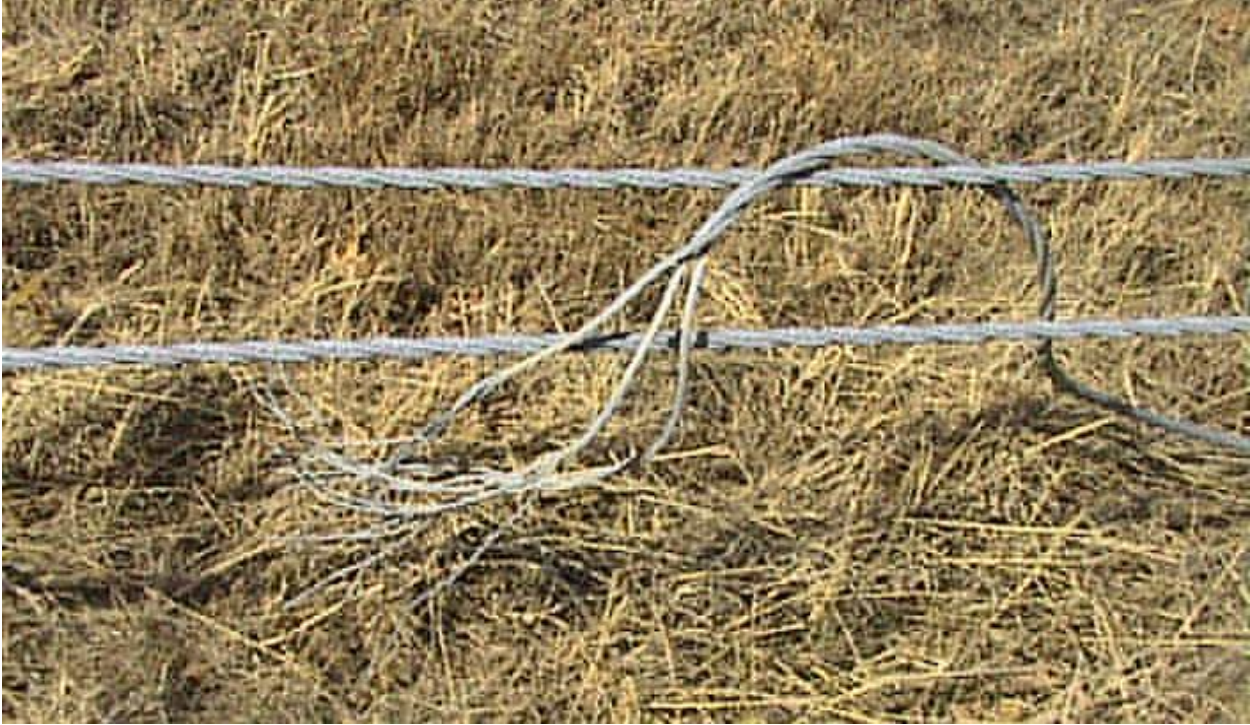
Figure 107. Splice Failure Penetration

Causes for bounce-over of low-tension systems were virtually identical to other systems. Out of a recorded 70 cable median barrier penetrations on low-tension cable median barriers, only 2 resulted in a bounce-over. These two penetrations occurred when the barriers were installed near shoulders in relatively narrow ditches where vertical vehicle rebound was highest. Bounce-over penetrations may also be reduced by easy release of the top cable. The low-frequency of bounce-over penetrations is likely related to the low top cable release load.

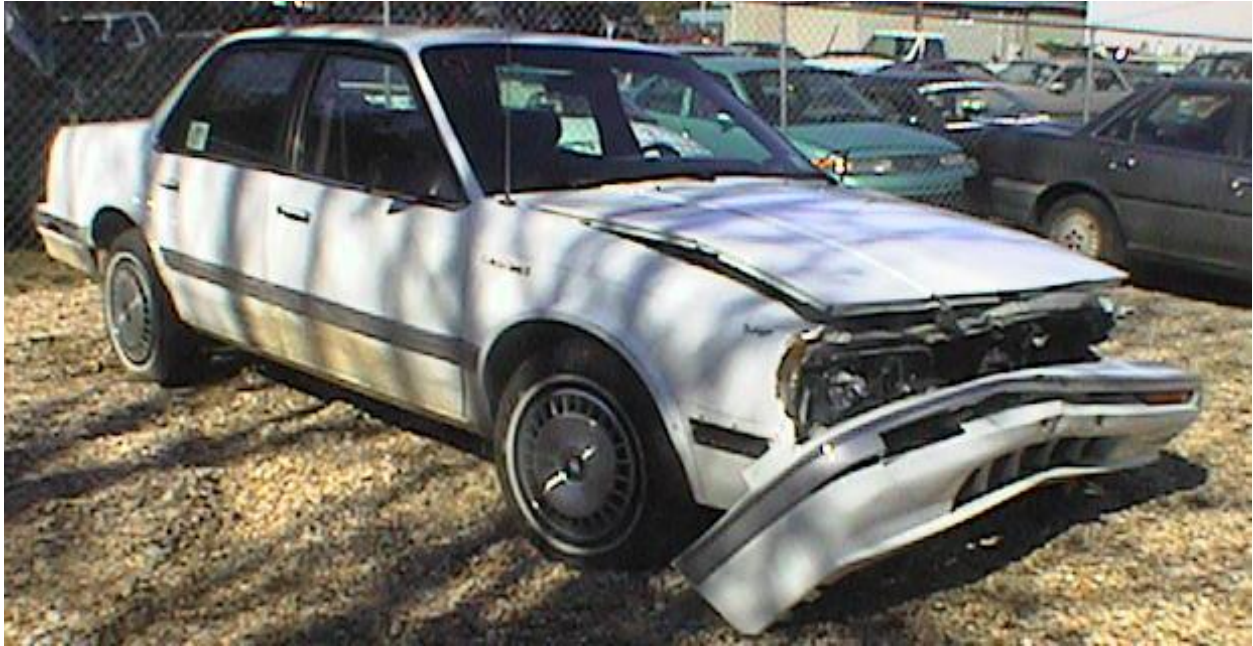
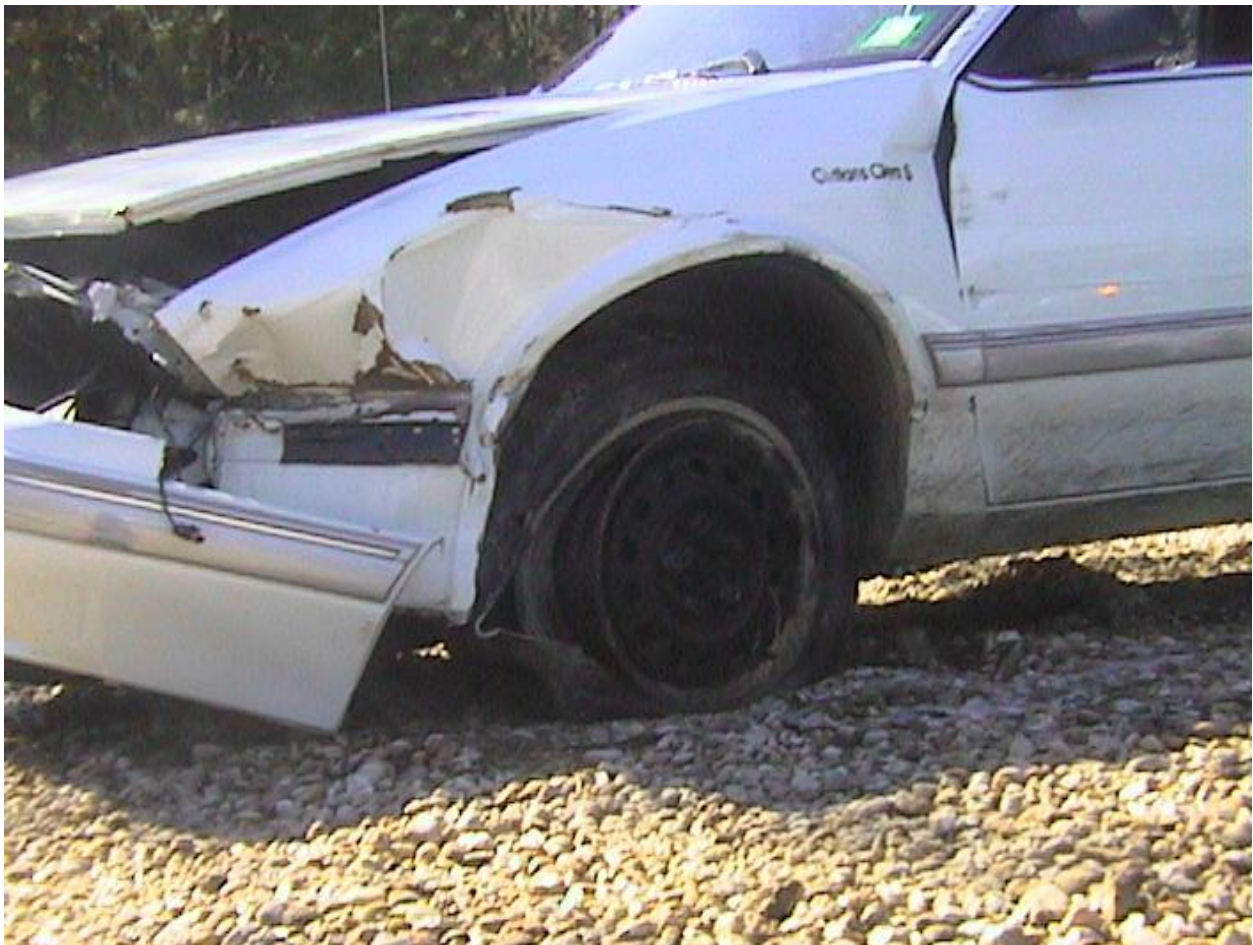
Figure 108. Splice Failure Penetration

Two cases of system failures were noted in the low-tension cable median barrier penetration database. In both crashes, the vehicle adequately engaged the tensioned cables and at least one cable formed a contact groove, fracturing the impacting corner headlight casing and collapsing the grill and fender around the cable. However, in both crashes, the low-tension cable splice failed, allowing the tensioned cable to rebound away from the vehicle. In one crash, the back-side bottom cable engaged the grill and headlight. As the cable deflected with the vehicle, the splice disengaged releasing the cable at a splice location. Similarly, in the other crash, the back-side middle cable engaged the bumper and grill of the impacting vehicle, crushing the fender and grill. As the cable deflected with the vehicle into opposing travel lanes, high tension was developed in the cable and exceeded the splice limits. In both crashes, weak cable-to-post attachments contributed to splice failure. Photographs of the first crash are shown in Figures 107 and 108.

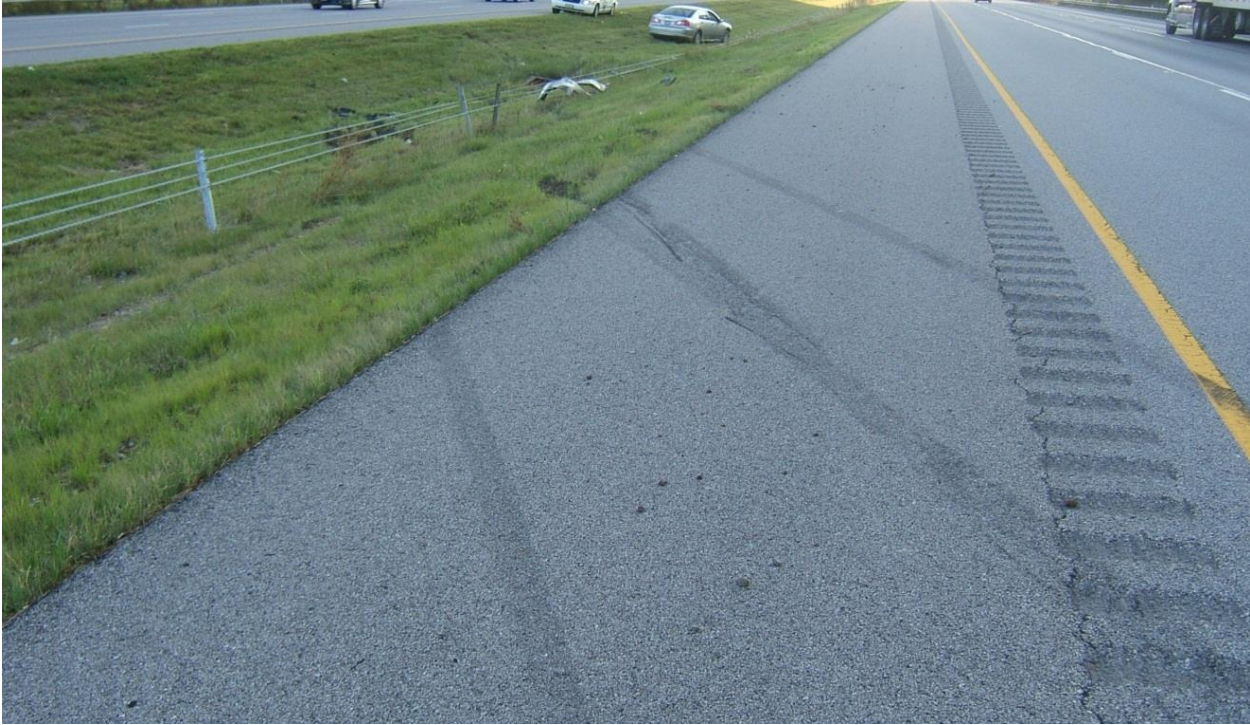
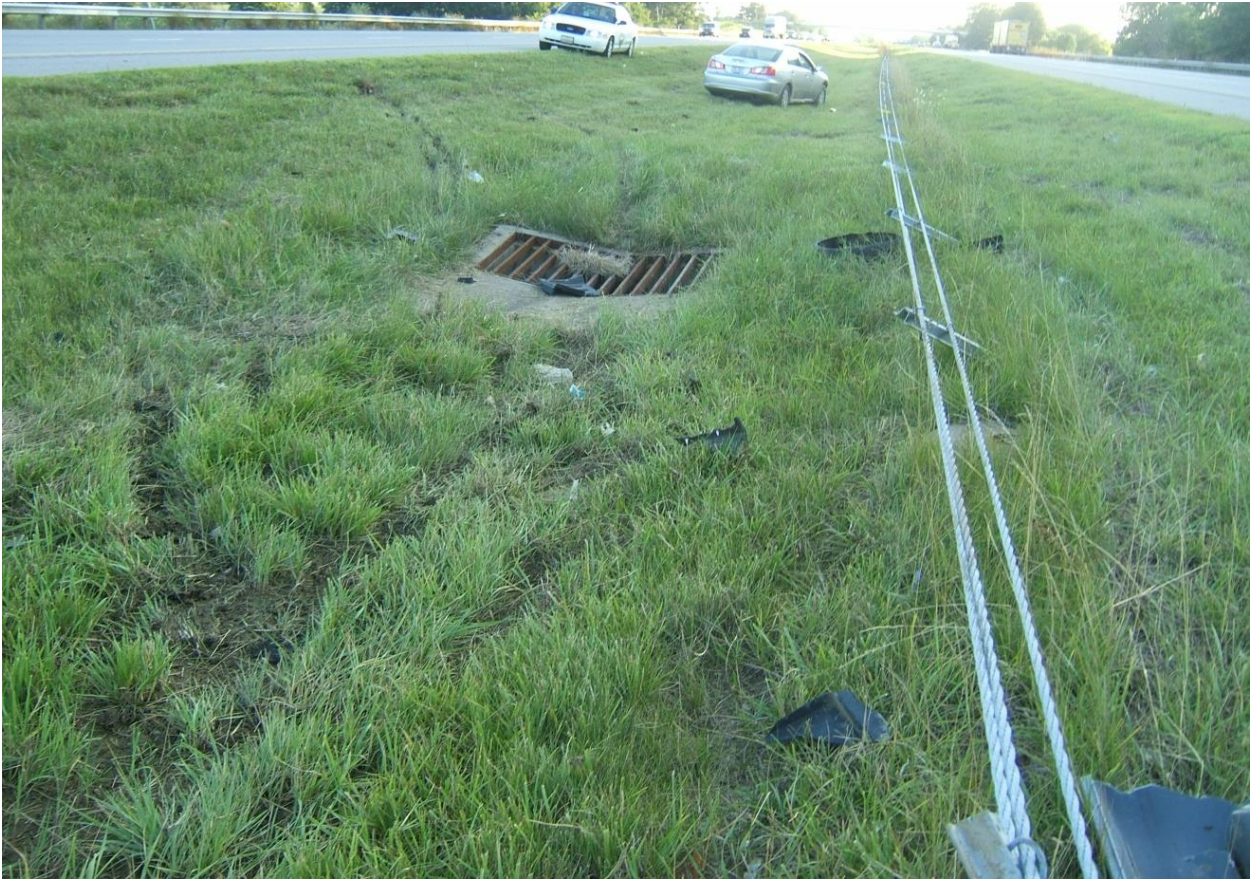
Figure 109. Crash Scene Photographs, Simulation No. 1

The impacting vehicle lost control, swerving off of the road into the median. The vehicle departed the road with a CG trajectory angle of 32 degrees and an orientation angle of 62 degrees relative to the roadway. Based on a rudimentary crash reconstruction, the speed of the vehicle at the point of departure from the lane was determined to be approximately 58.1 mph (25.6 m/s), based on skid marks on the road and shoulder, tire marks in grass, post deformations, and vehicle damage energy estimates. Photographs of the crash site are shown in Figures 109 and 110.

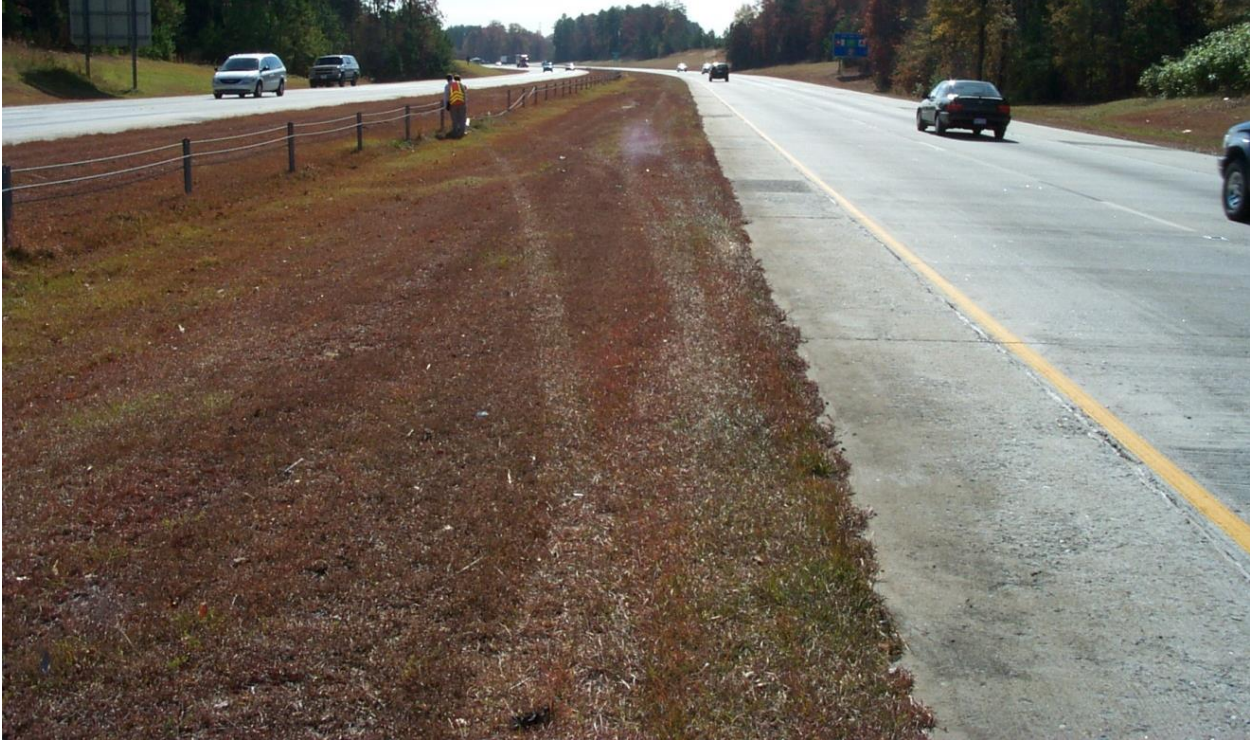
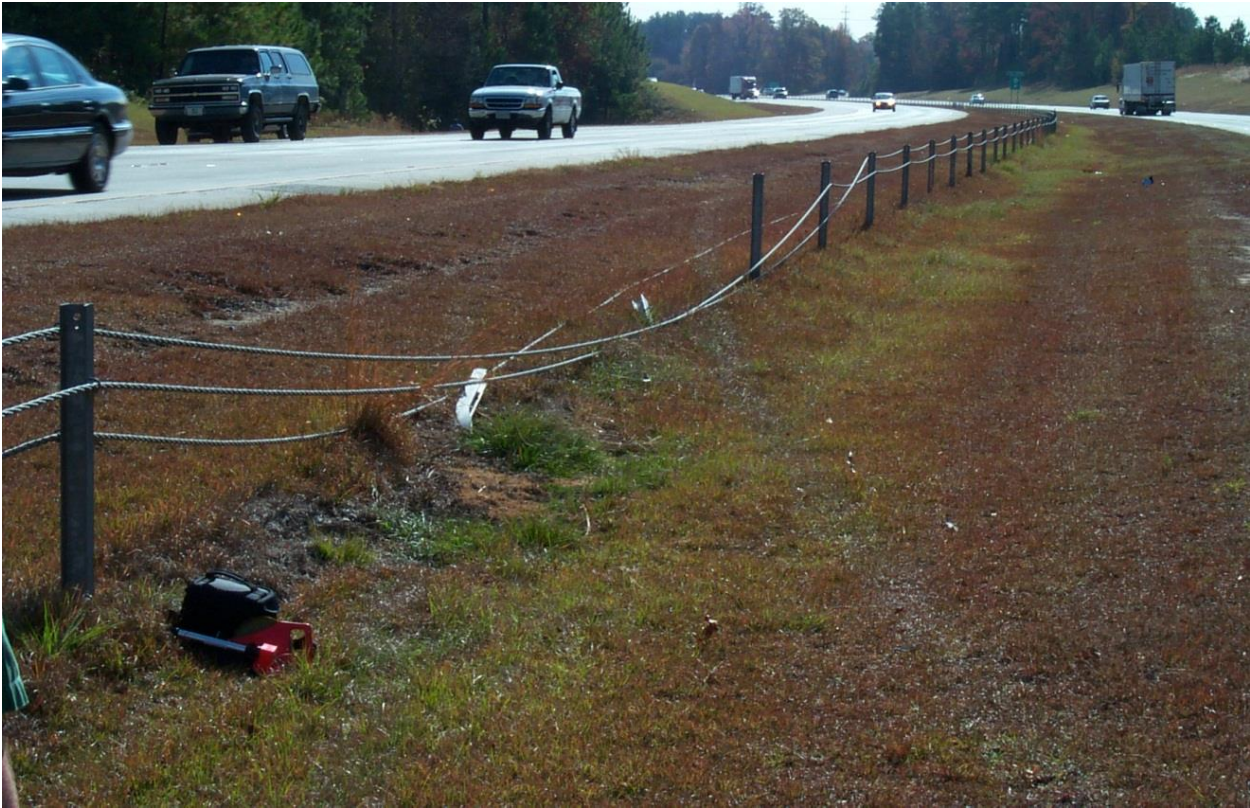
Figure 123. Crash Scene Photographs, Simulation No. 3

Post-crash photographs are shown in Figures 123 through 125. Based on scene diagram and trajectory information, it appeared that the driver either became incapacitated or fell asleep. The vehicle, a 2000 Mercury Grand Marquis, drifted off of the roadway with a CG trajectory and orientation angle of 7 degrees. There were no visible signs of braking or steering throughout the departure event. The vehicle passed through the bottom of the ditch, which increased the CG trajectory angle to 11 degrees prior to impact because of the slope contribution. The vehicle remained engaged with the bottom cable for a sufficient amount of time to remove the bottom cable from more than 15 posts downstream of impact. The vehicle had a small steering angle to the left, which resulted in the vehicle overriding the bottom cable, redirecting up the back slope and colliding head-on with a different vehicle in the opposite travel lanes.

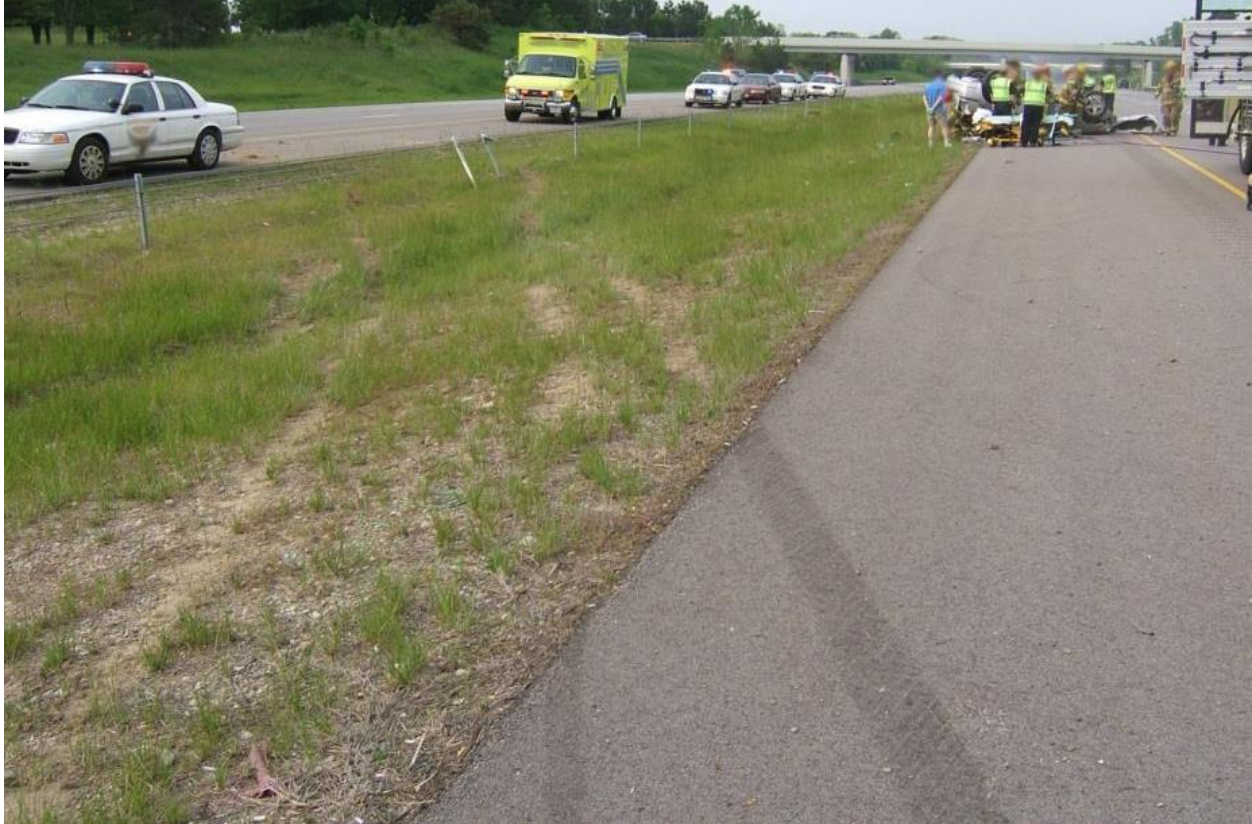
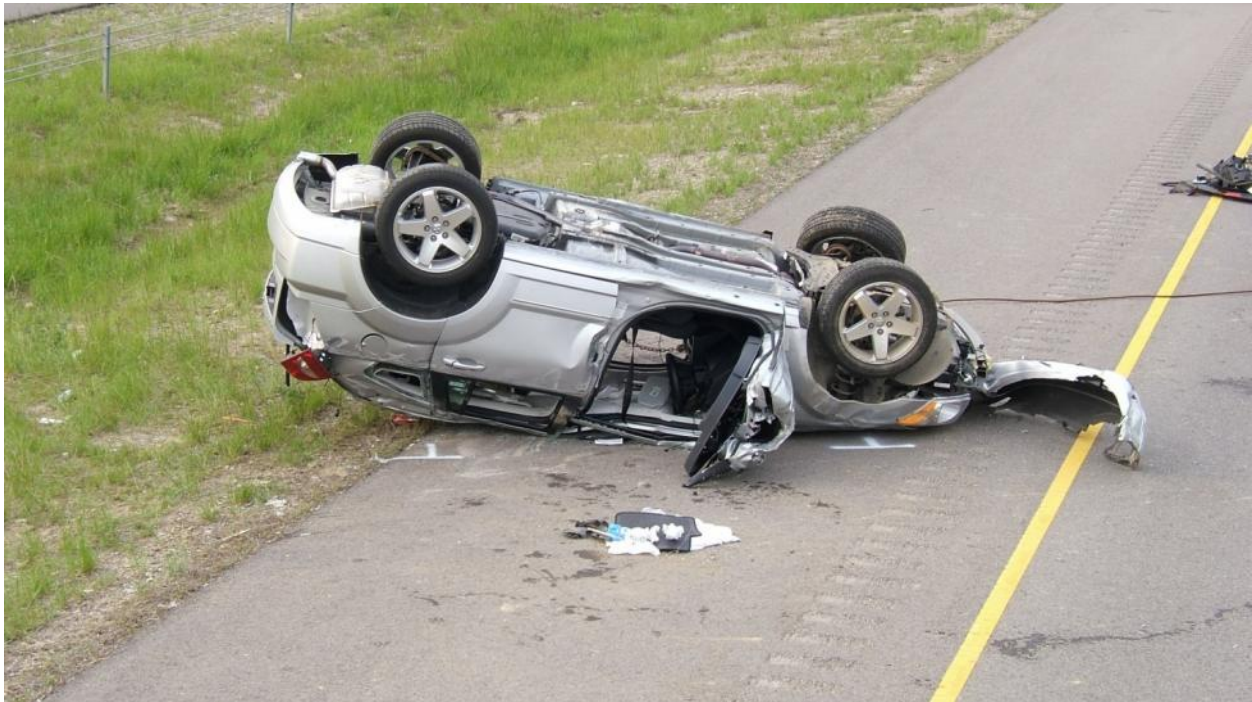
Figure 131. Example Rollover Crash Caused by High Redirection on Back Slope

Pickup trucks, vans, and SUVs were found to be the most susceptible to the median slope-related crashes in which the wheelbase and suspension stroke were large. Passenger cars were involved in only 4 out of the 25 potential median slope-related rollovers. Of these, two were full-size cars, one was a mid-size “crossover” class vehicle, and one was a compact car.

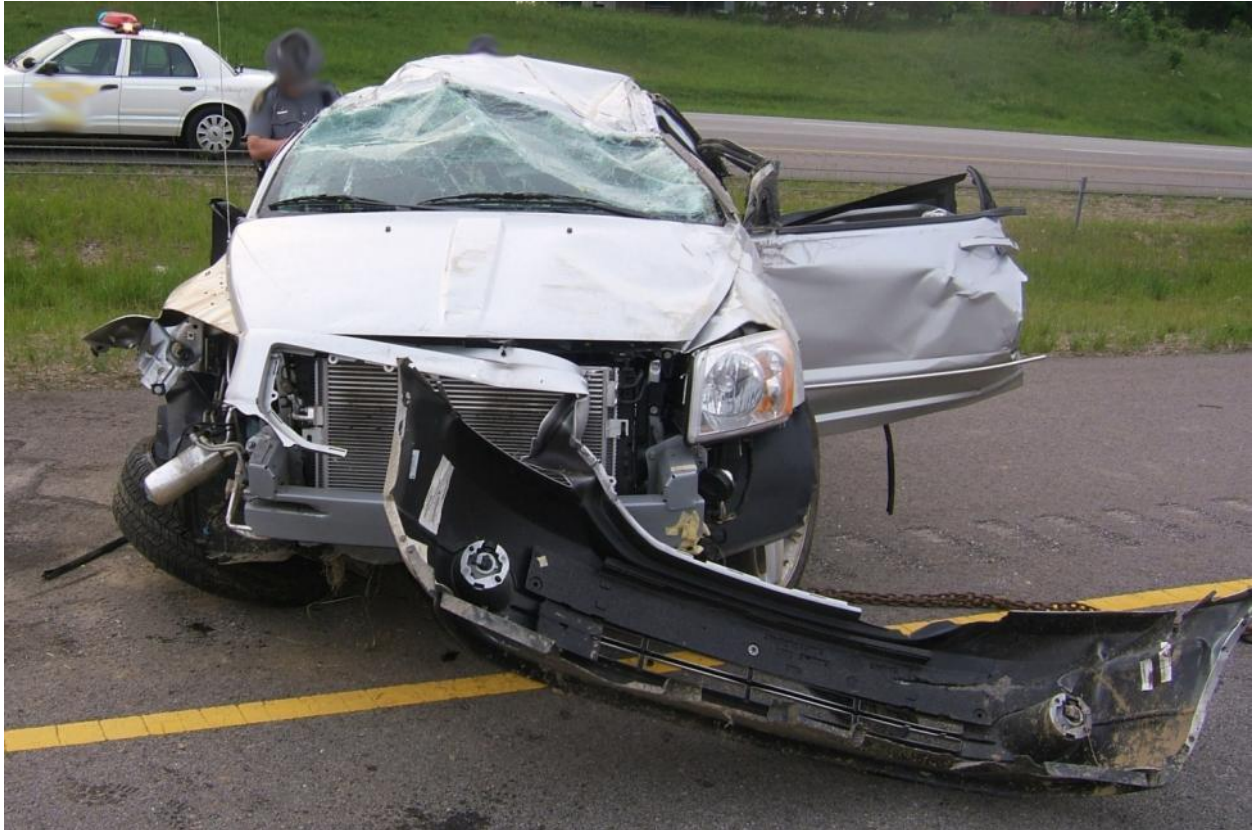
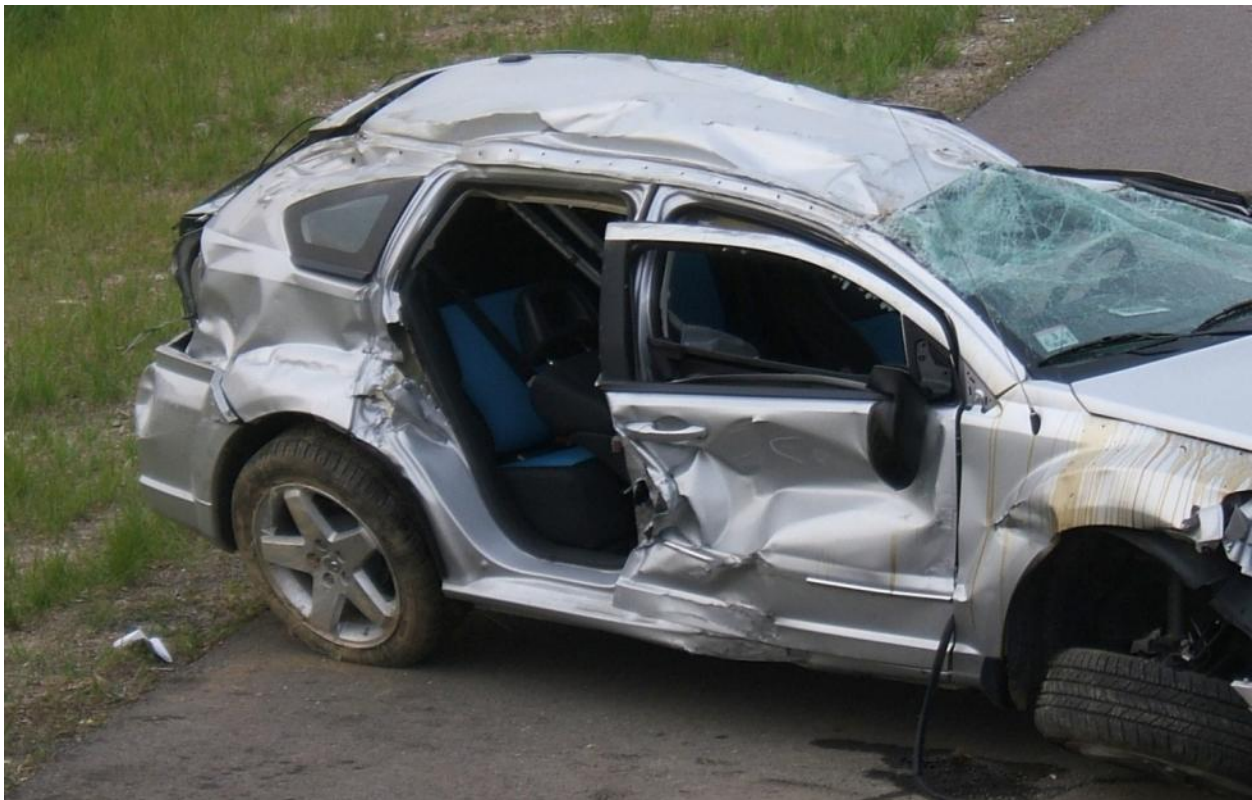
Figure 132. Example Rollover Crash Caused by Redirection on Back Slope (continued)

The third type of median slope rollover was caused when vehicles struck a cable median barrier installed on a V-ditch back slope. After redirection, some vehicles skidded laterally into the median and tripped due to the slope transition in the center of the median. An example of this crash type is shown in Figures 131 and 132. In this crash, a Dodge Caliber struck the cable median barrier with an orientation angle of approximately 110 degrees and a CG trajectory angle of approximately 21 degrees. The vehicle displaced one post and yawed to nearly 180 degrees before being redirected, then rebounded down the back slope and tripped. It is believed that the vehicle made two and a half complete revolutions. Because the vehicle rolled through the center of the V-ditch and back up the approach slope, vehicle damage was extensive.
