Cable Median Barrier Failure Analysis and Remediation Phase II

CABLE MEDIAN BARRIER FAILURE ANALYSIS AND REMEDIATION PHASE II

MIDWEST ROADSIDE SAFETY FACILITY

MwRSF Research Report No. TRP-03-319-13

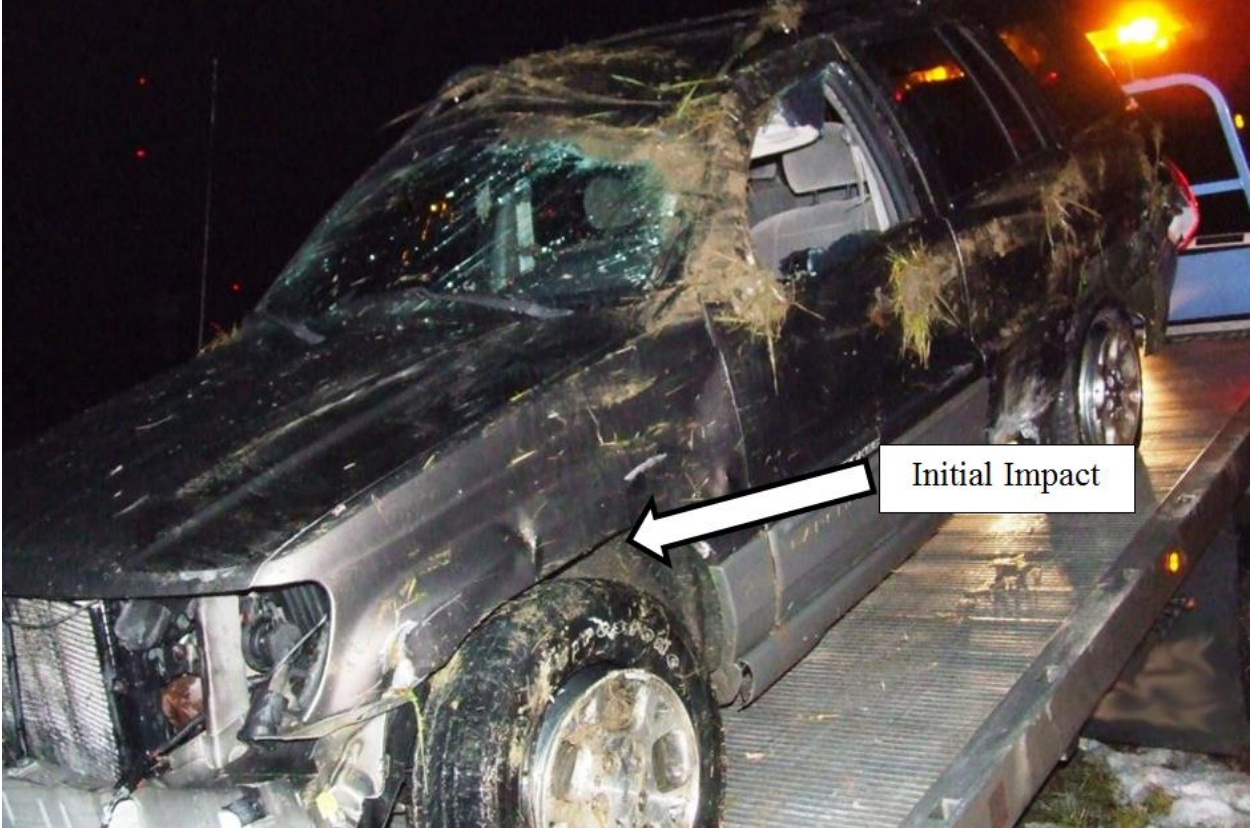
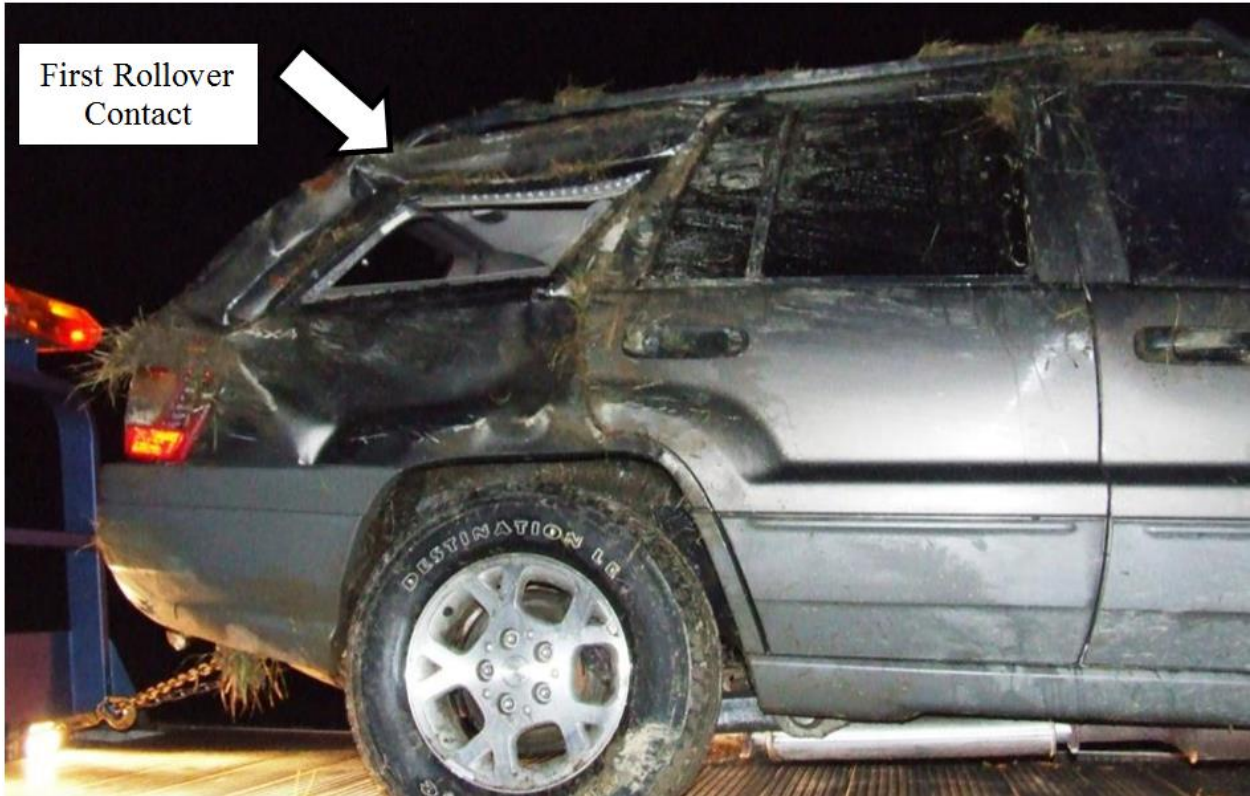
Figure 134. Example Rollover Crash Caused by High Orientation Angle at Impact

One crash involving a Jeep Grand Cherokee is shown in Figure 134. During this crash, the vehicle struck the cable barrier with the left-front corner in an oversteering configuration, yawed around the front end, and tripped as the vehicle approached a 90-degree orientation angle. The right-rear corner made first contact with the ground, shattering the rear windshield and right-rear window. As the vehicle rolled, the roof was crushed, but most of the remaining damage to the vehicle only occurred to the exterior body panels. A similar crash involving a Suzuki Grand Vitara which also yawed around the front end before tripping is shown in Figure 135.

Vehicle impacts at high orientation angles contributed to vehicle instability by increasing the overturning moment applied to the vehicle frame. A model and schematic diagram of the force interaction in a high-orientation angle crash is shown in Figure 133. During rollover crashes, new, energetically-favorable roll axes were generated through which the applied moments to the vehicle were maximized. The new roll axis was rotated with respect to the longitudinal axis of the vehicle to incorporate the contribution of a small pitch moment at the cable impact location.

Because of this shift in the vehicle's trip axis, the leading back corner of the vehicle was typically the first location to contact the ground. Frequently, first contact of the vehicle's upper body with the ground resulted in displacement of the upper frame rails, crushing near the rear-top corner of the vehicle, roof slant, and often an accumulation of dirt, grass, or median materials at the initial contact site. In addition to the increased pitch moment, vehicle-to-cable friction interaction caused yaw moments, which tended to increase the orientation angle. Thus, if the vehicle struck the barrier at a relative sideslip angle of 60 degrees, the frictional interaction with the barrier tended to accentuate vehicle yaw toward a 90 degree sideslip angle, increasing rollover propensity. Examples of oversteering rollover crashes are shown in Figures 134 through 136. In each of the crashes shown, the vehicle struck the cable barrier with the front end at a high orientation angle then tripped and rolled. None of the crashes were caused by an impact with a single post or series of posts. Median slopes contributed to some crashes, but wheels were not entrapped on a slope in any of the crashes. Further, no trailer attachments or towed units were present.

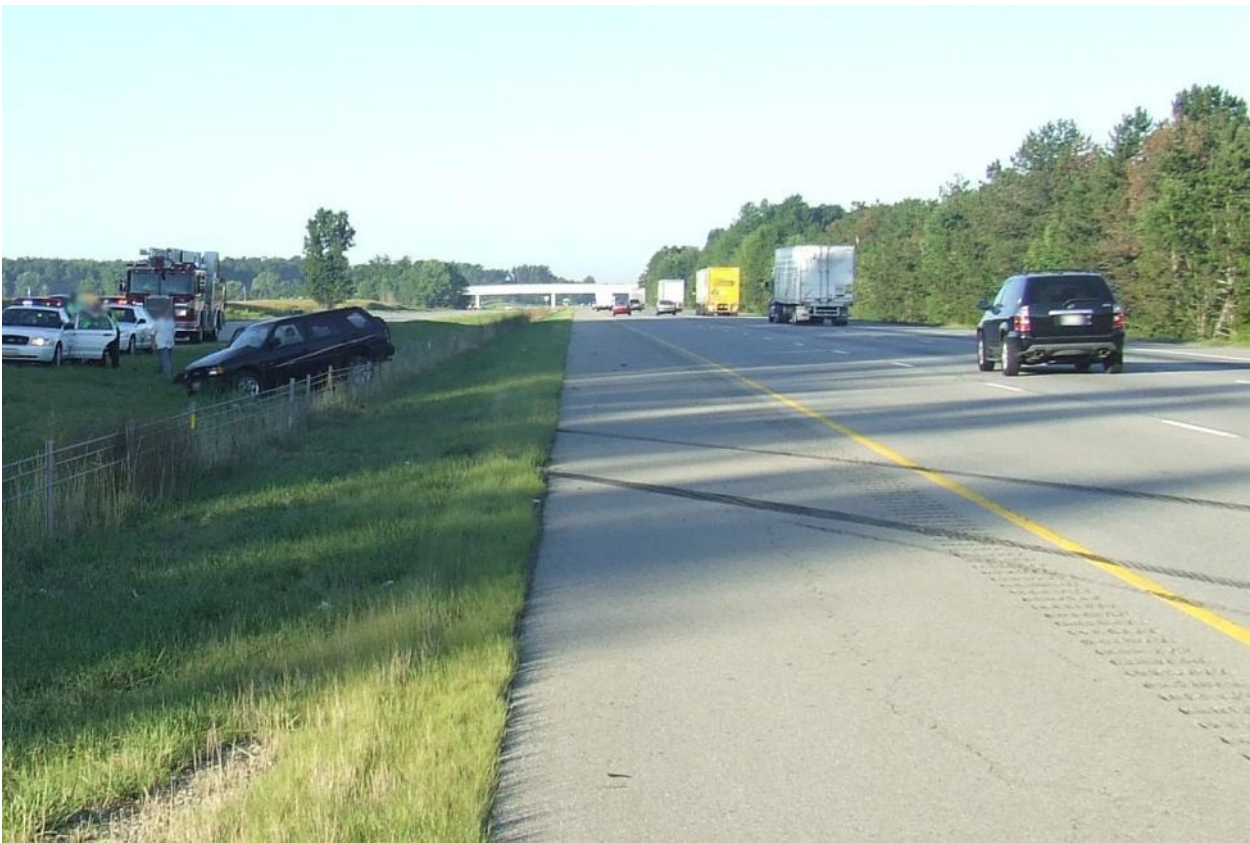
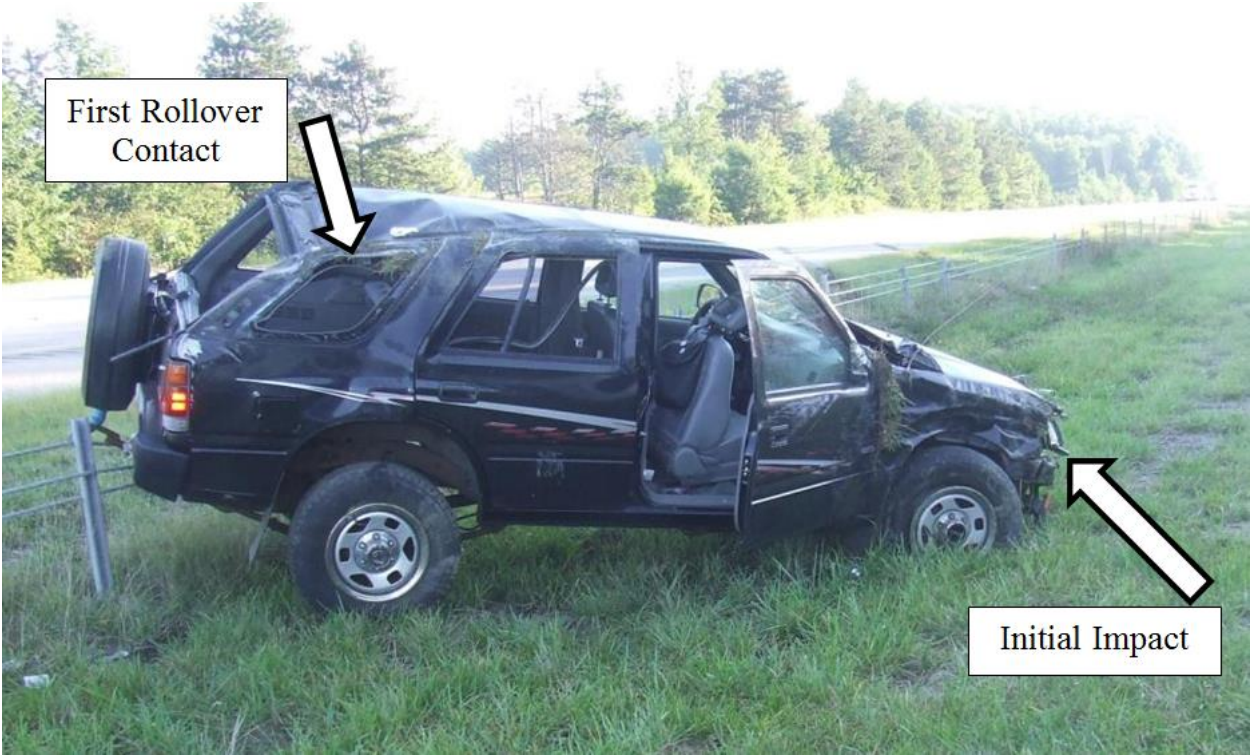
Figure 136. Third Example Rollover Crash Caused by High Orientation Angle at Impact

A second high-orientation angle rollover crash occurred involving an Isuzu Rodeo, as shown in Figure 136. During this crash, as the vehicle descended into the V-ditch, the right-front bumper corner engaged the cables. Combined with the large frictional moment from the tires, the vehicle tripped with the right-rear corner leading, and made one complete revolution, coming to rest on its tires. Most of the damage was concentrated on the right side.

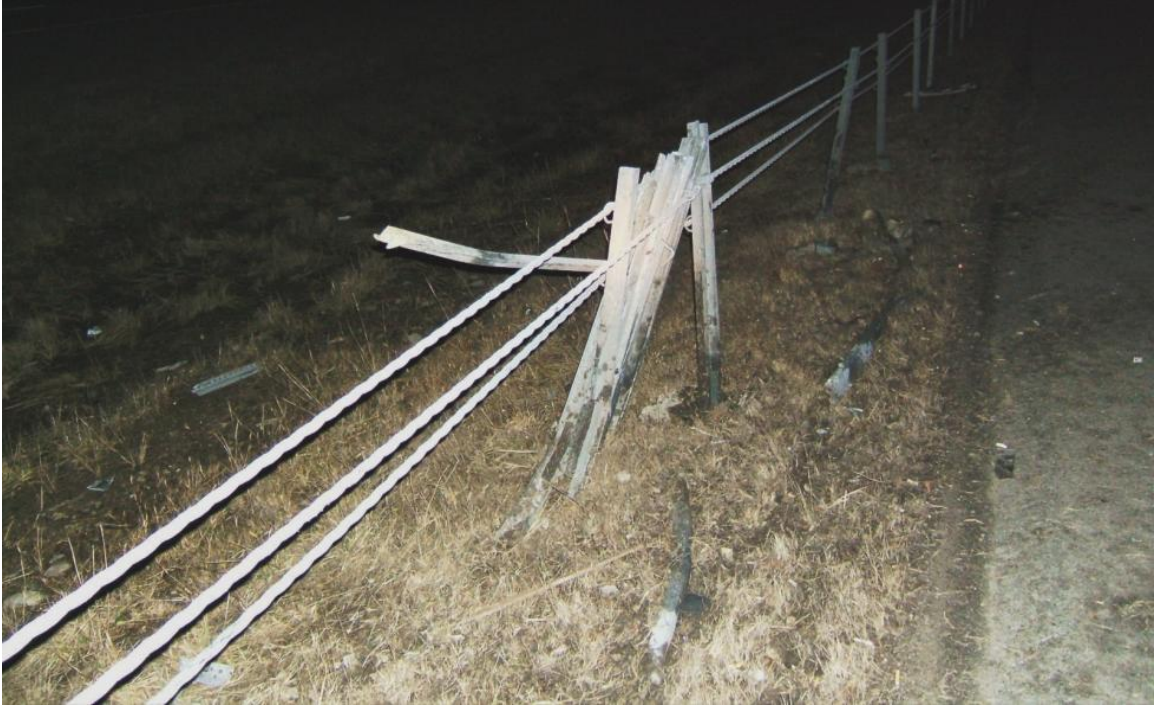
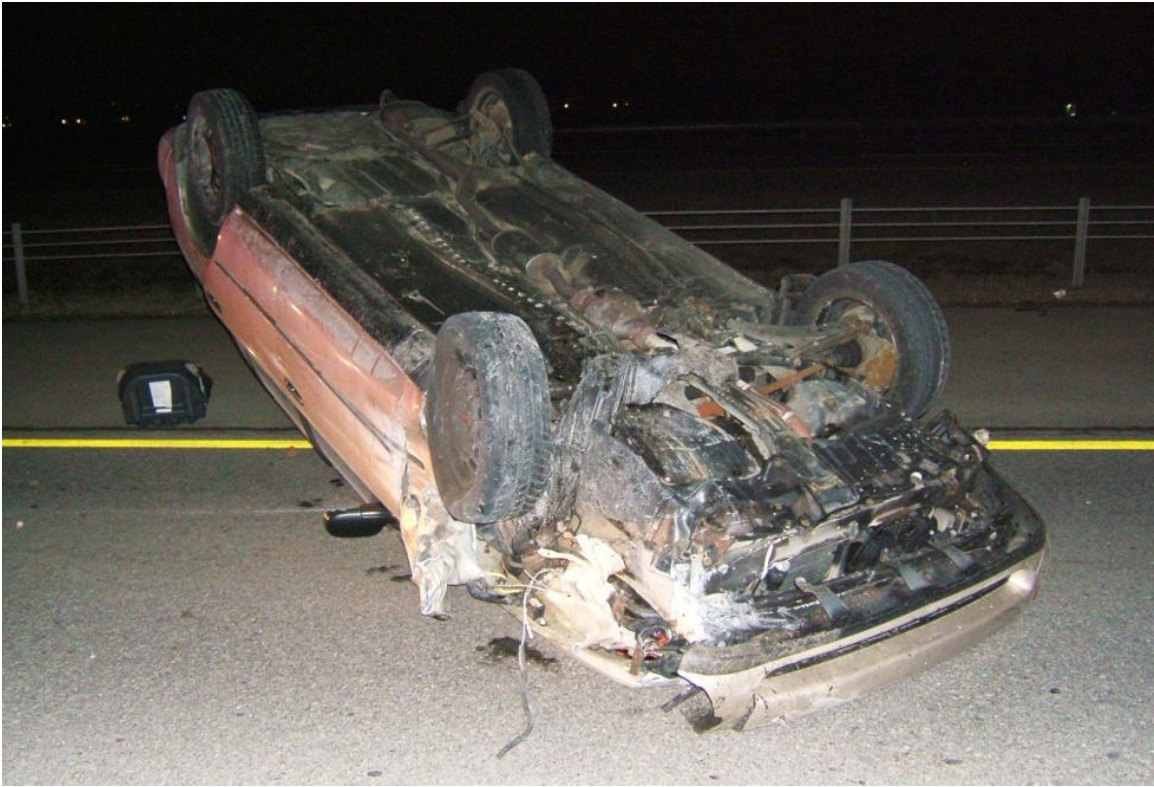
Figure 137. Example of Post Snag Rollover Crash

Note also that many rollovers occurring due to impacts with Nucor systems were caused as posts accumulated in front of the vehicle after being lifted out of the ground or sockets, or fracturing at the ground line. As the posts accumulated, the effective strong-axis strength of the next downstream post increased. This effect, unique to Nucor systems, may have increased the average rate of rollover if the cable-to-post attachment was weaker and if the posts-soil interaction was stronger. If the Nucor result followed the trend of the other high-tension cable median barrier systems, the expected rollover rate would be between 1.9% and 2.7%.

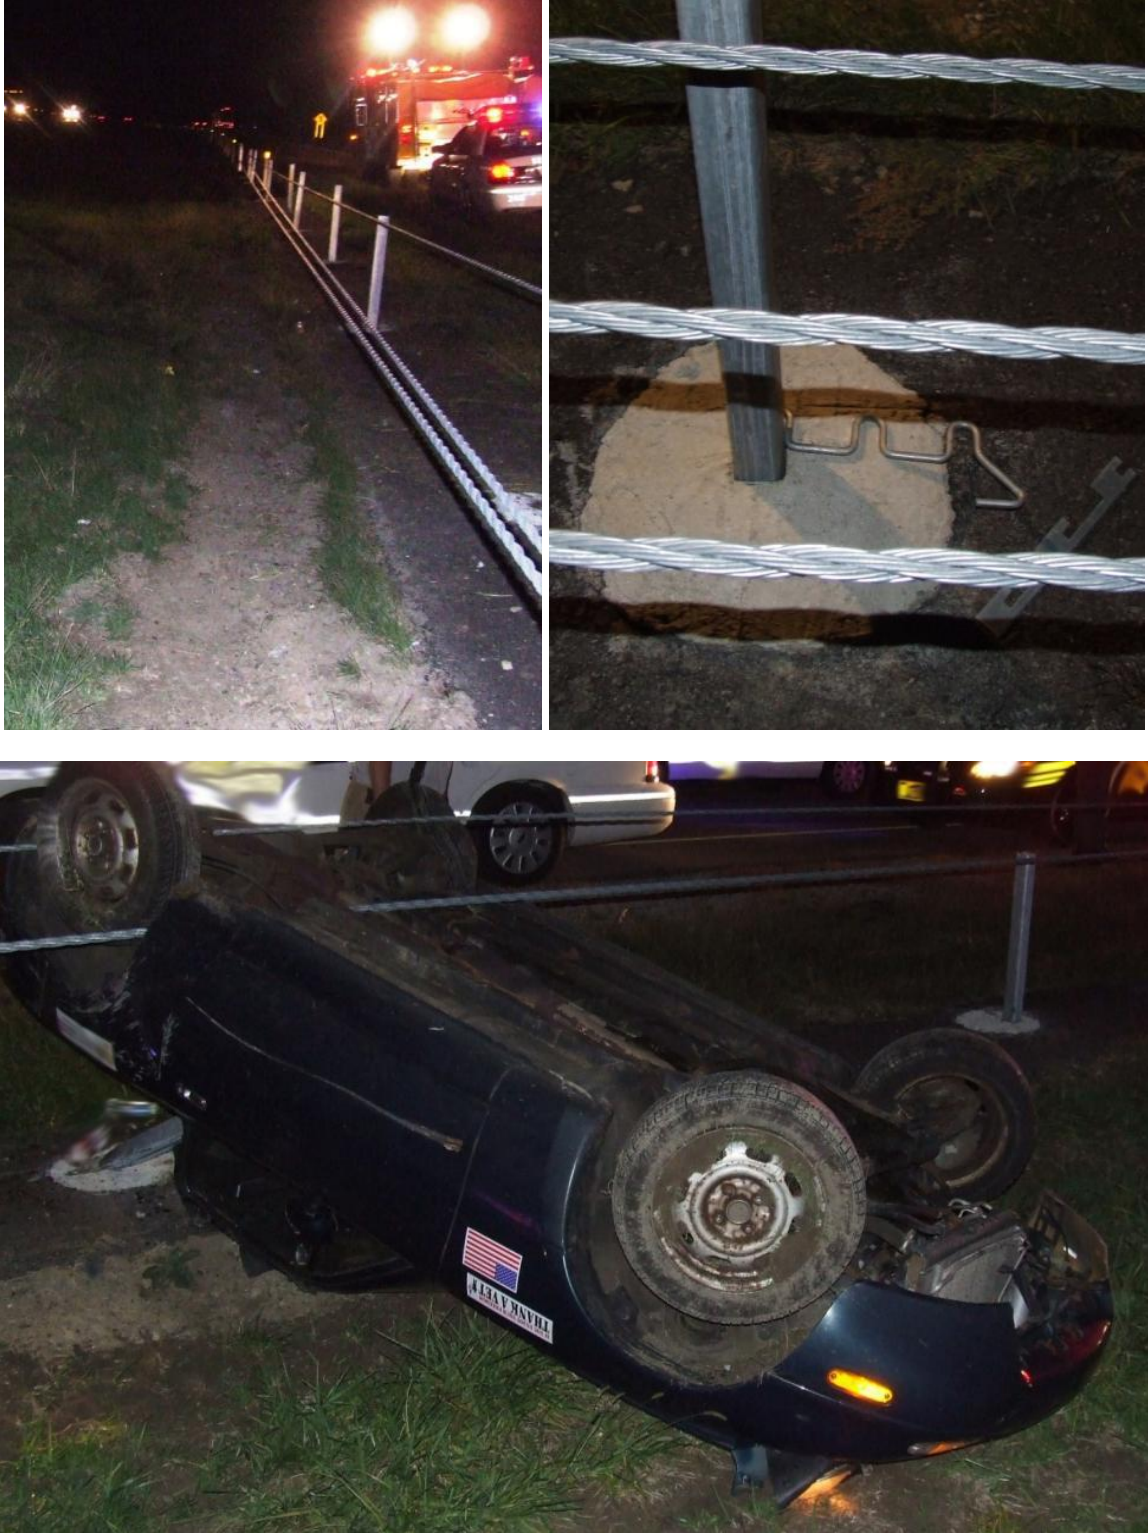
Figure 138. Example of Post Snag Rollover Crash

Rollovers caused by contact with posts were unique because the rollover initiator was wheel snag on a flange or web of the post. Although multiple compounding factors including friction contributed to most rollovers, contact with post rollovers also occurred in wet and snowy weather when roadside friction was reduced. The occurrence of these types of rollovers in low-friction conditions indicates that even weak posts can contribute to vehicle instability, which was noted historically [53]. Examples of post snag rollover crashes are shown in Figures 137 and 138.

The Gibraltar cable barrier system, with wide post spacings up to 30 ft (9.1 m) and installed on alternating sides of the cables, may exhibit a higher susceptibility to override penetration crashes. Vehicles impacting at the location of a post on the opposite side of the cables can cause complete post disengagement. Although the hairpin cable-to-post attachment was relatively strong, as shown in Figure 142, upward vertical bracket release could occur during impacts with low-height, sharp-nosed and narrow front-profile vehicles, as shown in Figure 138.
