Boy Scouts of America Concept Site Master Plan and Improvements

Boy Scouts of America Outdoor Education Center Concept Site Master Plan and Improvements

An Undergraduate Honors Thesis Submitted in Partial fulfillment of University Honors Program Requirements University of Nebraska-Lincoln

May 1, 2019

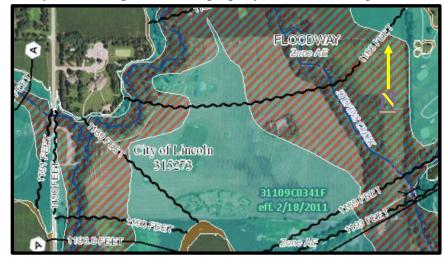
A majority of the property is currently within a floodway or floodplain. As determined by FEMA studies, the floodways and floodplains on the property are shown in Figure 4.

Figure 4. Floodway Map. Source: FEMA

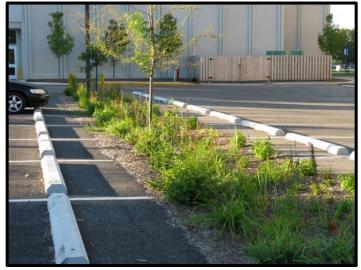
Our team is looking at three alternatives to provide the proper drainage for the proposed parking lot. The first drainage feature alternative our team looked at was a vegetated filter strip. This option includes grading the parking lot so that it drains west towards Scout creek and all water would be filtered through the existing grass before reaching the stream. This alternative is also discussed in the environmental memorandum of this report. The second drainage alternative our team discussed was integrating rain gardens in and around the parking lot. A typical rain garden is shown in Figure 8. This alternative is also discussed in the environmental section of this report. The last alternative our team looked at was a geogrid with a grass cover. Geogrid is shown in Figure 9. Geogrid is also discussed in the transportation section of the report.

Figure 8. Typical Rain Garden. Source: Butler University

After estimating the flow that will be running off the parking lot, our team would recommend the use of rain gardens to help collect the water that runs off the parking lot to prevent ponding for the paved parking lot. However, if a paved parking lot is no longer needed, our team would recommend using a geogrid with a grass top to provide parking when needed, but it still allows for full use of the grass area throughout the year when parking is not necessary.

We recommend the use of rain gardens both inside the large parking lot east of Scout Creek and on either side of the parking lot. This would add beautiful scenery to the parking lot and would be the most practical method of removing the pollutants from stormwater runoff. For the parking lot on the west of Scout Creek, G1 Engineering recommends the use of a direct inlet drain. Due to the small size of this parking lot, stormwater pollution effects would be negligible and there is also inadequate space for a vegetated filter strip. The gravity-fed sand filtration basin design option was not pursued due to high cost and maintenance levels.

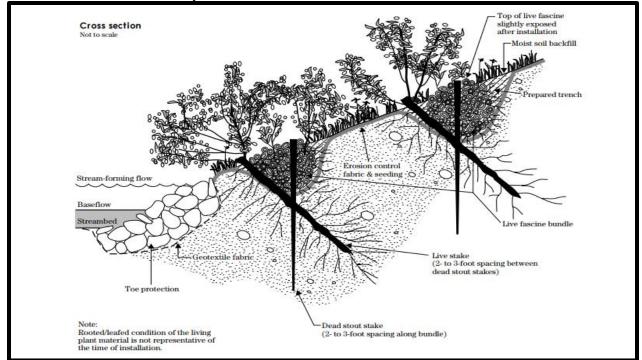
The first stabilization option is using a combination of riprap for toe protection along with live stakes, wattles, and seeding above the toe to create a living stabilized bank. A cross section of this stabilization technique is shown in Figure 16. Riprap is placed at the toe of the slope up to four feet along the slope to provide scour protection under normal flow conditions. Live stakes, wattles, and seeding will provide bank stabilization and scour protection under higher flow conditions. Live stakes are dormant cuttings which will sprout once they are planted in the ground. Their roots will bind the soil on the banks together. To install the live stakes, dig one-foot wide and deep trenches every four feet vertically along the slope above the riprap. Plant the live stakes at the bottom of the trenches as shown in Figure 16. Wattles are bundles of branches staked in place along the slope to reduce water velocity and prevent erosion. Branches from the trees removed for construction work could be trimmed and reused for the wattle material. To construct the wattles, trim branches that are approximately one inch in diameter and four to five feet in length from live trees. Tie the branches together with rope to create wattles that are approximately one foot in diameter. Place the wattles above the live stakes in the previously constructed trenches. Secure the wattles with three-foot-long stakes to prevent them from washing downstream during high flow events. Soil backfill should be placed to fill any unoccupied area in the trenches. Seeding should be placed between the live stakes and wattles to provide additional soil binding. To complete the installation, the area above the riprap should be watered for the first week to establish the sprouting. The long-term maintenance necessary for this stabilization option is trimming of any large shrubs, replanting any dead areas, and repairing any scoured areas after large storm events. This maintenance is similar to the maintenance already required for the wooded areas along the creek banks, so it is not excessively burdensome.

Figure 16: Cross Section of Brush Wattles and Live Staking. Source: United States Department of Agriculture Natural Resources Conservation Service

G1 Engineering recommends the use of a combination of riprap, brush wattles, live staking and seeding for streambank stabilization and armament. This option provides instant scour protection from the riprap while the living stabilized bank is being established. This option creates a natural looking streambank that prevents erosion in an ecologically friendly way by providing a habitat for insects and small animals and birds. This solution will be the most cost-effective option because the material for the wattles is already present on the site. This option requires very little additional maintenance to what is already being performed on the site. Since the brush wattles are staked in place and the live stakes are planted, there is little risk of them migrating downstream due to stream scour forces. We recommend this option because it is the most cost effective, aesthetically pleasing, and effective for preventing erosion from scour.

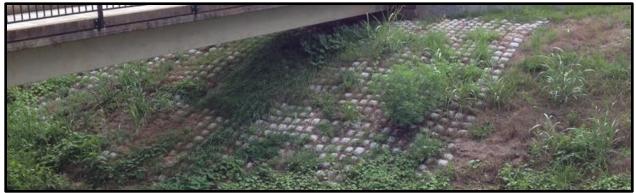
The second stabilization option is using a tied concrete block mat. This product, as pictured in Figure 17, consists of concrete blocks that are interwoven with a high strength geogrid. The concrete blocks are interlocked with 1.5 inch spacing between them to allow for flexibility and sprouting of vegetation growth that will cover the concrete blocks for a natural look. The banks are seeded with grasses, and then the tied concrete block mat is unrolled over the top. The block mat should be buried for a length of eighteen inches at the toe of the slope, and the geogrid can be staked along the slope to prevent movement of the block mat due to high stream scour forces. Visual inspection maintenance is required after large storm events to confirm the mat has not shifted and to ensure the integrity of the tied concrete block mat.

Figure 17: Tied Concrete Block Mat. Source: Brock White Manufacturing

The use of a tied concrete block mat for streambank stabilization could also be used. This option will provide excellent scour protection and will not migrate downstream because it is staked in the ground. This option is higher cost, doesn't provide habitat for wildlife, and does not fit the aesthetics the client desires as well; therefore, it is not the recommended option.

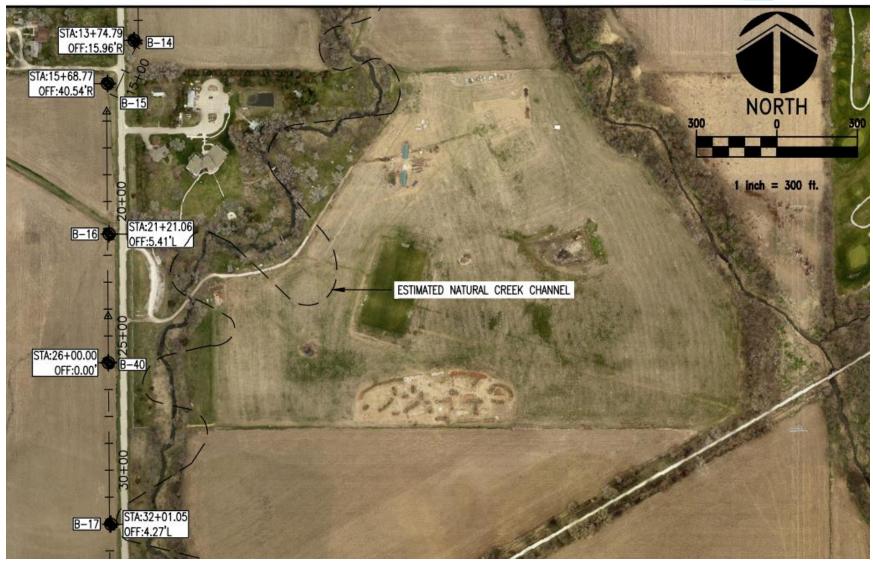
Figure 19: Boring Locations and Estimated Natural Creek Channel from the Sub-Basin E3 Trunk Sewer Report by Schemmer

Four borings from the Sub-Basin E3 trunk sewer project were taken near the OEC property. They provide information on the existing soil conditions. The location of these borings are shown on the concept plans in the appendix. The existing soil consists of alluvial materials of sand, silt, and clay. The profile has layers of clay that are underlain by layers of sand mixed with clay. This profile is typical of floodplain soils that have stronger layers above weaker layers. The wetting and drying cycles above the groundwater table strengthen the top layers of the soil profile.

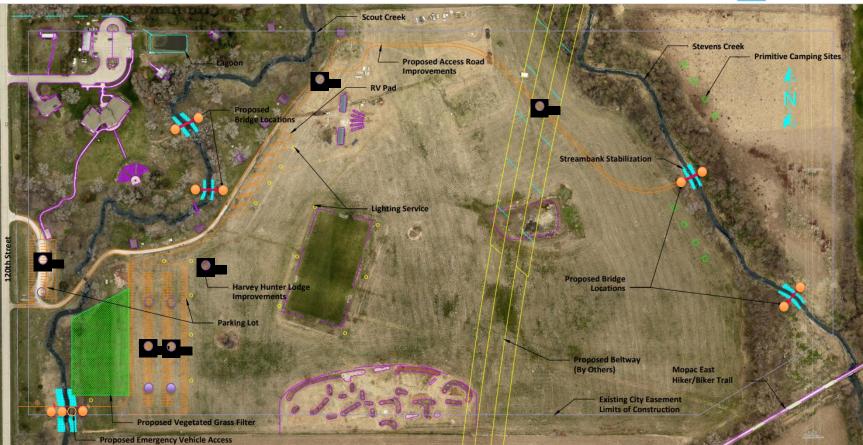
Figure 20: Proposed Boring Locations

To proceed with the design, additional borings will need to be taken to determine soil properties so foundations can be designed, and settlement can be determined. Information from the borings will also determine actual soil sufficiency as discussed in the findings section. Figure 20 shows the location of the proposed boreholes. The orange circles show boreholes at bridge abutments and piers. These boreholes will need to be 60 feet deep or as deep as the bedrock layer. One borehole should be taken at each bridge abutment and each pier for the bridge locations chosen for the design. The purple circles show boreholes used for the Harvey Hunter Lodge, parking lot design, and roadway design. These boreholes will need to be 35 feet deep.

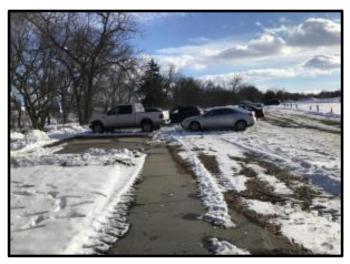
Figure 21: Existing parking lot located southwest of Scout Creek. View from north looking to south.

Due to increased usage of the site, guests have trouble finding parking in the limited parking areas. The first challenge is providing a sufficient number of vehicle parking spaces. In order for the OEC to have more guests, the site must be able to accommodate the high volumes of visitors. The client has requested a parking lot design to accommodate 300 parking spots for events that have high volumes of guests. The current, unpaved parking lot, located west of Scout Creek, provides a limited number of parking spaces due to inefficient design and portions of it extending into the city setback. Currently there are cones placed in the unpaved parking lot to prevent guests from parking in the setback area as shown in Figure 21. The dimensions for this existing parking lot made it challenging to provide enough space for vehicles to enter and exit parking spaces and limit congestion in the aisles. We were able to place 63 parking spaces in the unpaved parking lot that are 8.5 feet wide and 18 feet long. Another challenge with the existing, unpaved parking lot is providing enough space for emergency vehicles to maneuver without congestion. The paved parking lot on the northwest corner of the property serves the staff and day visitors for the site, but generally is not big enough to handle the large volumes of guests visiting the site. Setback

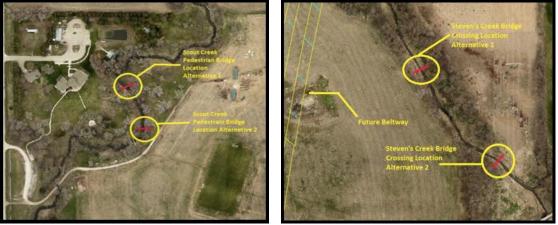
The locations of all proposed bridges are shown below in Figures 26-28. The reasoning behind the selection of these locations is discussed later in this section.

Figures 26-27. Proposed Pedestrian Bridge Locations Over Scout and Stevens Creek

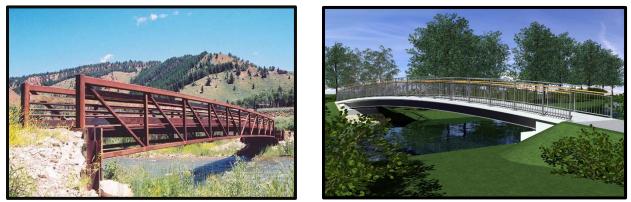
The second design option that our team is proposing for the pedestrian bridges is a steel twin girder bridge with a composite concrete deck. The abutment for this design option would be a steel sheet pile and steel bearing pile abutment. This design option works best for the shorter bridges since girder size and weight increases significantly at longer lengths such as lengths for the pedestrian bridges over Stevens Creek.

Figure 29 shown below on the left shows an example of a prefabricated truss bridge, and Figure 30 on the right shows an example of a twin girder bridge.

Figure 29. Prefabricated Truss Bridge with Steel Sheet Pile Abutment (left) Source: Wheeler-Con Figure 30. Steel Twin Girder Bridge (right) Source: Wheeler-Con

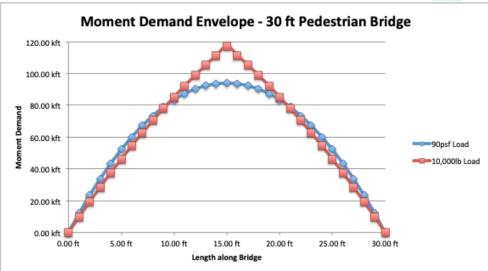
The design of the twin steel girder bridge with a composite concrete slab includes the design of the slab, girders, and abutment. The concrete slab must be designed to carry the load from the concrete deck to the girders. The deck system is composite which means that the concrete deck and the girders work together to resist load and deflection. This style of design requires the girders to be designed to withstand all loads before the concrete cures. This loading includes the self-weight of the girders, the weight of the wet concrete, and a construction load of twenty pounds per square foot. The girders should be designed to prevent plasticity as much as possible while the concrete cures. This allows for proper structural behavior after the deck is placed. Additionally, the bridge must be designed for the worst case between a ninety pounds per square foot live pedestrian load and the loading of an HS5 design truck. The HS5 design truck is a theoretical truck defined by AASHTO which is meant to simulate utility vehicles. To simplify the design for the preliminary design, the engineer has chosen to adopt Iowa Department of Transportation (IDOT) Specification Section 2429 which replaces the HS5 design truck with a ten thousand pound load at midspan increased for impact. The IDOT specification was used due to a lack of Nebraska specifications regarding pedestrian bridges. Additionally, this specification allows for simplified analysis that is ideal for thirty percent concept plans. This specification typically applies to truss bridges; however, it will be a reasonably close and simplified estimate to the HS5 truck due to the similarity of the loading. An example strength envelope is shown below in Figure 31 and Figure 32. These figures show the force effects that the designer must take into account in the design of the structures. The larger the force effects are, the larger the structure needs to be, and the more material the structure needs to use. The blue lines refer to the load effects experienced by pedestrian foot traffic, and the red lines refer to the load effects experienced by a utility truck. The values of the shear demand envelope show approximate end bearings for the pedestrian bridges. This value of the end bearings is used by the geotechnical engineer to determine the required size and depth of the foundations.

Figure 31. Moment Demand Envelope

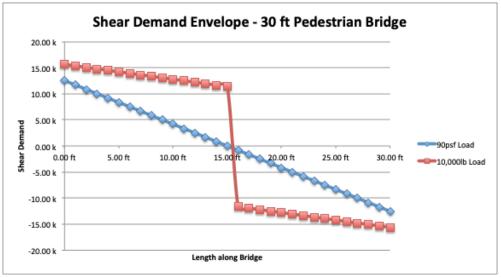
Figure 32. Shear Demand Envelope

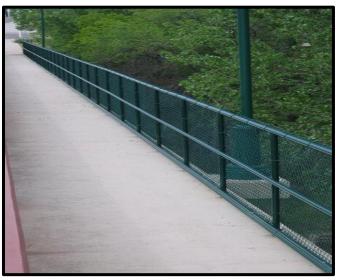
The pedestrian bridges shall all use a double steel channel cap with two HP12x53 bearing pile. Steel sheet pile will be used at each abutment to hold back channel soil. Each pedestrian bridge will also be seven feet wide to allow for two way pedestrian traffic and to allow for one way maintenance vehicle traffic. A steel or wooden safety fence will be used for the steel twin girder bridges in order to meet the requirements of a pedestrian rail specified earlier in this memo. The prefabricated truss bridges use the truss with intermediate horizontal rails spaced at 4 inches on center to act as a safety rail. Figure 33 shows an example of the safety fence for the pedestrian bridges.

Figure 33. Typical Safety Rail for Bridge. Source: Pascetti Steel

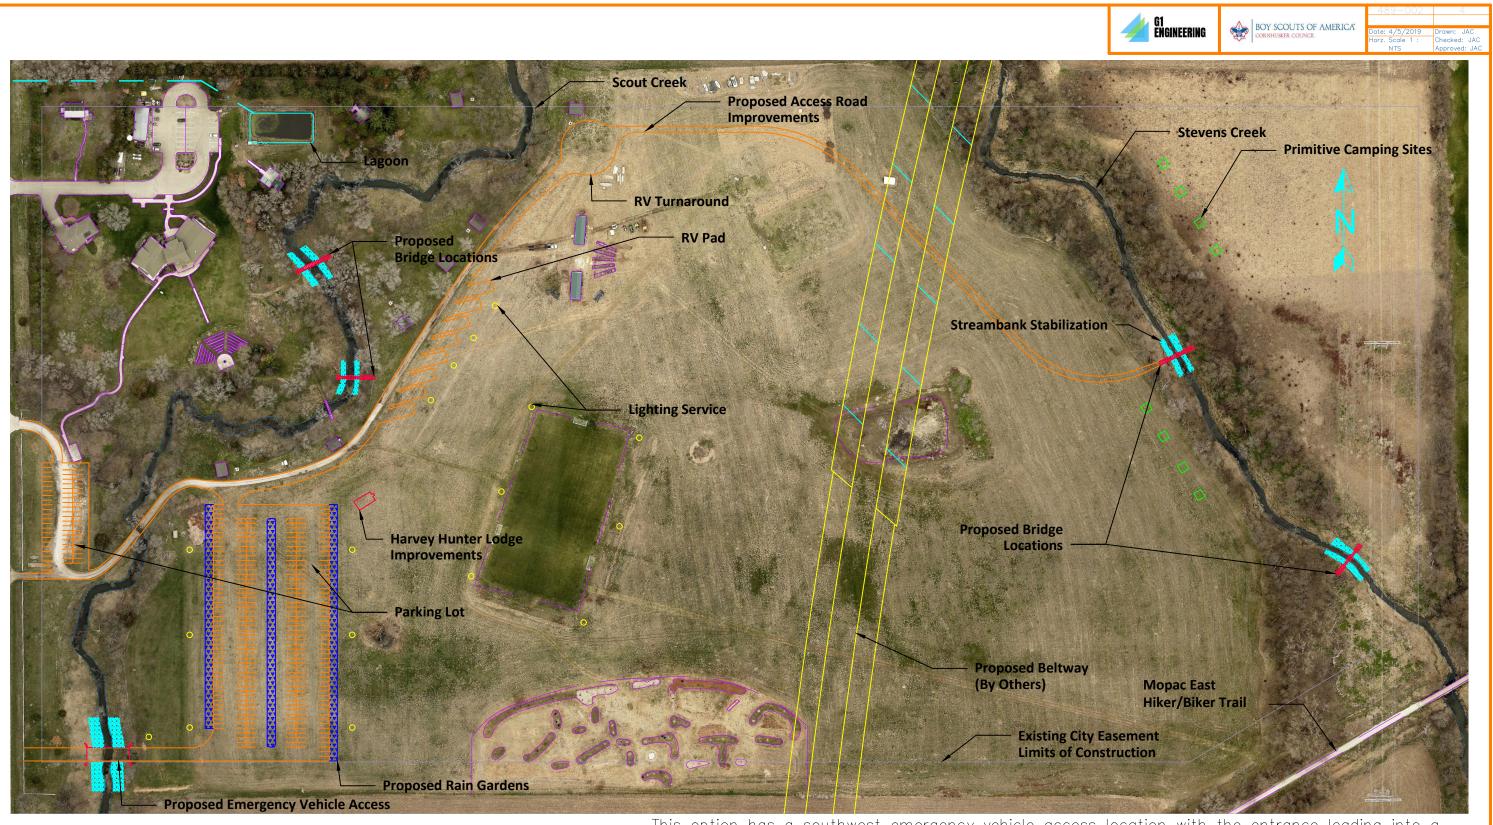
CONCEPTUAL SITE PLAN OPTION 1

NOT FOR CONSTRUCTION INFORMATIONAL USE ONLY This option has a southwest emergency vehicle access location with the entrance leading into a concrete paved 300 space parking lot. The existing gravel parking lot is upgraded to concrete and can accommodate 63 cars. Eight RV parking pads are located on the east side of the access road. The access road is concrete and one-way west to east from the 120th street parking lot. This road becomes two way after the main parking lot until the RV turnaround at the northern edge of the property. The access road returns to one lane asphalt after the RV turnaround leading to the Stevens Creek bridge. Pedestrian bridge location options over Scout and Stevens are shown. The wastewater lagoon should be emptied via vacuum truck and then normal lagoon operation should continue. Rain gardens are implemented for treatment of stormwater. Lighting is placed around the main parking lot, soccer field, and at RV parking pads. Eight primitive camping sites are located by Stevens Creek with four on each side.

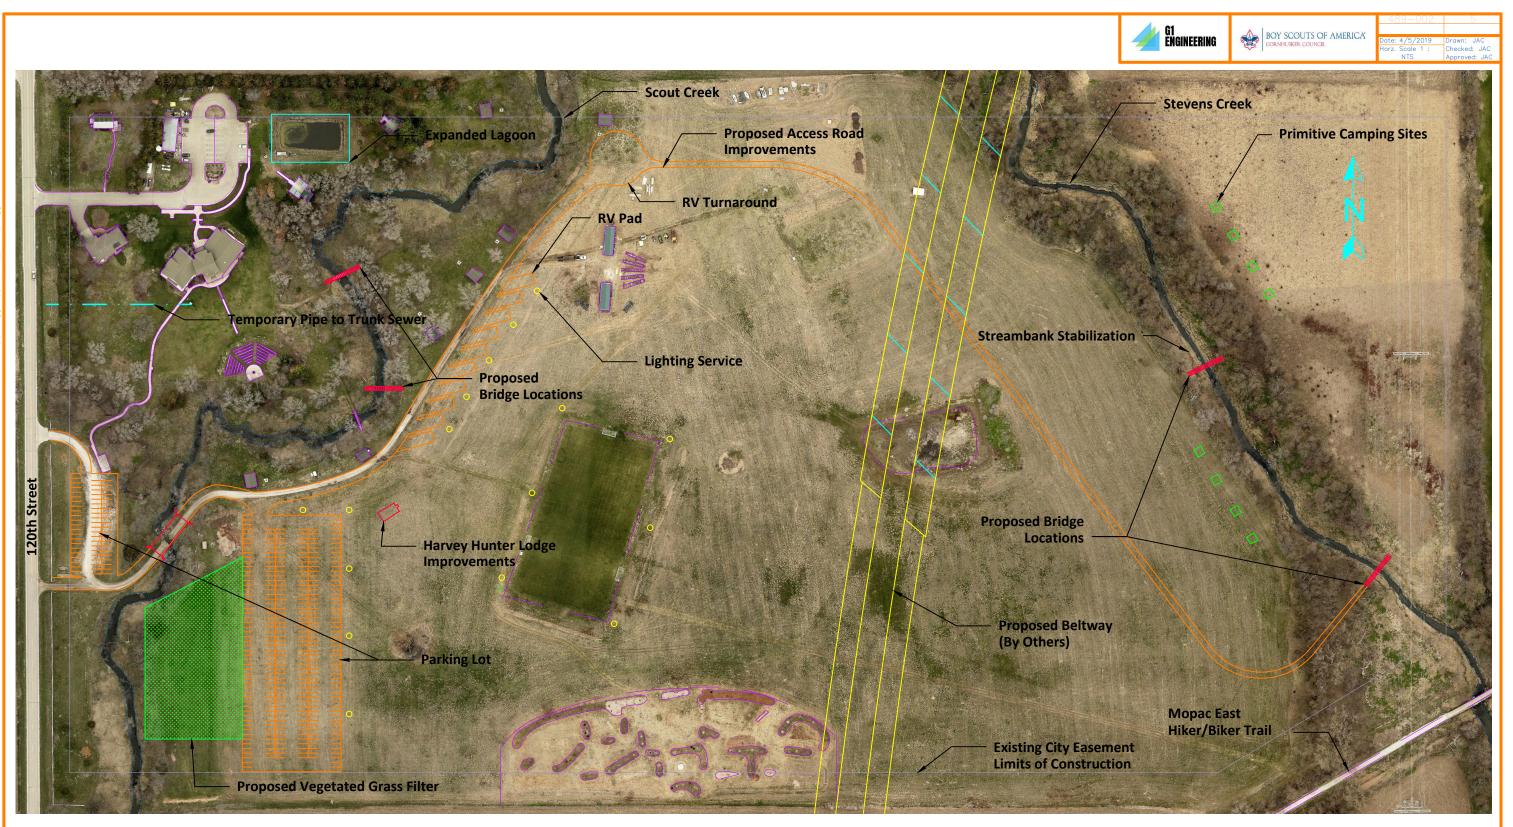
CONCEPTUAL SITE PLAN OPTION 2

NOT FOR CONSTRUCTION INFORMATIONAL USE ONLY This option has the emergency vehicle access at the current low-water crossing location. The existing gravel parking lot is upgraded to concrete and can accommodate 63 cars and a 300 space concrete parking lot is implemented. Ten RV parking pads are located on the east side of the access road. The access road is concrete and two-way until the RV turnaround at the northern edge of the property. The access road returns to one lane asphalt after the RV turnaround leading to the Stevens Creek bridge. Pedestrian bridge location options over Scout and Stevens are shown. The wastewater lagoon should be emptied via vacuum truck and then expanded. A vegetative filter strip is implemented for stormwater runoff filtration. Lighting is placed around the main parking lot, soccer field, and at RV parking pads. Eight primitive camping sites are located by Stevens Creek with four on each side.

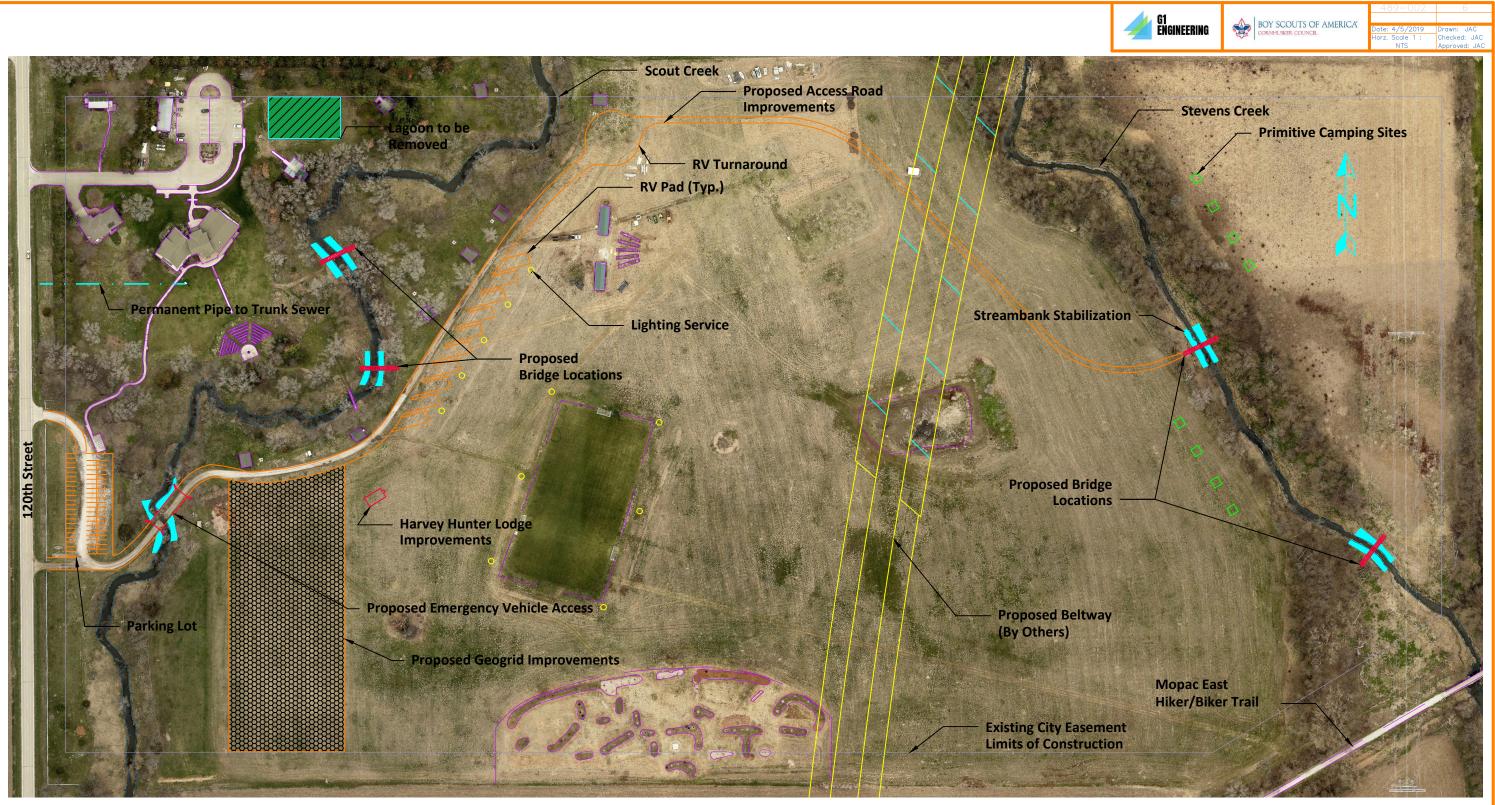
CONCEPTUAL SITE PLAN OPTION 3

NOT FOR CONSTRUCTION INFORMATIONAL USE ONLY This option has the emergency vehicle access at the current low-water crossing location. The existing gravel parking lot is upgraded to concrete and can accommodate 63 cars. Geogrid improvements allow for vehicle parking and retention of the field and require no stormwater filtration systems. Ten RV parking pads are located on the east side of the access road. The access road is concrete and two-way until the RV turnaround at the northern edge of the property. The access road returns to one lane asphalt after the RV turnaround leading to the Stevens Creek bridge. Pedestrian bridge location options over Scout and Stevens are shown. The wastewater lagoon should be emptied via vacuum truck, a permanent connection to the trunk sewer installed, and lagoon filled in. Lighting is placed around the main parking lot, soccer field, and at RV parking pads. Eight primitive camping sites are located by Stevens Creek with four on each side.
