FINAL REPORT ~ FHWA-OK-14-06

# REAL TIME MONITORING OF SLOPE STABILITY IN EASTERN OKLAHOMA

January 2014

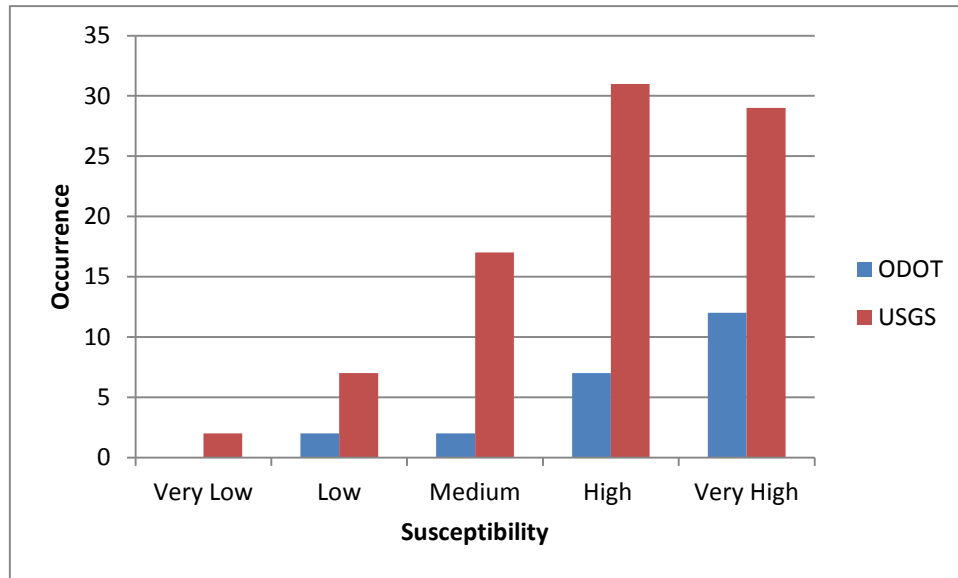
**Figure 7. Result statistics of the state map and landslide sites.**

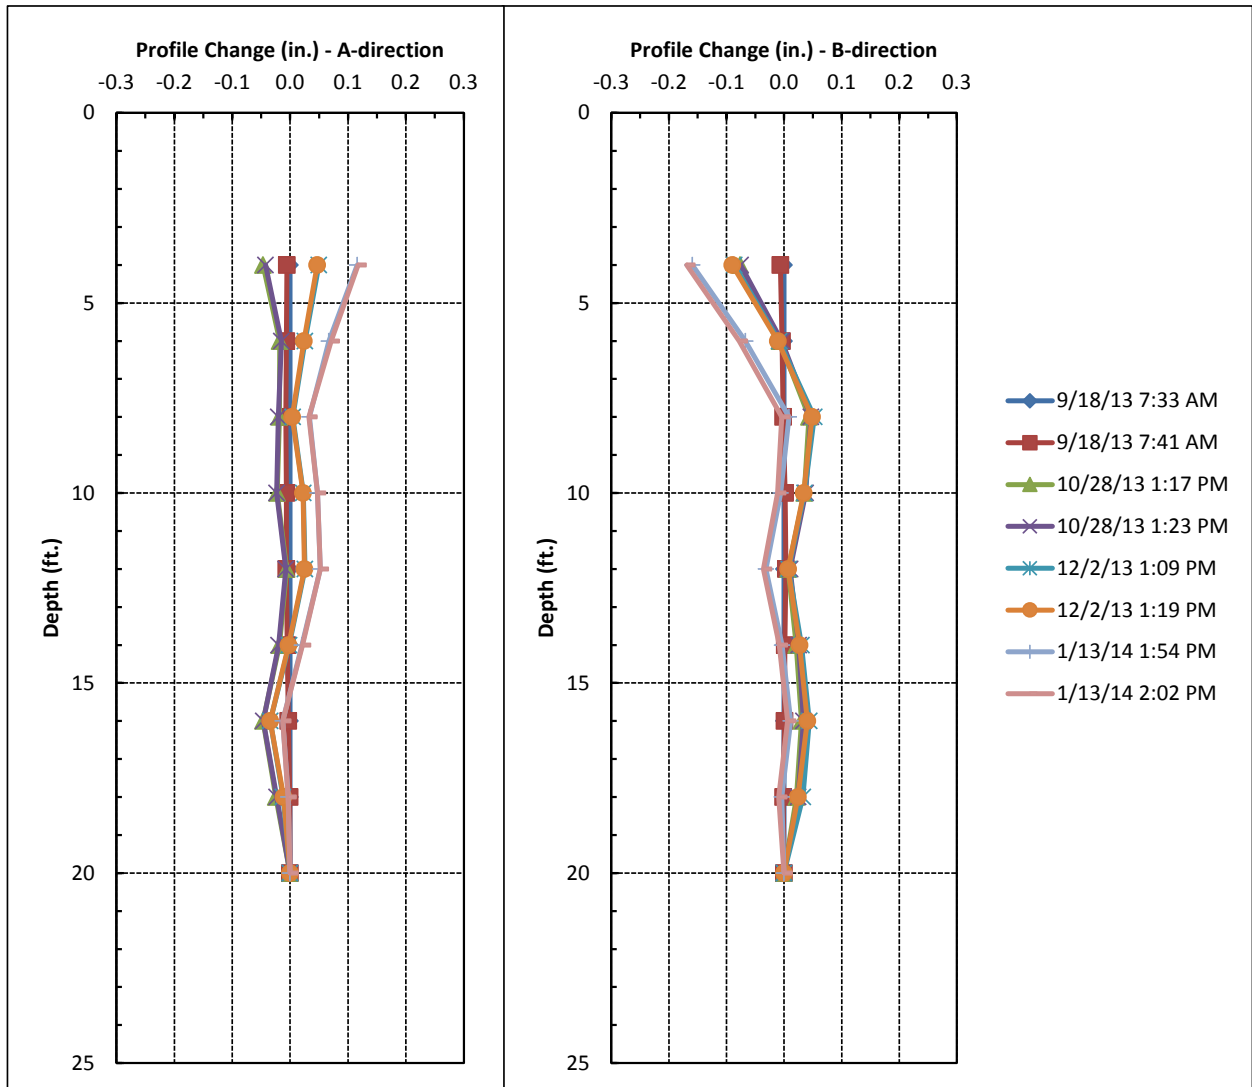
**Figure 8. Inclinometer #1 in slope in McCurtain County (data above 4' was clipped due to erratic readings possibly due to casing installation).**

The landslide on Route 70, near Idabel, OK, was chosen as one of the instrumentation sites. The weather station was installed in October 2012 and two inclinometers were installed five feet apart in the same cross-section in September 2013 (Figures 8, 9 and 10). The Materials Division took the initial inclinometer reading and has been taking readings once per month since installation. The instruments of the weather station include sensors to quantify rainfall, air temperature, relative humidity, wind speed, wind direction, solar radiation, and volumetric water content at three depths in the soil profile. At various times prior to, during and after installing the weather station, hand auger borings were advanced up to 10 feet in depth and samples were collected for moisture content determination and soil property tests. Laboratory testing included basic physical and index property tests including grain-size distribution, liquid and plastic limits. Strength tests, including triaxial and direct shear, were performed as well. All data are located in Appendix A.

The movement of the slope over the instrumentation period has been minimal; however, there was not a major rain event in those few months to trigger more movement. These inclinometers will be monitored monthly to see if and when there are any large slope movements and these will be correlated with the weather data. The data collected from this in situ monitoring instrumentation was used in the SLIDE model to attempt to predict, and then validate, slope failure.

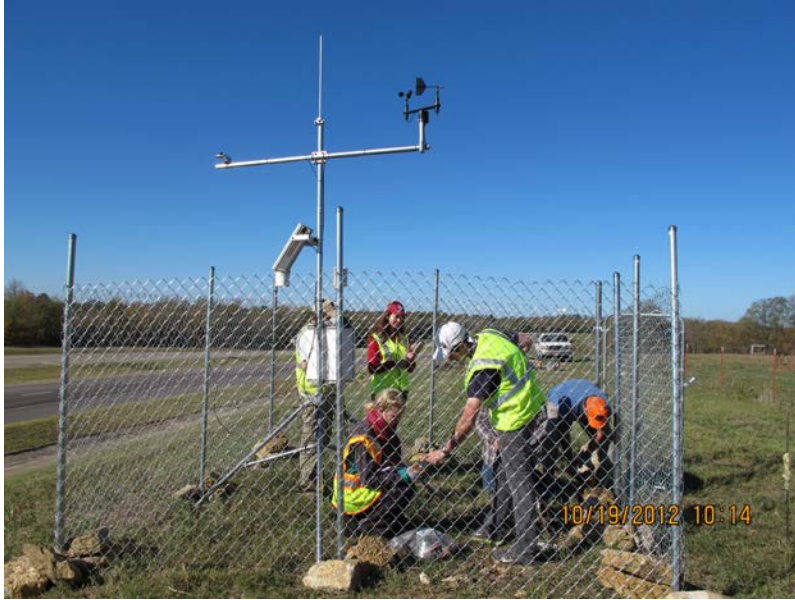
**Figure 10. Weather Station Installation on the Slope.**

In Idabel, an automatic hydrological monitoring system was installed in year October 2012, with a high temporal resolution (5-min) observation of rainfall, solar energy, wind, temperature, humidity and volumetric water content at three various depths (1ft, 3ft and 6ft). This study benefits greatly from very high quality one-year site-based in-situ measurements for the model evaluation.

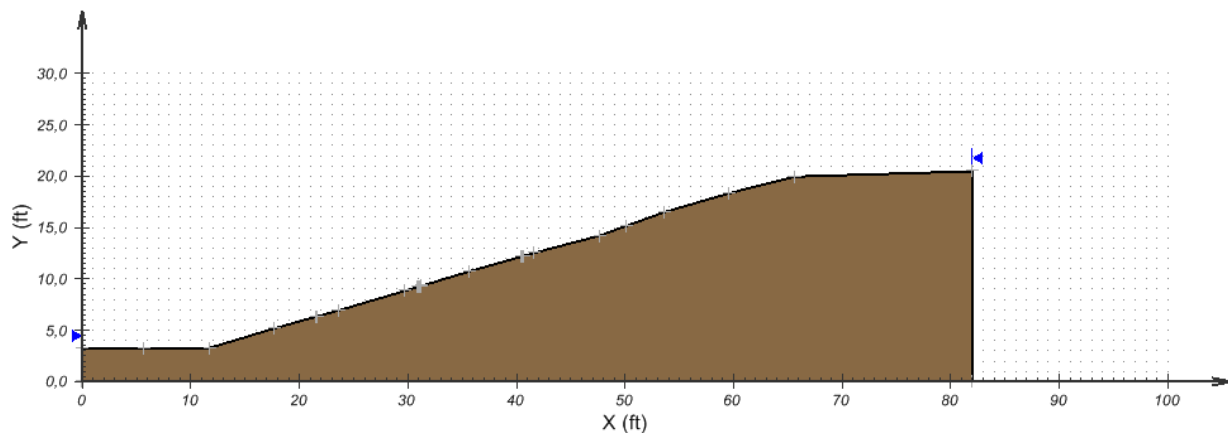
**Figure 12. Slope Geometry (from Bourasset 2013).**

The location of the slope failure site is west of Idabel (33.49°N, 94.52°W), Oklahoma in a reconstruction project of the westbound lanes of US-70 in McCurtain County by the Oklahoma Department of Transportation (ODOT). At an elevation of 360ft above sea level, the slope has an average inclination of 30° and is covered with grassland (Figure 12).

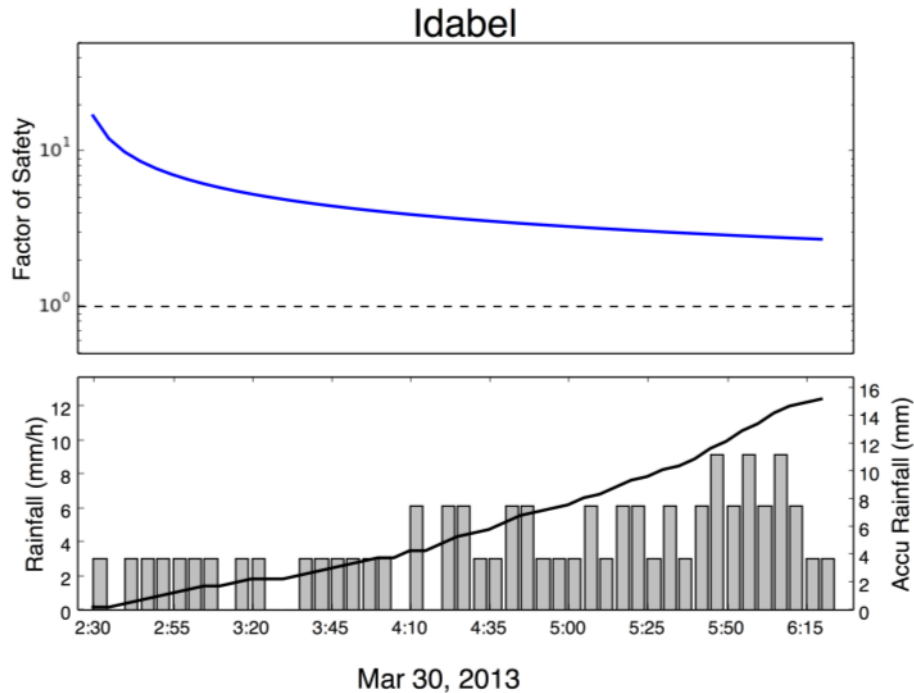
**Figure 13. Measured instantaneous and accumulated rainfall and trend of the FS as a function of time in Idabel**

In Idabel, we chose the representative rainfall event (R1) which happened from 2:30 a.m. to 6:15 a.m. on Mar 30, 2013. The highest recorded rainfall intensity of R1 was 8 mm/h, with an accumulation close to 15 mm in about 4 hours (Fig. 13, lower panel). However, according to SLIDE model, this rainfall event will not cause any landslide, as we can see from the top panel that the factor of safety within the entire time step is always larger than 1. We know from field surveys that the slope did not move, and so the SLIDE model predicted correctly that, with that particular rainfall event, the slope would not move.

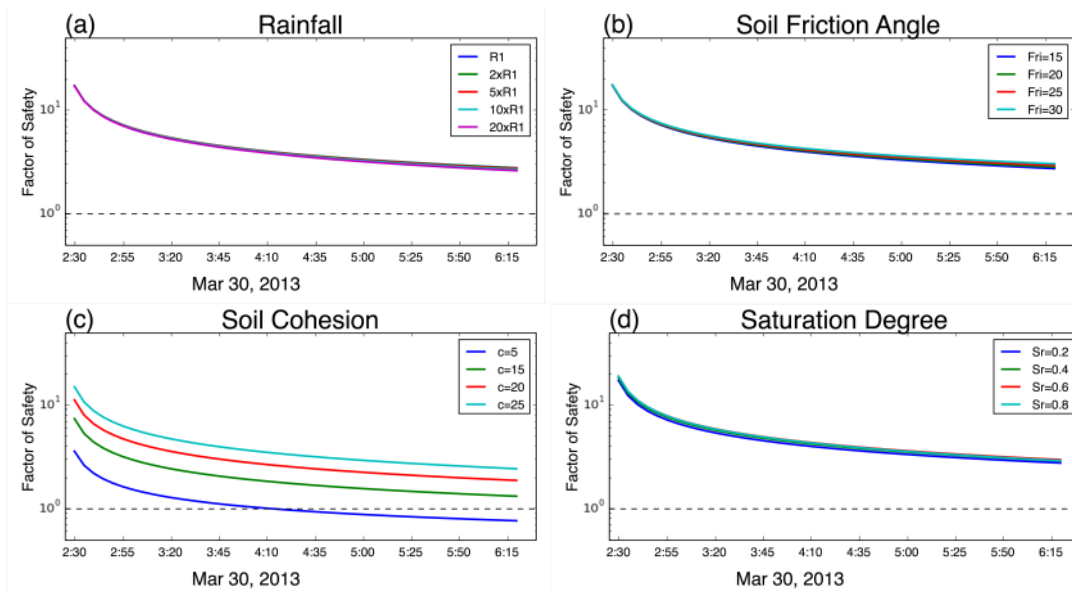
**Figure 15. Sensitivity of the FS to different (a) rainfall scenario; (b) soil friction angle; (c) soil cohesion; (d) saturation degree**

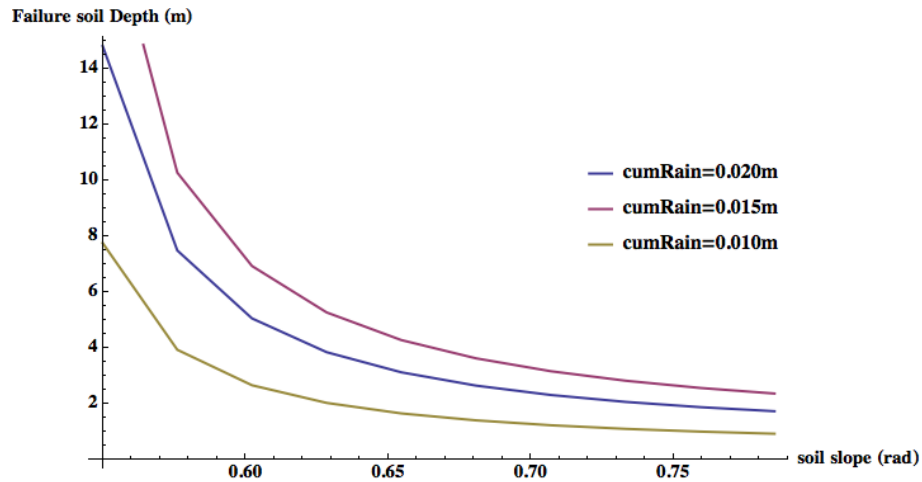
**Figure 16. Relationship between failure soil depth and soil slope with different cumulative rainfall.**

The failure soil depth provides very useful information to estimate the total volume of the detached material, if the displacement of landslide can be measured or estimated. Figure 16 illustrates the relationship between failure soil depth and slope angle under different cumulative rainfall conditions. From the figure, we can see that as slope angle increases, failure soil depth decreases quickly. This indicates that at a steeper slope, a shallow landslide (2~4 m) is much more easily induced by the rainfall; while for a relatively shallow slope, the landslide would be a deep landslide (>6m). The latter case contradicts the model's hypothesis, which assumes that landslides occur at shallow depths. This points out another way in which the SLIDE model should be improved.

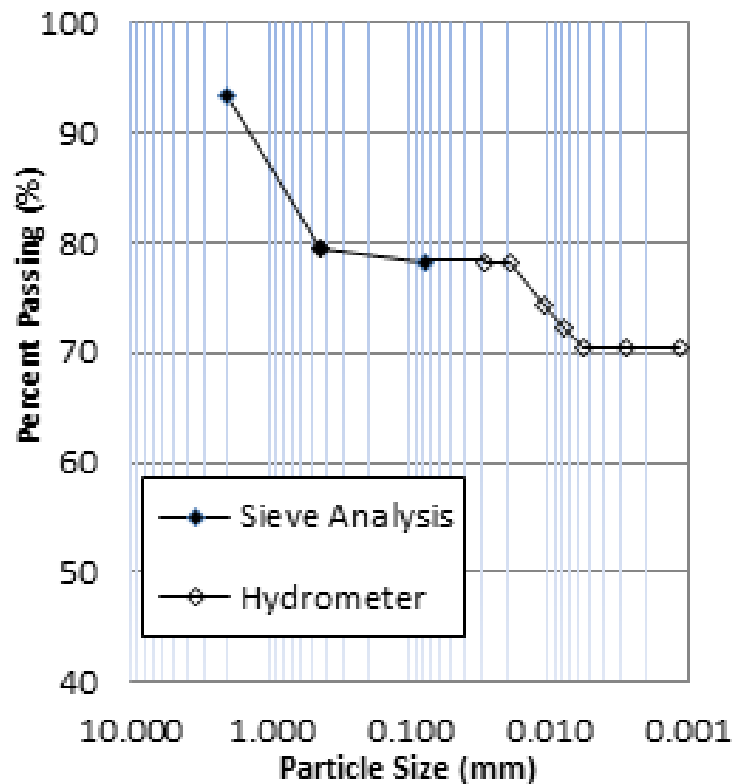
**Figure APX\_A 1. Grain Size Analysis from Idabel (from Bourasset 2013).**

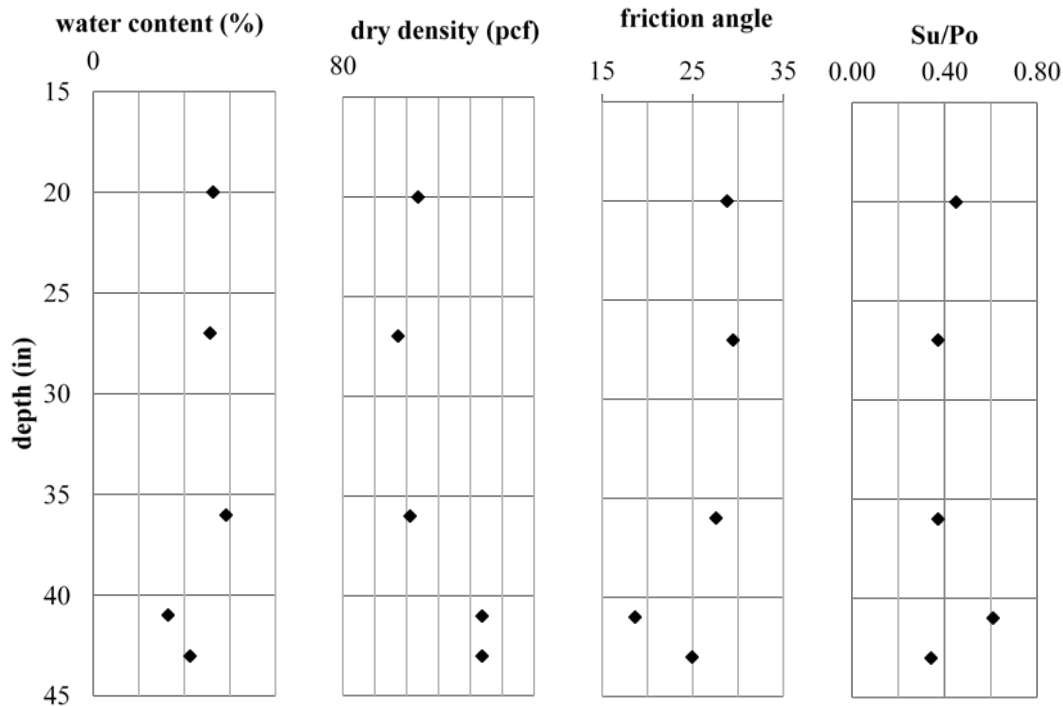
Figure\_APX\_A 5. Summary of Triaxial Results (from Bourasset 2013)

From these plots, a change of shear strength can be observed with an important decrease of the friction angle. The decrease in average friction angle below 30 inches is likely due to the increase in average PI below 30 inches as seen in Figure A5. It can be seen that the undrained shear strength increases as the depth increases.

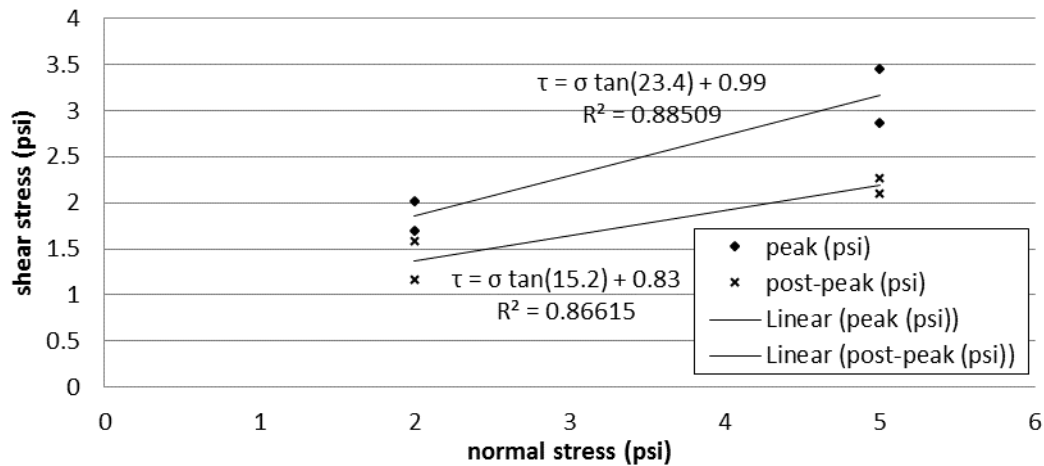
**Figure APX\_A 14. Results of direct shear tests on specimens recreating softened conditions for Idabel soil, peak and post peak strength (from Bourasset 2013).**

specimens is expected to be zero; which may not be the case here because of residual bonds between the particles (from the overconsolidated state).

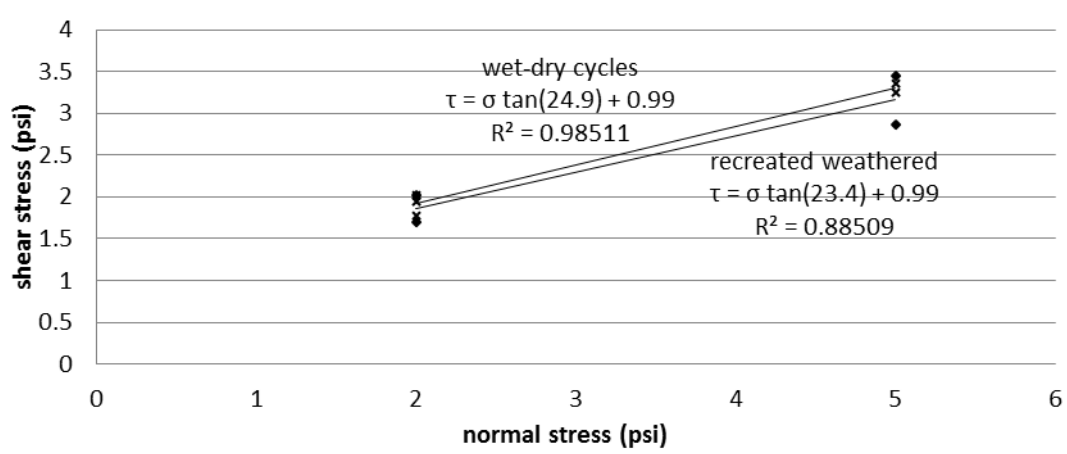
**Figure APX\_A 15. Comparison of failure envelopes between samples subjected to cycles of wetting and drying and samples recreating the final conditions (from Bourasset 2013)**

Figure A15 shows the results (peak strength) obtained from direct shear tests conducted on specimens subjected to cycles of wetting and drying and on specimens recreating the softened state (i.e., same dry density and moisture content). Both procedures resulted in a similar fully softened failure envelope.

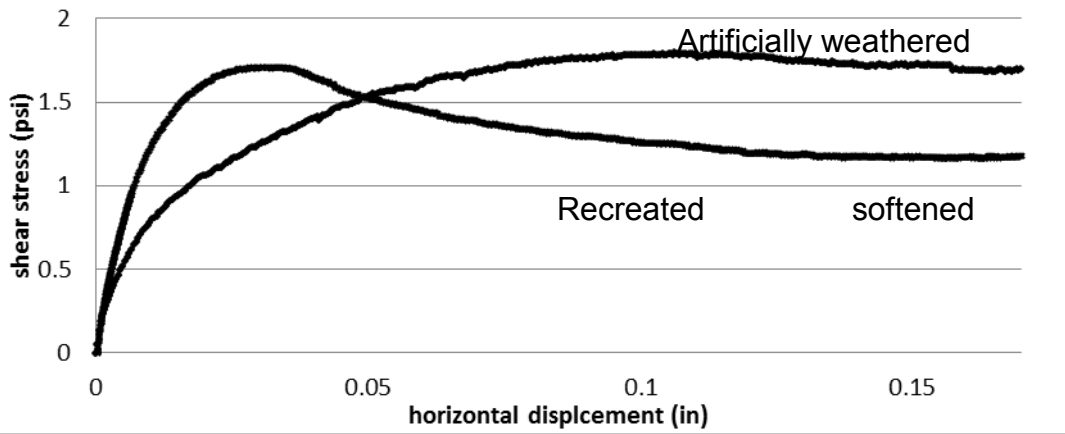
Figure APX\_A 16. Typical shear curve for cyclic sample and sample recreating softened conditions under 2psi confining pressure (from Bourasset 2013)

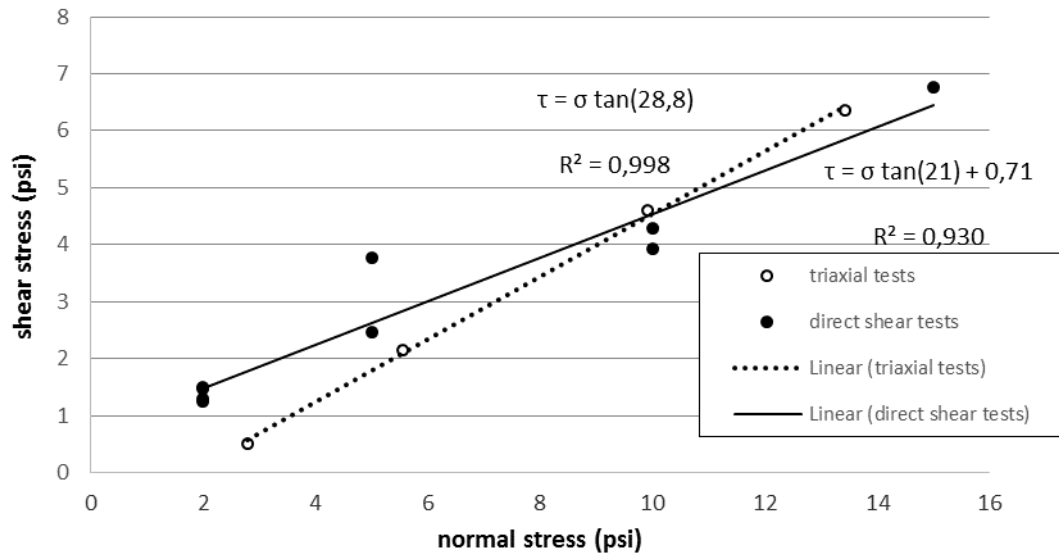
Figure APX\_A 17. Comparison of peak strength from direct shear and triaxial tests (from Bourasset 2013)

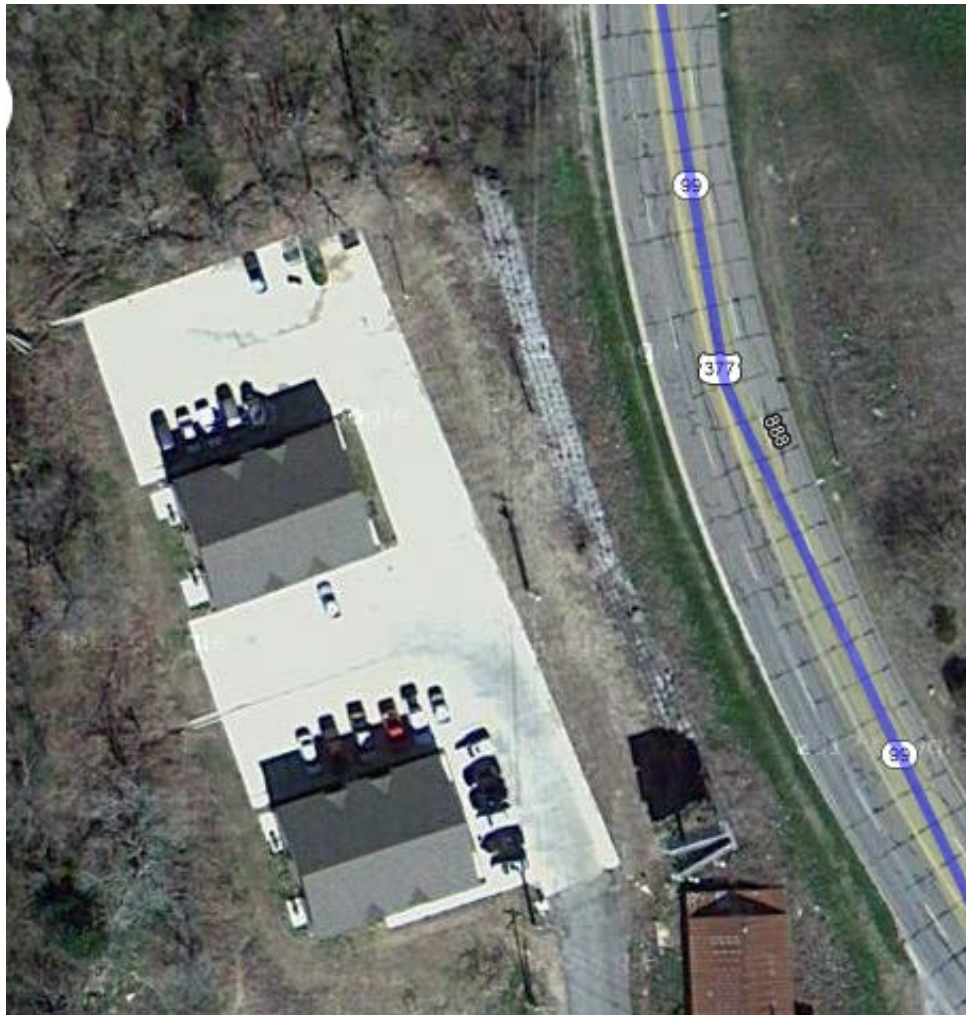
**Figure\_APX\_B 3. Ariel shot of problematic Area after fix (note Gabion Walls on left side of road).**

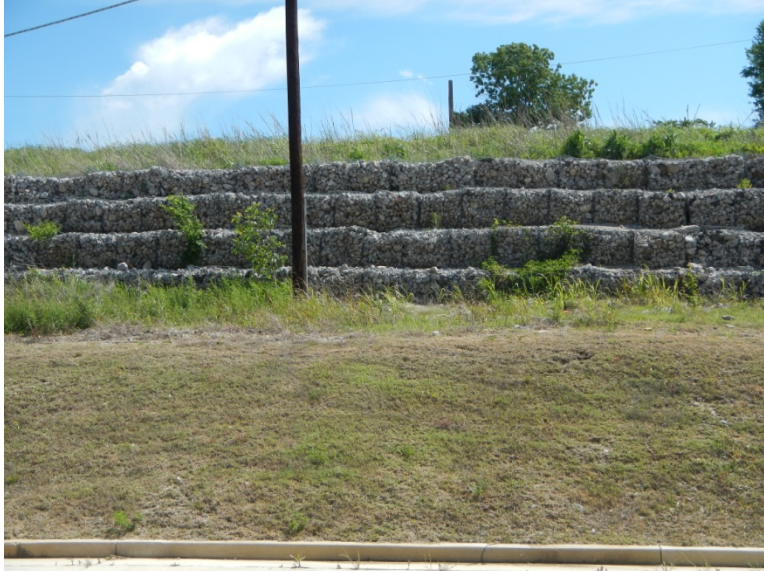
**Figure\_APX\_B 4. Gabion Wall as Retaining Structure.**

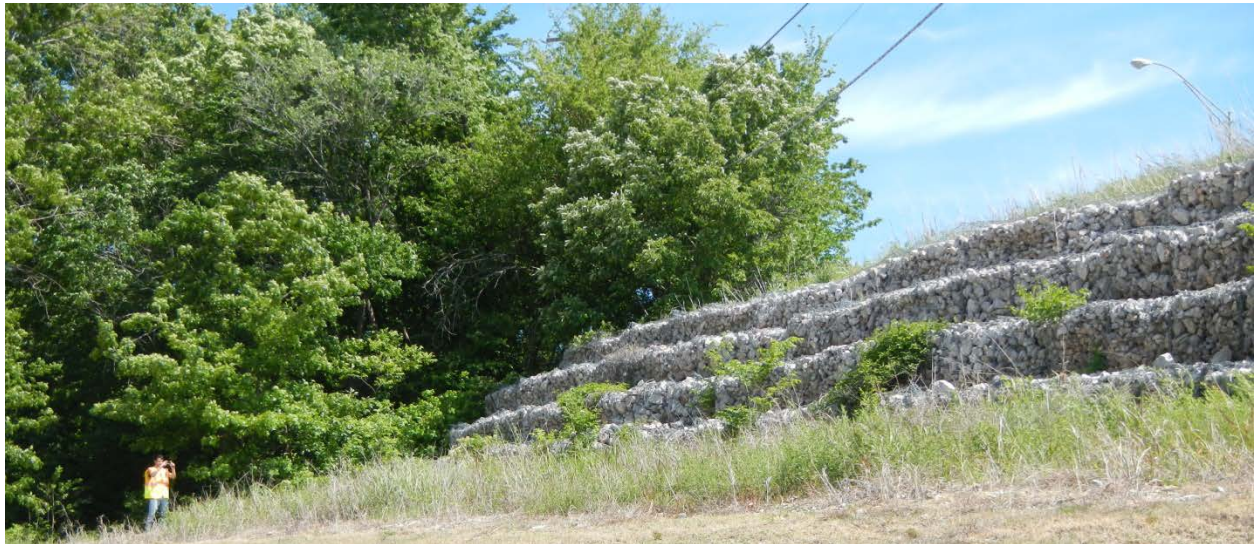
**Figure\_APX\_B 5. Gabion Wall as Retaining Structure.**

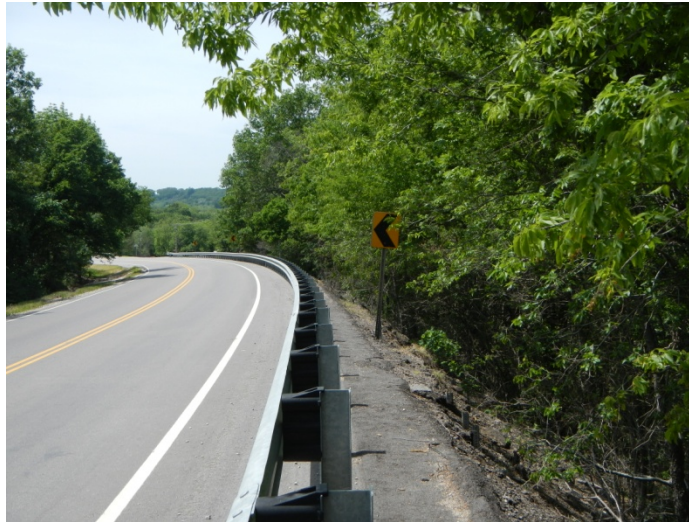
**Figure\_APX\_B 7. Looking west on Route 9. Landslide on the north side of road.**

Notes: Very steep slope, on a curve in road. Asphalt overlays approaching bottom of guardrail, and at the ends of the 240' long gabion basket retaining wall, the road is noticeably moving faster than the center part of the slide. The road was realigned by a few feet several years back to move the road away from the slope, however, slope is still slowly moving. See field sheet for sketch of slide.

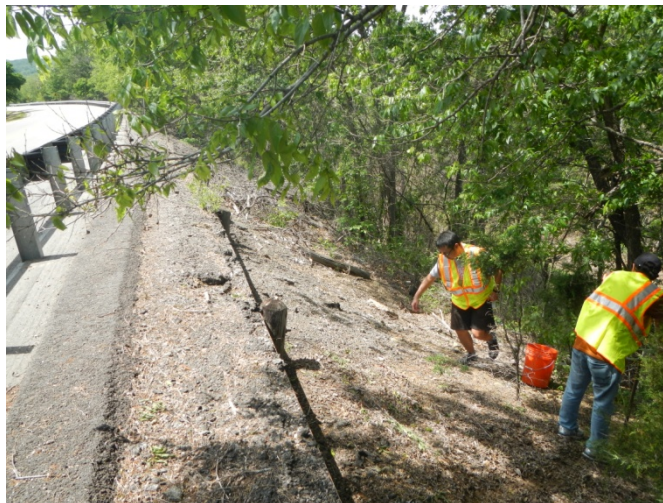
**Figure\_APX\_B 8. Can see old guardrail almost buried down the slope. The road was slightly realigned away from the slope a few years ago, although it is still moving.**

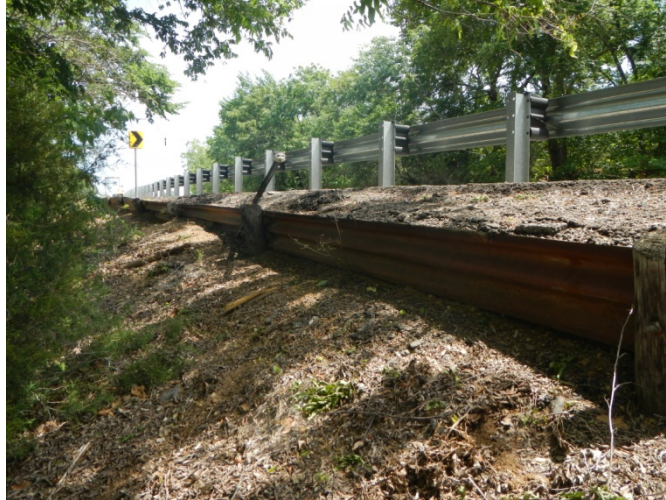
**Figure\_APX\_B 9. Old Guardrail is seen here actually acting as a retaining measure for additional asphalt overlays.**

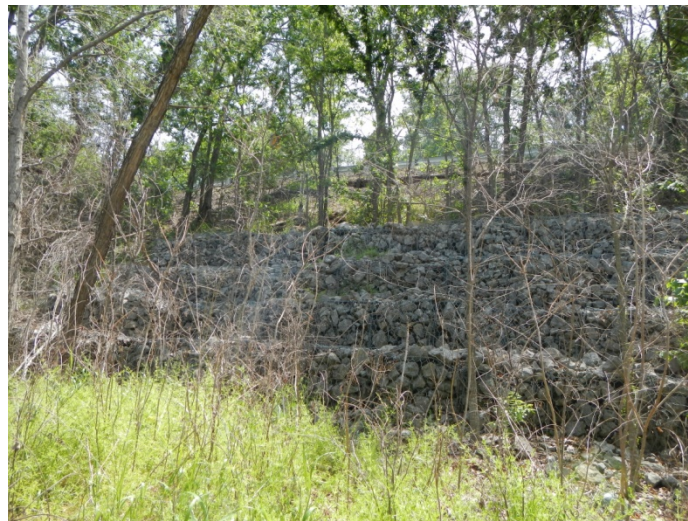
**Figure\_APX\_B 10. 240' long row of Gabion Baskets, stacked 4 high in stair step fashion.**

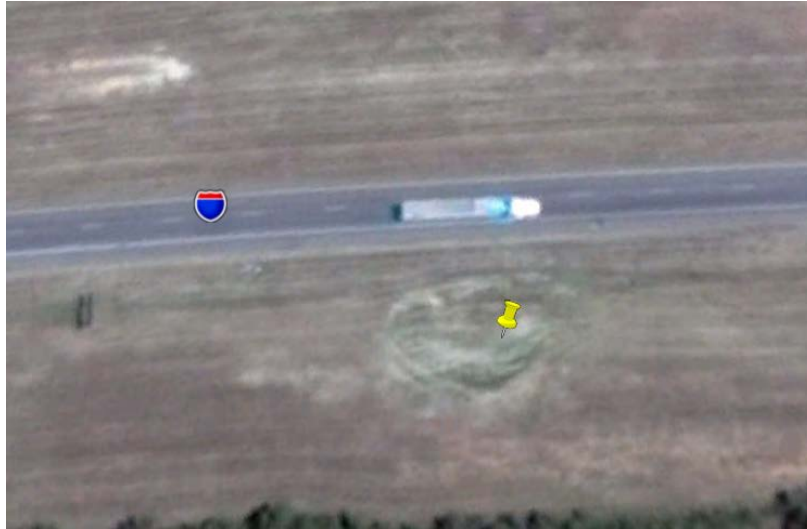
**Figure\_APX\_B 12. Satellite photo of slide outline. Note location of Exit sign in center left of photo, below eastbound I-40.**

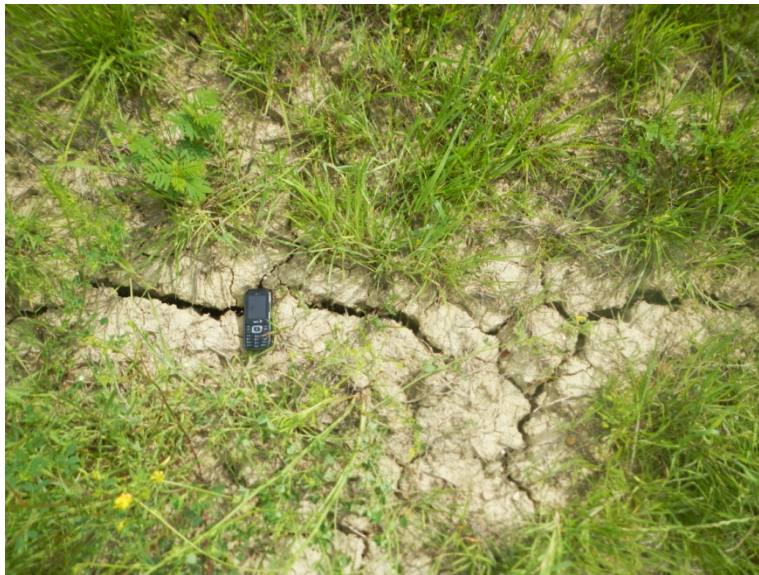
**Figure\_APX\_B 13. Desiccation Cracks all over slope, although water was found only 4 feet below the surface.**

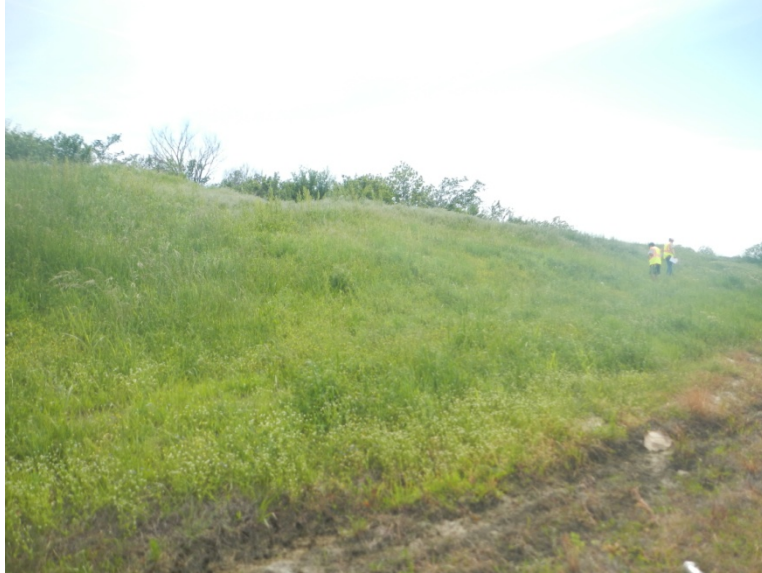
**Figure\_APX\_B 14. Looking back at the slide mass.**

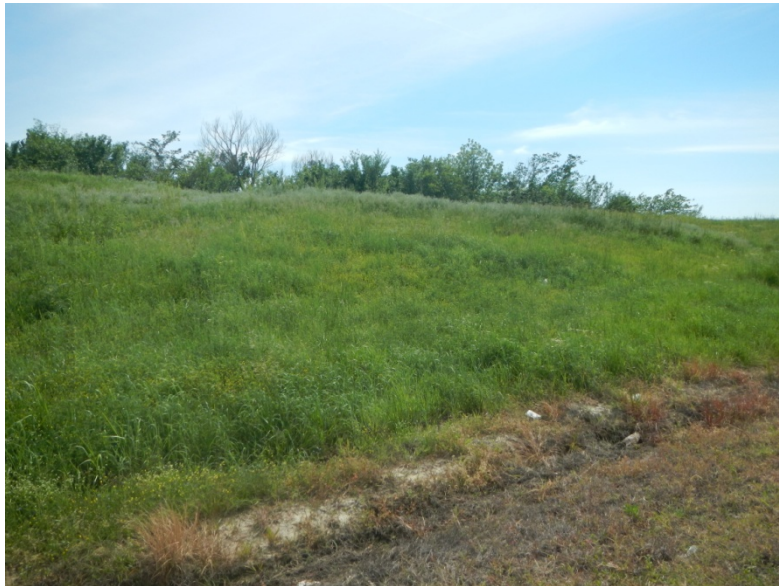
**Figure\_APX\_B 15. Can see the headscarp here as a change in vegetation cover.**

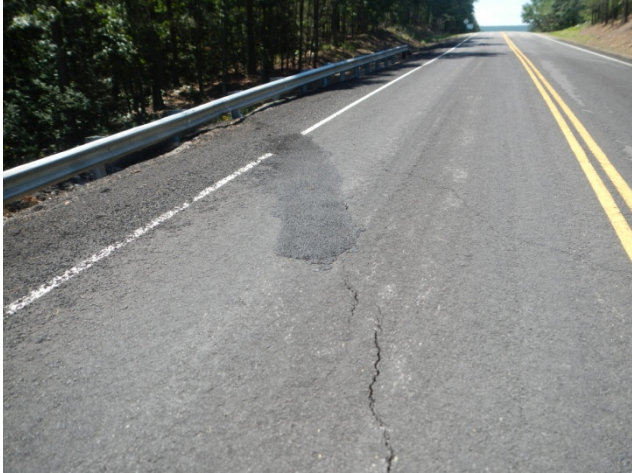
**B18. A.** Cracking in the road bed.

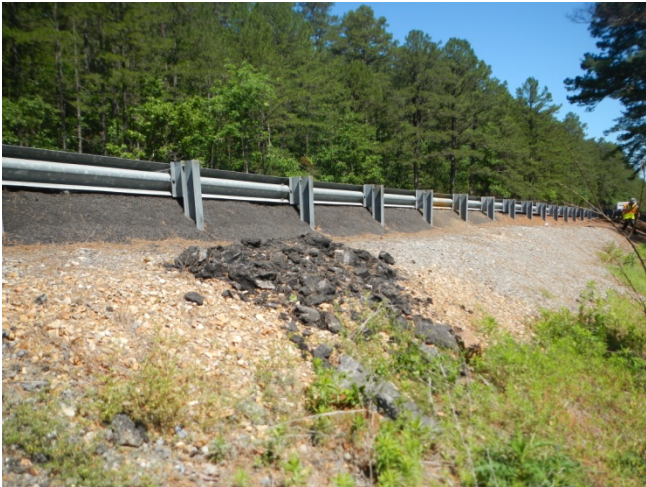
**C.** Depth of Asphalt overlay

**Figure APX\_B 17.** Cracking in the road bed (A). Example of subsurface encountered (B). Depth of Asphalt overlay (C). Vegetation (D).

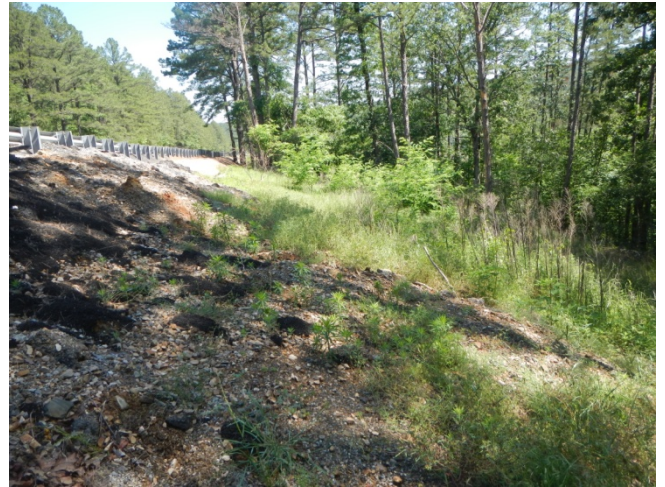
**D.** Vegetation.

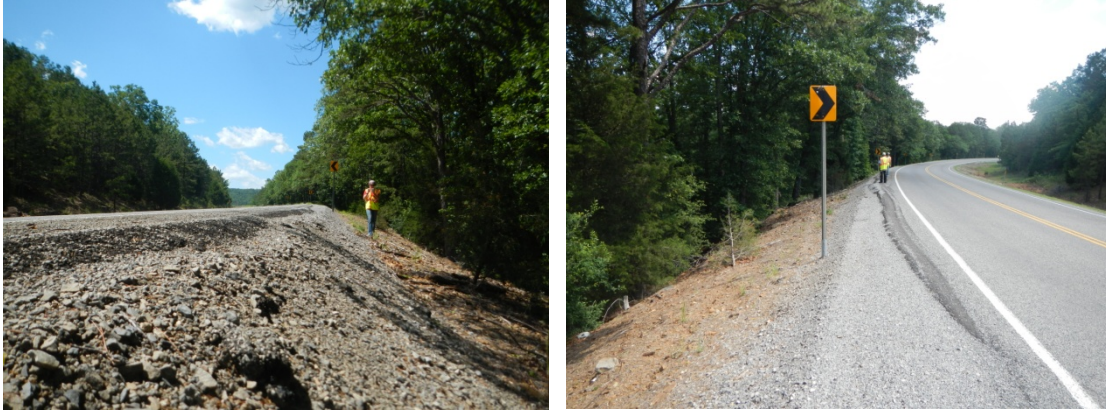
**Figure APX\_B 19. Shoulder pavement overlays.**

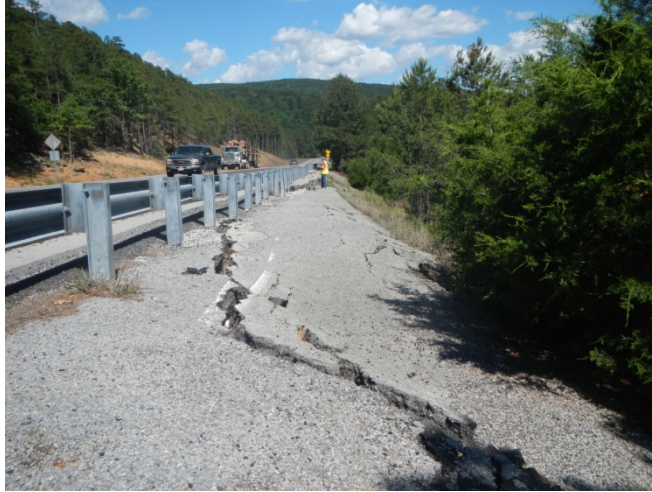
Slide notes: This is an active slide, where the current remediation is asphalt overlays to bring the road to the correct elevation. From what the project team could see, there was approximately 36" of asphalt visible above the existing ground line.

**Figure\_APX\_B 20. Route 271, after Talimena state park Looking south.**

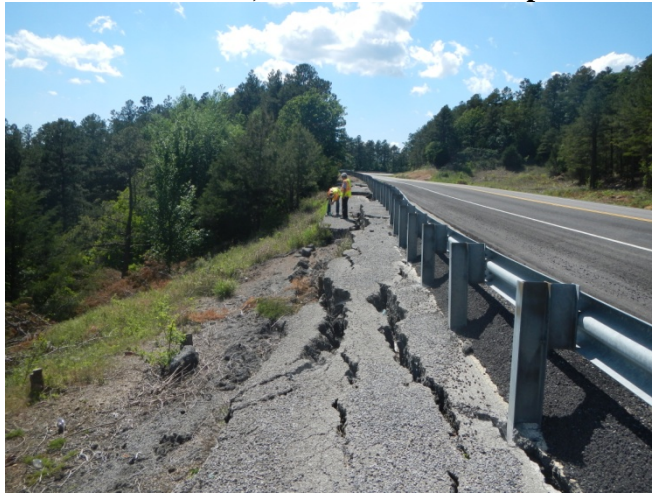
**Figure\_APX\_B 21. Route 271, after Talimena state park Looking north. Project team is measuring water table depth in monitoring well.**

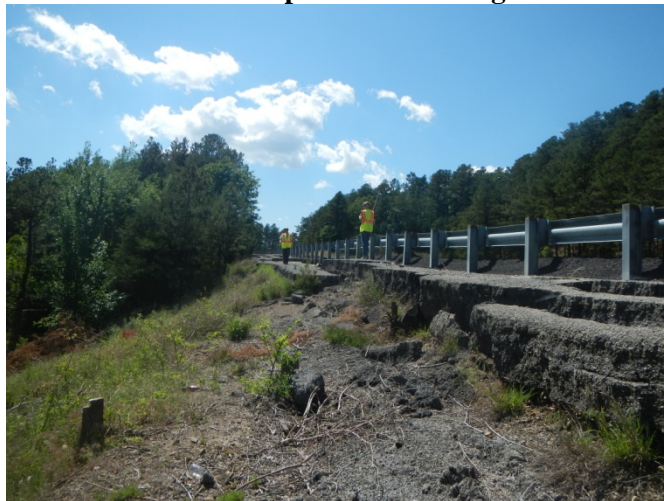
**Figure\_APX\_B 22. Route 271, after Talimena state park Looking north. 3 feet of asphalt overlay visible.**

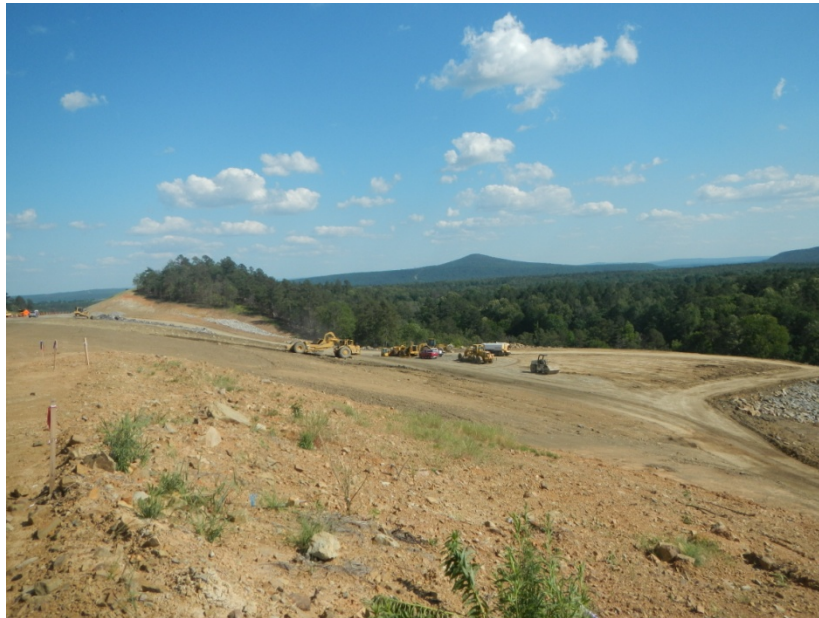
**Figure\_APX\_B 24. Repairing the slide.**

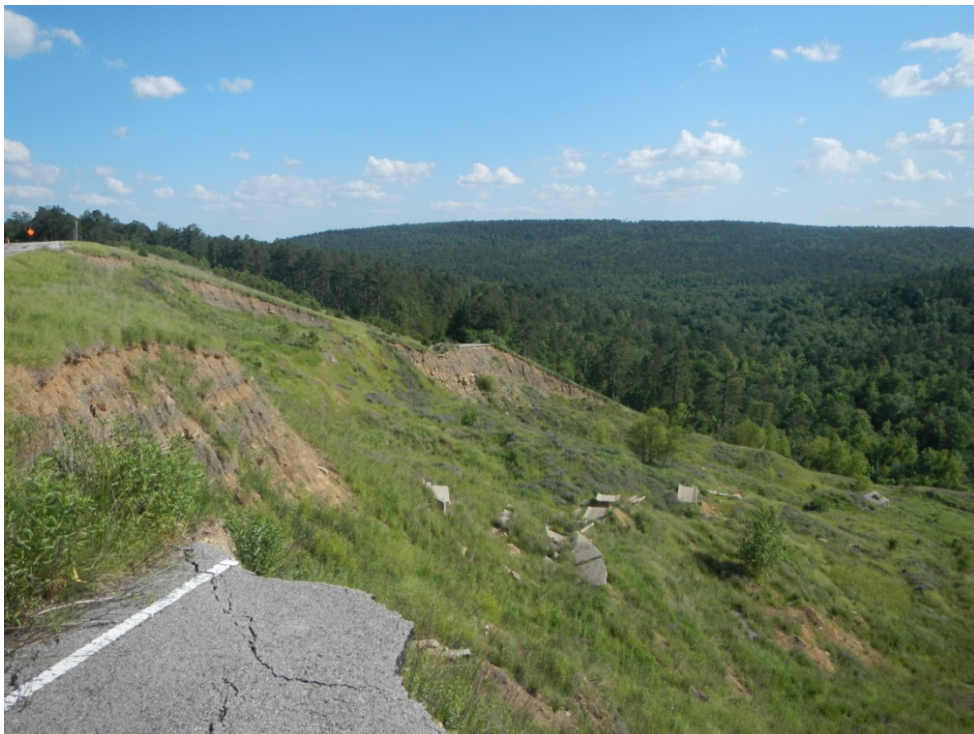
Slide notes: This was a big slide that occurred prior to 2003 as determined from historical satellite photos. For photos of the slide as it looked in 2008, please see [http://learys.smugmug.com/Work/Engineering-Geology-Landslides/4396561\\_wXCqK5#!i=258205353&k=oC4q5](http://learys.smugmug.com/Work/Engineering-Geology-Landslides/4396561_wXCqK5#!i=258205353&k=oC4q5). There has been nothing done to this site since the slide occurred. This might be a good location to use as verification of the model.

**Figure APX\_B 25.** Photo taken May 9, 2012 standing at the end of destroyed county road.

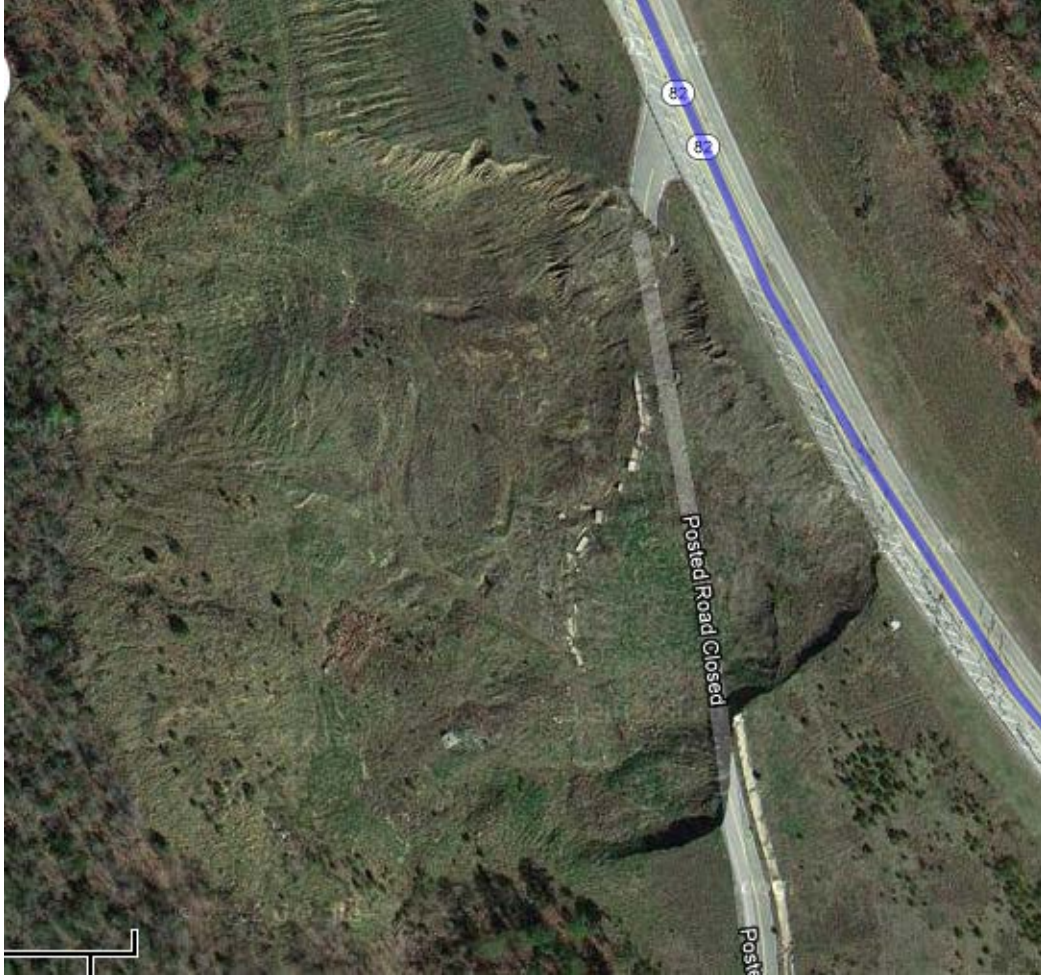
Figure\_APX\_B 26. Current satellite photo of the landslide mass.

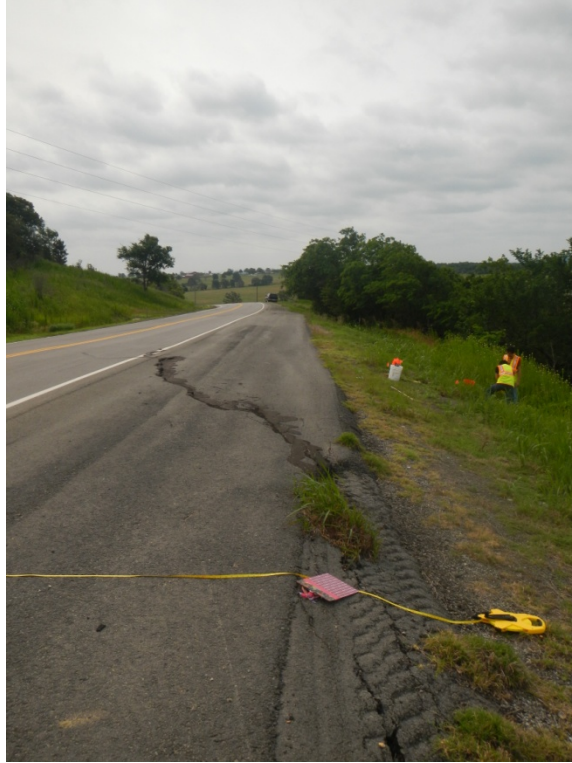
**Figure\_APX\_B 29. Route 9, 1 mile east of Turnpike, road realignment and landslide cracking in new shoulder (old east bound lane) visible.**

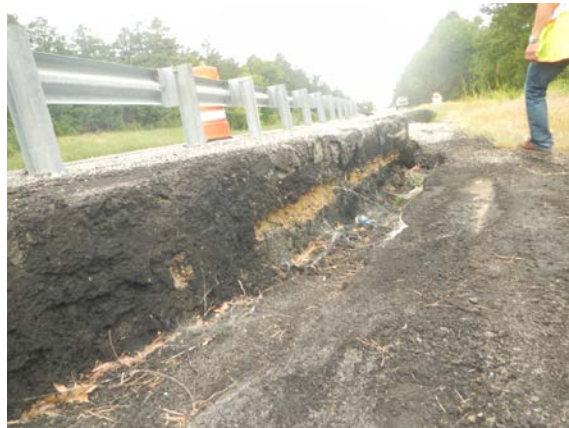
**Figure APX B 31. Route 2, 4 miles south of junction with Route 31, pavement overlay depth in active slide.**

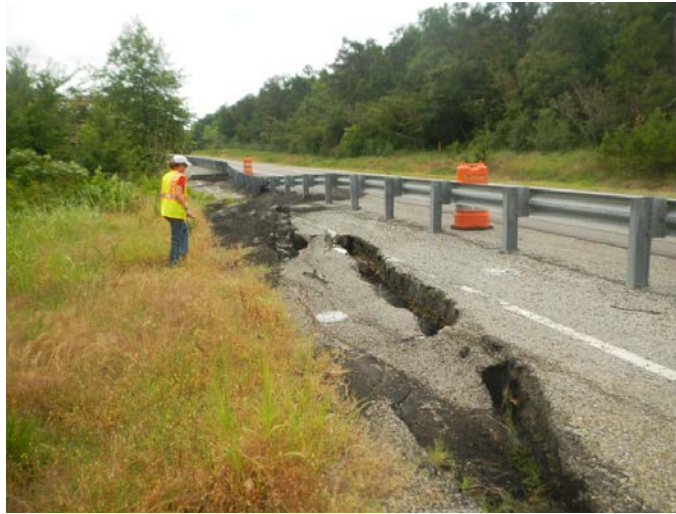
**Figure\_APX\_B 32. Route 2, 4 miles south of junction with Route 31, headscarp in active slide.**

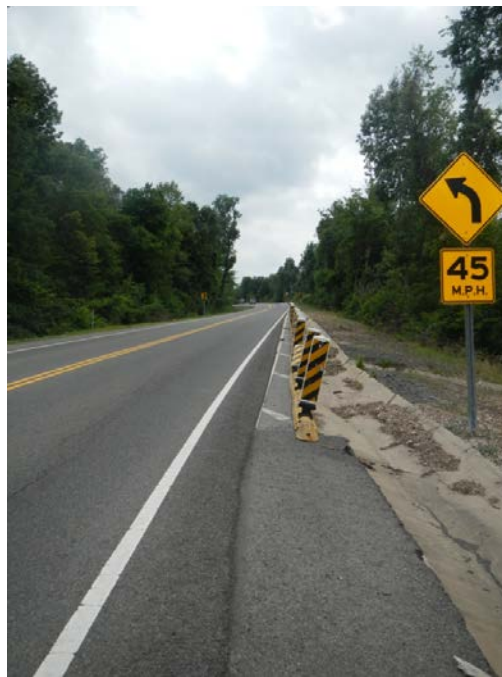
Slide notes: According to the Division 1 maintenance engineer, this is an active slide, where the remediation was large rip rap (3'+) rocks placed at the toe of the slide area, and asphalt overlays to bring the road to the correct elevation. This is still a problem area at the south end of repair. Note cracks appearing in southbound and crossing over into the northbound lane. There are also a concrete ditch and reflective barrier as the guardrail denoting the slide area.

**Figure APX\_B 34.** West side of Route 10, looking south, realignment is evident. Outline of slide is difficult to see.

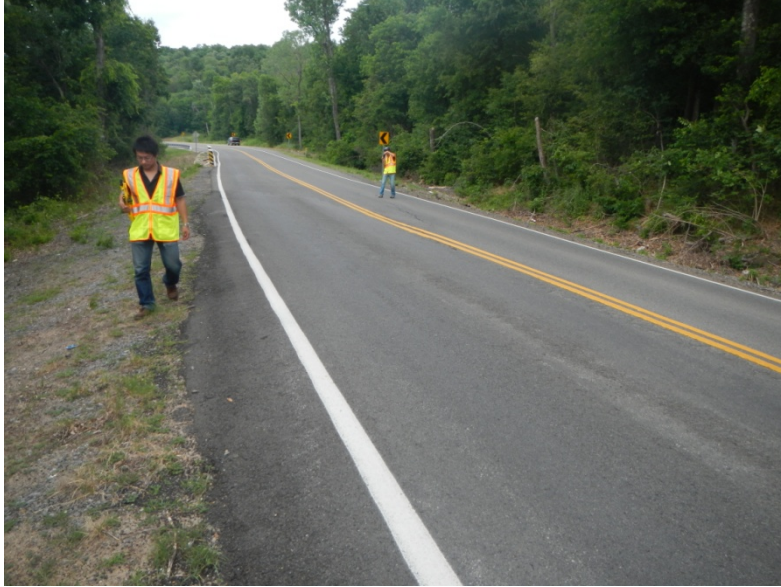
**Figure\_APX\_B 35. West side of Route 10, standing on south side of slide area looking north, new overlay is evident.**

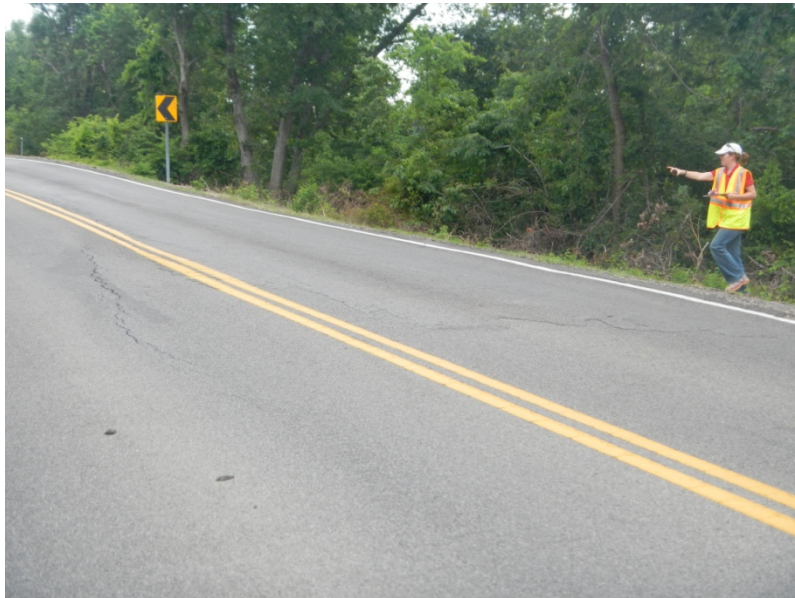
**Figure\_APX\_B 36. West side of Route 10, south side of reflective guardrail, circular cracking is evident. No riprap at toe in this location.**
