FINAL REPORT ~ FHWA-OK-14-06

# REAL TIME MONITORING OF SLOPE STABILITY IN EASTERN OKLAHOMA

January 2014

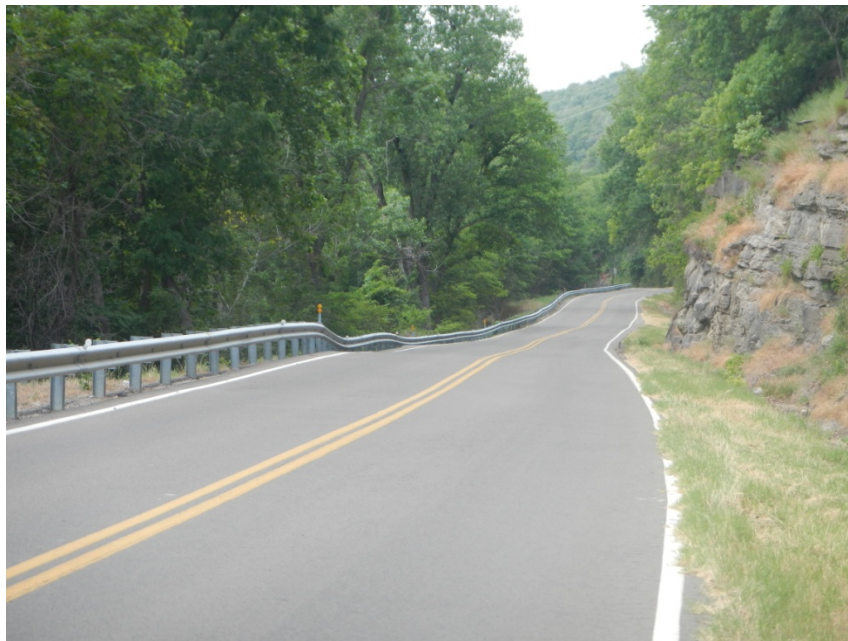
Slide notes: This is a very steep area, with large rock outcroppings on east side of road. Division engineer noted that the road was moved into the mountain (east) in 1988, and rip rap was placed at toe to attempt to stop the sliding. There was approximately 3' of visible asphalt overlays throughout the slide area. The division engineer said the repairs happened years ago (1988), including drainage, beaver slides, and nothing has been done in recent history. This slide seems to be continuing at a very small rate per year.

**Figure APX\_B 37.** Looking toward Fort Gibson Dam, slide is on left (west).

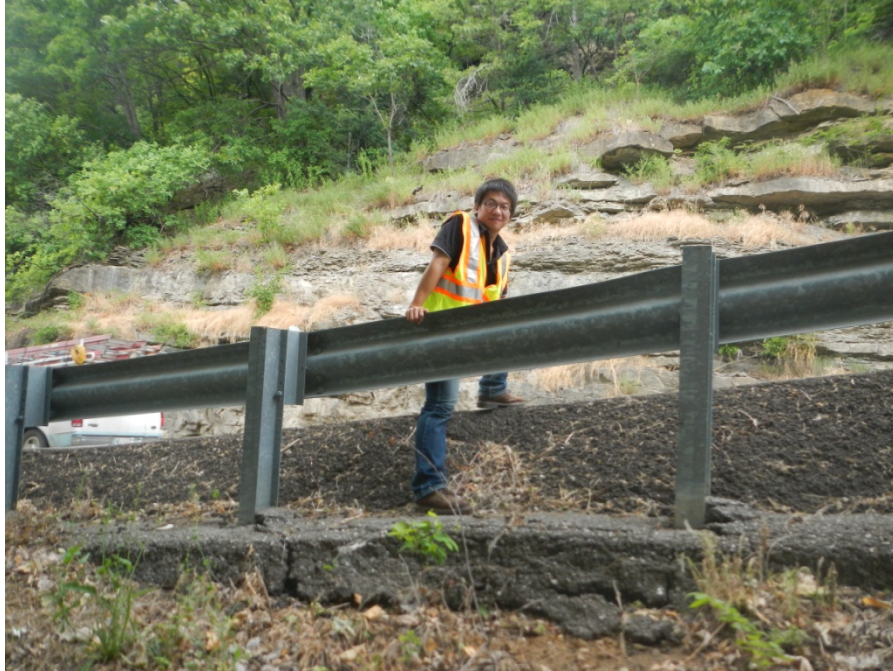
**Figure\_APX\_B 38. Route 80 just south of Fort Gibson Dam, 3' of overlay in middle of slide area.**

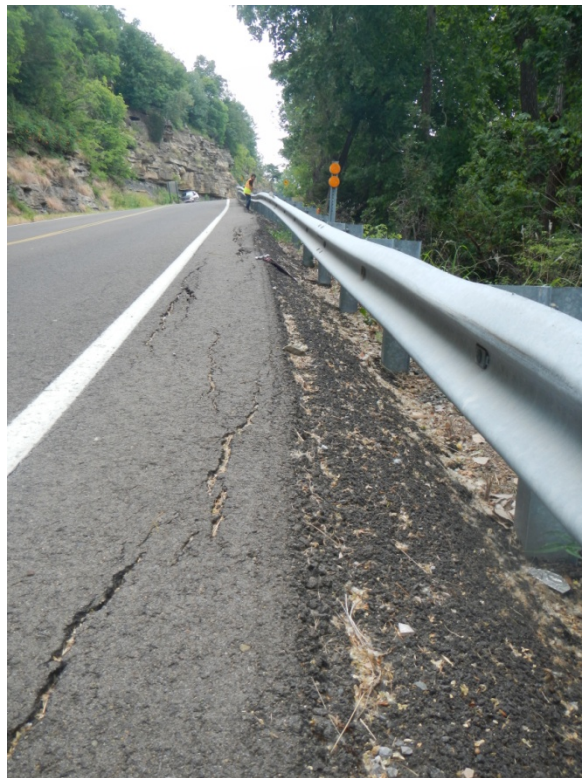
**Figure\_APX\_B 39. Looking south on Route 80 N (away from dam), shoulder cracking is seen, as well as overlay**

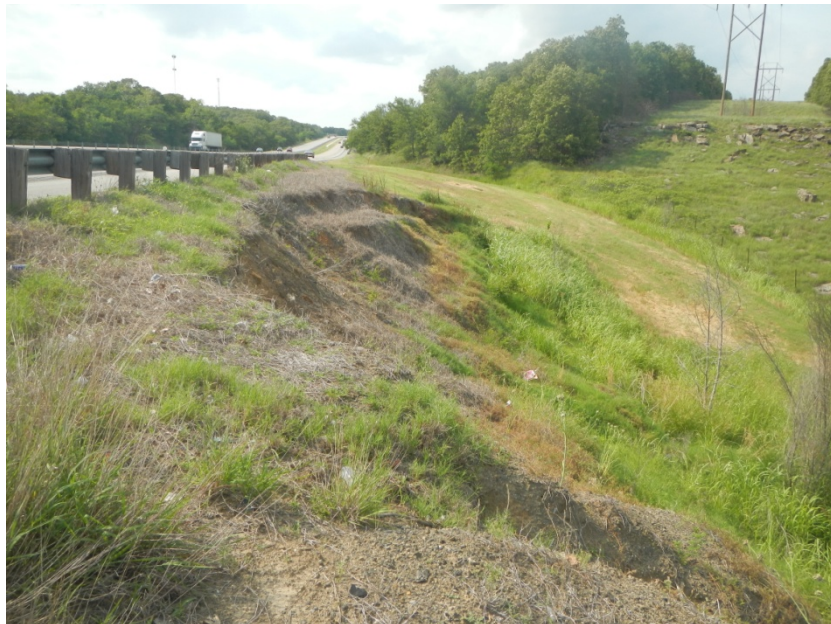
**Figure APX\_B 40.** Route 75, 0.6 miles north of Preston Road, slide area is well defined, toward north end of guardrail, where the natural tree toe support ends.

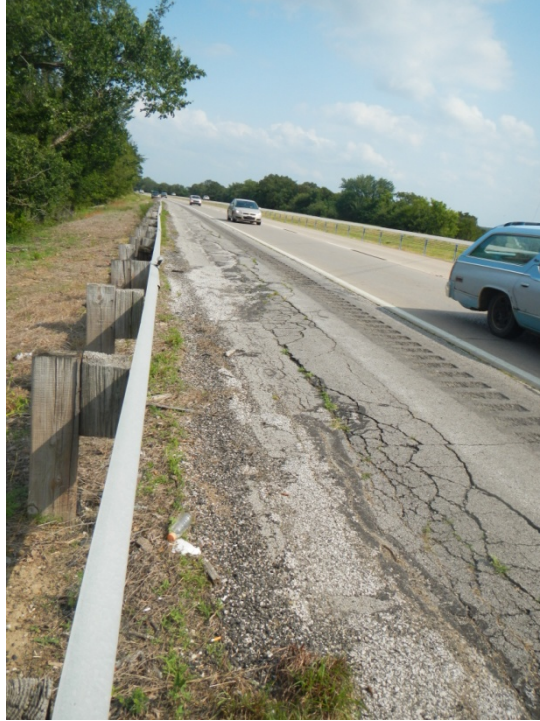
**Figure\_APX\_B 41. Route 75, 0.6 miles north of Preston Road, looking southbound, shoulder cracking is evident.**

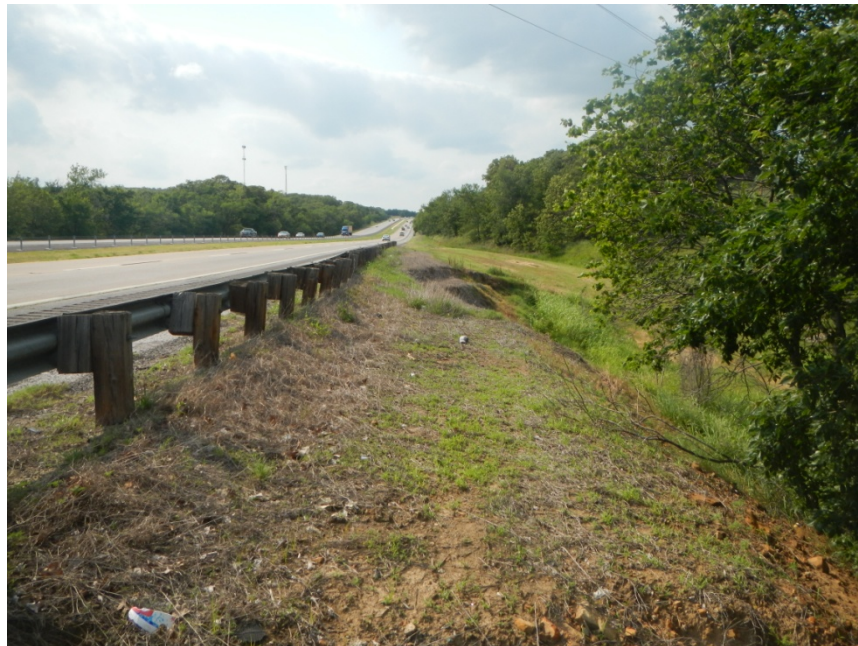
**Figure\_APX\_B 42. Route 75, 0.6 miles north of Preston Road, proximity of headscarp to guardrail. Note end of trees/toe support is where slide occurred.**

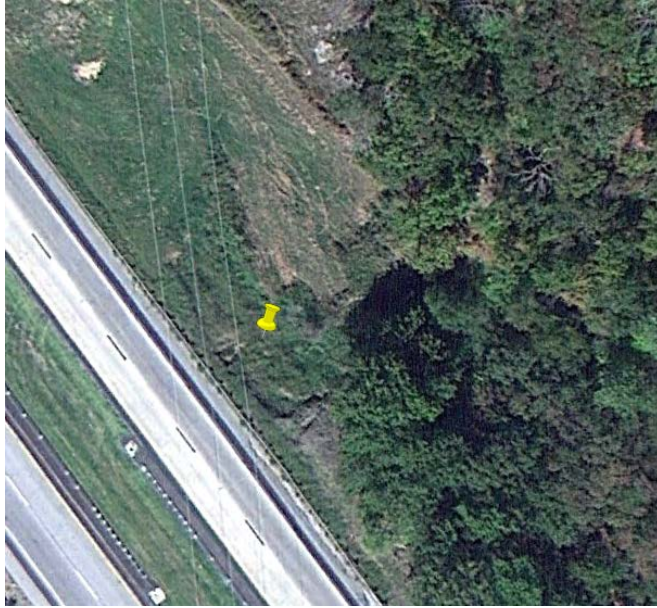
**Figure\_APX\_B 43. Route 75, 0.6 miles north of Preston Road, 2012 Google Earth Satellite Photo of Slide Area.**
