IMPROVING APPROPRIATE TECHNOLOGIES FOR  
SMALL SCALE IRRIGATION IN SEMI-ARID AREAS:  
A CASE STUDY ON MABOTE DISTRICT OF  
MOZAMBIQUE

Submitted to the Faculty of the  
Graduate College of the  
Oklahoma State University  
in partial fulfillment of  
the requirements for  
the Degree of  
MASTER OF SCIENCE  
April, 2011

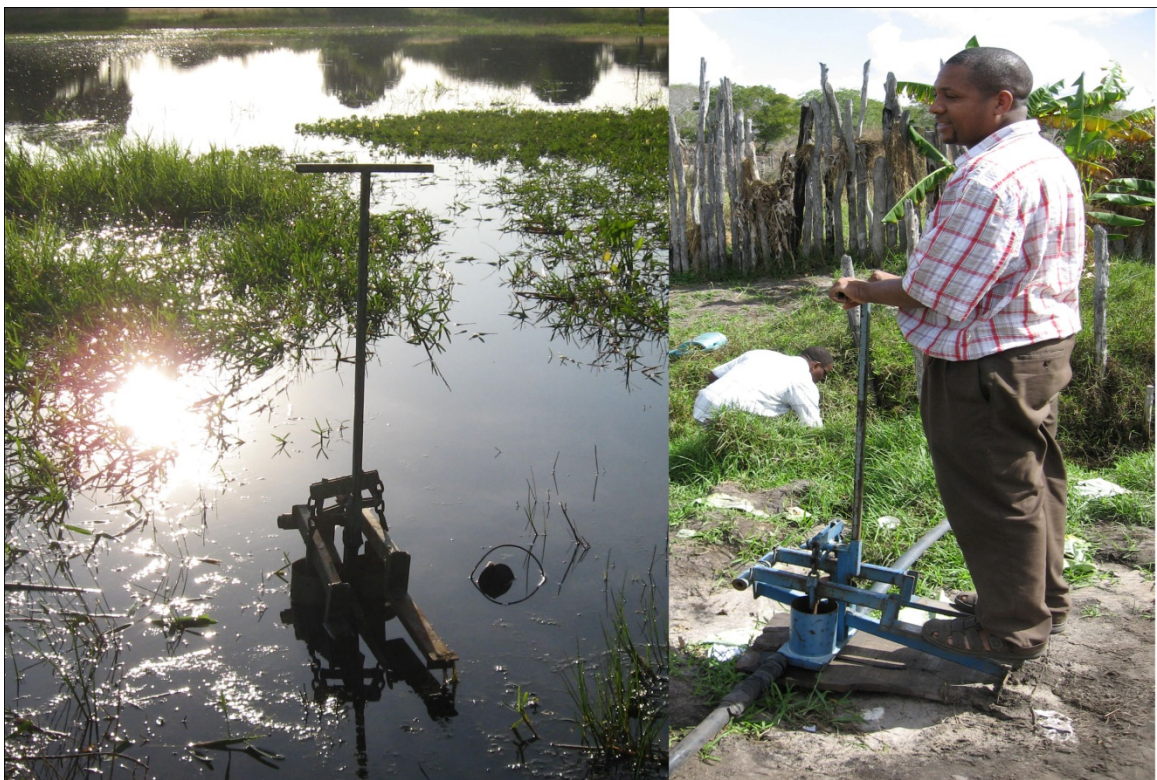
Figure 16: Broken treadle pumps in farmer fields in Mabote district, Mozambique.

Pump durability becomes an issue when breakdown occurs during the cropping season and in remote areas where pump repair may be troublesome due to lack of resources. As an example, the author observed broken treadle pumps in the Mabote district, an inland district from the Inhambane province of Mozambique (Figure 16).

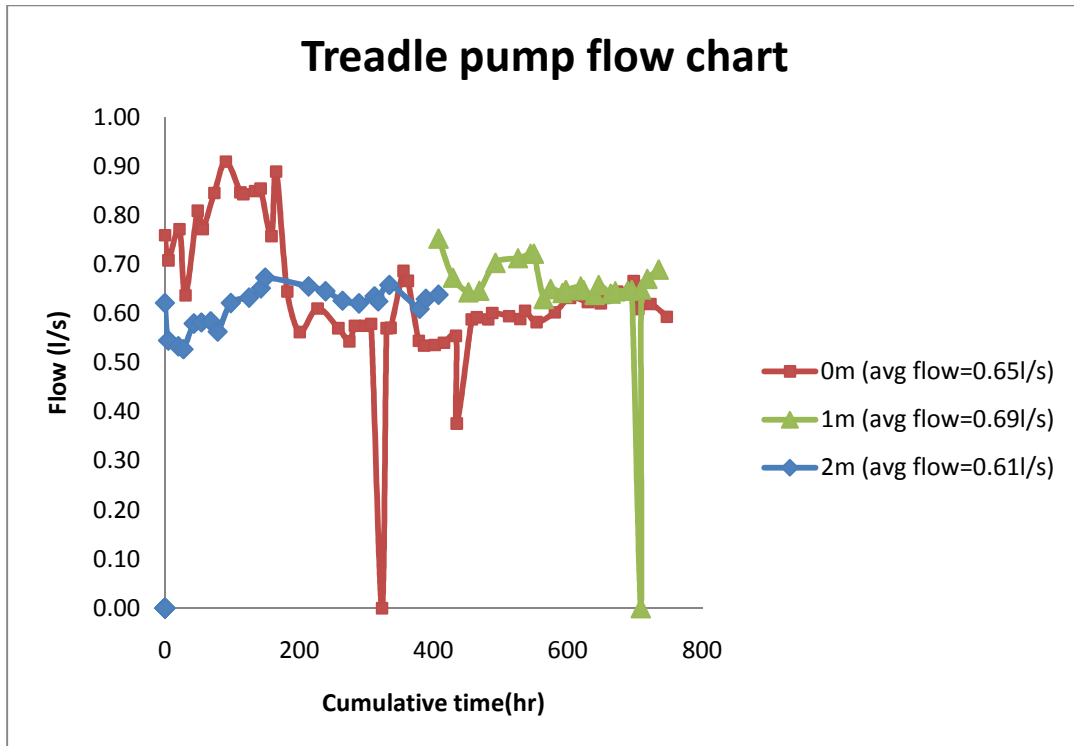
Figure 25: Flow chart for the treadle pump – 0m, 1m and 2m suction lifts.

Figure 25 shows that the flow provided by the treadle pump differed between all suction lifts, though the pump was tested at 33-35rpm for all of them. The lower suction lift provided the lower flow after a flow drop from  $\approx 0.80\text{l/s}$  to  $\approx 0.60\text{l/s}$ , after approximately 200 hours of operation. This goes against the results provided by Faulkner and Lambert (1991) and Faulkner (1991) that showed that flow decreases as the suction lift increases. 1m suction lift provided higher flow when compared to the 2m suction lift, which agrees with the results obtained by the same authors.

Measured pump flows for the treadle and rower pumps, for both testing periods and for the different lifts, are presented in Figures 25 and 26.

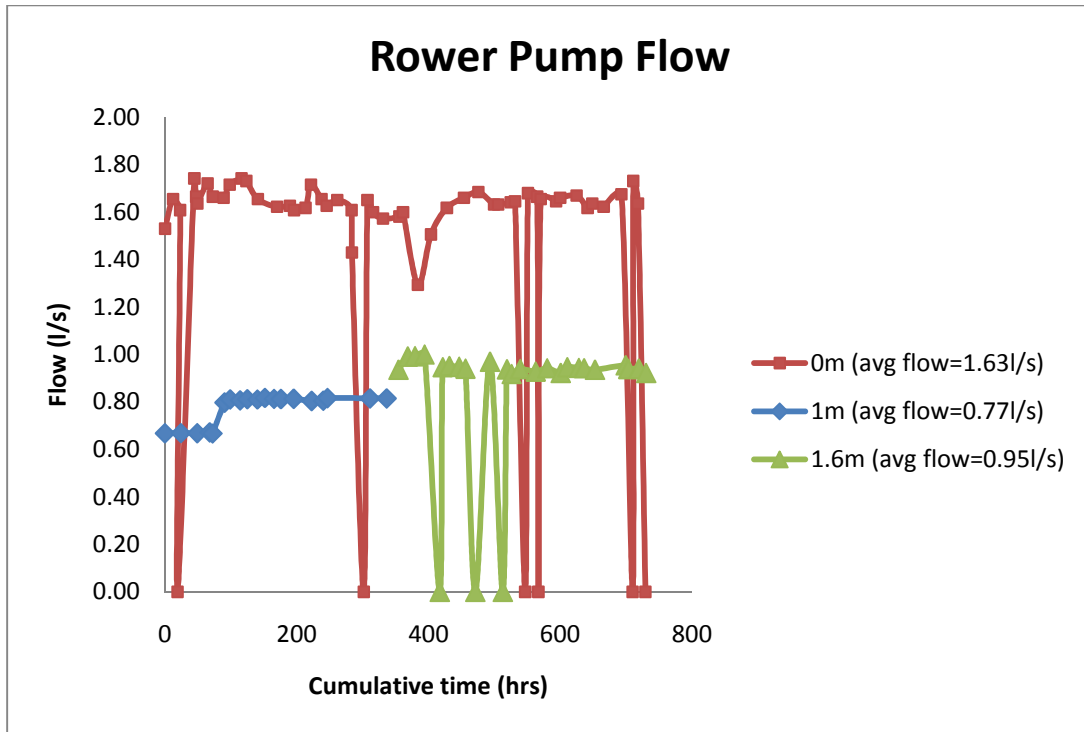
Figure 26: Flow chart for the rower pump – 0m, 1m and 1.6m suction lifts.

The electric motor used (which provided 13rpm) with the CPOA for the rower pump broke down at the end of the first testing period and was replaced by an electric motor that provided a lower rpm (6.5rpm). As a result, the testing for 1m and 1.6m suction lifts were performed on a different rpm and therefore the flow readings had to be adjusted for analysis. Because the rpm reduced by half, the flow readings were multiplied by a factor of two.

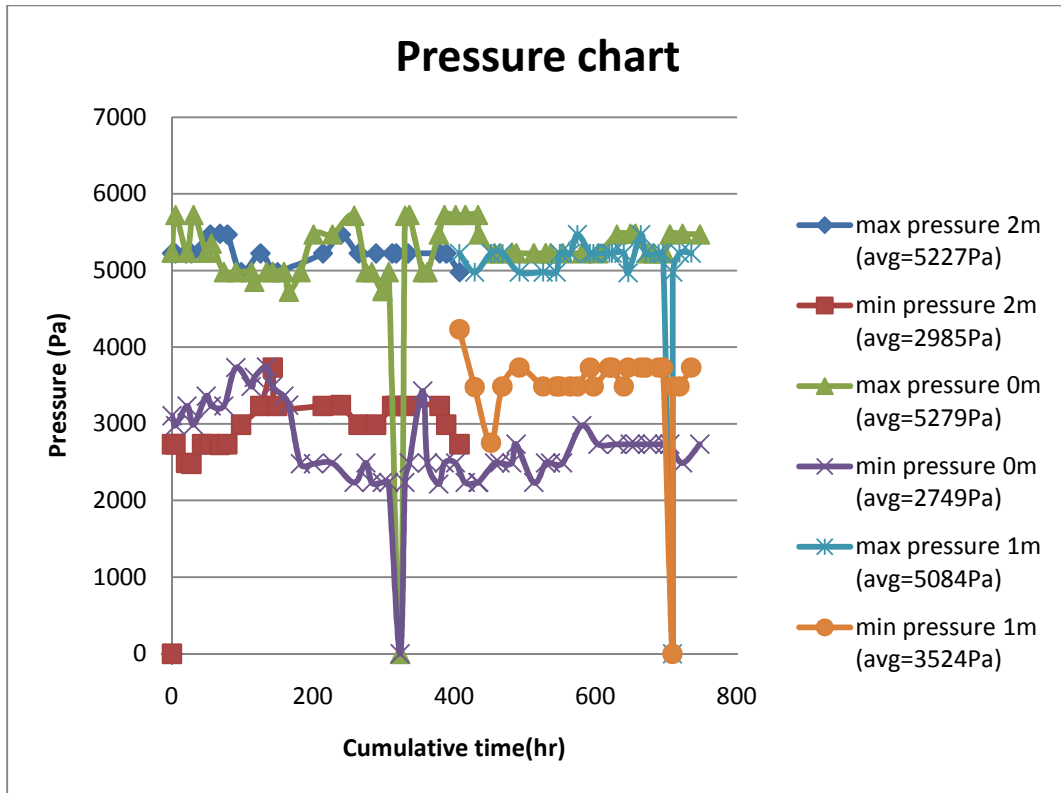
Figure 27: Treadle pump pressure – 0m, 1m and 2m suction lifts.

During pump operation it was noted that the water height in the manometer varied throughout strokes. As a result, the minimum and maximum values were recorded at each data collection event. From Figure 27 we can extract that the pressure differed for each suction lift, but the maximum pressure varied slightly when compared to the variations in flow. On the other hand, the minimum lift followed the same variation pattern as the flow measurements, and therefore, we can assume that this is the real pressure delivered by the treadle pump. The minimum pressure showed that the pump was able to create enough suction to move the water from the water source to the outlet and provided enough pressure at the outlet to provide pressurized discharge. Though the pressure was maintained throughout testing, it was noted that more effort was needed for 2m suction lift, where pump priming required a higher operation speed. The pressure drops presented in Figure 27 also indicate changes in pump performance and part failure, which are discussed next.

Variation in pump pressure at the treadle pump outlet was recorded. The results are presented in Figure 27.

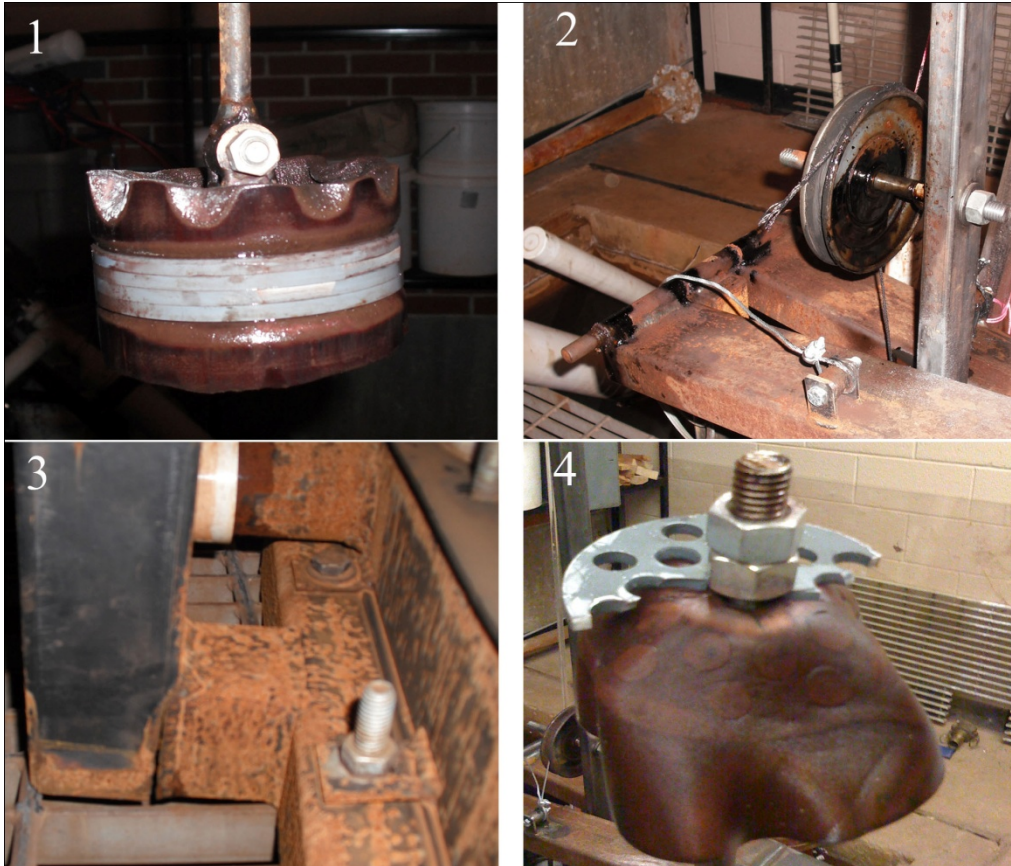
Figure 28: Broken parts: 1-treadle piston with damaged leather cups; 2- treadle pulley assembly with broken cable; 3-treadle body with broken support; 4- rower piston with broken disk.

According to Table 5, though the number of occurrences was low, the parts that failed were the pistons for both pumps and the pulley wire for the treadle pump resulting in damage to the treadle pump body. All these events resulted in pump breakdown, excepting the second piston failure for the treadle pump which led to a drop in pump flow due to leakage in a piston. Note that the piston cups were made of leather, a good alternative material considering that it is a byproduct of cattle production, and therefore, its availability could be guaranteed, as opposed to rubber cups whose assembly and purchase can be difficult in remote areas. The cups failed at around 150-200hrs of

For the rower pump, piston failure was caused by a broken disc (see piston schematics for details). This problem was determined to have been caused by an assembly error where a washer with a wrong size was used, resulting in more stress to the disc which led to its failure. This problem was solved by replacing the disc and assembling it with a suitable washer. This occurrence supports Kay and Brabben (2000) findings, who stated that evaluation of such devices can be hindered by differences in design, materials used, dimensions of components and manufacture standards.

Valves and seals performed well for both pumps during both test periods, which is a good result when we take into consideration the simplicity of the designs used. Figure 28 shows a composition with the different parts that broke.

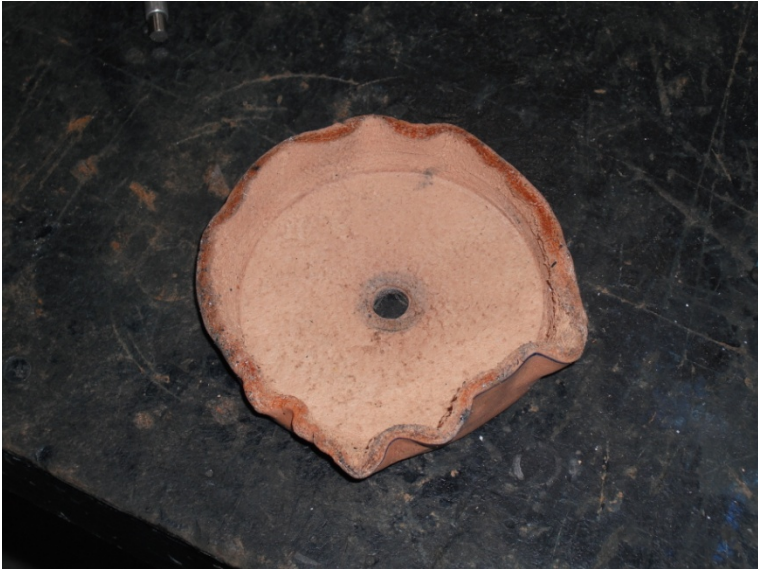
Figure H: Piston cup in PVC cylinder.
