Mass wasting as a geologic hazard in the Province of Salta, Argentina

William J. Wayne

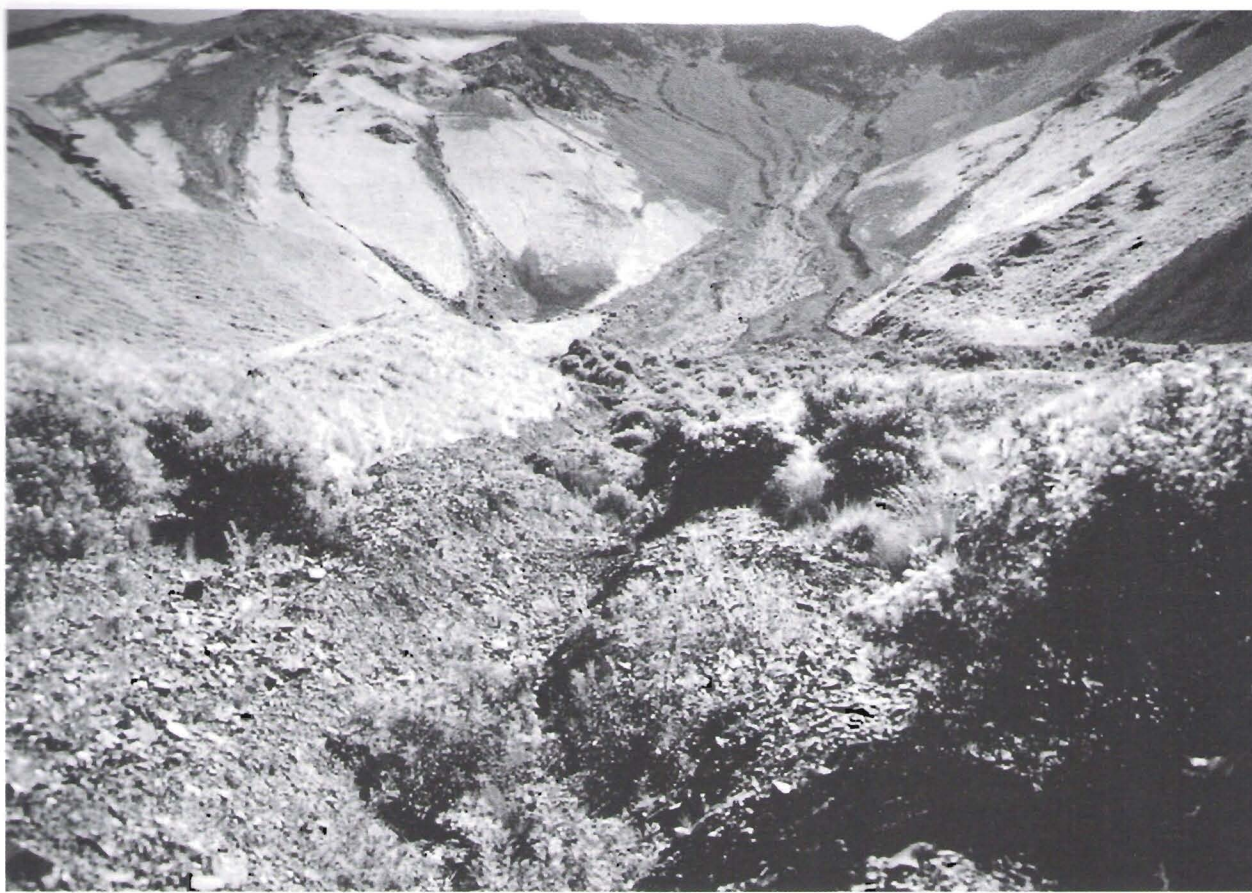
Figure 2. Small debris flows produced by an intense rainfall on colluvium-filled hollows in the headwaters of río Escopeo.

slates, phyllites and graywackes of the Upper Precambrian/Lower Cambrian Puncoviscana Formation and related igneous rocks (Salfity et al. 1998). These low grade metamorphic rocks have been folded and faulted; thus they are highly fractured. In the frost-dominated climate above 3500 m. they weather readily to angular rock fragments in a matrix of silt and sand-sized particles. This rock debris covers most of the slopes and moves slowly downward into swales at the heads of ravines, where it becomes mobilized into debris flows during episodes of heavy precipitation in early summer. Airphoto review and field observations indicate the existence of many colluvium-filled hollows in the higher parts of both the Cordillera Oriental and Calchaquenia that are underlain by the Puncoviscana Formation. These thick accumulations that result from creep and solifluction of frost-shattered rock (Fig. 2) provide source material for potentially destructive debris flows.

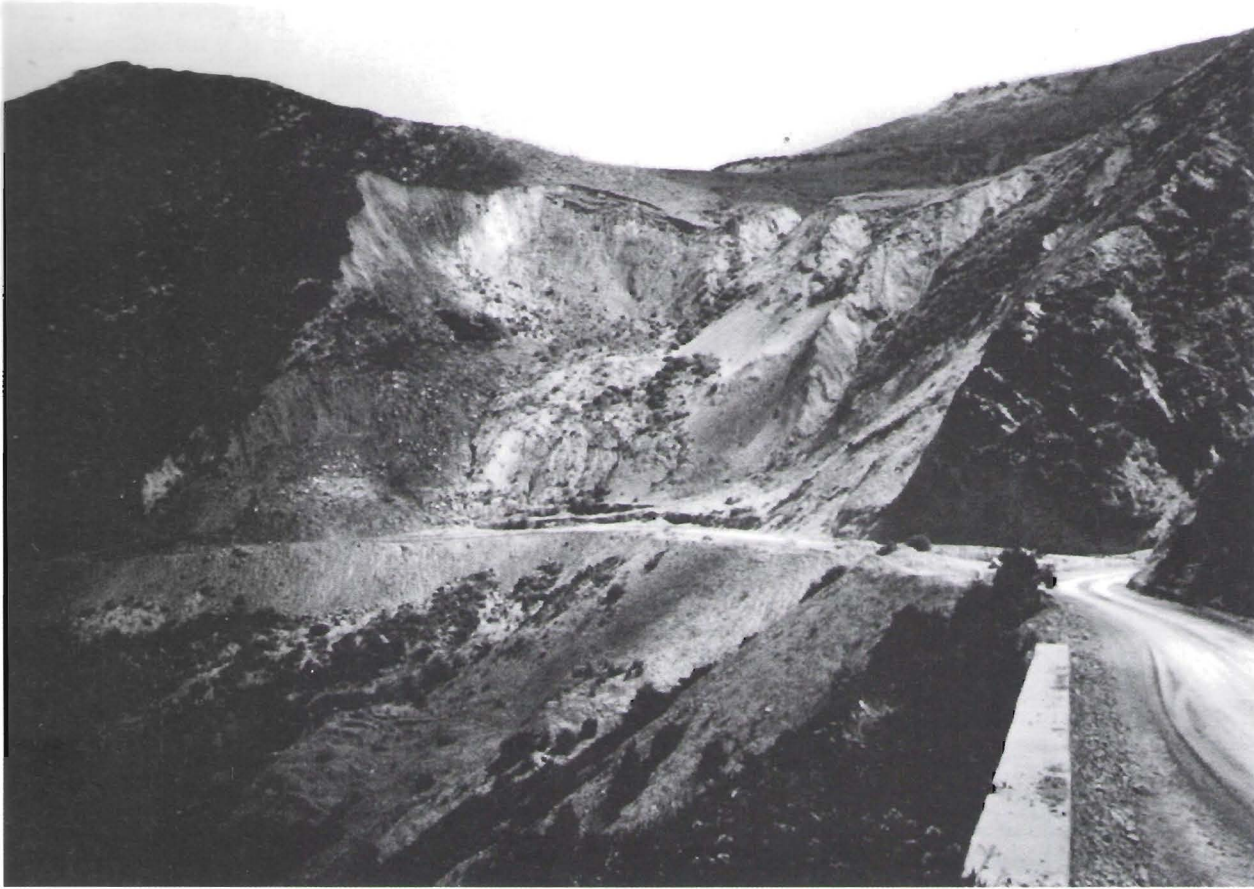
Figure 4. Slump blocks at the top of the active slump/earthflow that is crossed by the Chicoana-Cachi highway.

Two active earthflows were recognized in this study; both are on the slopes of the Cuesta del Obispo, but only one crossed repeatedly by route 33 constitutes a hazard. This earthflow is stable during the dry months but moves slowly in summer. Rainfall saturates the gravel in the slumped surface at the top of the earthflow and the water is transmitted downward through the permeable material to the highly broken sedimentary rocks beneath. Drainage of water from the surface of the upper displaced block would reduce the amount available to infiltrate the flow, and emplacement of horizontal conduits in the flowing mass beneath the top may reduce the water content to slow the flowage significantly, perhaps even stabilize it, thus reducing the annual costs of maintenance of the road (Gedney and Weber 1978).
