EVALUATION OF SURFACE PREPARATION AND BOND ANGLE
COMBINATIONS FOR JOINT REPLACEMENT USING ULTRA-HIGH
PERFORMANCE CONCRETE

A THESIS

A THESIS APPROVED FOR THE
SCHOOL OF CIVIL ENGINEERING AND ENVIRONMENTAL SCIENCE

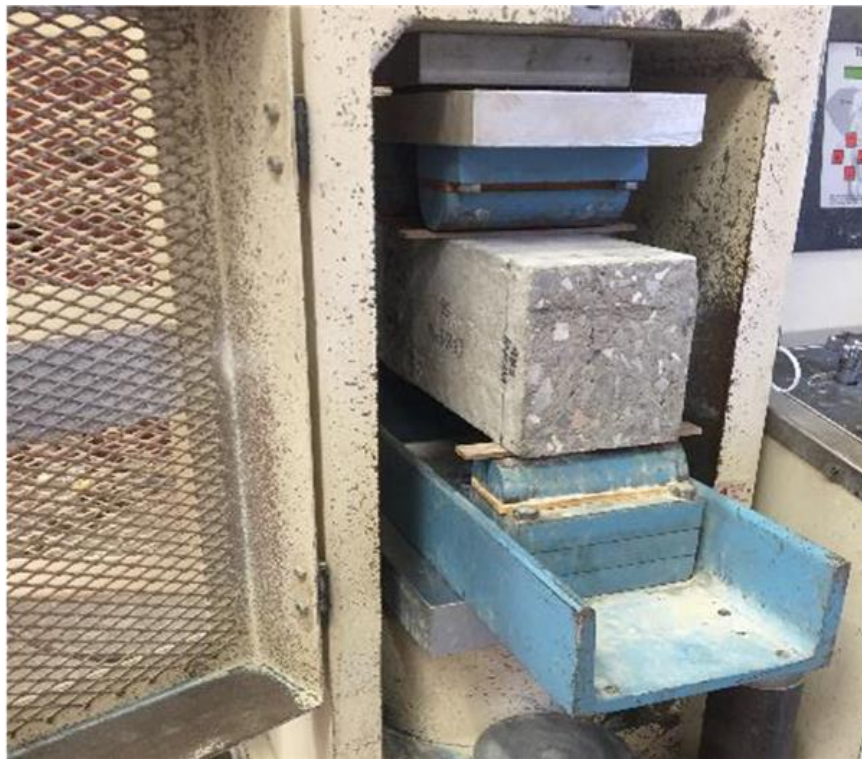
Figure 23. Testing setup for composite MOR specimens

All of the composite MOR specimens were tested as simple beams with third-point loading in accordance with ASTM C78 once the UHPC portion reached 28 days of age. This testing was done using a Forney testing machine and the apparatus shown in Figure 23. The purpose of this test was to determine flexural strength and evaluate the effects, if any, each tested variable had on the flexural strength at the interface. At failure, a caliper was used to take measurements of the exact length and width of the failure surface. If the specimen failed along the interface, length and width measurements were taken for both sides of the specimen. These measurements were used to calculate the flexural stress at failure. In the instance of interface failure with two sets of measurements, the lowest flexural stress value was recorded.

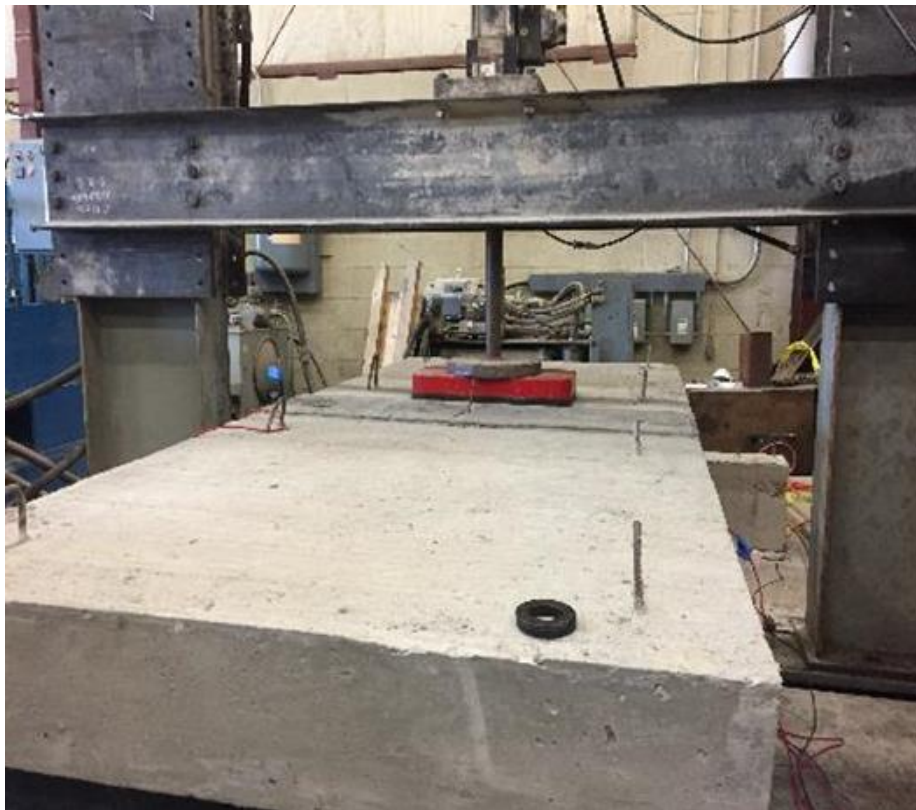
Figure 31. Testing setup for slabs

calculated cracking moment. Initially, the calculated cracking moment was determined to be 13.9 kips, for which the applied cyclic load was 12.5 kips. Because the testing setup varied slightly from that assumed for initial calculations, the load was lowered to 9 kips for the first 3 million cycles. After the first 3 million cycles, the load was to be increased to a maximum load 5% greater than the load corresponding to the calculated cracking moment (14.6 kips) with the same instrumentation for 2 million more cycles (or until failure). Testing was stopped and restarted once each day due to data storage limitations. After 5 million total cycles, the slab was to be statically loaded to failure (if not already failed). Figure 31 depicts one of the slabs prior to testing.

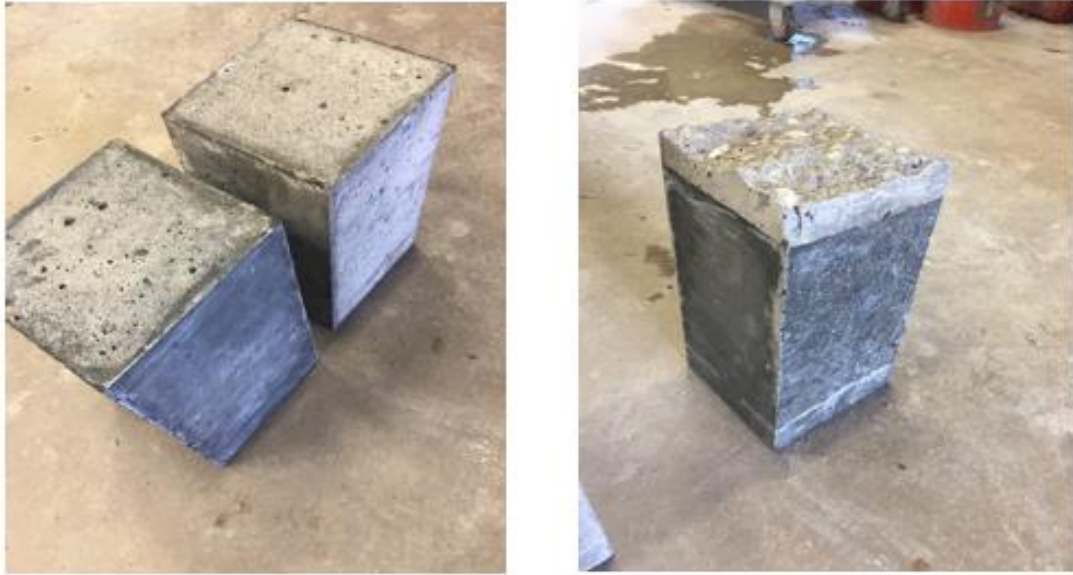
Figure 32. Interface failure (left) and base concrete failure (right)

Tables 13-16 contain the results for each individual specimen with relation to its interface configuration and surface preparation. For each specimen, WB indicated wire brushed, SB indicates sand blasted, and EA indicates exposed aggregate. Almost all specimens failed in the base concrete. The three specimens that failed at the interface were all 90 degree wire brushed specimens. The 90 degree specimens had 5 wire brushed specimens and 3 sand blasted specimens, contrary to the original casting plan seen in Table 5. Figure 32 shows the two different failure types.

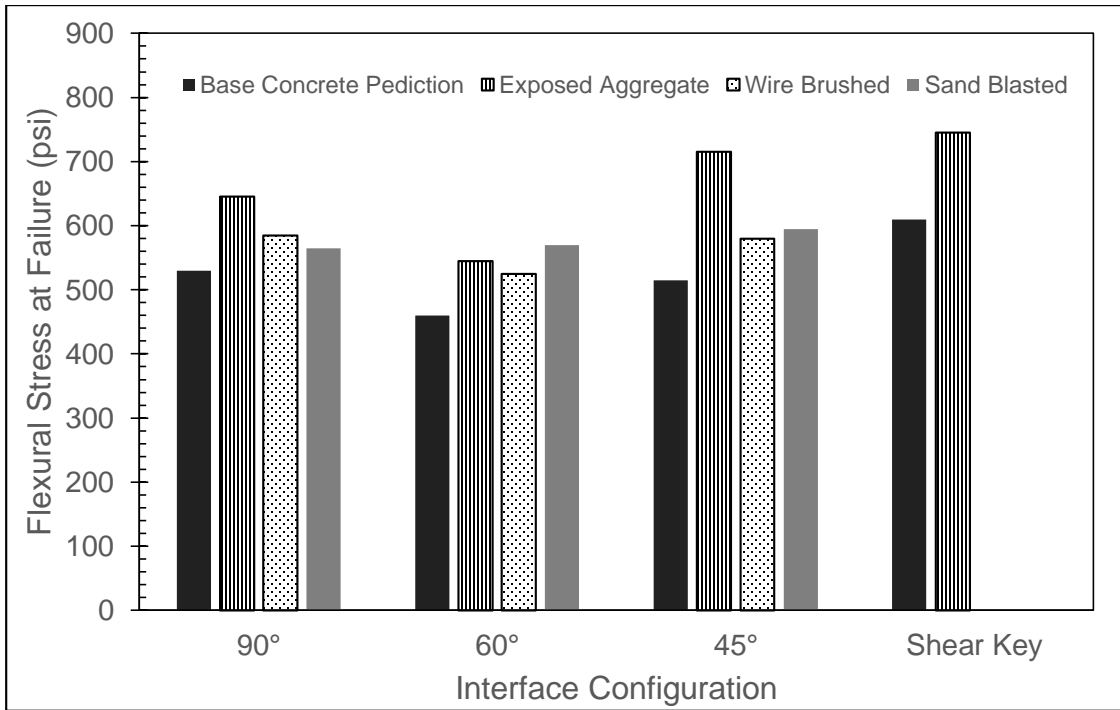
Figure 34. Average Maximum Flexural Stress vs. Interface Configuration with adjusted values

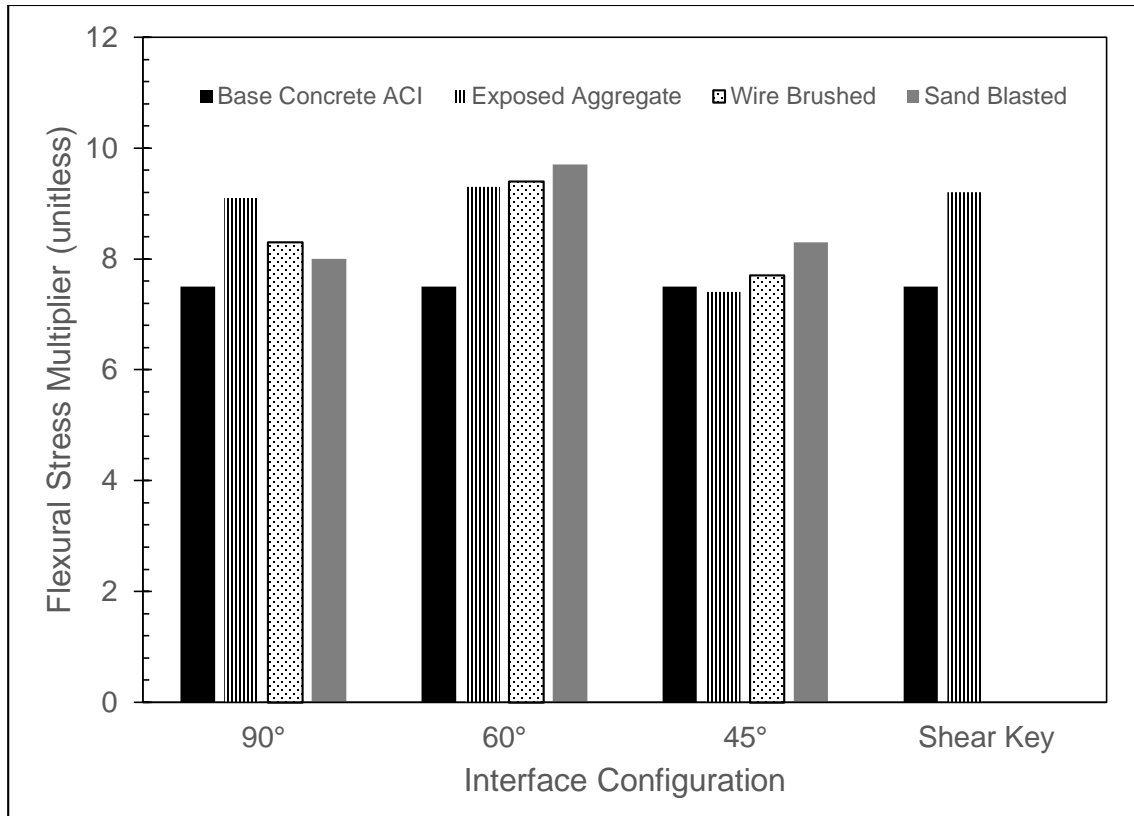
Figure 35. Flexural Stress Coefficient vs. Interface Configuration including all values

In Equation 2, the normalized flexural stress coefficient is 7.5, which is based on a large quantity of experimental results. Figure 35 depicts the normalized flexural stress coefficients for all the values (including the two unusual values previously mentioned) based on the MOR measured for the specimens and the compressive strength of the NSC portion. The MOR calculated from the measured results was divided by the square root of the compressive strength in order to obtain the normalized values. When comparing the normalized results, it appears that the 60 degree specimens had higher average flexural stress coefficients than the other interface configurations indicating slightly better performance.

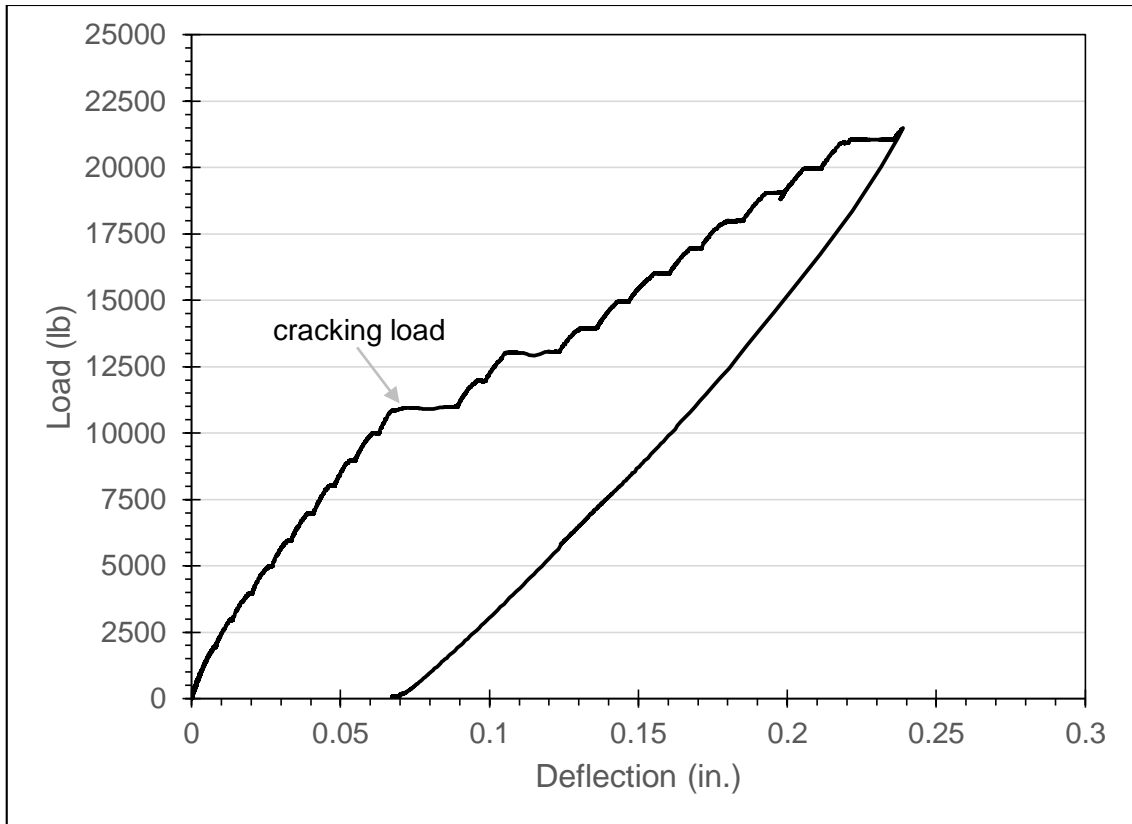
Figure 37. Load vs. Deflection curve for slab 1, part 1

The maximum load reached by slab 1 before proceeding to part 2 of testing was approximately 21.3 kips. Because of the loading limitations of the MTS system, the test was stopped at this point. The first cracks were observed in the base concrete during part 1 of the test at a load of approximately 14 kips. This cracking load was determined at the time that the first crack became visible to the naked eye. Further analysis suggests the first crack may have occurred before the load reached 14 kips. Figure 37 depicts the load vs. deflection curve for slab 1 part 1. This curve shows that initial cracking occurred at approximately 10.9 kips, rather than the visually determined 14 kips. This was determined by locating the point in the load vs. deflection curve where the deflection experienced an increase, but load did not. At this point, the slope of the remaining portion of the curve became less steep. The load corresponding to the calculated cracking moment for a monolithic NSC slab with the same reinforcement and dimensions was originally calculated to be 13.9 kips, but after further evaluation, it was estimated to be 11.7 kips (calculations in Appendix C). This calculation was performed using the measured value for the compressive strength of the NSC portion of the slabs and the span of the specimen setup. The graphically determined cracking load of 10.9 kips is less than the expected 11.7 kips. This could potentially be attributed to variability in concrete tensile strength or the method of graphically determining this value. Upon unloading the specimen, the magnitude of total deflection decreased back down to a residual deflection of approximately 0.07 in.

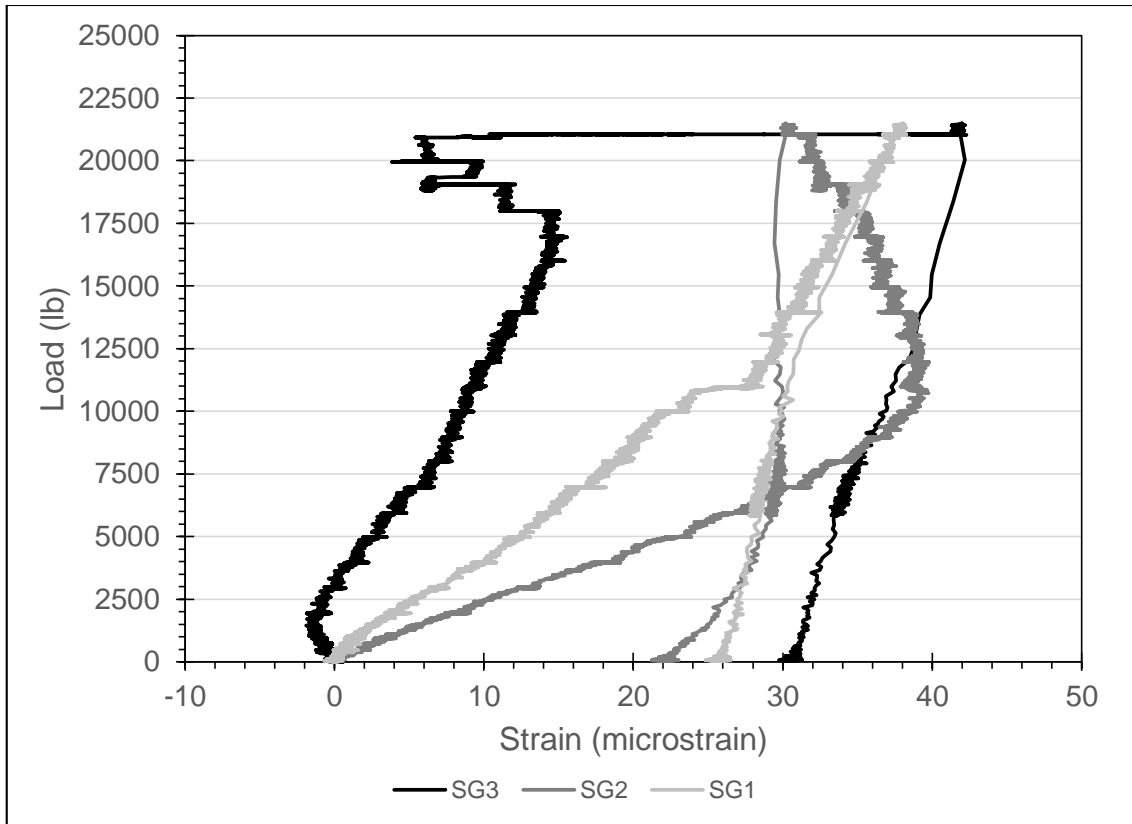
Figure 38. Load vs. Strain curve for slab 1, part 1

Figure 38 depicts the load vs. strain curve for strain gages 1-3 for the first portion of loading. Refer to section 3.6 for strain gage locations. Strain gage 4 is not included because it produced unreliable results. The general trend for these curves is that the strain increases with increasing load until cracking of the slab releases tension in the area of the gage. The maximum microstrain values for the strain gages are slightly less than the tensile strain in the concrete at cracking, but the values are generally in a reasonable range (less than 100 microstrain). Strain gages 1 and 3 are somewhat unclear, but strain gage 2 shows a good representation of this behavior, confirming that the first crack occurred at approximately 10.9 kips.

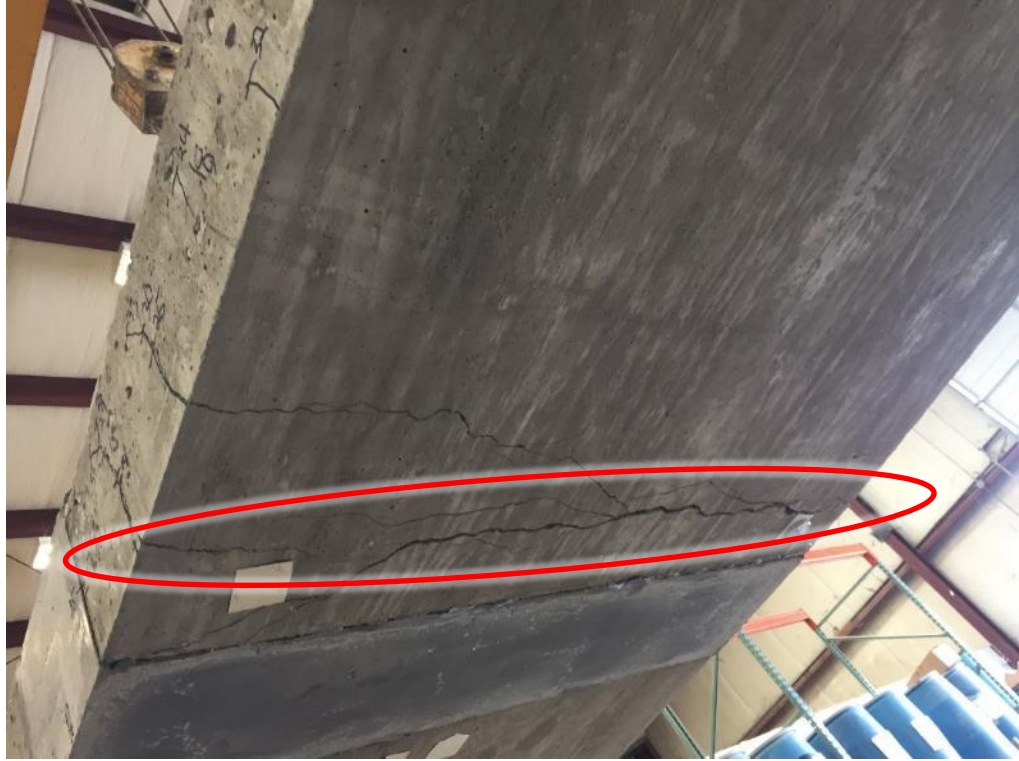
Figure 41. Major cracking underneath load point for slab 1

The major crack at failure occurred in the base concrete directly below the load point, at approximately 5 inches away from the interface between the UHPC and the NSC (directly beneath the load point). There was also minor separation at the interface closest to the load point. Some of the cracks can be seen in Figures 41-43. These cracks followed a logical progression moving outward from the load point as load increased.

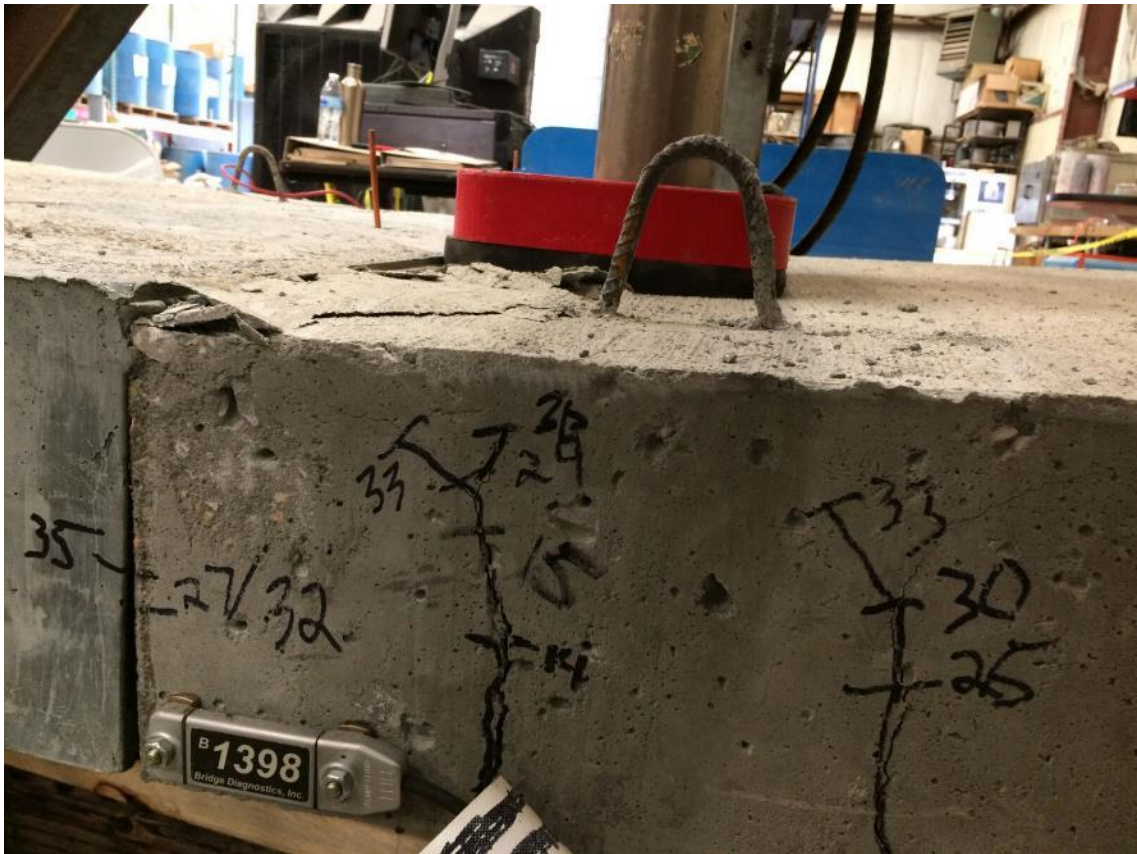
Figure 43. Cracks formed underneath load on south side of slab 1 and concrete crushing at the top compression fiber

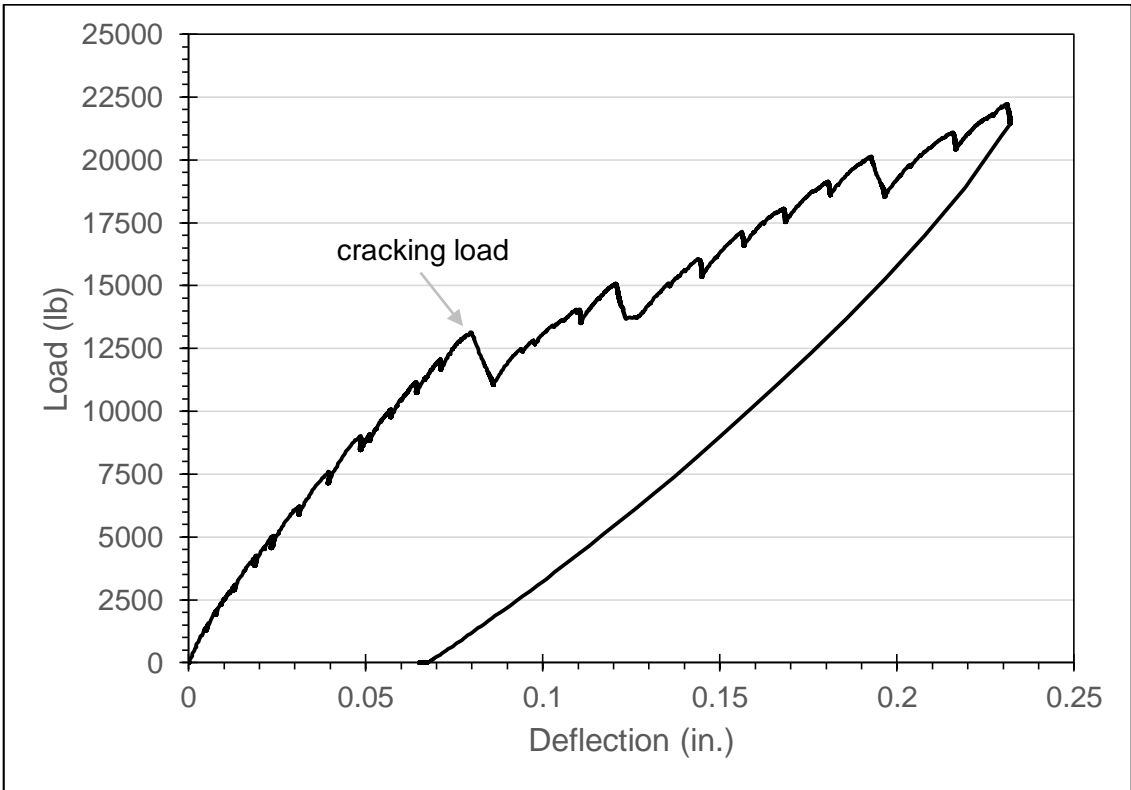
Figure 44. Load vs. Deflection curve for slab 2, part 1

visually determined 14 kips. This was determined by locating the point in the load vs. deflection curve where the deflection experienced an increase, but load did not. At this point, the slope of the curve became less steep. The calculated cracking load for a monolithic NSC slab with the same reinforcement and dimensions was estimated to be 11.7 kips. Upon unloading the specimen, the magnitude of total deflection decreased from the maximum observed back down to a residual deflection of approximately 0.067 in. Figure 45 depicts the load vs. strain curve for the first portion of loading for slab 2. Again, while strain gages 1 and 3 are not generally useful, strain gage 2 confirms that initial cracking of the specimen likely occurred at a load of around 13.1 kips, rather than the visually determined 14 kips.

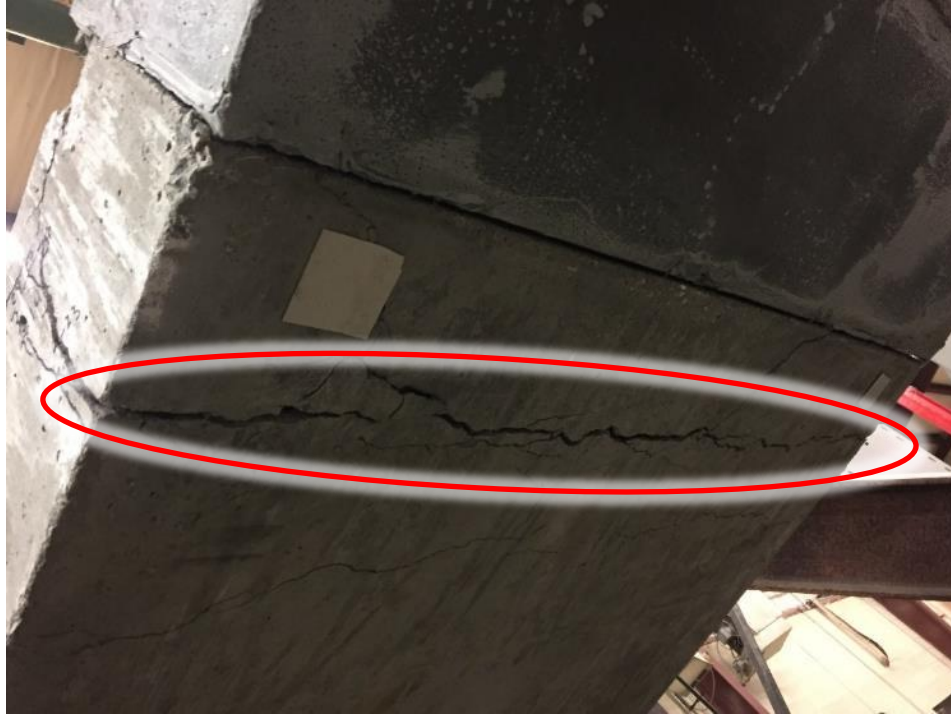
Figure 48. Major cracking underneath load point for slab 2

At failure, there were no observed cracks within the UHPC joint itself. The major crack at failure occurred in the base concrete near the load point, at approximately 6 in. away from the interface between the UHPC and the NSC (1 in. east of the load point). There was also minor separation at the interface closest to the load point. This separation at the interface was only visible during loading and could not be seen once the load was removed from the slab. Some of the cracks can be seen in Figures 48-50.

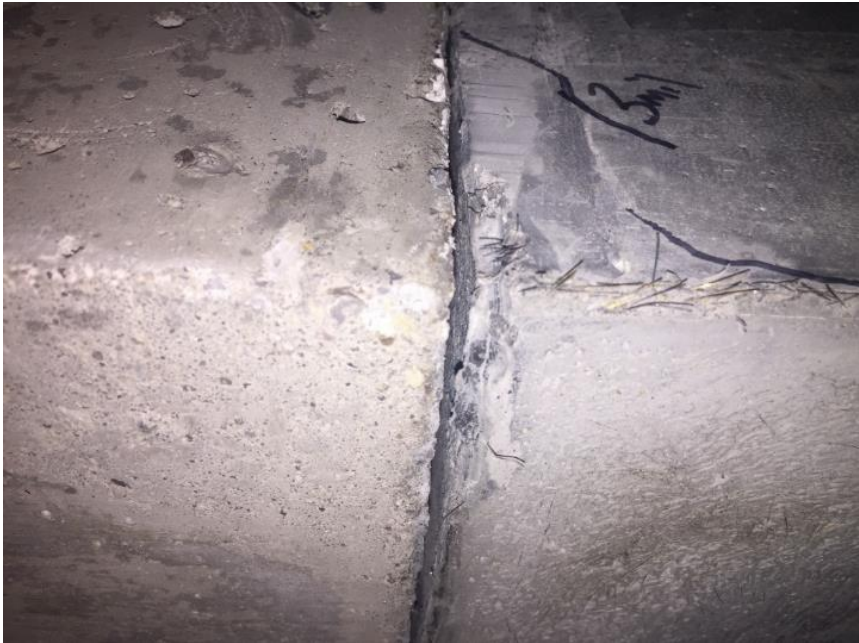
Figure 76. Crack at interface on north side of slab after fatigue loading

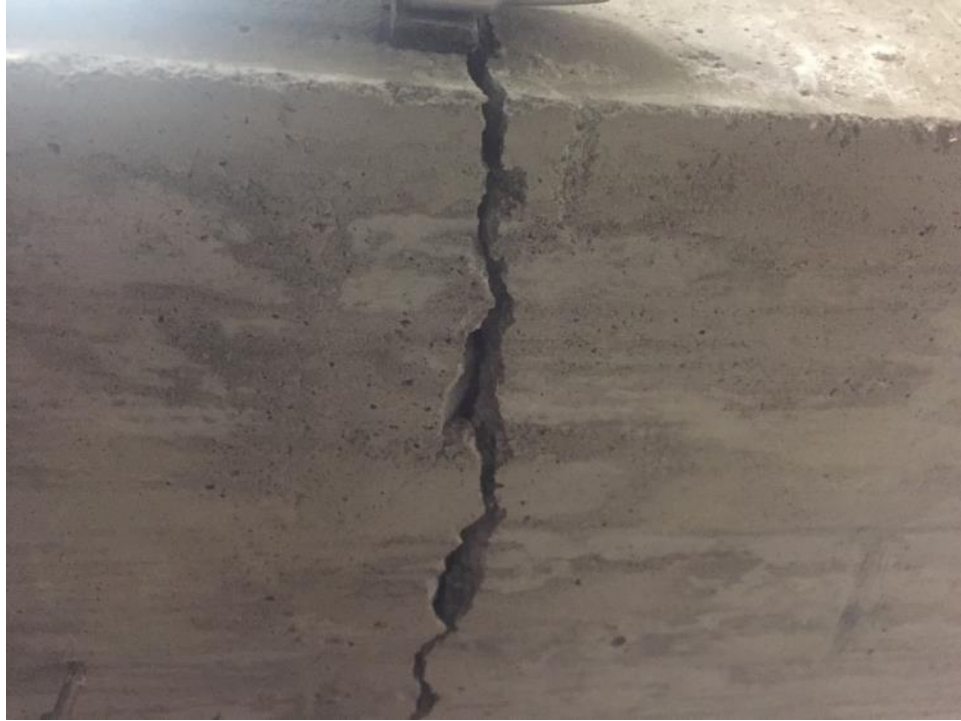
Figure 77. Crack in base concrete on south side after fatigue loading

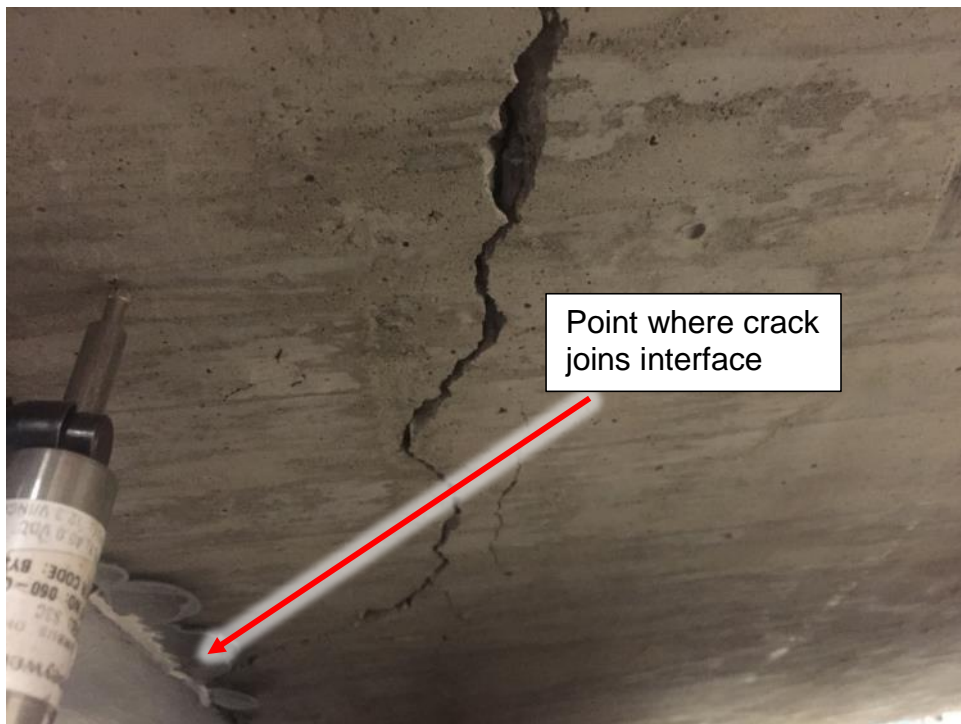
Figure 78. Path of crack underneath slab from base concrete to interface

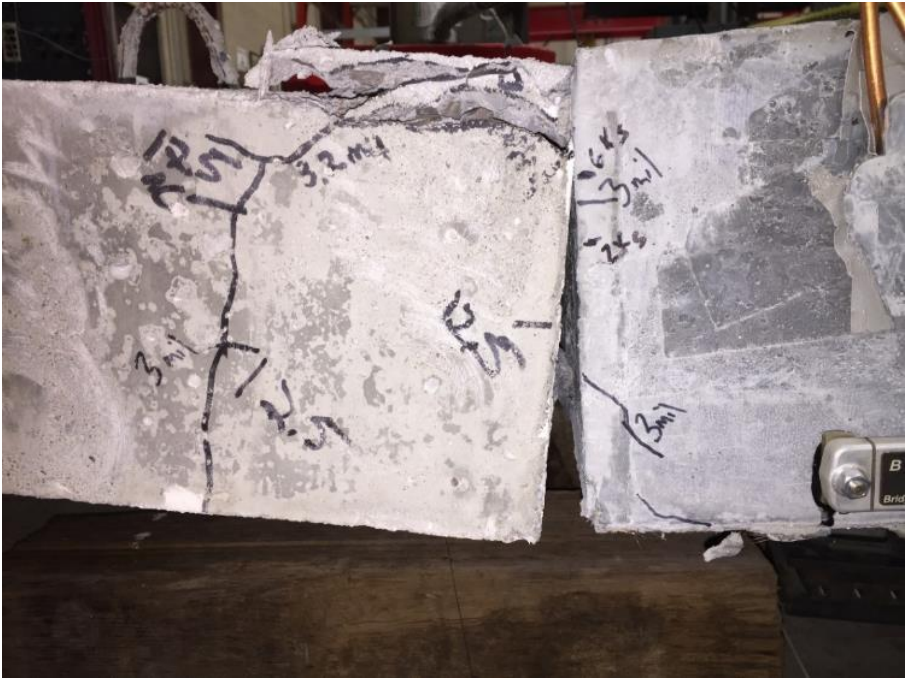
Figure 82. Crack at interface on north side of slab after final static loading and crushing of the top compression fiber in the base concrete

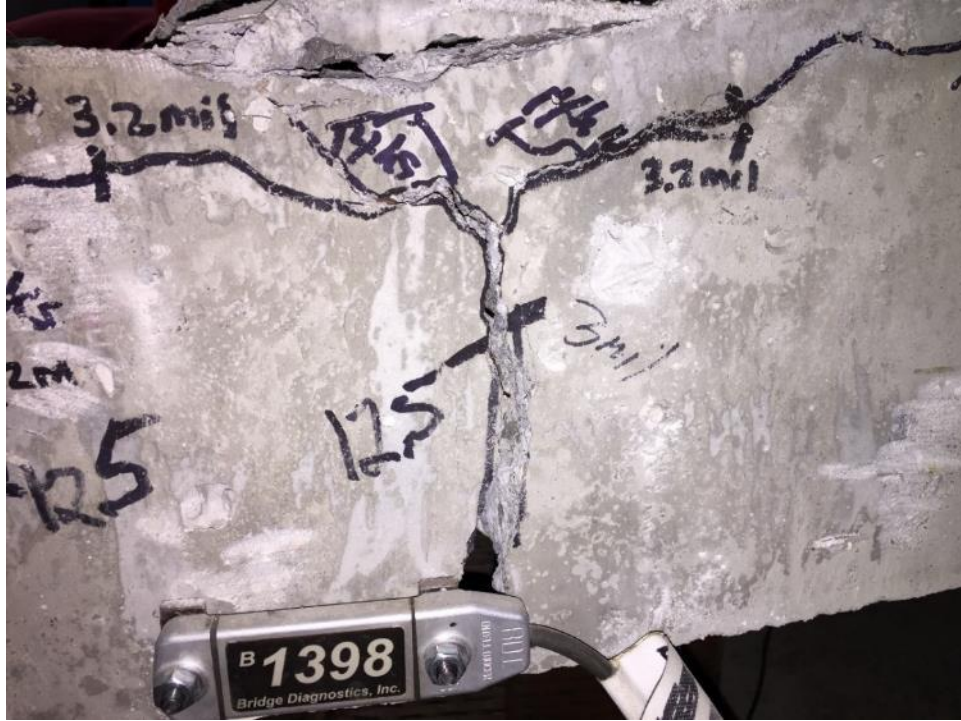
Figure 84. Crack in base concrete on south side and crushing of the top compression fiber after final static loading

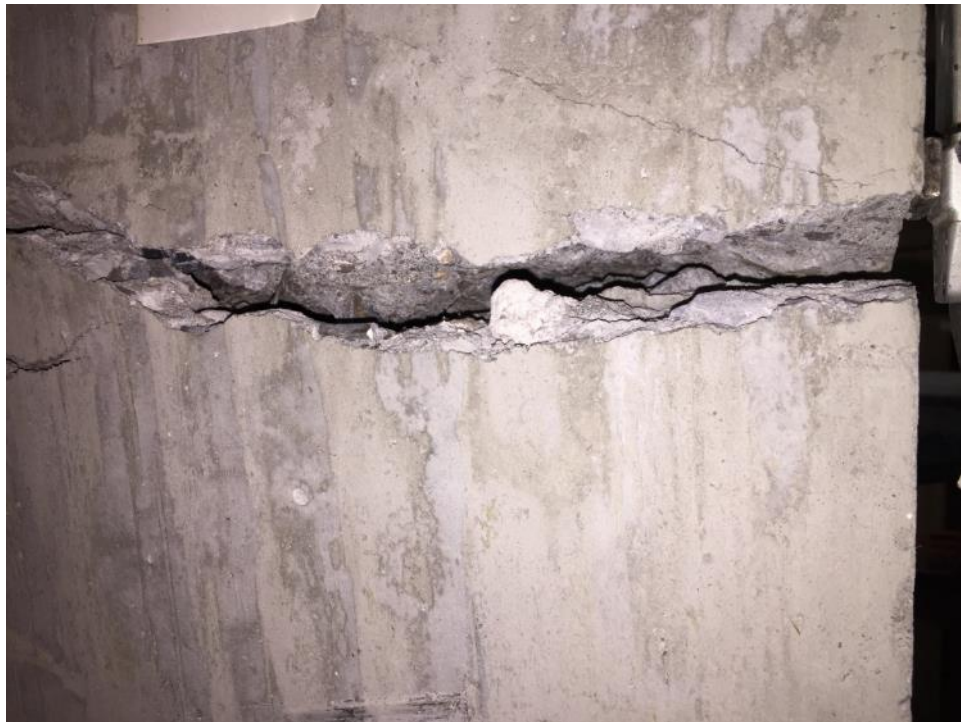
Figure 85. Crack in base concrete on south side from underneath

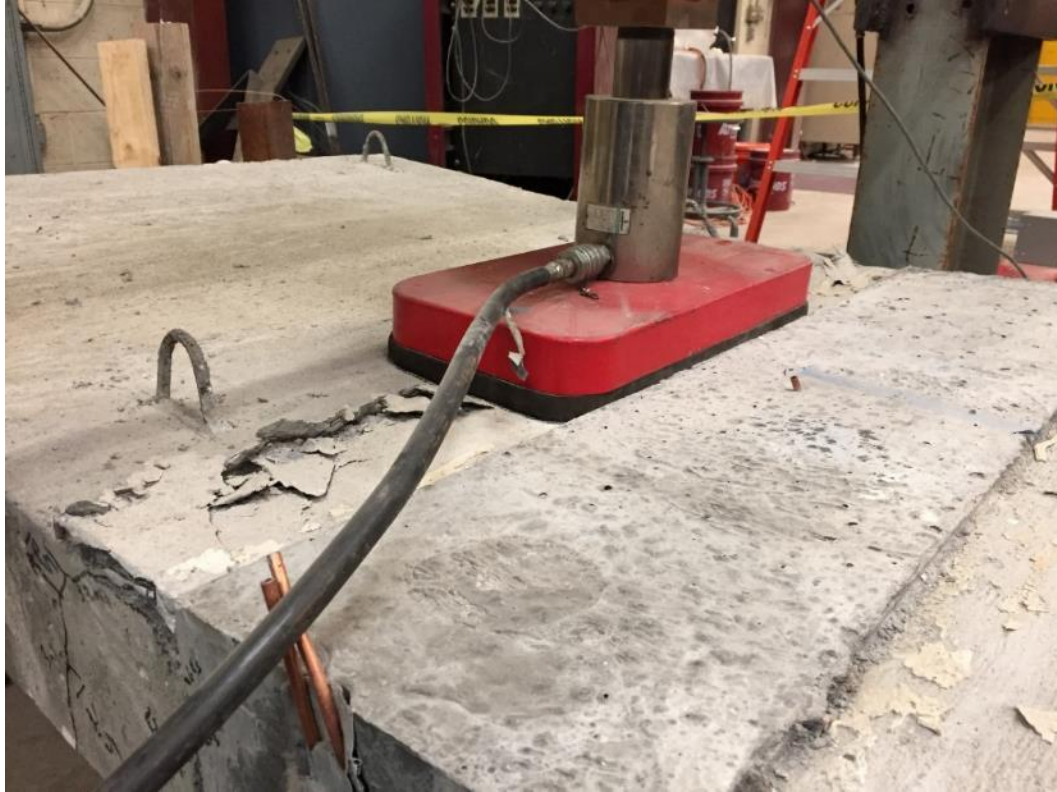
Figure 86. Crushing of concrete on top of slab after final static loading
