INVESTIGATION OF PLASTIC FILTER CLOTHS

Submitted to the Faculty of the Graduate College
of the Oklahoma State University
in partial fulfillment of the requirements
for the Degree of
MASTER OF SCIENCE
July, 1972

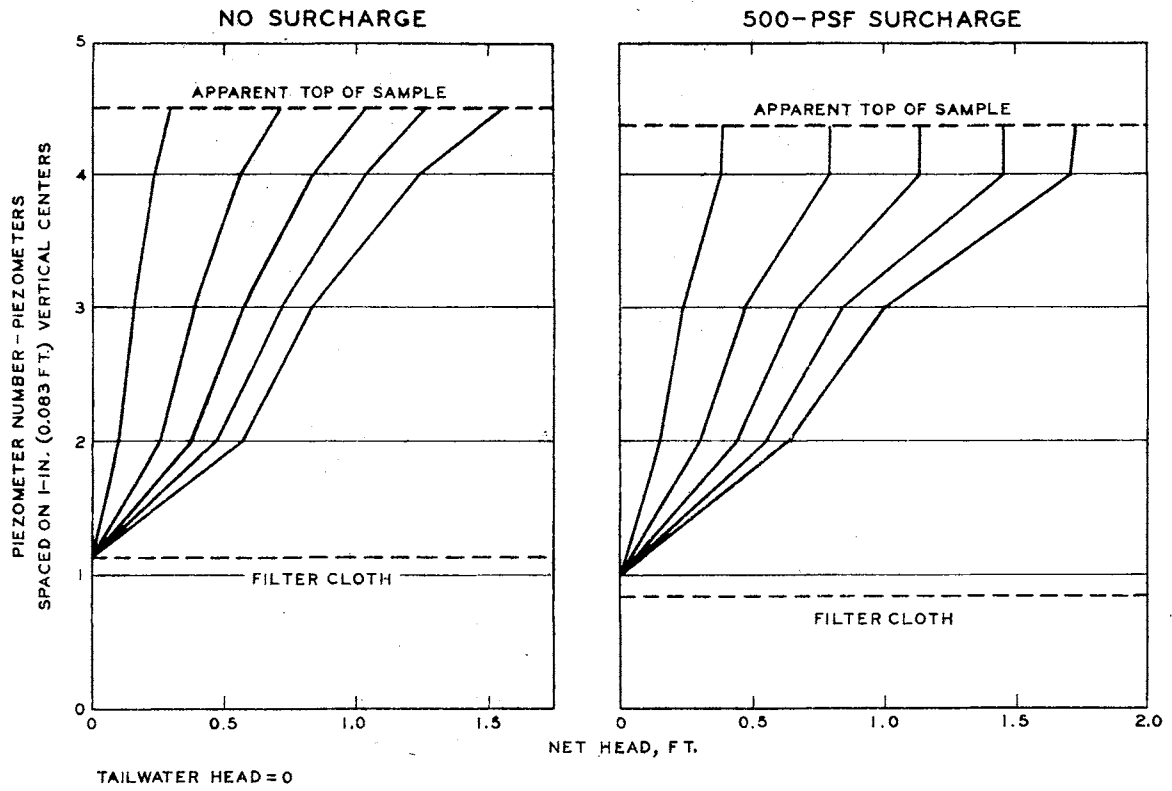
having been reinforced with steel bands, but the filter cloth separated from the aluminum ring to which it had been bonded and the test had to be terminated. In spite of the fact that 67 percent of the test sand could be washed through the filter cloth, there was no indication of infiltration of sand at any time during the filtration test (maximum water velocity = 0.15 ft./min.); the gradation of the material taken from the top of the sample at the end of the test was practically identical to that of the bottom. The condition of the cloth after testing was similar to that shown in Figure 11. There were no tears or punctures. Head losses through the sand and filter cloth under 0 and 500 lb./ft.² surcharge were plotted in Figure 12.

Figure 12. Head Losses Through Sample and Cloth B, Test 2

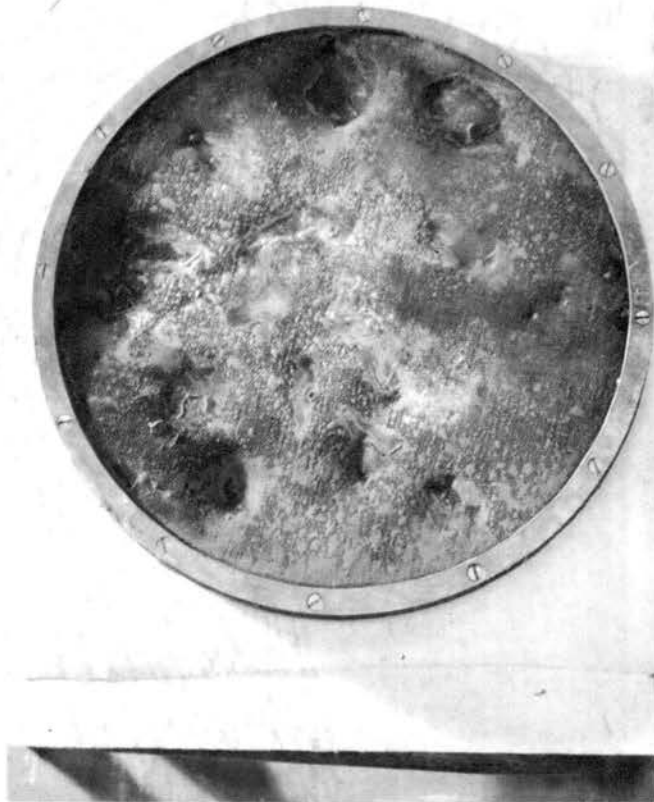
Figure 14. Cloth B After Completion of
Test 5 (Underside of Cloth)

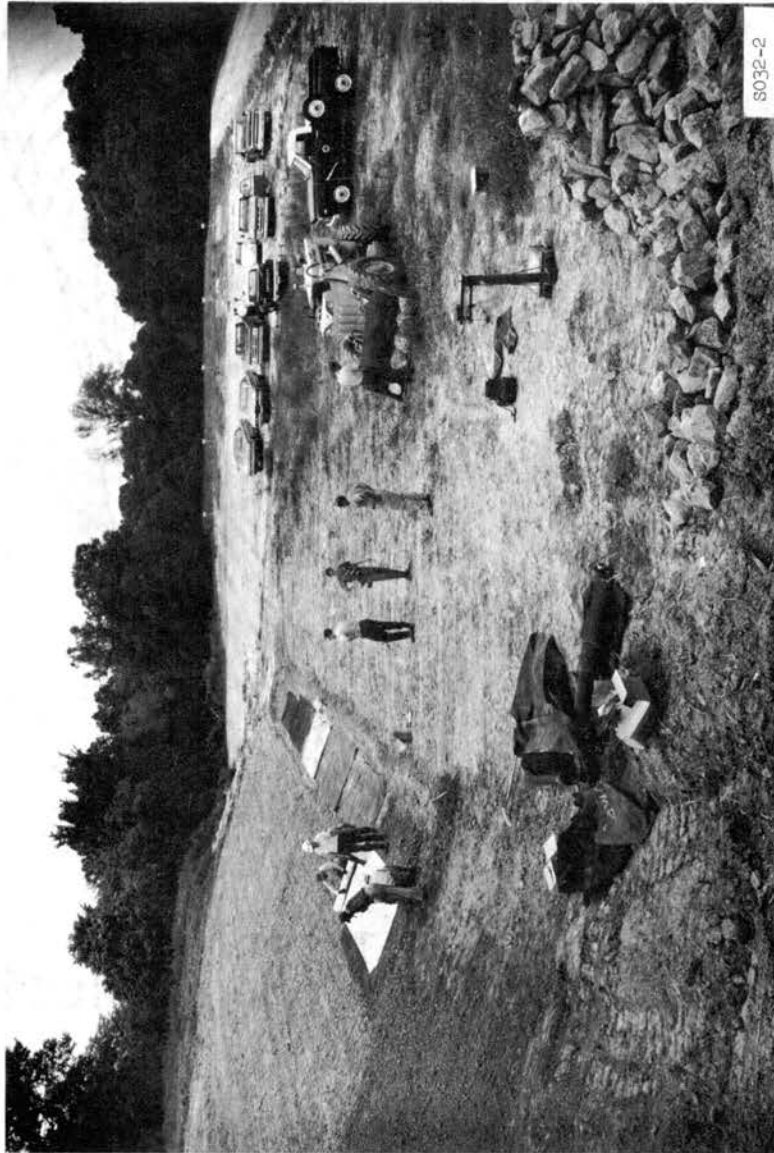
Figure 33 is a photograph of the test site. A loess bank was graded to a 1 on 3 slope for placement of the cloths. Initially, it was planned to loosen the upper 2 to 4 in. of the slope with a pulvimixer. However, it was found to be difficult for the pulvimixer to operate up and down the slope and to mix the material to a uniform depth. Also, the resulting surface was thought to provide too soft a bed. Consequently it was decided to simply hand rake the slope before placing the cloths, which provided a smooth uniform bed.

Figure 33. Overall View of Drop Test Site

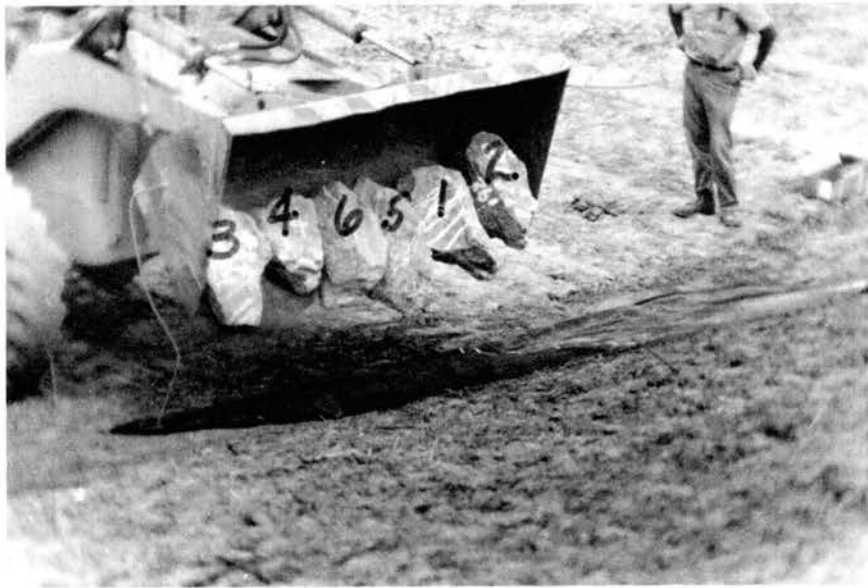
In the principal tests, six stones were dropped simultaneously from the bucket of a front-end loader. The weights of the chunky, rather angular stones were as follows:

Figure 34. Stones Being Dropped From Bucket

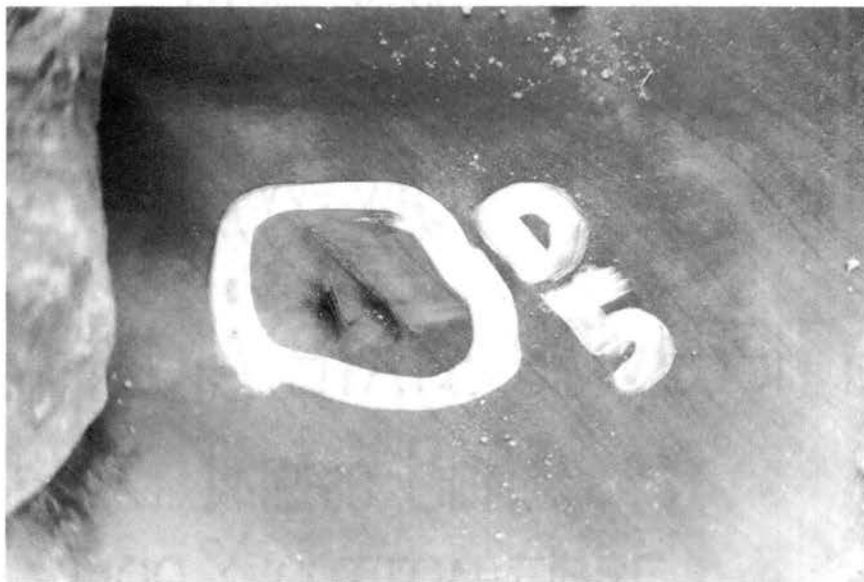
Figure 38. Cloth D, One and Two Inch Tears After
4.5 ft. Drop

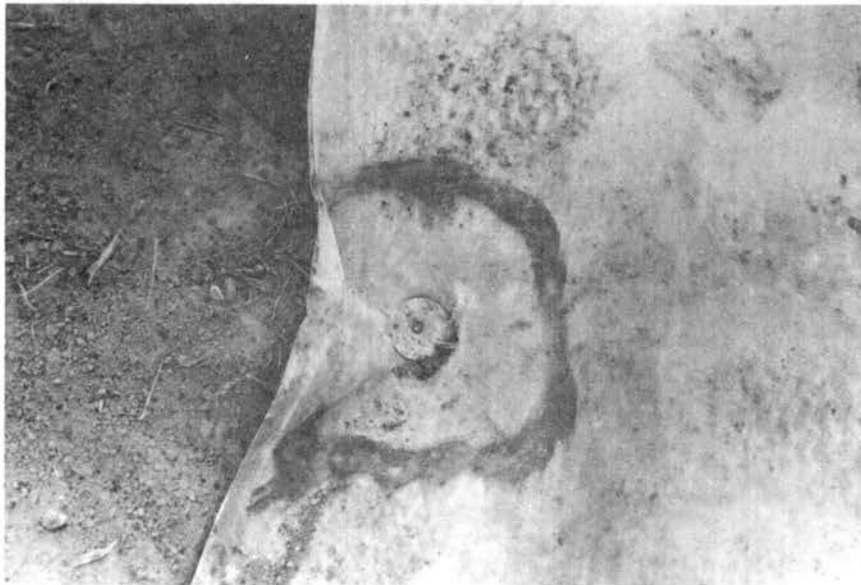
down the slope. It should be noted that the full bucket drop was conducted approximately one week after the other tests had been completed. Heavy rains had occurred during the interim period, and the soil on the slope was noticeably harder (even after raking) than during the previous tests. There were five tears in the cloth, resulting from the 4.5 ft. drop. Four of the tears were 1 to 1-1/2 in. long; however, the other tear was about three inches long and was caused by the 186 lb. stone (No. 3). In addition to these tears, one stone hit directly on top of a securing pin washer, and the washer cut the cloth around approximately 1/2 the circumference of the washer (Figure 39).

Figure 39. Cloth E, Tear Caused by Direct Hit of Stone on Securing Pin Washer

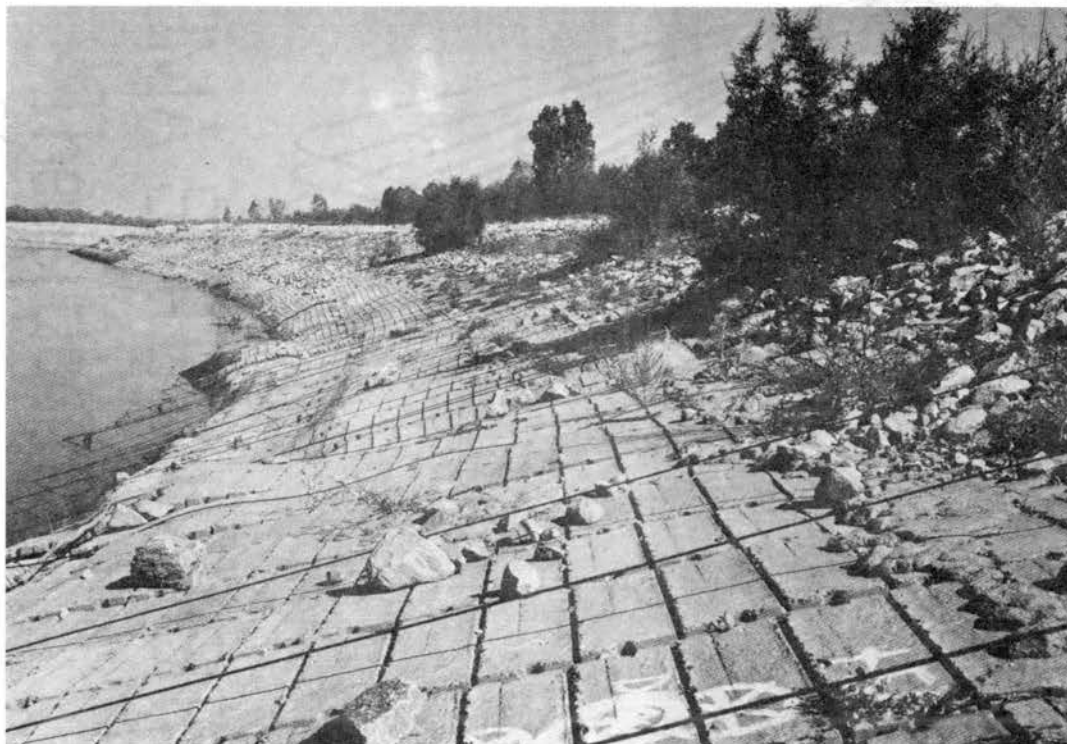
Figure 43. Island 63 Revetted Area Underlain With Filter Cloth
