FINAL REPORT ~ FHWA-OK-14-13

# DEVELOPMENT AND IMPLEMENTATION OF A MECHANISTIC AND EMPIRICAL DESIGN GUIDE (MEPDG) FOR RIGID PAVEMENTS — PHASE 2

M. Tyler Ley, Ph.D., P.E.  
Amir Hajibabaei  
Morteza Khatibmasjedi  
School of Civil and Environmental Engineering  
College of Engineering, Architecture and  
Technology  
Oklahoma State University

October 2014

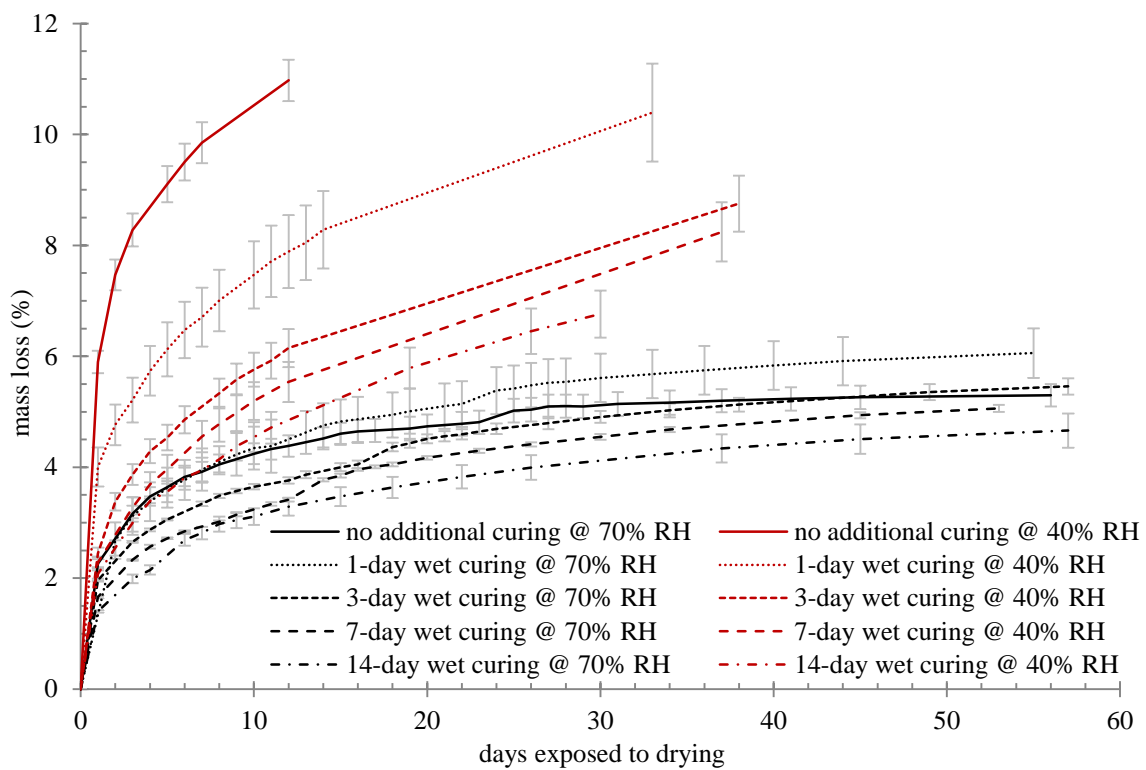
**Figure 3 - Comparison between the mass loss of the paste beams over the time**

The mass loss of the paste samples in 70% RH is shown in **Fig. 3** in comparison with that of the samples in 40%.

As shown above, the mass loss of the paste samples in 40% RH is greater than the samples that were exposed to 70% RH. The maximum mass loss of the no curing at 40% RH is the most and the least mass loss was observed in 14-day wet curing in 70% RH. Also, the difference between the mass losses of different curing

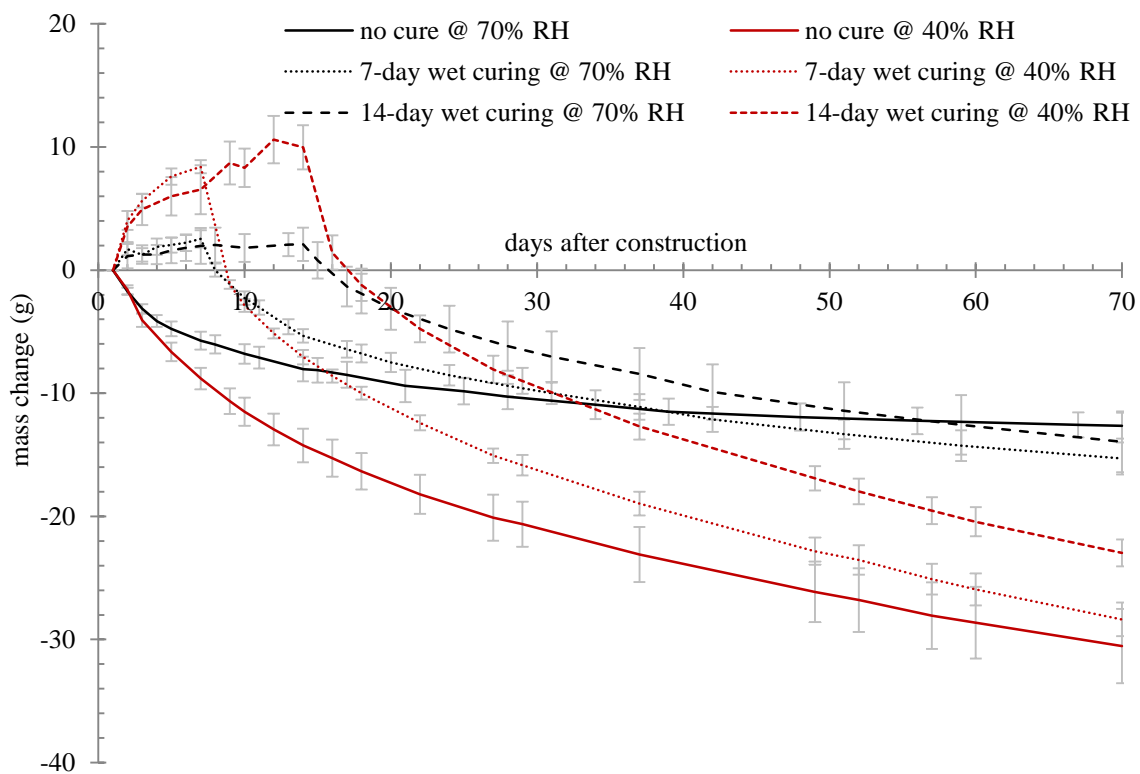
**Figure 5 - Comparison between the mass changes of concrete beams in 40% vs. 70% RHs**

The mass change of the concrete beams in the 40% versus 70% RH is shown in Fig. 5.

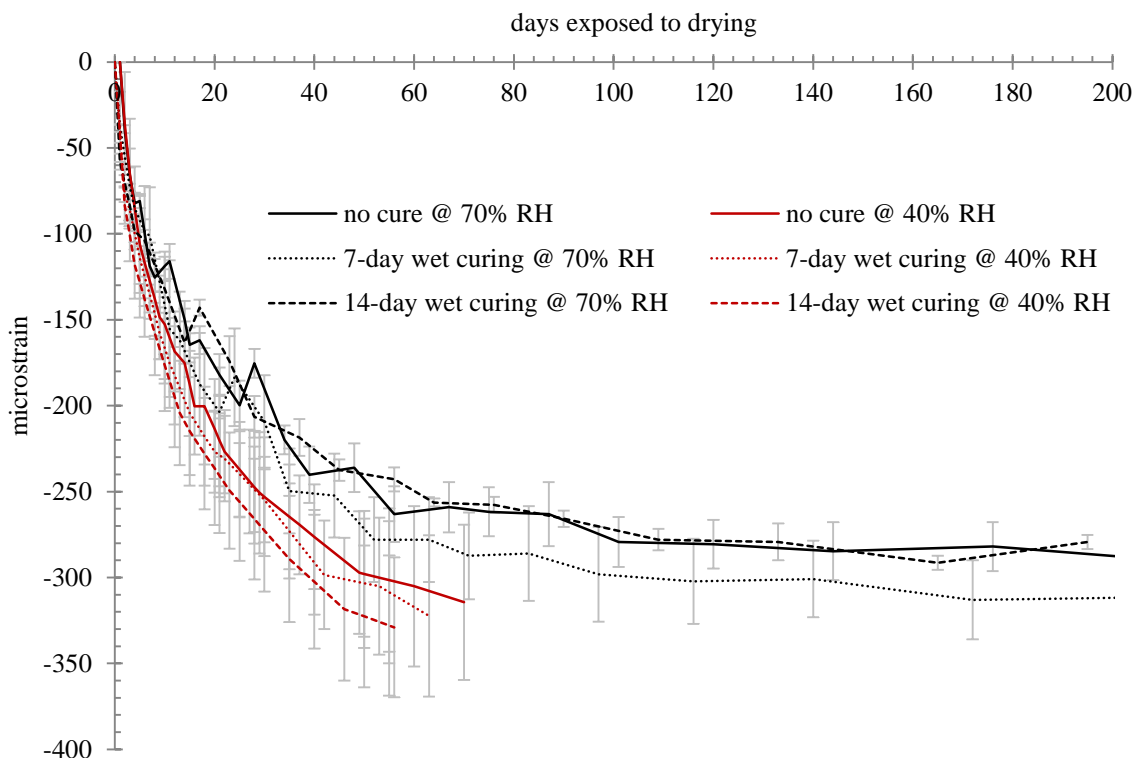
**Figure 7 - Comparison between the shrinkage profiles in 40% vs. 70% RH.**

The shrinkage of the concrete beams at 0.525" depth is shown in **Fig. 7** for 40% versus 70% RH. The shrinkage of the samples in 40% RH is greater and as the curing length was increased then so did the amount of shrinkage that occurred. The rate of shrinkage is greater during the initial drying for the 40% RH samples when compared to the 70% RH.

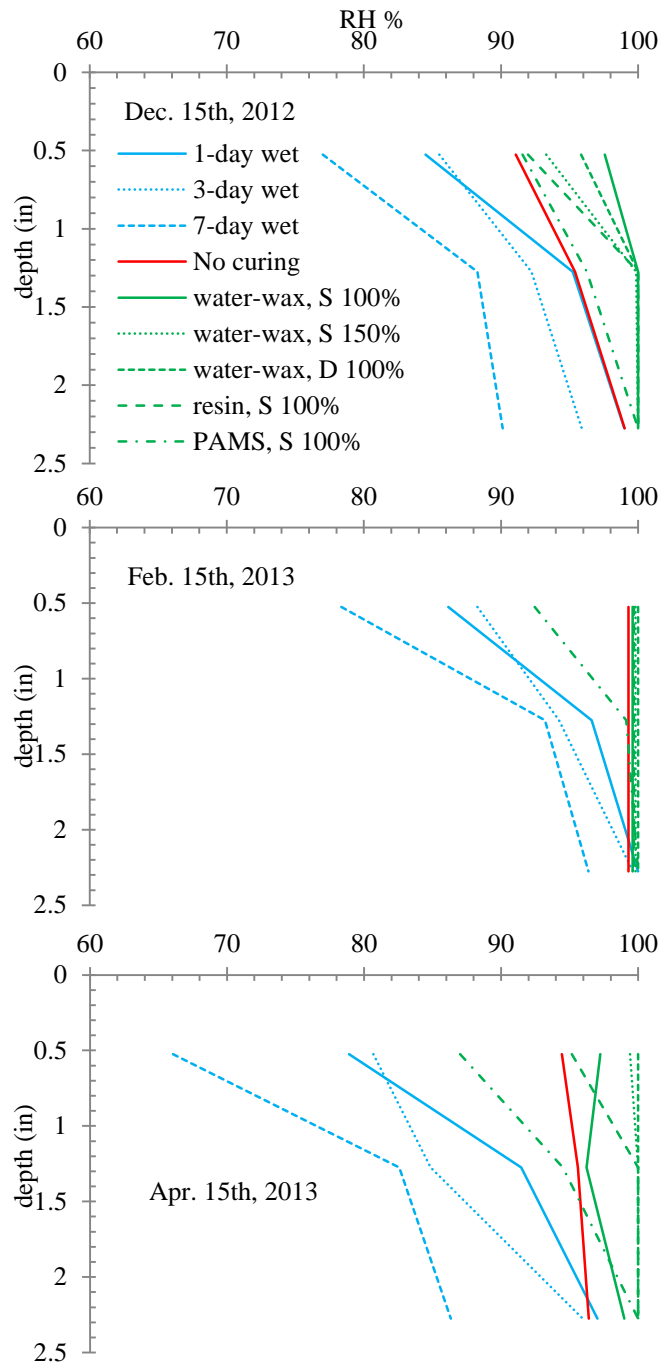
**Figure 14 - Average RH profiles for different curing methods**

**Figure 14** shows the RH profiles over the depth in the middle of three months December, February, and April.

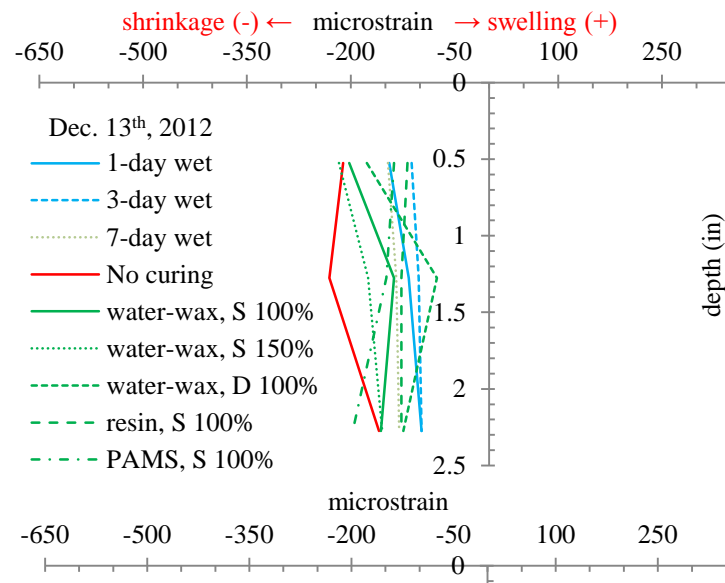
**Figure 16 - Average strain profiles for different curing methods**

**Figure 16** shows the strain profiles over the depth at every six months for the strain values modified with the thermal strain as mentioned above.

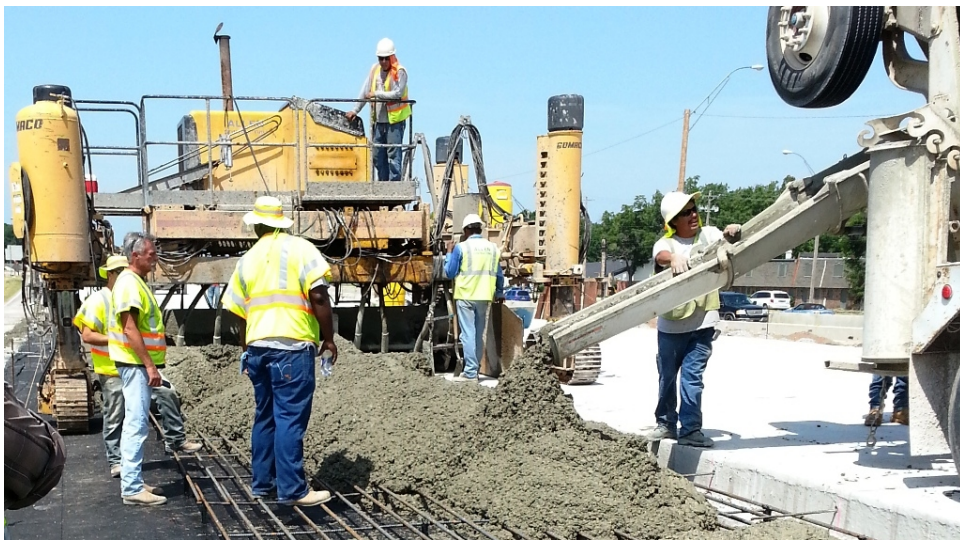
**Figure 17 - Casting the concrete pavement**

The goal of the research was to compare four different curing methods and the impact they have on the curling of concrete pavements. **Fig. 17** shows the truck mixer and the paver used on the project.

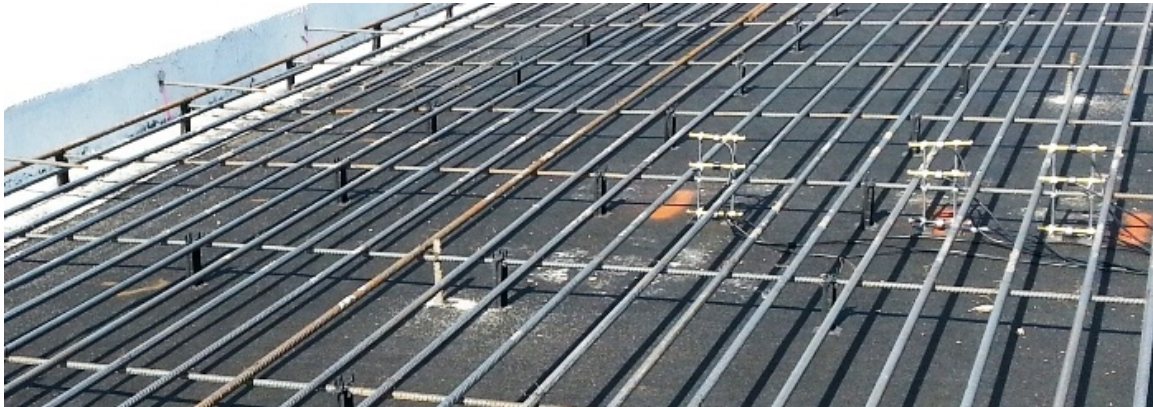
**Figure 22 - The strain gage locations for each curing method**

The gauges as placed in the pavement are shown in in **Fig. 22**.

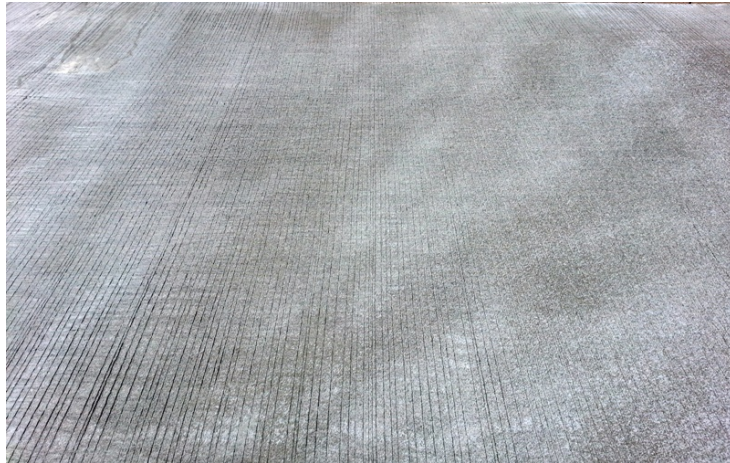
**Figure 23 - The water-wax based curing compound applied by the contractor approximately 30 minutes after paving**

Both of the curing compounds were manually applied to the surface of the pavement. The water-wax based curing compound was sprayed manually by the contractor and the PAMS was sprayed by the researchers. Examples of their sprayed surfaces is shown in **Fig. 23** and **24**. **Figure 25** shows the wet burlaps under the white plastic sheet to cure this section of the pavement for five days. After five days and before drilling, the curing was terminated and the burlaps were still moist. The last section of this field experiment was cured by using misting. This was done manually every hour for the first 24 hours after placement of the concrete.
